NATIONAL TRANSPORTATION SAFETY BOARD

Office of Research and Engineering
Materials Laboratory Division
Washington, D.C. 20594

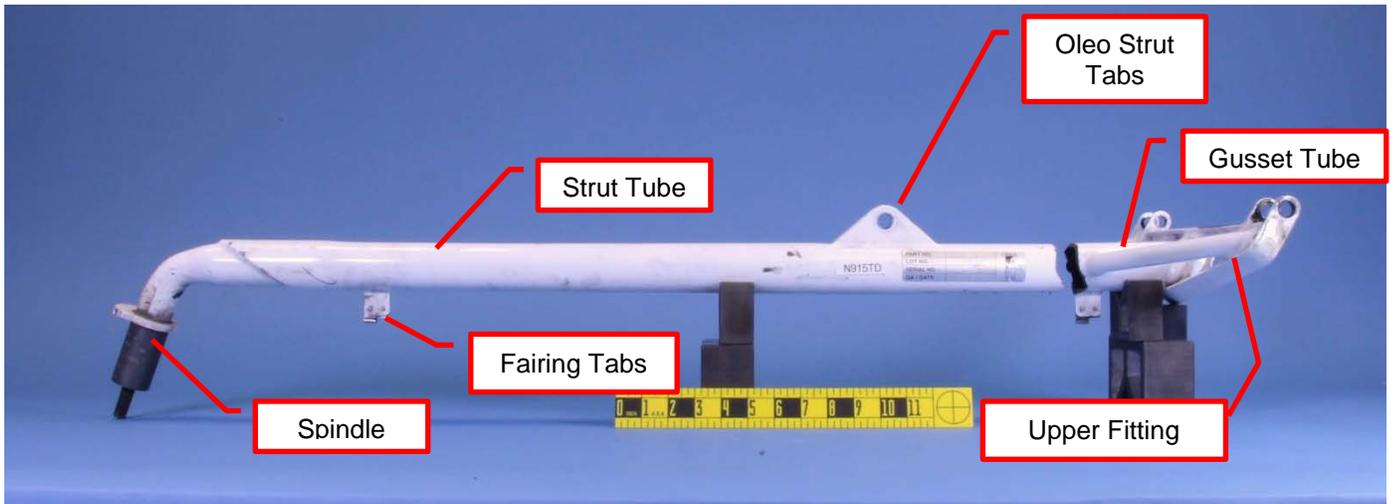
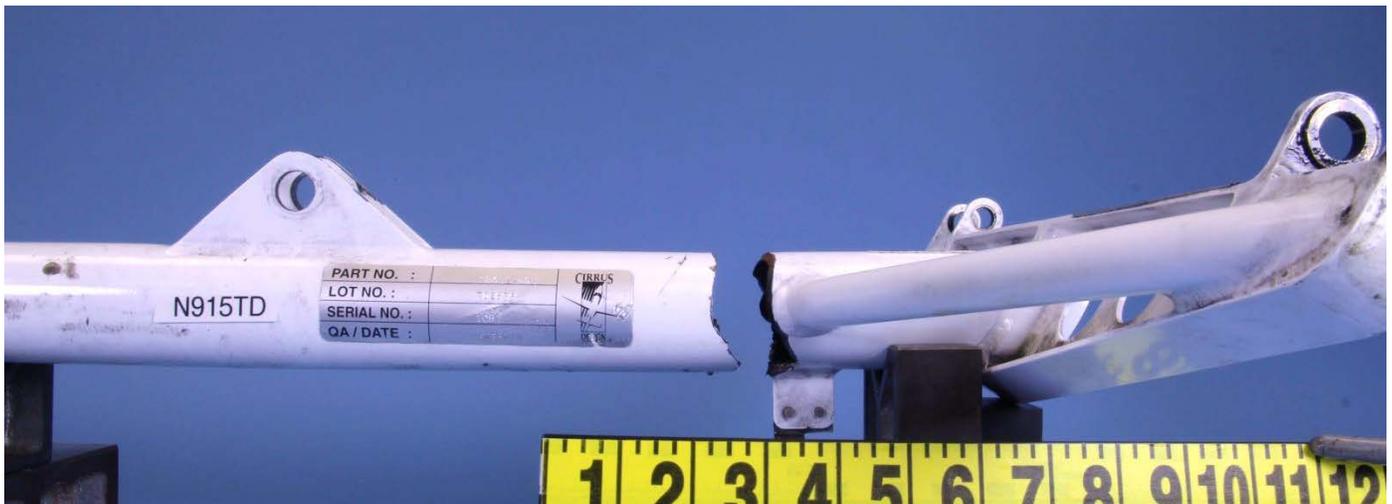
Figure 1. Left side views of the fractured strut assembly overall at top and closer view of the fracture area below. Aircraft forward at left.

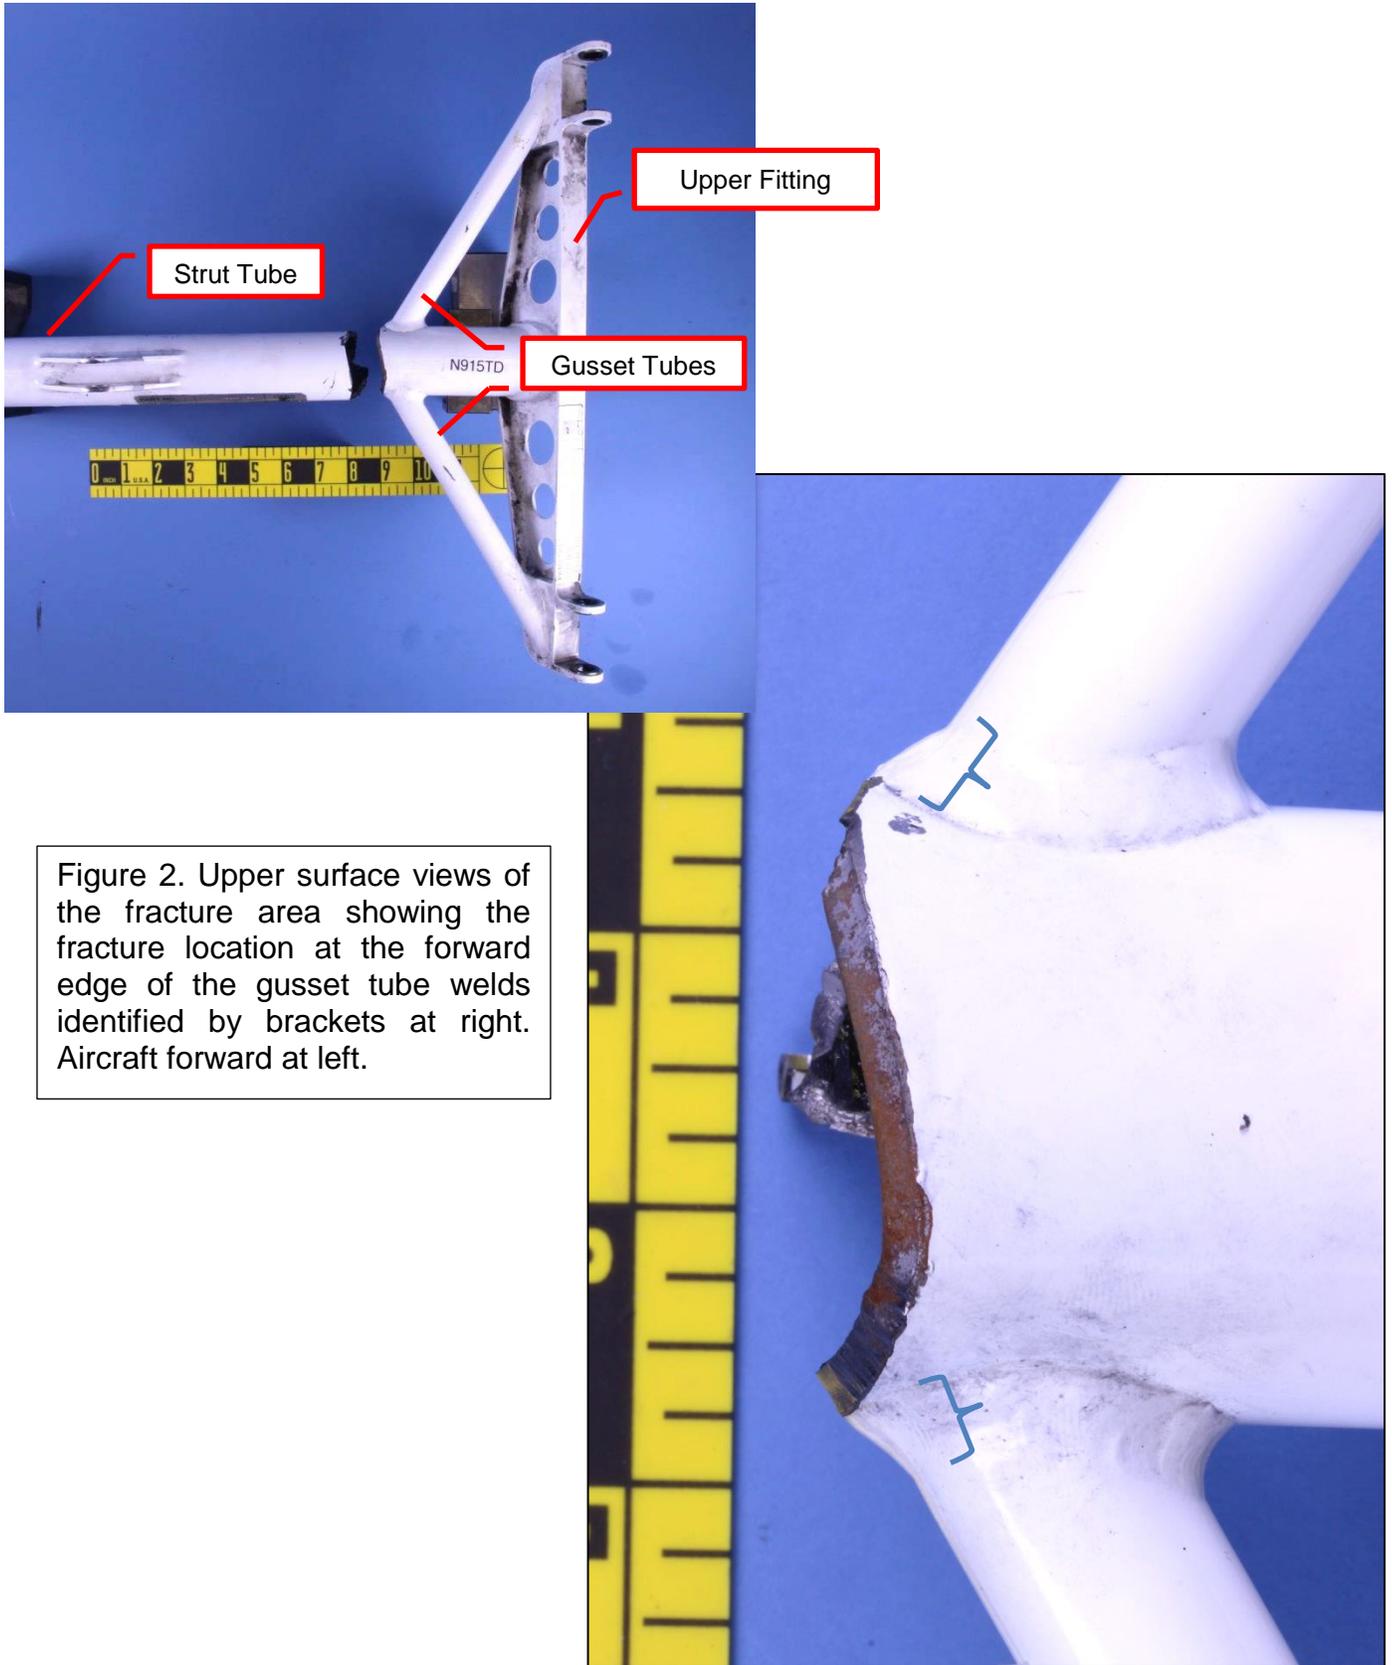
Figure 2. Upper surface views of the fracture area showing the fracture location at the forward edge of the gusset tube welds identified by brackets at right. Aircraft forward at left.

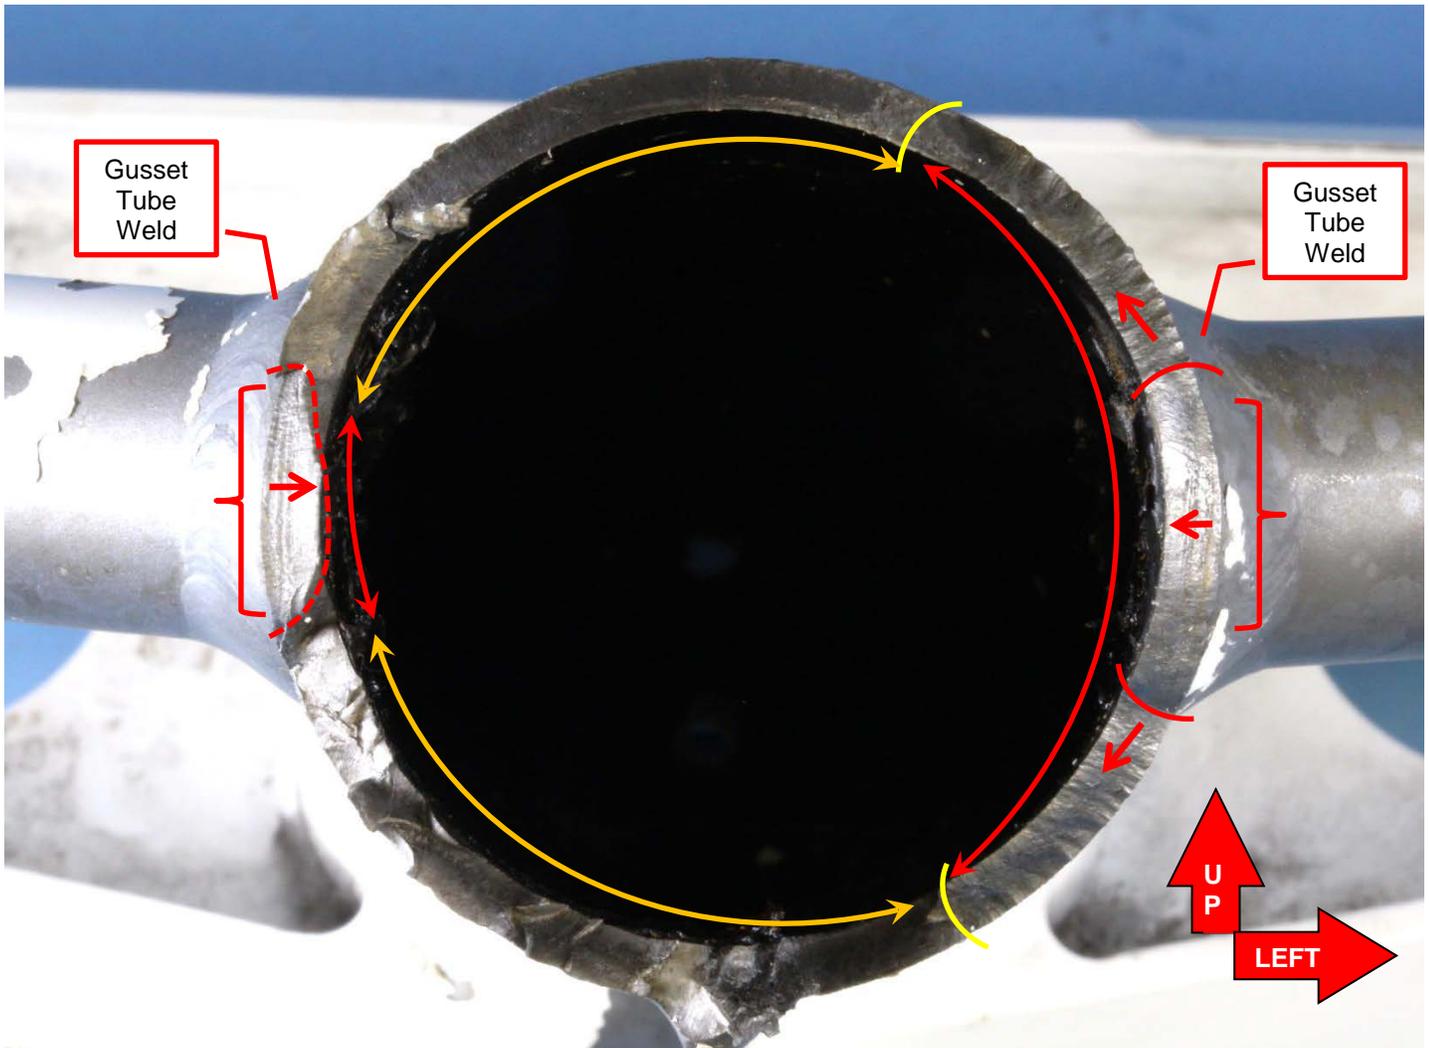
Figure 3. Looking aft at the fracture face. Double headed red arrows denote the reflective regions and orange arrow the overstress areas. Red brackets denote initiation locations of through the wall crack portions at the toes of the gusset tube welds. Circumferential extensions (two directions) of the left crack are between the red and yellow arcs. Arrows indicate local crack propagation directions.

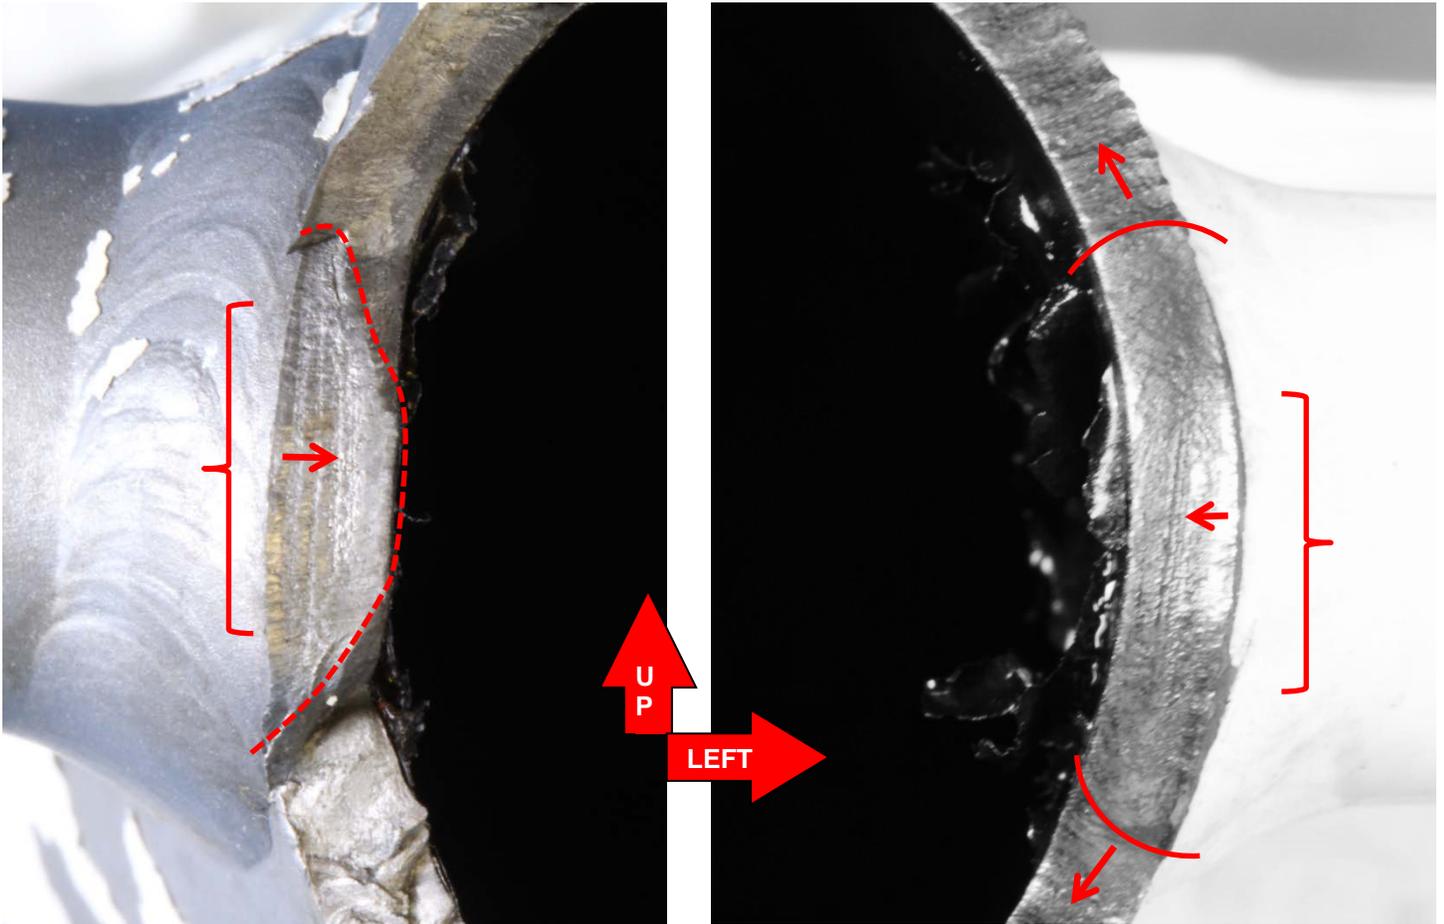
Figure 4. Closer views of the left and right crack initiations and through the wall penetration showing the crack arrest markings. Arrows indicate local crack propagation directions.

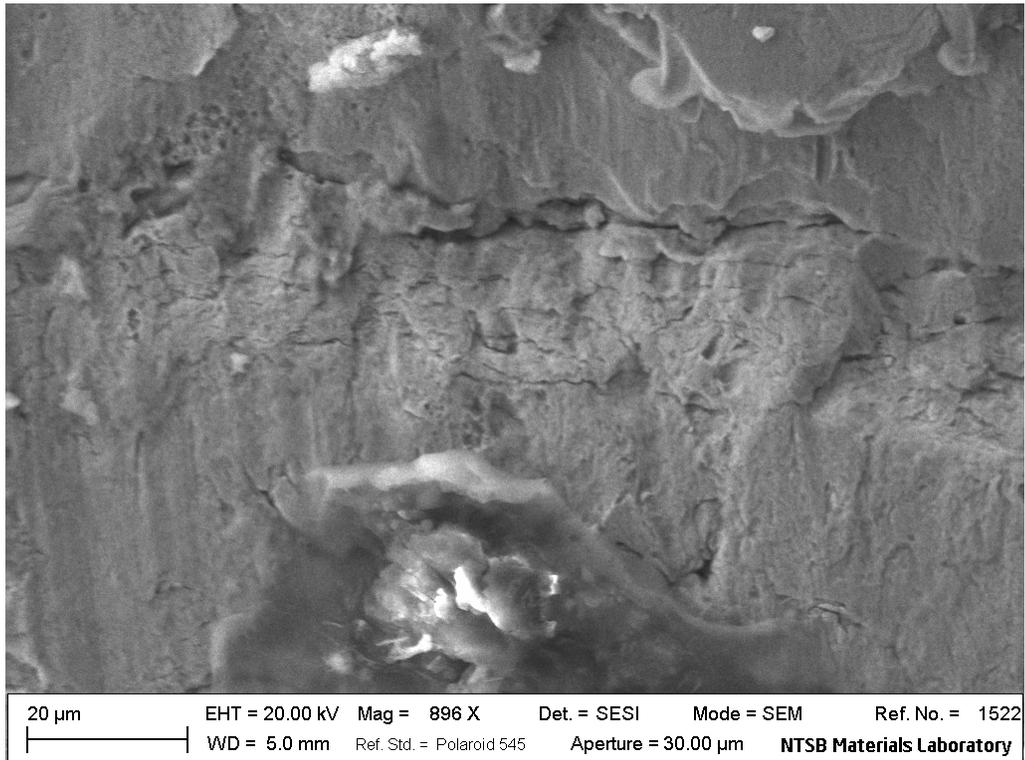
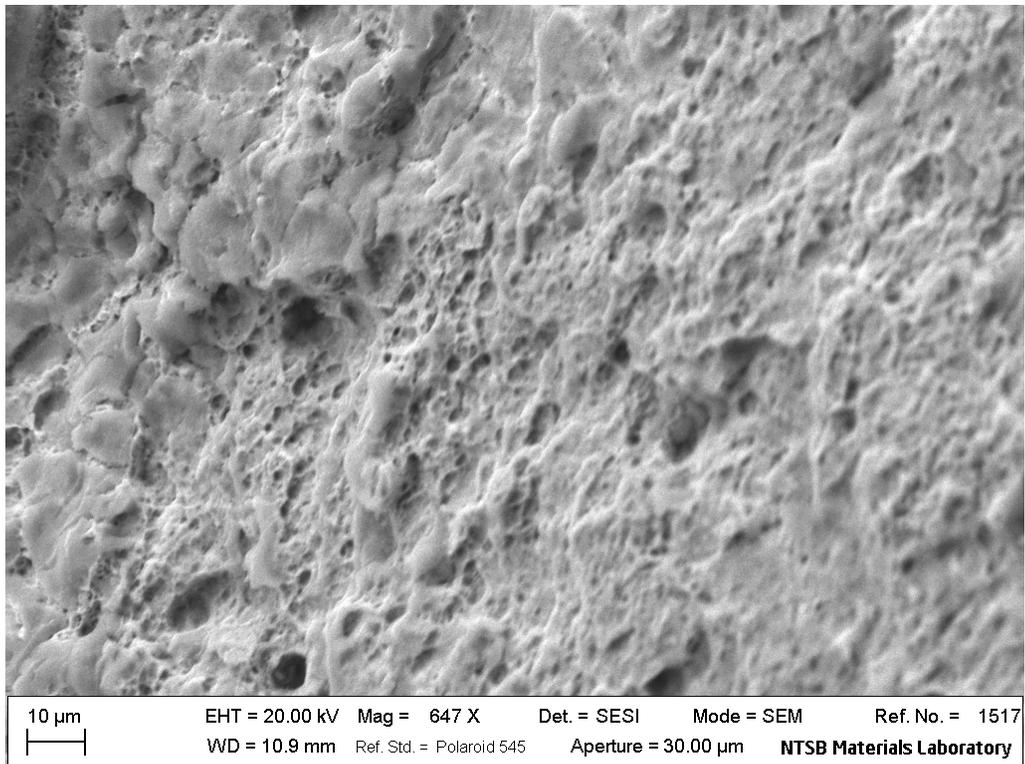
Figure 5. At top an SEM image showing a band of striations indicative of high stress fatigue propagation in the through the wall region of the left reflective band. The lower view displays typical ductile dimples uncovered about midway in the circumferential propagations of the left reflective region.

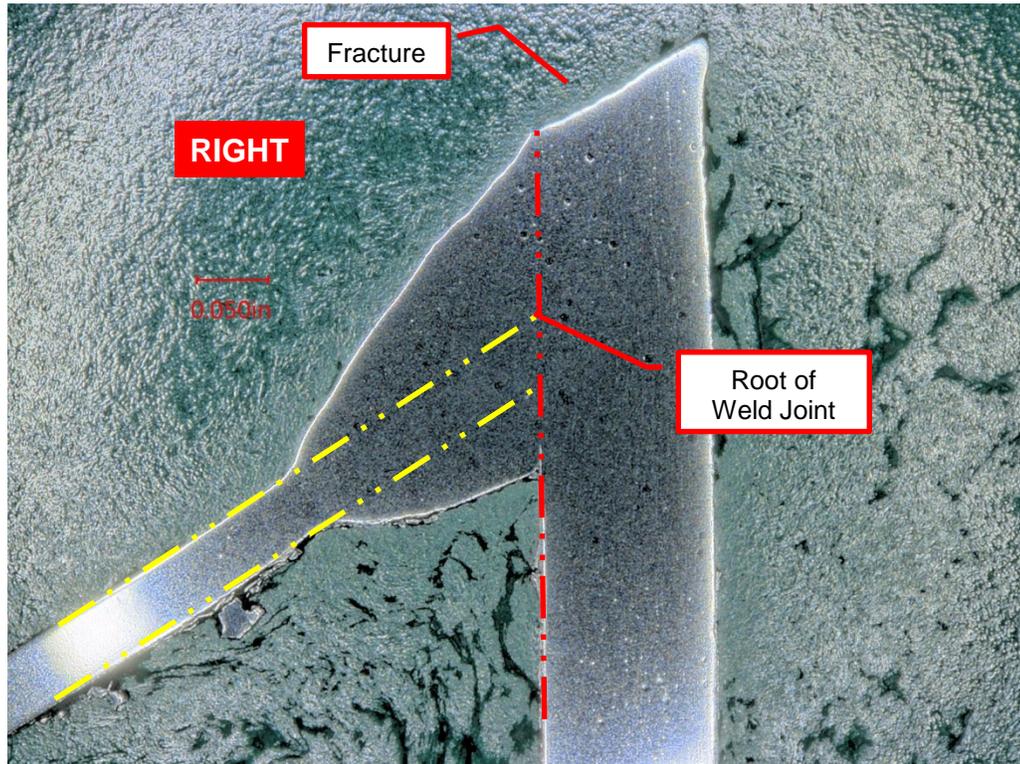
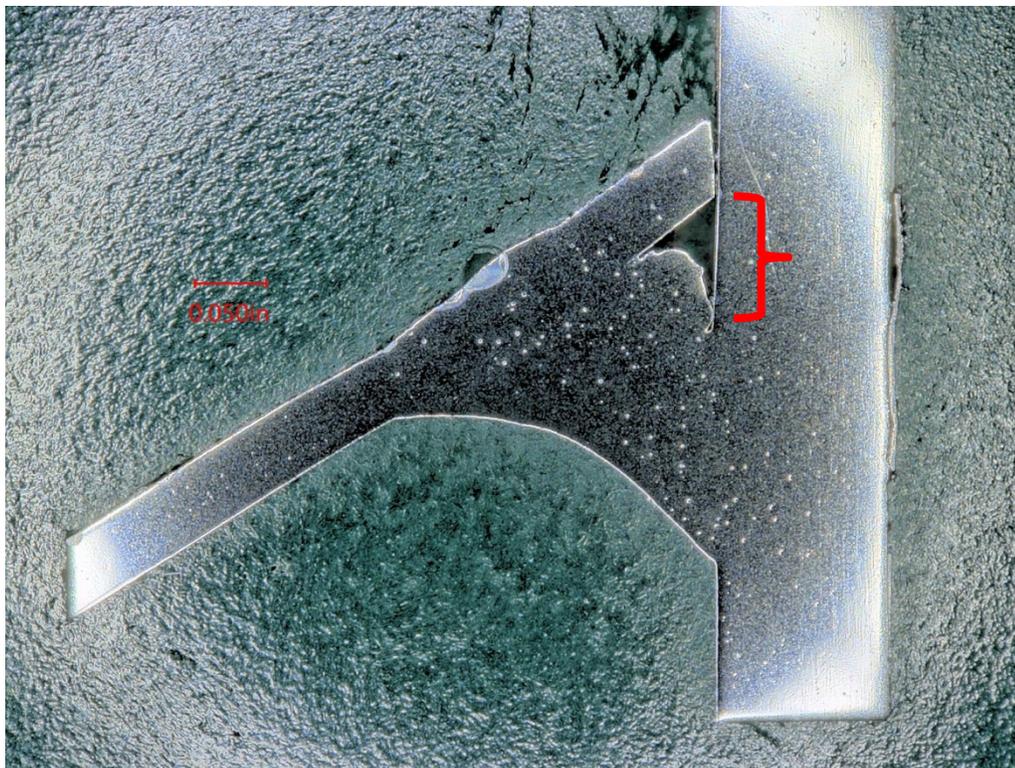
Figure 7. Metallographic views of the forward and aft portions of the fillet weld on the right gusset tube weld. Forward portion at top shows more than 100% root penetration. Yellow and red lines denote the approximate original gusset and strut tube surfaces. Note the slant profile of the fracture plane at top. Lower view shows the aft portion of the weld with the red bracket denoting the area of incomplete root penetration.

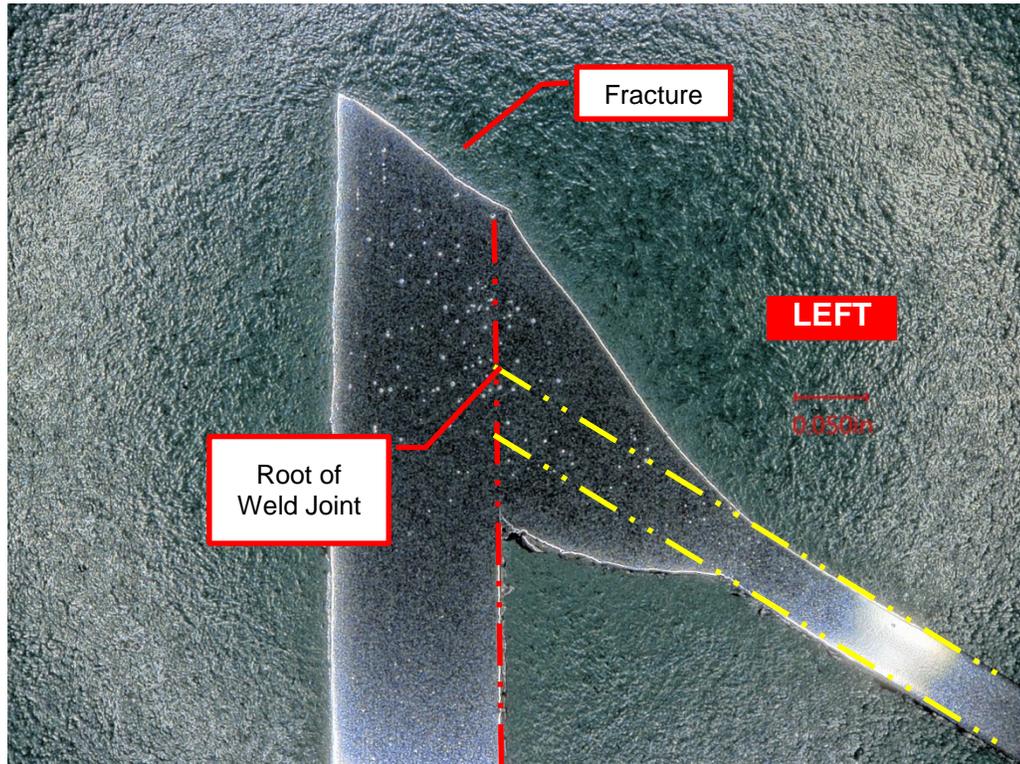
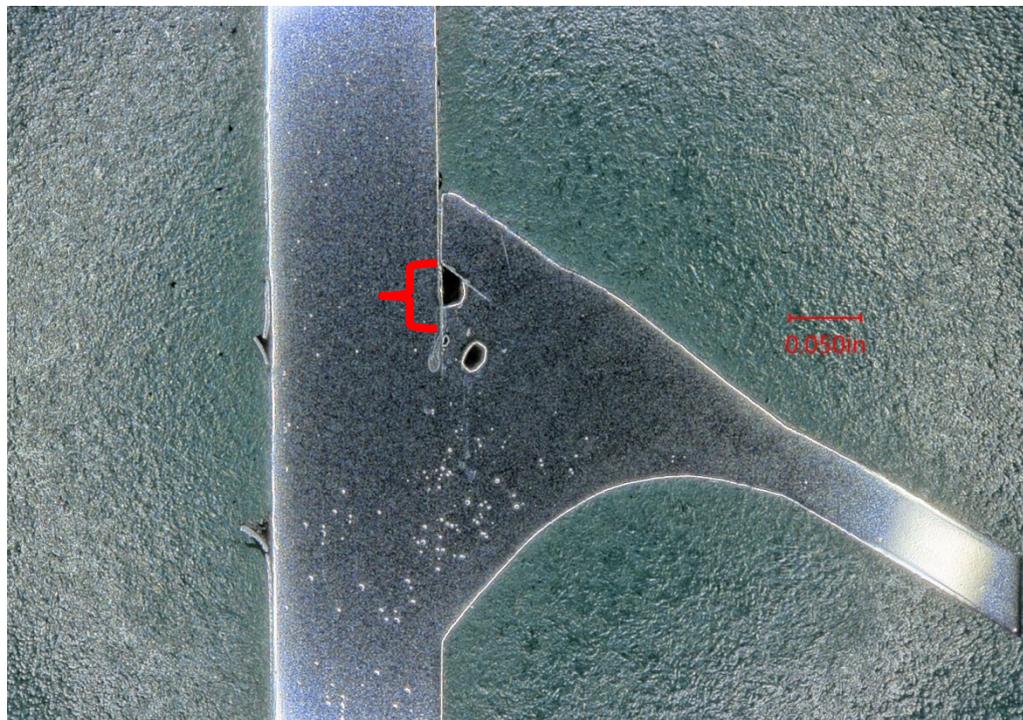
Figure 8. Metallographic views of the forward and aft portions of the fillet weld on the left gusset tube weld. Forward portion at top shows more than 100% root penetration. Yellow and red lines denote the approximate original gusset and strut tube surfaces. Note the slant profile of the fracture plane at top. Lower view shows the aft portion of the weld with the red bracket denoting the area of incomplete root penetration.

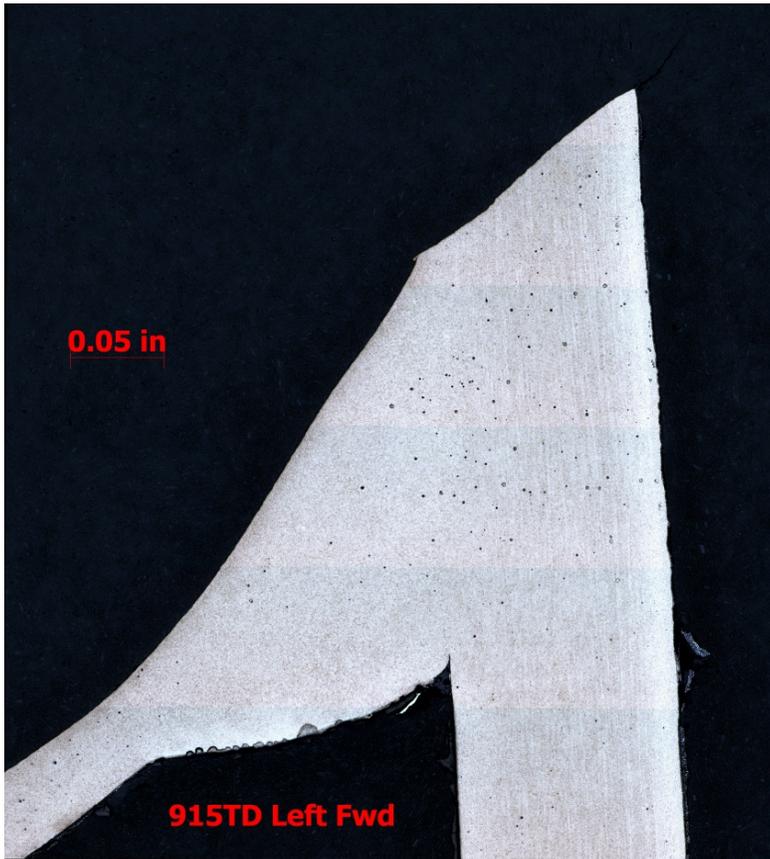
Figure 10. The etched microstructures of the forward welds of the left (top) and right gusset tubes showing a fully martensitic microstructure except at inner diameter of strut tube. See Figure 11. Images mirrored from figures above.

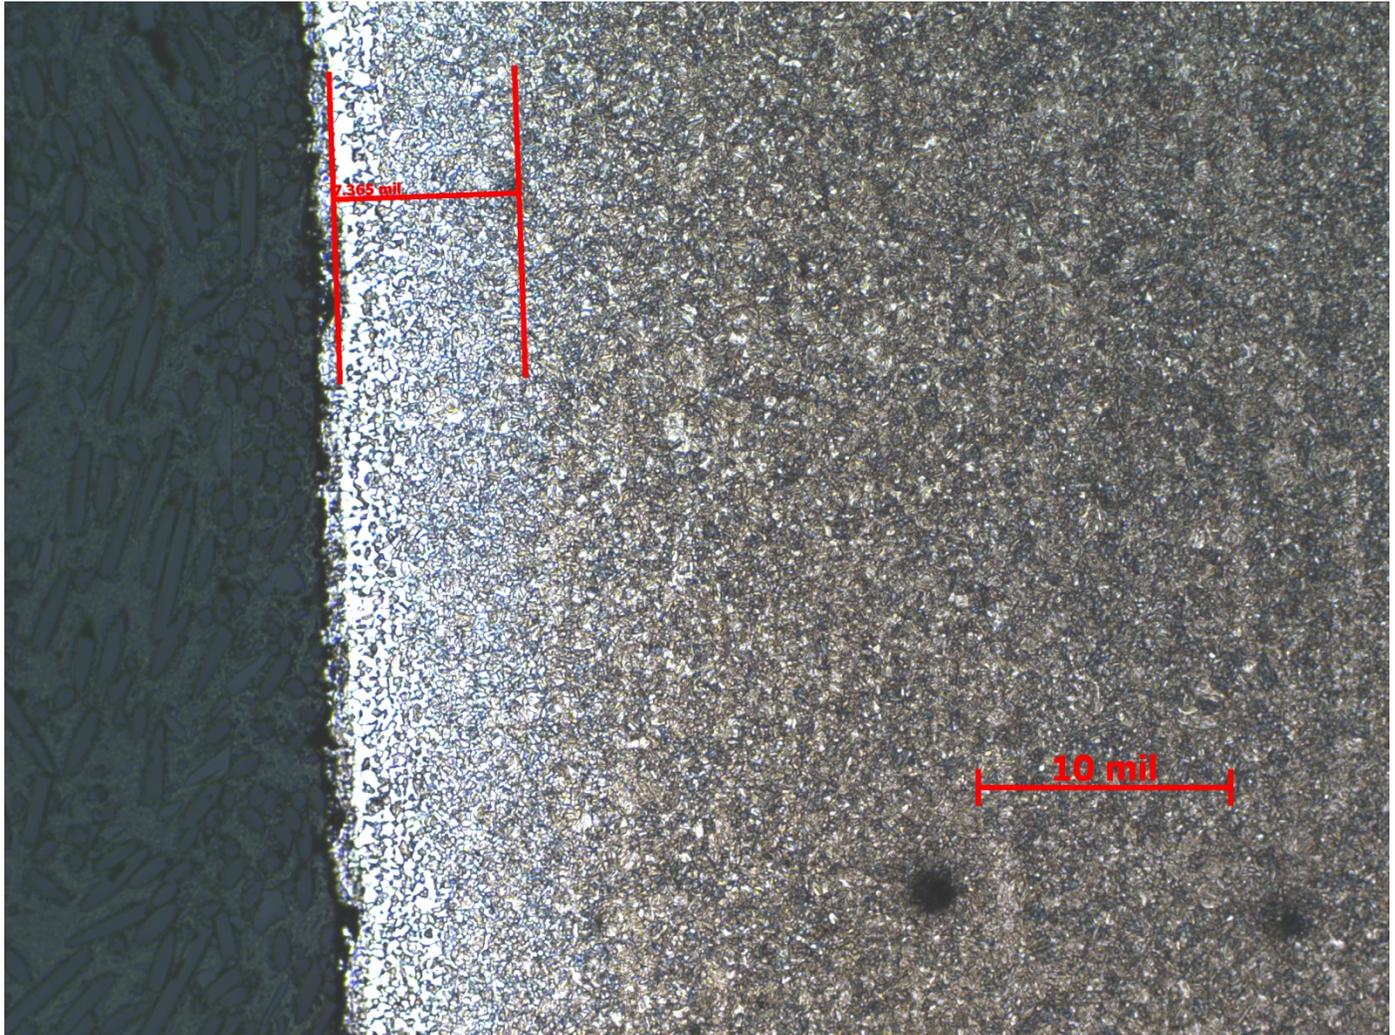
Figure 11. Closer view showing decarburized layer at inner diameter surface of strut tube. Visually measured about 0.007 inch at this location.
