# NATIONAL TRANSPORTATION SAFETY BOARD

MATERIALS LABORATORY FACTUAL REPORT

Report No. 16-013

Place : Paso Robles, California  
Date : November 7, 2015  
Vehicle : Cirrus SR22T, N999VX  
NTSB No. : WPR16IA025  
Investigator : Kristi Dunks, AS-WPR

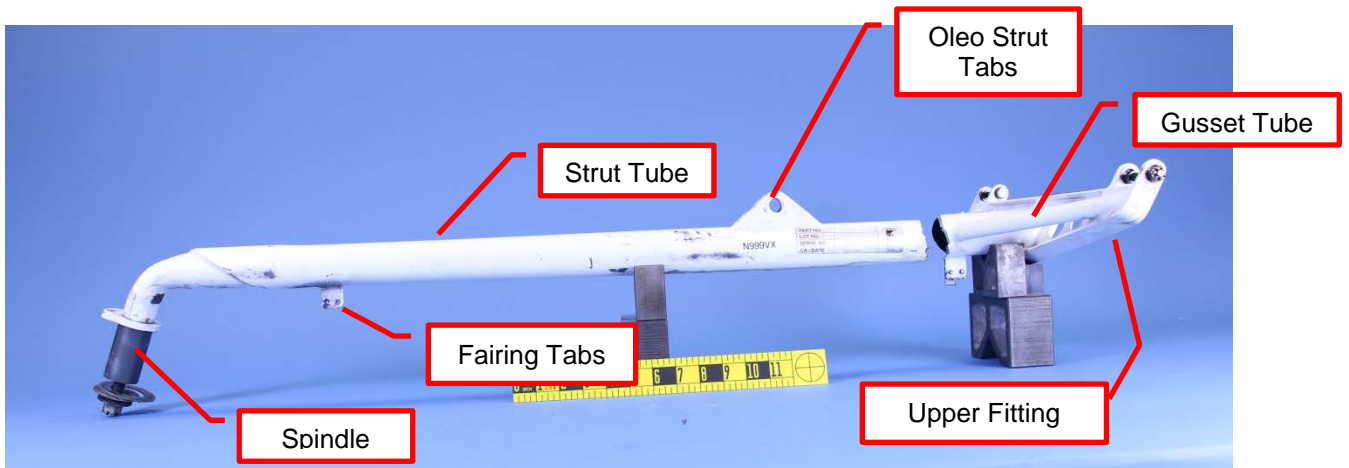
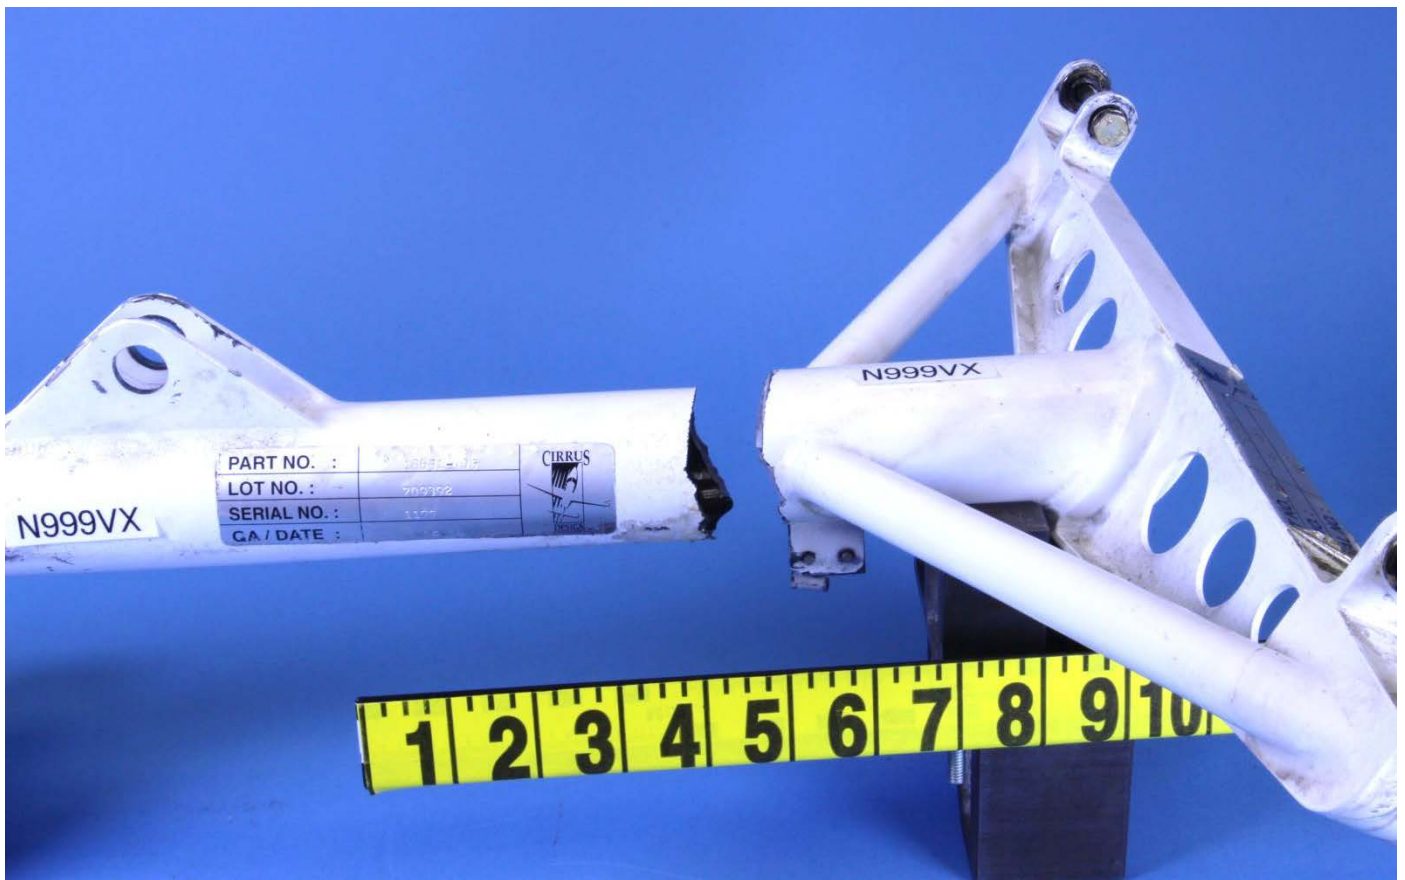
The as-received nose landing gear (NLG) strut assembly was fractured through the strut tube adjacent to the forward edge of the gusset tube attachment welds. The fractured assembly is displayed from the left side in figure 1 and from the top in figure 2. The label affixed to the strut tube indicated the part number as 18631-405, from lot 709392 with serial number 1177 and a QA date of 8/19/14. A representative of Cirrus Aircraft indicated that this lot had contained 12 total strut assemblies.

Figure 1. Left side views of the fractured strut assembly overall at top and closer view of the fracture area below. Aircraft forward at left.

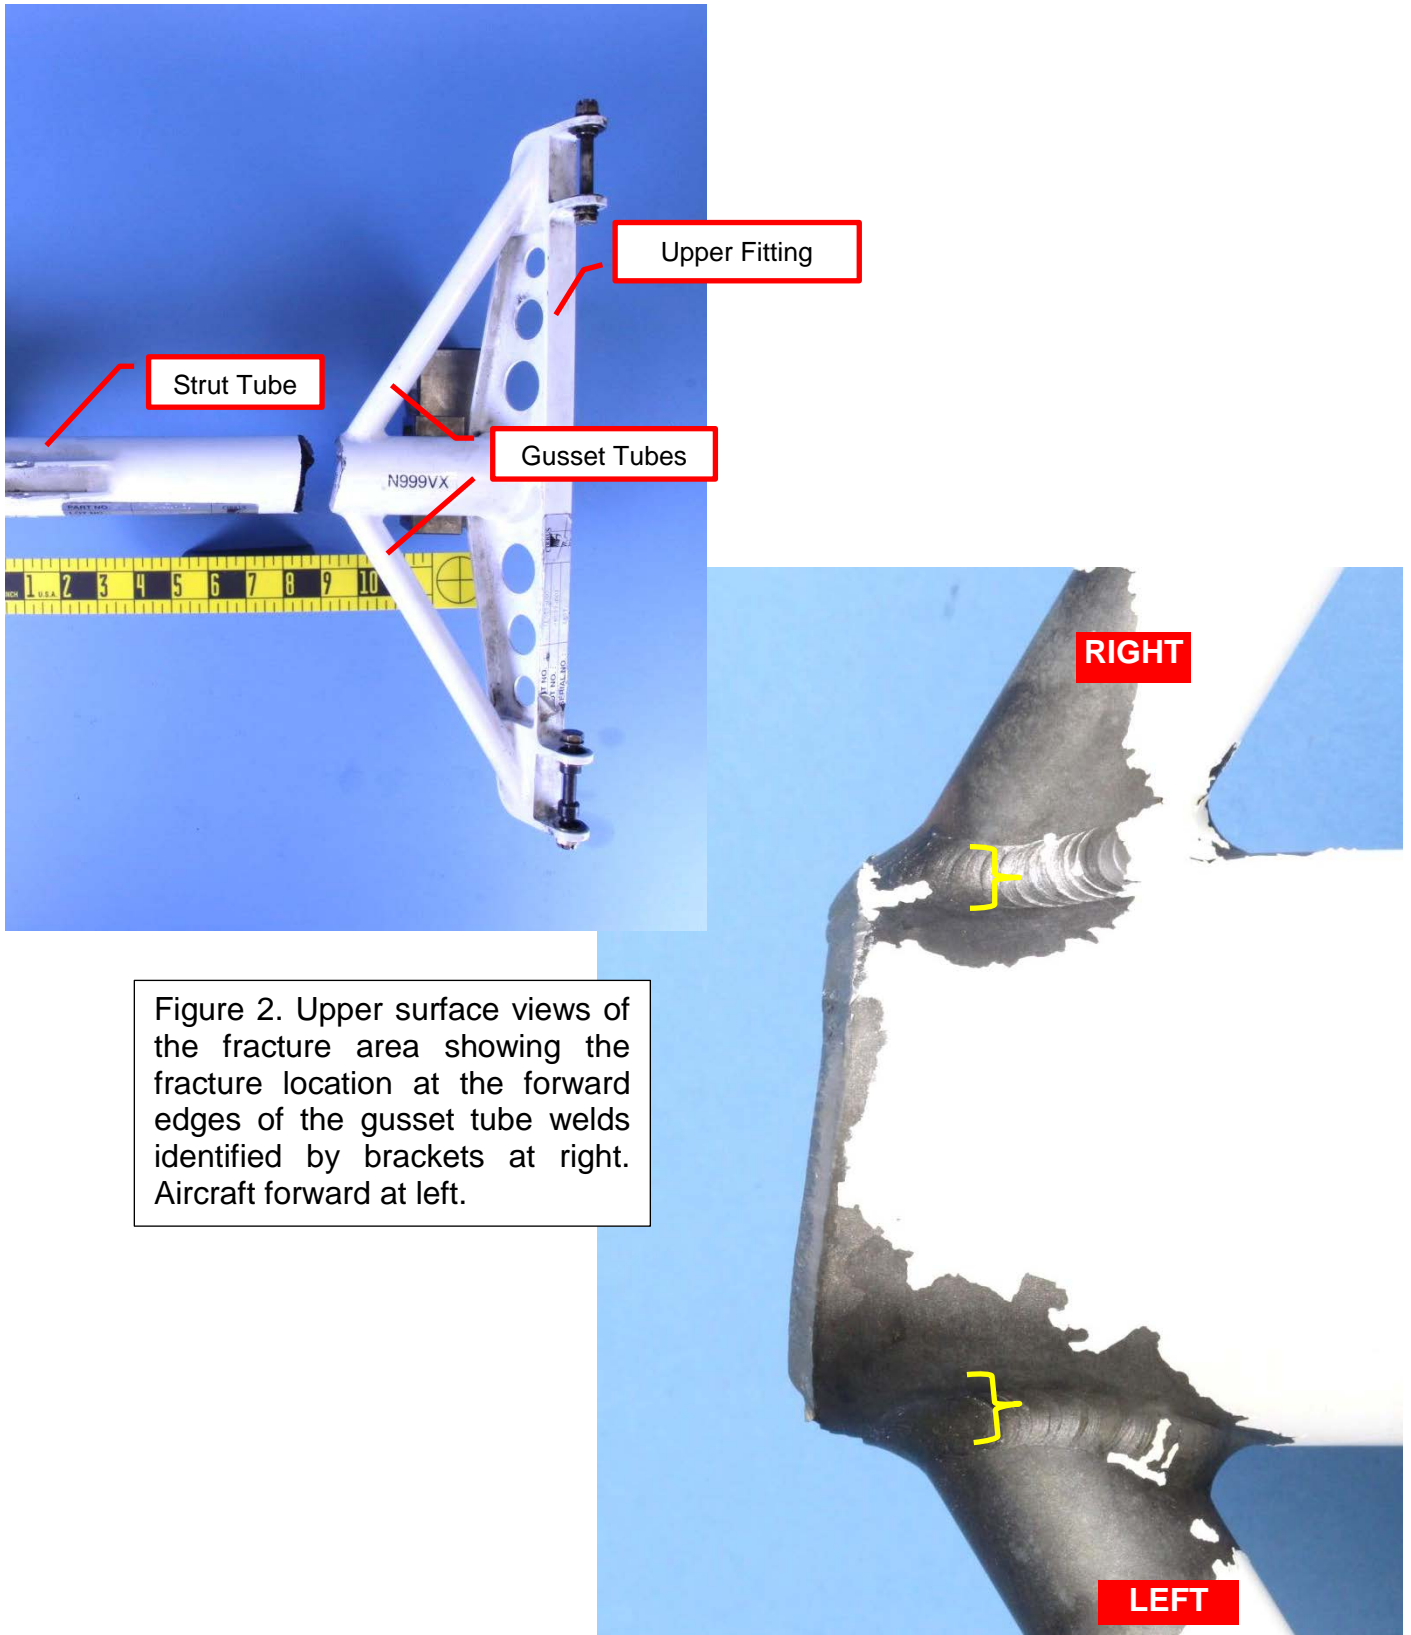
As shown in figure 2, the fracture through the strut tube was located at the forward edges (toes) of the gusset tube welds to the strut tube. Visual examinations of the fracture faces found multiple fracture regions on multiple fracture planes with various features within each region as identified on the aft fracture face displayed in figure 3. All of the fracture regions were oriented on slanted planes through the wall thickness of the strut tube.

Figure 2. Upper surface views of the fracture area showing the fracture location at the forward edges of the gusset tube welds identified by brackets at right. Aircraft forward at left.

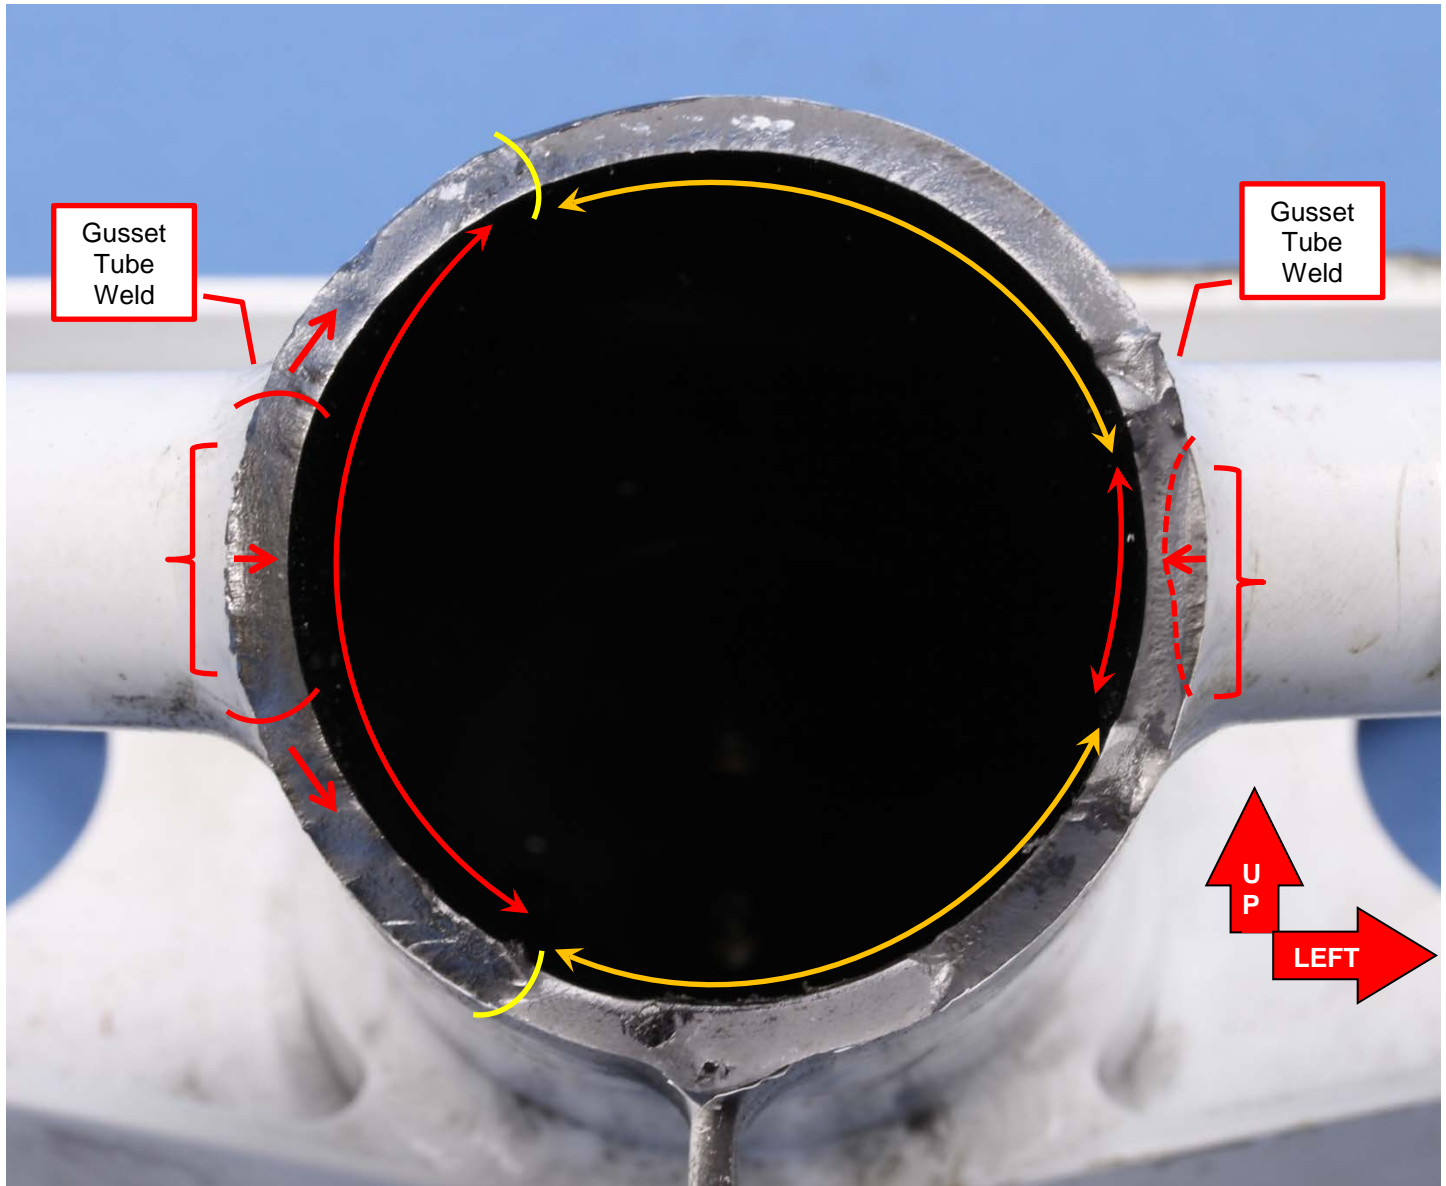
Most prominent, were opposed reflective (shiny) regions at the right and left sides of the fracture, as denoted in figure 3. Both shiny regions were approximately centered at the weld intersections of the respective gusset tubes with the strut tube. Magnified stereoscopic examinations revealed wide spread and extensive mechanical surface damage within these regions consistent with repeated mutual crack face recontact damage during crack closure. The damage was indicative of preexistent cracks present prior to total strut separation.

The reflective region on the right side (image left) of the strut measured approximately 2.2 inches around the circumference of the strut tube. Crack arrest markings visible in the left side image of figure 4, indicated initial through the wall propagation from the forward toe of the right side gusset tube weld bead. The through the wall penetration area was on an approximate 45 degree plane through the strut tube wall. At the margins of the through the wall area fracture (red arcs in figures 3 and 4) markings indicated circumferential progress in both the upward and downward directions as denoted by arrows in figure 3 and the left view of figure 4.

Figure 3. Looking aft at the aft fracture face. Double headed red arrows denote the reflective regions and orange arrows the overstress areas. Red brackets denote initiation locations of through the wall crack portions at the toes of the gusset tube welds. Circumferential extensions (two directions) of the right crack are between the red and yellow arcs. Arrows indicate local crack propagation directions.

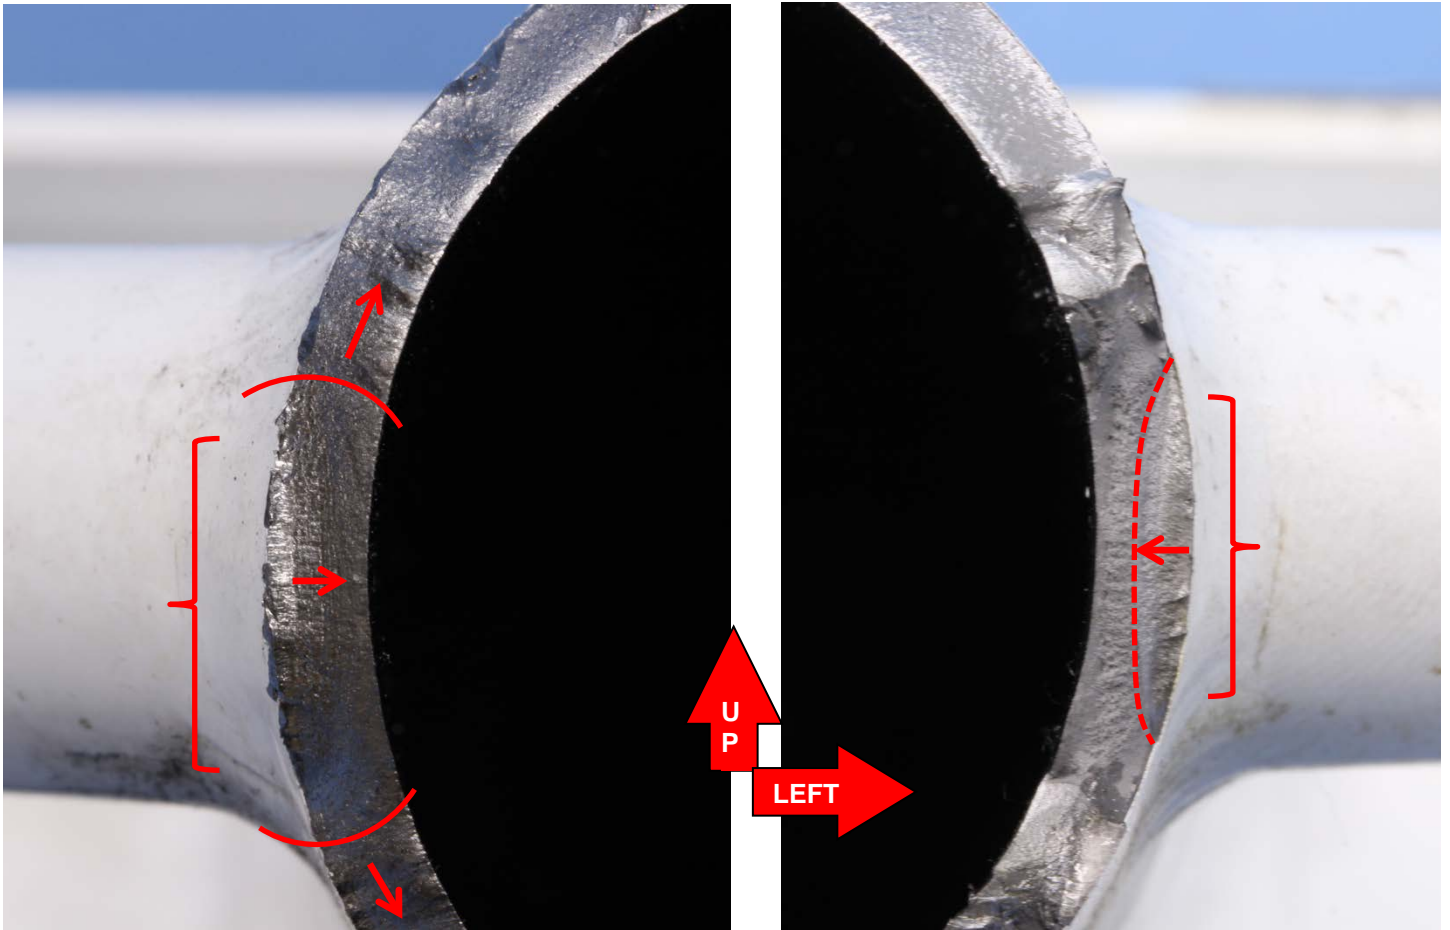
The left side reflective region (image right) was much smaller measuring only 0.5 inch circumferentially. Similar to the right side, fracture markings indicated through the wall thickness crack penetration from the forward toe of the respective gusset tube weld bead. However, unlike the right side region, the crack area did not penetrate through the strut wall (terminus denoted in figure 4 by dashed red line) and no circumferential progression was noted on the right side.

Figure 4. Closer views of the left and right crack initiations and through the wall portions. Arrows indicate local crack propagation directions. Arcs denote the approximate extent of the through the wall portion of the right regions. The terminus of the left region is indicated by the dashed line.

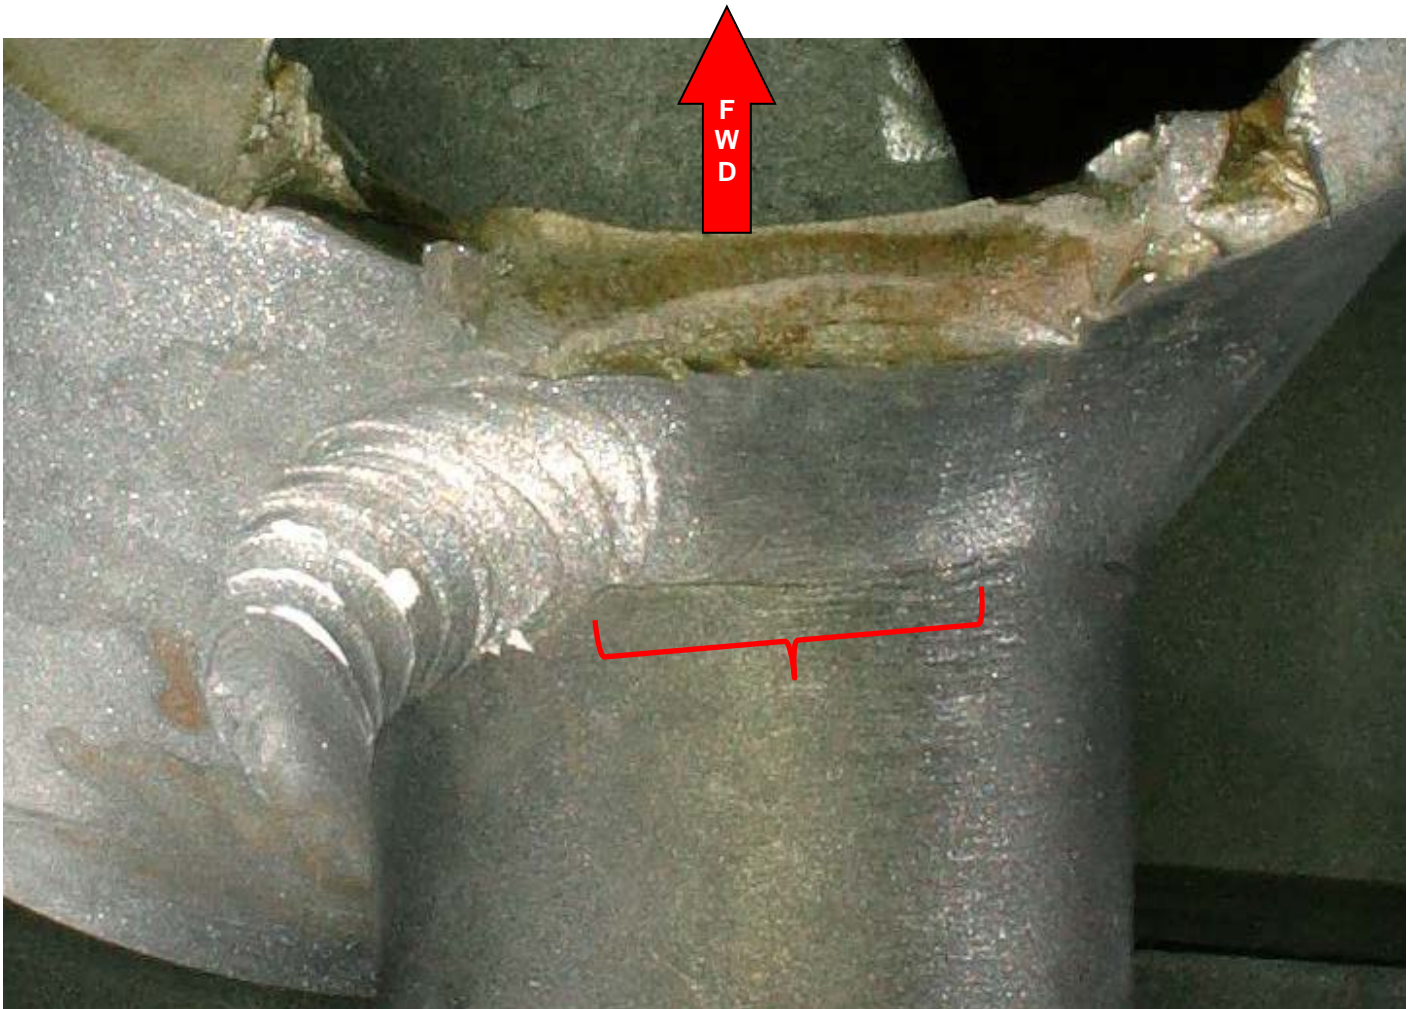
With the paint mostly removed, the weld beads and surrounding surfaces were visually inspected at low magnification with a stereo microscope. The surfaces had fine mottled textures consistent with grit blasting prior to painting. The weld puddle solidification ripple pattern indicated that both gusset tube-to-strut tube-welds were made in a counter-clockwise direction when the individual welds are viewed looking at the strut tube. The start / stop points of the welds were not clearly apparent. The forward surfaces of the weld beads had been ground after welding in the area adjacent to the through the wall portions of both reflective regions. The left side gusset weld shown in figure 5 is typical of both sides.

Additionally, a crack was visible at higher magnification at the aft toe of the weld on the left gusset tube as denoted by the red bracket in figure 5. Scanning electron microscope (SEM) examinations confirmed the presence of the crack as shown in figure 6. The crack was sharply delineated at the surface indicating its formation after the surfaces were grit blasted.

Figure 5. Optical view of the left gusset tube to strut weld showing a crack (bracket) at the aft toe of the weld. Also note the post weld grinding of the weld bead surface at the forward edge.

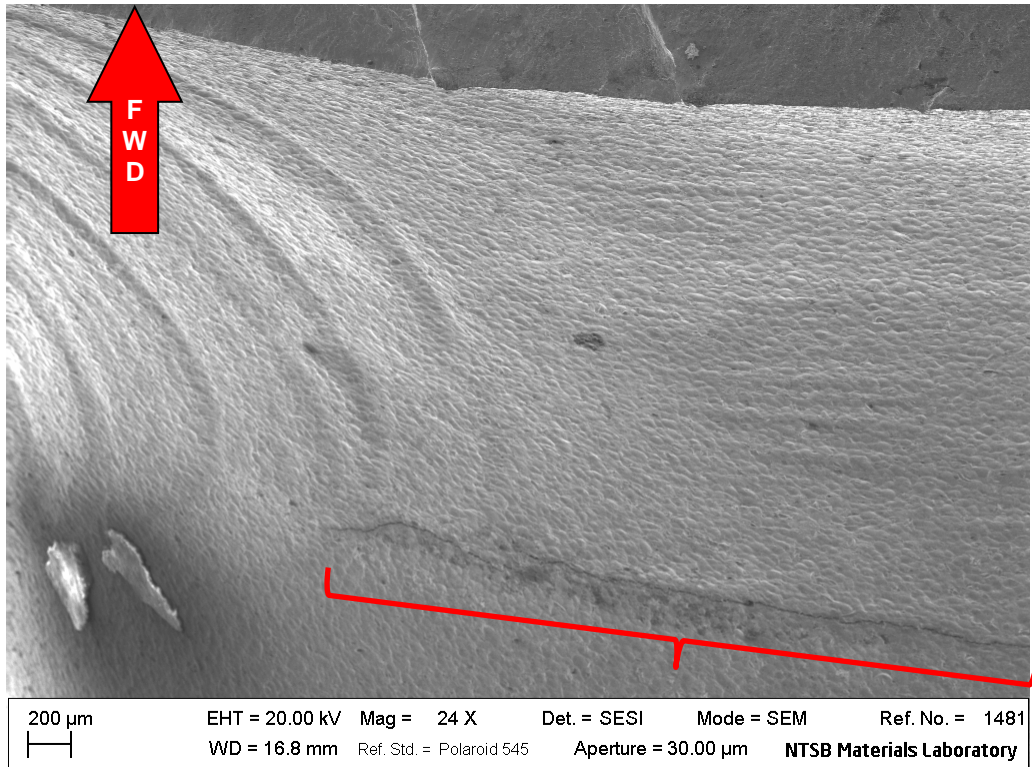
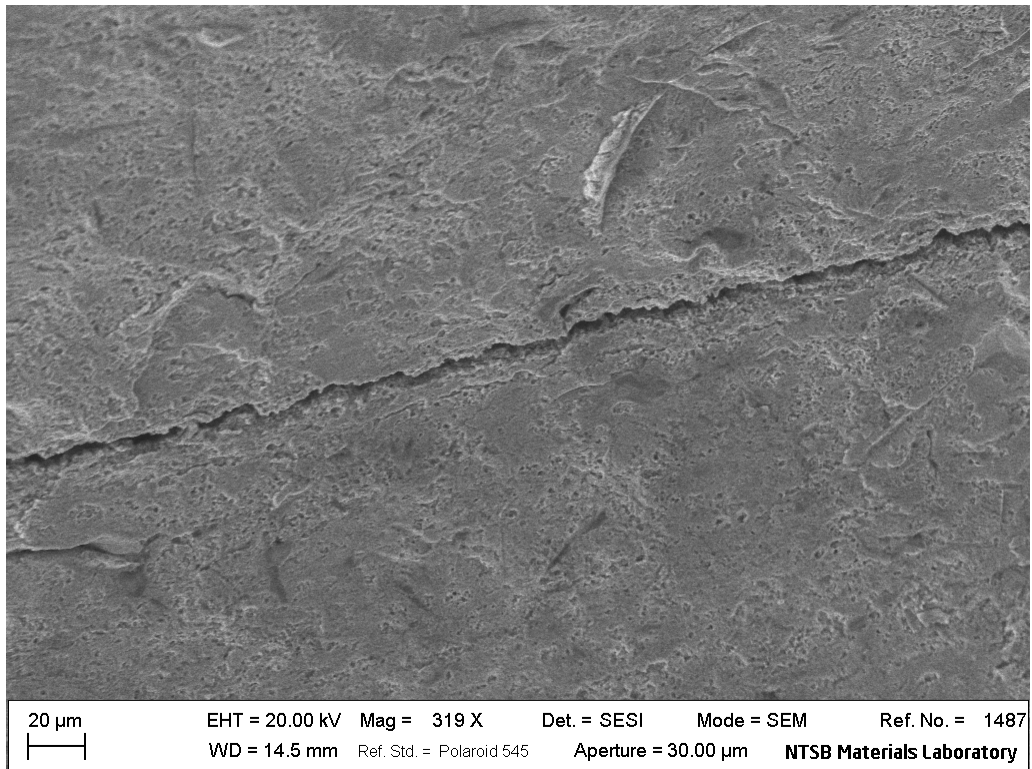
Figure 6. SEM views of the left gusset tube crack from figure 5 at low (top) and high (bottom) magnifications.

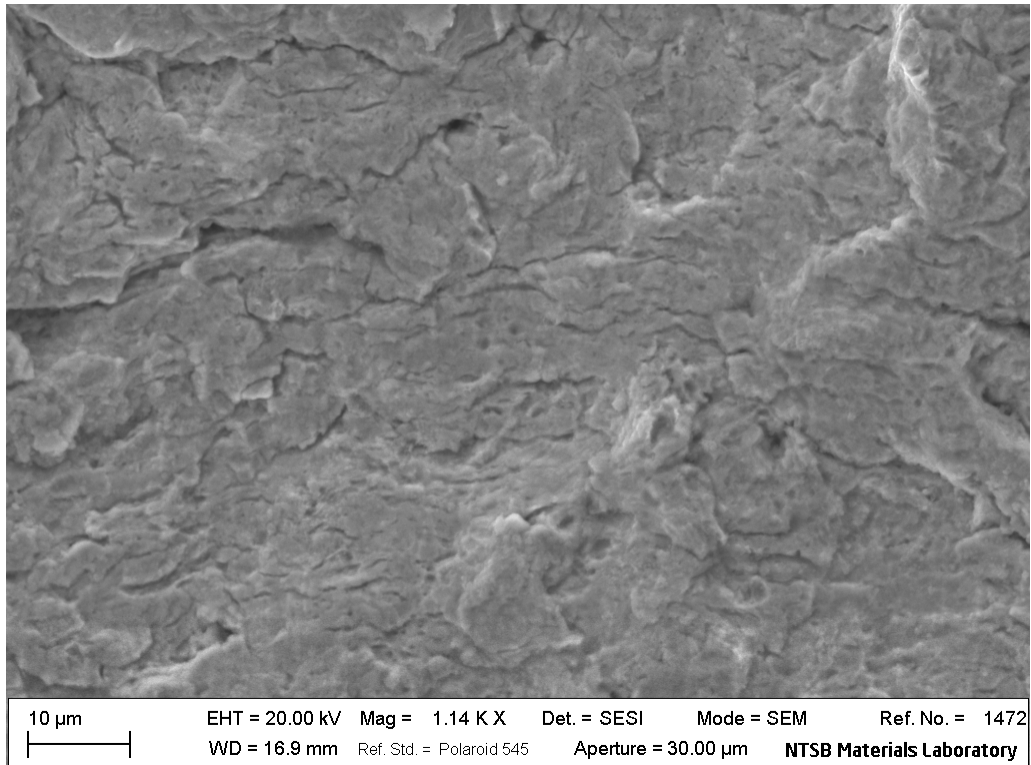
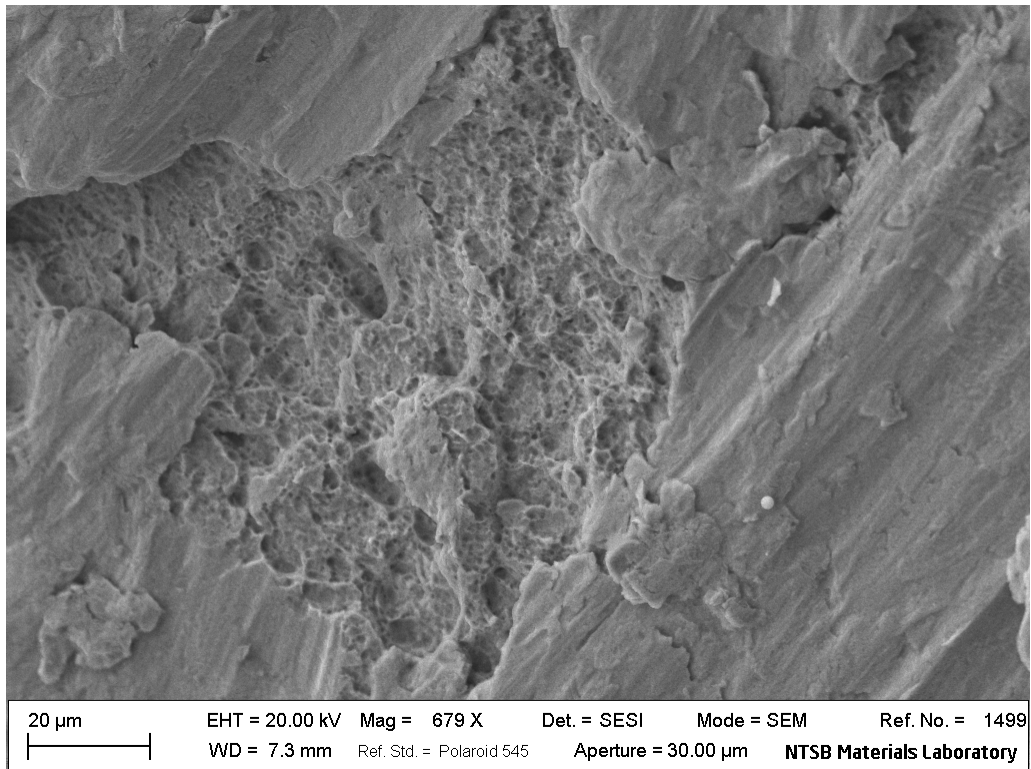
Scanning electron microscope examinations of the aft fracture face found the recontact mechanical damage to be extensive in the reflective regions, obliterating almost all of the fine fracture features within the left and right reflective regions. Small areas of intact features were located in the through the wall area of the right reflective region that were highly suggestive of high stress fatigue propagation. These are shown in the upper view of figure 7. Identifiable ductile dimples were found starting about midway in the circumferential progression areas and continuing to the termini. Indicating that this portion of the fracture was overstress in nature. These are shown in the lower image of figure 7. Ductile dimples were also found in the overstress regions between the reflective fracture regions.

Figure 7. At top an SEM image showing of striations indicative of high stress fatigue propagation in the through the wall region of the left reflective band. The lower view displays typical ductile dimples uncovered about midway in the circumferential propagations of the left reflective region.

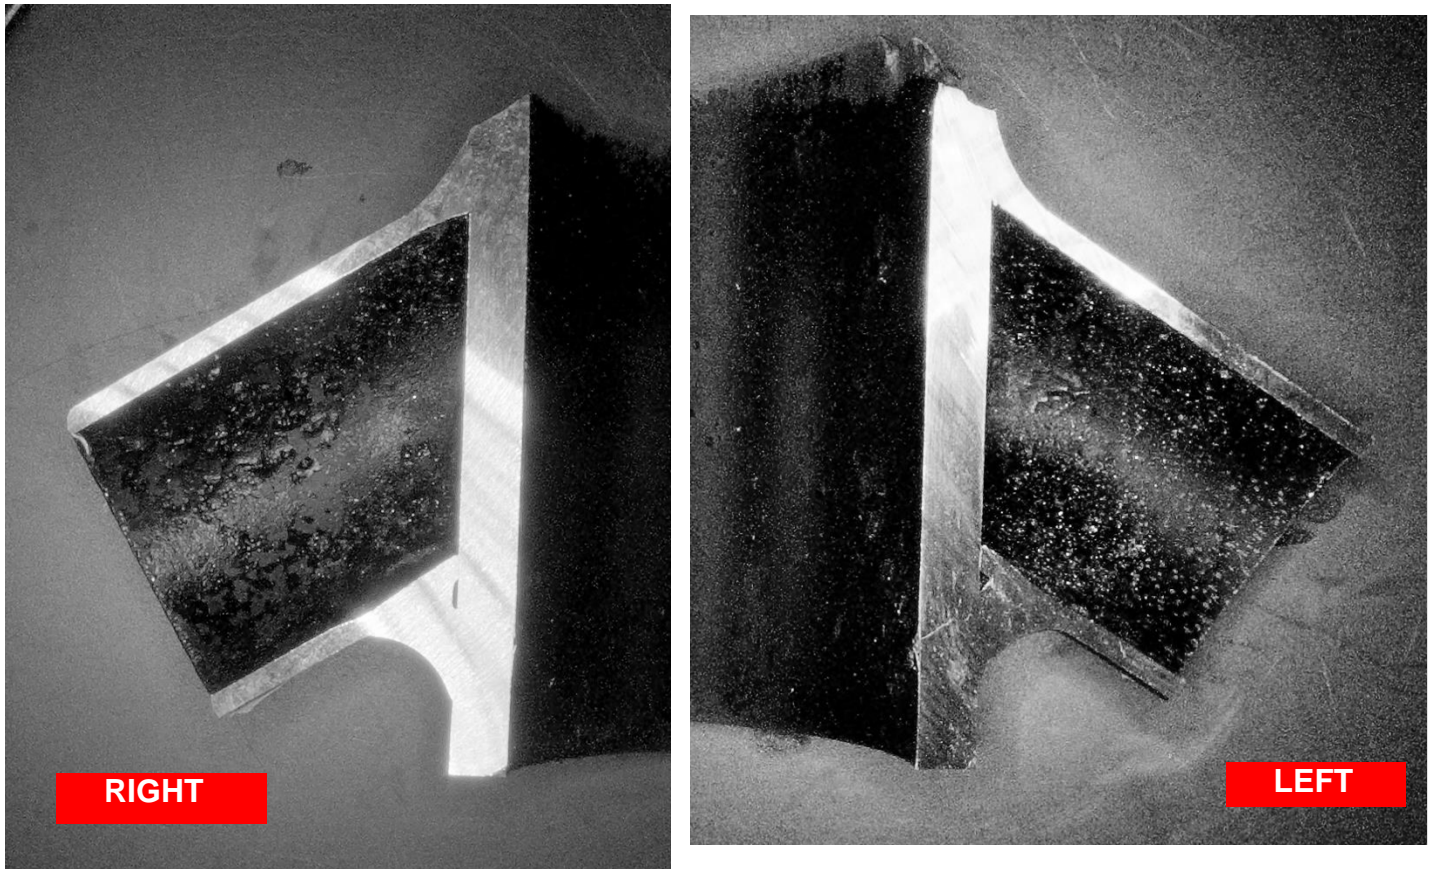
The aft fracture face along with the gusset tubes welds was transversely saw cut from the strut and then sectioned along the horizontal plane through the approximate center lines of the gusset tubes as shown in figure 8. The pieces shown were then mounted and metallographically prepared. Figures 9 and 10 display the as-polished welds at the forward (top) and aft (bottom) sides of the right and left gusset tubes, respectively.

Sectioning revealed a dark brown organic coating on all of the interior surfaces of the strut and gusset tubes, see figure 8. A representative of Cirrus described the coating as LPS Hardcoat. The coating was bubbled adjacent to the weld regions but still covered the surfaces. No internal corrosion was noted.

Figure 8. An overall view of the sectioned intersections of the left and right gusset tubes with the strut tube showing the welds in cross section and further shown below. Aircraft forward is at top. Interior tube surfaces coated with a dark brown material.

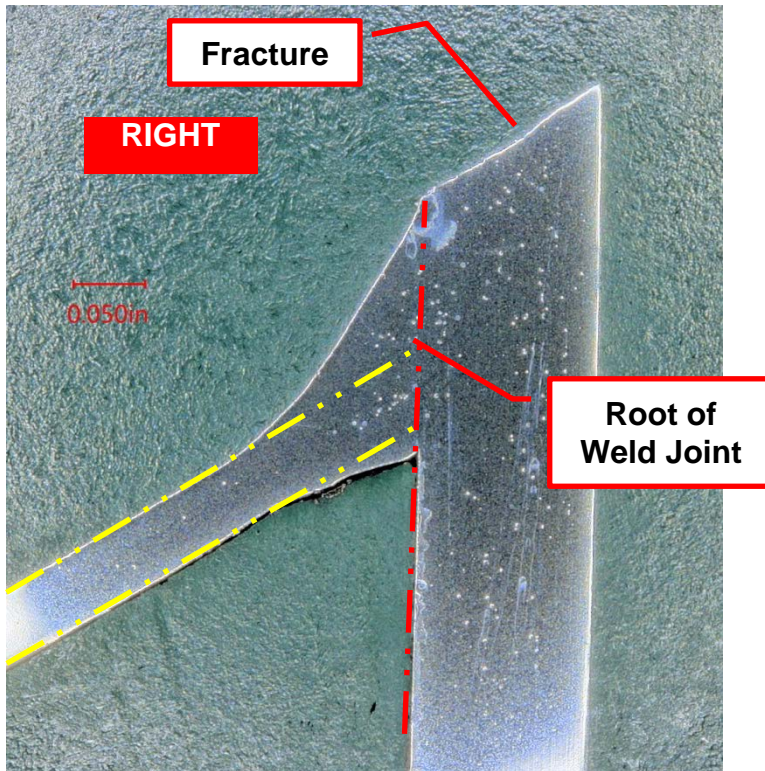
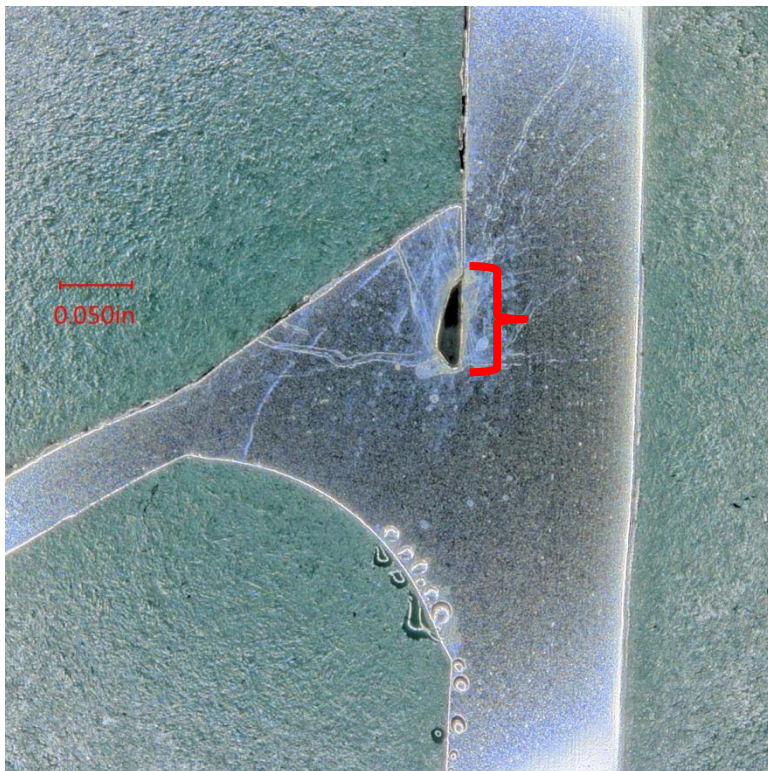
The fracture was at the forward toes of the forward gusset tube welds as shown in the upper views of figures 9 and 10. Also note the slanted nature of the fracture through the strut tube wall thickness.

As shown in the upper image of figure 9, the weld bead at the forward edge of right gusset tube completely melted the end of the tube and incorporated it into the fusion zone. The left tube weld, shown in the upper view of figure 10, did not completely melt the tube section but incorporated most into the fusion zone. Both welds satisfied the welding specification requirements for complete root penetration plus 10%. The measured weld sizes for both leg lengths “L” and throat depths “K” were near the middle of the size range specified by the process specification.

The welds on the aft sides of the gusset tubes displayed incomplete penetration to the root of the joint as shown in the lower images in figure 9 and 10. Figure 4.5.3-4 of the weld specification allows for incomplete root penetration for angled tube joints where the acute angle between the tube is 45 degrees or less. The measured angle between the strut and gusset tubes was measured between 55 and 60 degrees.

Figure 9. Metallographic views of the forward and aft portions of the fillet weld on the right gusset tube weld. Forward portion at top shows more than 100% root penetration. Yellow and red lines denote the approximate original gusset and strut tube surfaces. Note the slant profile of the fracture plane at top. Lower view shows the aft portion of the weld with the red bracket denoting the area of incomplete root penetration.

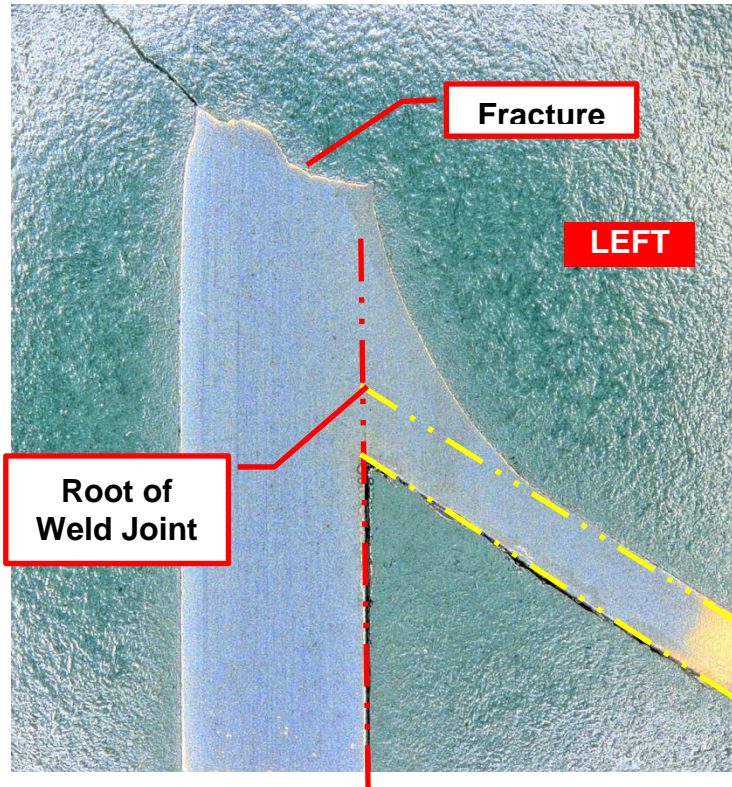
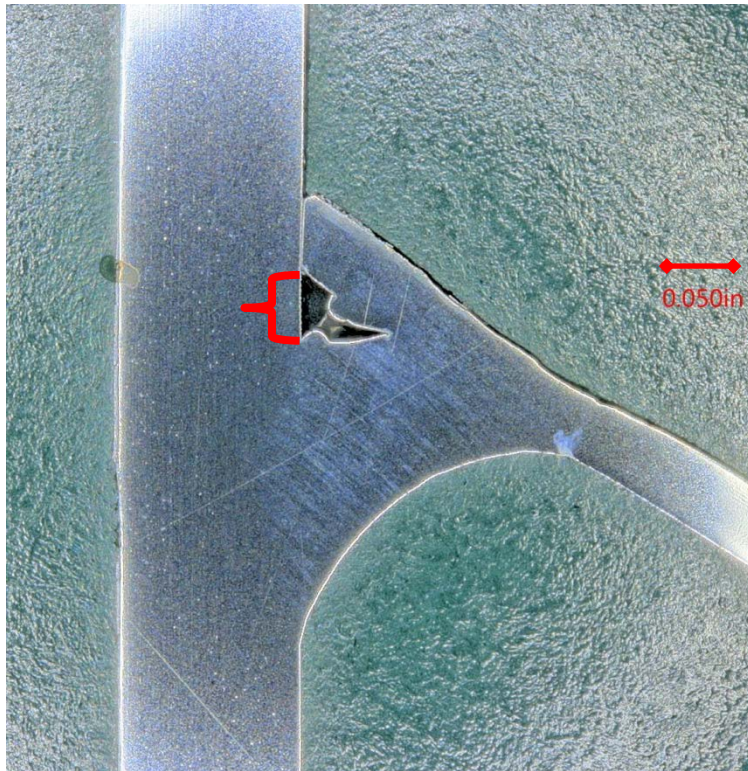
Figure 10. Metallographic views of the forward and aft portions of the fillet weld on the left gusset tube weld. Forward portion at top shows more than 100% root penetration. Yellow and red lines denote the approximate original gusset and strut tube surfaces. Note the slant profile of the fracture plane at top. Lower view shows the aft portion of the weld with the red bracket denoting the area of incomplete root penetration.

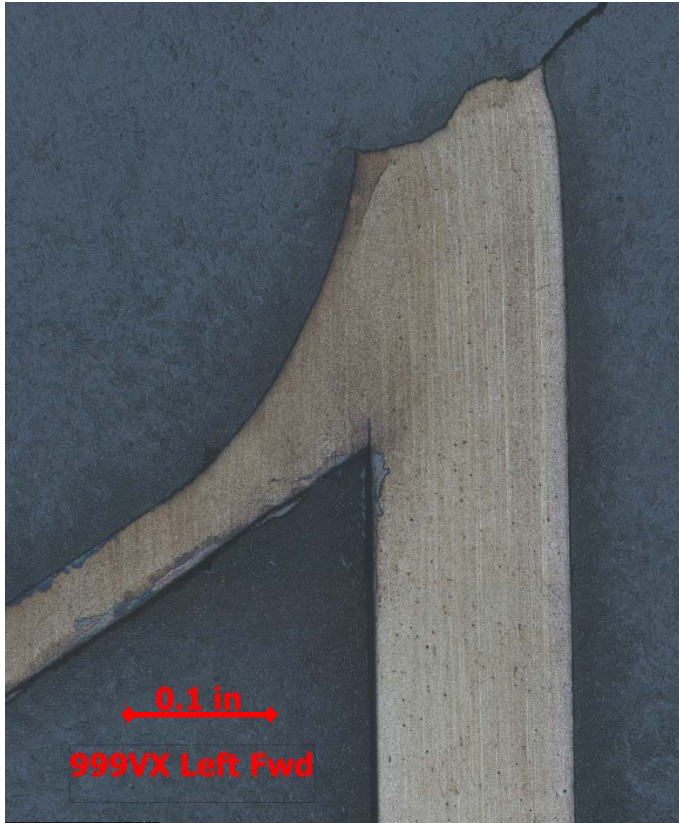
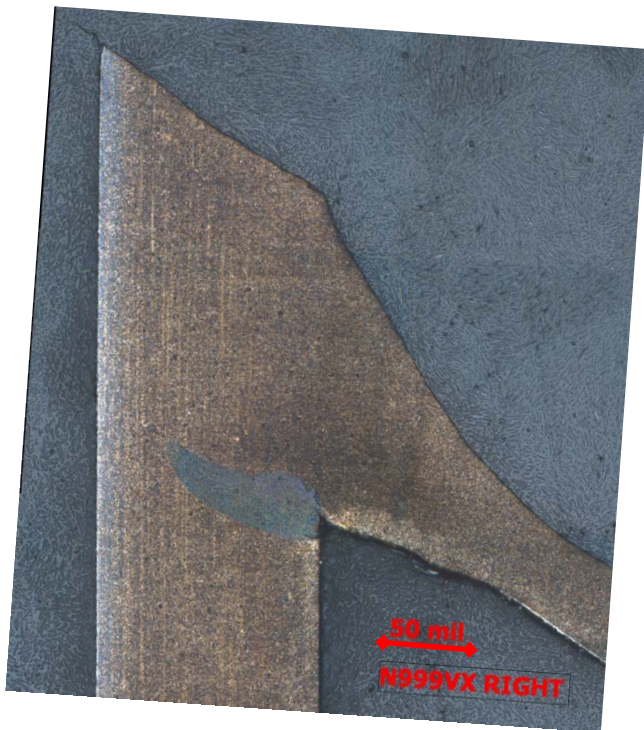
When etched with 2% Nital<sup>6</sup>, the welds and surrounding tube structures showed tempered martensitic structures consistent with the post welding specified quench and tempered heat treatment, see figure 11. The strut tube microstructure showed an elongated structure consistent with the drawing direction of the original tube. Partial decarburization was also noted on the inner diameter of the strut tube as shown in figure 10. The decarburization both complete and partial was visually measured to be about 0.003 inch in depth. The outer diameter of the strut tube, the welds and gusset tube surfaces did not display any decarburization. Heat treating is required to be in accordance with MIL-H-6875H which limits decarburization for this hardness level to 0.005 inch or less as determined by a micro hardness survey.

Figure 11. The etched microstructures of the forward welds of the left and right gusset tubes showing a fully martensitic microstructure except at inner diameter of strut tube. See Figure 13. Images mirrored from figures above.

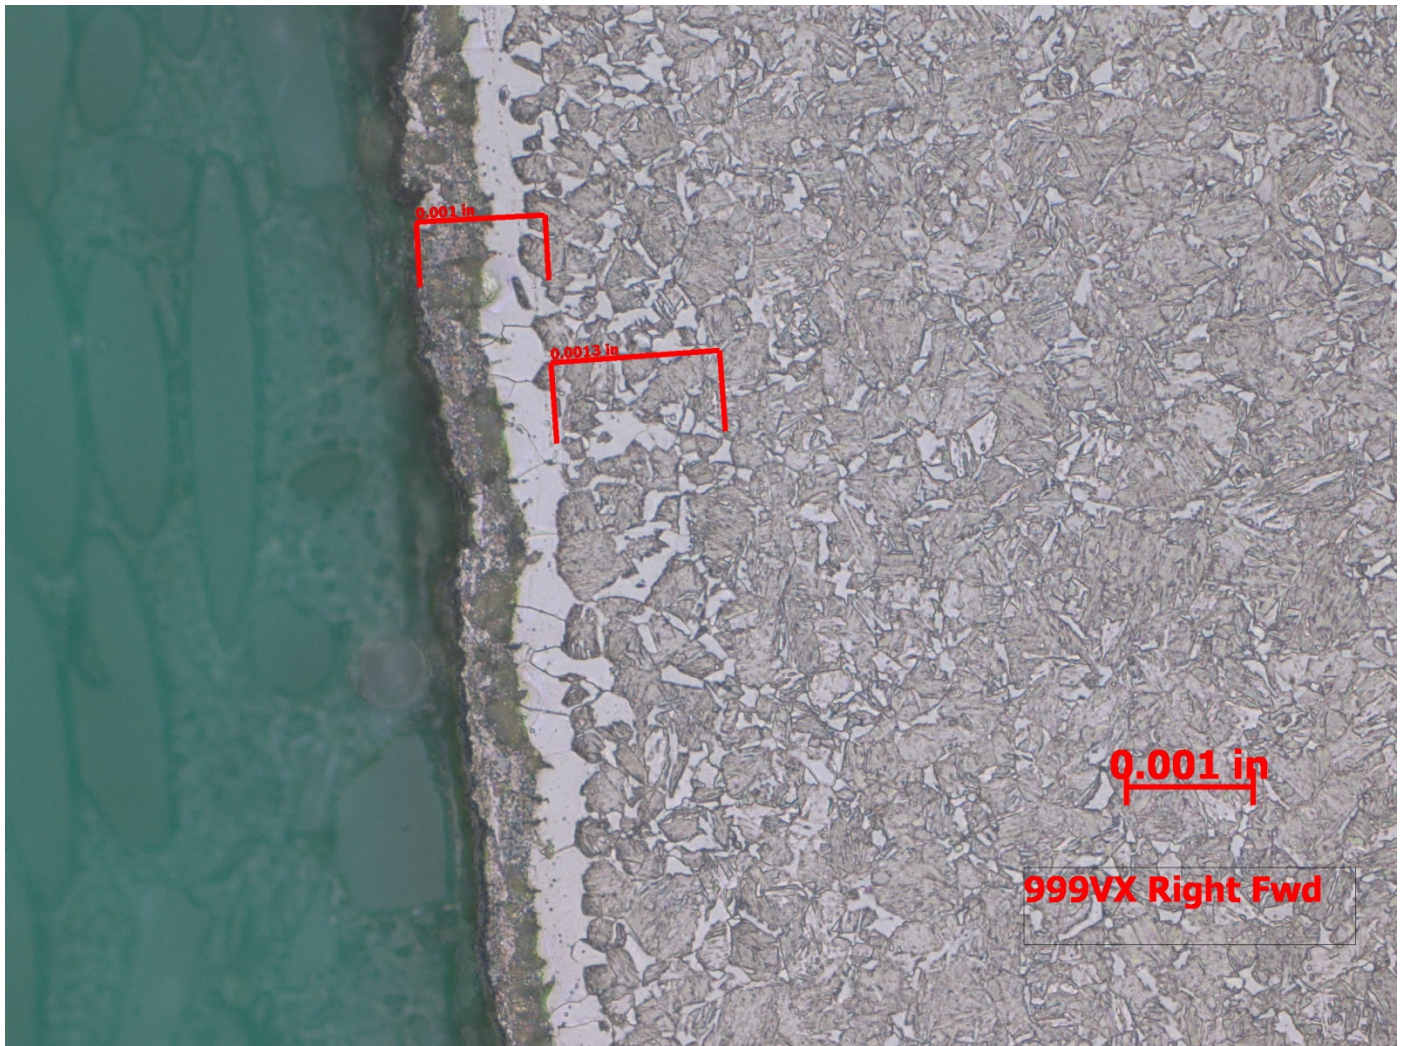
Figure 12. Closer view showing decarburized layer at inner diameter surface of strut tube. Visually measured about 0.003 inch at this location.

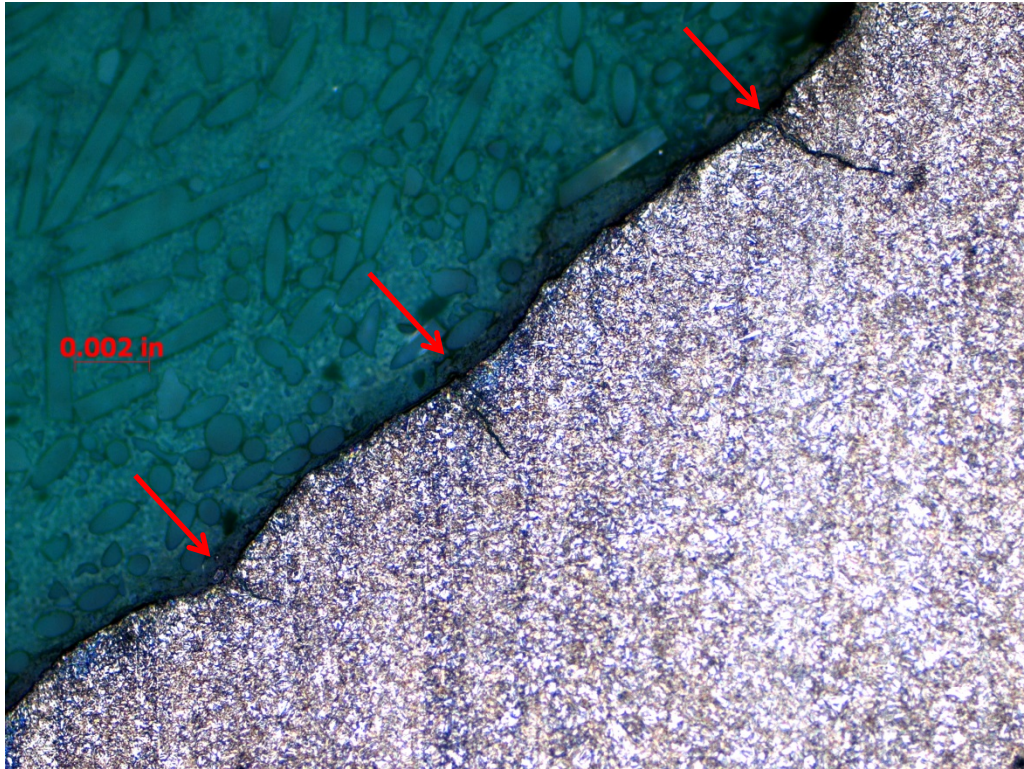
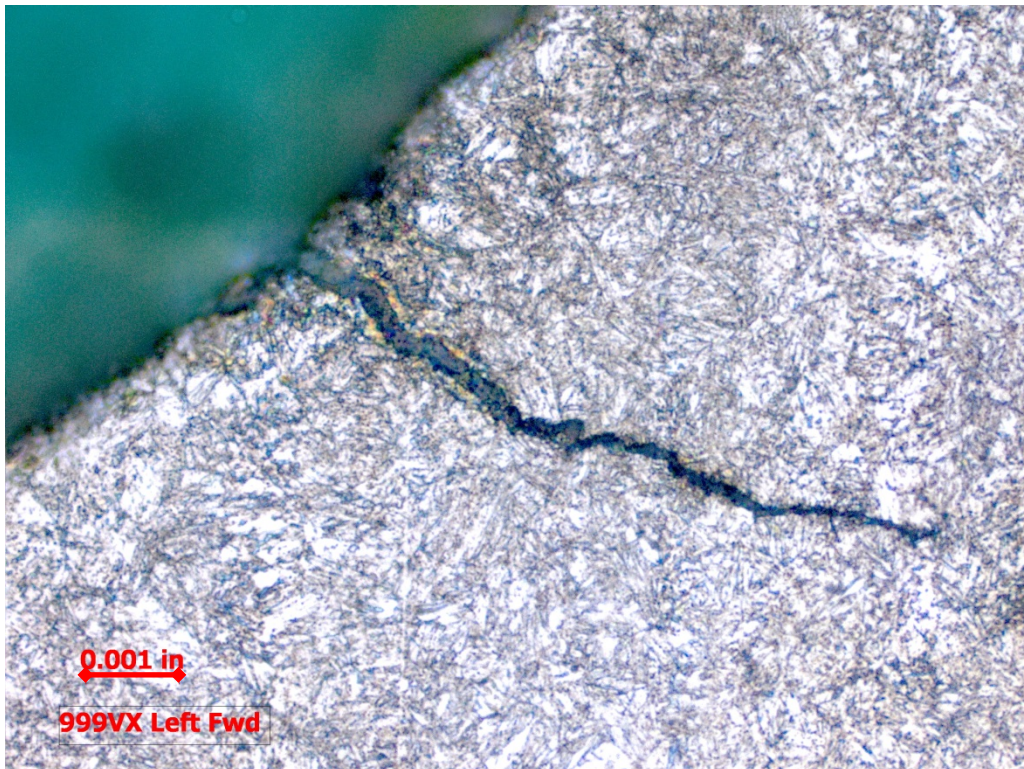
Examinations of the metallographic sections also uncovered three small (< 0.005 inch) surface cracks in the surface of the left weld fusion zone as shown in figure 13. The cracks were oxide-filled indicating their presence during heat treatment. The cracks were located away from the weld toe.

Figure 13. Two metallographic views of the forward portion of the left gusset tube weld showing the three cracks (red arrows) at top. The oxide filled largest one is show at bottom.
