NATIONAL TRANSPORTATION SAFETY BOARD

MATERIALS LABORATORY FACTUAL REPORT

Report No. 16-097

Place : Silver Spring, Maryland
Date : August 10, 2016
Vehicle : Washington Gas service pipe and gas regulator assemblies
NTSB No. : DCA16FP003
Investigator : Ravi Chhatre

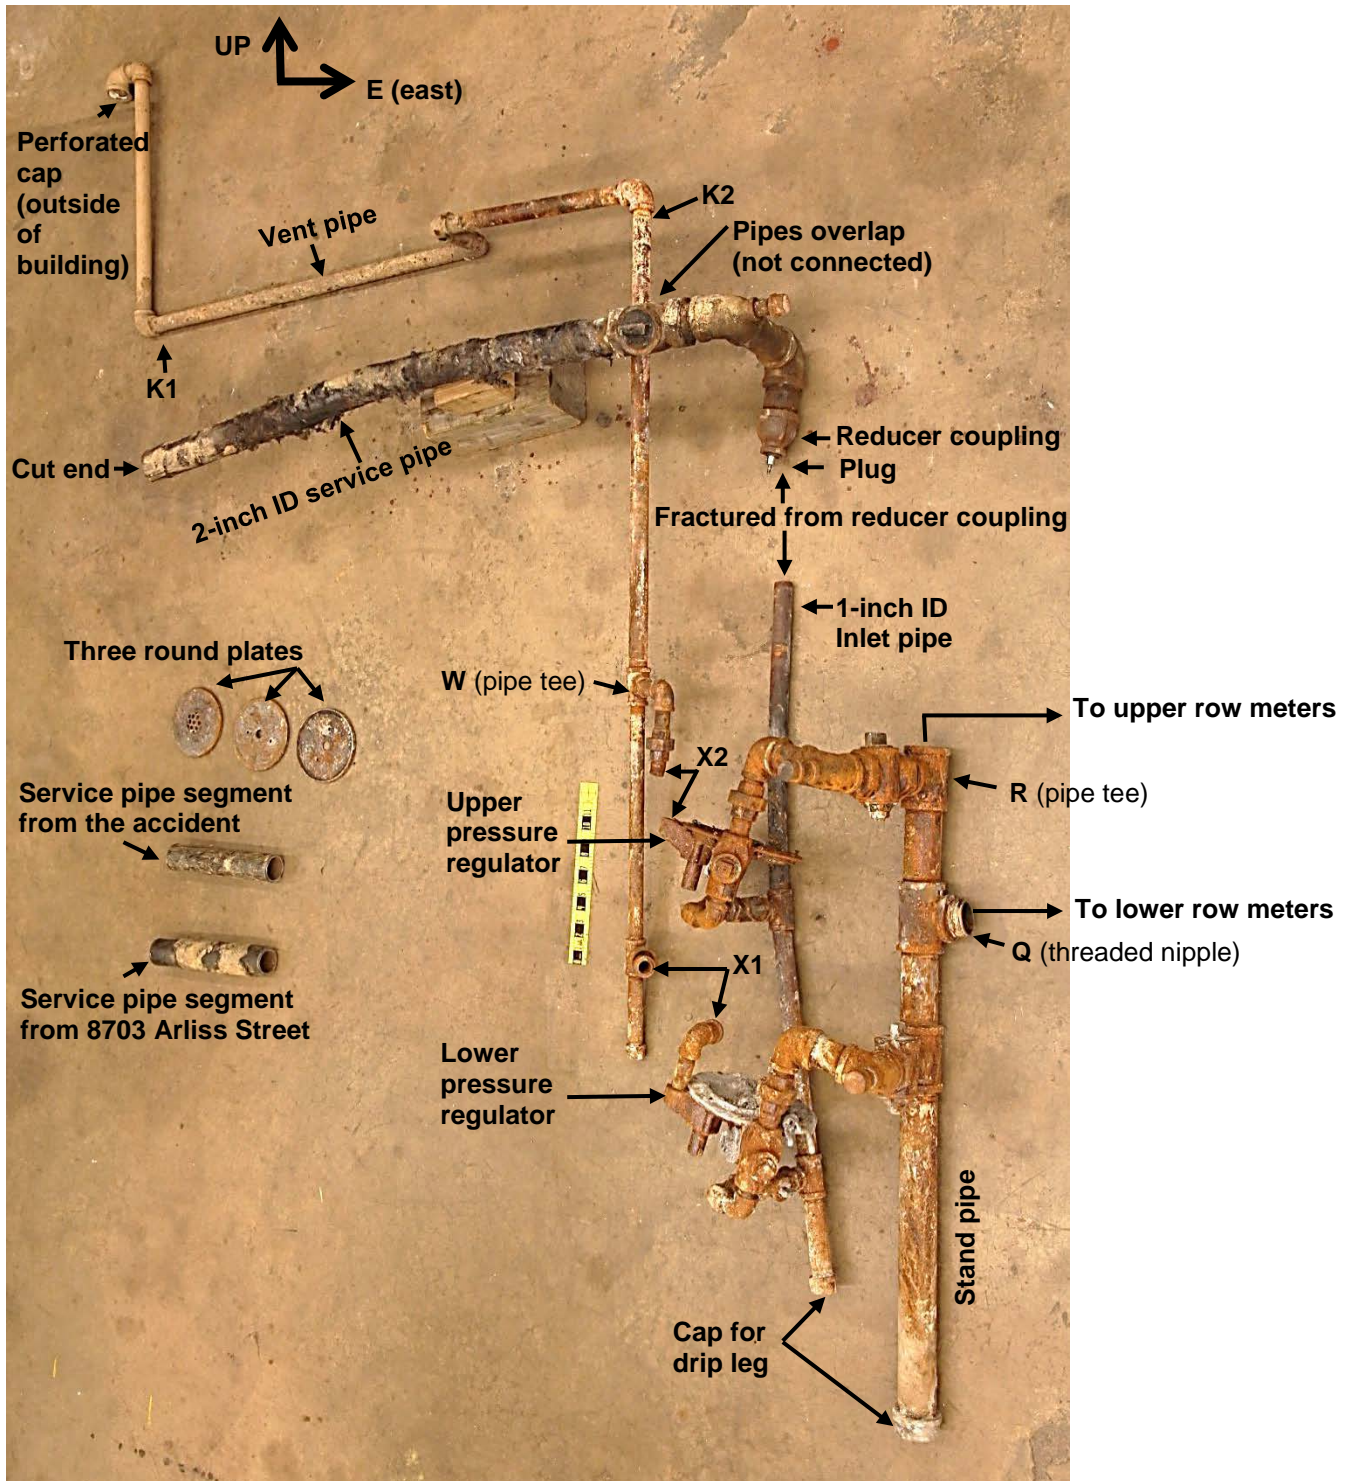
As indicated earlier, the union assembly for the lower gas regulator assembly separated in the area indicated by arrows "X1" in figures 1, 2 and 5. The union assembly is comprised of three components – the nut which has been referred as the retaining nut or "collar; the male part of the union which has been referred as a "tail piece", male spherical component, or insert; and the female part of the union which has been referred as the mating socket component. The female part of the union has the external threads, which mate to the union nut. For the purpose of this report, the three components will be referred as the nut, insert, and mating external threaded socket (see figure 5). The union assembly separation was between the external threaded socket portion and the nut portion.

Figure 1. Photograph of the two as-received natural gas pressure regulator assemblies and associated pipes, relative to each other as if installed. The regulator assemblies separated from the vent pipe in the areas indicated by arrows “X2” and “X1”. The up and east (E) orientations are indicated in the photograph. Vent pipe segments were disassembled at NTSB Materials Lab at the elbow locations in areas indicated by arrows “K1” and “K2”.

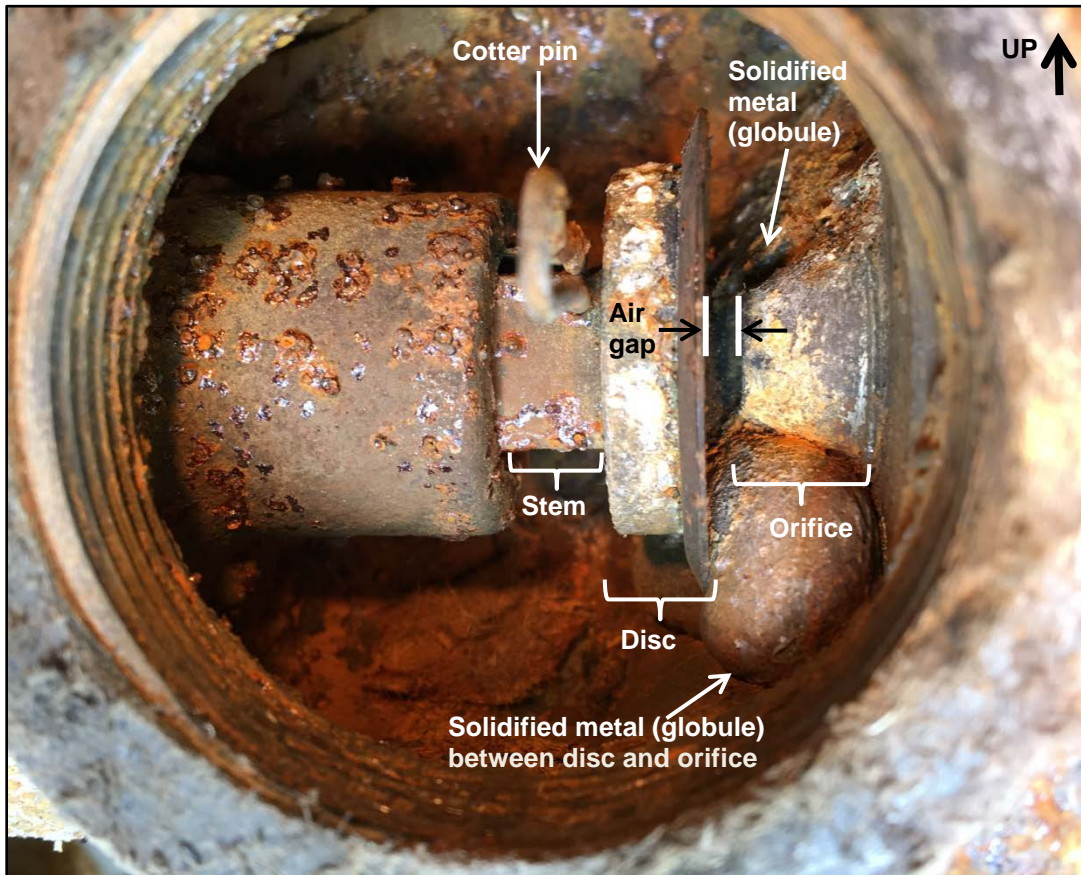
Figure 4. View through the 2-inch diameter internal threaded side port of the lower gas regulator assembly after disassembly of the plug, after cleaning the internal cavity with a soft bristle brush.

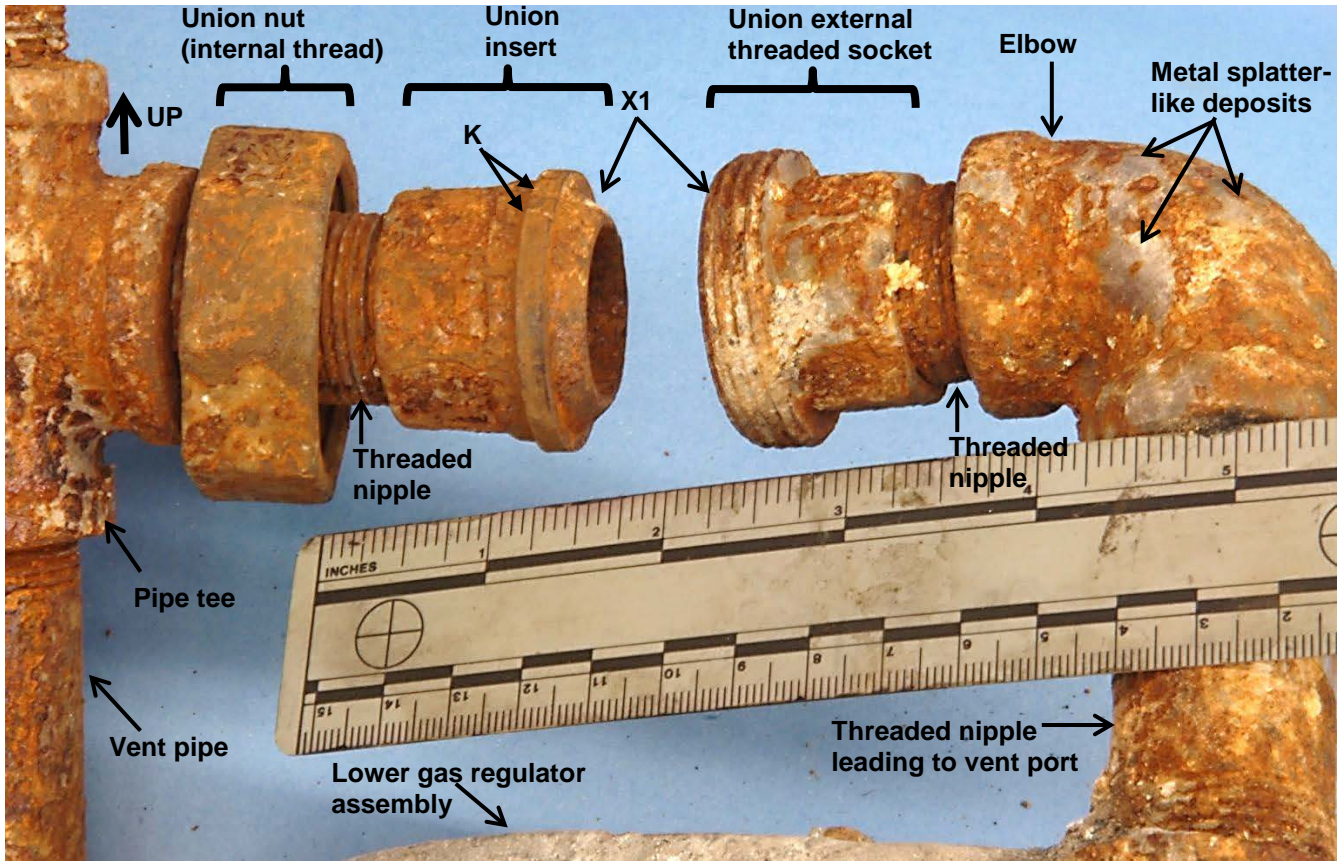
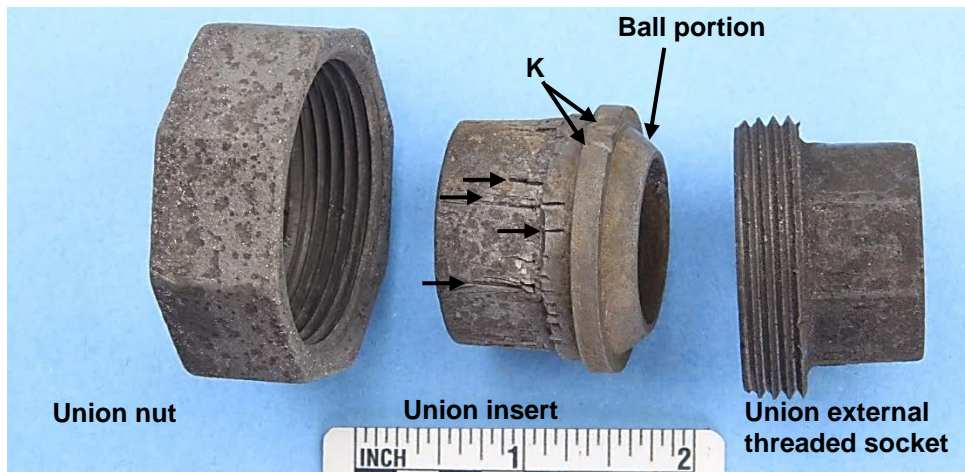
Figure 5. Photograph on upper side of page shows the union assembly for the lower gas regulator assembly that separated in the area indicated by arrows "X1". Parts were intentionally aligned next to each other at the NTSB Materials Laboratory for the purpose of describing the different parts of the union assembly. Photograph on the lower side of the page shows the disassembled lower union assembly (union nut, union insert and external threaded socket) after cleaning with EVAPO-RUST®. Unmarked arrows indicate tool marks from a pipe wrench that was used at the NTSB Materials Laboratory to disassemble the union assembly. Arrows "K" indicate tool marks that were present prior to disassembly and cleaning.

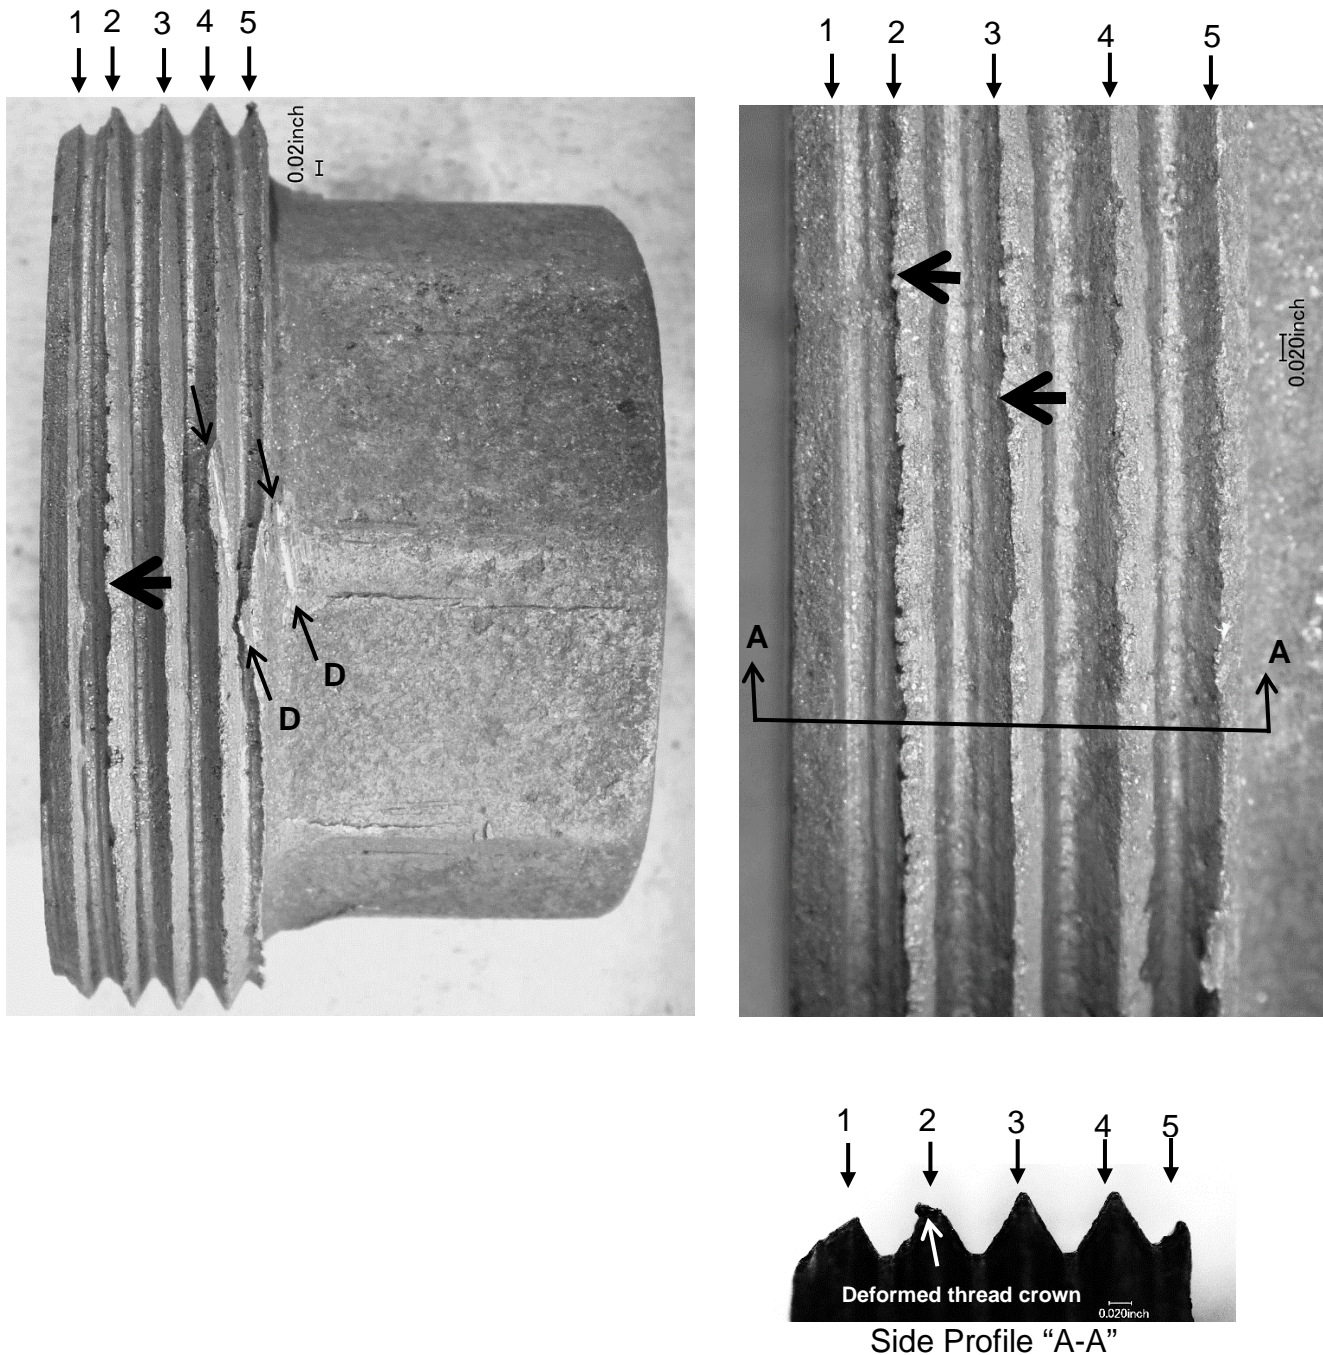
The external threads of the external threaded socket contained five threads, indicated by arrows “1” through “5” in figure 6. External thread arrowed “1” was a partial thread, whereas, those arrowed “2” through “5” were full threads. The crown portion of the first two full external threads arrowed “2” and “3” showed evidence of minor deformation that extended for the most part all around the socket. Metal deformation was found in the general direction indicated by arrows in figure 6. The NTSB Materials Lab could not determine when these deformation marks occurred. The external threads contained two dents, between arrows “D” in figure 6, one of which intersected the crown portion of the next to the last external thread arrowed “5”. The dents were parallel to each other. The external threaded socket showed no evidence of major deformation.

Figure 6. View of the disassembled union external threaded socket from the lower gas regulator (left upper corner of page); close-up photograph of the external threads (right upper right corner of page); side profile of external threads (lower right corner of page). Crown portion of the threads were randomly numbered "1" through "5". For the purpose of this report, thread "1" is the first thread. Minor deformation was found on the crown of the threads in the area indicated by unmarked arrows in the two upper photographs. Direction of metal flow is indicated by the unmarked arrows. Parallel dent marks are indicated by arrows "D".

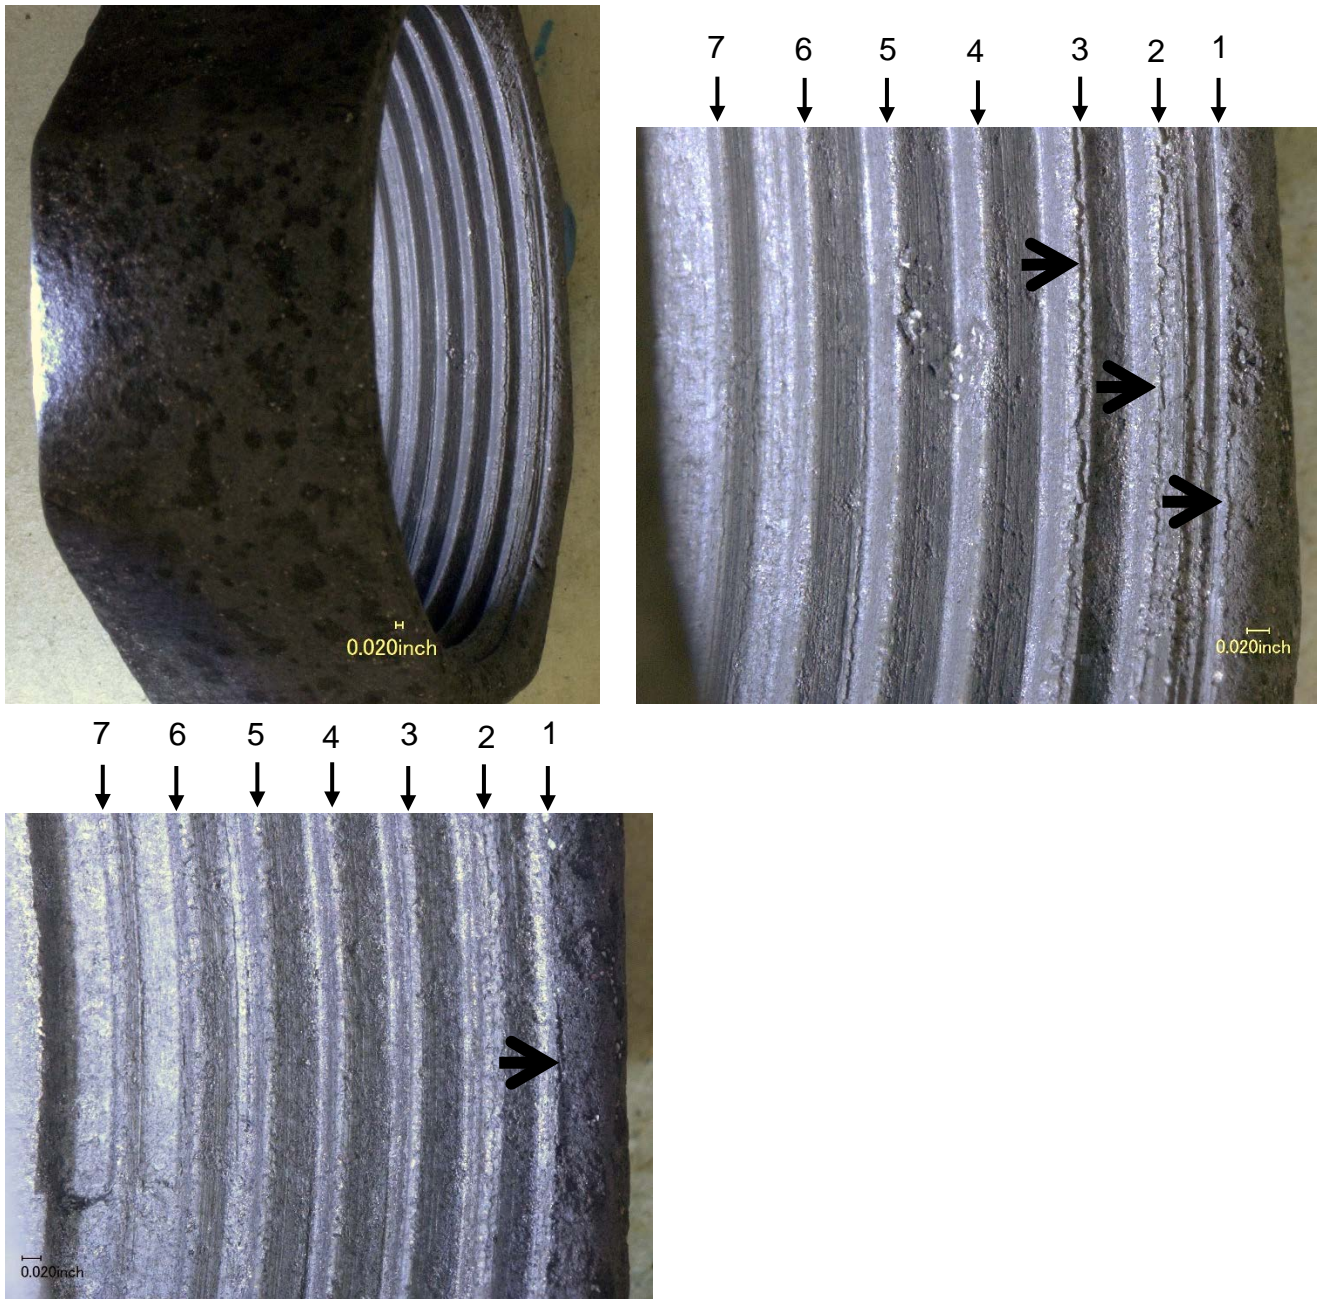
The nut contained seven internal threads, indicated by arrows “1” through “7” in figure 7. Internal thread arrowed “1” and “7” were partial threads, whereas, those arrowed “2” through “6” were full threads. The crown portion of the first three internal threads arrowed “1” through “3” showed evidence of minor deformation on one side of the nut. The crown portion of the first thread indicated by arrow “1” in figure 7 on the diametrically opposite side showed evidence of minor deformation only on an isolated area. Metal deformation was in the general direction indicated by an arrow in figure 7. The NTSB Materials Lab could not determine when these deformation marks occurred.

Figure 7. Photographs of the nut showing the internal threads (upper left corner of page); close-up view of the internal threads (upper right corner of page); and close-up of internal threads on the diametrically opposite side (lower left corner of page). Crown portion of the threads are randomly numbered “1” through “7”. Minor deformation was found on the crown of the first three threads in the area indicated by unmarked arrows, and on the crown of the first thread in the diametrically opposite side. Direction of metal flow is indicated by arrow. For the purpose of this report, thread “1” is the first engaging thread.

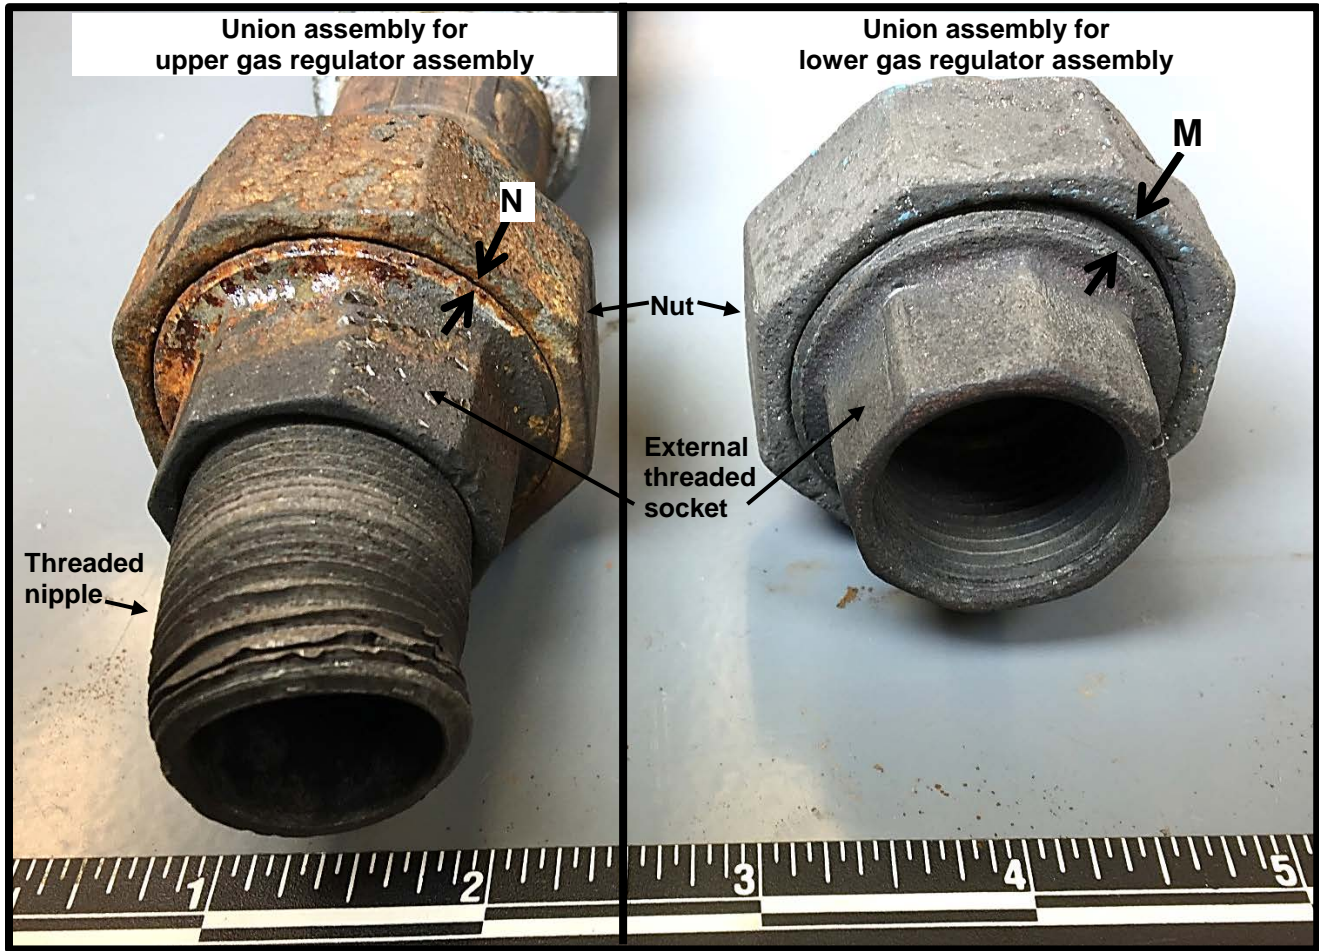
The union insert, nut and external threaded socket portions were reassembled by hand. The nut was manually rotated by hand and hand pressure was used to tighten the nut. The assembly remained intact and could not be pulled apart by hand. Figure 8 shows a photograph of the union assembly for the lower gas regulator assembly (after re-assembly). The union assembly for the lower pressure regulator assembly contained a gap between the nut and mating threads on one side of the assembly, in the area between arrows "M" in figure 8. In comparison, the union assembly for the upper regulator assembly contained a gap between the nut and the mating threads that was minor (see area between arrows "N" in figure 8) compared to that on the lower gas pressure regulator assembly.

Figure 8. Photograph of the union assembly for the upper and lower gas regulator assemblies when placed next to each other for comparison (after the union assembly for the lower gas regulator was re-assembled). Note the gap between the nut and mating threads on the union assembly for the lower gas regulator assembly in the area between arrows “M”, compared to same respective area on the other assembly (between arrows “N”).

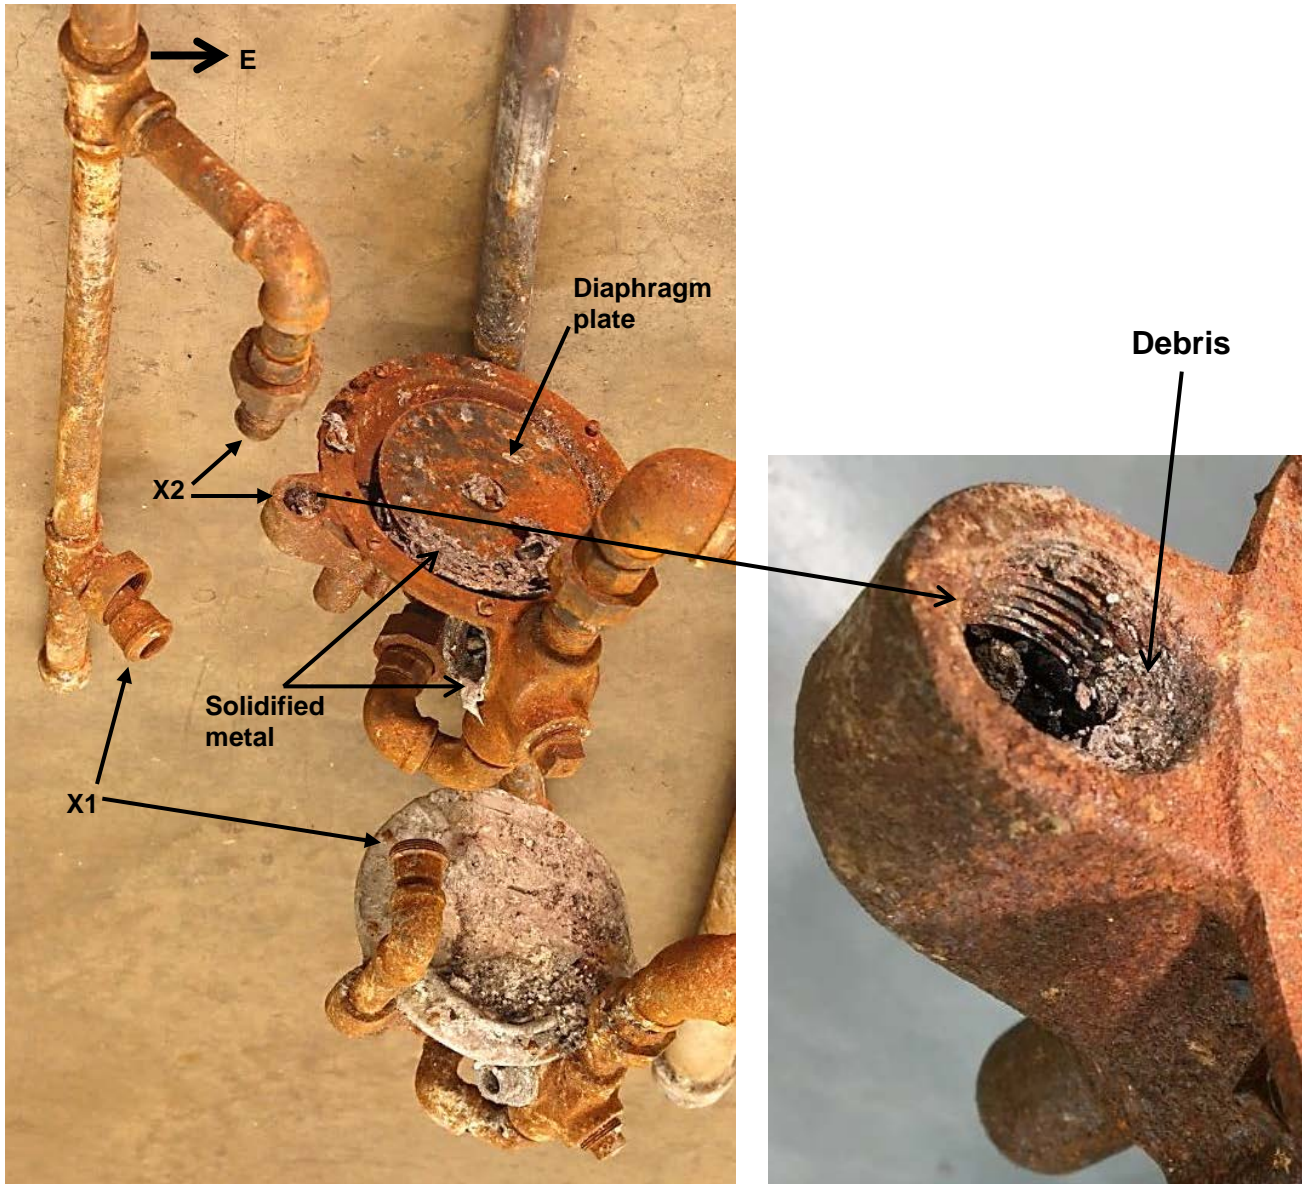
Figure 9. View of the internal threaded portion at the vent port of the upper gas regulator assembly.

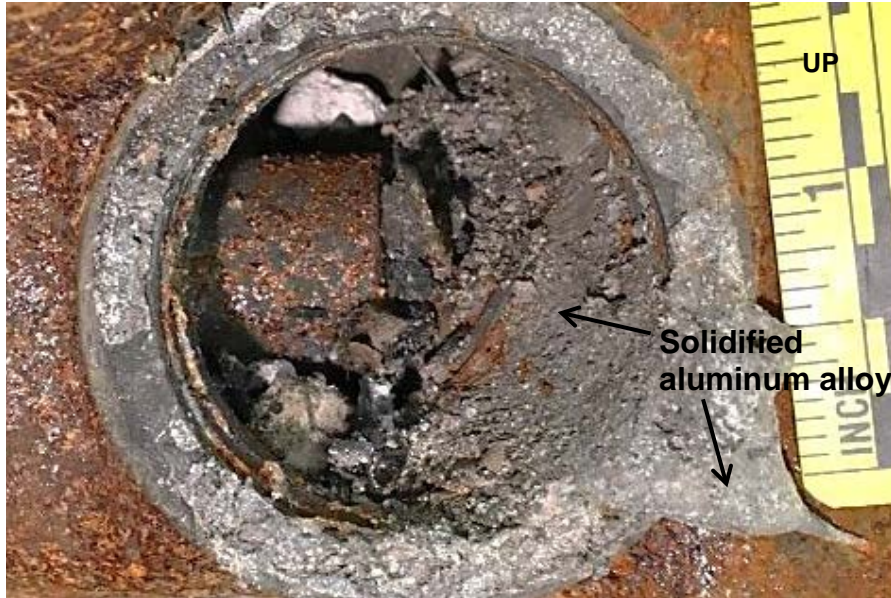
An attempt was made to move the diaphragm plate in the vertical (up and down) orientation. This exercise did not result in movement of the disc. The disc and orifice were fully encased in an aluminum alloy solidified globule that prevented movement of the

Figure 10. View through the 2-inch diameter side port of the upper gas regulator assembly showing solidified aluminum alloy that encased the orifice and disc portions.

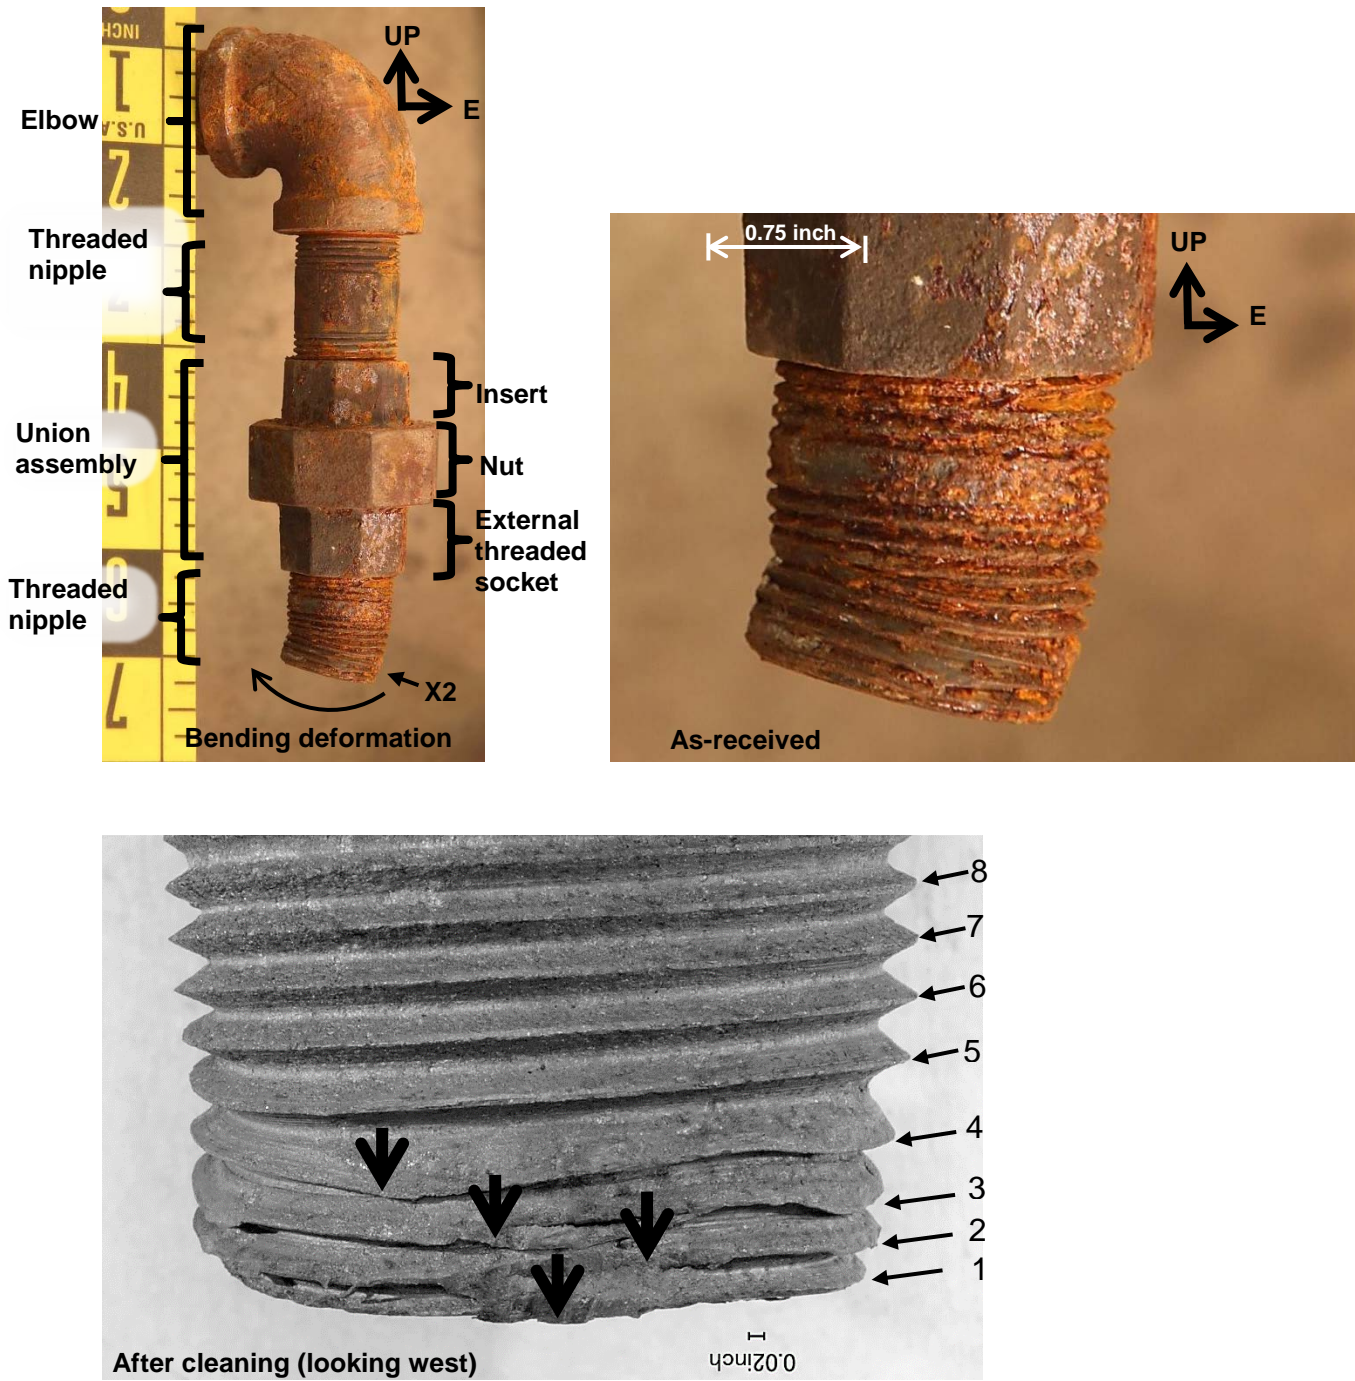
The vent port of the upper regulator assembly contained internal threads. A threaded nipple separated from the vent port of the upper gas regulator assembly, in the area indicated by arrow "X2" in figures 1, 2 and 11. The bottom end of the threaded nipple showed evidence of bending deformation relative to the length of its axis. The bending deformation was in the general direction indicated by an arrow in figure 11. The length of the deformed end measured approximately 0.22 inch. The bending deformation extended through approximately four threads. Each of the four threads showed evidence of severe bending deformation that was toward the exit port. The exposed threaded nipple and union assembly were covered with brown iron oxide. The first four threads on the vent port showed thread damage that coincided with those on the nipple (see figure 12).

Figure 11. View of the exposed external threaded pipe that separated from the vent port for the upper regulator assembly. The mating internal threads are shown in figure 12. Crown portion of the first eight threads were randomly numbered “1” through “8”. For the purpose of this report, thread “1” is the first engaging thread. Bending deformation was found on the first four threads in the areas indicated by unmarked arrows, and also in the direction indicated by the respective arrows. For the purpose of this report, thread “1” is the first engaging thread.

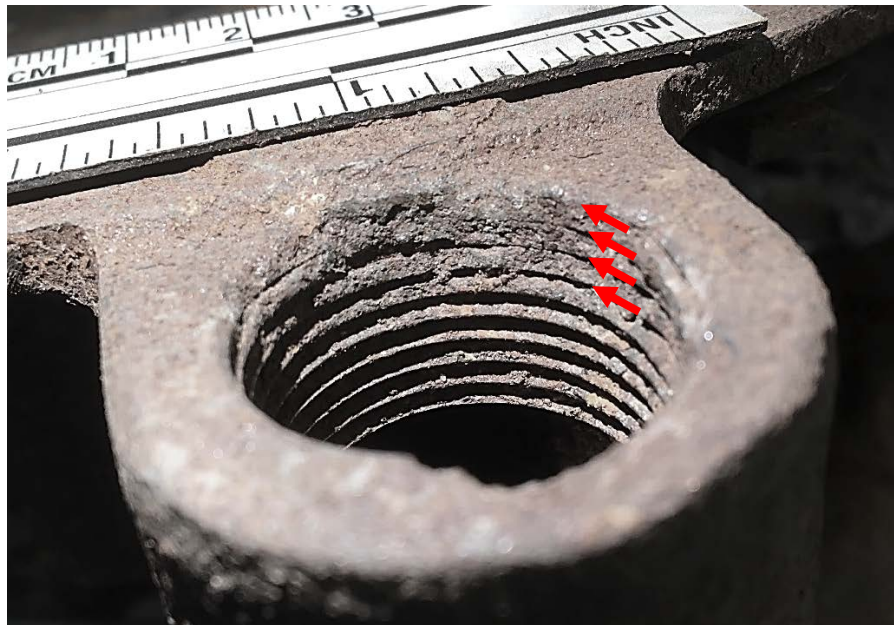
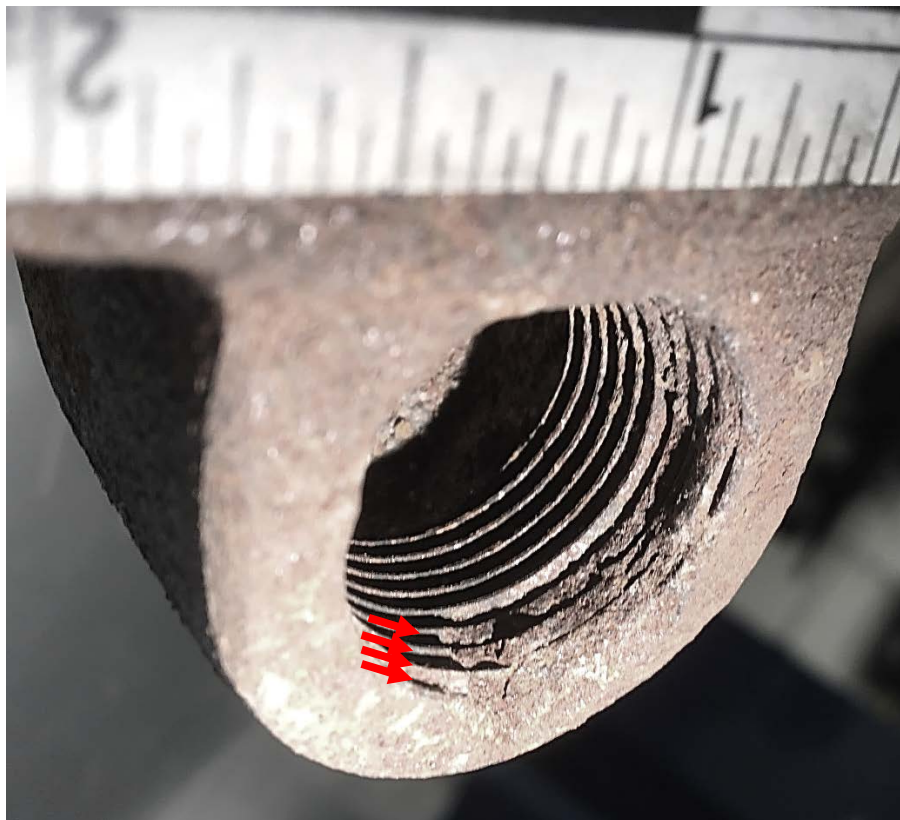
Figure 12. Views looking into the vent port of the upper gas regulator assembly, after brush cleaning with methanol, showing mechanical damage to the first four threads adjacent to the opening of the vent port, areas indicated by arrows.

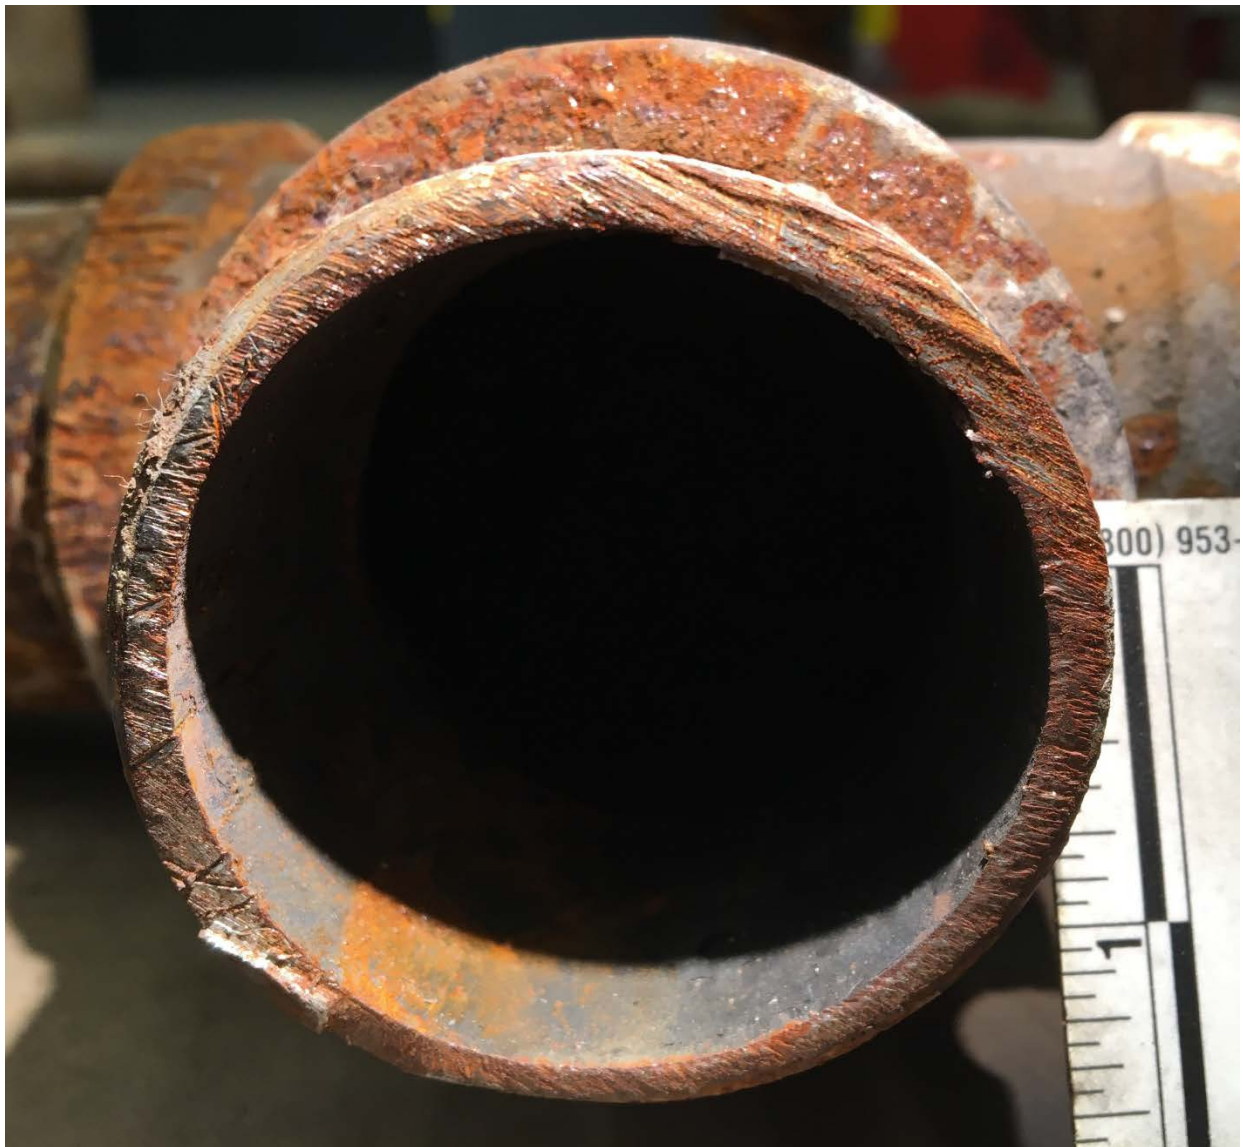
The threaded nipple, indicated by arrow “Q” in figures 1, 2, 13, and 14, led to a pipe tee for the lower row of gas meters. Magnifying glass examination of the threaded nipple “Q” revealed the separated face contained parallel texture features consistent with a saw cut that extended through the diameter portion of the thread (see figure 15).

Figure 15. The threaded nipple, indicated by arrow "Q" in figures 1, 2, 13, and 14 that led to a tee for the lower row of gas meters showing saw cut features that extended through the entire diameter.

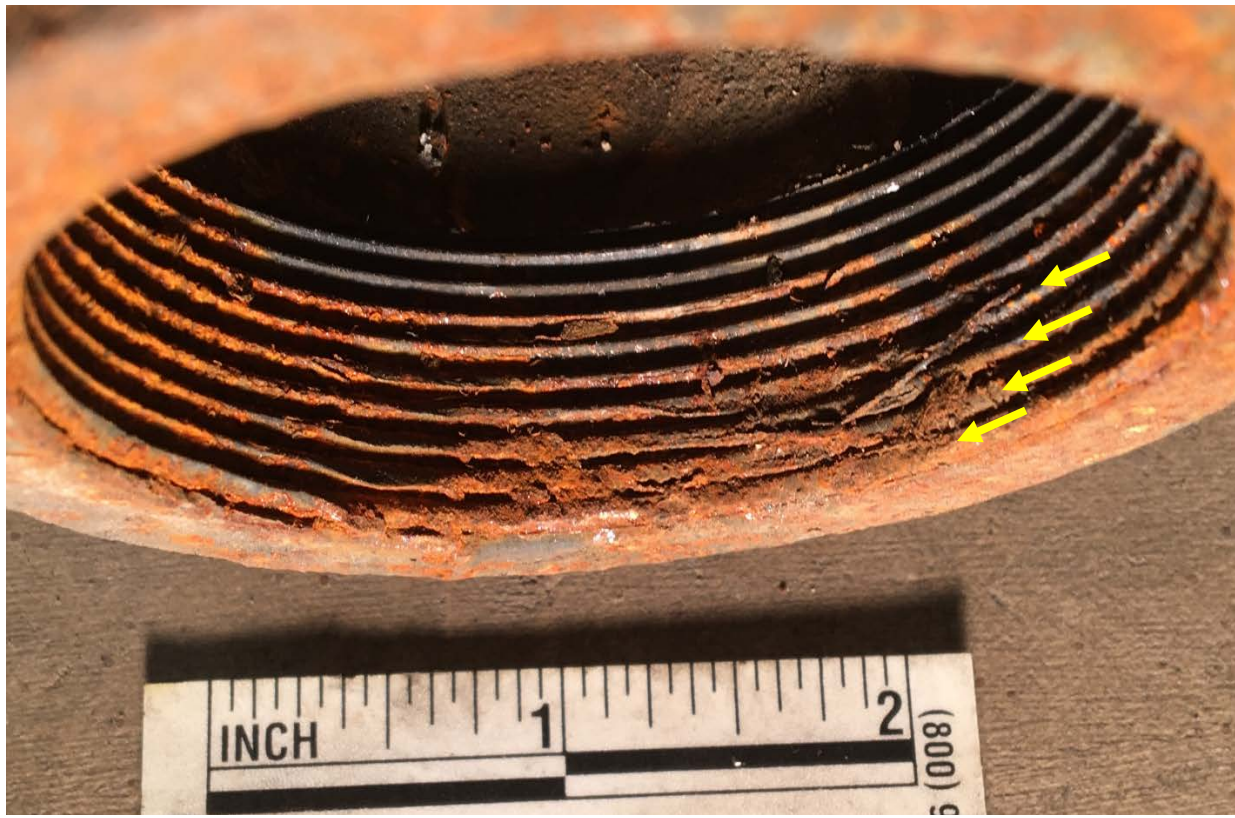
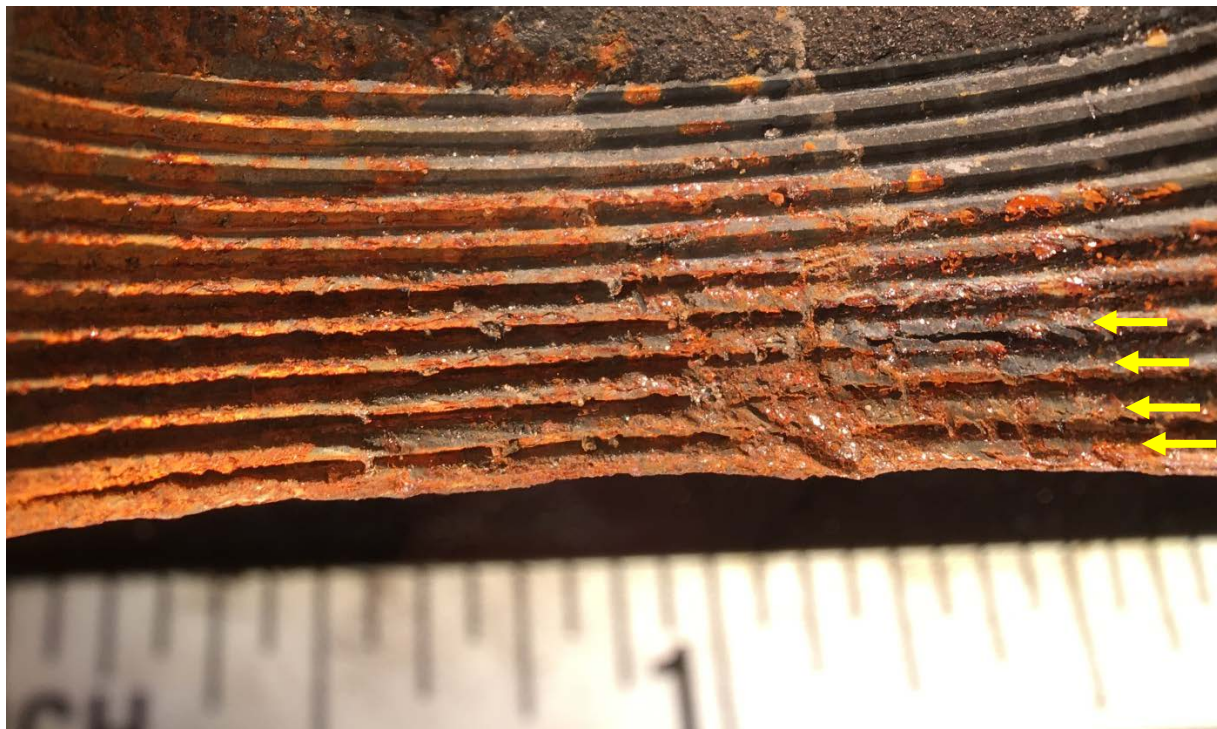
The pipe tee indicated by arrow “R” in figures 1, 2, 13, and 14 led to the upper row of gas meters. The pipe tee contained internal threads. Magnifying glass examination of the internal threads revealed the crown portions contained evidence of deformation damage (see figure 16). The crown portion of the threads showed evidence of deformation that was toward the open (exposed) end.

Figure 16. Views looking inside of the pipe tee indicated by arrow "R" in figures 1, 2, 13, and 14 that leads to the upper row of gas meters. Photograph at the bottom of the page shows the diametrically opposite side. The first four threads adjacent to the opening in the areas indicated by arrows exhibited thread deformation damage.

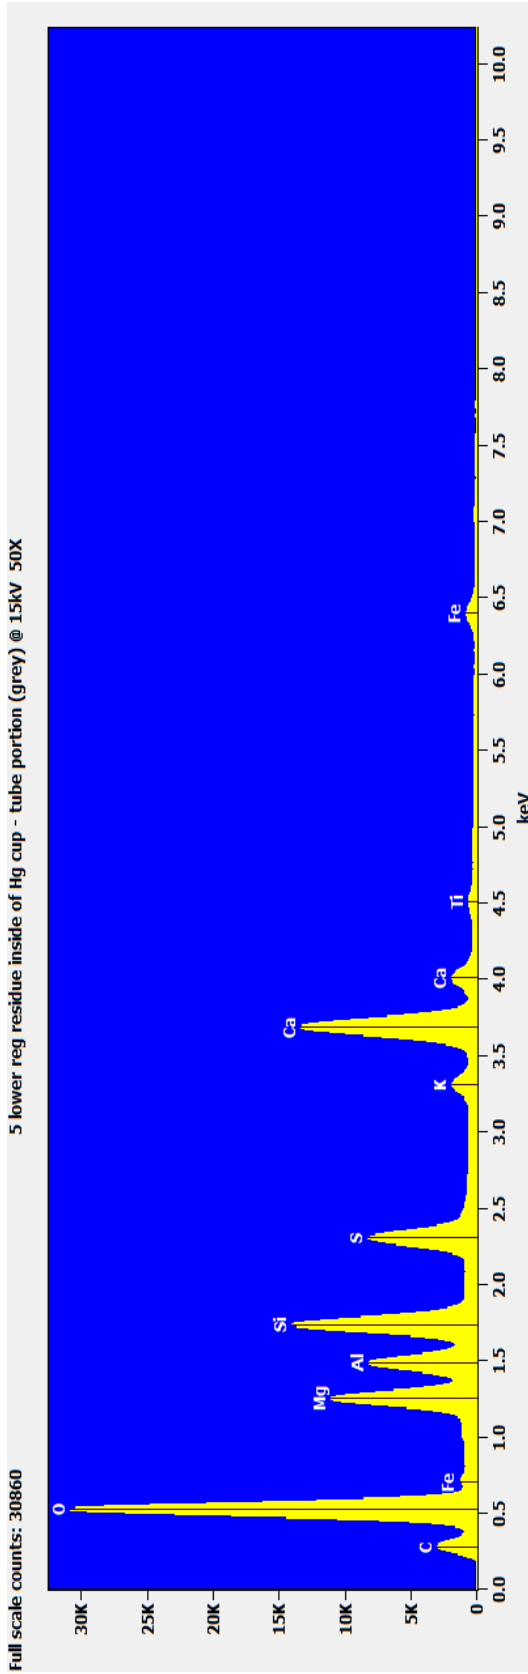
Figure 17. EDS spectrum of a typical residue that was found inside of the mercury cup for the lower regulator assembly.
