NATIONAL TRANSPORTATION SAFETY BOARD

MATERIALS LABORATORY FACTUAL REPORT

Report No. 16-097

Place : Silver Spring, Maryland
Date : August 10, 2016
Vehicle : Washington Gas service pipe and gas regulator assemblies
NTSB No. : DCA16FP003
Investigator : Ravi Chhatre

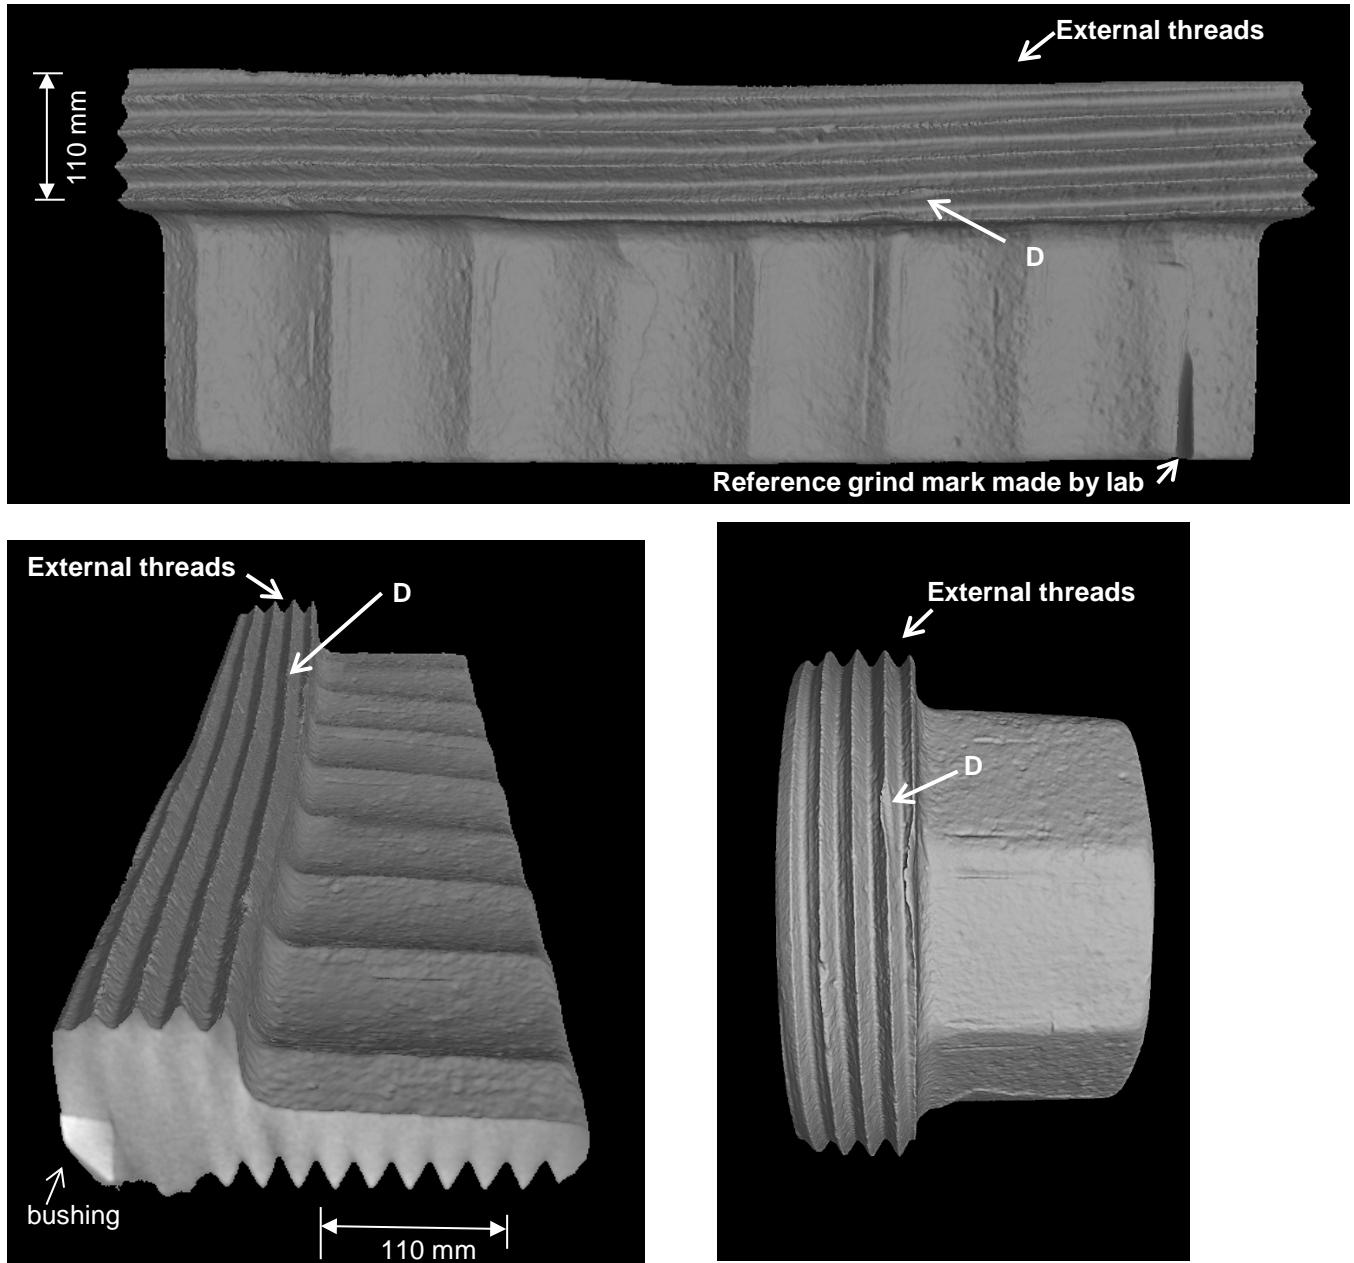
The disassembled external threaded socket and mating nut from the union assembly of the lower gas regulator assembly were subjected to X-ray computed tomography (CT) scan. X-ray CT scanning was contracted to Chesapeake Testing in Belcamp, Maryland. A Nikon Metrology 450 kV micro focus X-ray tube was used to inspect the lower gas regulator assembly. Each CT volume was evaluated using the Volume Graphics Studio Max software package to reconstruct a three-dimensional image of the separated threads. The software package has the capability to take the external surface of a cylinder and unroll/unwind the surface, so that the external surface that extends all around the cylinder is virtually spread out and represented on a flat plane. Appendix 4 show virtual reconstructed images of the external threads of the external threaded socket that were unrolled and spread out on a flat plane. Appendix 5 show a virtual reconstruction images of the mating nut that was unrolled and spread out on a flat plane.

Appendix 4. X-ray CT reconstructed images of the union external threaded socket from the lower pressure regulator assembly. The image on the upper side of the page shows the external threads that were virtually unrolled on a flat plane; the image on the bottom left side of the page shows an oblique view of the flat unrolled external threads and a cross section through the threads at one end of the threads; and the image on the bottom right shows the entire side view of the external threaded socket. The external and internal threads were intact. "D" indicates one of the diagonal dents in figure 6.

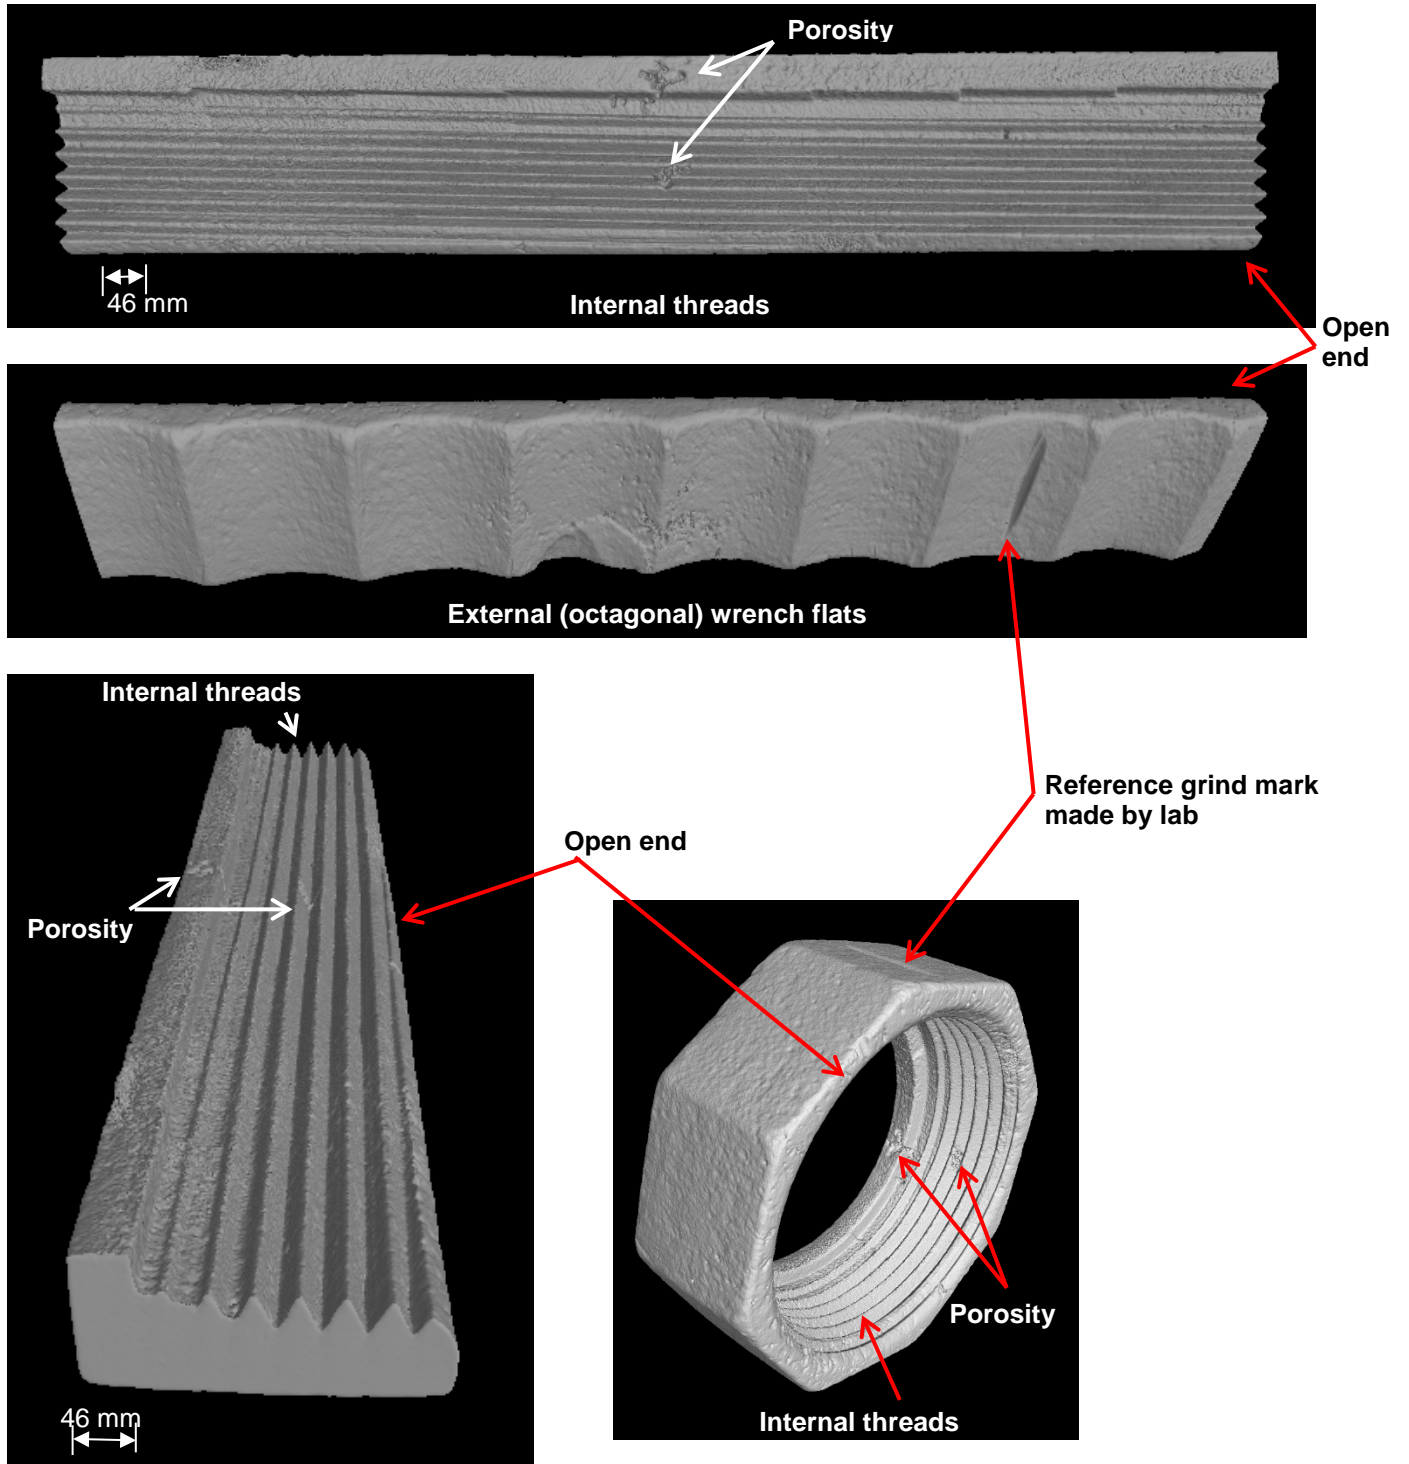
Appendix 5. X-ray CT reconstructed images of the union nut from the lower pressure regulator assembly. The image at the upper side of the page shows the internal threads that were virtually unrolled on a flat plane, image in the center of the page shows virtual unrolled view of the external wrench flats; the image at the bottom left side of the page shows an oblique view of the flat unrolled internal threads with a cross section at one end of the threads; and the image at the bottom right side of the page shows the entire nut. The threads were intact.

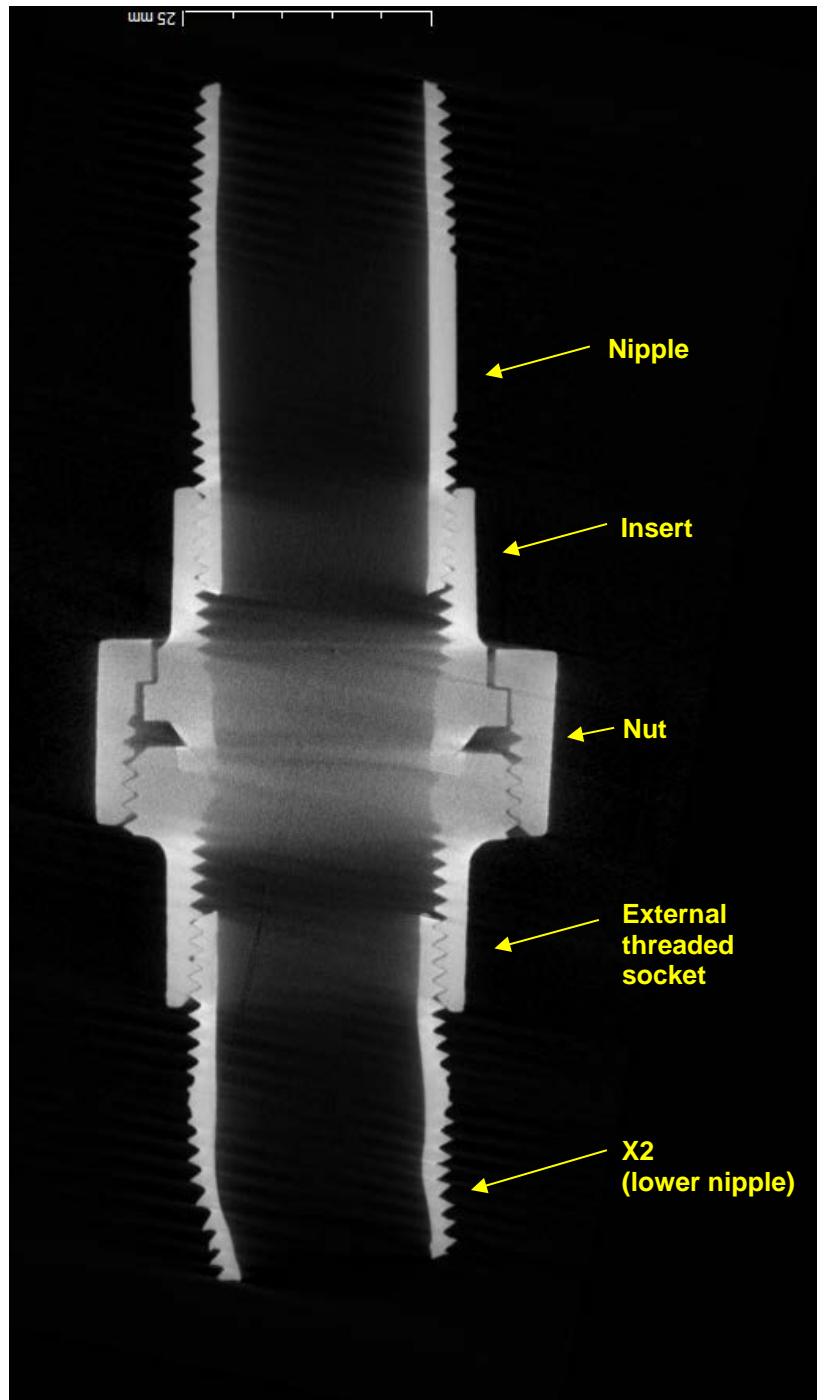
The union assembly was scanned by X-ray CT. Review of the reconstructed image of the union assembly showed that the threads for the external threaded socket and mating nut were intact (see Appendix 6). The external threaded socket was fully inserted into the nut, with the exceptions noted earlier regarding the ability to rotate the nut and external threaded socket relative to the insert portion.

Appendix 6. X-ray image showing the cross section of the union assembly for the upper gas regulator assembly.
