# NATIONAL TRANSPORTATION SAFETY BOARD

MATERIALS LABORATORY FACTUAL REPORT

Report No. 17-001

Place : New Martinsville, West Virginia  
Date : August 27, 2016  
Vehicle : AXLX 1702 Liquid Chlorine Tank Car  
NTSB No. : DCA16SH002  
Investigator : Paul Stancil, RPH-20

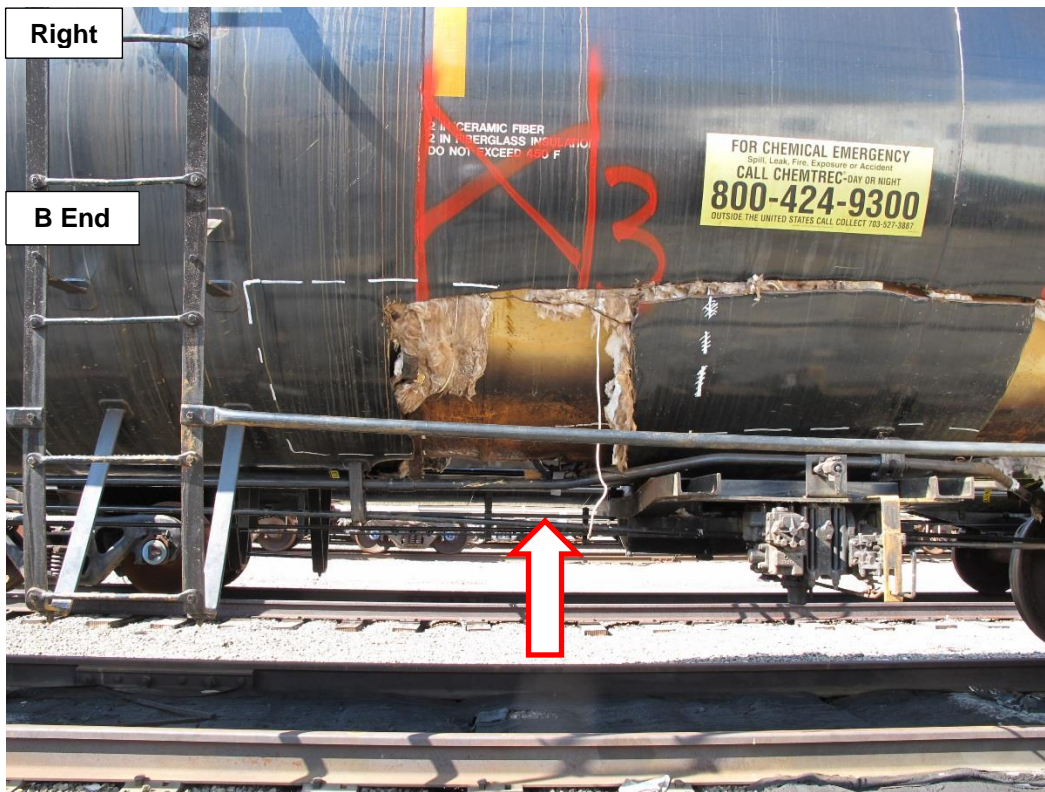
During the initial inspections of the car on September 1, portions of the jacket and insulation had been previously removed, shown in figure 2. Examinations of the tank through the removed portions revealed an approximately 42 inch long, mostly circumferential, crack in the 4<sup>th</sup> ring of the tank near the inboard end of the A end stub sill, as shown in the upper view of figure 3. The crack surfaces and surrounding area of the tank had been sprayed with a preservative compound<sup>5</sup> prior to NTSB examinations. Additional portions of the car jacket and appliances were removed at the direction of the Safety Board and the tank was again examined the following week. In addition, the jacket, insulation and appliances were removed from the area of the inboard end of the stub sill at the B end of the car.

Figure 2. The leak area (red arrows) as viewed on September 1, 2016 with portions jacket and insulation already removed.

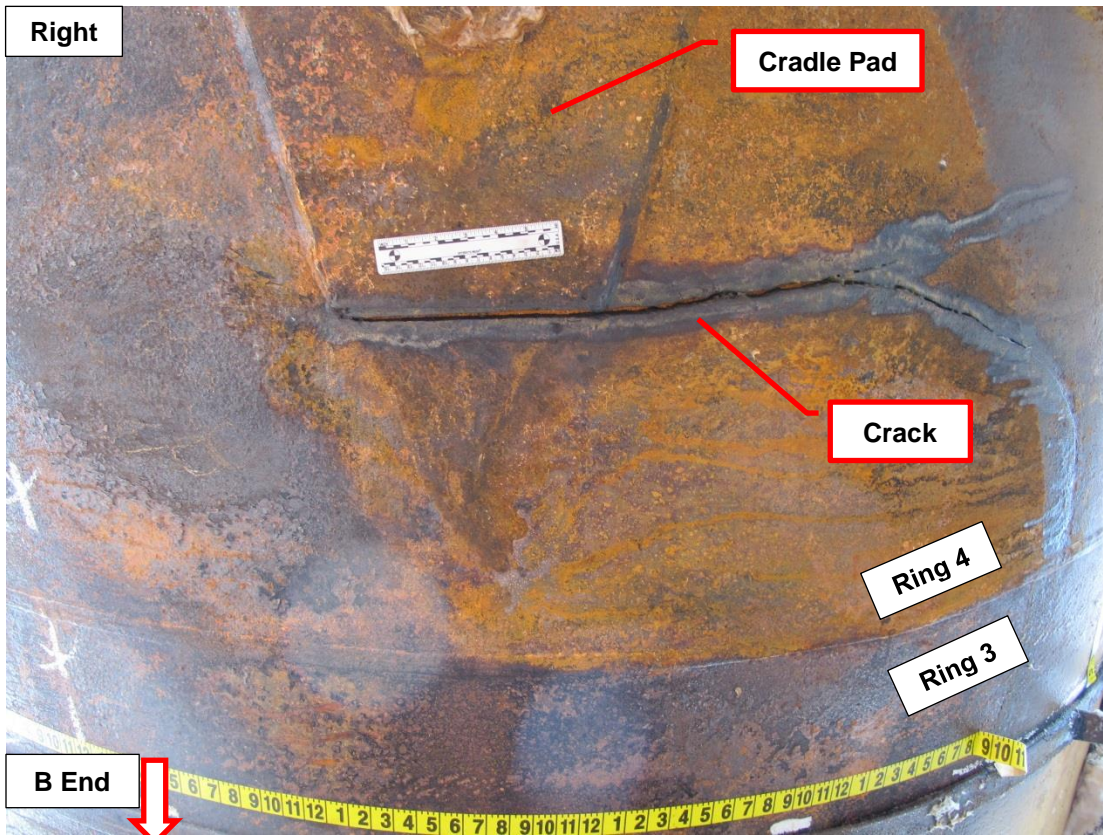
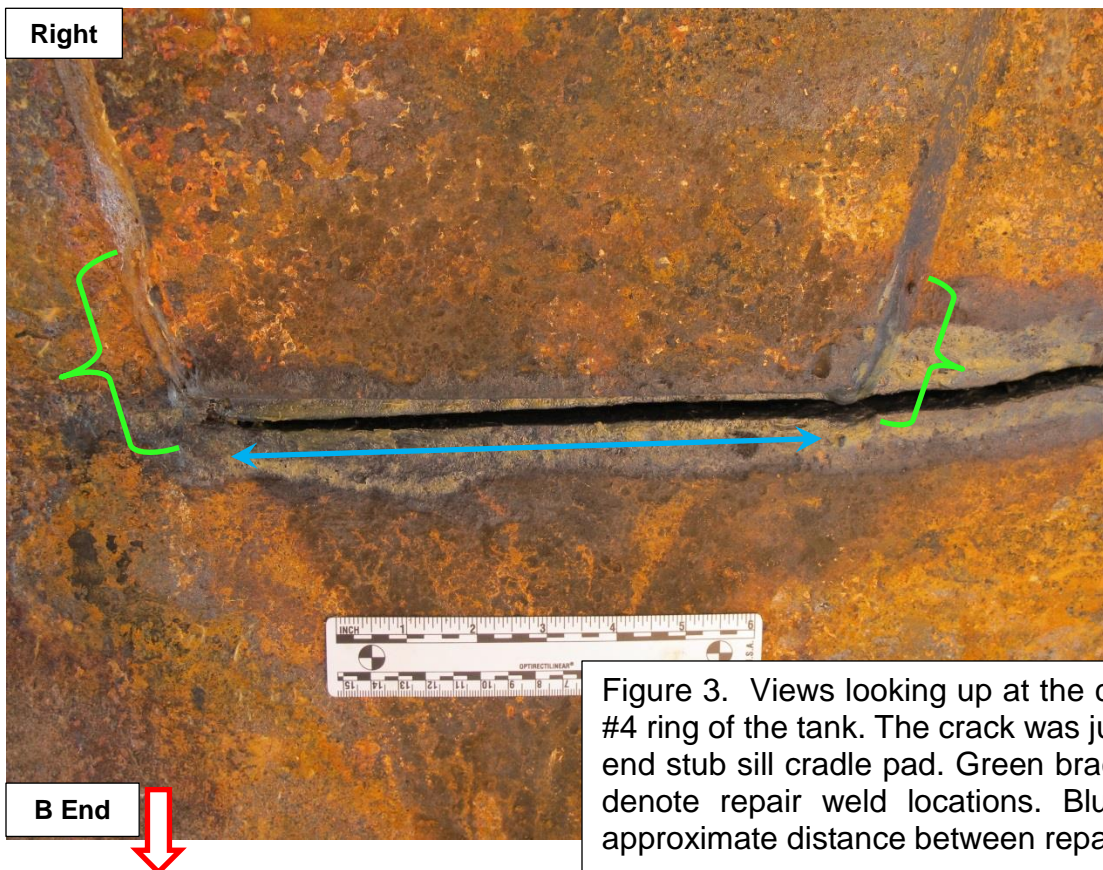
The crack was located about 0.25 to 0.5 inch inboard of the A end stub sill cradle pad and ran circumferentially across the bottom of the tank. To the right (left in views), the crack ended near the right corner of the cradle pad and showed local yielding of the tank material. To the left, the crack ran partially up the side of the tank and split into two legs. One leg continuing circumferentially about 13 inches before arresting and the other leg turned horizontally toward the B end. This leg terminated at the fusion weld between the 4<sup>th</sup> and 3<sup>th</sup> rings. The crack faces were gapped apart about 0.25 inch at the bottom of the tank. However, the only visible yielding deformation was at the right end of the crack.

Different appearing welds were apparent at the inboard ends of both right and left cradle pad to tank welds, see green brackets lower view of figure 3. The different weld were consistent with manually applied shielded metal arc repair welds as documented in the 2010 repairs. On the right side, the repair weld was about 2.5 inches long and about 2 inches long on the left side of the cradle pad.

Photographic measurements at the end of the cradle pad prior to opening of the cracks found approximately 8.5 inches between the welds (indicated by blue arrow in the lower view of figure 3). Complying with the drawing<sup>6</sup> notation of “no weld 8” 2 PLCS” for the end of the cradle pads.

Figure 3. Views looking up at the cracked area of the #4 ring of the tank. The crack was just inboard of the A end stub sill cradle pad. Green brackets in lower view denote repair weld locations. Blue arrow indicates approximate distance between repair welds.

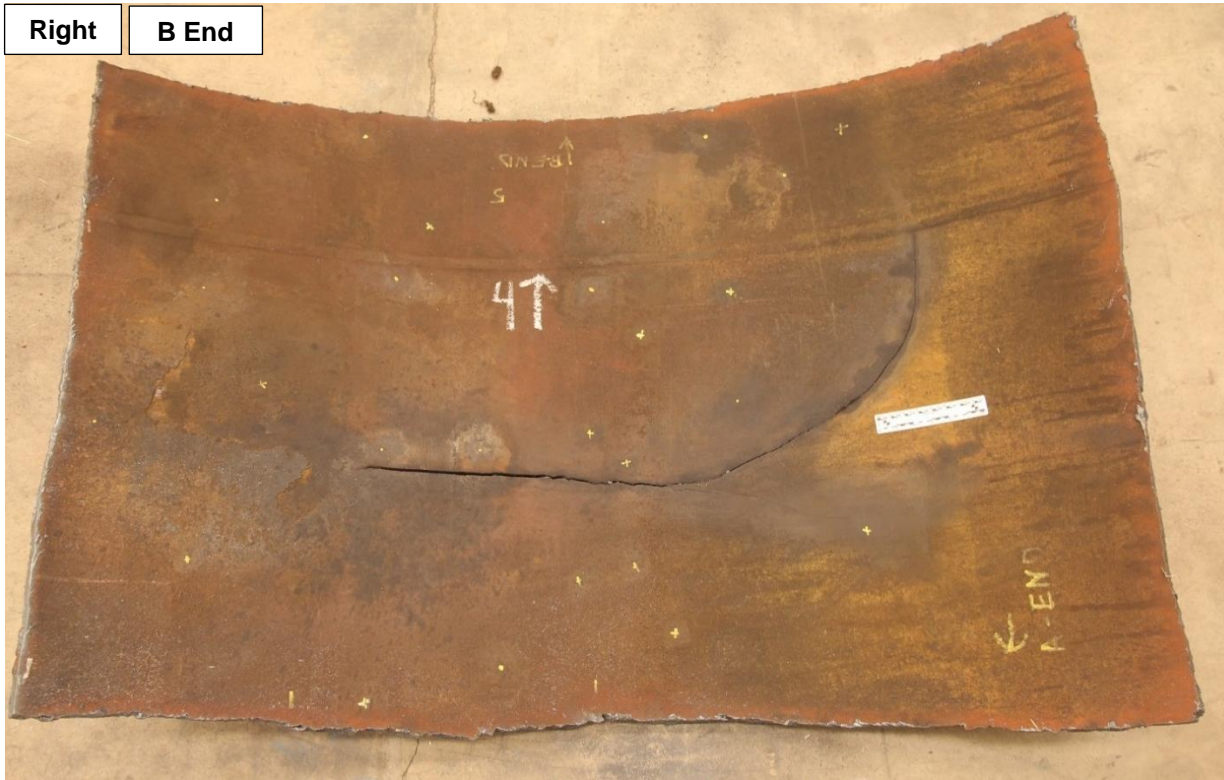
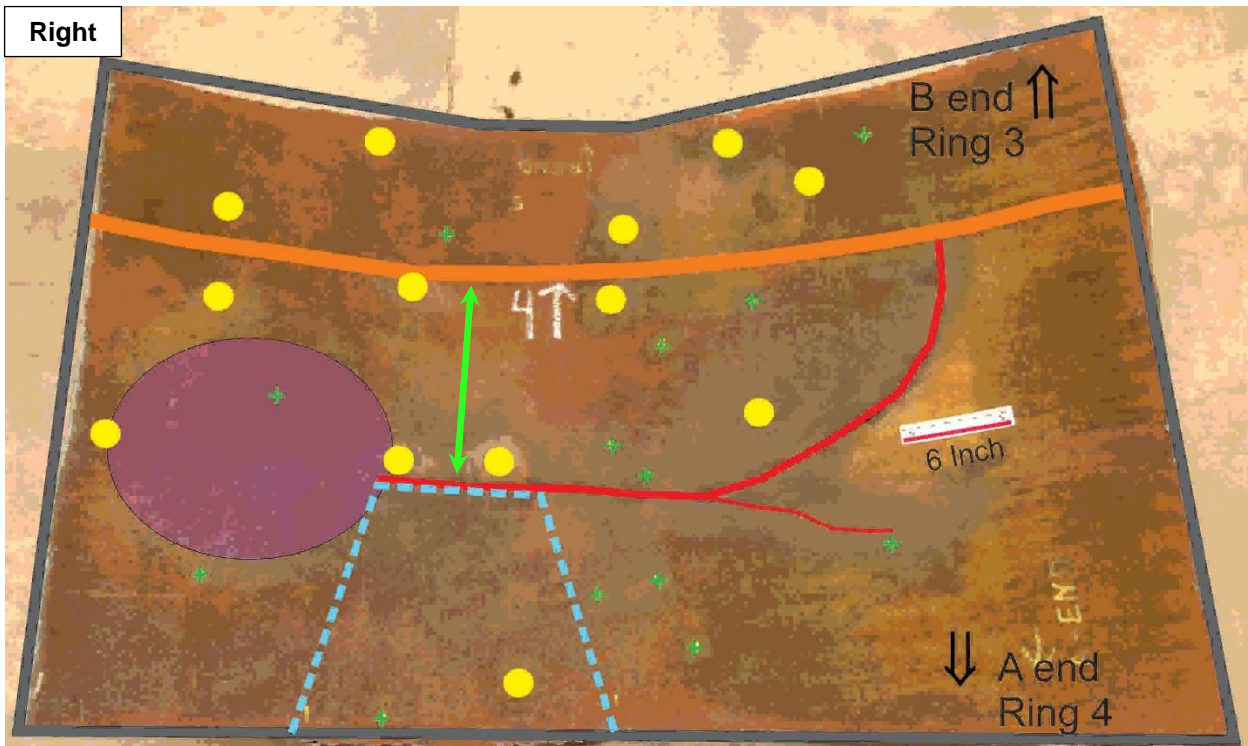
Internal inspections of the tank were performed after the samples were removed. Multiple weld repairs and places where the surface had been abrasively ground were noted on the interior surface but no corrosion pitting was noted. The interior surface of the removed cracked section had 13 visible weld repairs. Of these, eight welds and 11 ground spots were noted in ring 4 and five repair welds and two ground spots were found in ring 3. Two weld repair areas were just inboard of but did not intersect the crack. The interior surface of the removed sample at the A end is displayed in upper view of figure 4. The lower view of figure 4 is marked and annotated to show the locations of the weld repairs and ground spots. In addition, the shape and location of the end of the cradle pad located on the opposite side is illustrated (dashed blue lines).

Using a straight edge, a deformation of the ring 4 was noted between the crack at the cradle pad and the ring 3 to 4 weld joint. In the approximate 11 inch distance, the interior surface was deformed downward approximately ½ inch. The circumferential extent of the deformation was not established. The measurement location for this deformation is denoted by the double green arrow in the lower view of figure 4.

Figure 4. Upper view shows the interior tank surface of the removed A end section containing the crack. The lower view is annotated showing the crack location, red line, the weld repair spots, yellow circles, the ground spots green plus marks and the manufacturing weld between ring 3 and ring 4, wide orange line. The shape of the cradle pad is also indicated by the dashed blue line. The purple oval on the left indicates the visible scaling on the interior surface. (see figure 5)

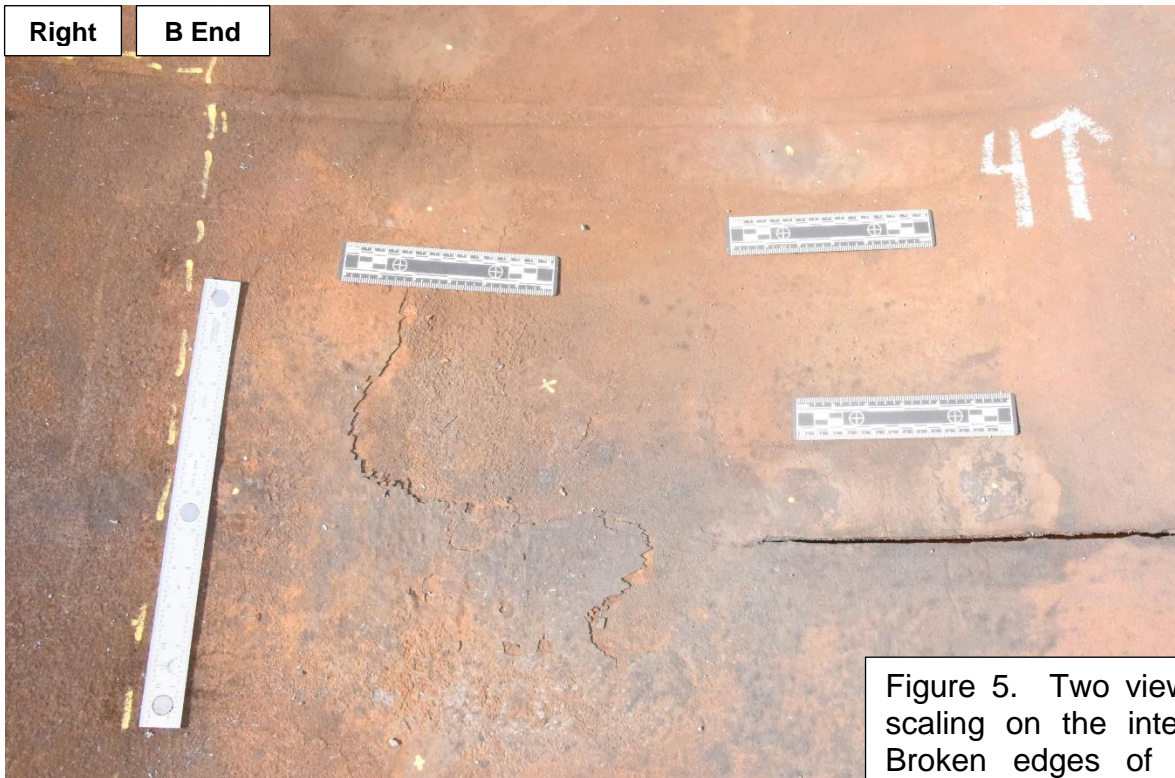
Inspections of the interior surface also uncovered an area of heavy surface oxide (scale) near the right corner of the A end cradle pad, as shown in the two views of figure 5. The boundaries of the scaling were indistinct but estimated to be at least 12 inches in diameter and included the right side termination of the crack, denoted by the purple area in the lower view of figure 4. The scaling was indicative of high temperature exposure and later measured to be greater than 0.03 inch in thickness, as shown in figure 6.

Figure 5. Two views of the surface scaling on the interior of the tank. Broken edges of oxide scale are visible.

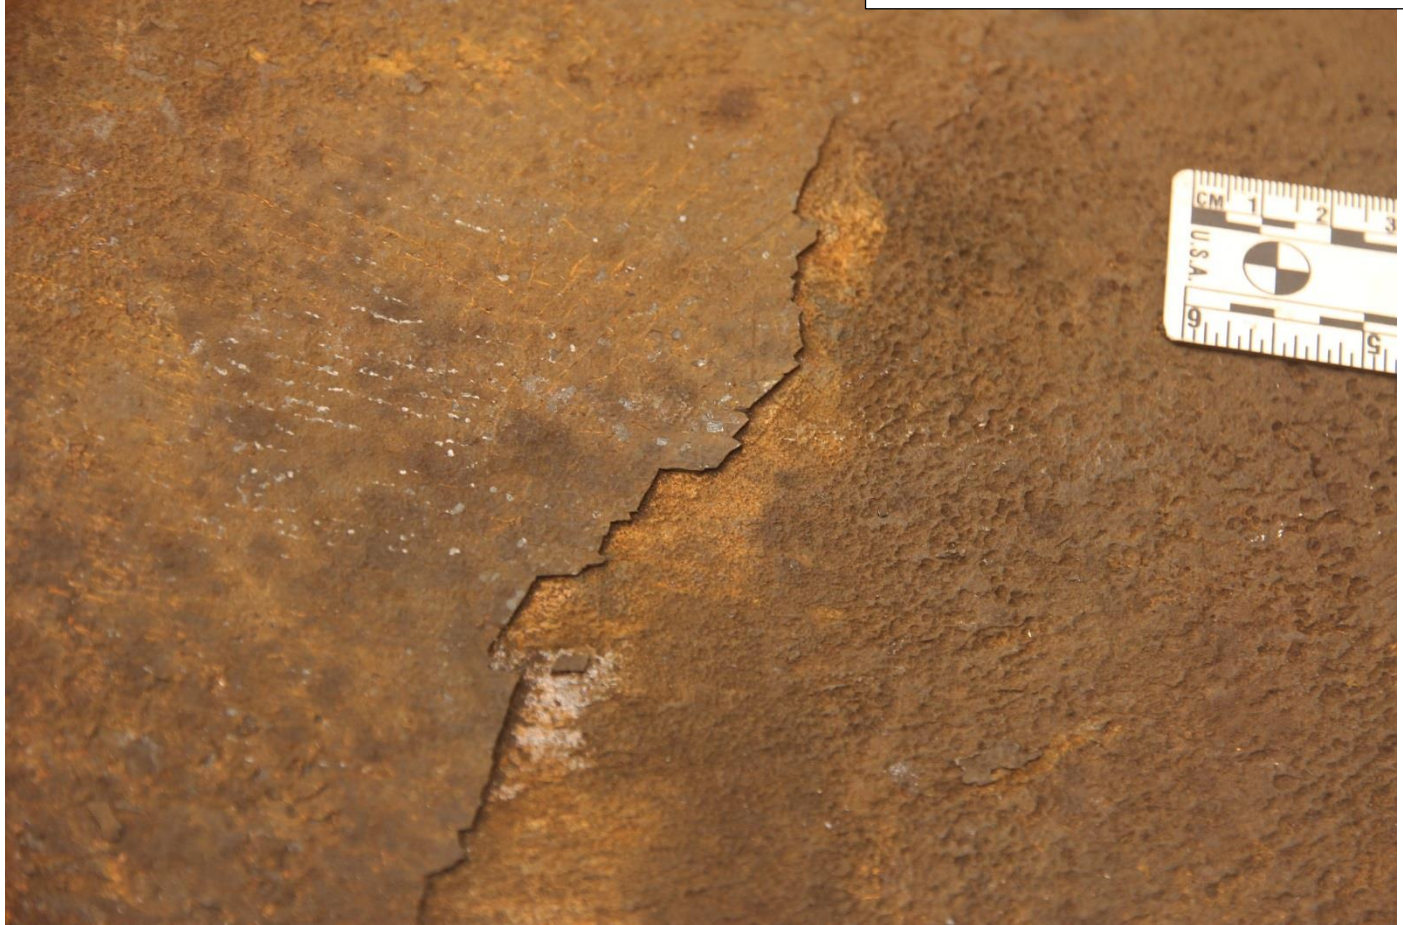
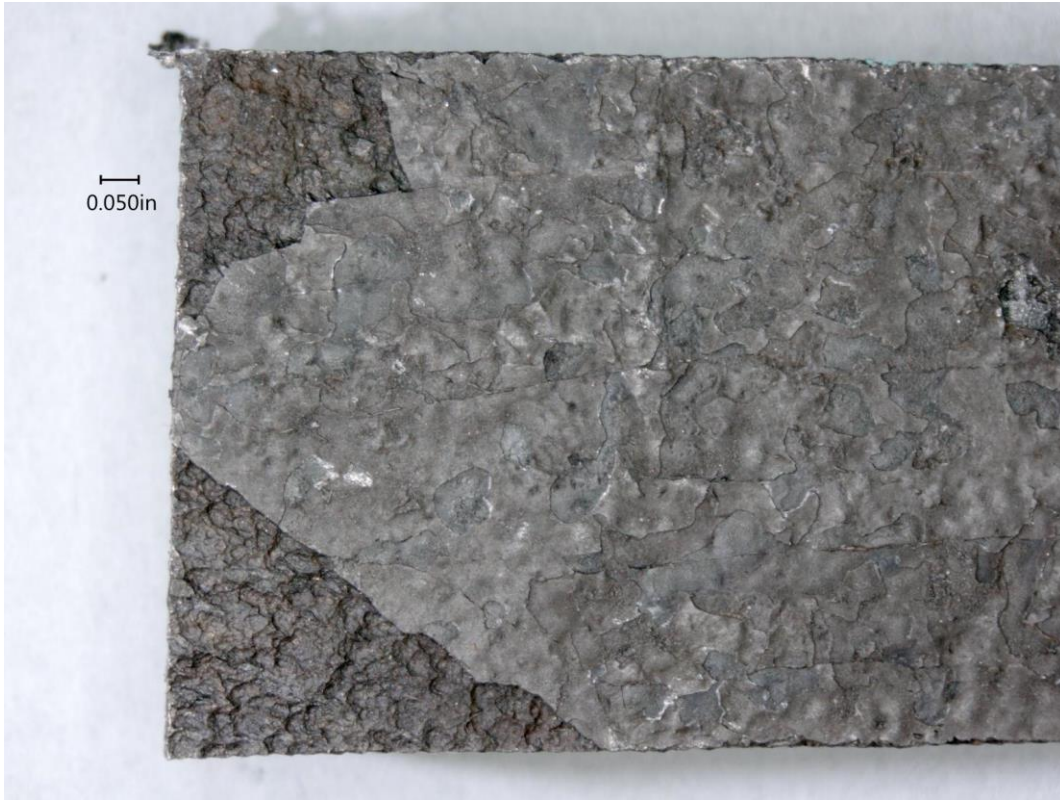
Figure 6. At top is a closer view of the surface scale where it has partially flaked off a cut piece of the tank. The lower view shows the scale in cross section with thickness measurements.

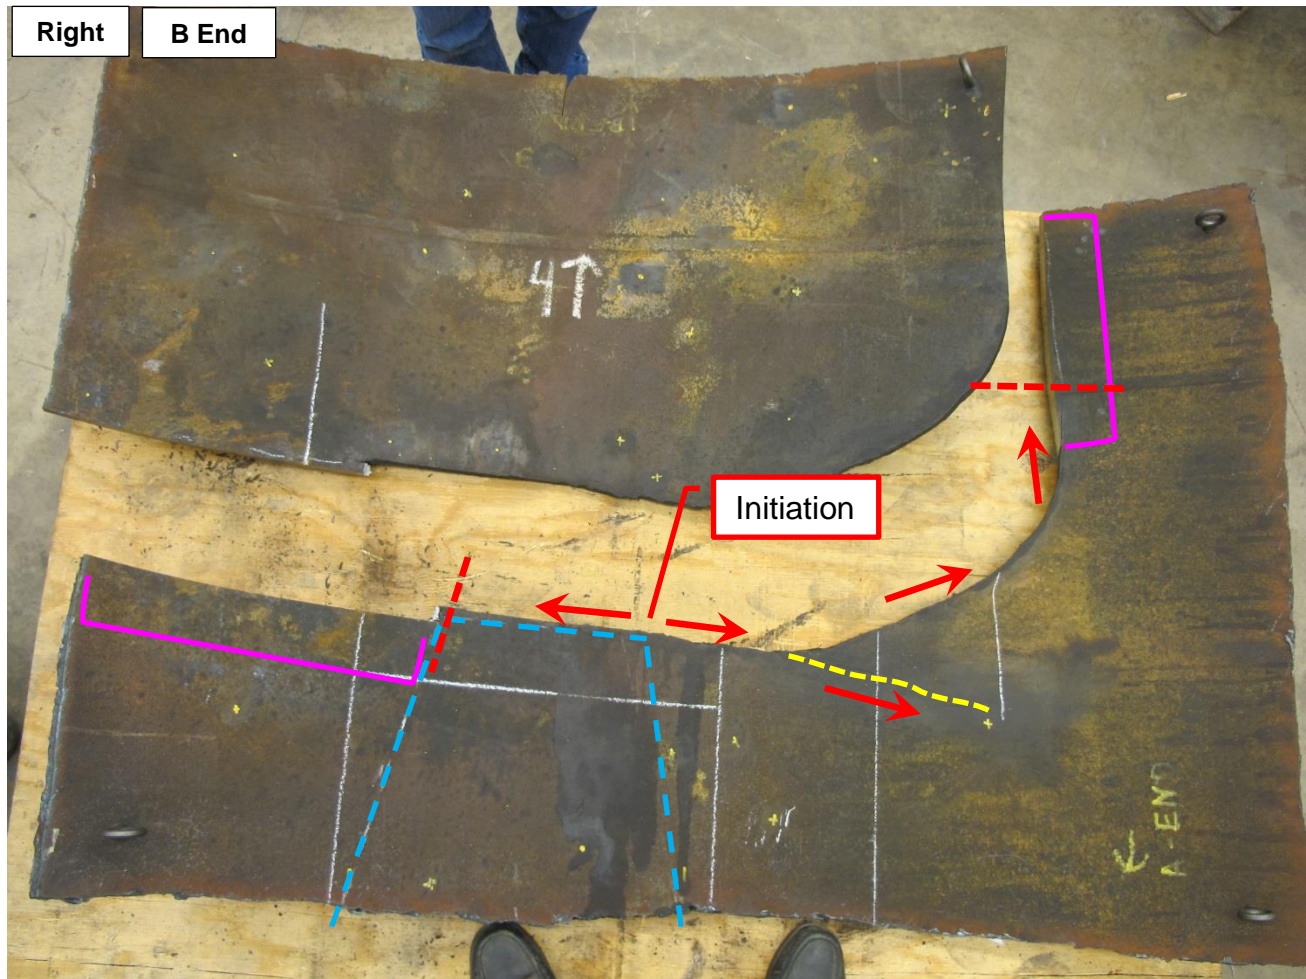
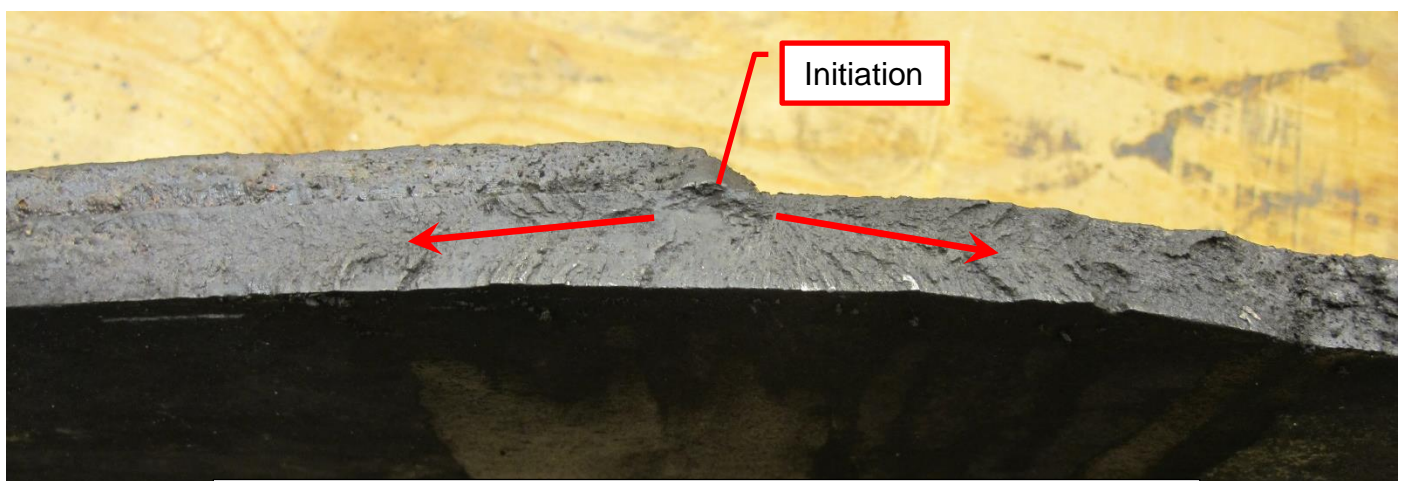
The A end crack was opened by band saw cuts (purple brackets) to near the ends of the crack and applying force to break the remaining ligaments, as shown in figure 7. Features on the revealed crack faces (lower view figure 7) were consistent with brittle fracture propagation for the entire length of the crack. Chevron markings on the crack faces demonstrated that the crack initiated near the toe of the left hand repair weld bead, as shown in figure 7. Propagation was circumferentially away from the left weld. Progression to the right side arrested (dashed red line) near the right cradle pad repair weld, but did not intersect the weld or its apparent heat affected zone. Crack propagation to the left continued to propagate circumferentially before splitting into two legs with the longer portion turning toward the B end of the car and arresting in the fusion weld (dashed red line) connecting rings 3 and 4. The shorter leg of the crack (dashed yellow line) continued for a distance and arrested in the middle of the plate.

Figure 7. Top view shows the interior surface of the tank after the crack was opened by saw cut (purple brackets). The initiation area at the left repair weld of the cradle pad (outlined as dashed blue) is shown with the propagation directions indicated by red arrows to the crack termini at the dashed red lines. Lower view shows brittle propagation away (red arrows) from the initiation at the repair weld.

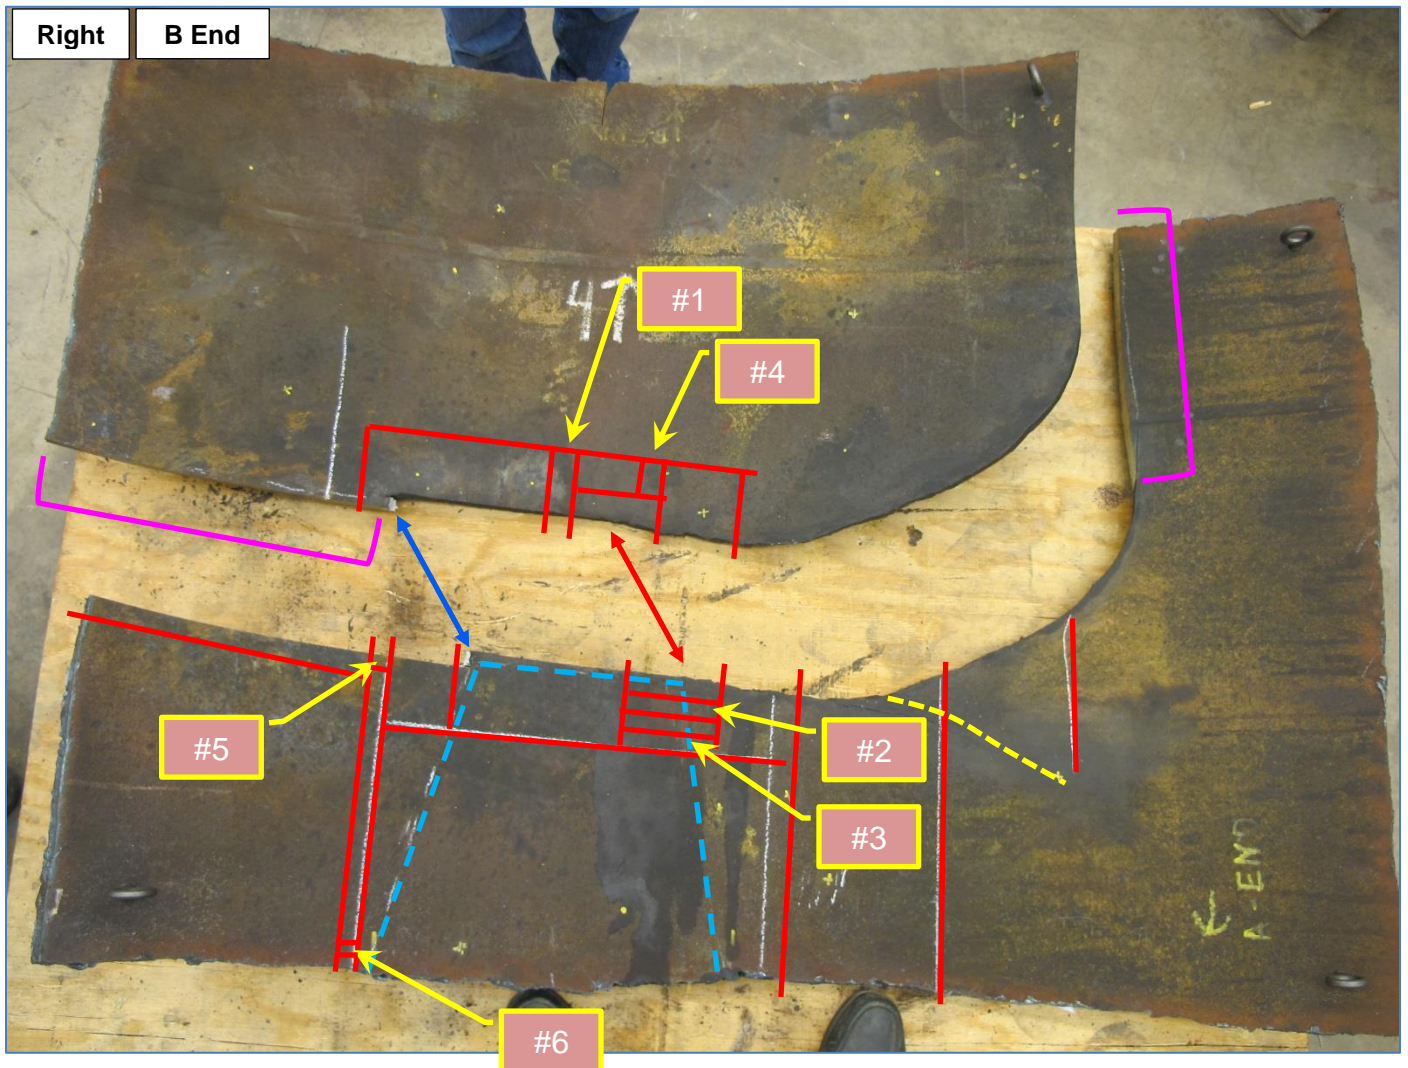
The crack area near the cradle pad and welds was further sectioned as indicated in figure 8. The removed pieces of crack were cleaned and the previously sprayed on corrosion preventative compound was removed by ultrasonic agitation in toluene. The sections containing the crack initiation are shown in figure 9. Closer inspection of the initiation area after cleaning uncovered a darker-colored elliptically-shaped region at the weld toe. The dark coloration and magnified appearance were consistent with an oxide layer. The elliptical region was oriented at about 45 degrees to the plate surface approximately bisecting the intersecting surfaces of the weld bead and the surface of the plate. The dark region was poorly defined but was estimated to be about 0.7 inch wide by about 0.2 inch deep.

Figure 8. The opened crack with the initial saw cuts at the purple brackets and subsequent sectioning lines indicated by red lines. Double headed arrows denote mating locations on the two pieces of tank. Locations of metallographic sections #1 thru #6 are also indicated. Dashed blue lines denote the location of the cradle pad on the opposite of the shell.

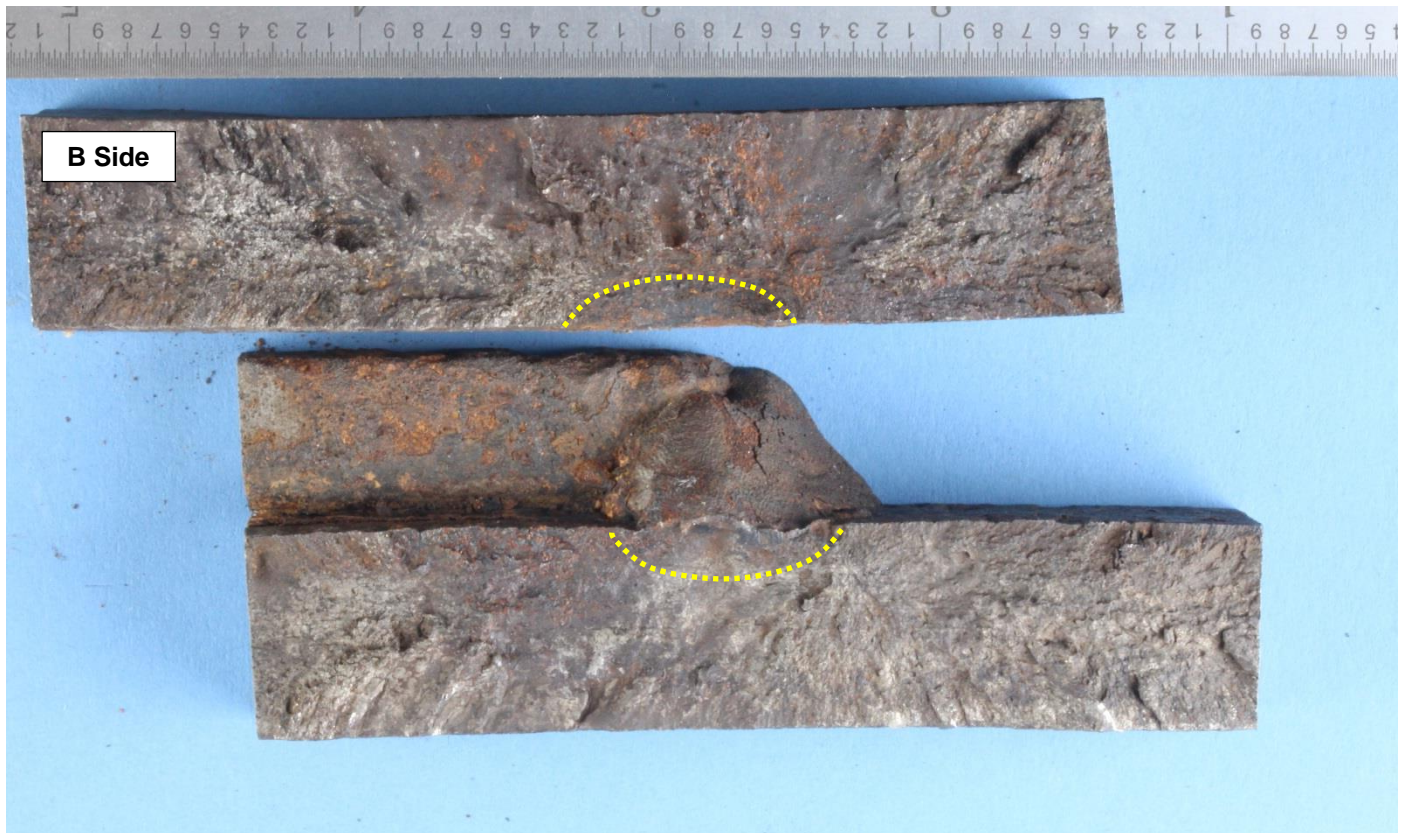
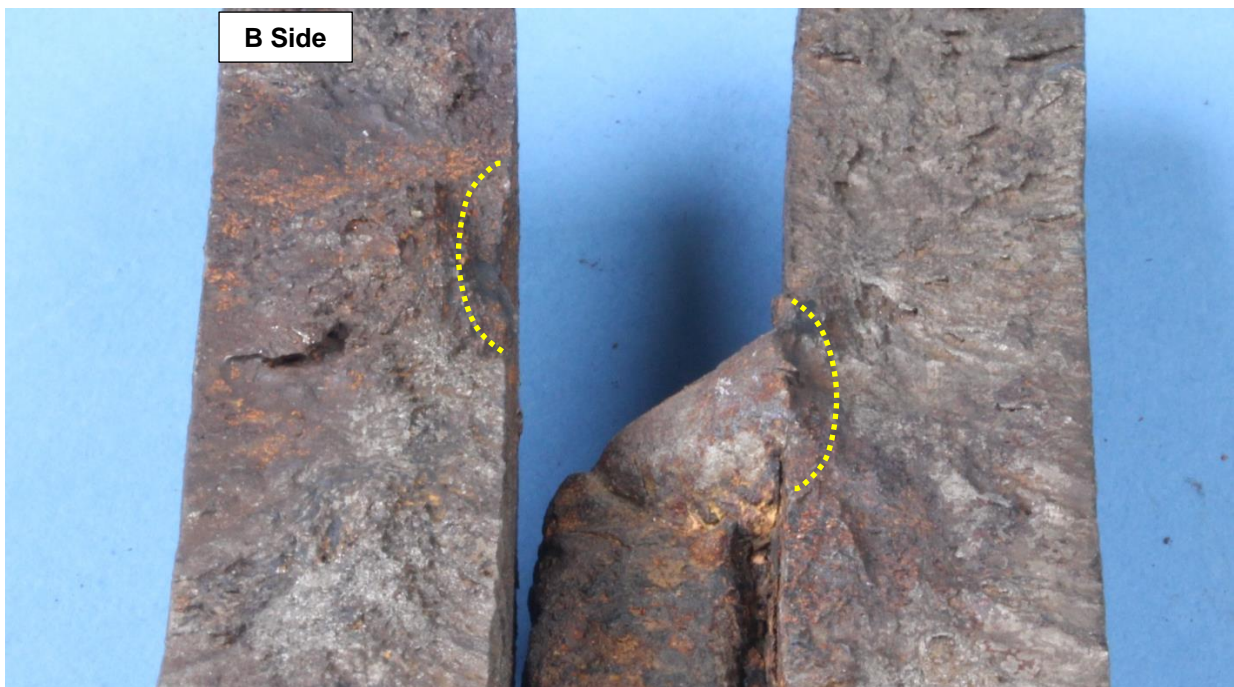
Figure 9. Two views of the mating fracture faces showing the initiation area at the toe of the repair weld with the dotted lines indicating the dark oxide region. Upper view is looking straight at the fracture surface while the lower view is at an oblique angle showing the angled orientation of the oxide region.

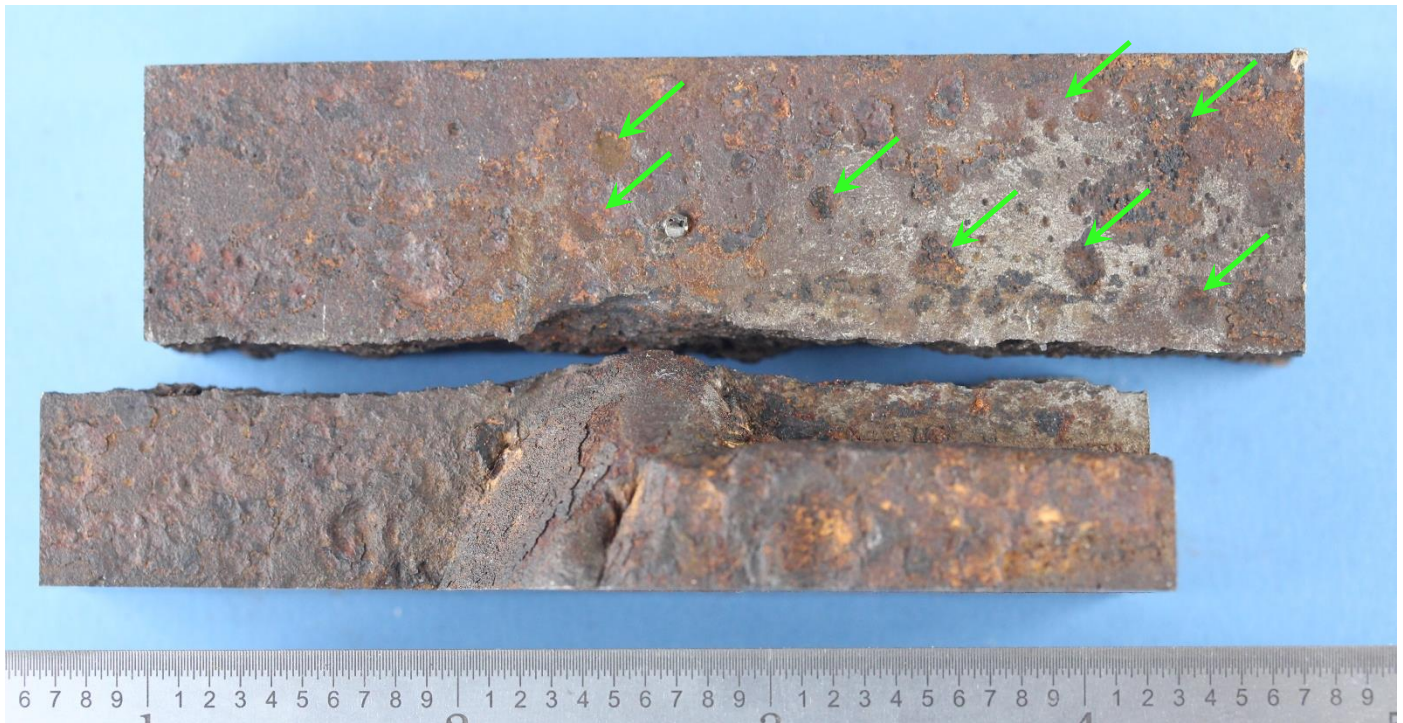
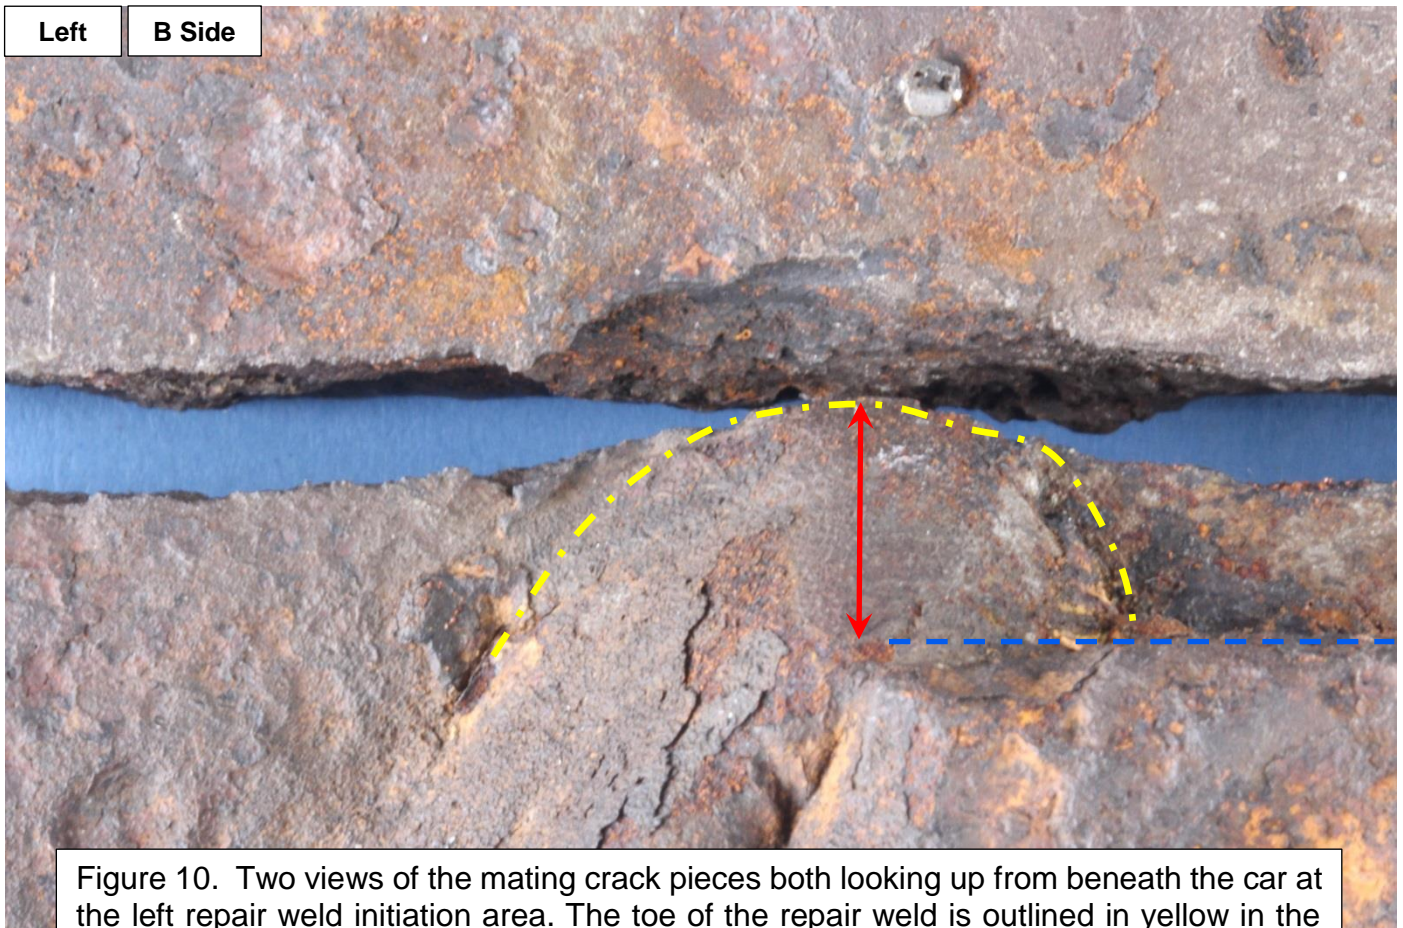
The initiation region also roughly followed the curved shape of the toe of the weld as shown in figure 10. The lower view of figure 10 also shows the toe of the repair bead (outlined in yellow) projecting past the end of the cradle pad (dashed blue line) by almost 0.30 inch (double red arrow). The repair weld bead was about 0.76 inch wide at the end of the pad. Also note in the upper view that the exterior surface of the tanks exhibited extensive surface corrosion pits (green arrows).

Figure 10. Two views of the mating crack pieces both looking up from beneath the car at the left repair weld initiation area. The toe of the repair weld is outlined in yellow in the lower view with the blue line indicating the end of the cradle pad. Green arrows in the upper view denote some of the corrosion pits in the outer surface of the tank.

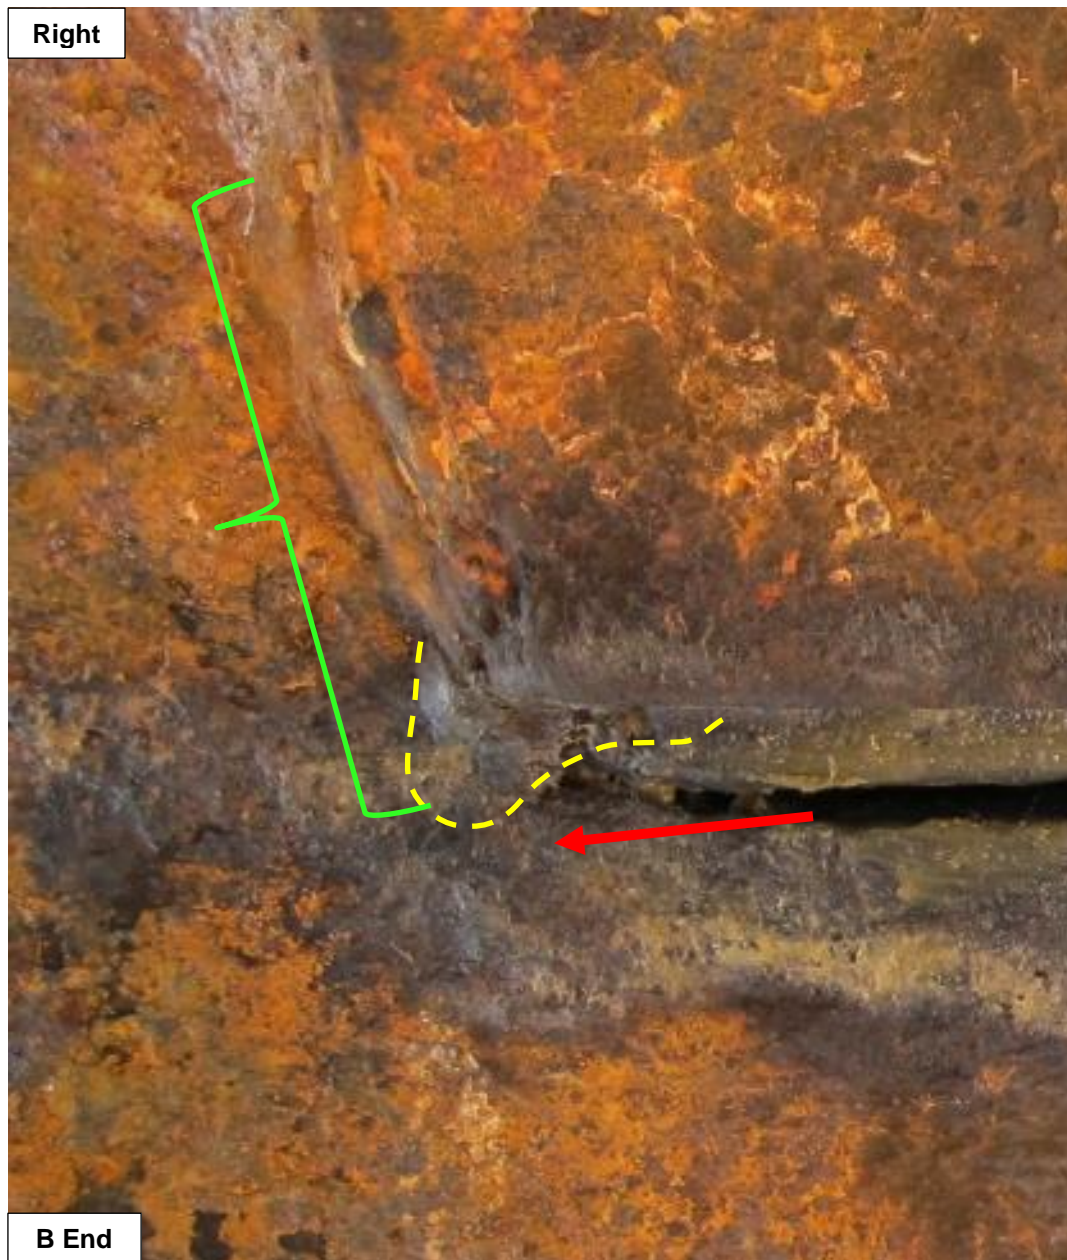
As shown in figure 11, the right terminus of the crack (red arrow) did not intersect the right side cradle pad repair weld (outlined by the dashed yellow line) but rather arrested just inboard of the repair weld. The end of the crack exhibited significant bulk yielding deformation not seen at any other location along the crack. During opening of the crack, the repair weld was partially cut into but details remained showing that the repair weld was made of several beads that did not blend smoothly together. The B end of the weld partially wrapped around the corner of the cradle pad and exhibited poor

Figure 11. An intact view showing the relationship between the right end (red arrow) of the crack and the nearby right side repair weld (green bracket) with surfaces covered by preservative. The inboard toe of the weld is outlined in yellow.

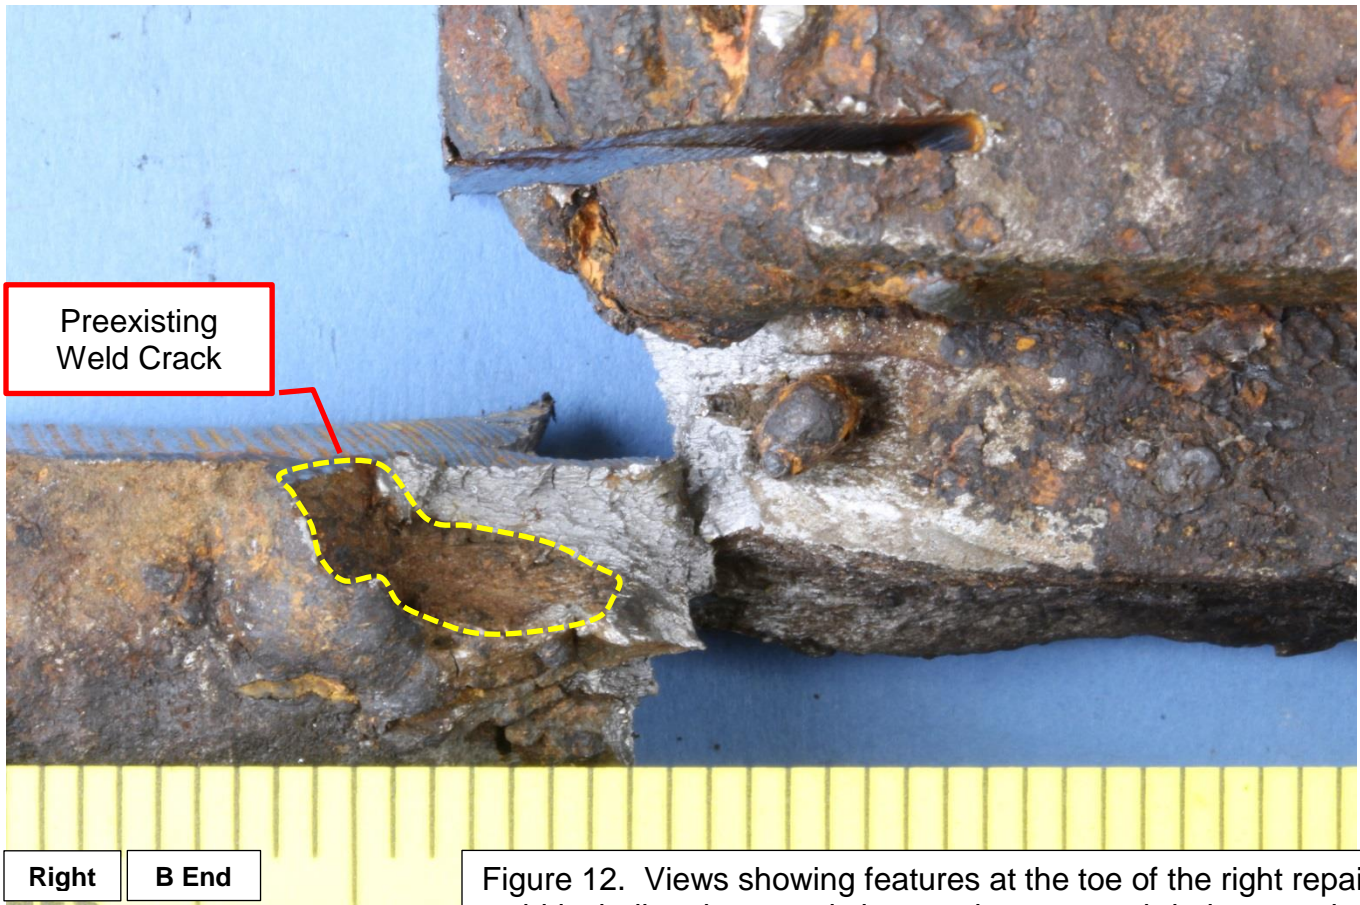
workmanship with a large undercut area at the end and adjacent large melt balls, see figure 12. The repair weld also visually exhibited surface-connected pores on the sides and lack of penetration at the end.

Opening the large crack also opened an oxide-covered preexisting crack through the repair weld. The preexisting weld crack measured about 0.6 inch wide and 0.3 inch deep is outlined in yellow in figure 12.

Figure 12. Views showing features at the toe of the right repair weld including the preexisting crack uncovered during opening of the large crack. A large surface connected pore, areas of lack of fusion and undercutting and melt balls are also denoted.
