# NATIONAL TRANSPORTATION SAFETY BOARD

MATERIALS LABORATORY FACTUAL REPORT

Report No. 17-001

Place : New Martinsville, West Virginia  
Date : August 27, 2016  
Vehicle : AXLX 1702 Liquid Chlorine Tank Car  
NTSB No. : DCA16SH002  
Investigator : Paul Stancil, RPH-20

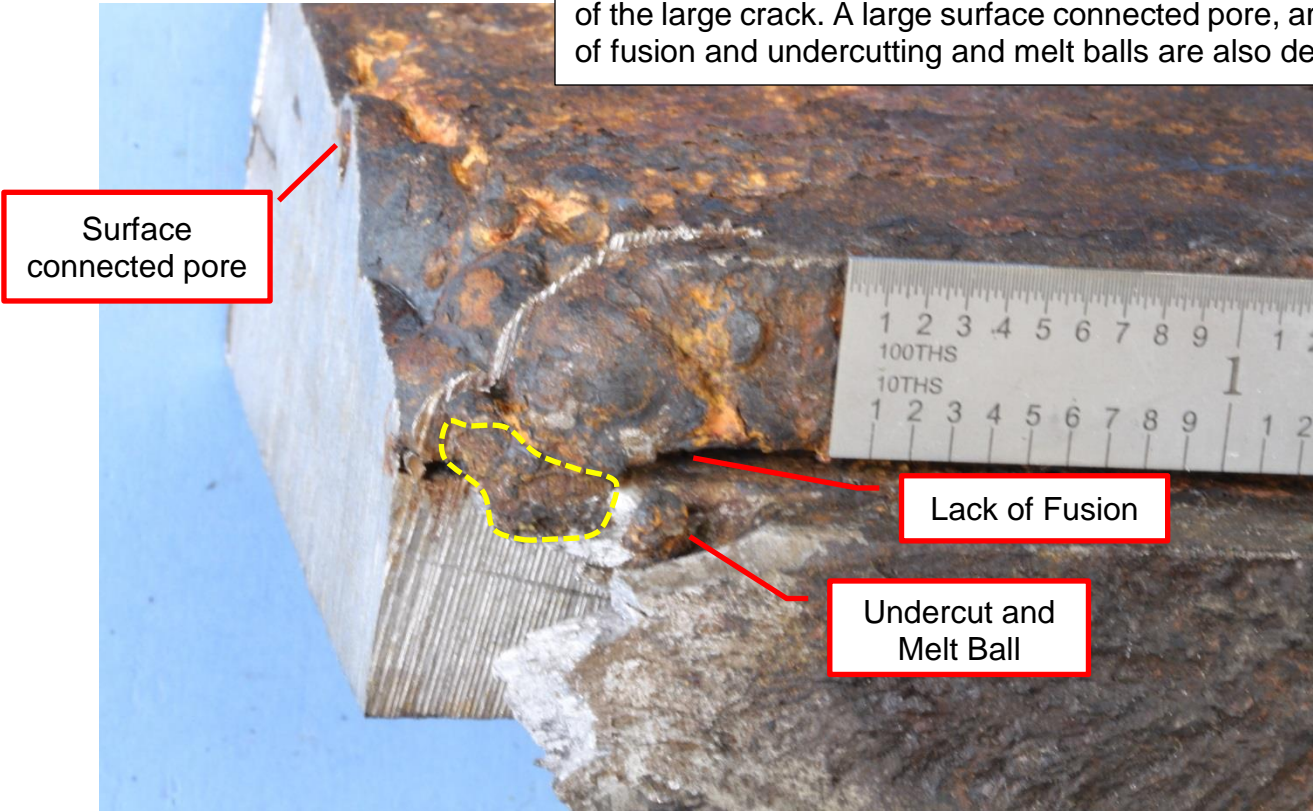
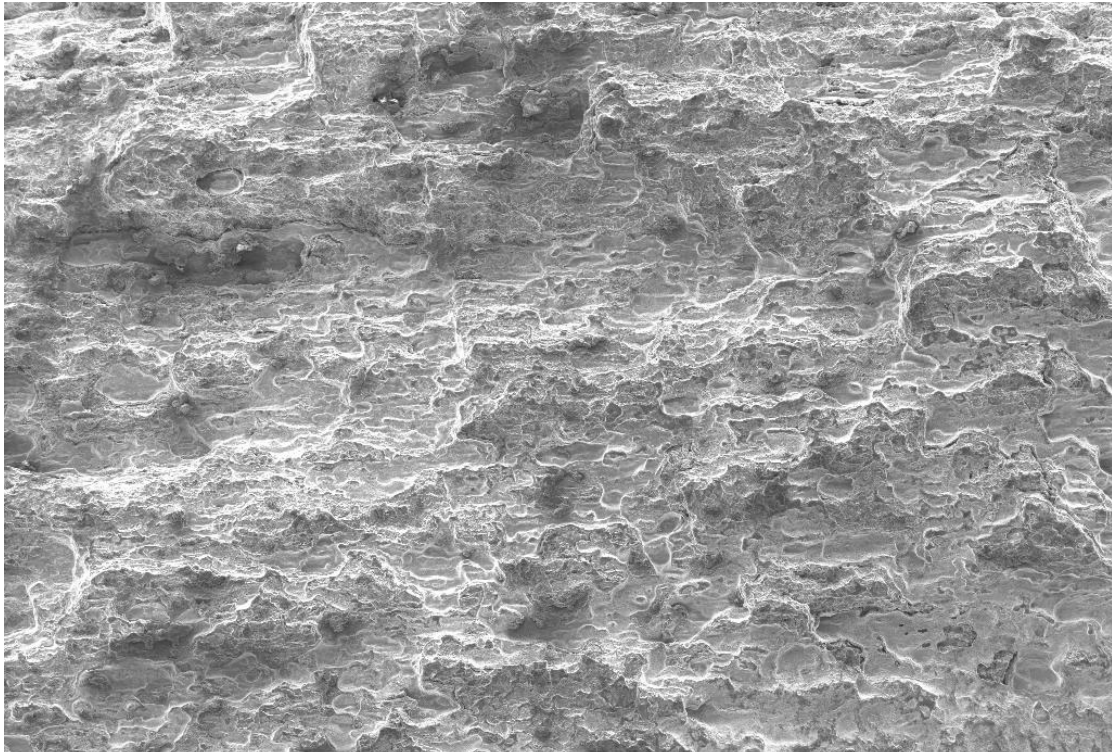
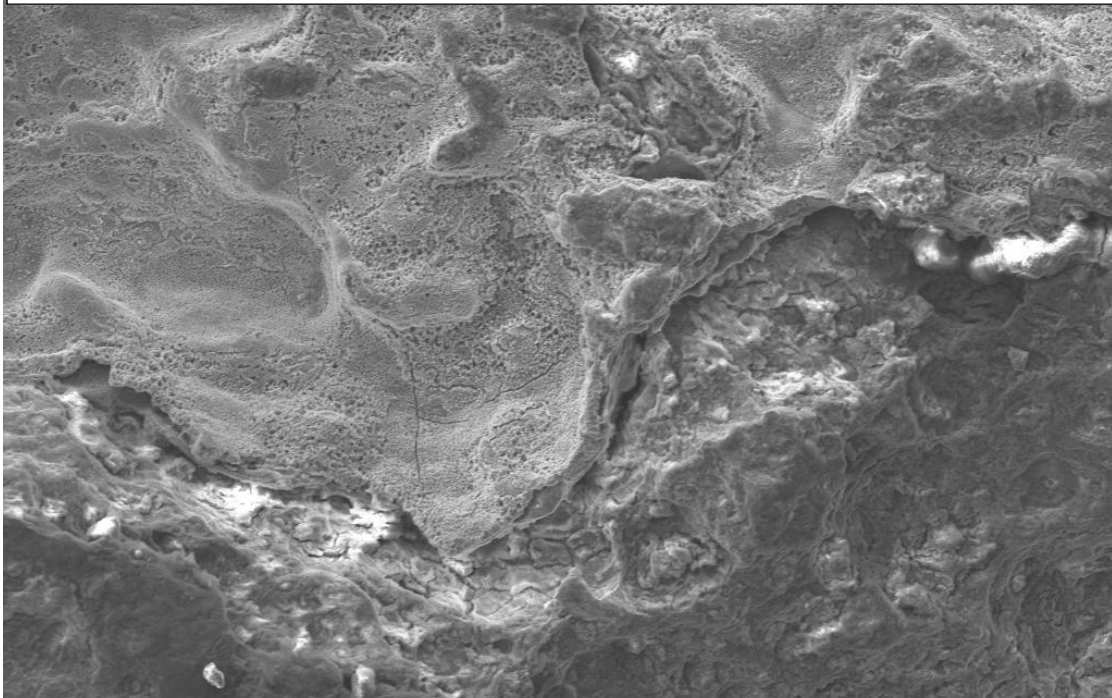
After extensive ultrasonic cleaning in detergent and alcohol, the inboard side (B side) of the crack initiation and surrounding areas were examined with a scanning electron microscope (SEM). At lower magnification, the initiation area displayed a woody fracture topography as shown in the upper view of figure 13. Closer viewing and Energy Dispersive Spectrographic Analysis (EDS) showed that the woody initiation region was covered by a heavy oxide layer that obscured and obliterated the fine fracture features.

Figure 13. SEM views of the B side crack face in the initiation area showing woody fracture features above and a heavy oxide layer below.

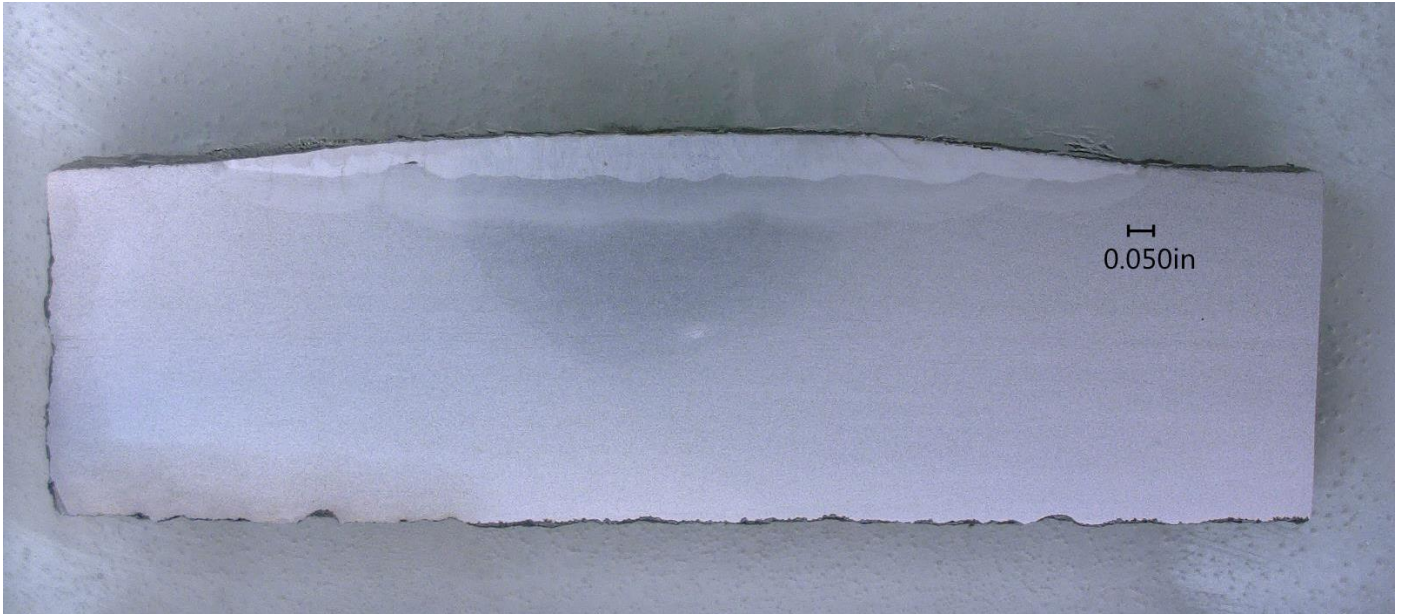
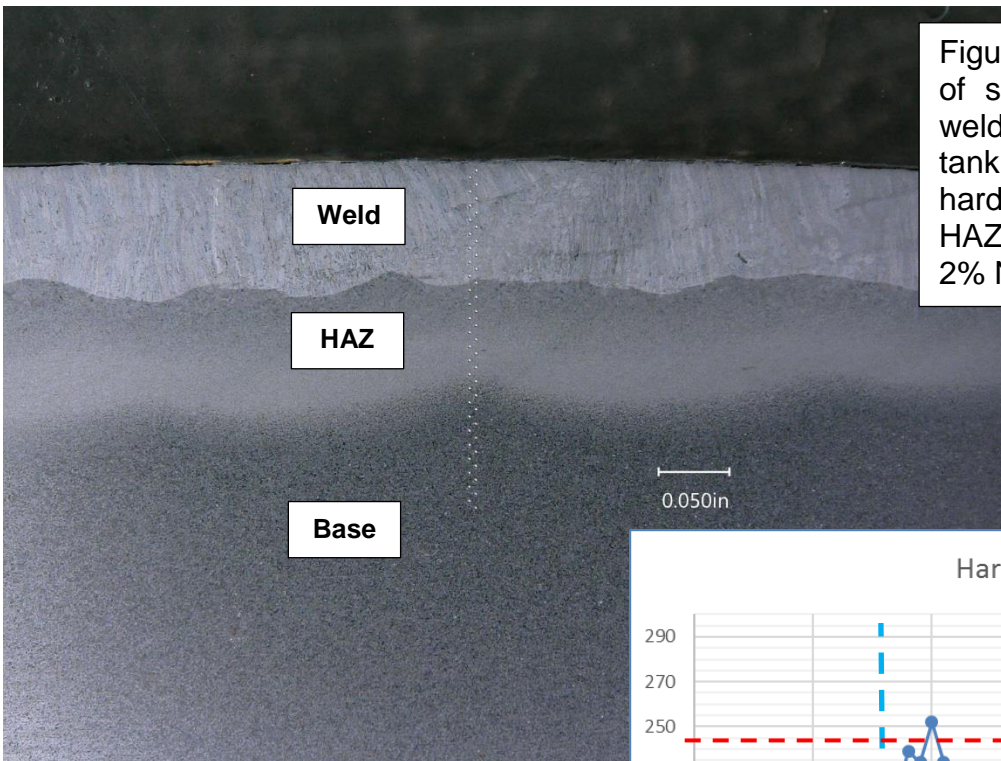
Section #1, figure 15, was through one of the interior surface weld repairs near the fracture. The weld fusion zone and underlying HAZ were each about 0.09 inch deep. A microhardness traverse revealed a generally uniform hardness across the weld, HAZ and base metal as shown by the chart in figure 15. Hardness ranged from 91 to 100 HRB.

Figure 15. Metallographic views of section #1 through a repair weld on the interior surface of the tank at left and above. Vickers hardness, profile across weld, HAZ and into base metal below. 2% Nital Etch.

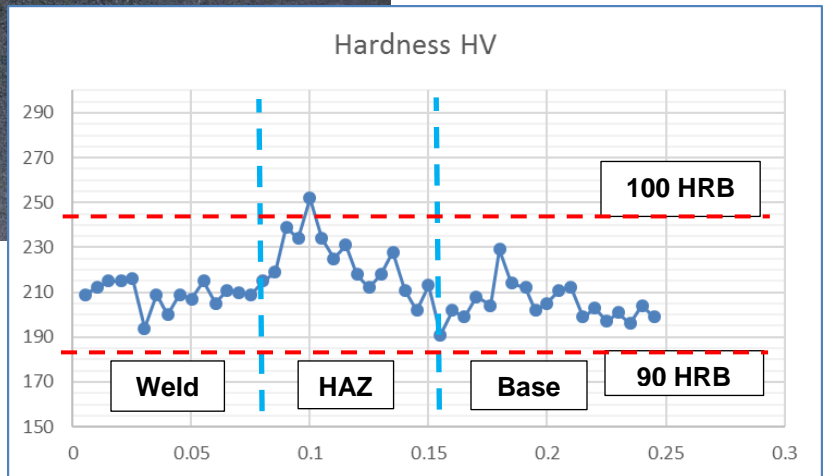
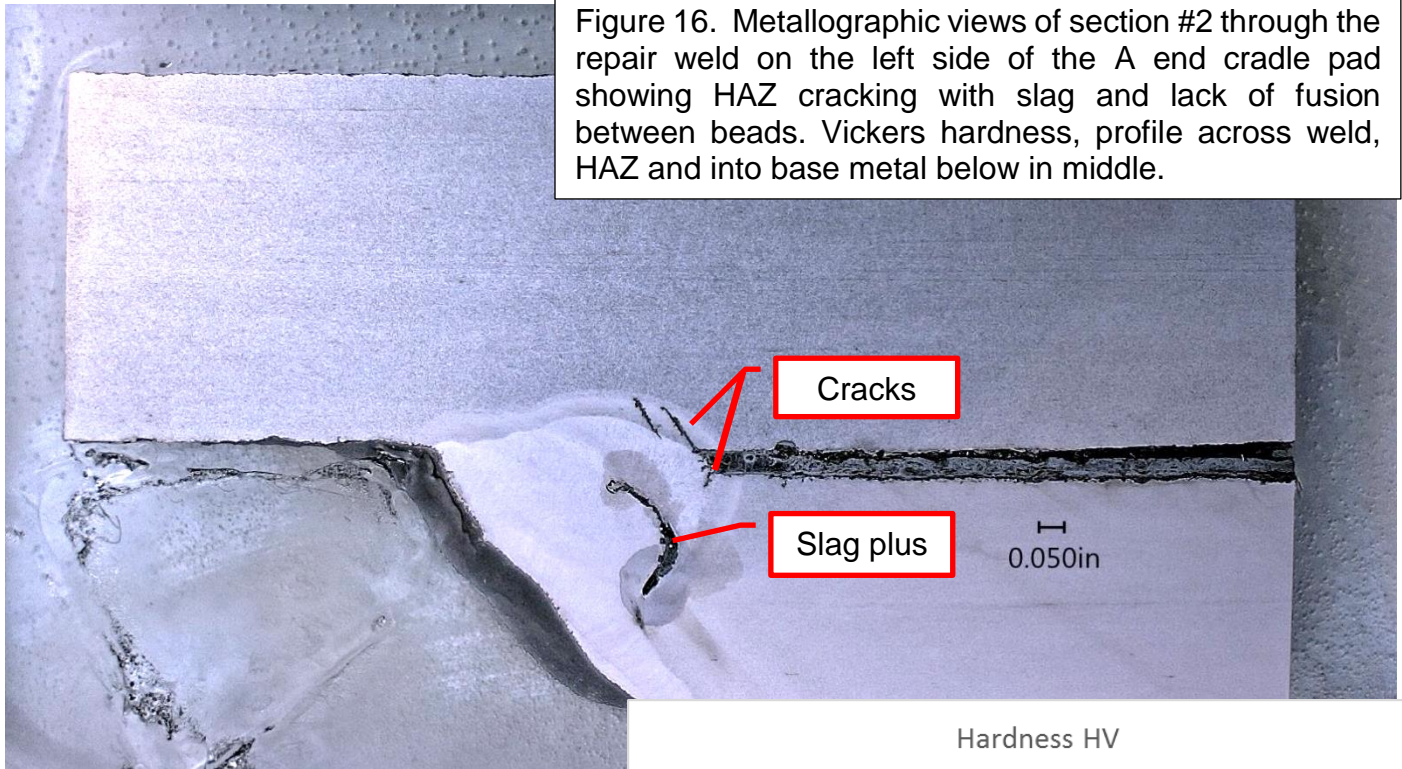
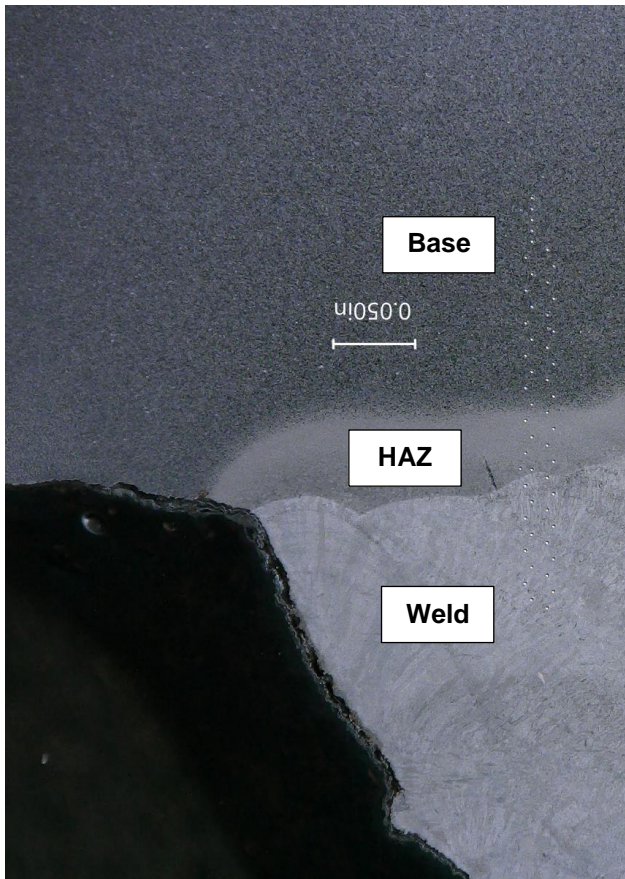
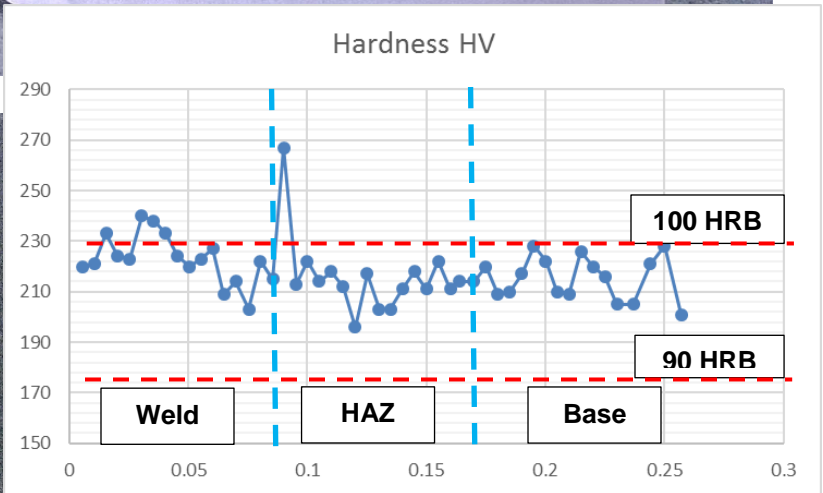
Section #2 was through the repair weld area just outboard (toward A end) of the crack initiation area on the left side of the cradle pad. As shown in figure 16, the repair weld contained multiple (possibly 5) beads with a large internal pore showing slag inclusions and a lack of fusion between two of the beads. The repair also contained two under bead cracks angling across the heat affect zone near the root of the weld. The cracks measured 0.094 inch and 0.109 inch deep. A third crack was present between the root pass fusion zone and HAZ measured 0.037 inch deep. The HAZ measured about 0.034 inch wide at the toe of the weld and slightly greater elsewhere. A microhardness

Figure 16. Metallographic views of section #2 through the repair weld on the left side of the A end cradle pad showing HAZ cracking with slag and lack of fusion between beads. Vickers hardness, profile across weld, HAZ and into base metal below in middle.

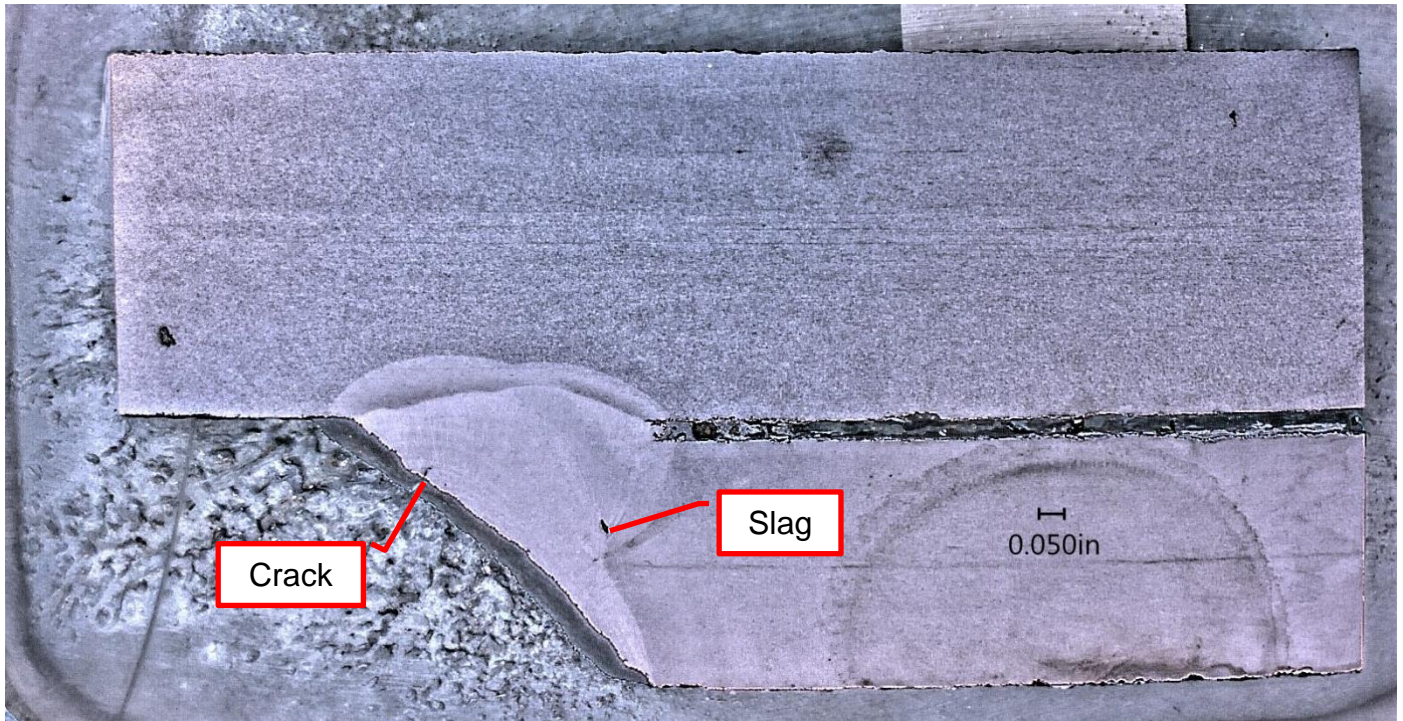
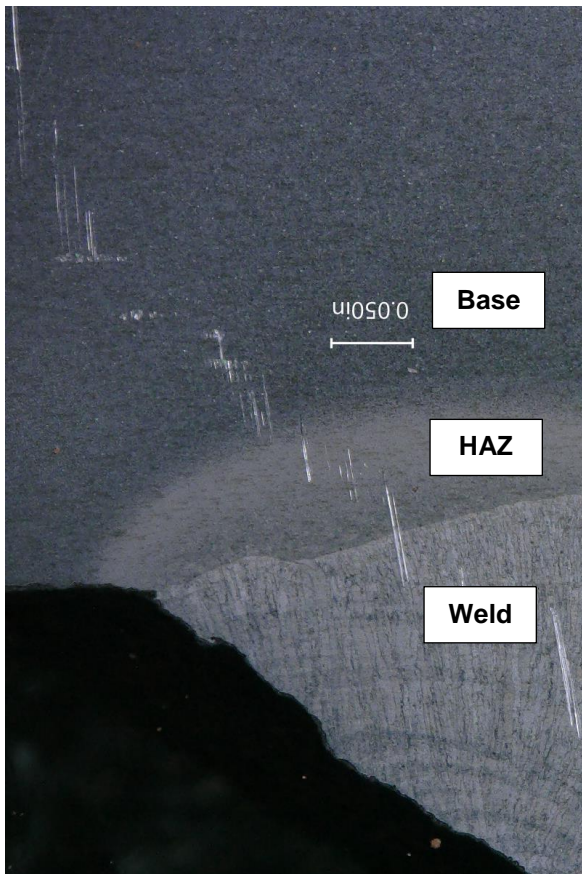
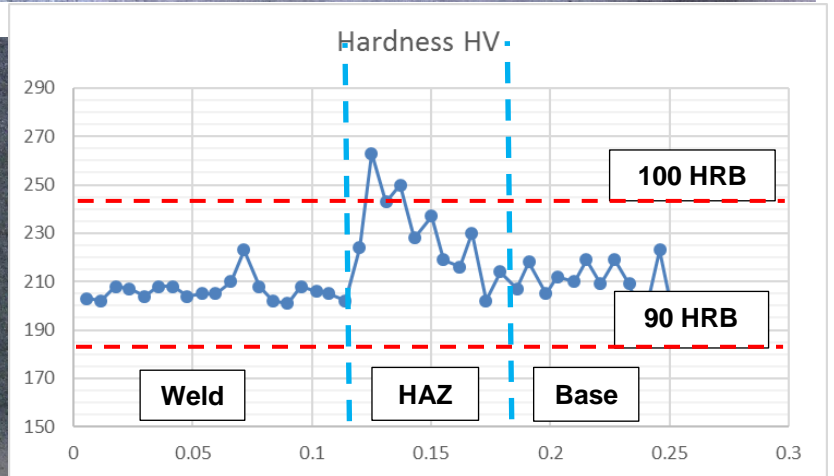
Metallographic section #3 was through the original manufacturing weld just outboard of the repair weld. As shown in figure 17, it appeared to be made with at least 2 beads and contained a small slag inclusion between them. The cap bead also had a small 0.03 inch surface crack. No undercutting was noted at the tank side toe of the weld and the heat affected zone measured about 0.03 inch at the tank side toe of the weld. A microhardness traverse revealed a generally uniform hardness across the weld, HAZ and base metal as shown by the chart in figure 17. Hardness ranged from 93 HRB to 24.5 HRC.

Figure 17. Metallographic views of section #3 through the original manufacturer's weld on the left side of the cradle pad showing small slag inclusion and a small cap bead crack. Vickers hardness profile across weld, HAZ and into base metal in middle. 2%Nital

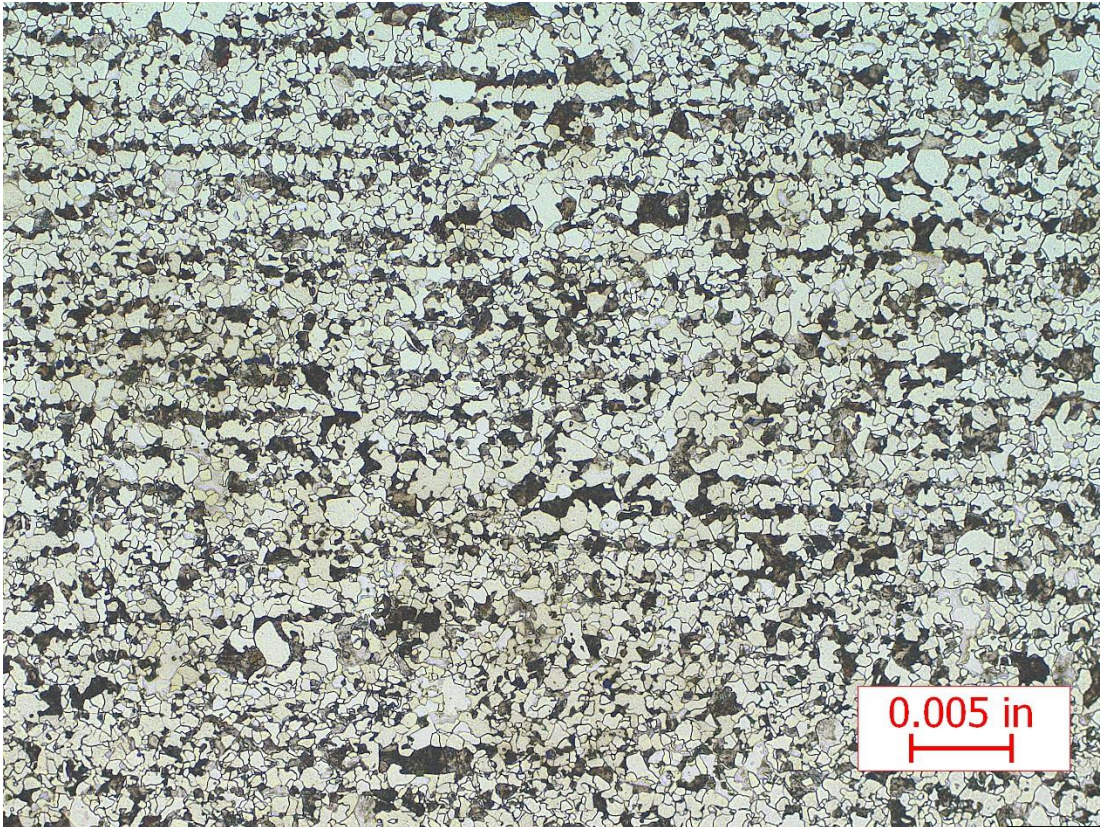
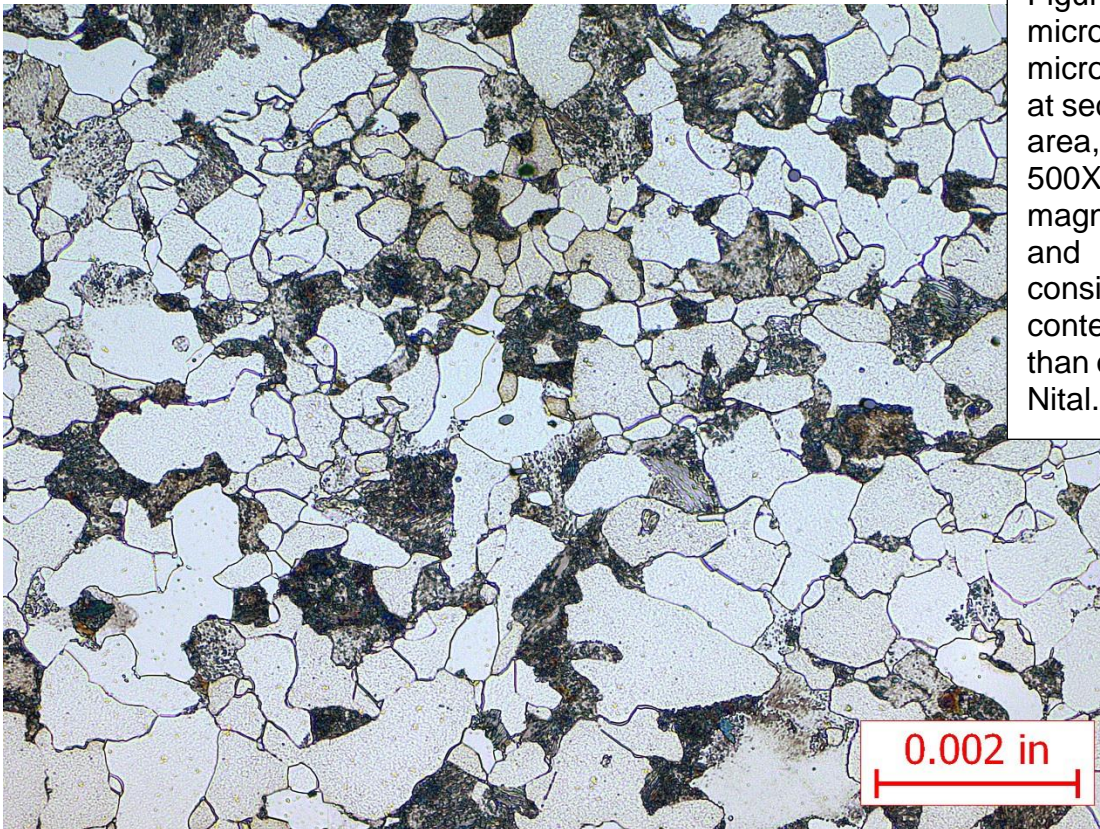
When etched with 2% Nital reagent, both specimens displayed clean microstructures similar to that described for sample #4 above. Sample #5, figure 19, exhibited more pearlite-pearlite banding compared to #6, figure 20. The grain size as measured by line intercept, as above, was slightly smaller for specimen #5 at 9.70 compared to 10.09 for #6. Average microhardness for #5 was 86.4 HRB while average hardness for #6 was 94.8 HRB.

Figure 19. Optical micrographs of the microstructure of the tank at section #5 in the scaled area, 100X above and 500X below original magnifications. Pearlite and ferrite in ratios consistent with the carbon content. More banding than other specimens. 2% Nital.

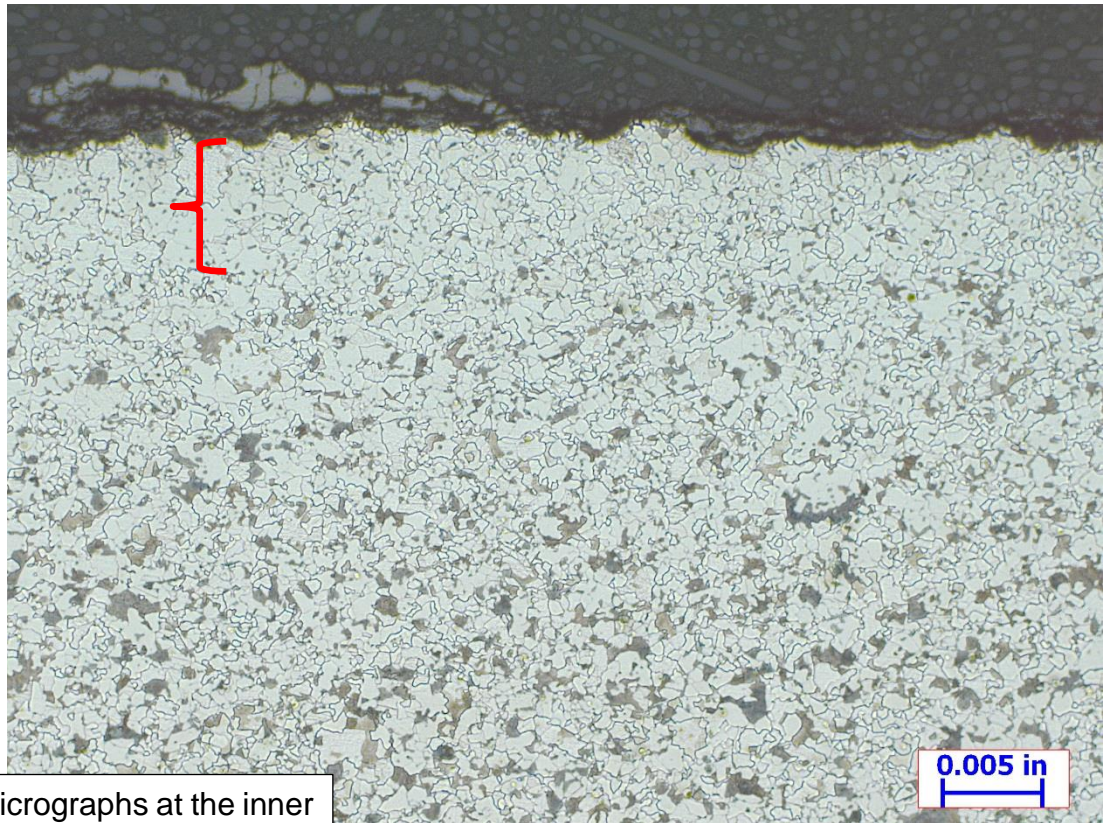
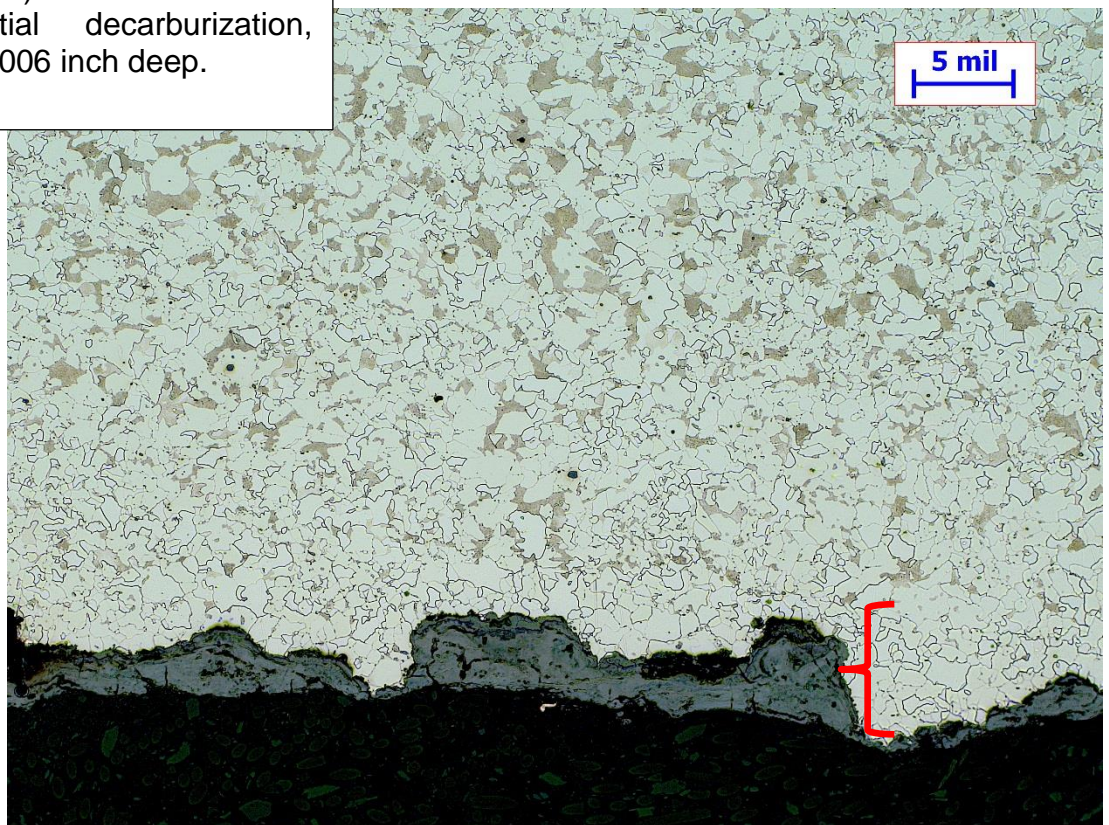
Figure 21. Optical micrographs at the inner (top) and outer (below) surfaces of section #5 showing partial decarburization, brackets, to about 0.006 inch deep. 2% Nital.

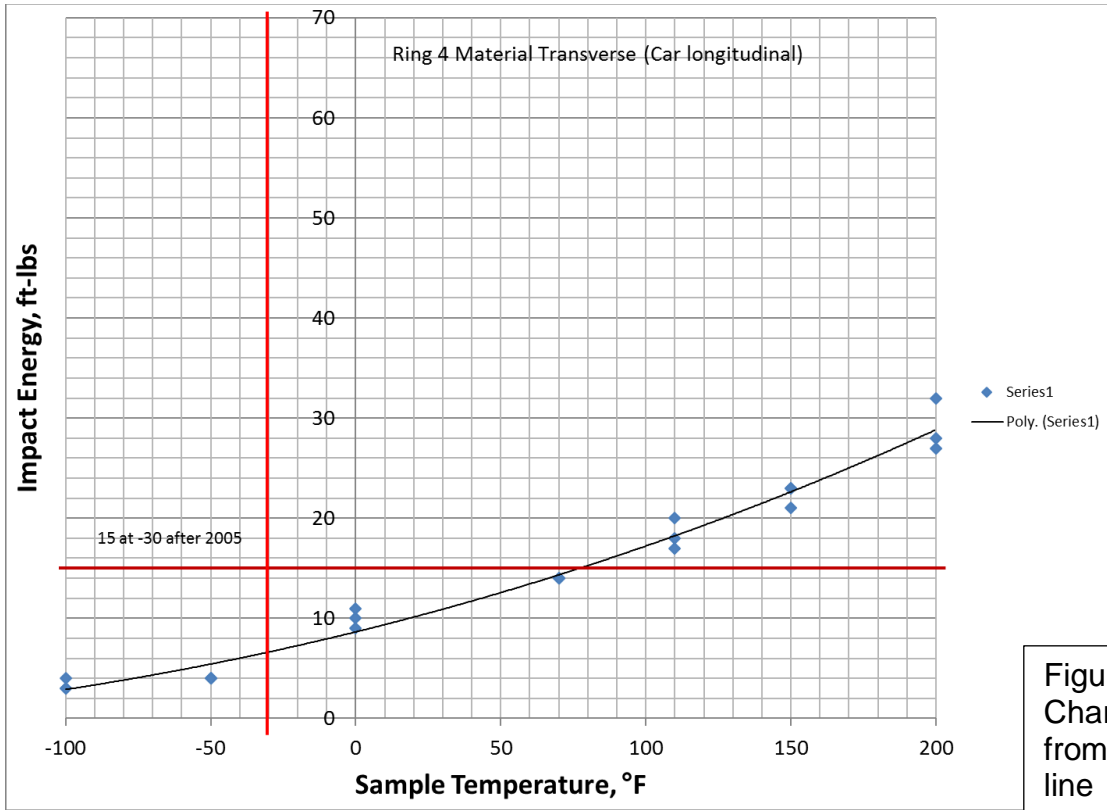
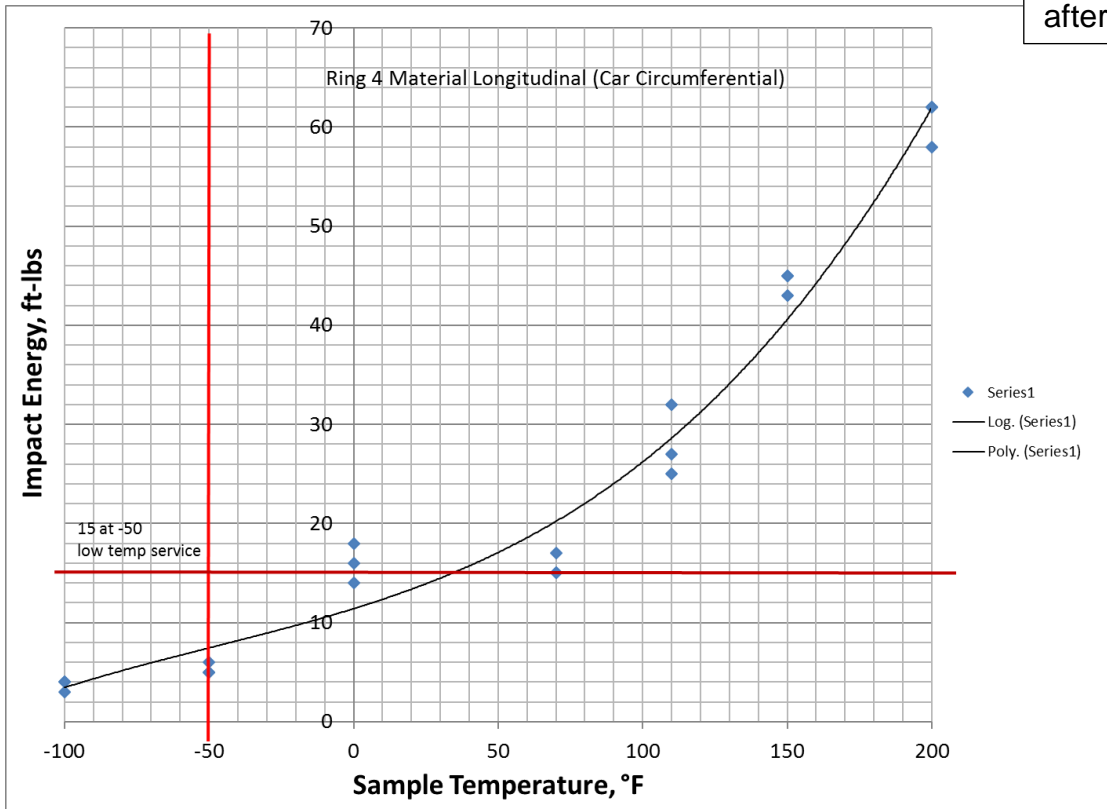
Although not required at the time of original tank manufacture, Charpy impact tests were also conducted at temperatures between -100 F and 200 F. Three specimens were broken at each temperature. The results are plotted and shown in figure 23. Effective August 1, 2005<sup>15</sup>, TC128 steel used for pressure tanks must be Charpy impact tested transverse to the rolling direction and must meet a minimum of 15 ft-lb at -30 °F. For “low-temperature service” cars, the plates must be 15 ft-lb or more at -50 °F. As shown, material from ring 4 of AXLX 1702 would not have met the present requirement in either direction.

Figure 23. Graphs of Charpy impact results from ring 4 material. Red line intersections denote minimum requirements after 2005.

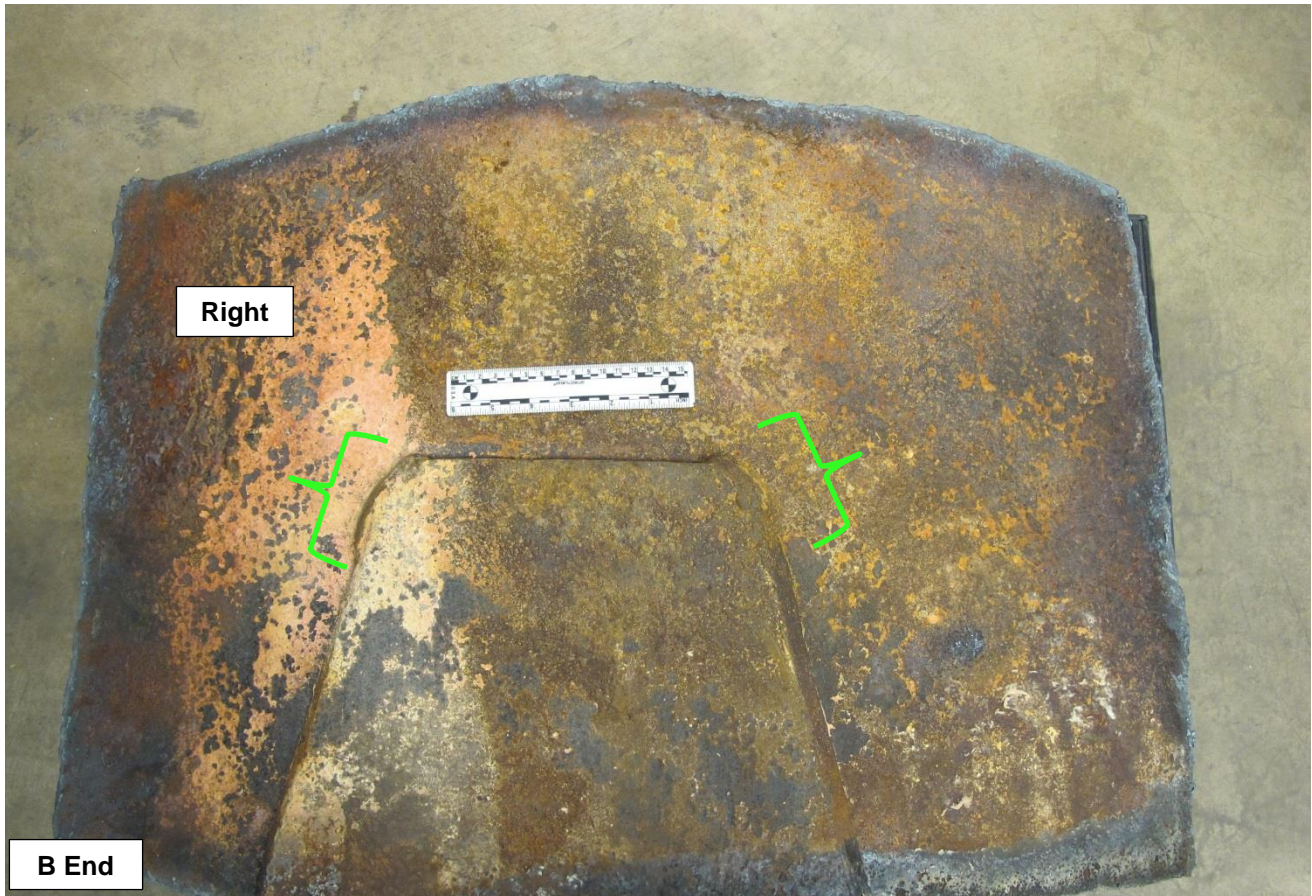
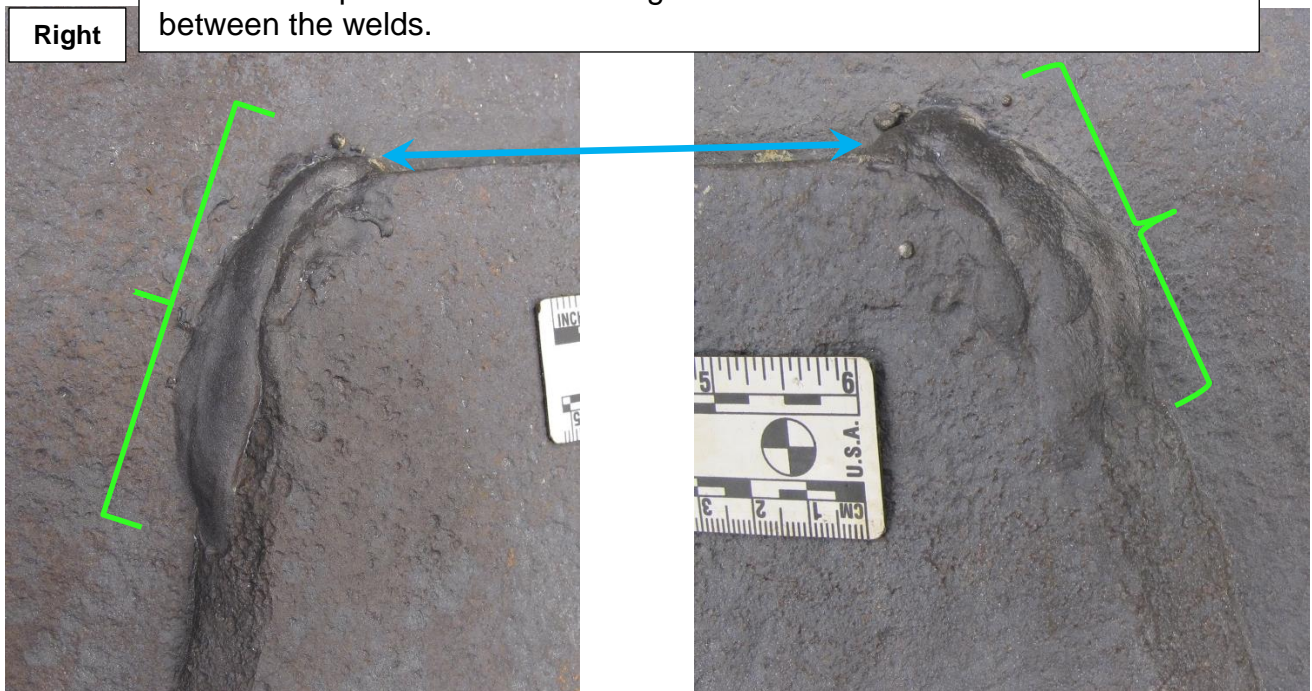
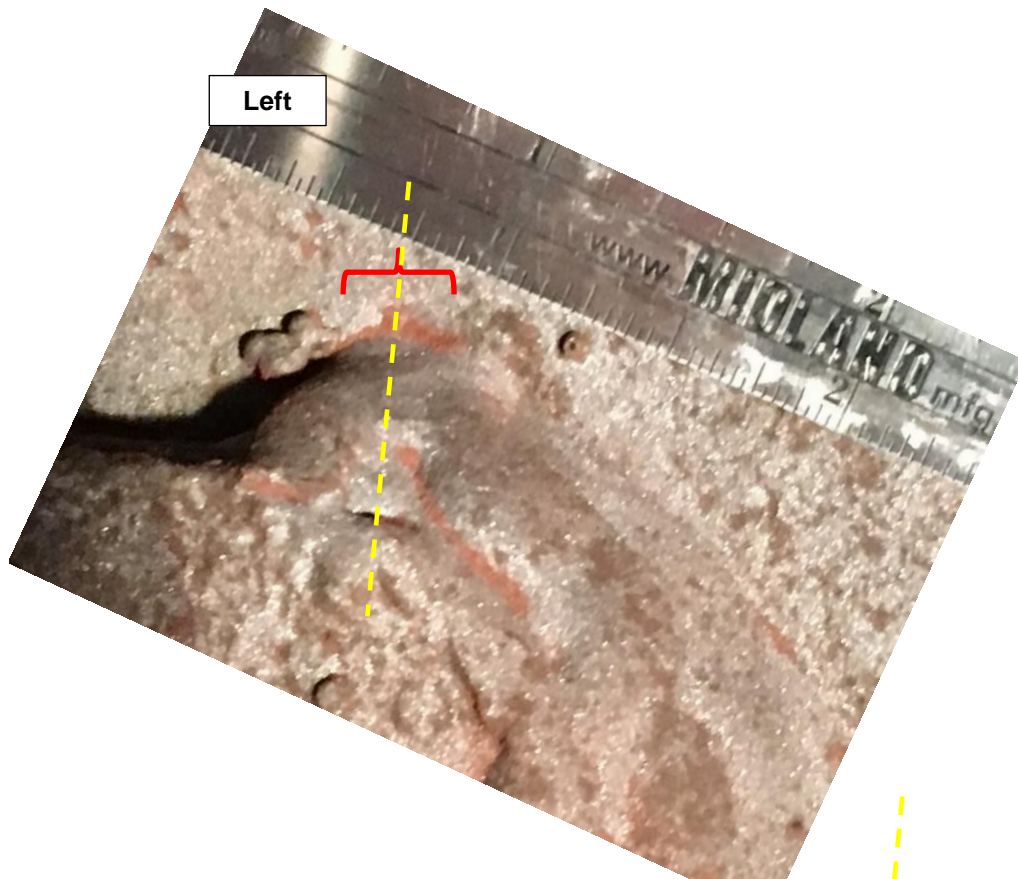
B End

As previously noted and shown in figure 24, the inboard end of the cradle pad and adjacent tank shell from the B end of the car was also cut out of the tank for additional laboratory examinations. Visual examination found two to three inch long repair welds (green brackets), similar to those at the A end on both sides of the inboard end of the cradle pad.

Initial inspections found that the repair welds on both sides of the cradle pad slightly turned the inboard corners of the pad as shown in the lower view of figure 24. Photographic measurements at the end of the cradle pad found slightly less than 7 inches between the welds (blue double arrow). Not meeting the drawing<sup>16</sup> notation of “no weld 8” 2 PLCS” for the end of the cradle pads.

The outer surfaces of the B end sample were cleaned by baking soda blasting, see lower views of figure 24. The repair welds displayed poor workmanship with significant undercutting into the tank, uneven bead sizes, surface porosity and weld spatter.

Figure 24. Above, the removed section of the inboard end of the cradle pad from the B-end of the car. Below, closer views of the repair welds at the sides of the cradle pad after blast cleaning. Double blue arrow indicate the distance between the welds.

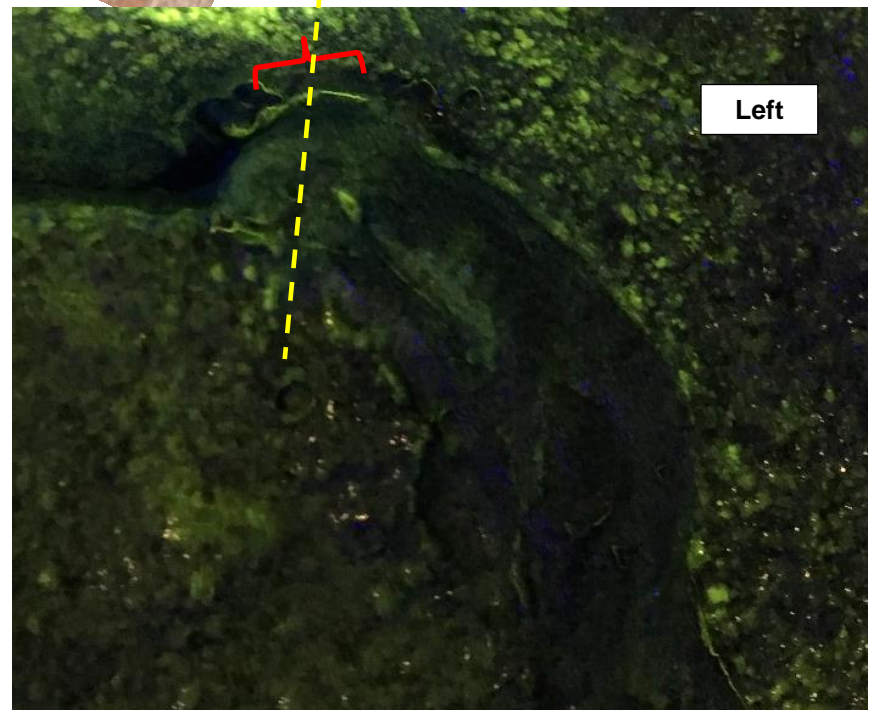
After additional grit blast cleaning of the exterior surfaces, the left side repair weld area was subjected to several nondestructive testing methods using nonstandard techniques<sup>17</sup> (NDT) including radiography, angle beam ultrasonic, visible dye penetrant and wet and dry magnetic particle testing. The magnetic particle techniques both detected crack indications in an undercut area at the inboard tip of the repair weld as displayed in figure 25. Visual examinations at low magnifications after testing did not visually confirm cracking.

Figure 25. Two views of the inboard toe of the left repair weld on the B-end showing magnetic particle NDT indications (red brackets). Dry powder at top and fluorescent wet particle at right. Dashed lines indicate approximate location of metallographic section B15 through the indication.

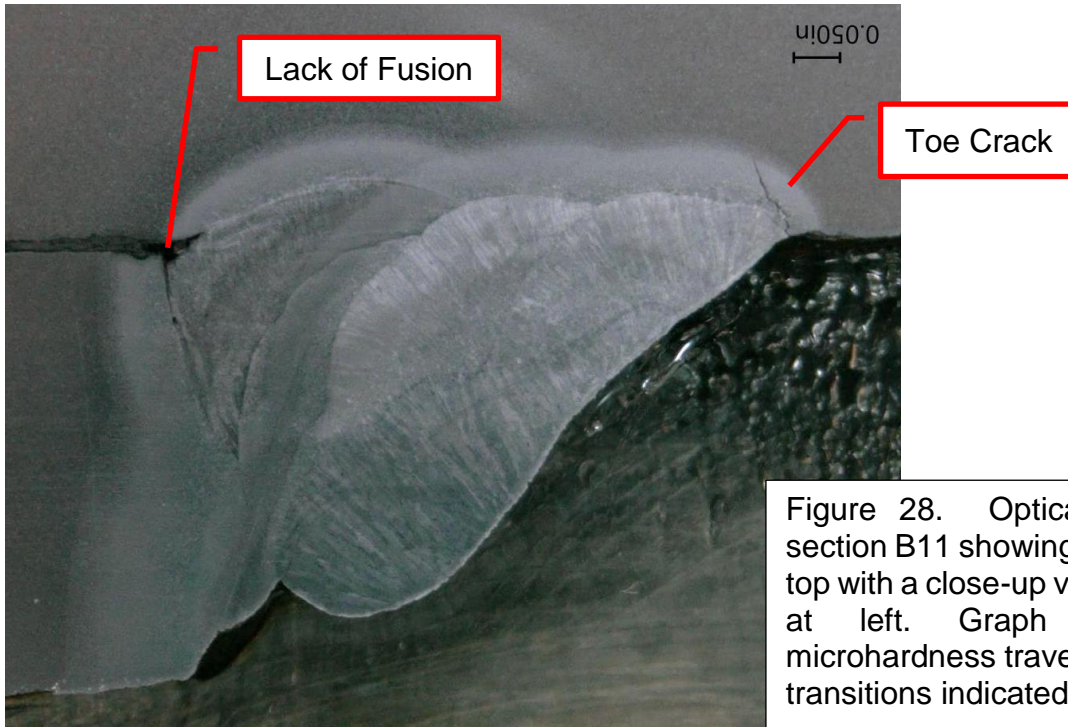
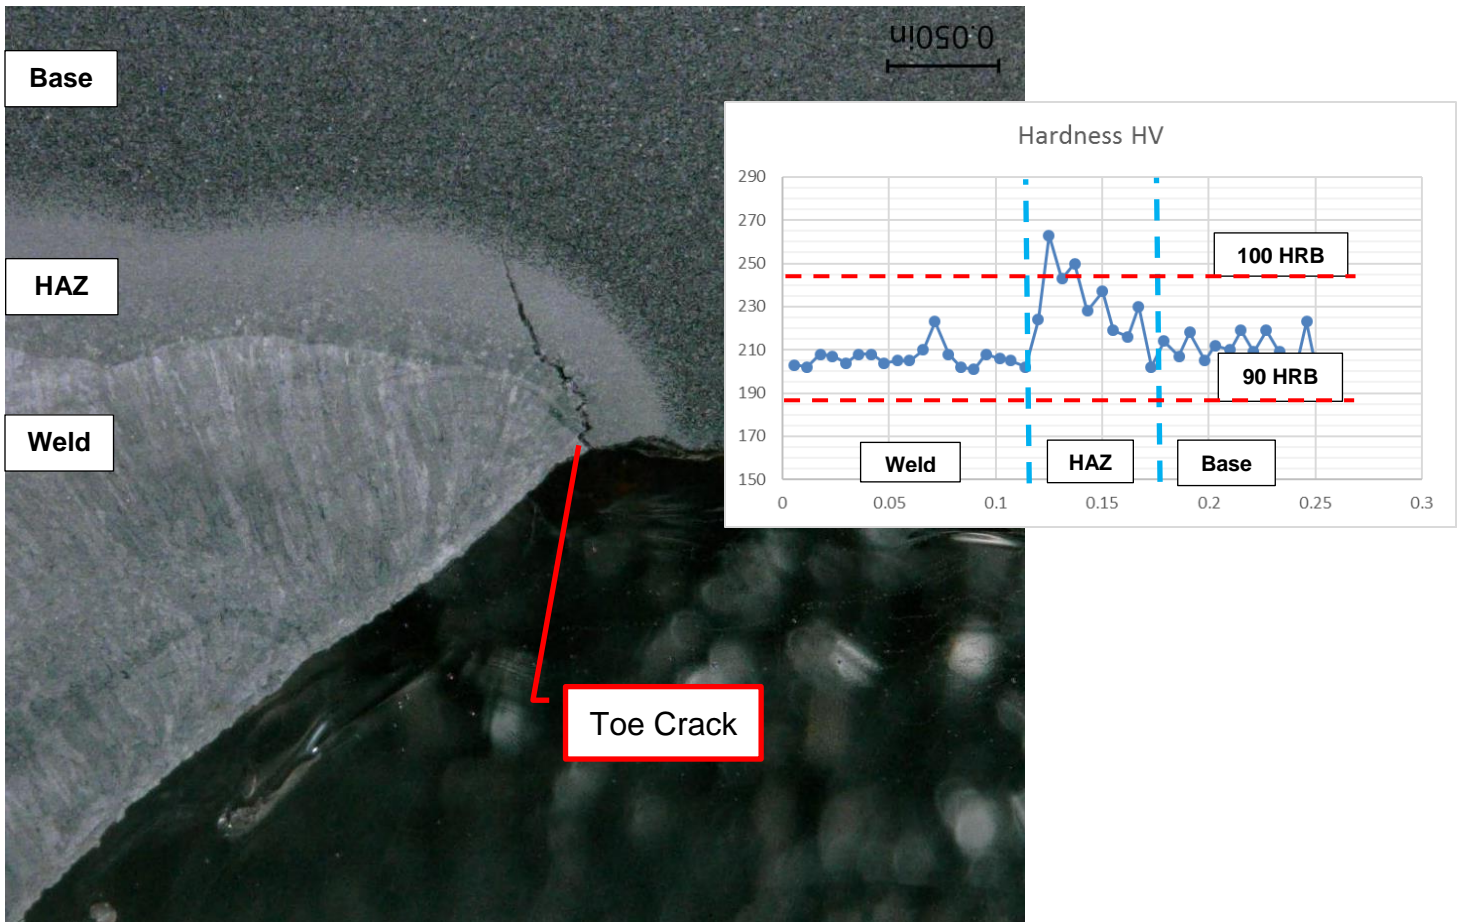
Figure 28 displays section B11 through the right side repair weld. As shown, the weld had a ~0.1 inch long crack at the tank side toe and some lack of fusion at the root. The toe crack was wholly contained within the HAZ. The weld also had a sharp toe at the pad side. A microhardness traverse across the weld, HAZ and into the tank base metal showed a somewhat harder HAZ compared to the adjacent areas.

Figure 28. Optical micrographs of section B11 showing the overall weld at top with a close-up view of the toe crack at left. Graph shows Vickers microhardness traverse with weld zone transitions indicated. 2% Nital etch.

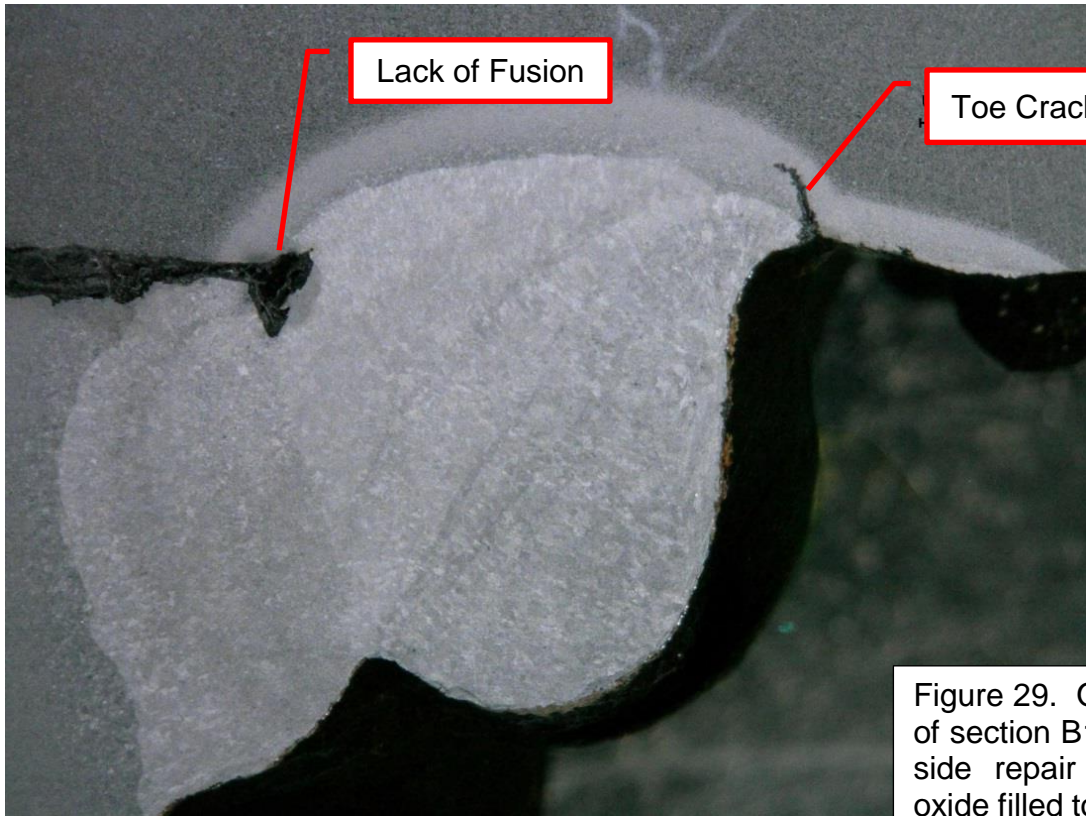
Section B12 was a longitudinal section through the right side repair weld and is displayed in figure 29. The repair weld contained an oxide-filled toe-crack and lack of fusion as indicated.

Figure 29. Optical micrographs of section B12 through the right side repair weld showing an oxide filled toe crack and lack of fusion at the root. 2% Nital Etch.
