# NATIONAL TRANSPORTATION SAFETY BOARD

MATERIALS LABORATORY FACTUAL REPORT

Report No. 17-001

Place : New Martinsville, West Virginia  
Date : August 27, 2016  
Vehicle : AXLX 1702 Liquid Chlorine Tank Car  
NTSB No. : DCA16SH002  
Investigator : Paul Stancil, RPH-20

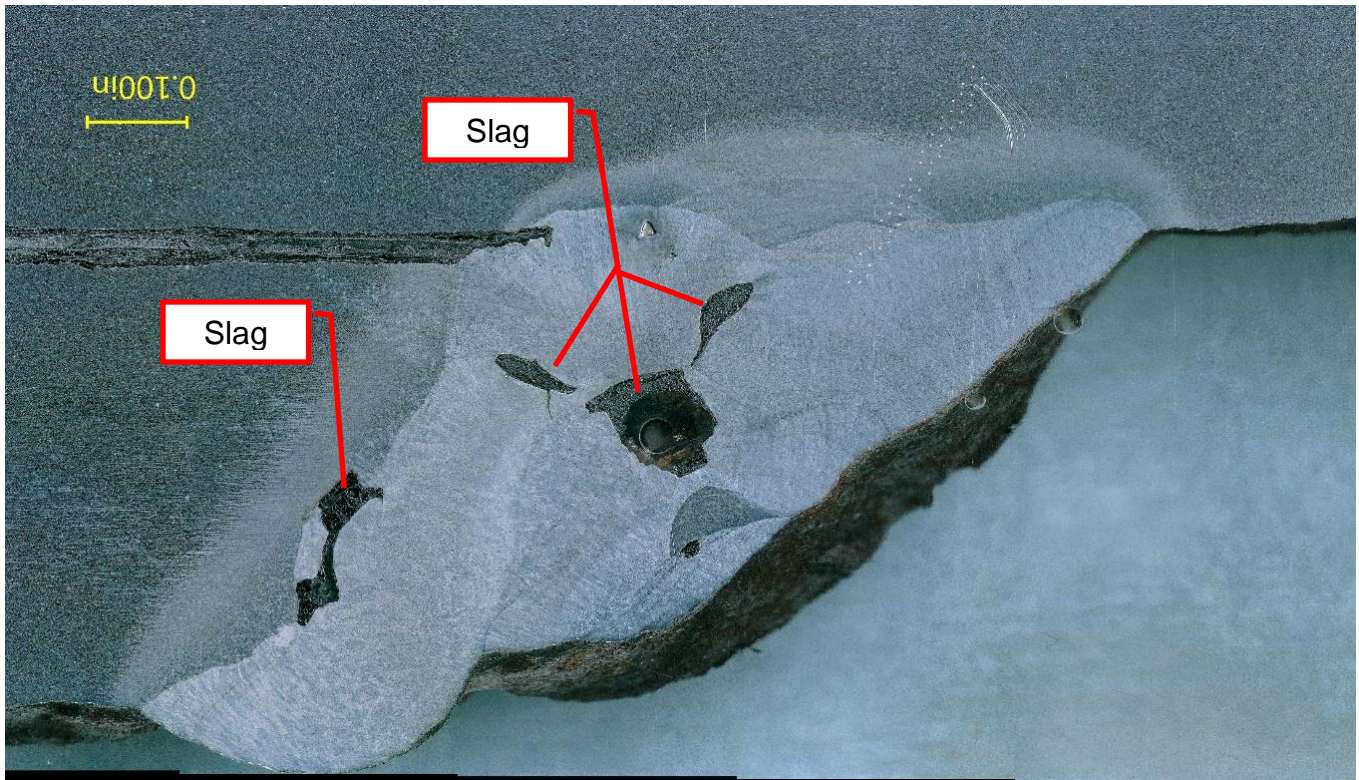
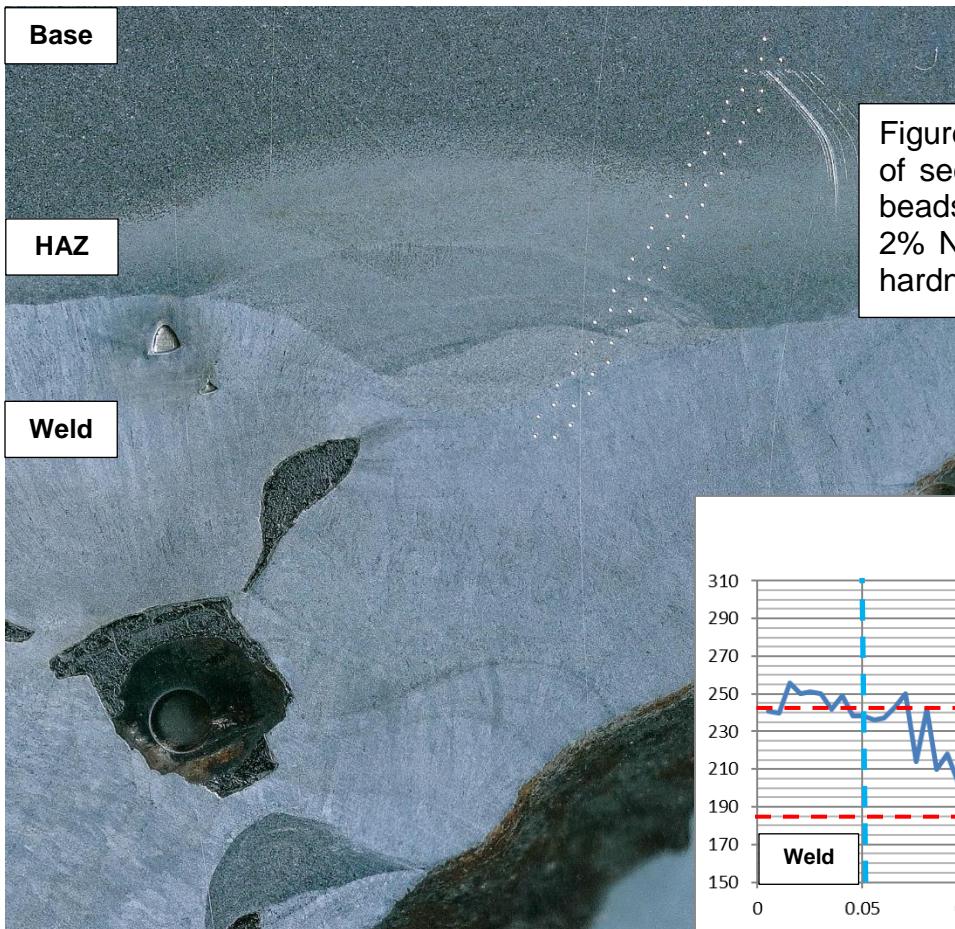
A transverse section, B14, through the left side repair weld on the B end revealed a multi-bead weld with several slag inclusions larger than 0.1 inch, as shown in figure 31. A microhardness traverse across the weld, HAZ and into the tank base metal showed a large HAZ that was both harder and softer than the adjacent weld and base metal.

Figure 31. Optical micrographs of section B14 showing multiple beads and large slag inclusions. 2% Nital etch. Graph of Vickers hardness, traverse below.

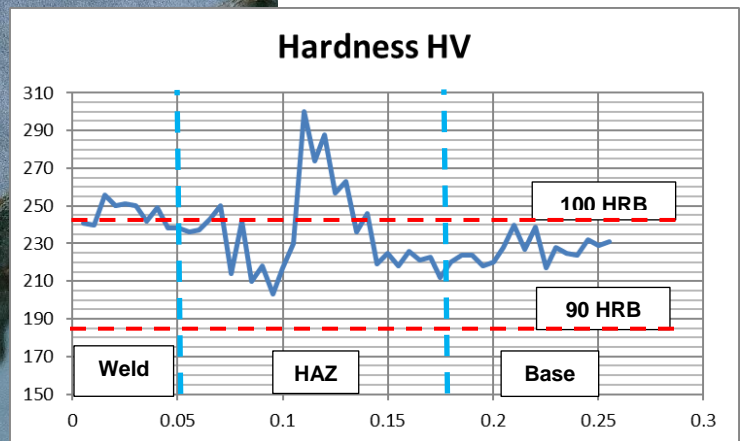
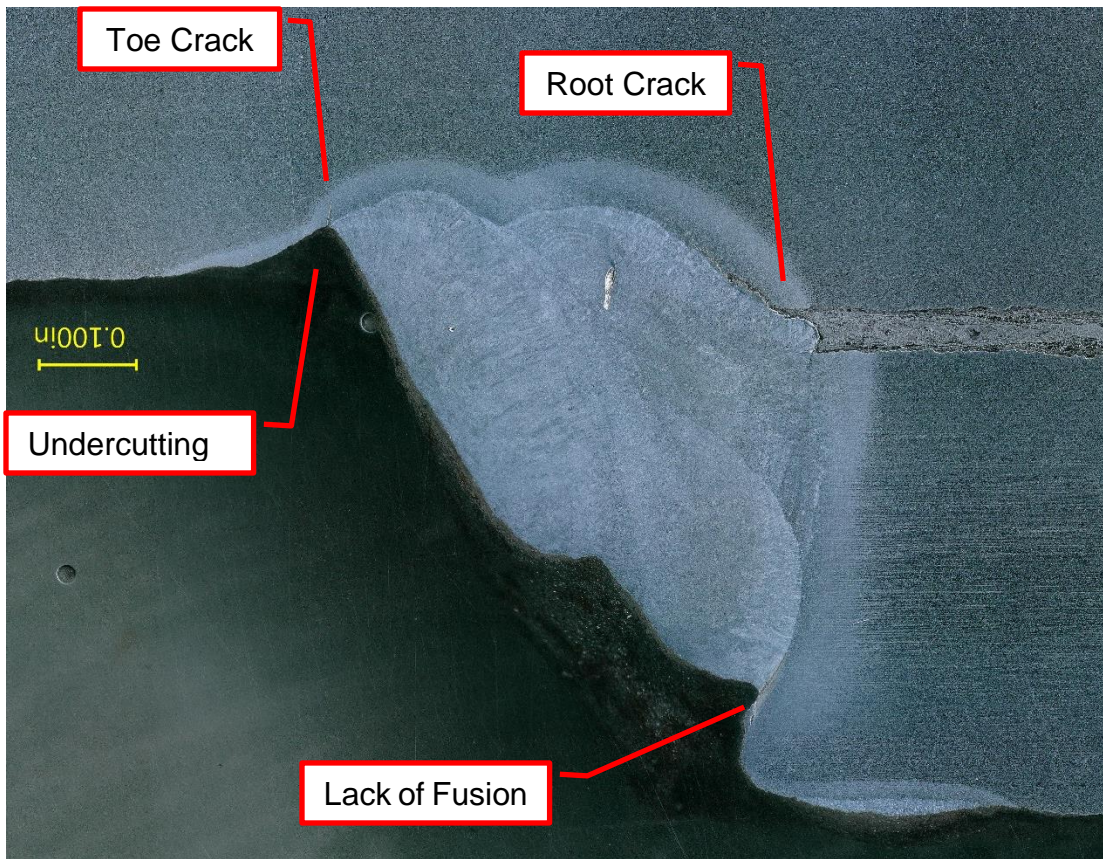
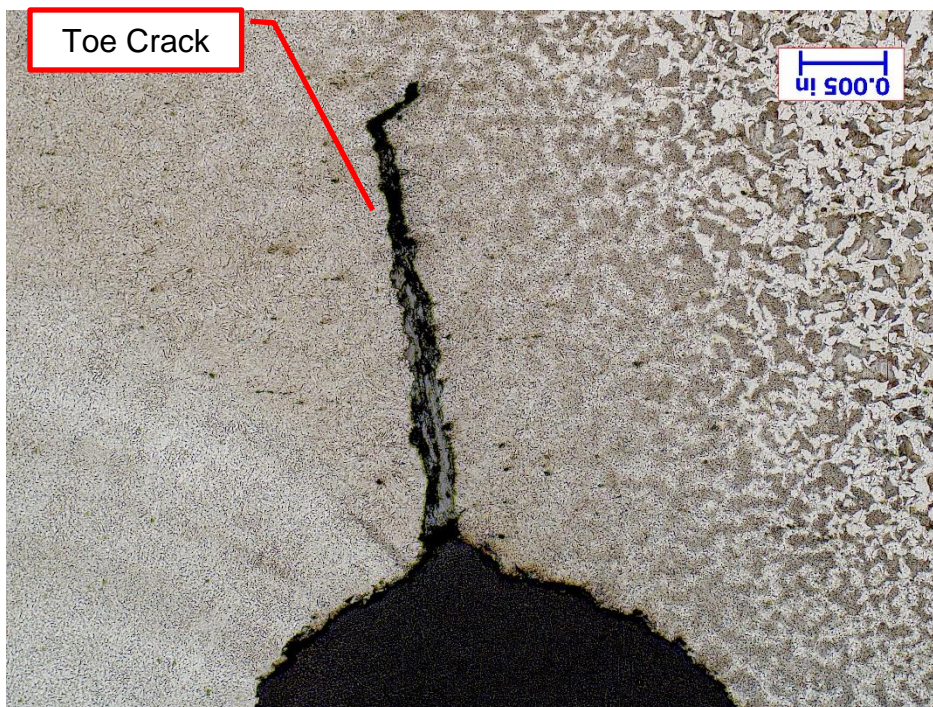
Figure 32. An overall micrograph, top, of section B15 showing the locations of the toe and root cracks and the areas of undercutting and lack of fusion. The toe crack is shown at greater magnification at left. Root crack and lack of fusion are shown in figure 33. 2% Nital Etch

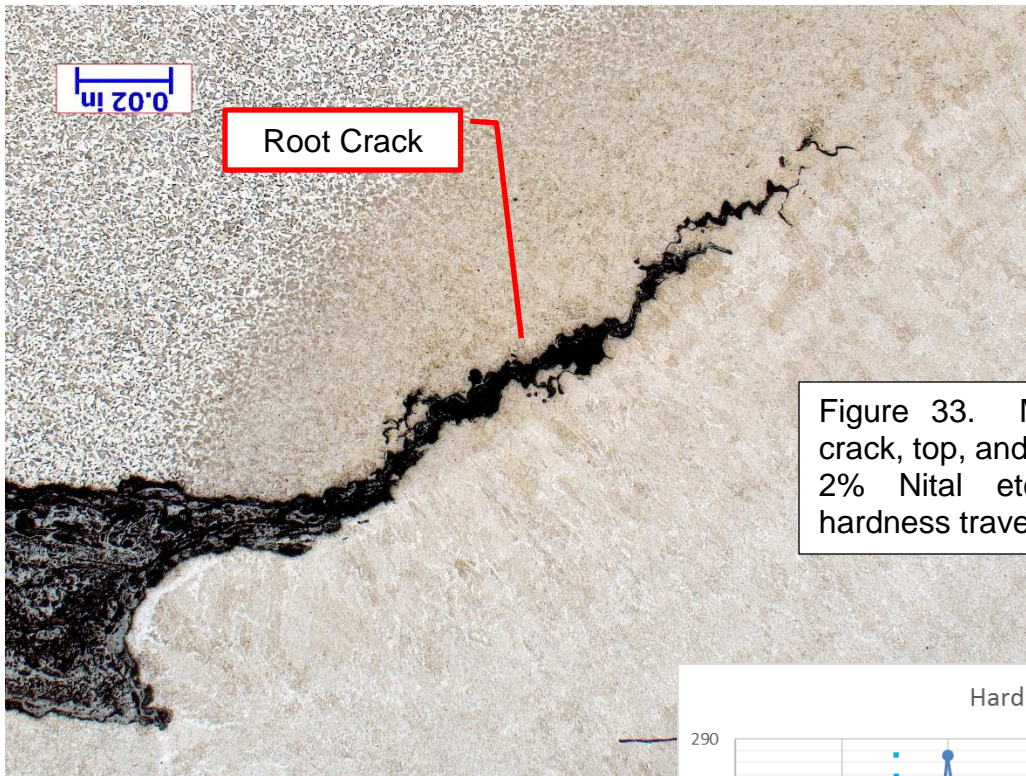
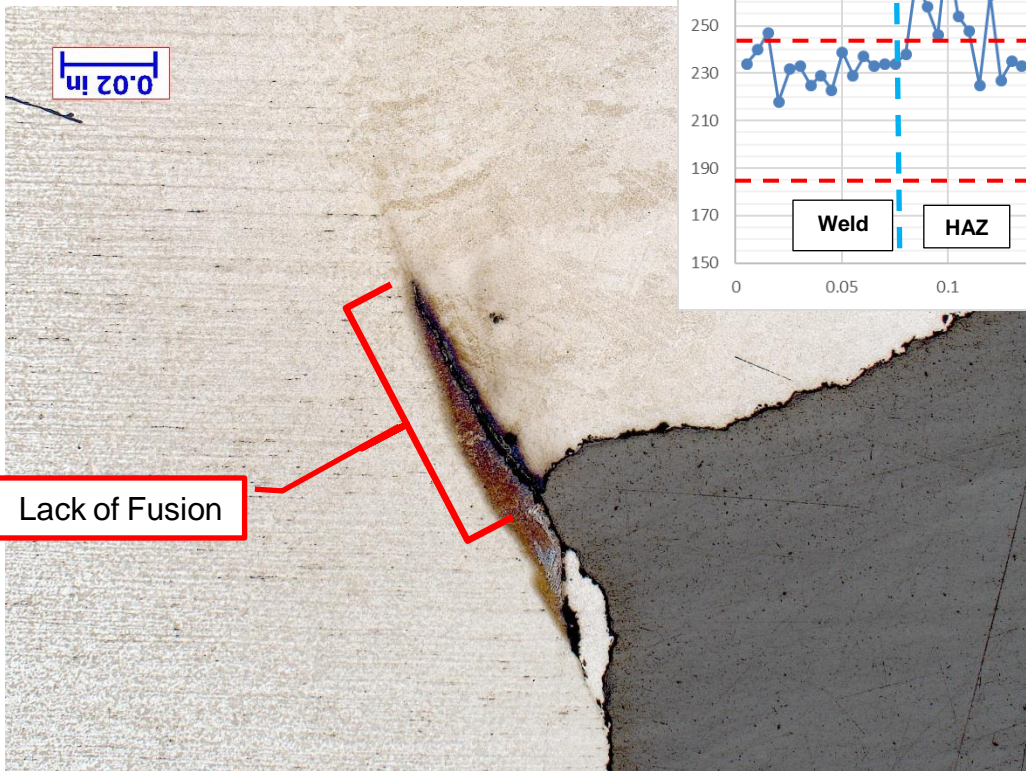
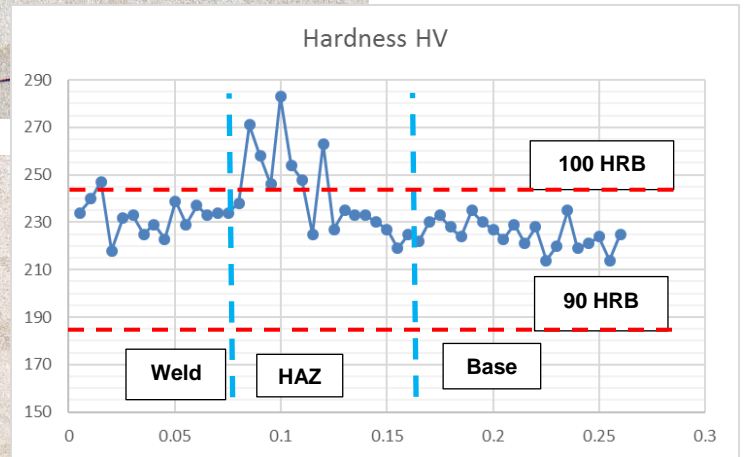
Figure 33. Micrographs of the root crack, top, and the lack of fusion, below. 2% Nital etch. Graph of Vickers hardness traverse in the middle.
