NATIONAL TRANSPORTATION SAFETY BOARD

MATERIALS LABORATORY FACTUAL REPORT

Report No. 17-029

Place : Osage Beach, Missouri
Date : October 22, 2016
Vehicle : Beech C23, N20087
NTSB No. : CEN17FA024
Investigator : Jason Aguilera, ASI-CEN

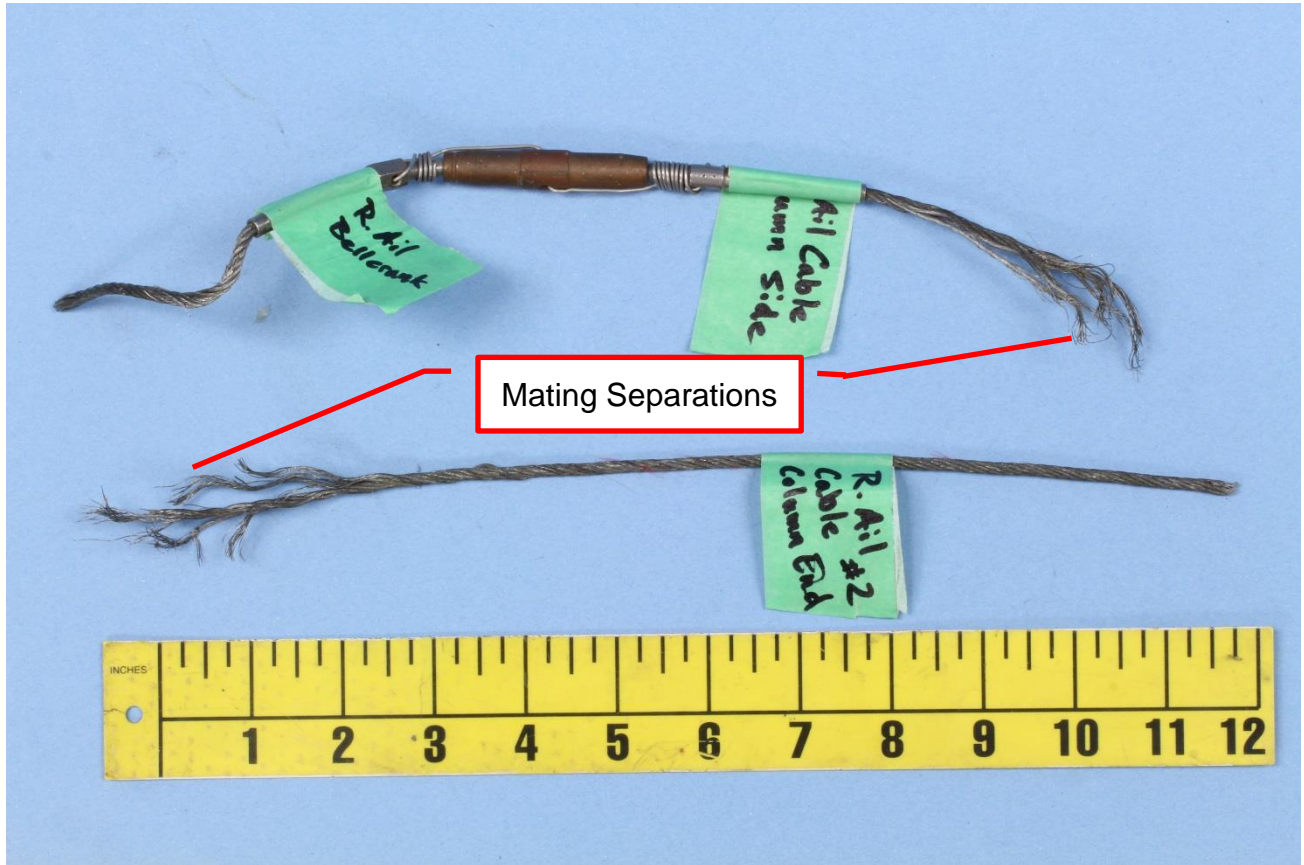
The two as-received pieces of right aileron cable are displayed in figure 1. One piece contained a turnbuckle, the 7 by 19, 1/8 inch wire rope on one side of the buckle was fractured as shown. The second cable piece contained the mating fracture. The fractured side of the turnbuckle was labeled "Column Side".

Magnified optical examinations of the individual fractures of the cable wires revealed cup and cone and slant fractures consistent with overstress separations of the individual wires and of the overall wire rope. No indications of preexisting fatigue, corrosion or wear, either internal or external, were uncovered during the examinations.

Figure 1. An overall view of the as-received aileron cable pieces with mating wire rope separations denoted.
