NATIONAL TRANSPORTATION SAFETY BOARD

MATERIALS LABORATORY FACTUAL REPORT

Report No. 17-046

Place : Money, Mississippi
Date : April 30, 2017
Vehicle : Crude oil tank car
NTSB No. : DCA17SH002
Investigator : Paul Stancil, RPH-20

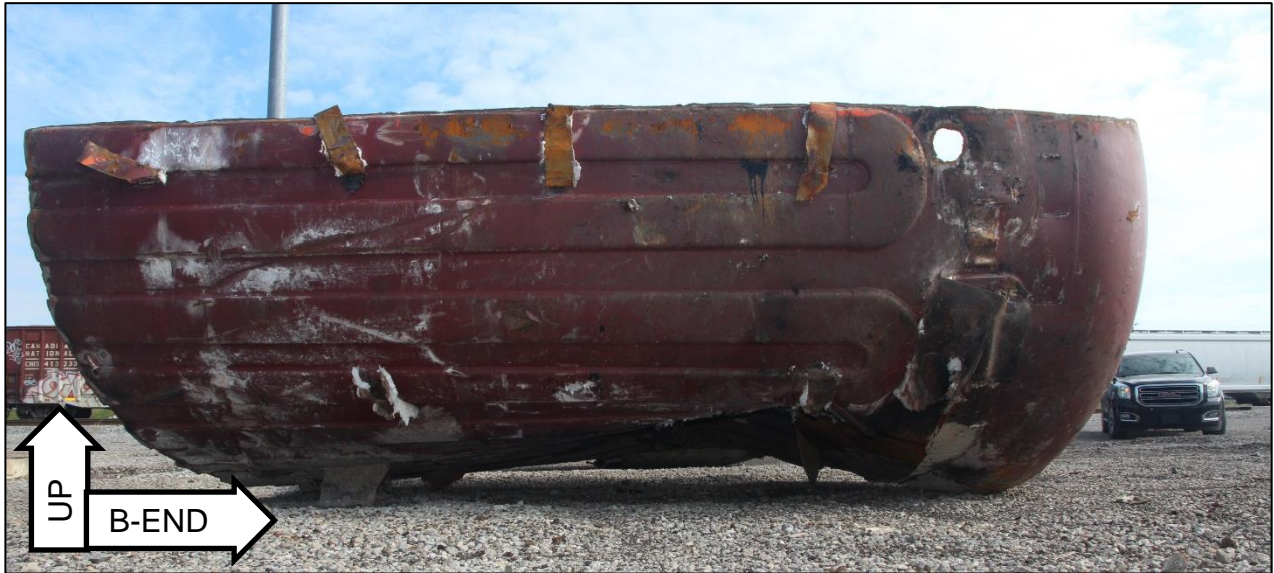
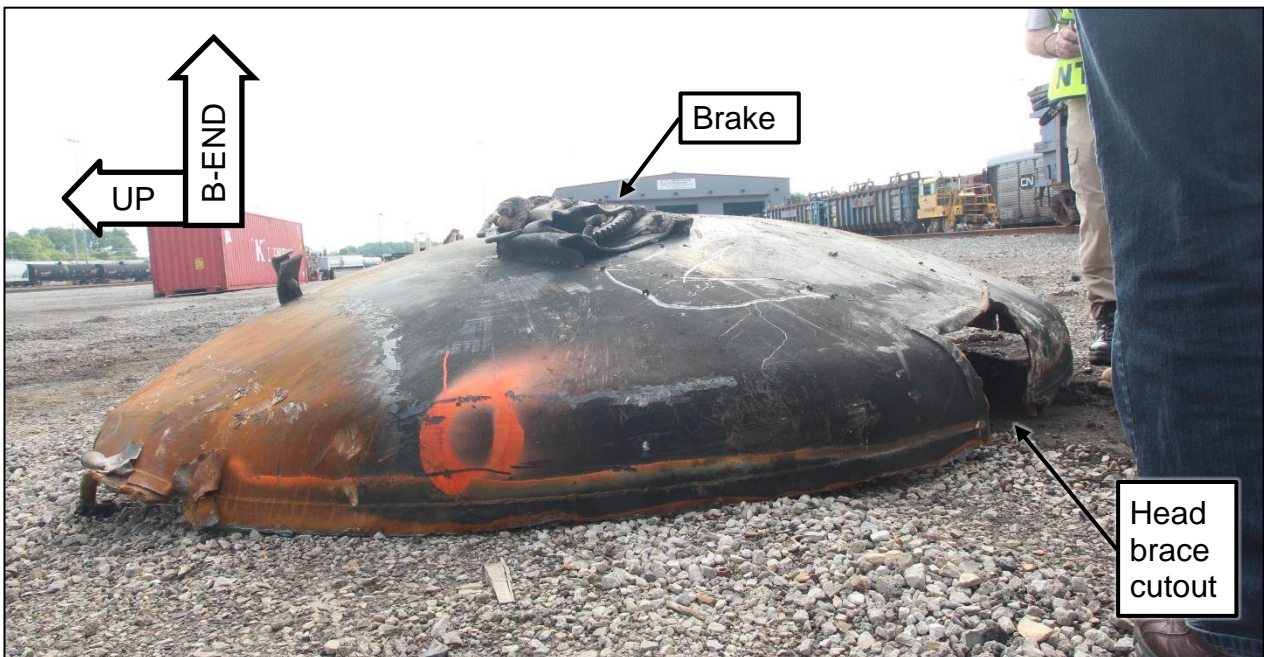
The tank car pieces shown in figure 1 were from the B-end of the tank car. Prior to the examination, the jacket and appliances for tank car CBTX 718470 had been removed from the tank, and the tank was cut into the pieces shown in figure 1. The remainder of the tank car not shown in figure 1 including the draft sills were scrapped. The tank car had been involved in a collision that resulted in a release of crude oil from the adjacent tank car. Based on a review of photographs provided by CN, the draft sill at the B-end of tank car CBTX 718470 fractured nearly completely from the tank car and buckled under the tank as it was displaced toward the A-end of the tank. Tank car CBTX 718470 remained upright, and the B-end was then exposed to a pool fire.

The tank shell pieces showed areas of discoloration consistent with heat damage. The head on the tank was dented inward in an area corresponding to the location of the

brake wheel on the head shield. The lower side of the tank was dented inward with the largest depth of denting located above the draft sill attachment location near the tail end of the stub sill.

Figure 1. Overall views of the tank car pieces showing the left side of the tank section (upper image) and the head shield (lower image).

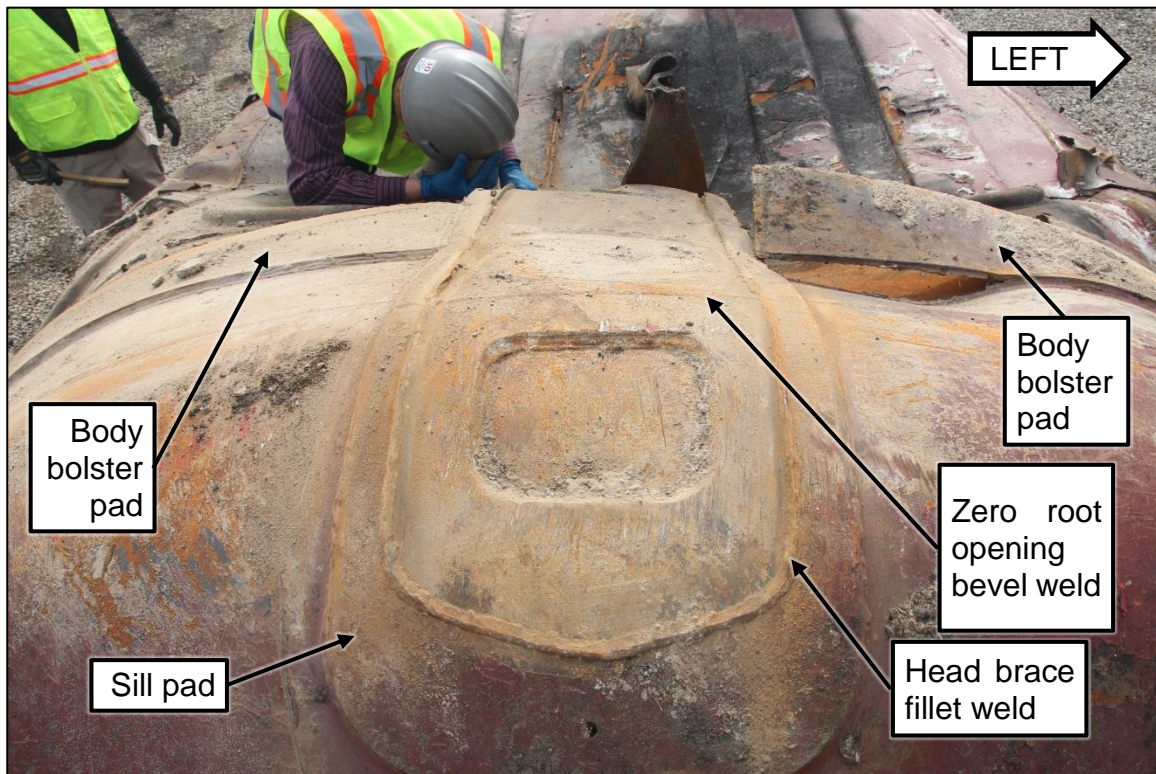
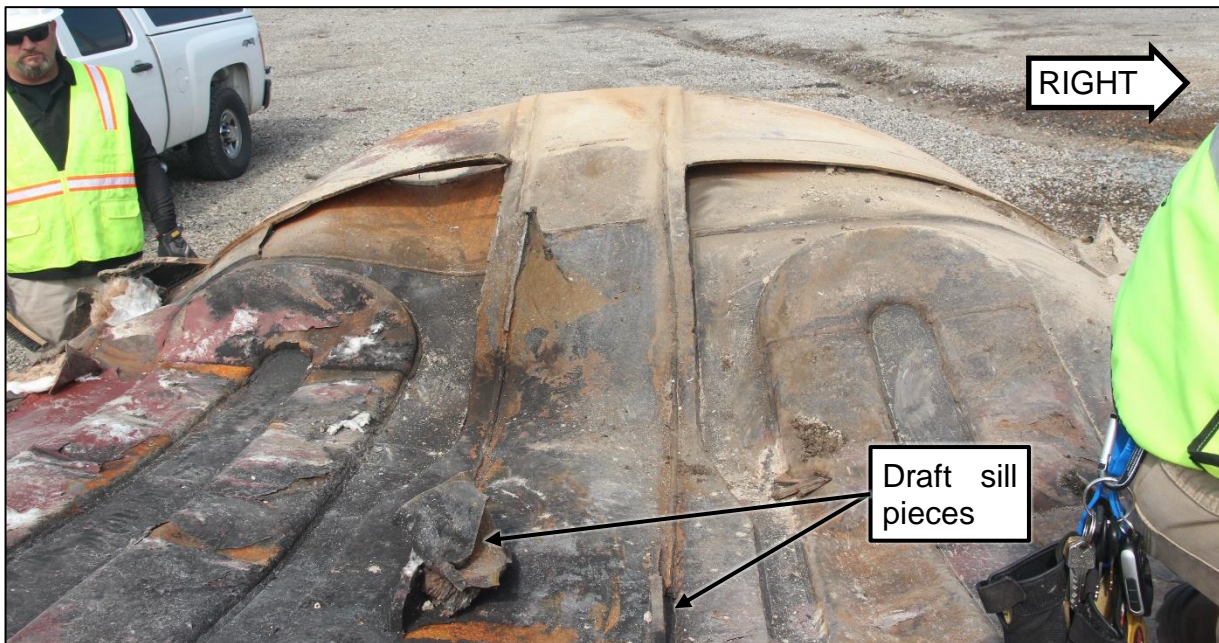
After an initial examination of the tank piece in the position shown in figure 1, the tank piece was rotated 180 degrees to view the underside of the tank. Views of the draft sill attachment areas are shown in figure 2. The head brace and most of the draft sill fractured from the sill pad as shown in figure 2. Small pieces of the draft sill remained attached at the tail end of the draft sill attachment as indicated in the lower image in figure 2. The sill pad remained attached at the head end and at the tail end of the pad but was fractured from the tank wall along a length extending from the A-end edge of the body bolster pads.

In general, the pad and draft sill attachment welds appeared to be well formed and uniform. Spot checks of fillet weld dimensions were conducted by the representative from Greenbrier using a Fibre-Metal fillet weld gage, and the reported measurements were consistent with drawing requirements. Welds at the inboard edges of the body sill pads were specified as zero root opening bevel welds, which is expected to produce little or no penetration into the tank wall at those locations. As shown in figures 3 and 4, the inboard ends of the body bolster pads were not welded to the tank shell, consistent with the weld configuration specified at those locations. A zero root opening bevel weld is also specified for the transverse weld in the sill pad as indicated in figure 2. No attempt was made to

determine if the tank wall was also free from weld penetration at the location of the zero root opening bevel weld indicated in figure 2.

Figure 2. Views of the lower side of the tank car as viewed facing toward the A-end (upper image) and toward the B-end (lower image).

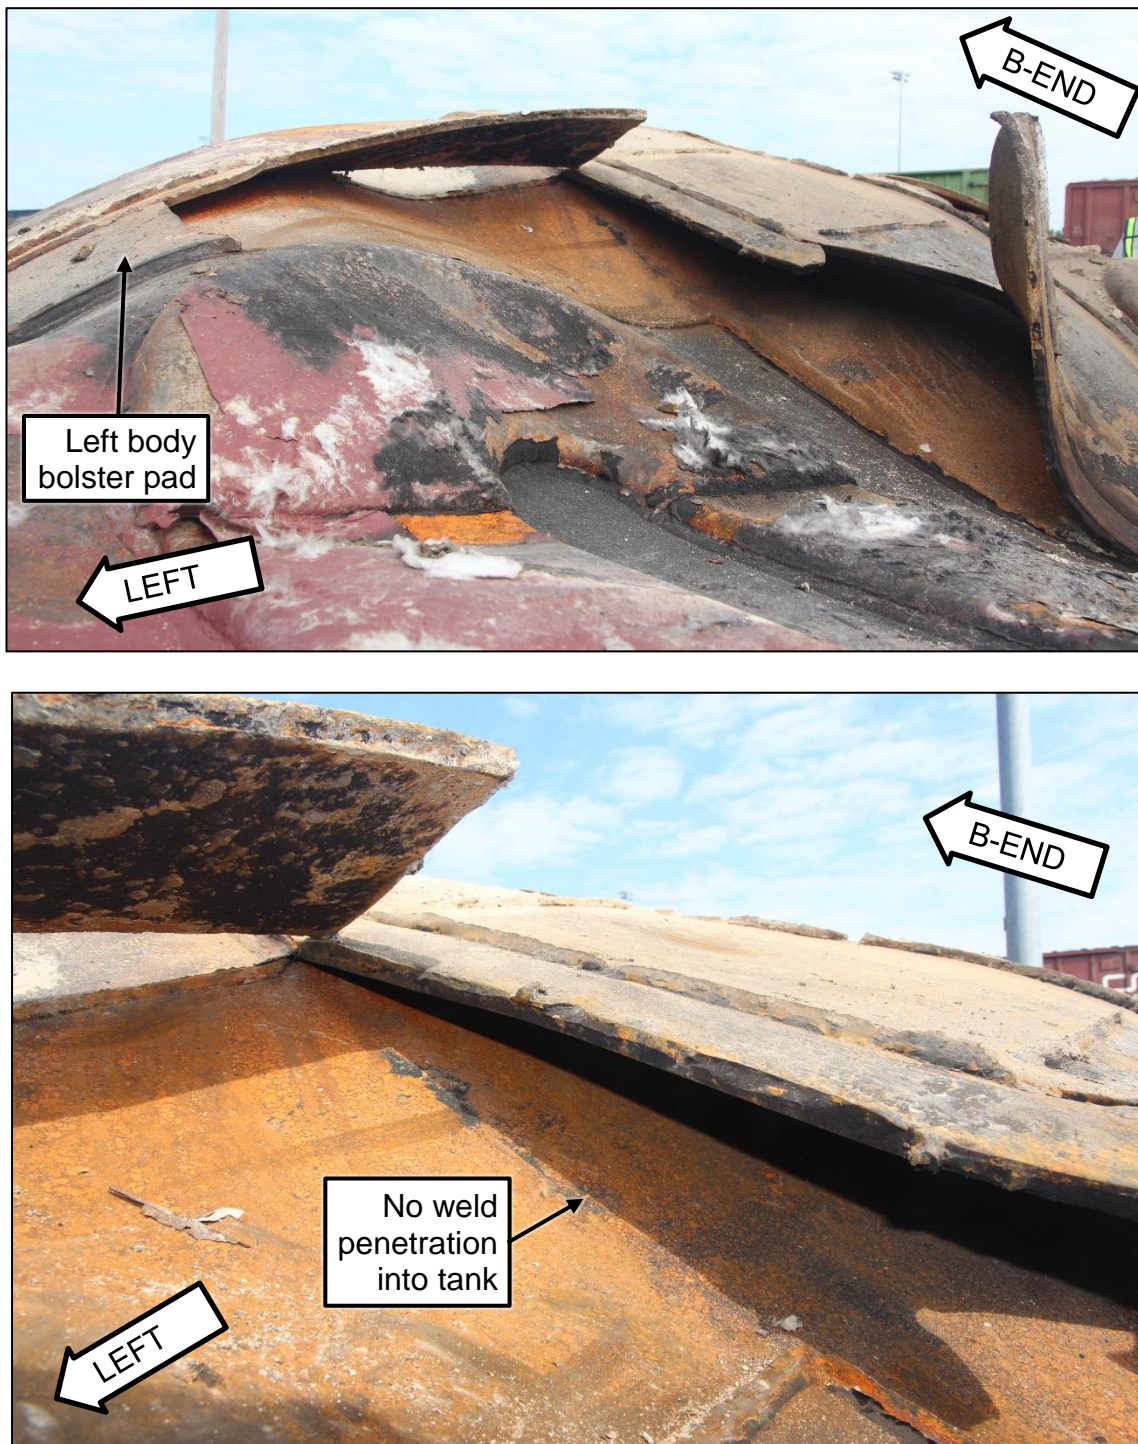
Additional views of pad fractures and areas where the pads separated from the tank shell are shown in figures 3 and 4. At the left side of the tank car shown in figure 3, the left body bolster pad was fractured around part of the circumference at the bolster web attachment weld, and the inboard end to the A-end side of the body bolster pad was missing. The inboard end of the body bolster pad was also fractured from the edge of the sill pad, and the inboard end of the remaining left bolster pad piece had a twisting deformation where the corner defined by the inboard and circumferential fractures was displaced downward relative to the other inboard corner.

Figure 3. Views of deformation at the left side of the sill pad where it intersected the body bolster pad. No weld penetration into the tank was observed where the body bolster pad was welded to the sill pad, consistent with the zero root opening bevel weld specified at the inboard end of the body bolster pad.

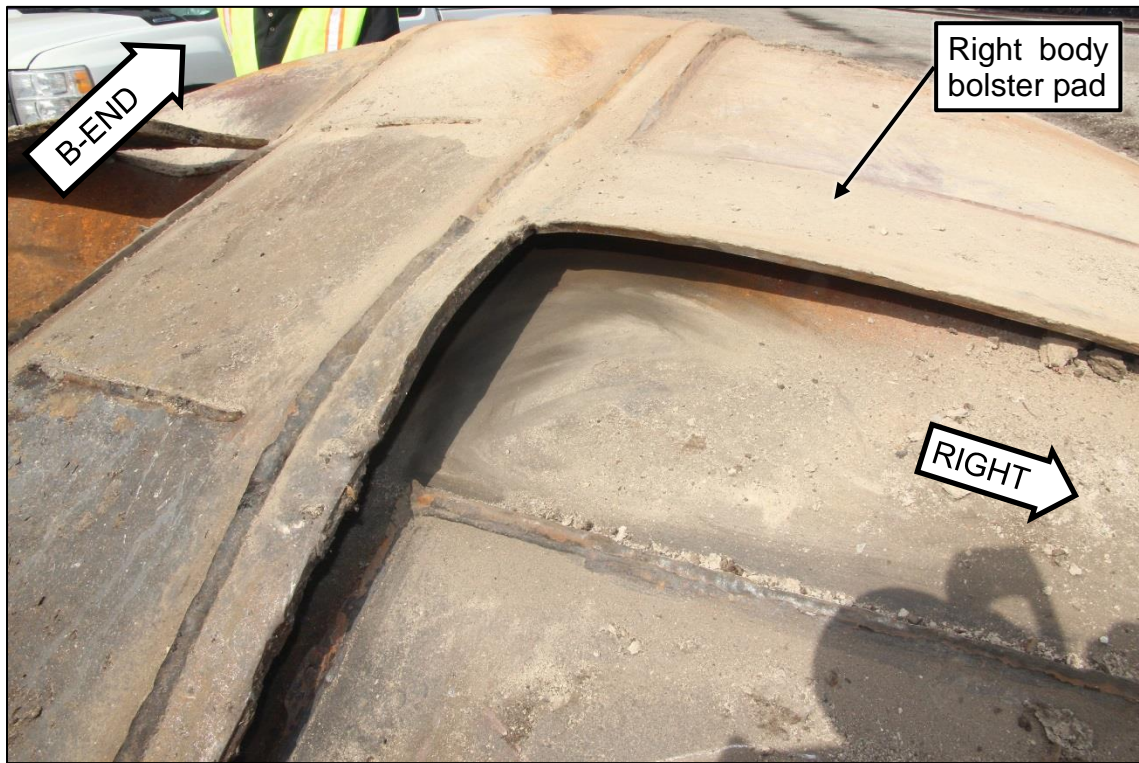
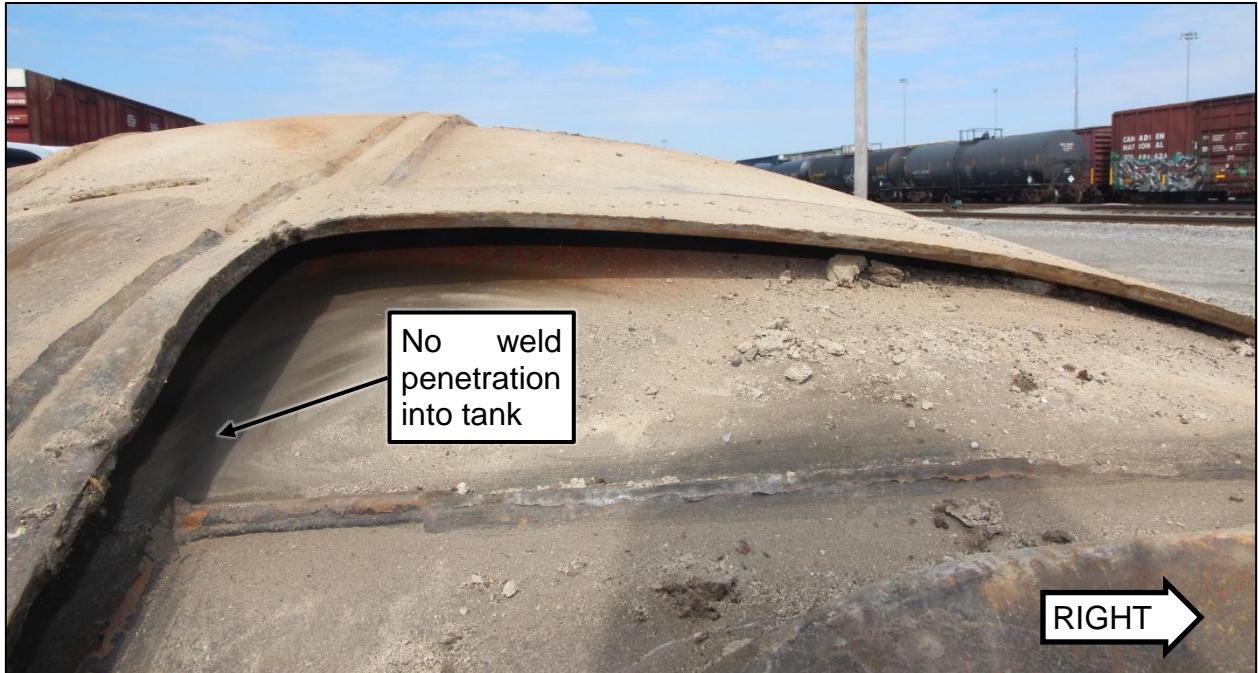
Views of the fractured right body bolster pad are shown in figure 4. The right body bolster pad was fractured circumferentially at the attachment location for the body bolster web, and the inboard end was fractured from the draft sill. The fractured section of right body bolster pad was missing. A gap was present between the right body bolster pad and the tank shell which was greatest at the inboard, A-end corner of the pad. The circumferential edge of the pad closer to the head remained attached to the shell.

Figure 4. Views of deformation at the right side of the sill pad where it intersected the body bolster pad. No weld penetration into the tank was observed where the body bolster pad was welded to the sill pad, consistent with the zero root opening bevel weld specified at the inboard end of the body bolster pad.
