NATIONAL TRANSPORTATION SAFETY BOARD

MATERIALS LABORATORY FACTUAL REPORT

Report No. 17-078

Place : Arlington, Texas
Date : September 22, 2017
Vehicle : Union Pacific Railroad train Y-GW51R-22
NTSB No. : DCA17FR013
Investigator : Georgetta Gregory, RPH-10

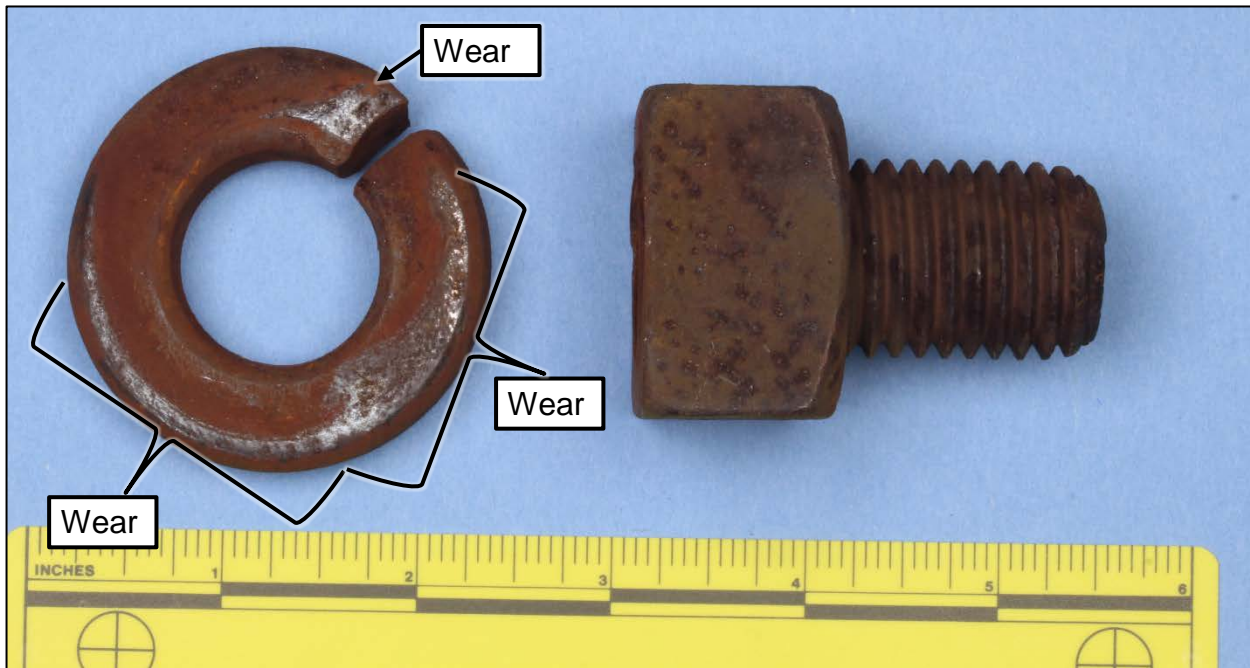
An overall view of the submitted joint bar attachment bolt piece, nut, and washer are shown in figure 1. The bolt was fractured through the threaded shank in a plane approximately coinciding with the clamping face of the nut. The nut remained attached to the submitted bolt piece as shown in figure 1.

Contact surfaces for the washer are shown in figures 1 and 3. Relatively shiny gray areas were observed corresponding to contact with the joint bar (surface shown in

figure 1) and the nut (surface shown in figure 3). The areas of wear contact are indicated with brackets and arrows on each face. As shown in figures 1 and 3, the contact areas were observed around approximately 75% of the circumference on each side of the washer.

Figure 1. Overall view of the submitted components.

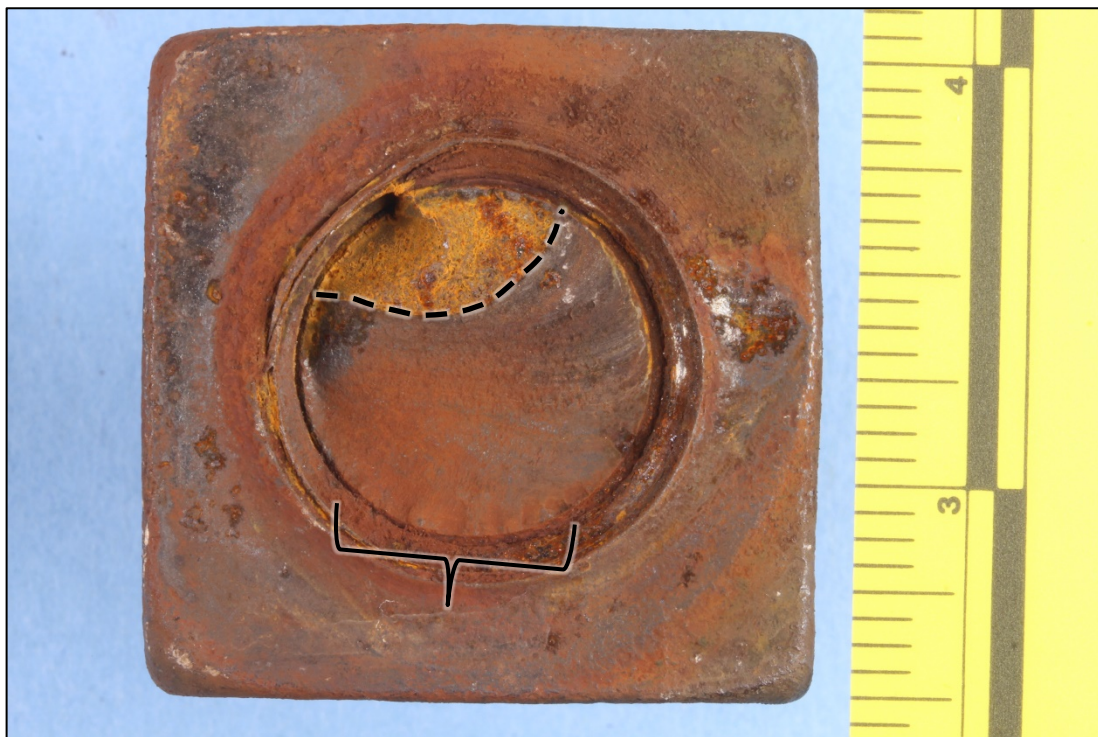
An overall view of the bolt fracture face is shown in figure 2. A portion of the fracture surface was relatively smooth with dark oxides, features consistent with fatigue cracking. Curving crack arrest lines were observed emanating from multiple origins at one side of the bolt. A bracket in figure 2 indicates the approximate origin area. Step features consistent with ratchet marks¹ were observed at the origin area, consistent with multiple origins. A dashed line in figure 2 indicates the fatigue boundary. The remainder of the fracture surface was rough and mostly covered with orange oxides, features consistent with overstress fracture followed by oxidation of the exposed fracture surface.

The image of the fracture surface shown in figure 2 was analyzed to determine the extent of fatigue cracking prior to overstress fracture. The number of pixels associated with the fatigue region was compared to the number of pixels associated with the entire fracture surface, and the area percentage was calculated from the pixel counts. The estimated size of the fatigue region relative to the cross-sectional area in the plane of fracture was approximately 78%.

Figure 2. Close view of the bolt fracture surface. A bracket indicates the fatigue origin area, and a dashed line indicates the fatigue boundary.

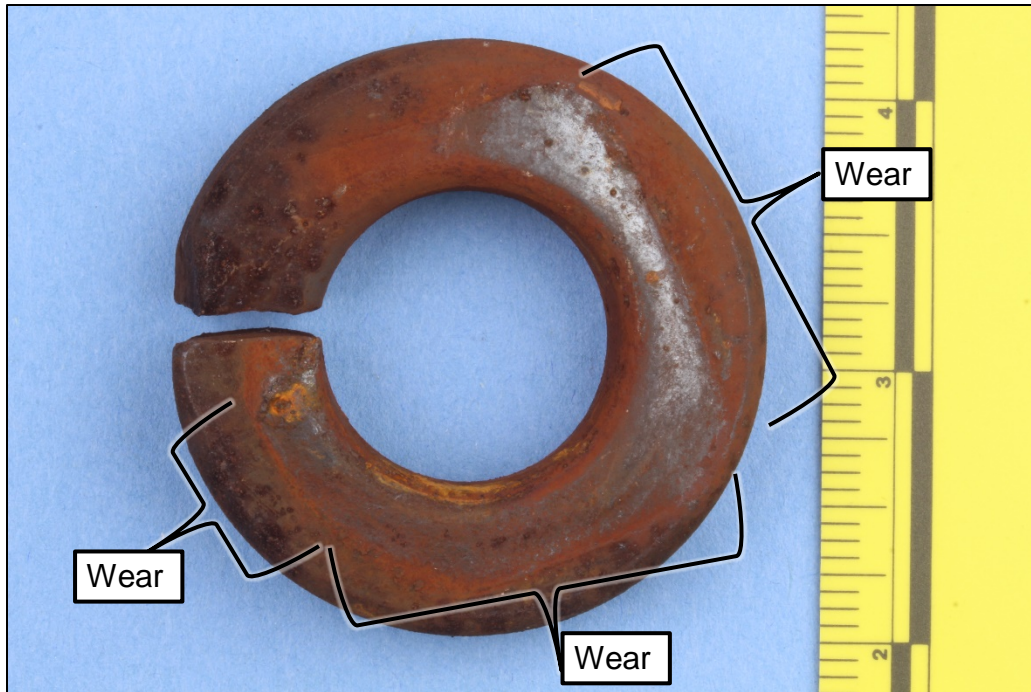
Figure 3. Close view of the face of the washer spring mating to the nut face. Areas of wear are indicated with brackets.

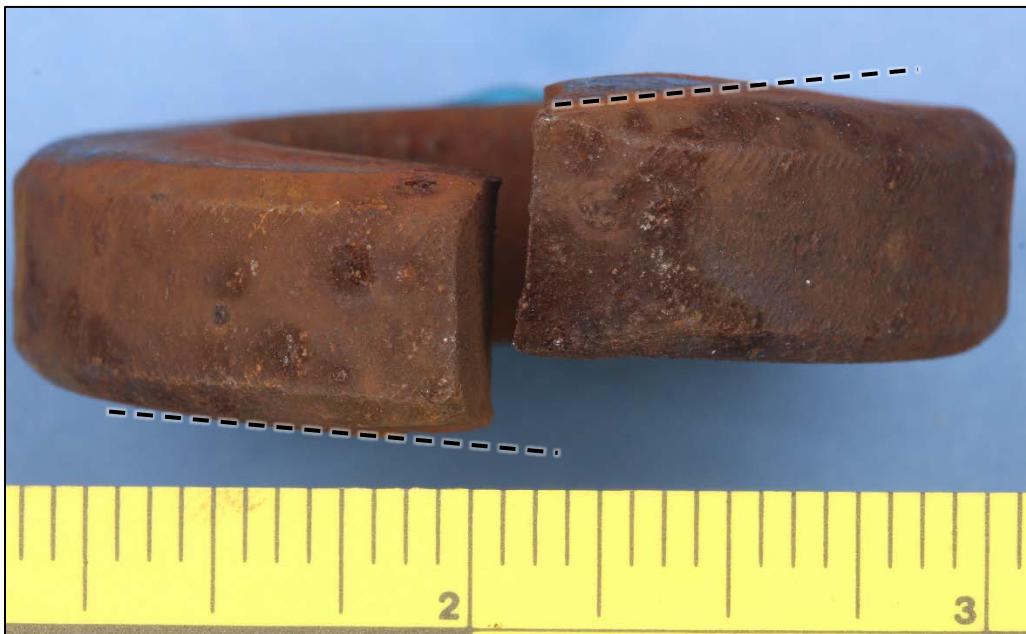
A side view of the washer at the split line is shown in figure 4. Dashed lines indicate the orientations of planes associated with wear surfaces on either side of the split line. The planes of wear were angled relative to each other with the spring in the unloaded position as shown in figure 4.

Figure 4. Side view of the washer. Dashed lines indicate planes of wear on either side of the split with the split in the washer sprung open as shown.
