NATIONAL TRANSPORTATION SAFETY BOARD

MATERIALS LABORATORY FACTUAL REPORT

Report No. 17-095

Place : Minneapolis, MN
Date : 8/2/2017
Vehicle : N/A
NTSB No. : DCA17MP007
Investigator : Roger Evans

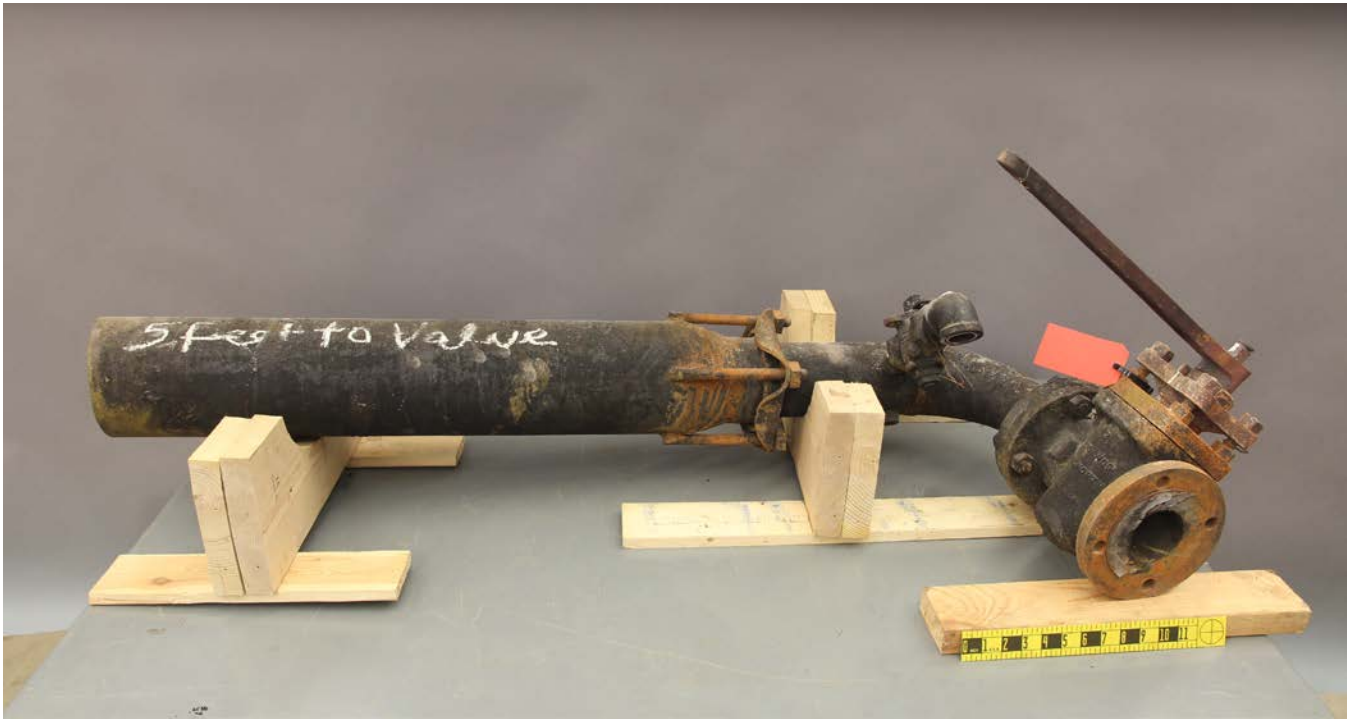
The accident plug valve was shipped to the laboratory with a portion of the pipeline still attached. The valve handle and valve body had chalk alignment marks indicating the valve handle was found in the position perpendicular to the valve body (figure 1). Examination of the valve bore from the free end revealed that the valve was in the open position. A portion of gasket material was attached to the flange of the free end of the valve. Overall the valve and attached piping exhibited areas of soot covered surface as well as areas of oxidized surface. No paint remained on the valve body. The valve handle also exhibited an overall oxidized appearance.

Figure 1: As received accident plug valve with handle and portion of piping attached.

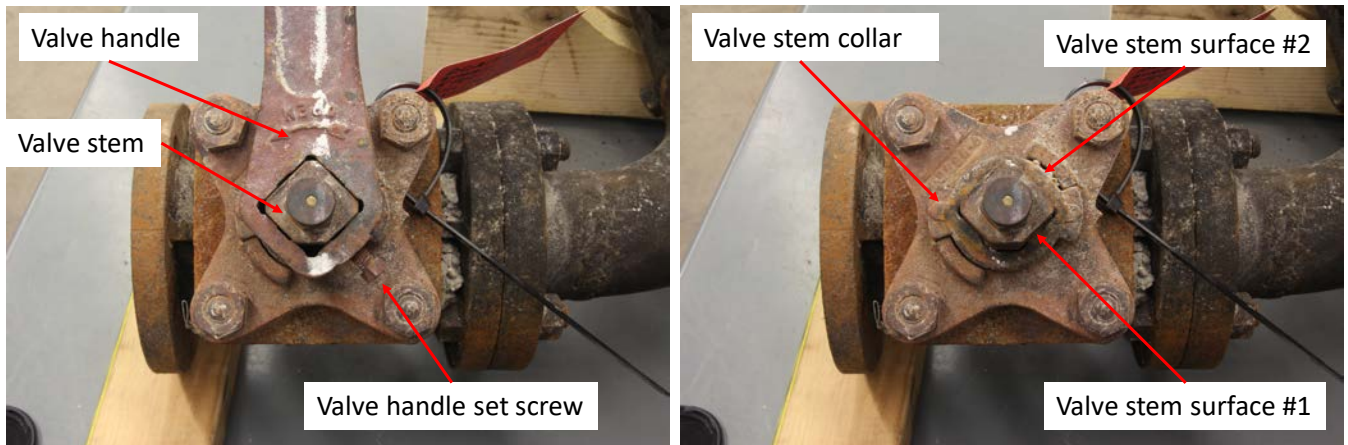
The valve handle had a square hole and a set screw on one end for engagement with the valve stem (figure 2). The valve stem was a square (1-3/8") shaft with one of the edges beveled. There were no features in the relationship between the valve handle and valve stem to ensure an alignment between the two components consistent with the state of the valve. In the position that the valve handle was found, perpendicular to the direction of flow, the valve handle set screw would have pressed against valve stem surface #1 as labeled in figure 2. With the valve handle installed parallel to the direction of flow, the handle set screw would have pressed against valve stem surface #2 as labeled in figure 2. Examination of the valve stem surface #1 revealed a faint witness mark consistent with the handle's set screw (figure 3). Examination of the valve stem surface #2 revealed two distinct witness marks consistent with the handle set screw (figure 4). These witness marks on surface #2 were deep and had made indentations on the valve stem.

Figure 2: Top view of valve showing valve handle and valve stem engagement.

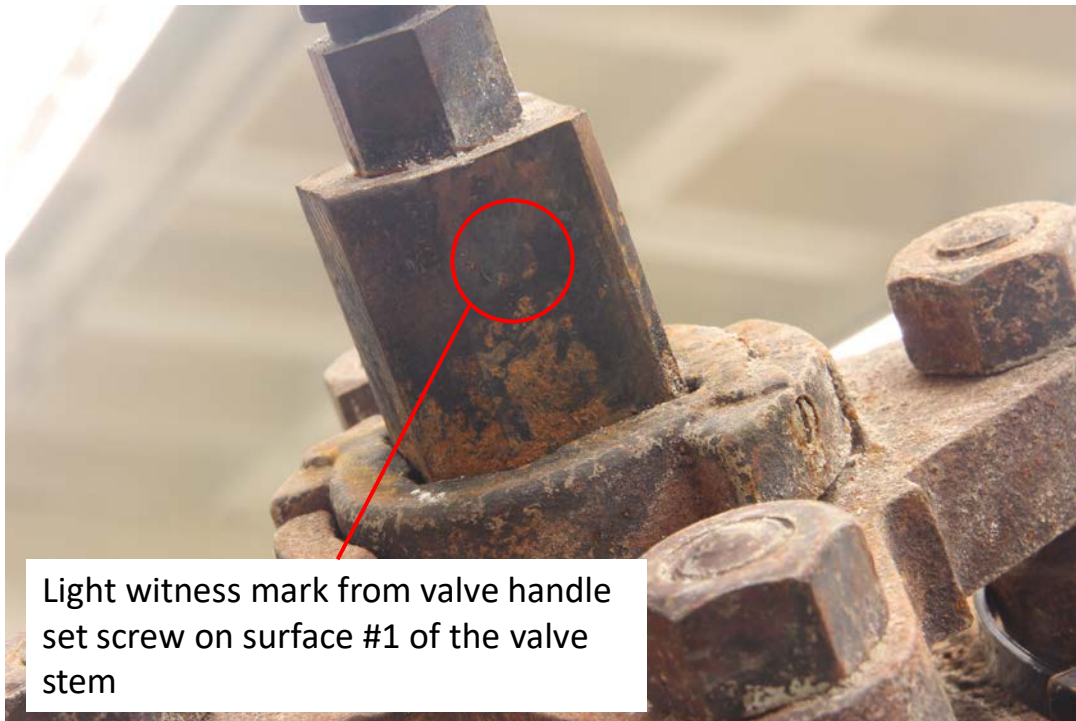
Figure 3: Witness mark on valve stem surface #1 (consistent with as found handle position)

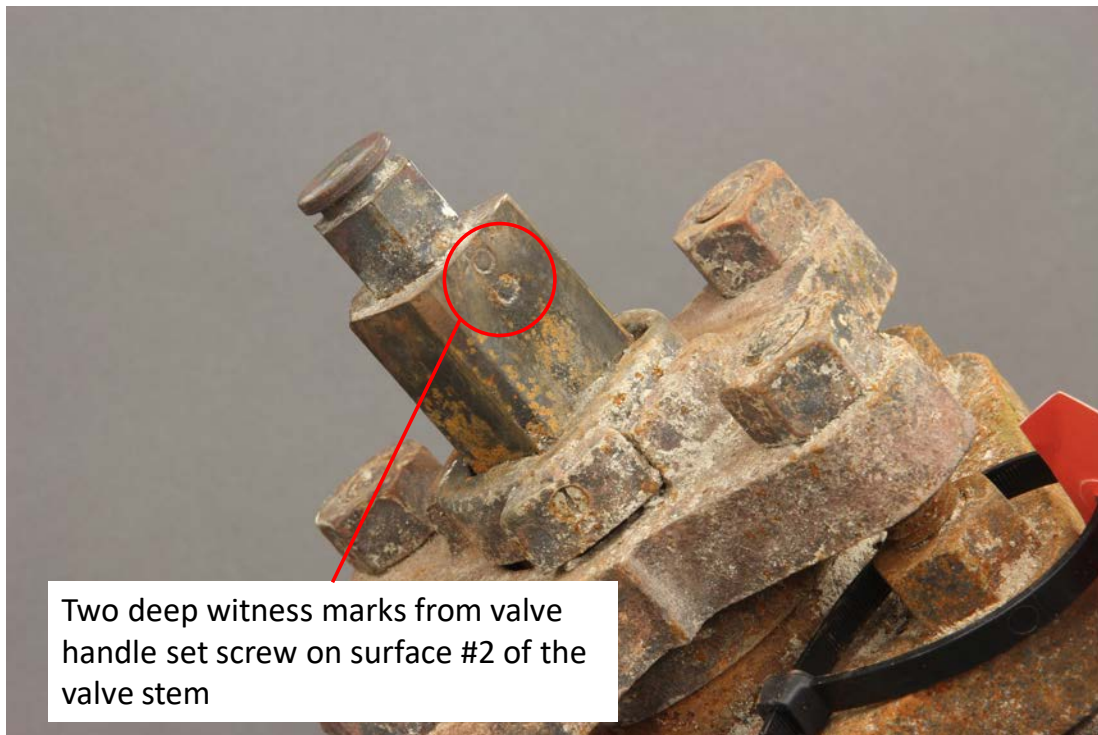
Figure 4: Witness marks on valve stem surface #2 (correct position of handle with regard to the state of the valve)

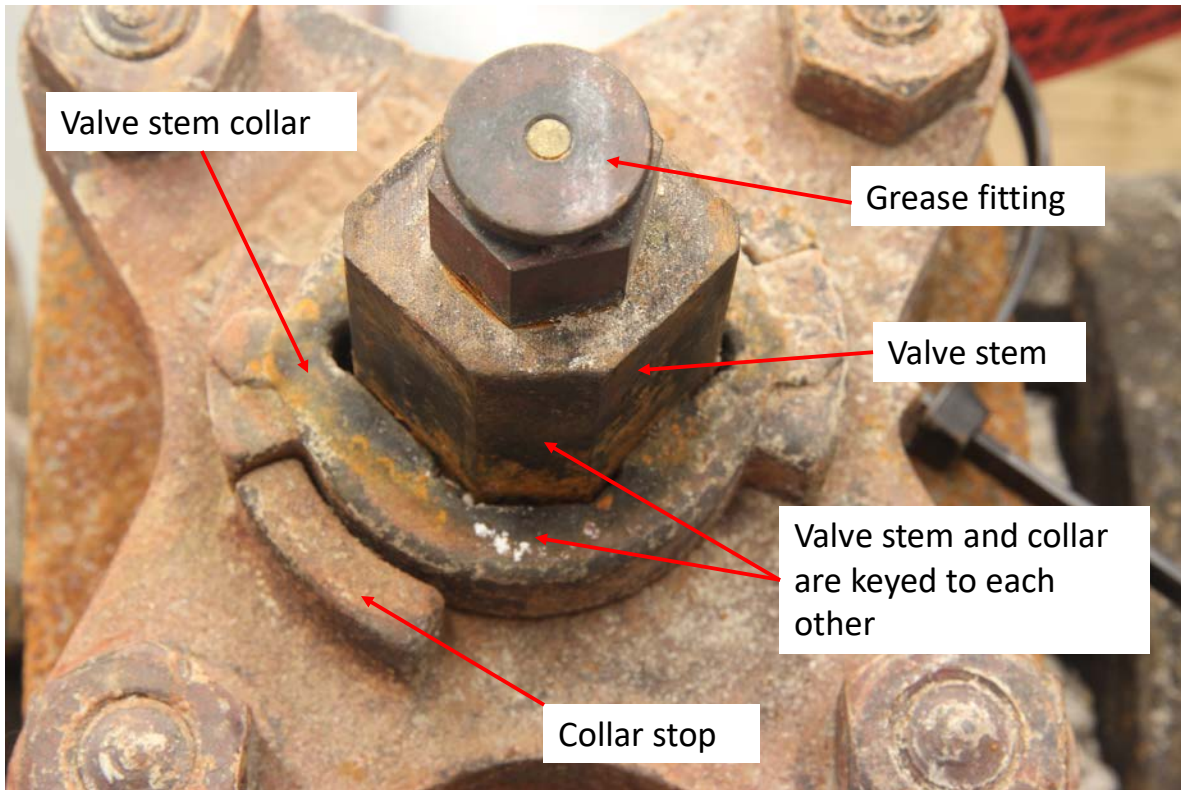
The valve stem had a collar attached where it protruded from the top of the valve (figure 5). Examination of the relationship between the valve stem collar and the valve stem revealed that these two components were keyed to each other as shown in figure 5. The valve stem collar had arrows embossed onto the part indicating the state of the valve. After the accident the arrows on the collar were parallel to the direction of flow, consistent with the valve being in the open state. Collar stops on the top of the valve engage with the valve stem collar limiting the valve stem rotation to 90 degrees.

Figure 5: Valve collar and valve stem relationship.

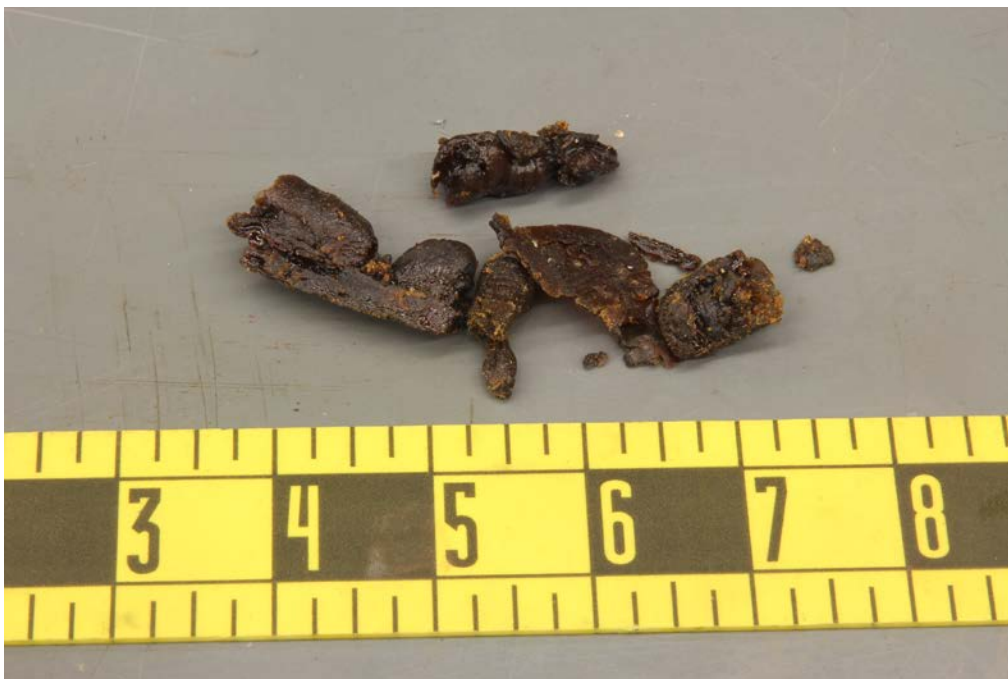
The accident plug valve was separated from the attached piping to facilitate a bench-top measurement of the torque needed to close the valve. An exemplar valve was used for comparison purposes. The exemplar valve had been in natural gas service prior to removal and shipping to NTSB. The exemplar valve body was painted with a silver paint that covered all surfaces. This silver paint also covered the top of the grease fitting at the end of the valve stem. The exemplar valve was received in the open state with blank flange covers bolted to each of the flanges on the valve body. After removal of the blank flange covers and looking through the bore of the exemplar valve a dry rubbery substance was identified at the edges of the tapered valve plug and valve body interface. This dry rubbery substance (figure 6) appeared to be hardened valve lubricant.

Figure 6: Material recovered from exemplar plug valve bore.

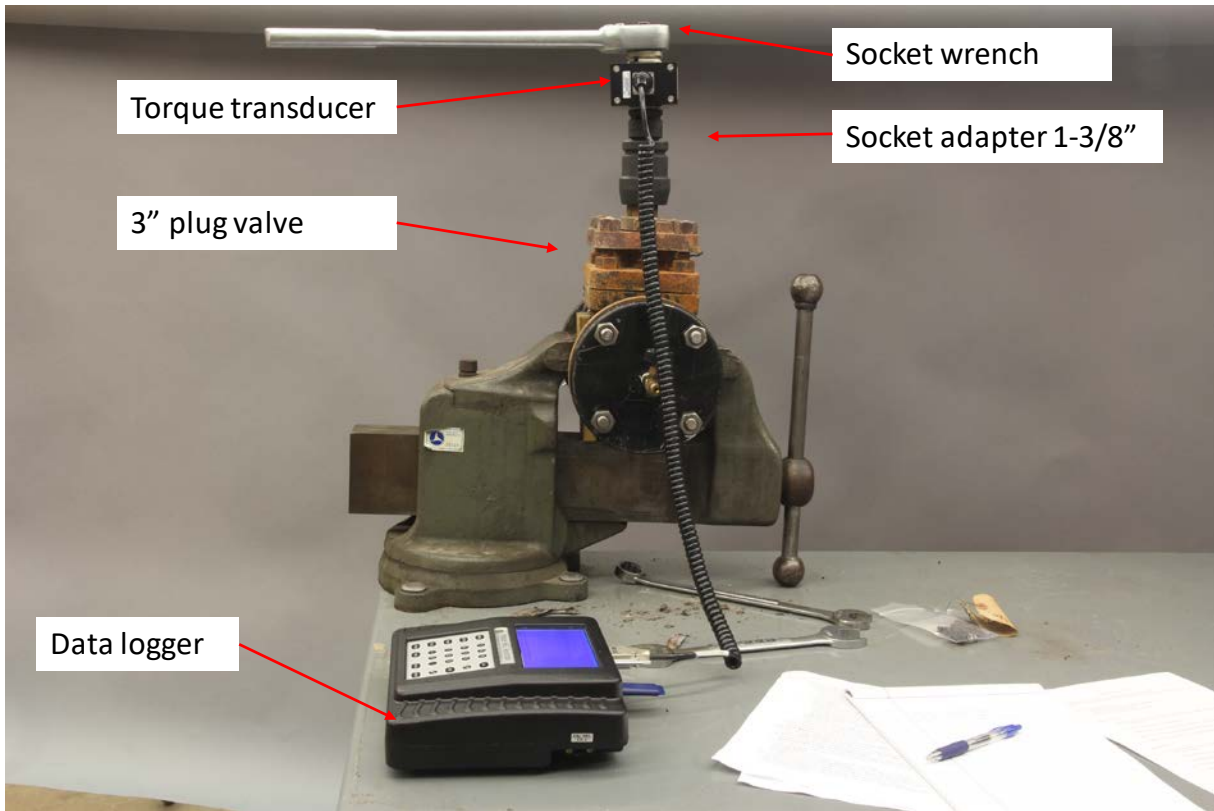
Measurements were made to establish the operating torque needed to change the state of the valves. These measurements were done by holding the valve bodies in a bench vise and using a socket wrench with an electronic torque transducer to record the torque (figure 7). Blank flange covers modified with compressed air fittings were installed on the valves to allow for pressurization of the valve bodies during the test. This arrangement worked for the exemplar valve. The accident valve had a higher operating torque that could not be achieved while using the arrangement shown in figure 7. To prevent the valve body from rotation and gain better leverage to apply the operating torque, the accident valve was secured by one of its flanges to the T-slotted work table of a band saw as shown in figure 8. In this arrangement it was not possible to install the modified blank flange covers and the valve body pressurization was omitted from the test protocol. The operating torque to change the state of both the exemplar and accident valves are listed in tables 1 & 2.

Figure 7: Arrangement for measuring the operating torque needed to change the state of the valve.

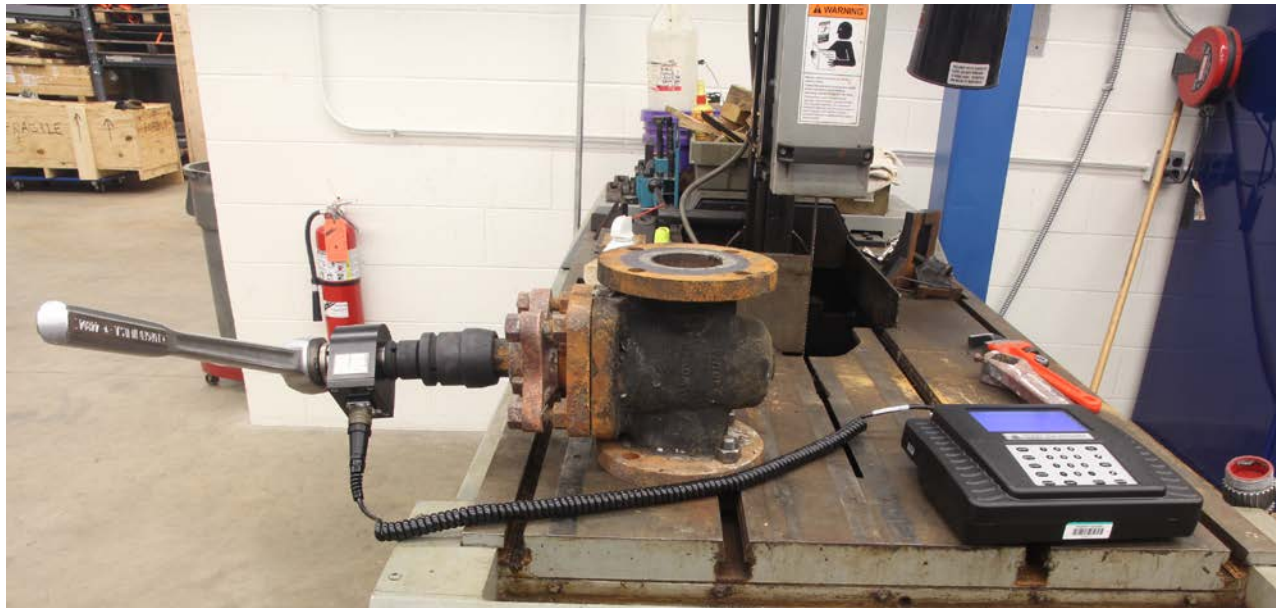
Figure 8: Alternate arrangement for measuring the valve operating torque.
