NATIONAL TRANSPORTATION SAFETY BOARD

MATERIALS LABORATORY FACTUAL REPORT

Report No. 18-078

Place : Scottsdale, AZ
Date : April 9, 2018
Vehicle : Piper PA-24-260 (N9456P)
NTSB No. : WPR18FA119
Investigator : Maja Smith, AS-WPR

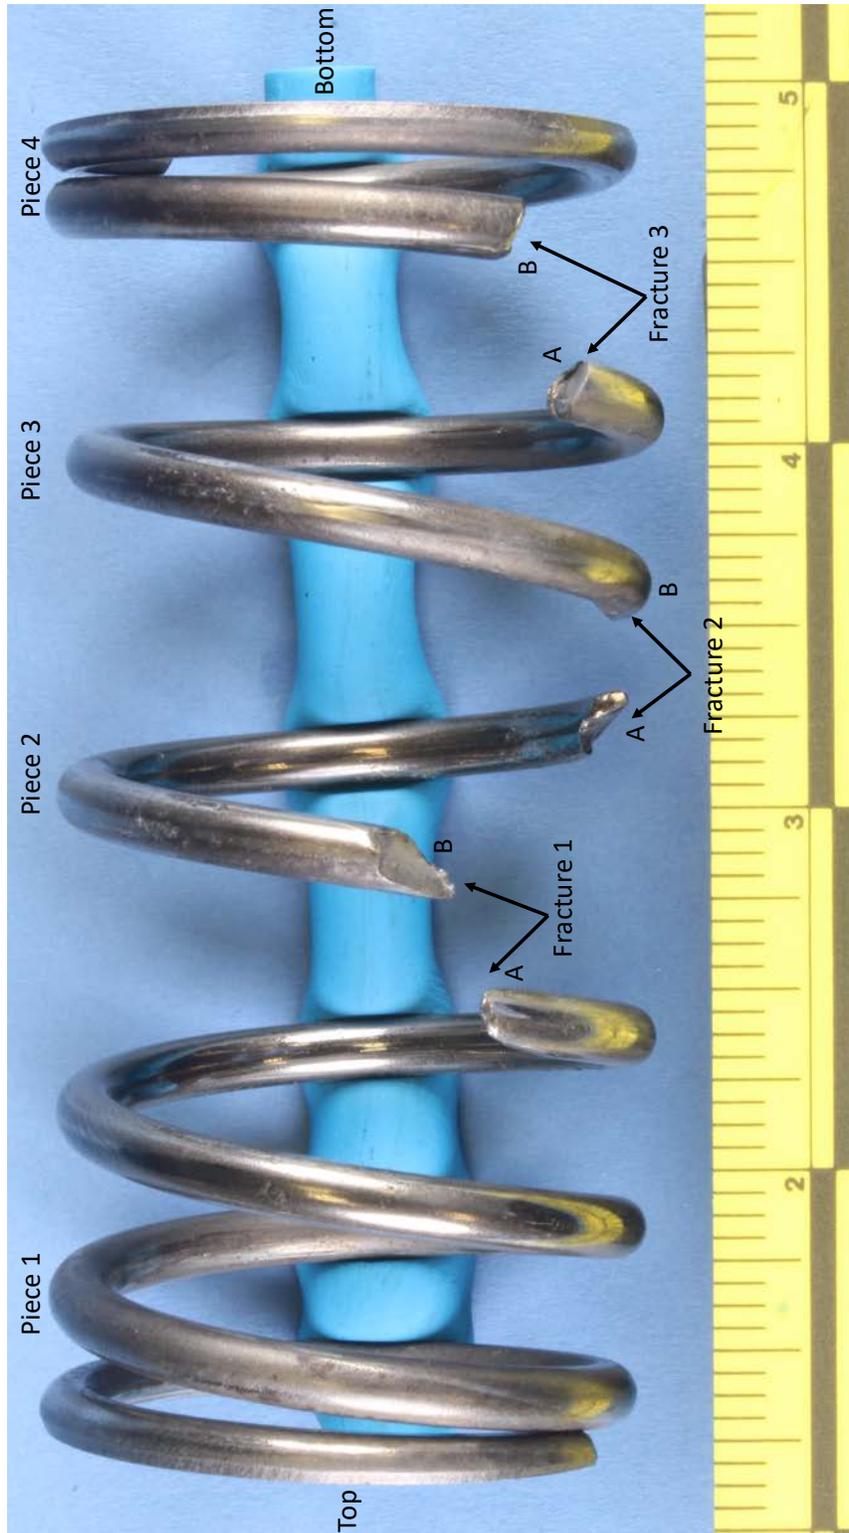
The as-received fractured spring pieces are shown in Figure 1, approximately arranged in their positions preceding the fractures. Each fracture is numbered, and each face of each fracture is identified with the letters A and B as shown in the figure.

Figure 1 The as-received fractured spring pieces. The as-installed spring orientation (top and bottom) is also indicated.

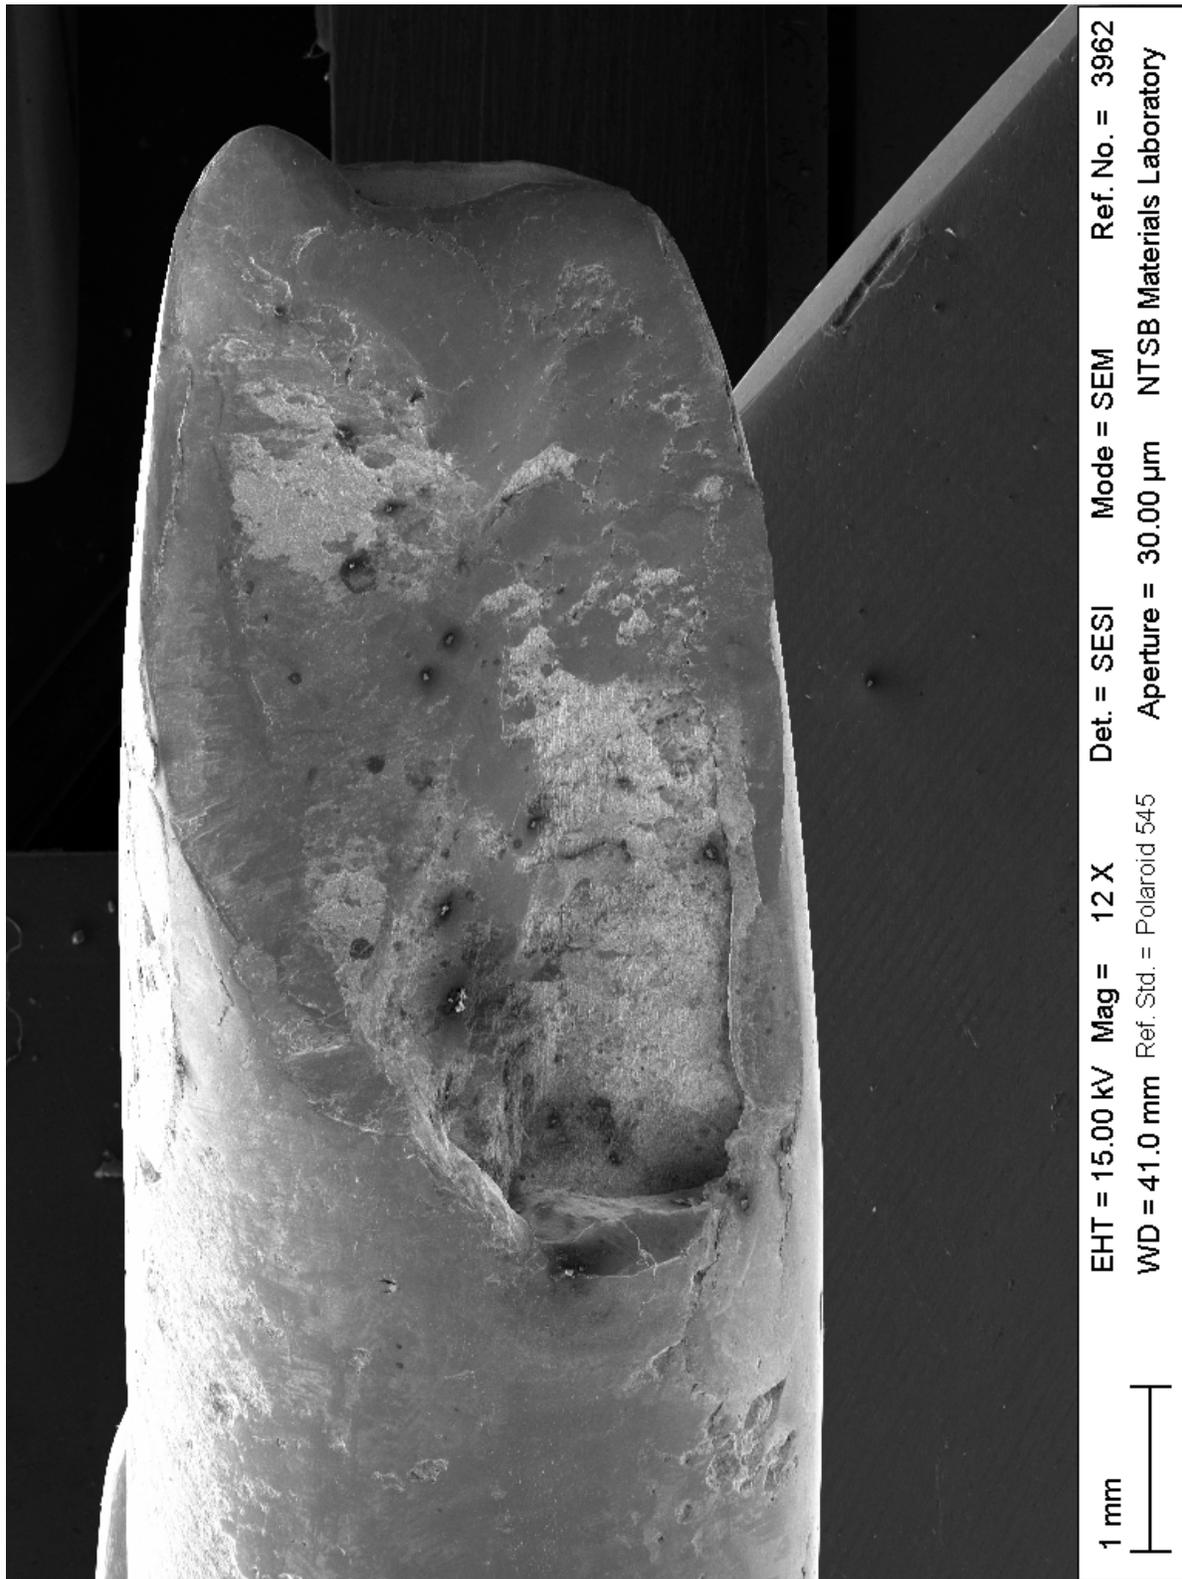
Fracture location (Figure 1)	Fracture face (Figure 1)	Observation	Figure number
Fracture 1	A	Fracture face was obscured by mechanical contact damage, unable to determine fracture macro- and micro-mode.	Figure 2
	B	Fracture macro-mode is consistent with fatigue fracture (origin at a surface pit on the helix inside diameter) through 40% of the diameter, with final fracture due to micro-void coalescence overstress fracture. The surface pit is approximately 247 μm (0.009 inch) deep. Mechanical contact damage prohibited fracture micro-mode confirmation.	Figures 3, 4
Fracture 2	A	Fracture macro-mode revealed a flat fracture with crack progression lines, fracture micro-mode revealed fine striations indicating fatigue fracture (origin at a surface pit on the helix inside diameter) through 50% of the diameter, with final fracture due to micro-void coalescence overstress fracture. The surface pit is approximately 275 μm (0.010 inch) deep.	Figures 5, 6, 7, 8, 9

Figure 2 Overall SEM fractograph of Fracture 1A. Smooth areas indicate mechanical contact damage.

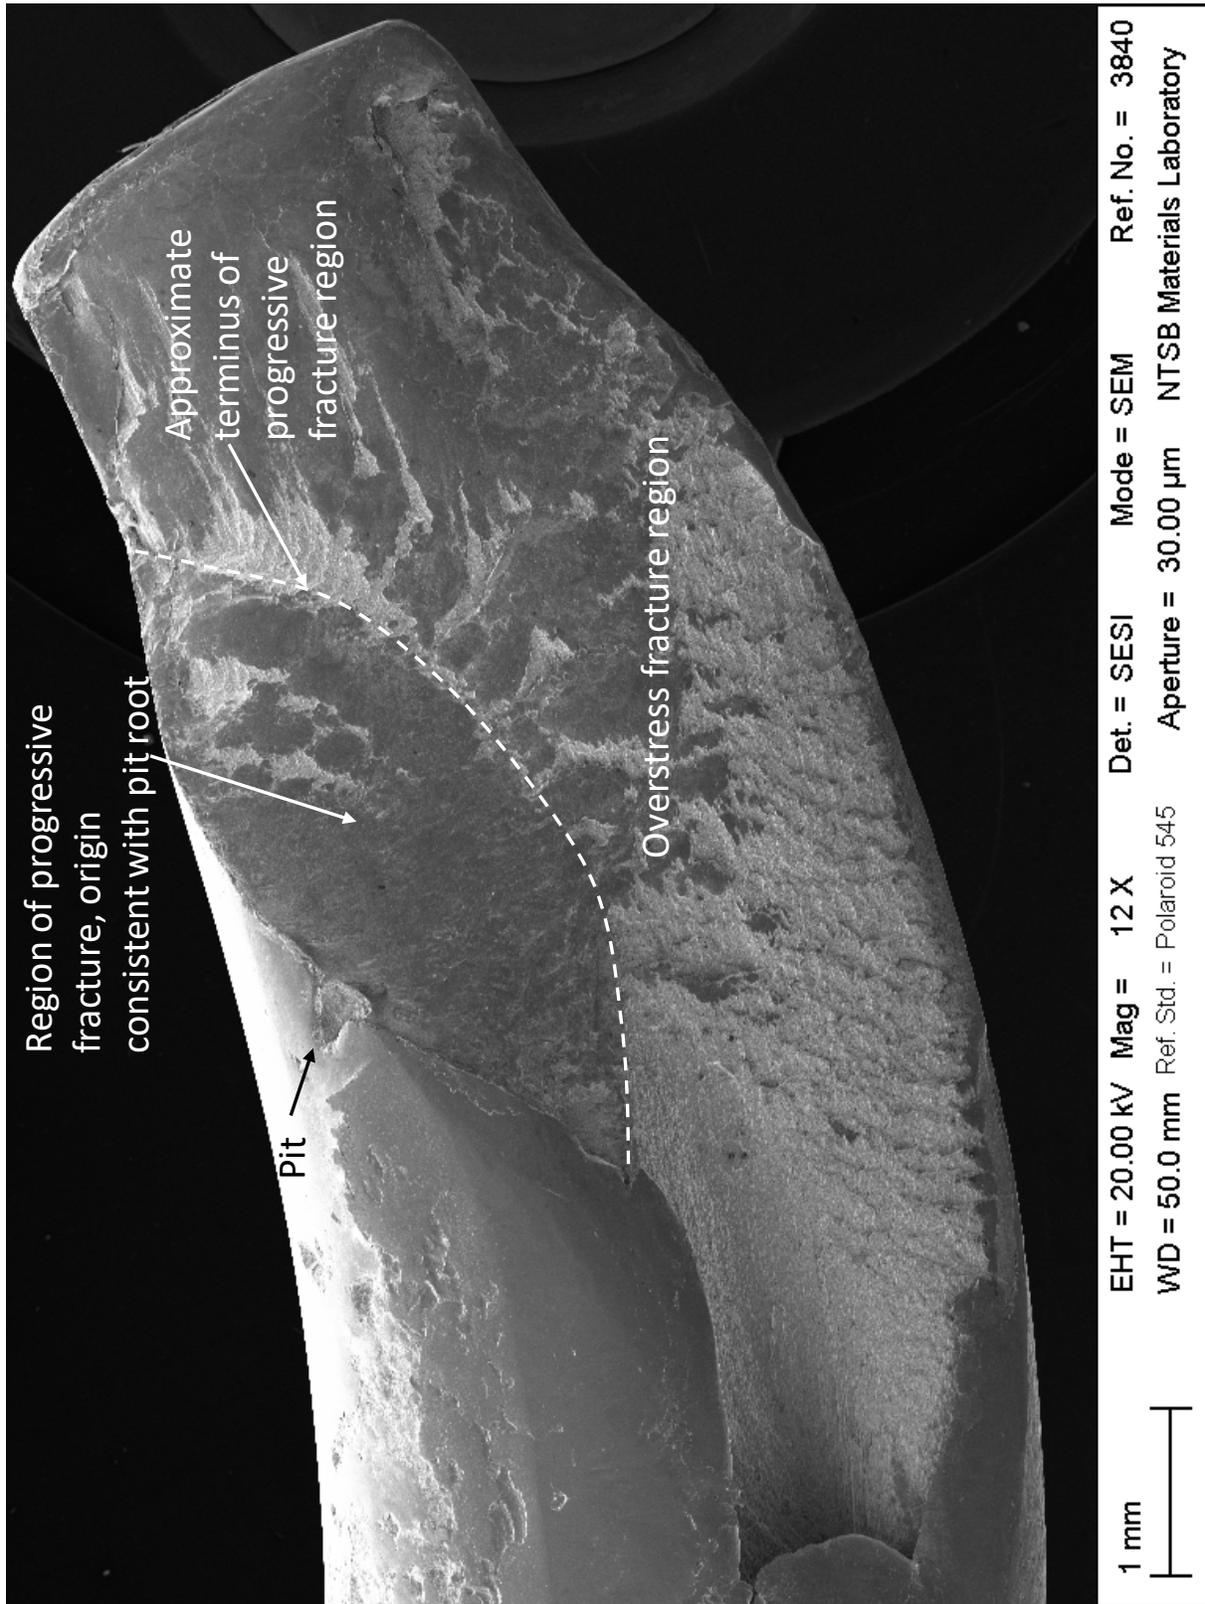
Fractures 1 and 2 initiated at pits on the inside diameter of the helix and propagated due to fatigue crack growth through about 40% to 50% of the diameter before final fracture due to overstress. The fractures propagated along a 45° plane that is consistent with the superposed direct-shear, torsional-shear, and curvature-shear stresses found in axially-loaded helical springs. Fracture 3 was nearly perpendicular to the wire axis and the fracture surfaces were obscured by mechanical damage; determination of the fracture origin or the fracture macro- and micro-mode was not possible.

Figure 3 Overall SEM fractograph of Fracture 1B. Smooth areas indicate mechanical contact damage. Key fracture features are annotated on the image.

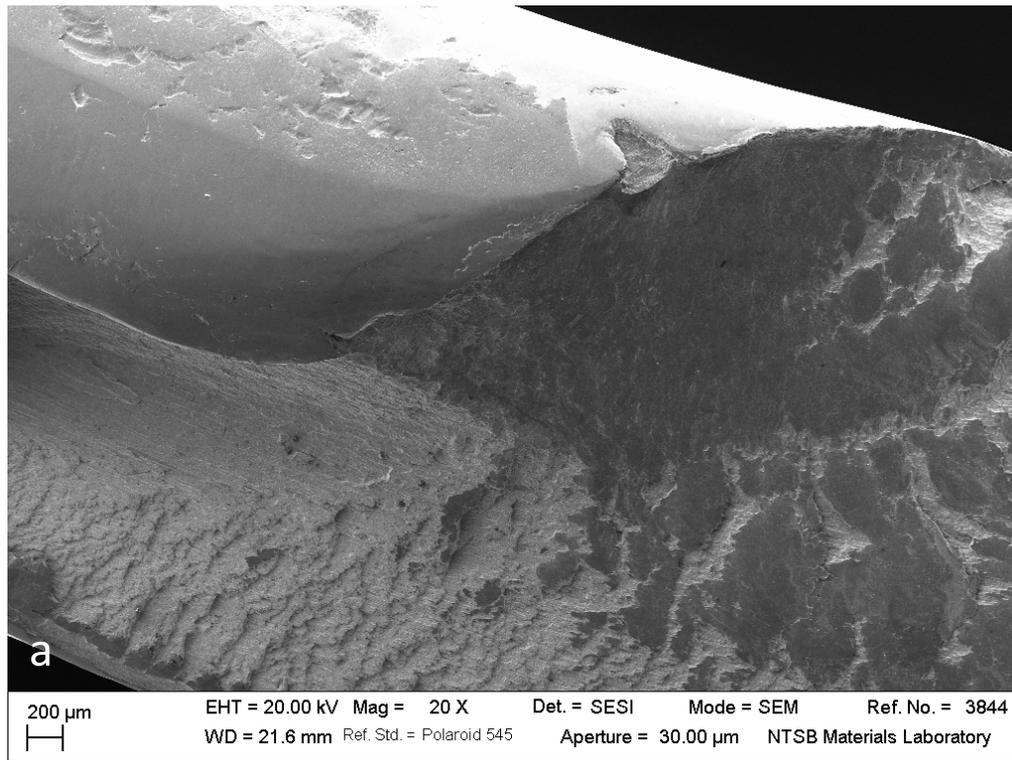
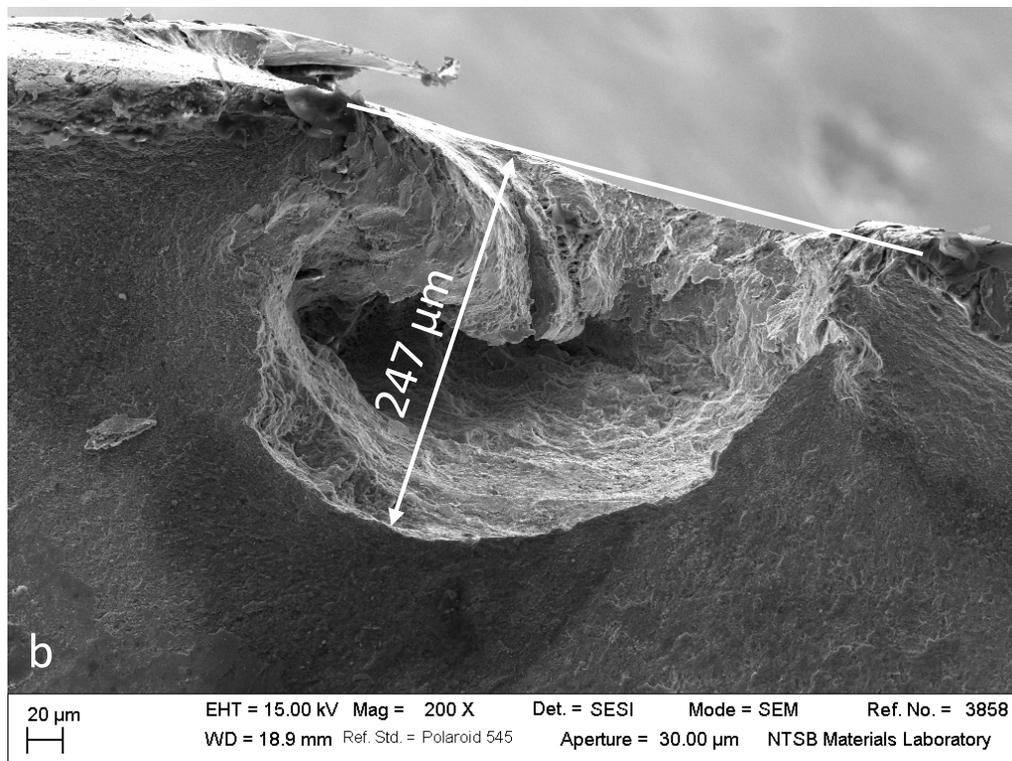
Figure 4 SEM fractographs of Fracture 1B showing closer views of the fatigue fracture-initiating surface pit in the spring wire. The approximate depth of the is shown in view b.

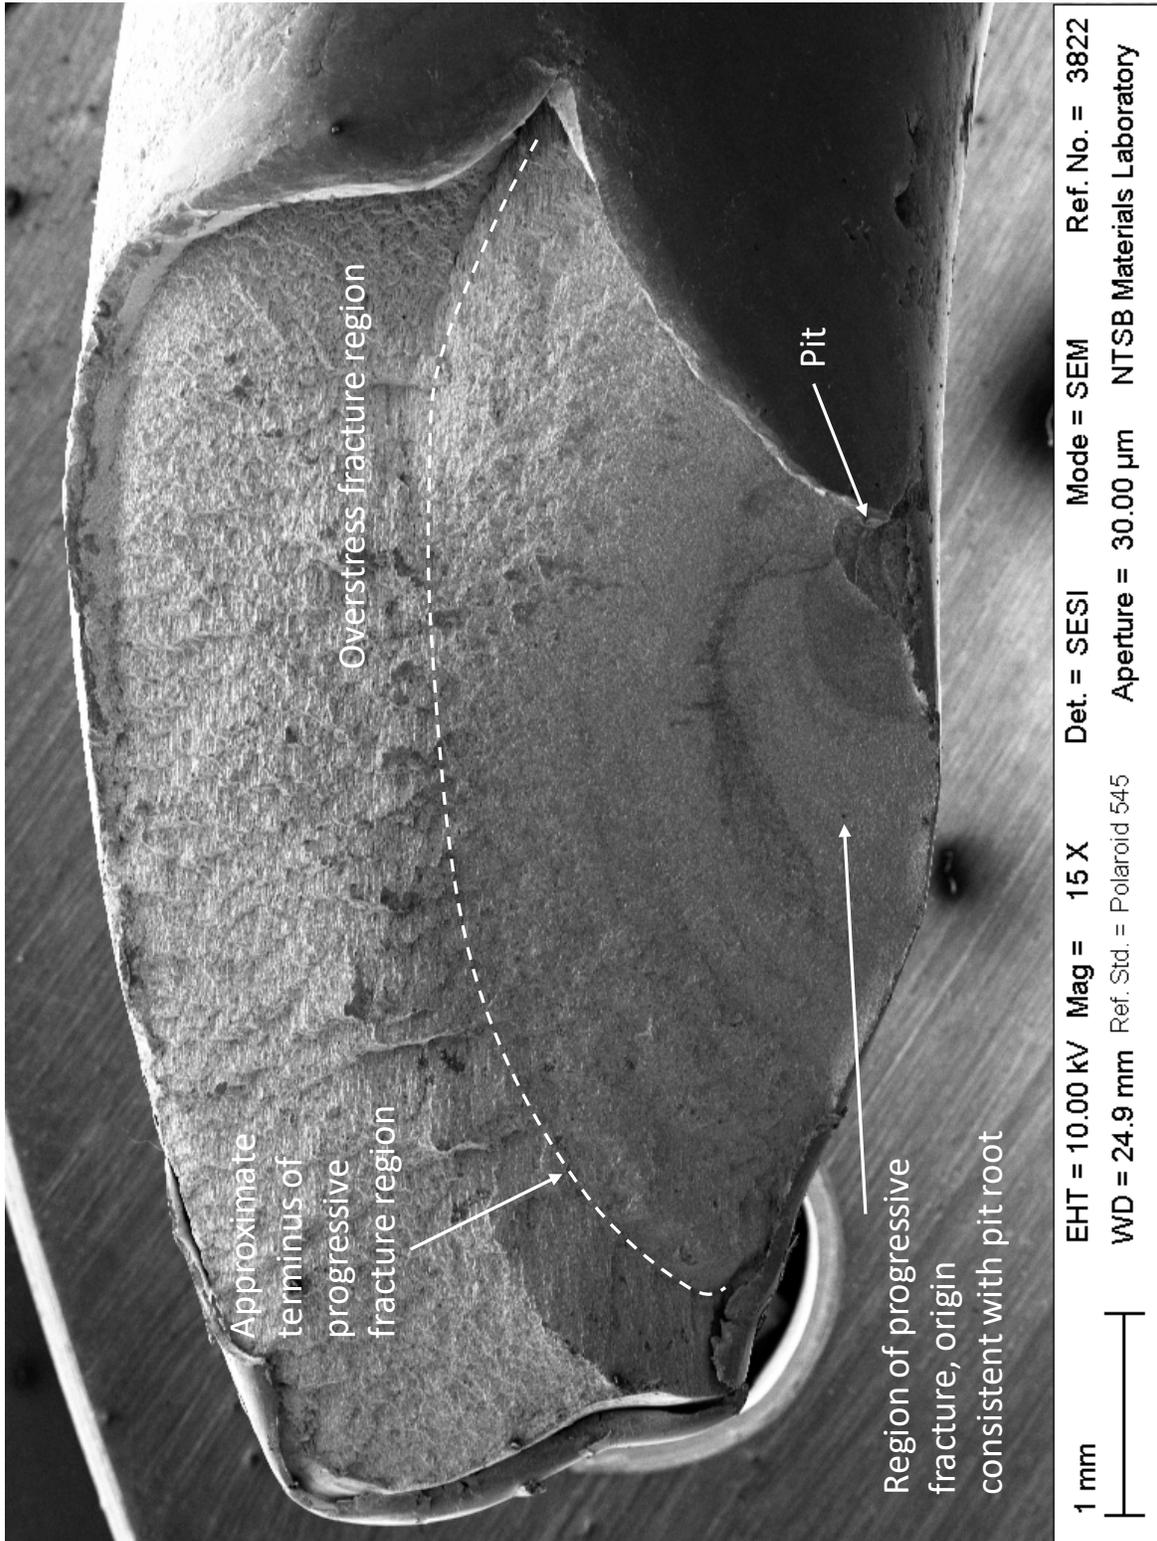
Figure 5 Overall SEM fractograph of Fracture 2A. Key fracture features are annotated on the image. The fatigue fracture-initiating surface pit in the spring wire is indicated.

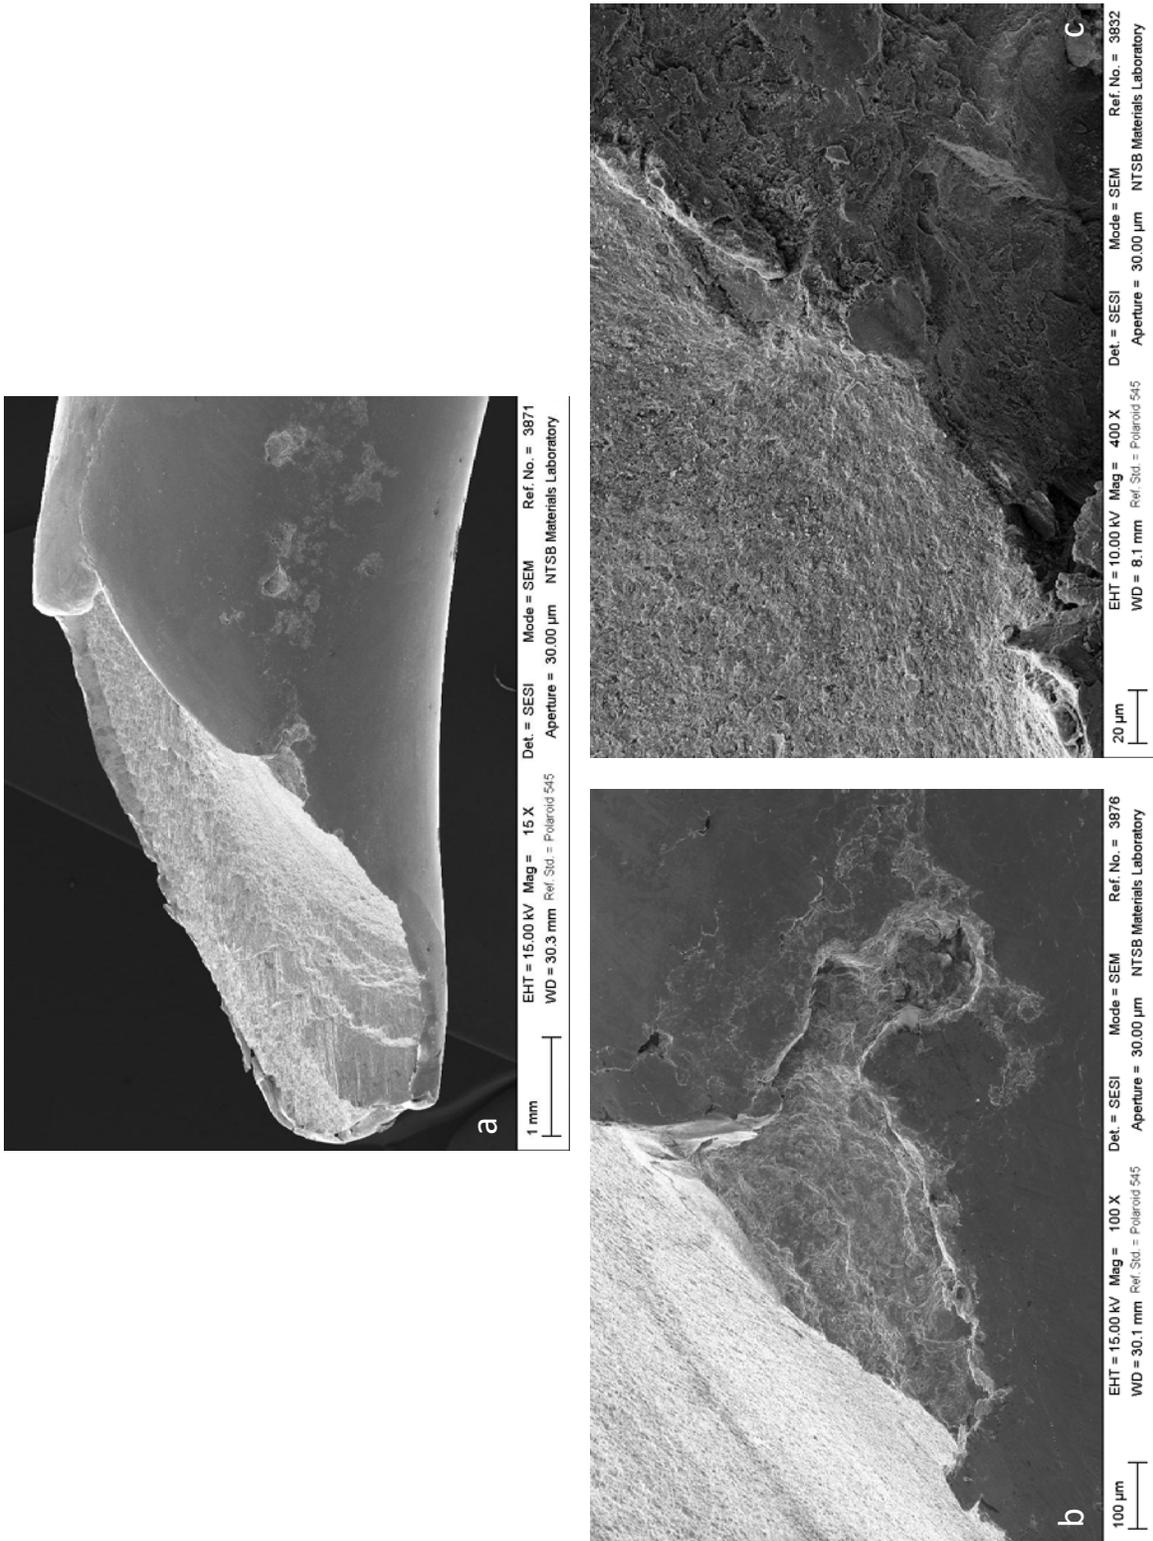
Figure 6 SEM images of Fracture 2A showing progressively higher magnification images of the fatigue fracture-initiating surface pit in the spring wire.

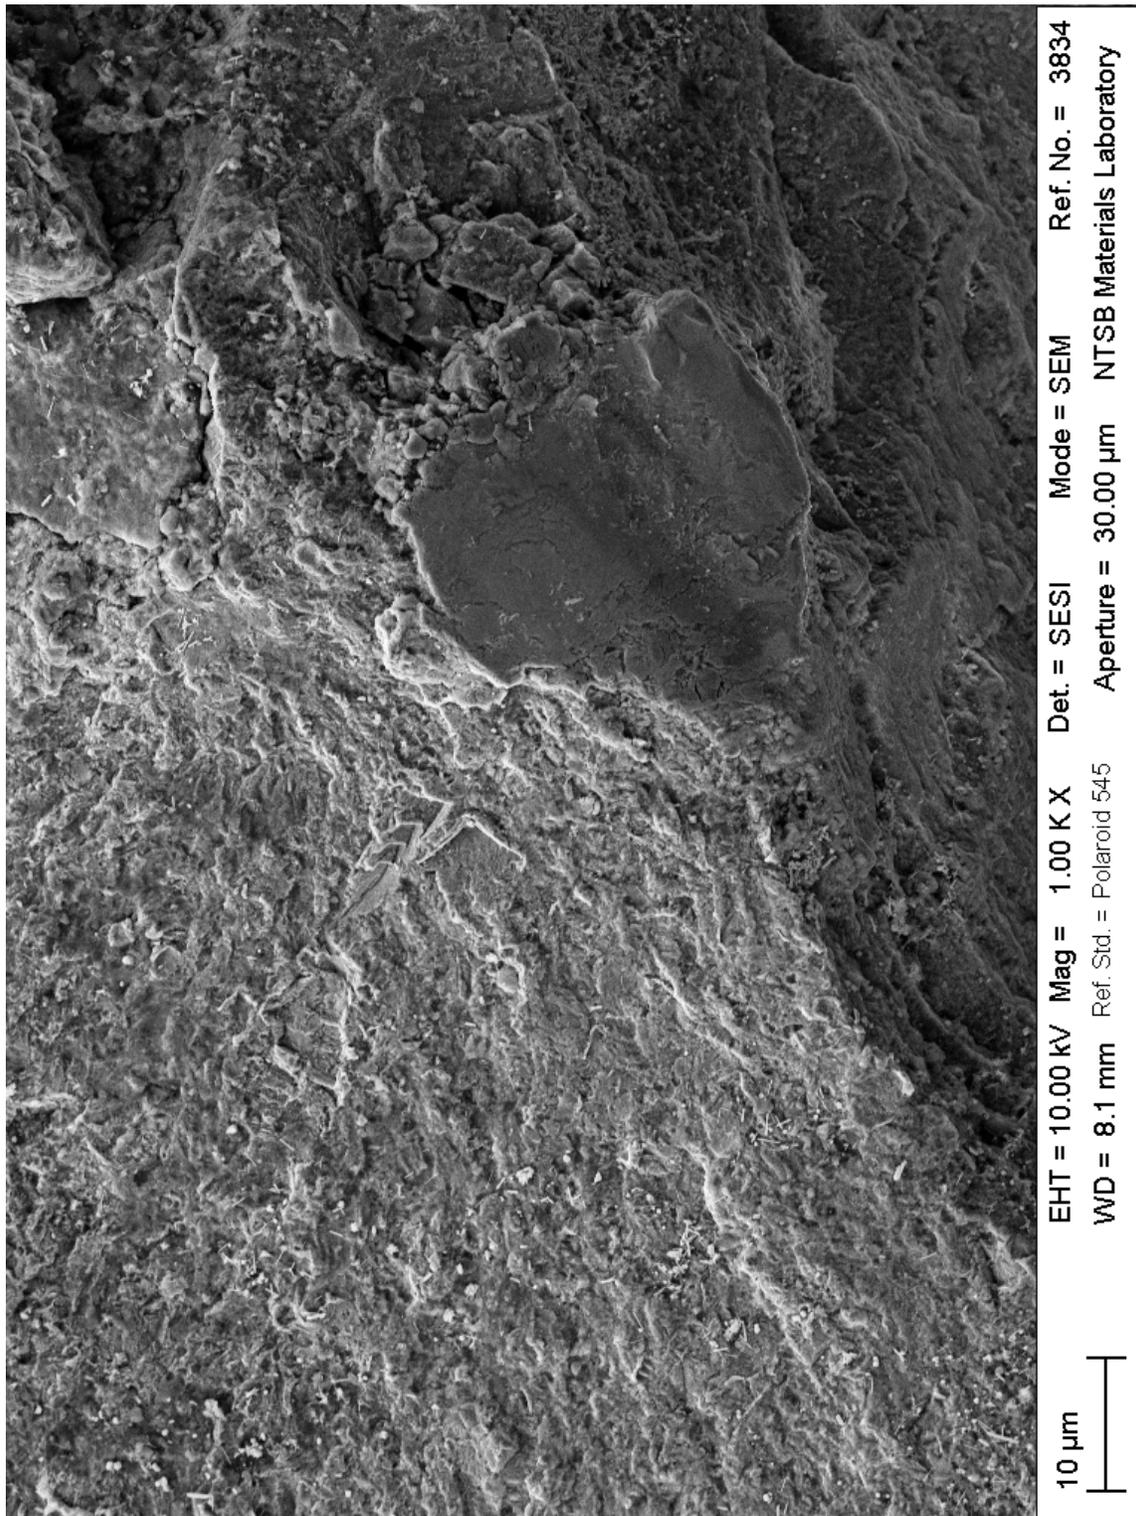
Figure 7 Higher magnification image of the fatigue crack origin area shown in Figure 6c.

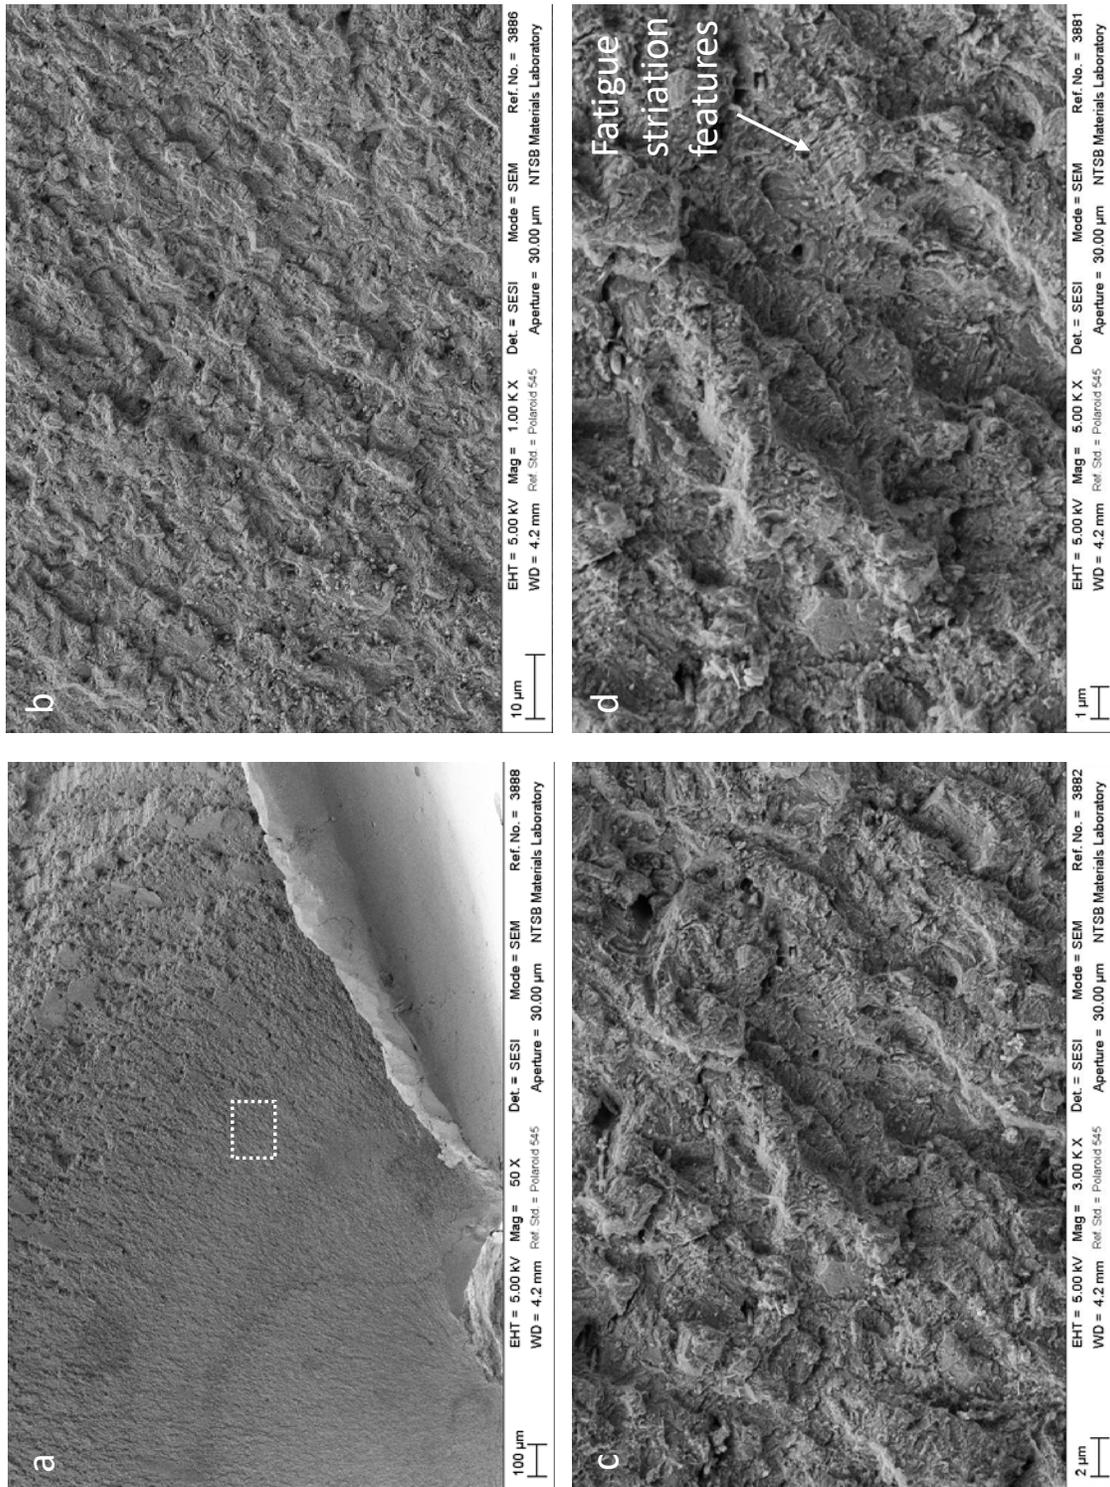
Figure 8 SEM fractographs of progressively higher magnification, showing an example fracture surface in the fatigue fracture region of Fracture 2A. Views b, c, and d are from the region marked by the dashed box in view a. Fatigue striations are noted in views c and d.

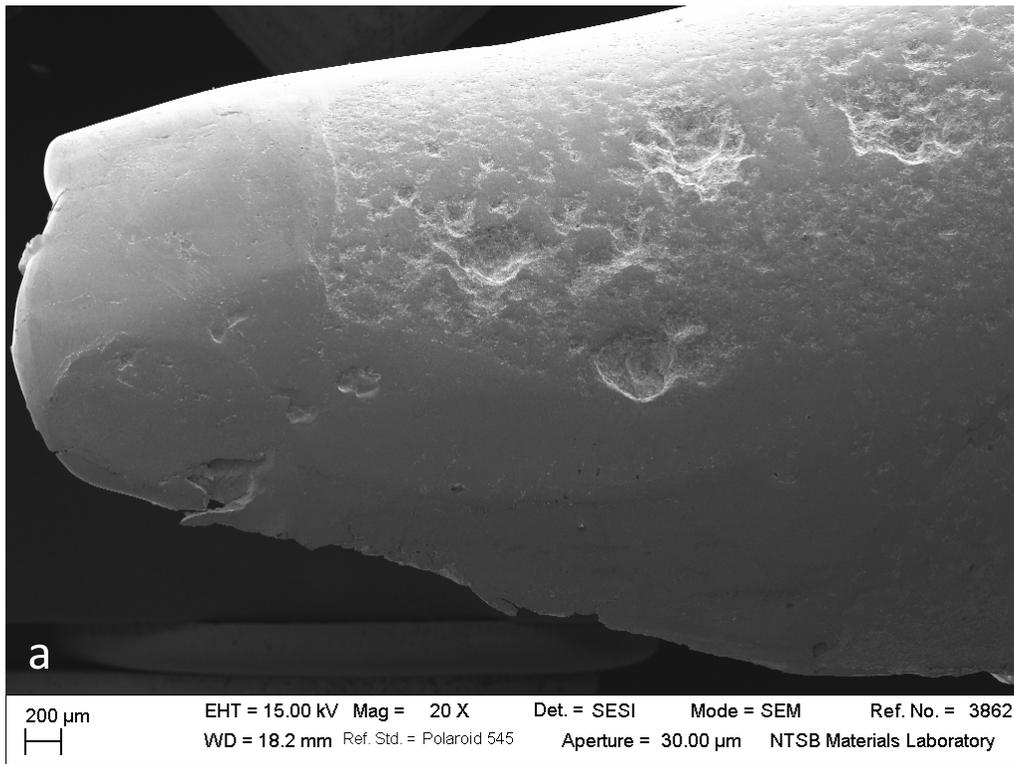
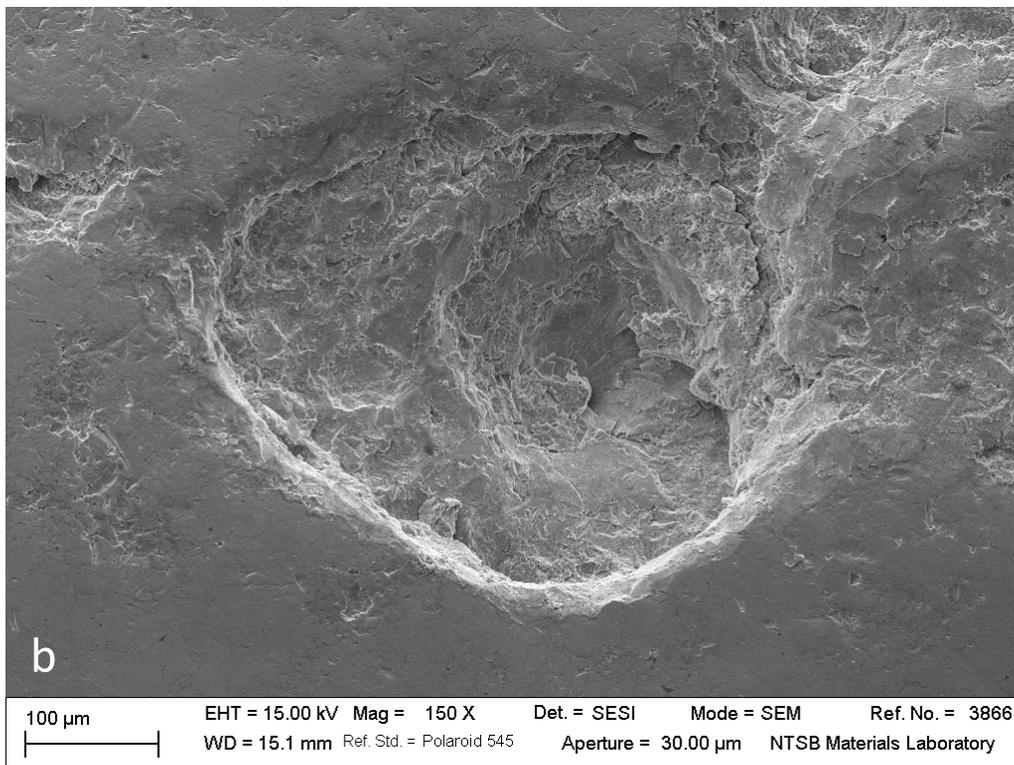
Figure 9 Close SEM images of example surface pits in the spring wire adjacent to Fracture 2A.

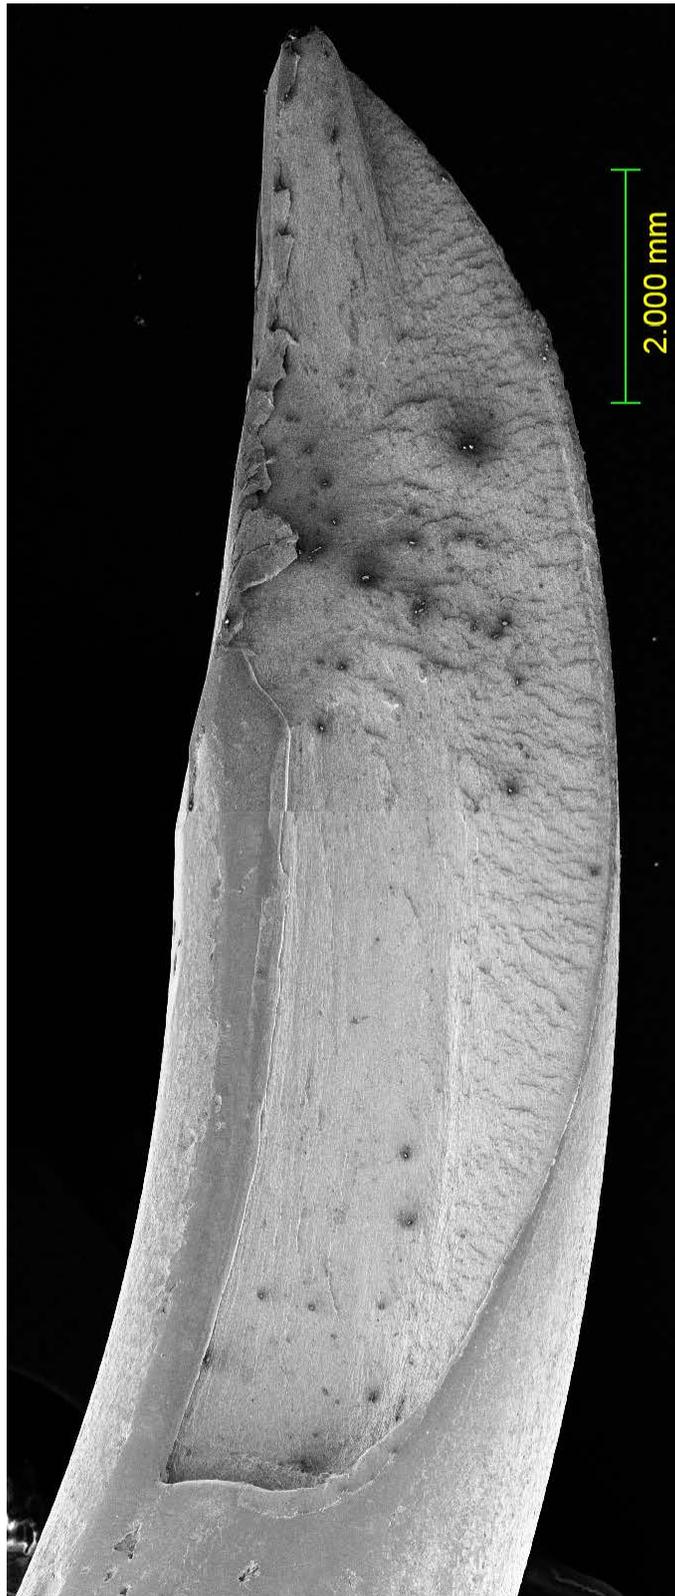
B	Fracture macro-mode is consistent with fatigue fracture (origin obscured by mechanical contact damage).	Figures 10, 11
Fracture 3	A	Fracture face was nearly perpendicular to the wire axis and was obscured by mechanical damage, unable to determine the fracture origin or the fracture macro- and micro-mode.	Figure 12
	B	Fracture face was nearly perpendicular to the wire axis and was obscured by mechanical damage, unable to determine the fracture origin or the fracture macro- and micro-mode.	Figure 12

Figure 10 Overall SEM fractograph of Fracture 2B.

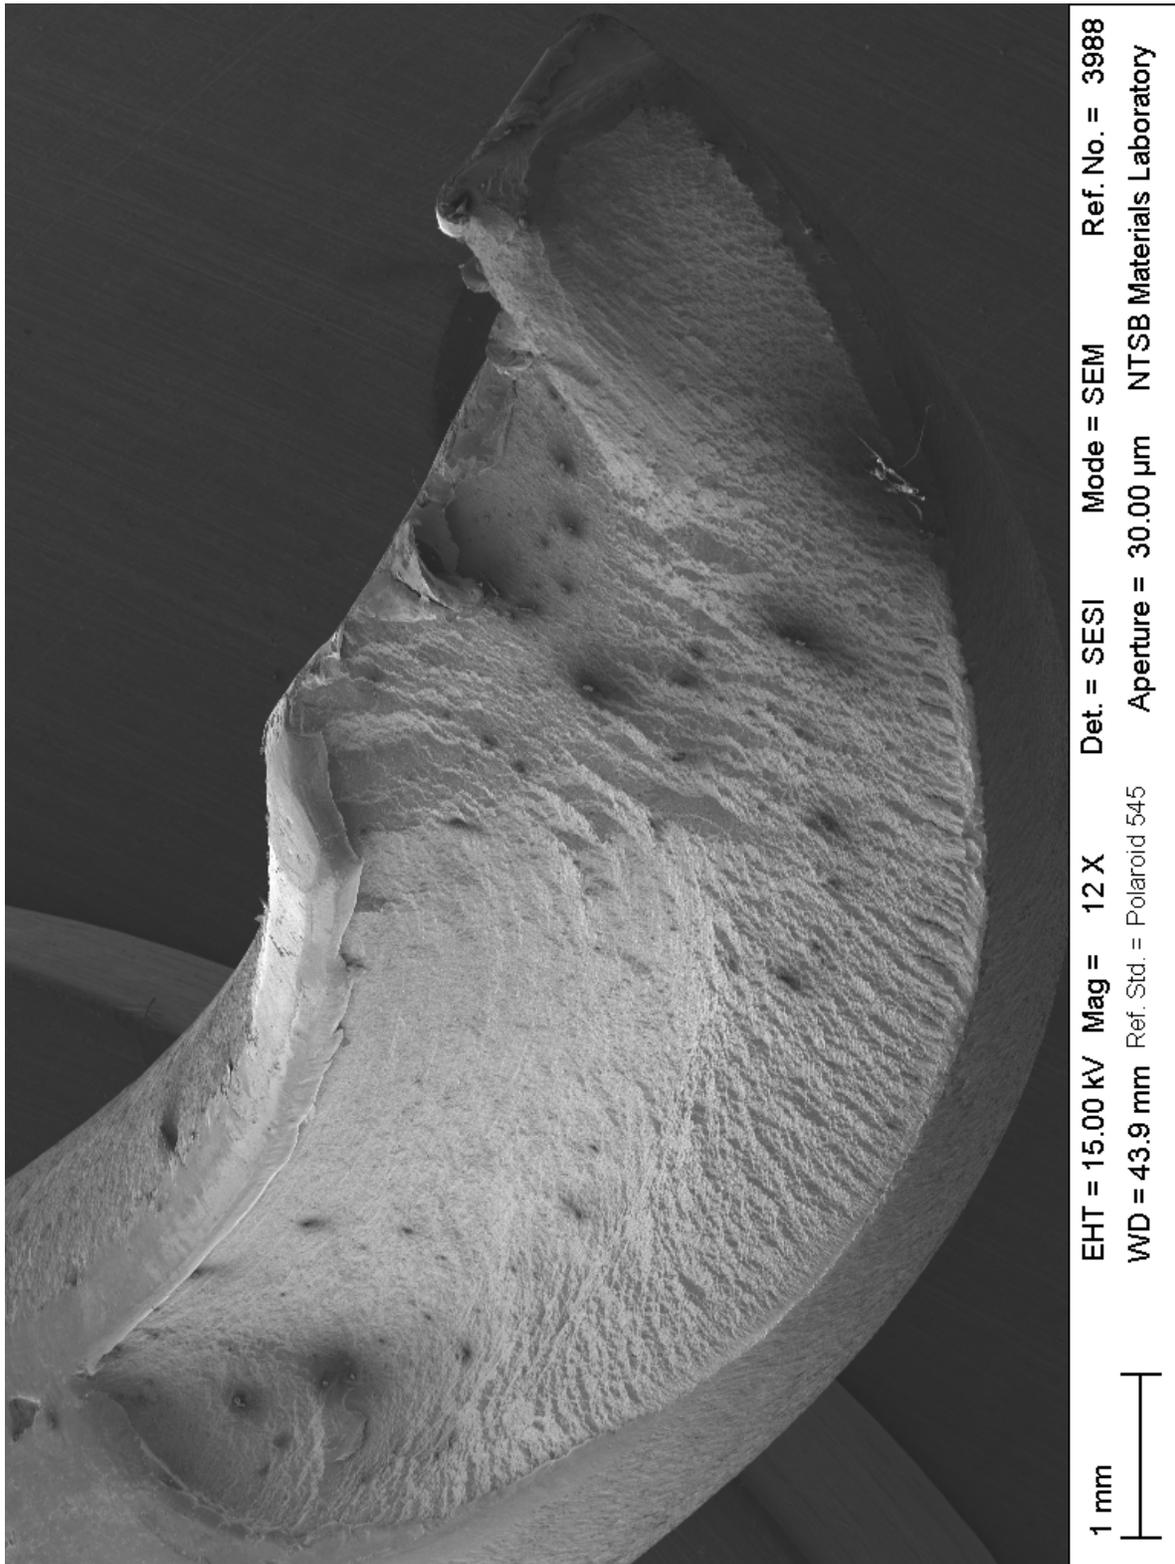
Figure 11 Overall SEM fractograph of Fracture 2B, oblique view.

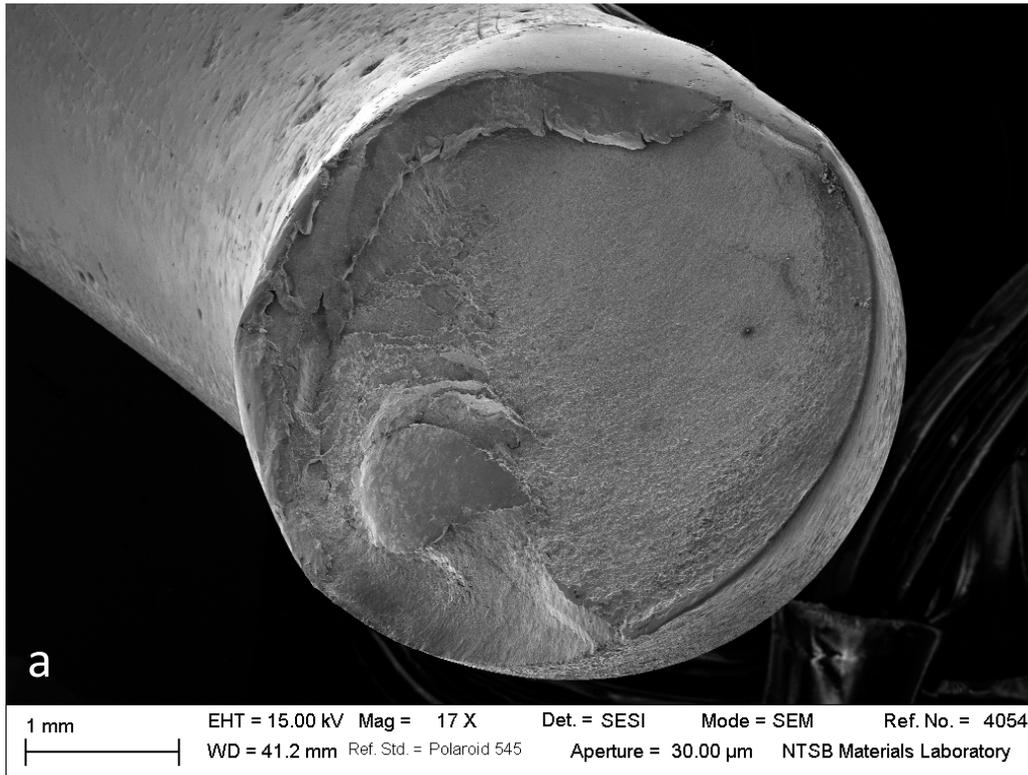
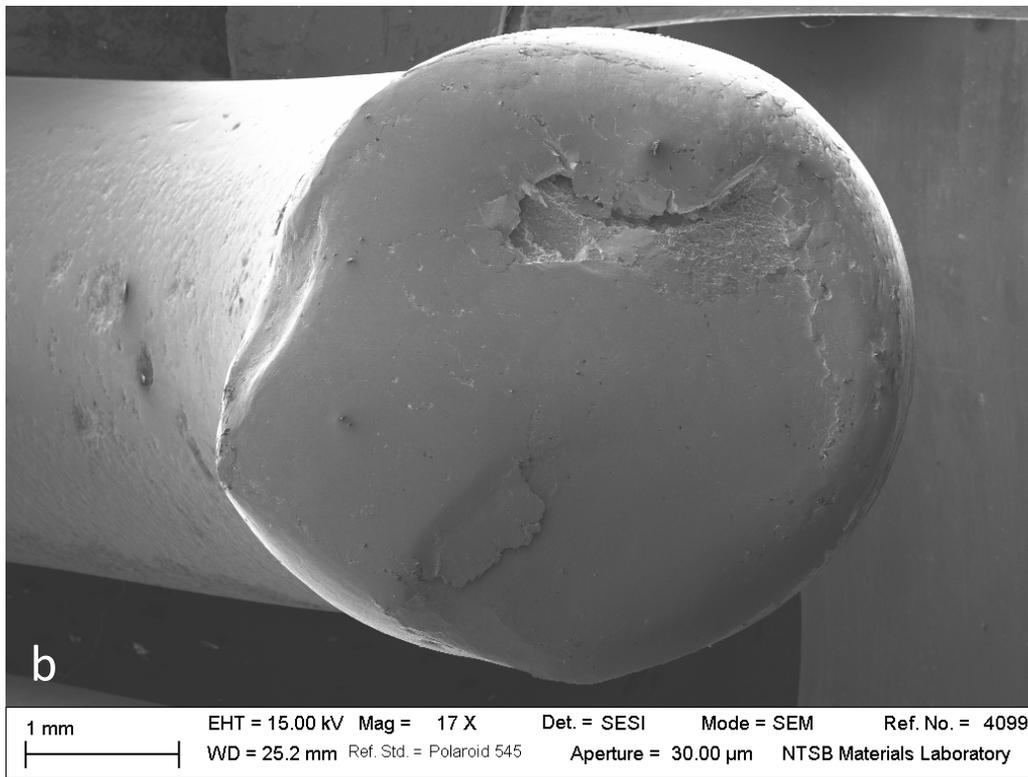
Figure 12 Overall SEM fractographs of Fracture 3. View a is Fracture 3A and view b is Fracture 3B.
