# NATIONAL TRANSPORTATION SAFETY BOARD

MATERIALS LABORATORY FACTUAL REPORT

Report No. 15-021

Place : Bedford, Massachusetts  
Date : May 31, 2014  
Vehicle : Gulfstream IV  
NTSB No. : ERA14MA271  
Investigator : Adam Huray (AS-40)

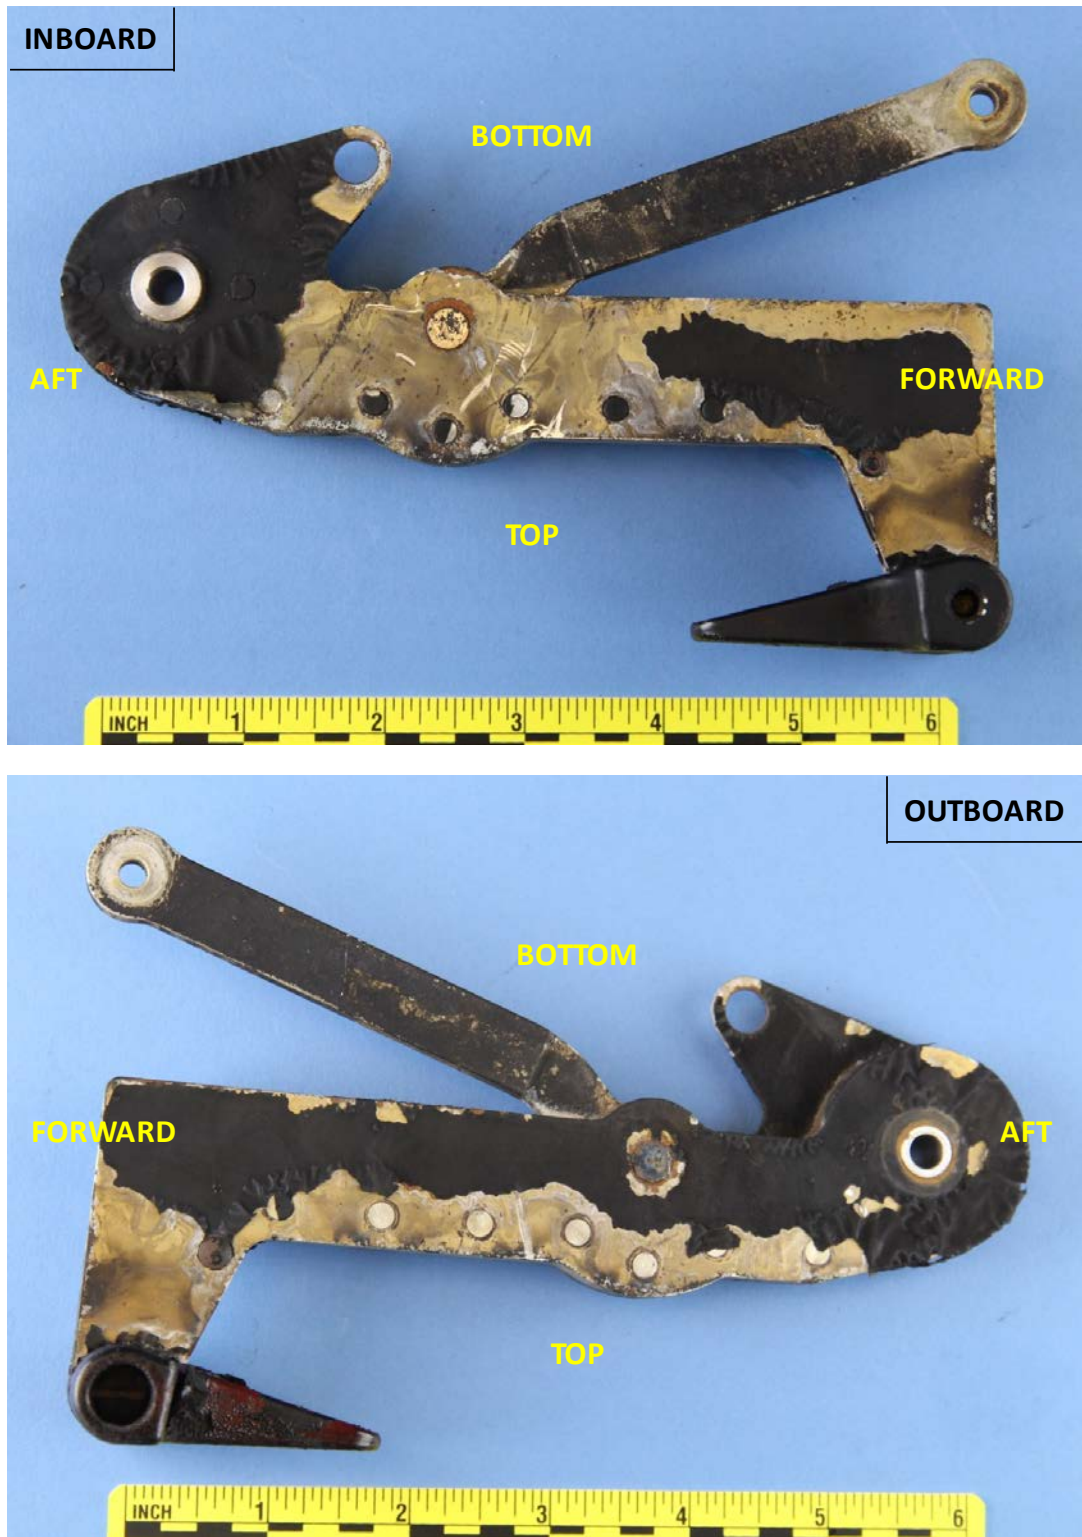
The gust lock handle was submitted assembled, as shown in Figure 1. Labelling in Figure 1 indicates the directionality of the gust lock handle as-installed on the aircraft. The surfaces on the link of the gust lock handle had dark-colored deposits consistent with soot, and charred, peeling coating was observed on the external surfaces of the body. Red/brown rust-like deposits consistent with corrosion were also observed on some areas of the body, link, and slider assembly.

**Figure 1:** Overall photos of the submitted gust lock handle.

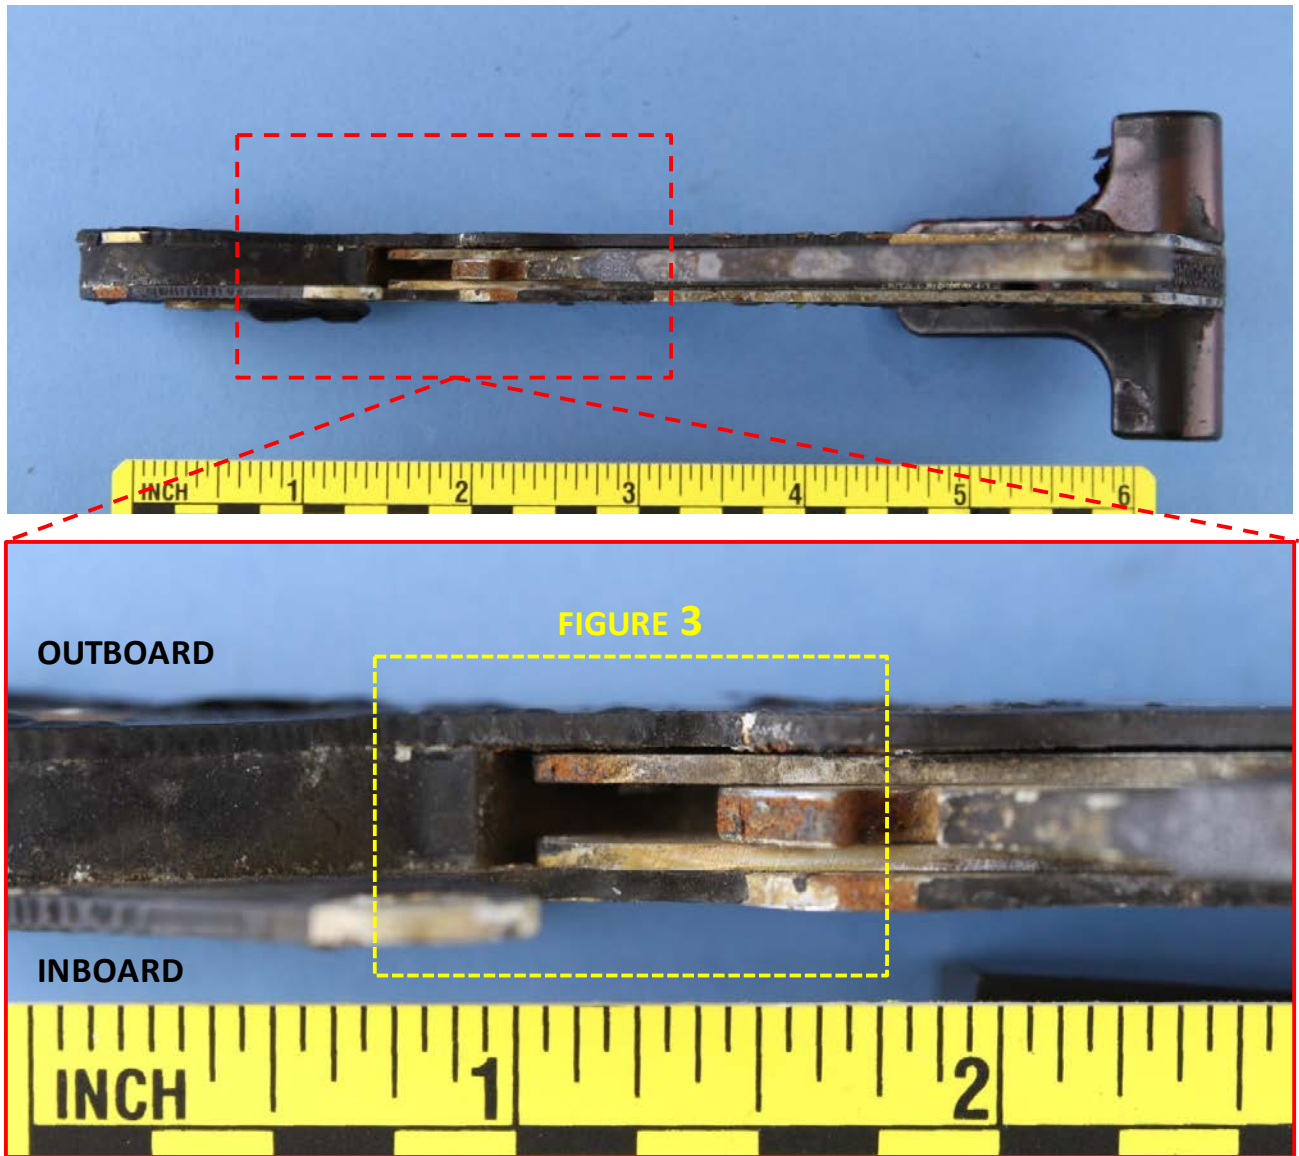
Figure 2 and Figure 3 show that the lock pin that mated with the link was fractured within the gust lock handle assembly. One piece of the lock pin was recessed into the mating slider assembly bracket; another piece of the lock pin on the opposite side of the gust lock handle protruded past the slider assembly bracket and contacted the side of the link. The recessed lock pin piece was on the inboard side of the gust lock handle and fell out of the inboard bracket of the slider assembly during examination. The protruded lock pin piece was on the outboard side of the gust lock handle and remained in the outboard bracket of the slider assembly during examination. The recessed lock pin piece on the inboard side is shown in Figure 4; the protruded lock pin piece on the outboard side is shown in Figure 5. Deposits consistent with corrosion were observed on the majority of the fracture surface of the inboard lock pin piece, while the fracture surface of the outboard lock

**Figure 2:** Close-up photos showing the lock pin that mated with the link was fractured within the gust lock handle assembly.

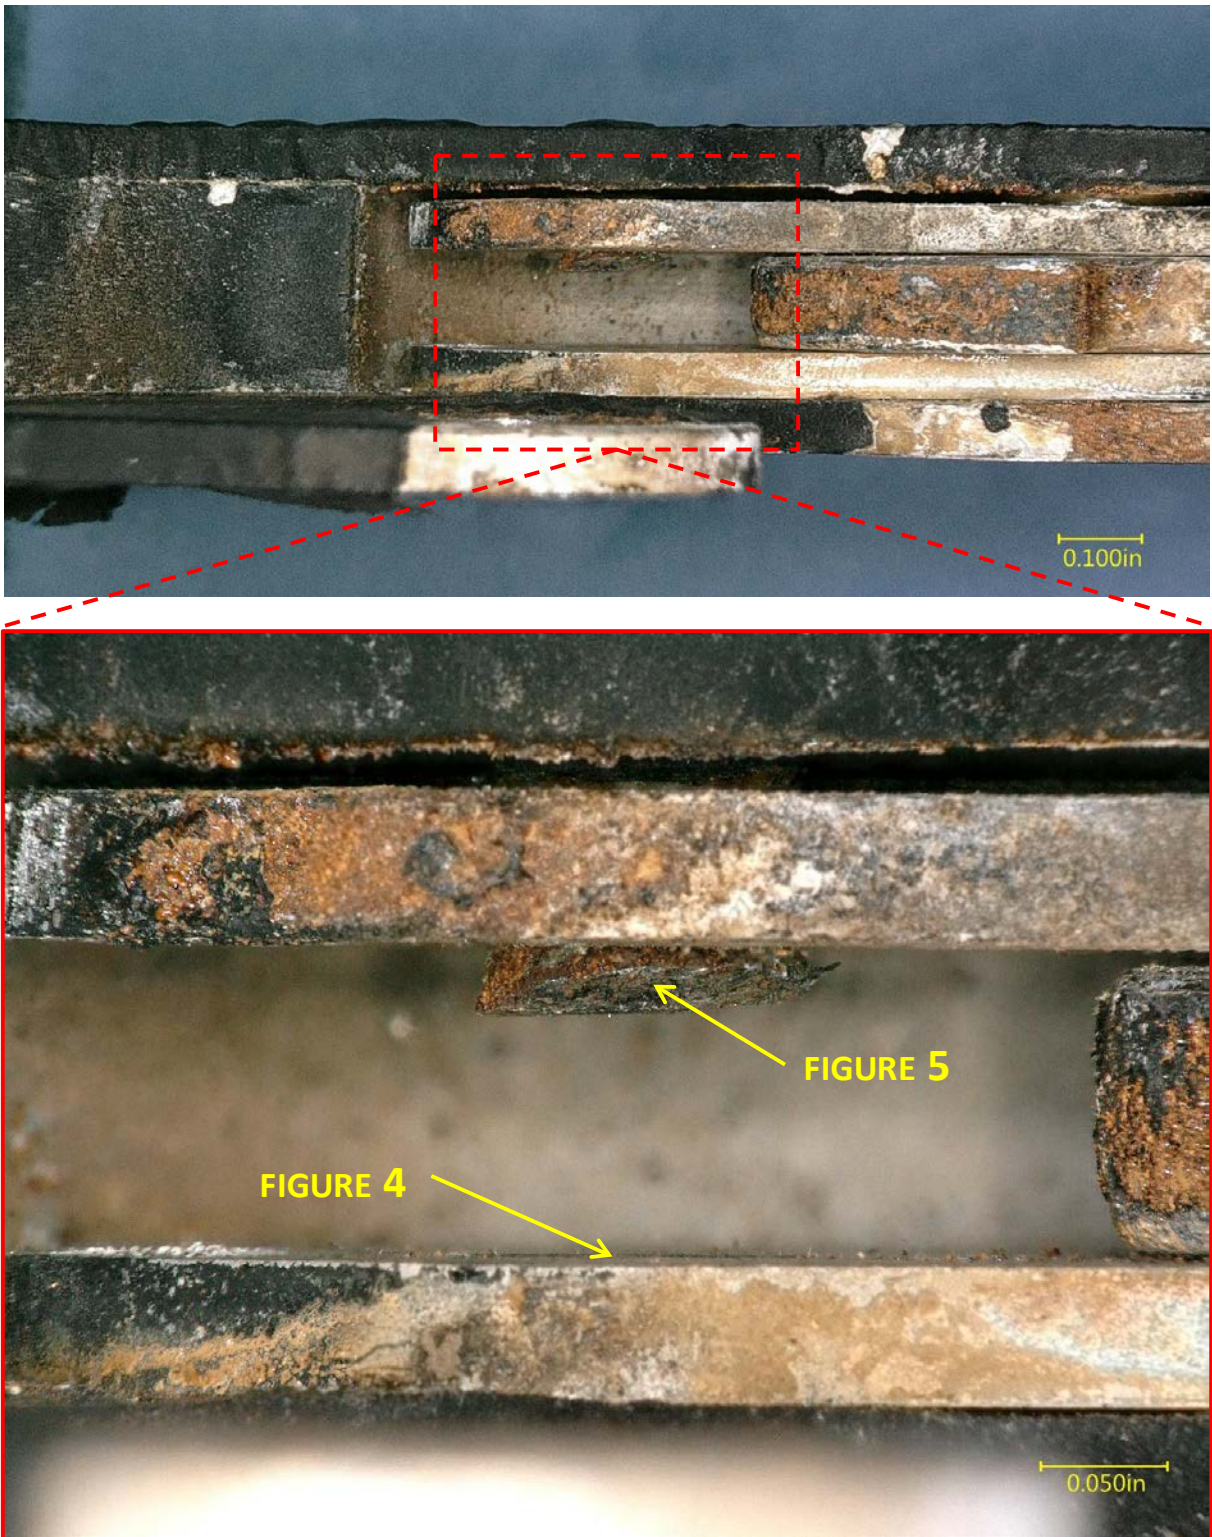
**Figure 3:** Digital microscope photos showing the lock pin that mated with the link was fractured within the gust lock handle assembly.

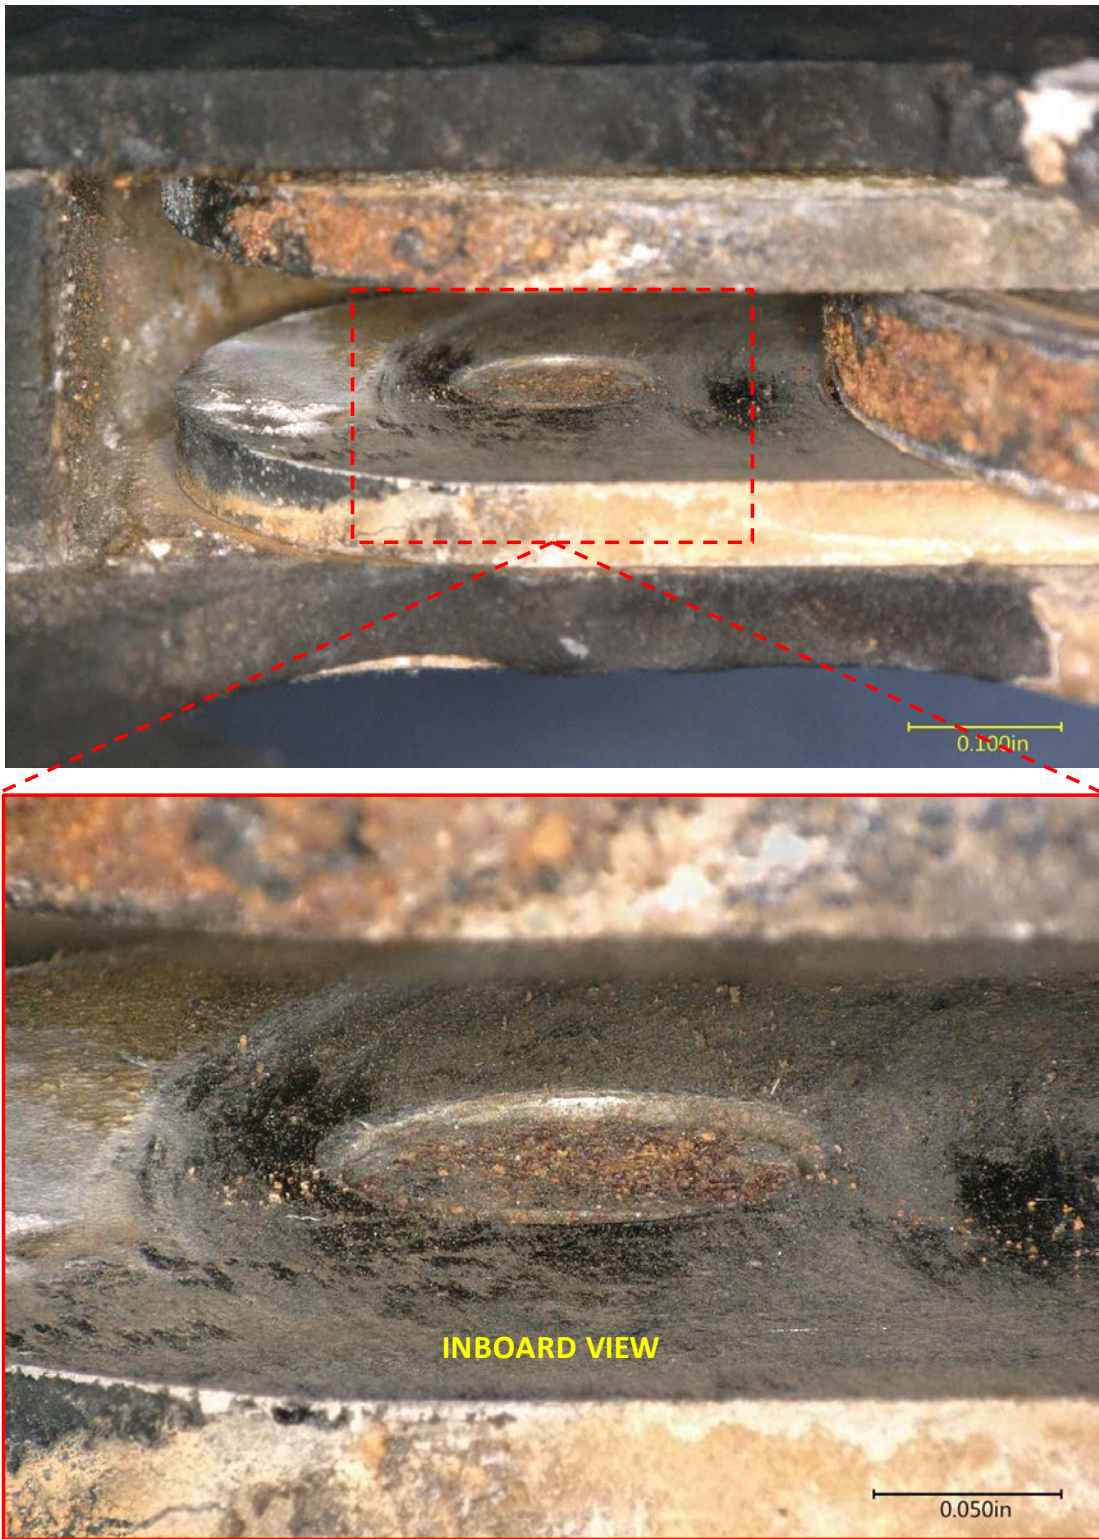
**Figure 4:** Digital microscope photos of the recessed lock pin piece on the inboard side of the gust lock handle.

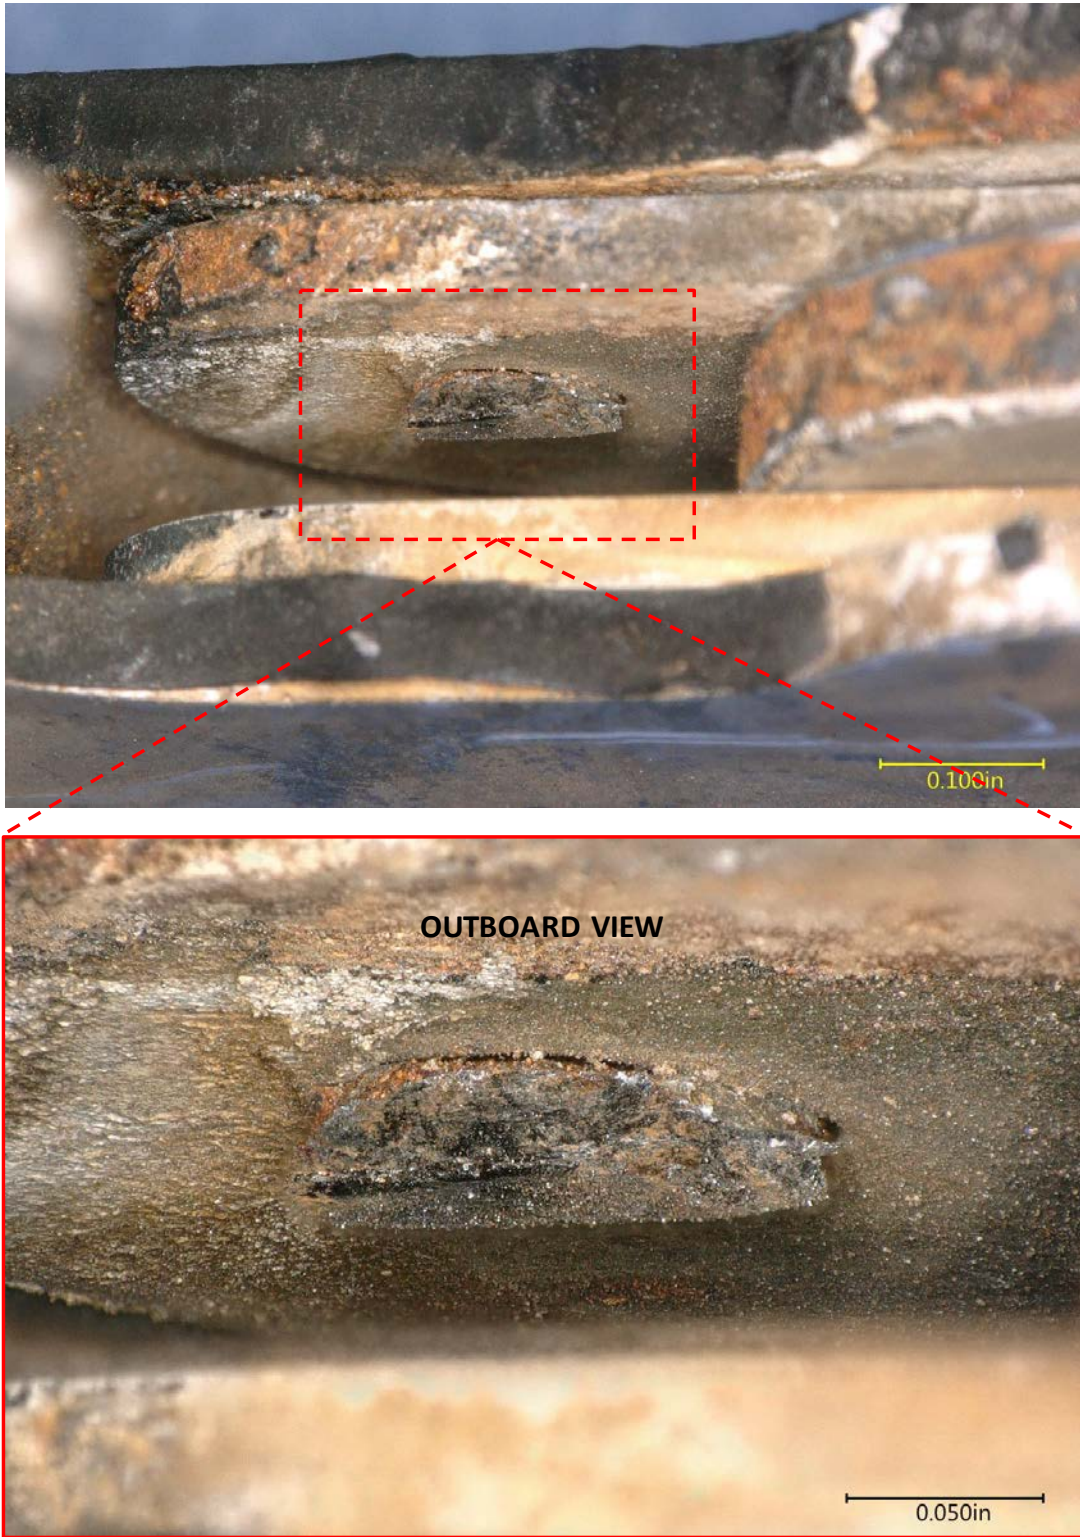
**Figure 5:** Digital microscope photos of the protruded lock pin piece on the outboard side of the gust lock handle.

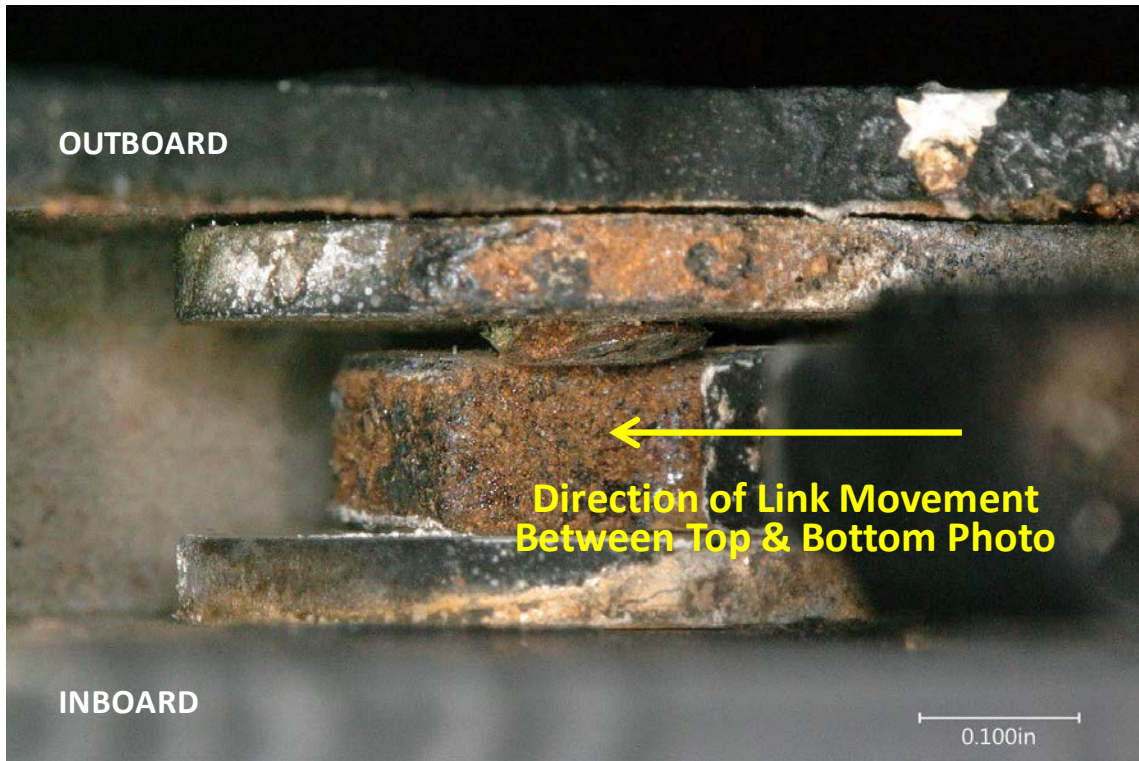
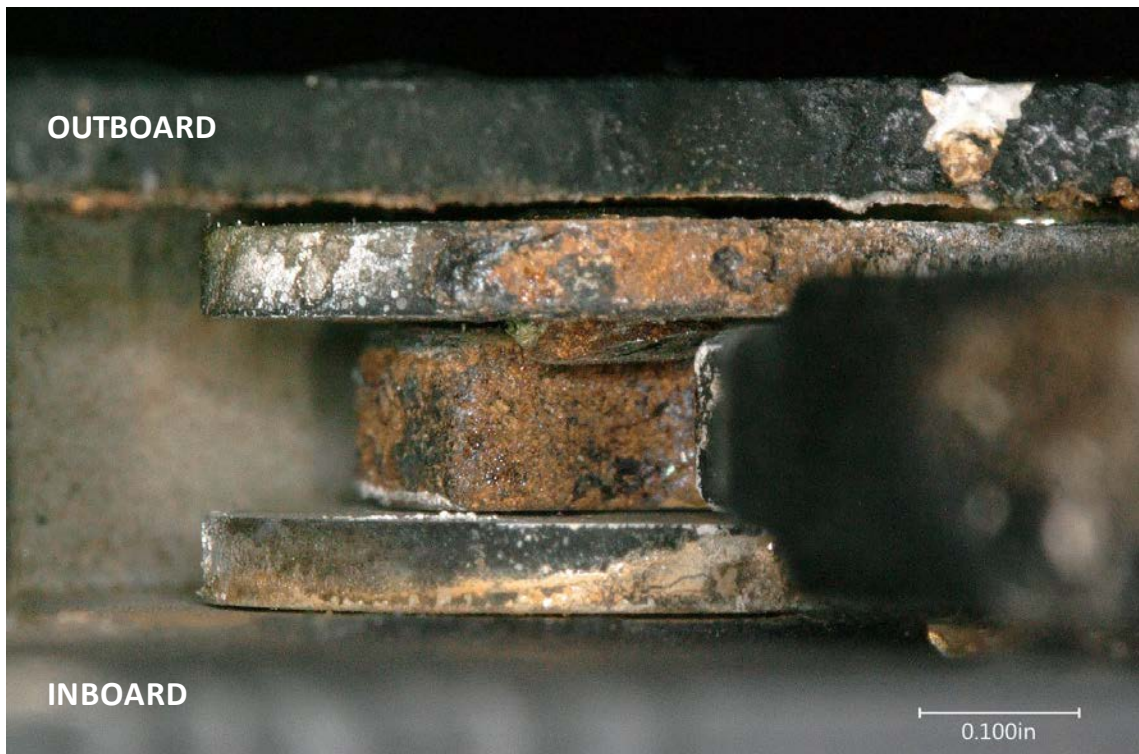
pin piece had notably fewer deposits. Manual manipulation of the gust lock handle revealed that the protruding outboard lock pin piece contacted the outboard side of the link when the link was rotated, as illustrated in Figure 6. The green arrows in Figure 7 point to circumferential marks on the outboard surface of the link in the area where the protruded outboard lock pin piece made contact.

**Figure 6:** Digital microscope photos showing the protruding outboard lock pin piece contacted the outboard side of the link when the link was rotated within the gust lock handle.

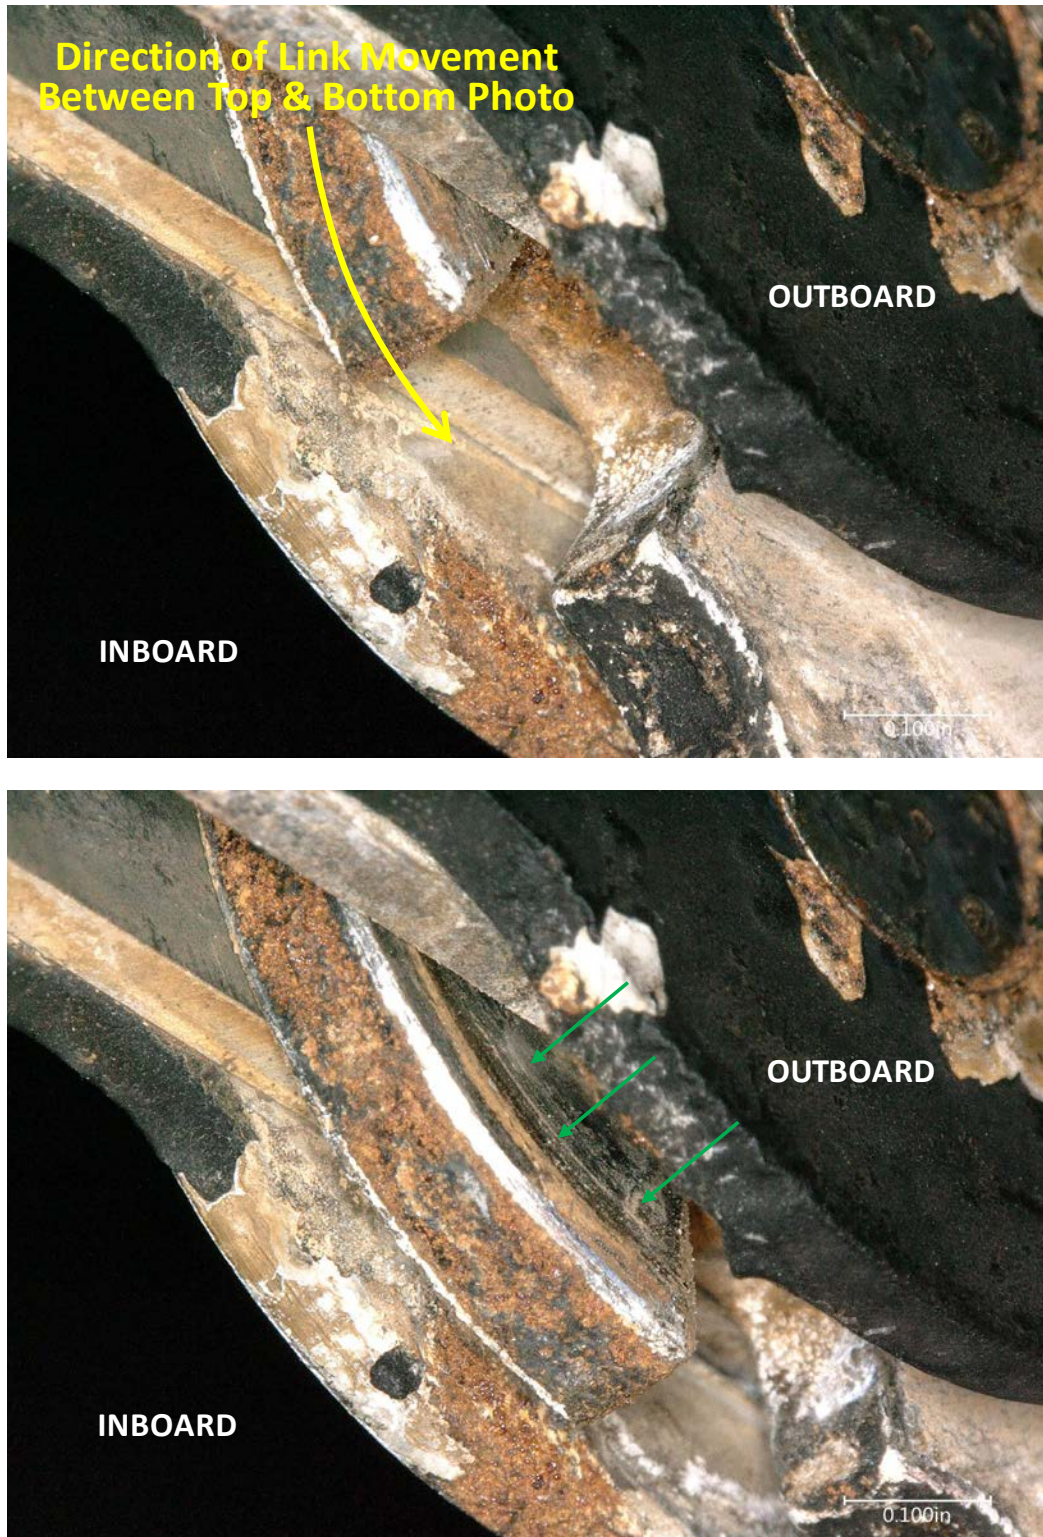
**Figure 7:** Digital microscope photos of circumferential marks (green arrows) on the outboard surface of the link in the area where the protruded outboard lock pin piece made contact when the link was rotated within the gust lock handle.

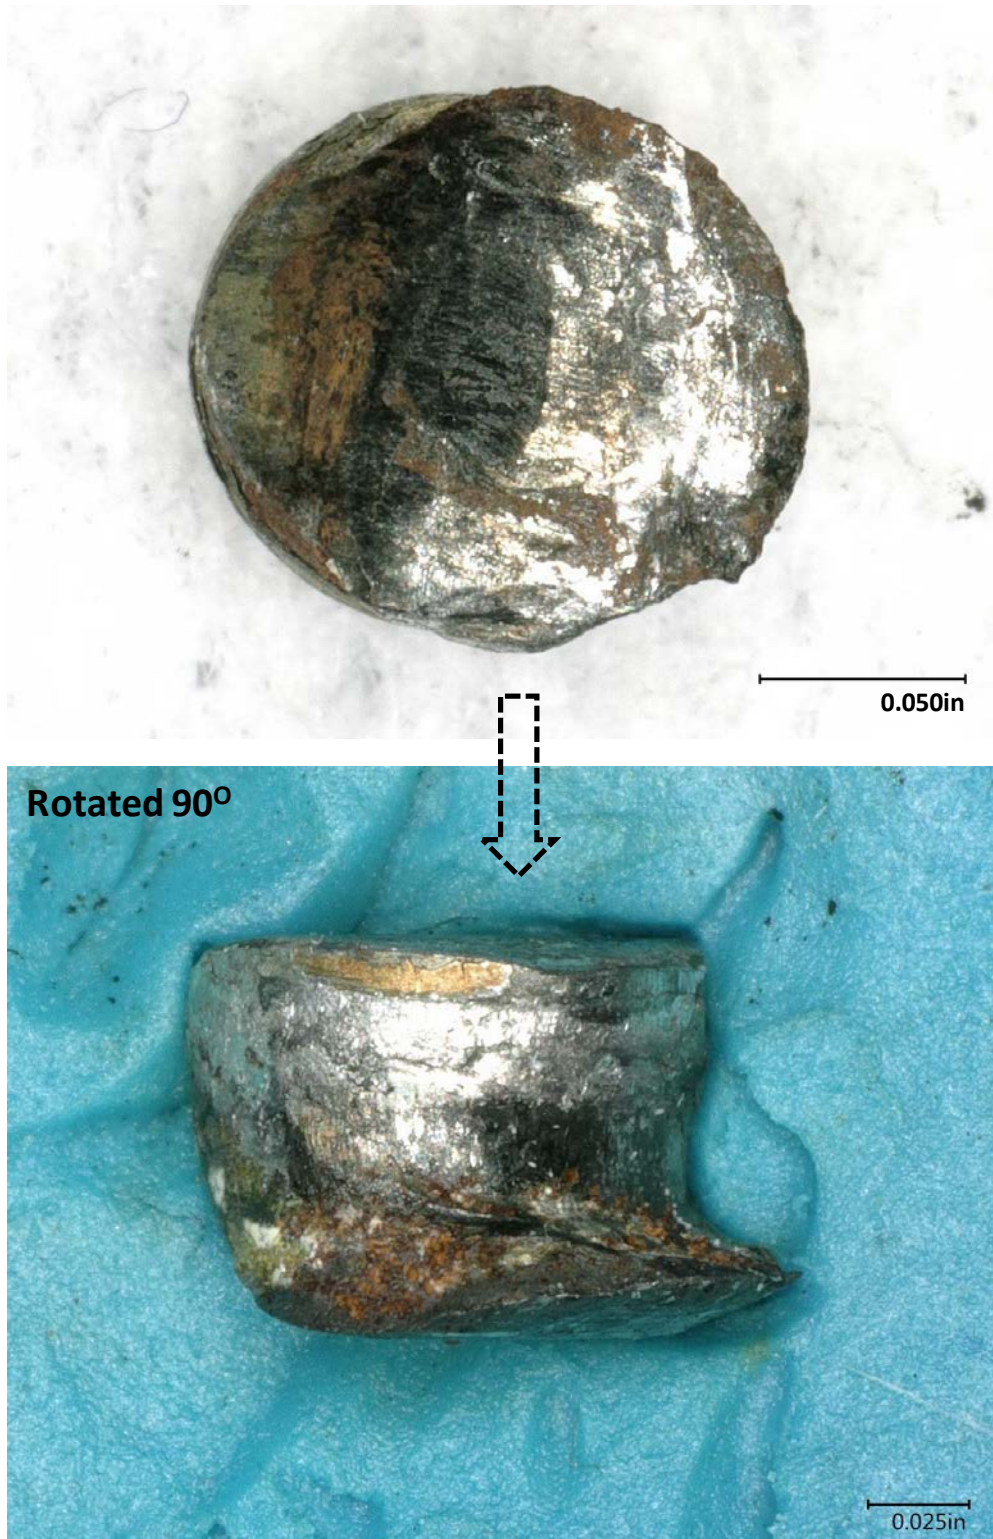
There was damage and corrosion around the entire circumference of the outboard lock pin piece. Some of the material had been pushed towards one side, which gave the outboard lock pin piece a wedge-shaped appearance when viewed in profile, as shown in Figure 8. The as-received orientation of the wedge-shaped outboard lock pin piece was determined to have the short end towards the top/aft side of the gust lock handle and the longer end with the smeared lip of material towards the bottom/forward side of the gust lock handle. Damage was also observed on the bottom surface of the outboard lock pin piece, as shown in Figure 9. The damaged areas were silver in color and had a smeared appearance. Gold-colored material was observed on the undamaged areas around the circumference and on the bottom surface of the outboard lock pin piece.

**Figure 8:** Digital microscope photos of the fracture surface (top) and profile (bottom) of the outboard lock pin piece from the gust lock handle.

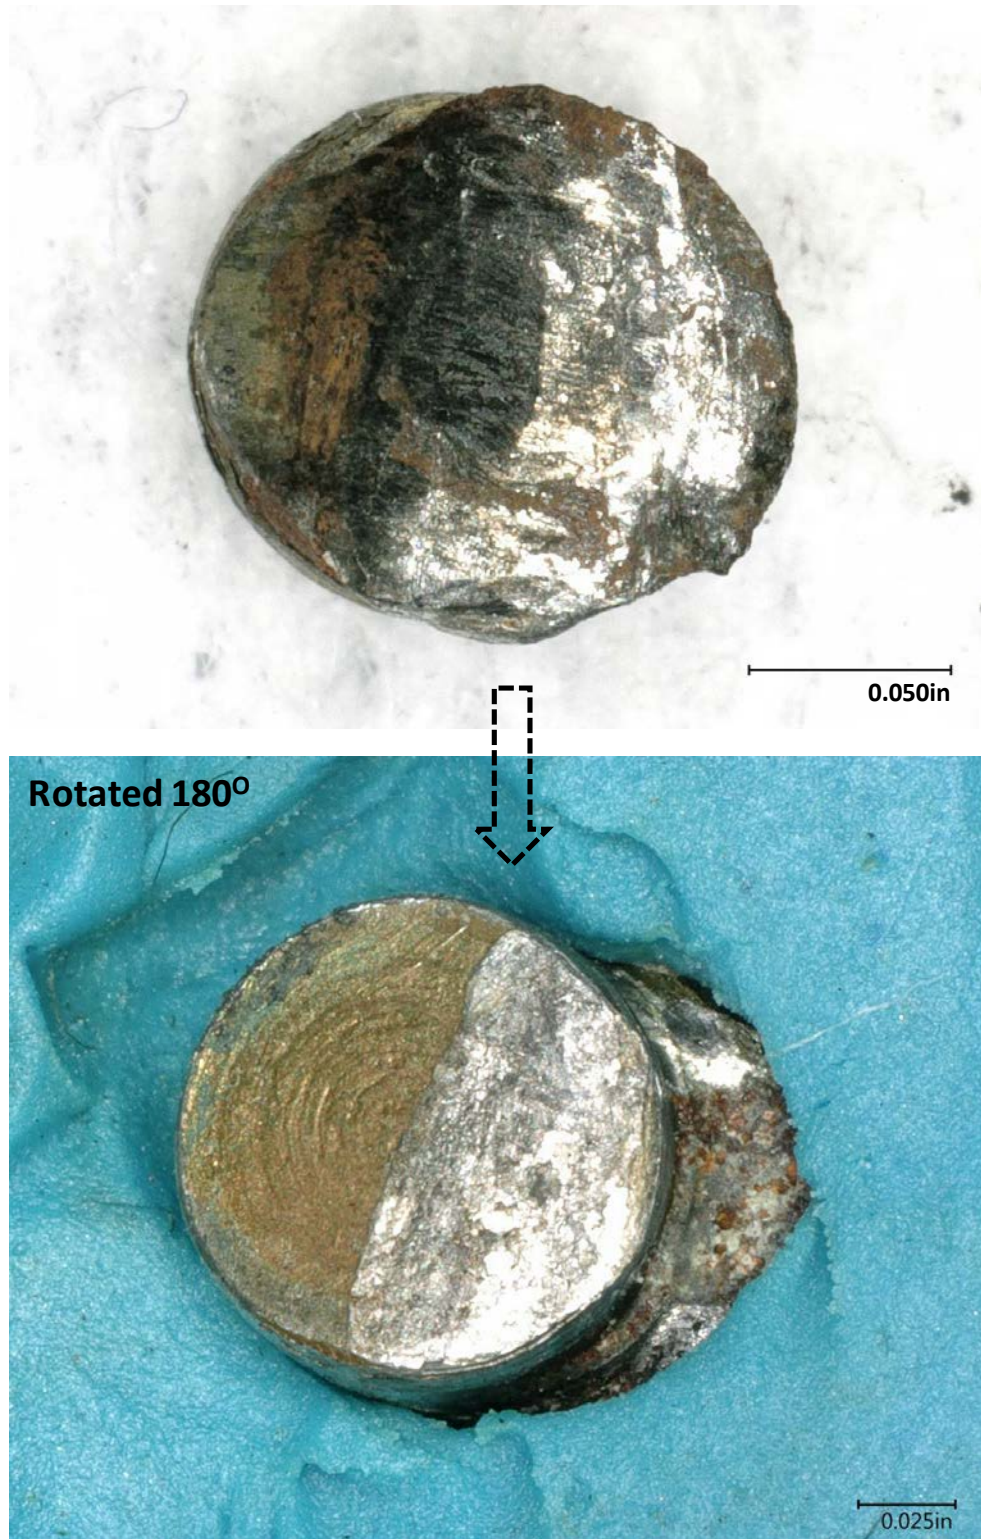
**Figure 9:** Digital microscope photos of the fracture surface (top) and bottom surface (bottom) of the outboard lock pin piece from the gust lock handle.

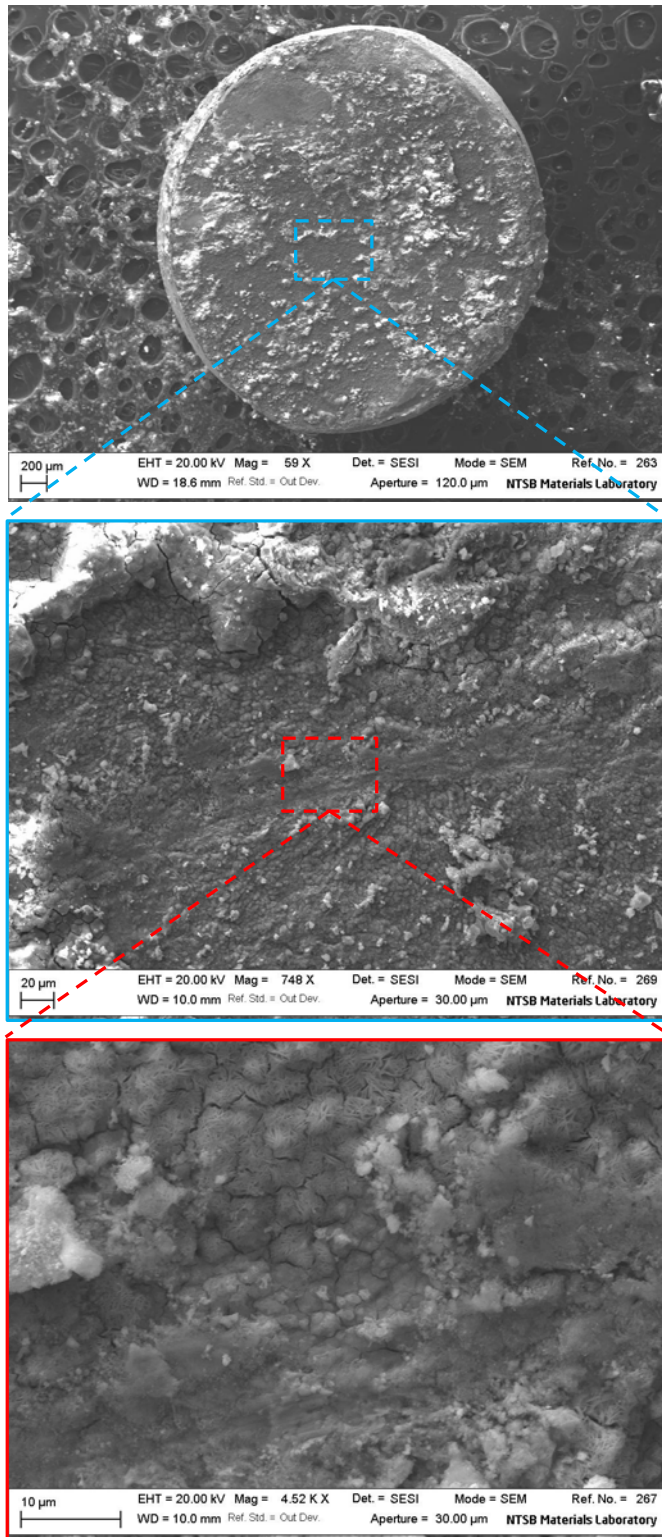
**Figure 10:** SEM images of the fracture surface on the inboard lock pin piece from the gust lock handle prior to cleaning.

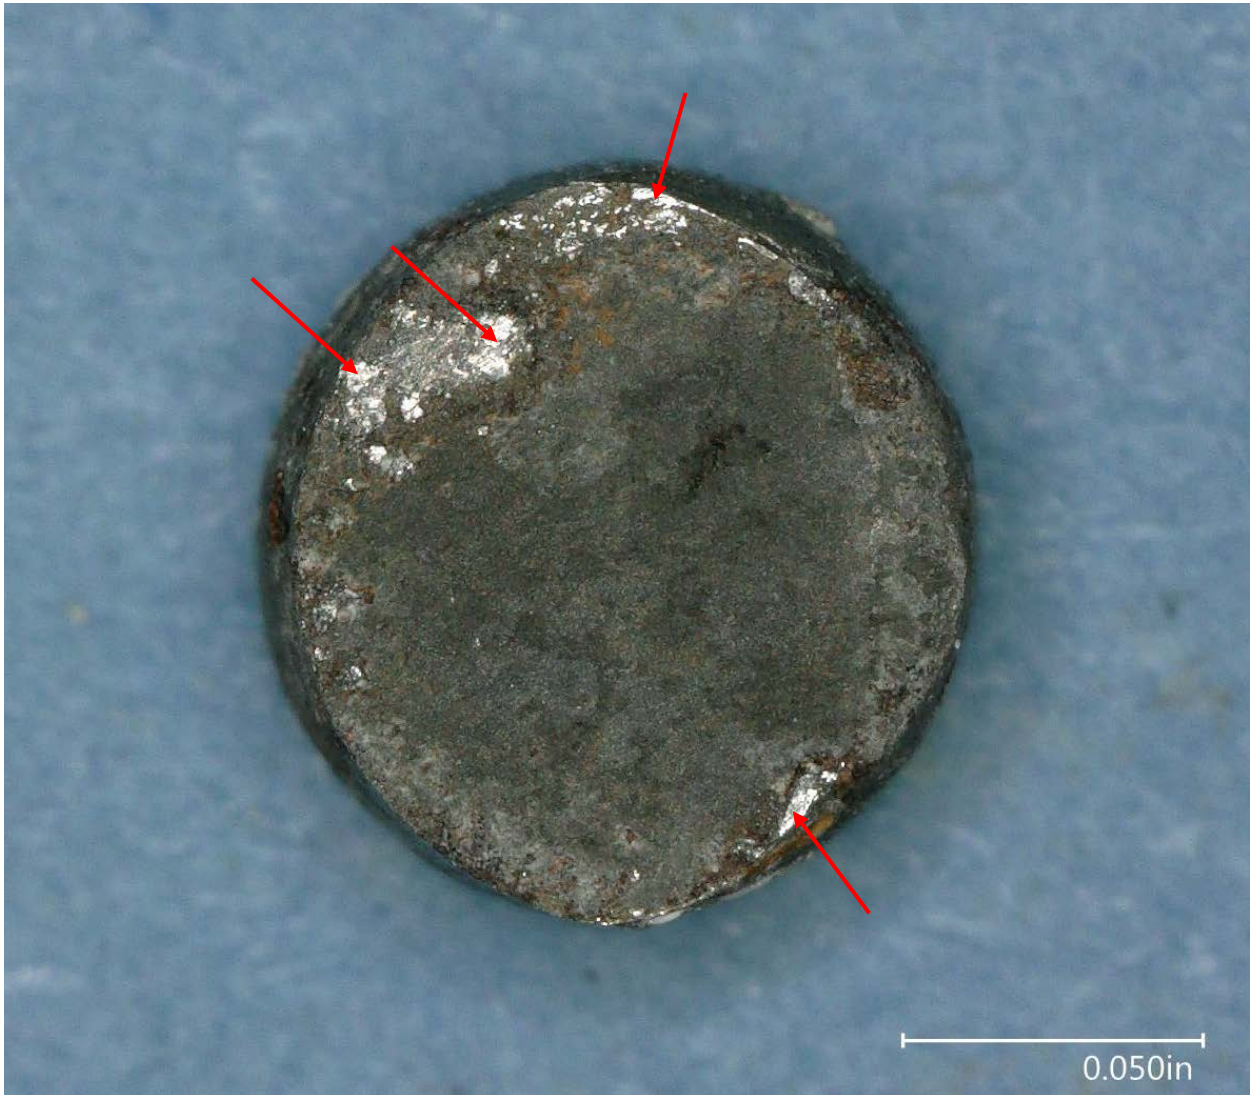
**Figure 11:** Digital microscope photo of the fracture surface on the inboard lock pin piece from the gust lock handle after cleaning. The red arrows point to shiny areas visible on the fracture surface.

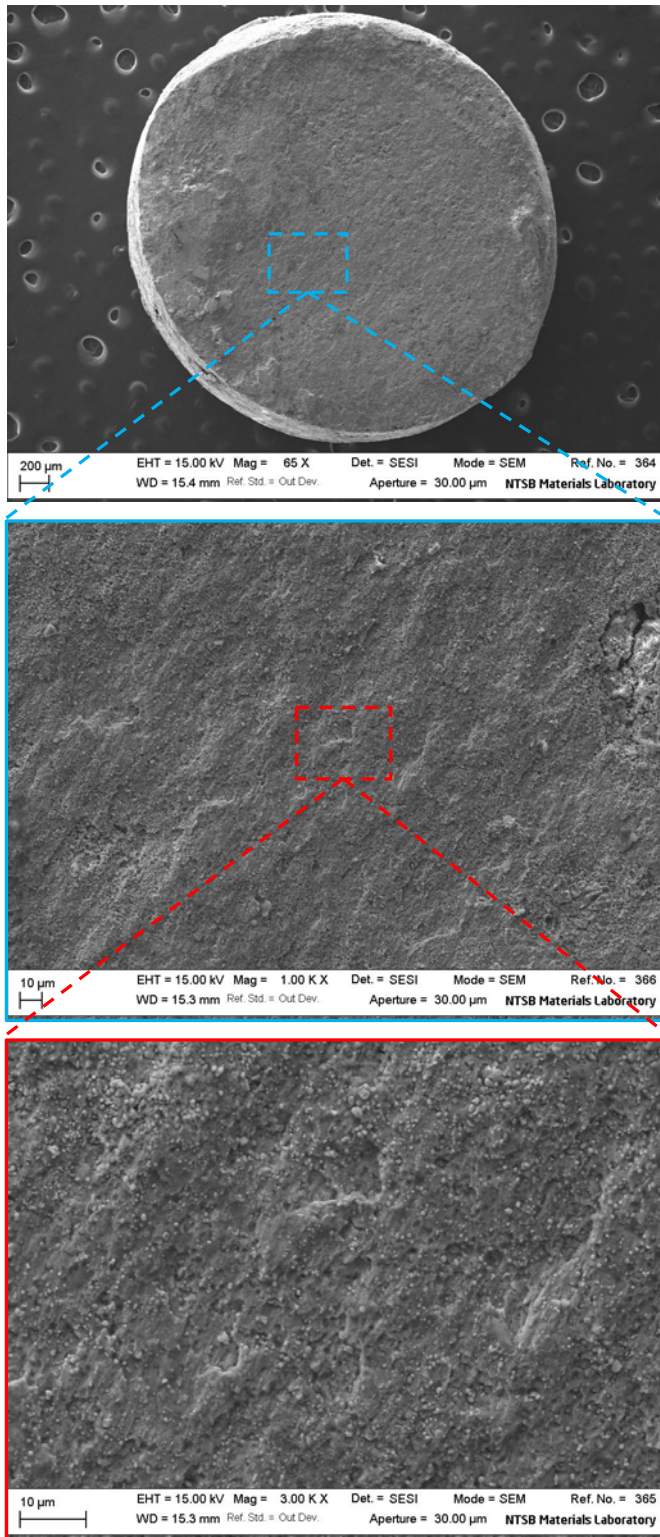
The fracture surface of the inboard lock pin piece was flat. Because the inboard lock pin piece was recessed within the mating slider assembly bracket and did not appear to contact the mating inboard link surface during manual manipulation of the gust lock handle, the fracture surface of the inboard lock pin piece was examined using a Scanning Electron Microscope (SEM) in the as-received condition prior to cleaning. Heavy corrosion deposits obscured the fracture surface features on the uncleaned inboard lock pin piece, as shown in Figure 10. The inboard lock pin piece was cleaned using Evapo-Rust™ (Harris International Labs, Springdale, AR) and an acetone rinse and, as seen in Figure 11, some shiny areas consistent with contact damage were observed on the fracture surface. Reexamination of the cleaned inboard lock pin piece fracture surface in the SEM did not reveal any distinguishing features. Instead, the fracture surface of the cleaned inboard lock pin piece had flattened and smeared areas, with some residual corrosion products. Exemplar SEM images of the cleaned inboard lock pin piece fracture surface are shown in Figure 12.

**Figure 12:** SEM images of the fracture surface on the inboard lock pin piece from the gust lock handle after cleaning.

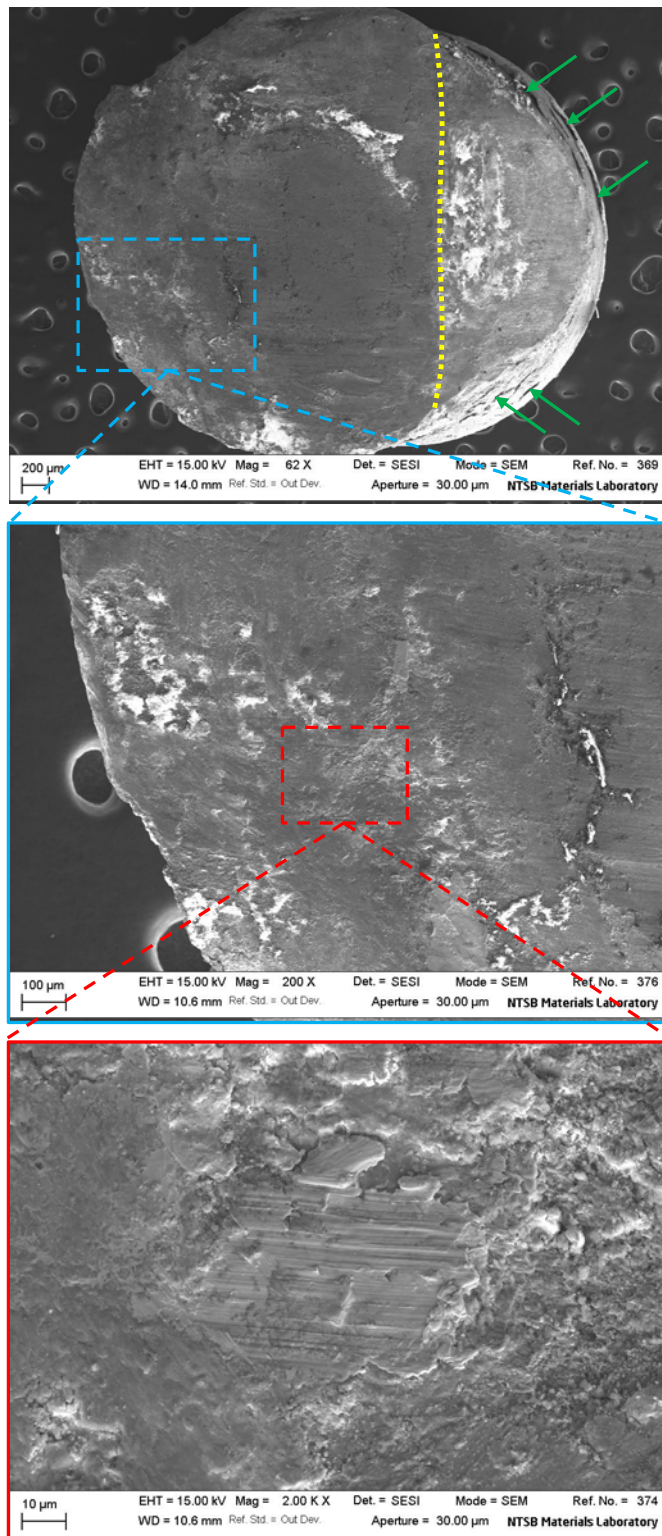
SEM examination of the outboard lock pin piece fracture surface showed it was covered in corrosion products, and had features that were mostly flattened. There were numerous areas with smearing damage on the fracture surface, with the smearing damage having pushed the pin material towards one side of the gust lock handle. The fracture surface appeared to consist of multiple flattened planes, with a distinct step visible between the two largest planes, as indicated by the yellow dotted line in Figure 13. Some layers of peeling material (green arrows in Figure 13) were observed on the outer diameter (OD) of the outboard lock pin piece in one area.

**Figure 13:** SEM images of the fracture surface on the outboard lock pin piece from the gust lock handle. The yellow dotted line traces a distinct step visible between the two largest flattened planes on the fracture surface. Layers of peeling material (green arrows) were observed in one area on the OD of the outboard lock pin piece.

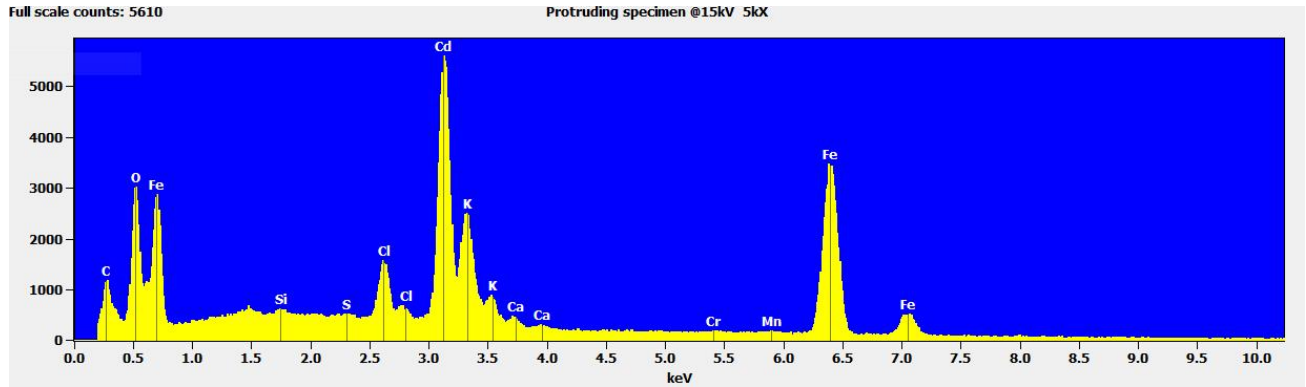
consistent with steel, as seen in the representative spectrum shown in Figure 14. The EDS spectrum also showed evidence of corrosion products and cadmium plating.

**Figure 14:** Semi-quantitative EDS spectrum of the fracture surface on the outboard lock pin piece.

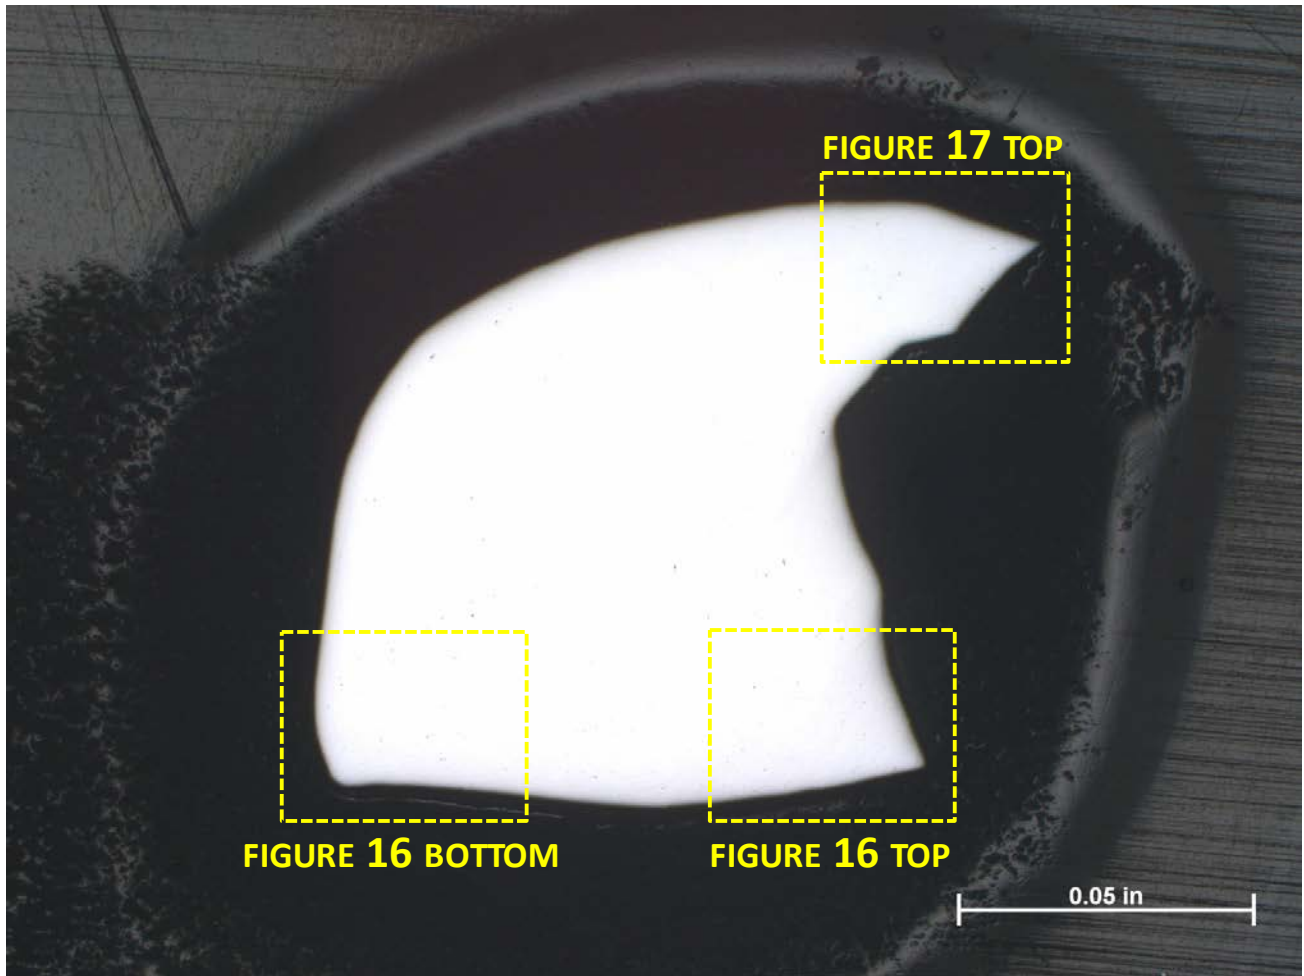
A cross-section was prepared through the outboard lock pin piece. The cross-section showed the wedge-shaped appearance of the outboard lock pin piece, as well as the non-flat bottom surface and the irregular OD. An overall image of the cross-section was shown in Figure 15. An external layer was observed on the edges of some areas of the outboard lock pin piece, as indicated by the red arrows in Figure 16. The external layer was noted in the locations of the undamaged gold-colored material observed during the initial visual examination on the circumference and bottom surface of the outboard lock pin piece. Standard-less semi-quantitative EDS analysis confirmed the external layer was cadmium-rich, as seen in the EDS spectrum shown in Figure 17.

**Figure 15:** Metallographic image of the cross-section prepared through the outboard lock pin piece from the gust lock handle. (Unetched)
