# NATIONAL TRANSPORTATION SAFETY BOARD

MATERIALS LABORATORY FACTUAL REPORT

Report No. 15-021

Place : Bedford, Massachusetts  
Date : May 31, 2014  
Vehicle : Gulfstream IV  
NTSB No. : ERA14MA271  
Investigator : Adam Huray (AS-40)

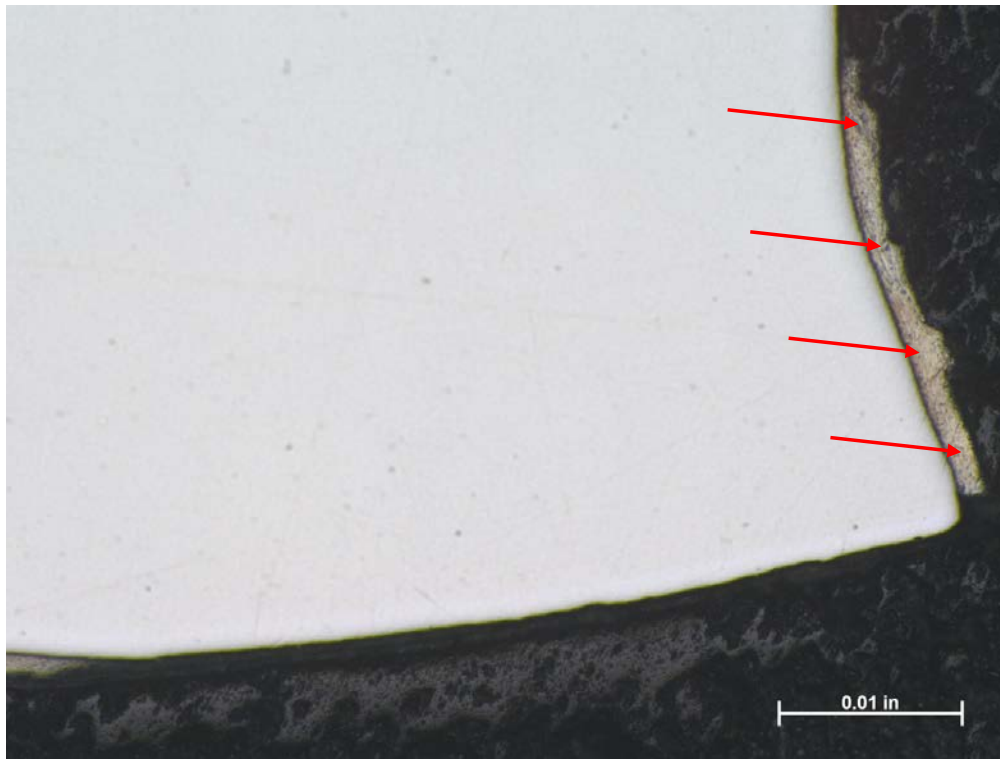
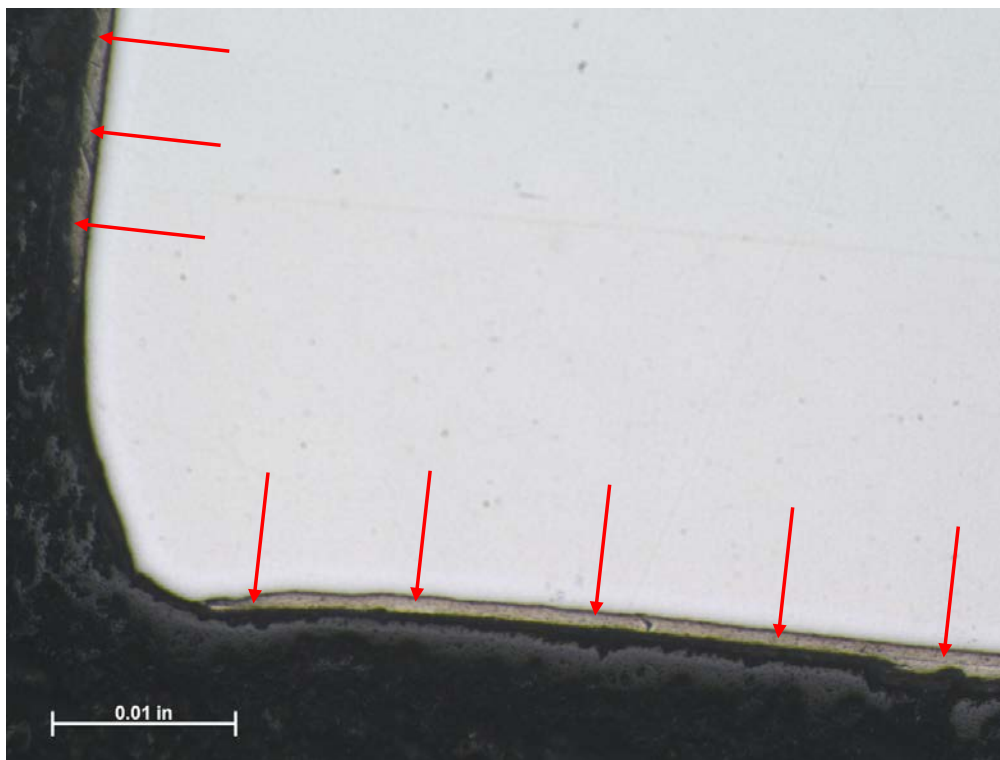
**Figure 16:** Metallographic images the external layer (red arrows) observed on the edges of some areas of the cross-section prepared through the outboard lock pin piece from the gust lock handle. (Unetched)

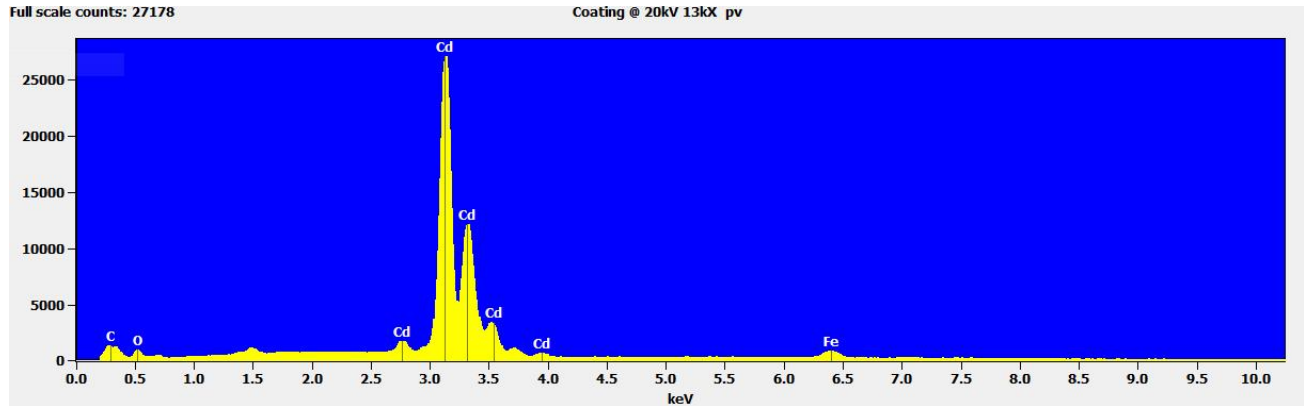
A cross-section was prepared through the outboard lock pin piece. The cross-section showed the wedge-shaped appearance of the outboard lock pin piece, as well as the non-flat bottom surface and the irregular OD. An overall image of the cross-section was shown in Figure 15. An external layer was observed on the edges of some areas of the outboard lock pin piece, as indicated by the red arrows in Figure 16. The external layer was noted in the locations of the undamaged gold-colored material observed during the initial visual examination on the circumference and bottom surface of the outboard lock pin piece. Standard-less semi-quantitative EDS analysis confirmed the external layer was cadmium-rich, as seen in the EDS spectrum shown in Figure 17.

**Figure 17:** Semi-quantitative EDS spectrum of the external layer around the edges of areas on the cross-section through the outboard lock pin piece.

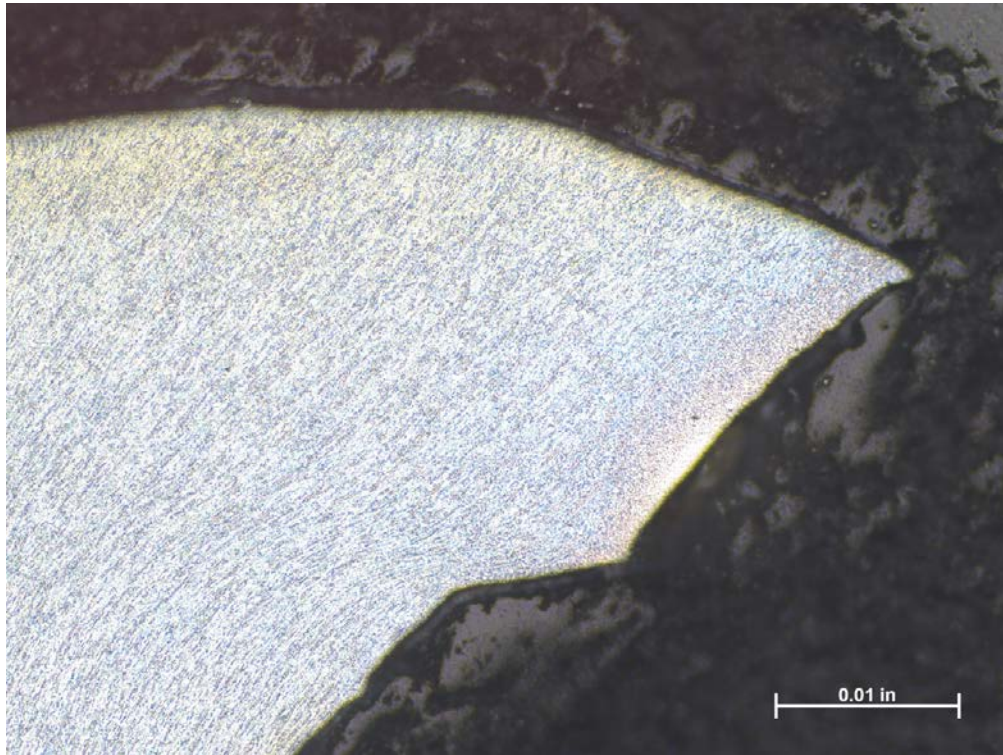
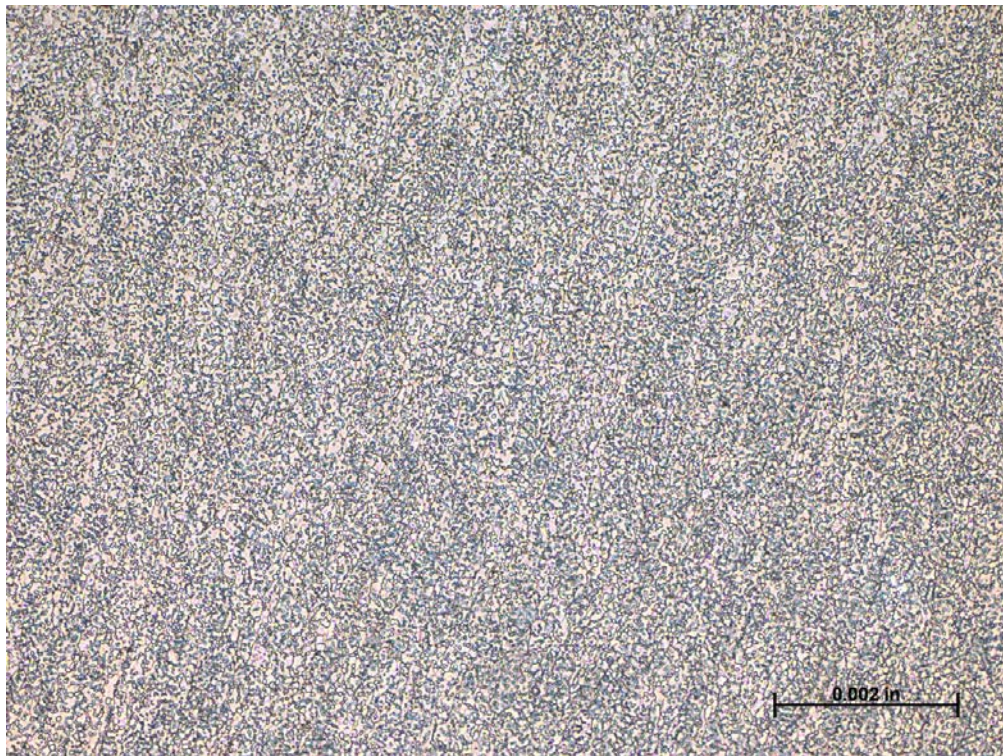
Per Gulfstream personnel, the lock pin (Part Number (P/N) 43906-463) assembled within the gust lock handle assembly (P/N 43083-402-1) is supposed to be made from drill rod material. A representative of Rockwell Collins, the manufacturer of the gust lock handle assembly, reported the drill rod material should have been Type A2 tool steel that met the requirements of ASTM A681, according to the Rockwell Collins material supplier. A standard-less semi-quantitative EDS analysis revealed that while the composition could meet the parameters for drill rod, it did not meet the ASTM A681 specification for Type A2 tool steel. An EDS spectrum representative of the base material is shown in Figure 18. The hardness was measured on the cross-section through the outboard lock pin piece using a LECO automatic microindentation hardness tester per ASTM E384.<sup>1</sup> The hardness of the outboard lock pin piece averaged 30 HRC (302 HV<sub>500</sub>), which indicates the material was not quench hardened and tempered. The microstructure of the outboard lock pin piece material, shown in Figure 19, consisted of spheroid carbides in a ferrite matrix, which is consistent with steel in a spheroidized condition.

**Figure 19:** Metallographic images showing the microstructure of the base material of the outboard lock pin piece cross-section. (2% Nital etch)

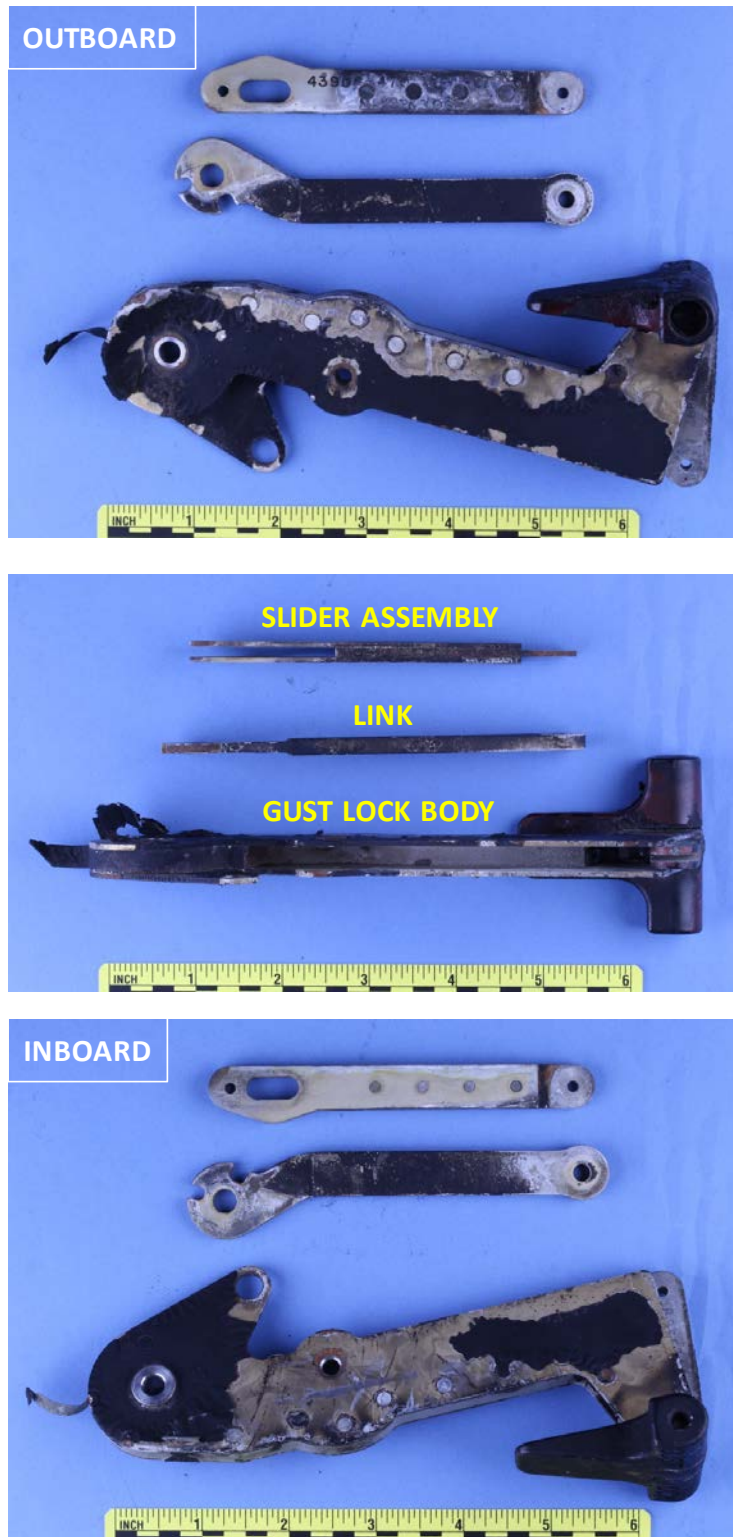
The disassembled gust lock body, link and slider assembly are shown in Figure 20. There was a distinct linear soot mark visible on the faces of the link. The link was inserted into the gust lock body with the soot mark in-line with the gust lock body edge. The angle between the link and the gust lock body measured 16 degrees, as shown in Figure 21. Gulfstream indicated this position was consistent with the gust lock handle in the stowed position.

**Figure 20:** Overall photos of the disassembled gust lock body, link and slider assembly from the gust lock handle.

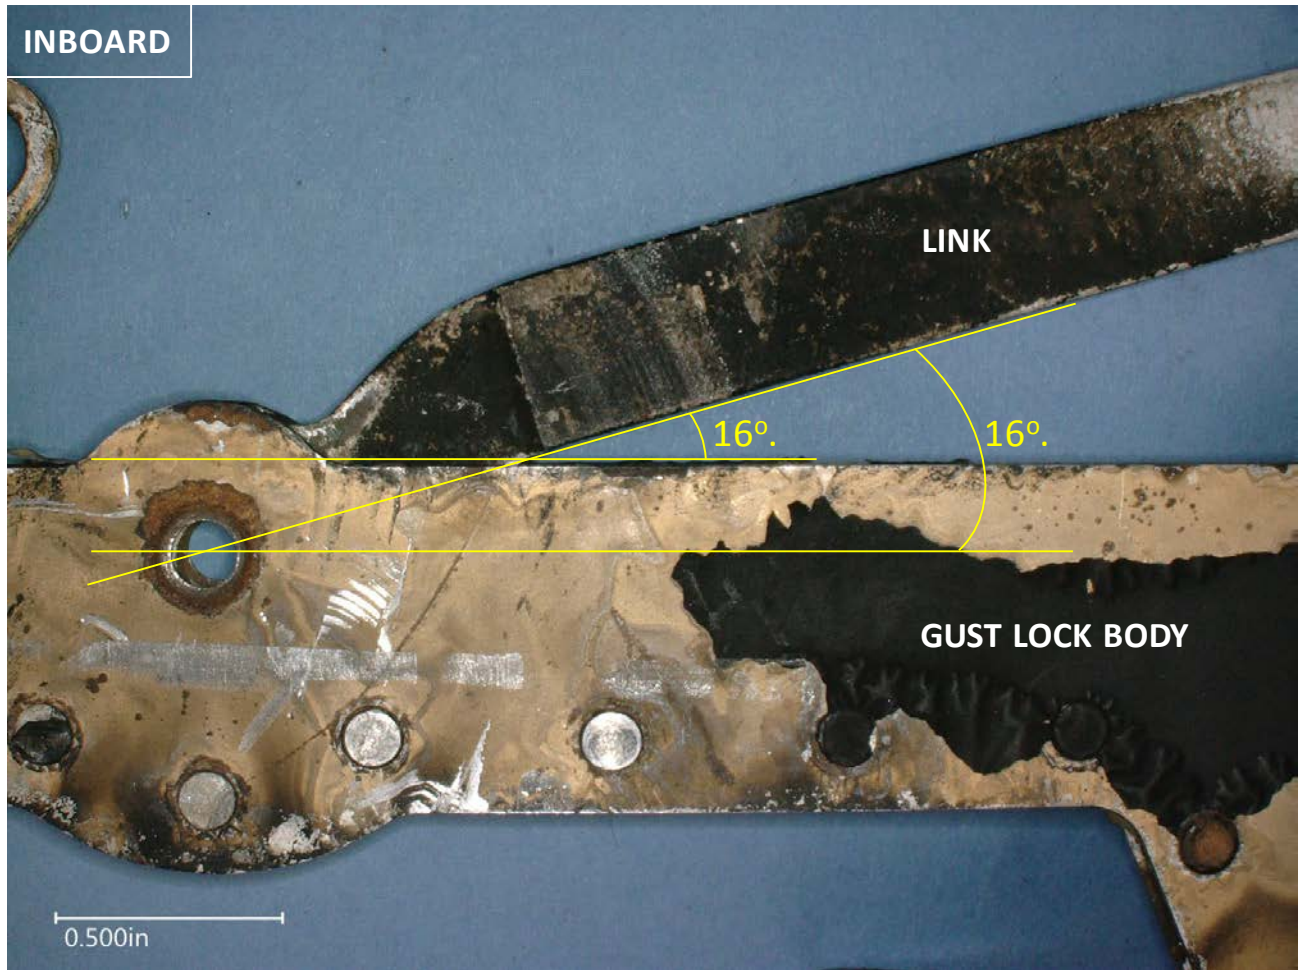
**Figure 21:** Digital microscope photo showing the angle between the gust lock handle components when the link was inserted so the soot mark on the link surface was in-line with the gust lock body.

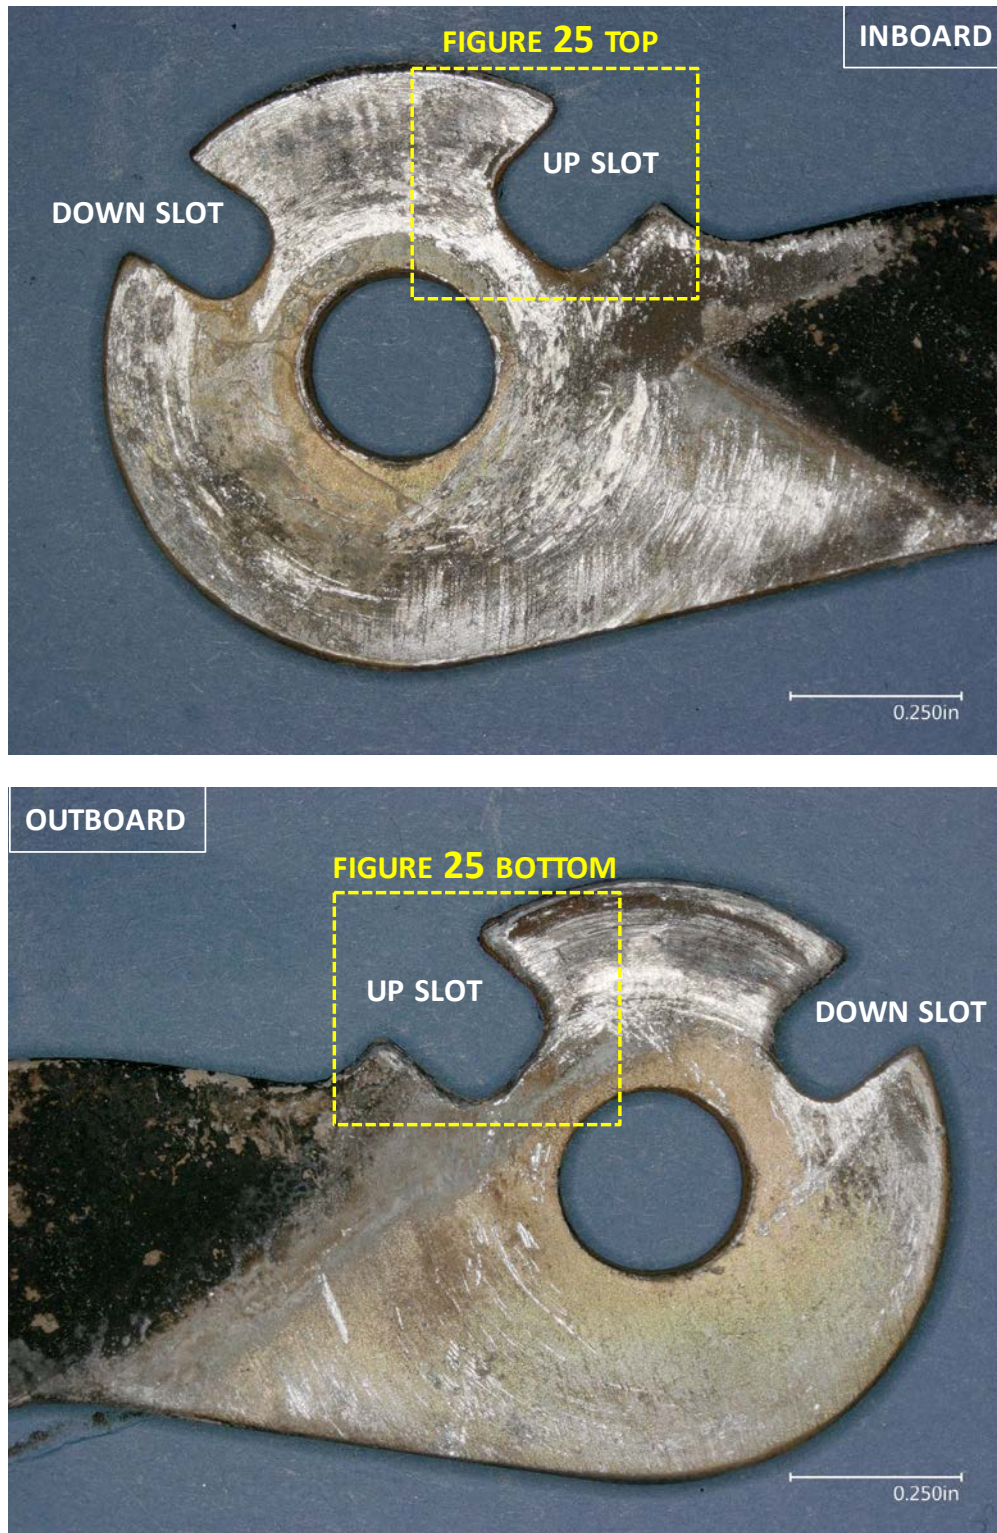
There were contact marks on most of the inboard surface of the link; similar contact marks were observed on the outboard side of the link, but the marks were confined to between the up and down slots and just past the other side of the down slot. The contact marks on the inboard and outboard link surfaces are shown in Figure 22. The majority of the contact marks were circumferential, and were in the direction the link rotated.

**Figure 22:** Digital microscope photos showing the contact marks on the inboard and outboard surfaces of the link from the gust lock handle.

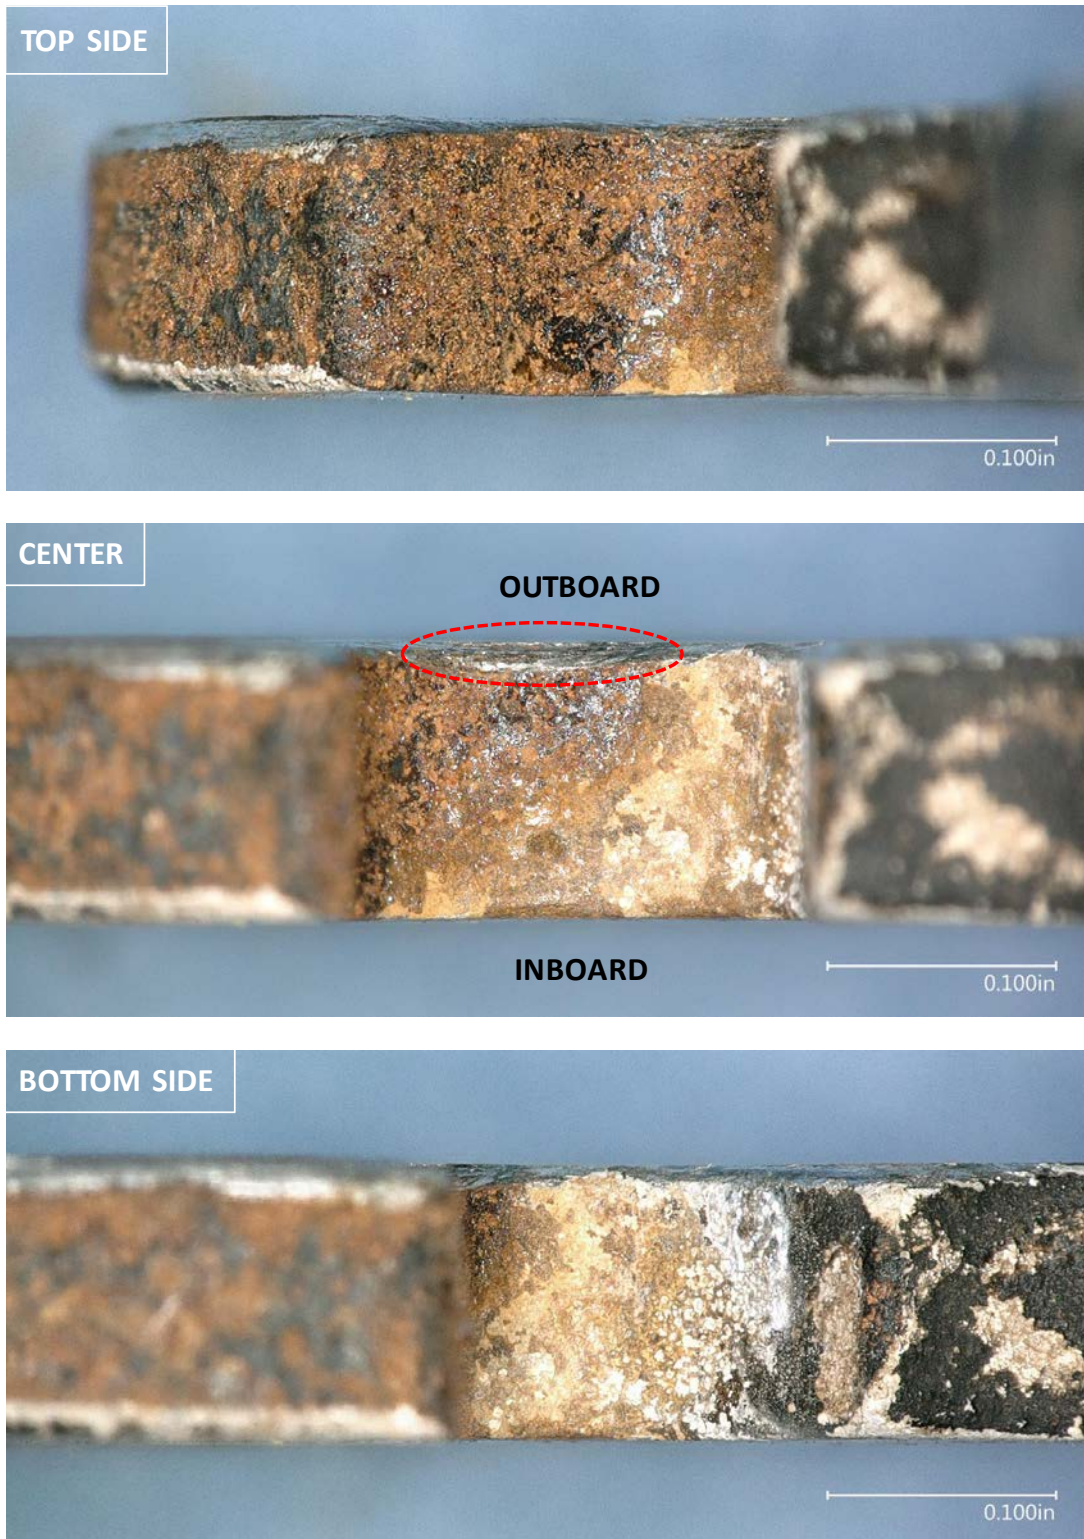
**Figure 24:** Digital microscope photos showing the up slot surface on the link from the gust lock handle. The red dashed line encircles material rolled off the outboard face of the link into the slot.

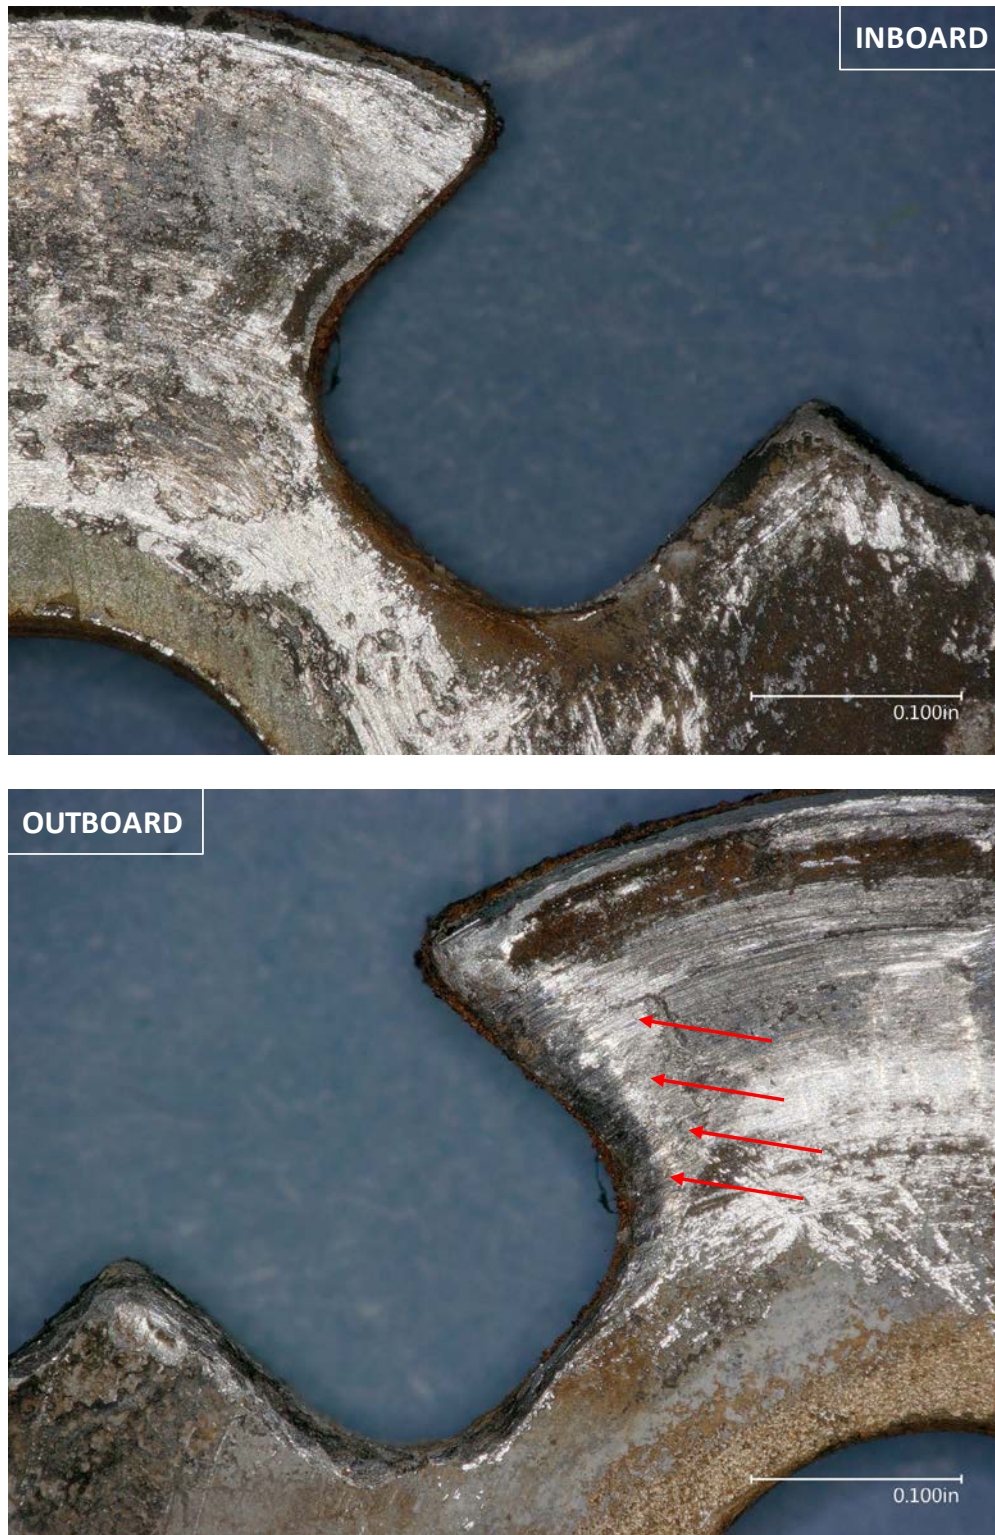
**Figure 25:** Digital microscope photos showing the contact marks surrounding the up slot on the inboard and outboard surfaces of the link from the gust lock handle. Material deposited onto the outboard face of the link is indicated by the red arrows.

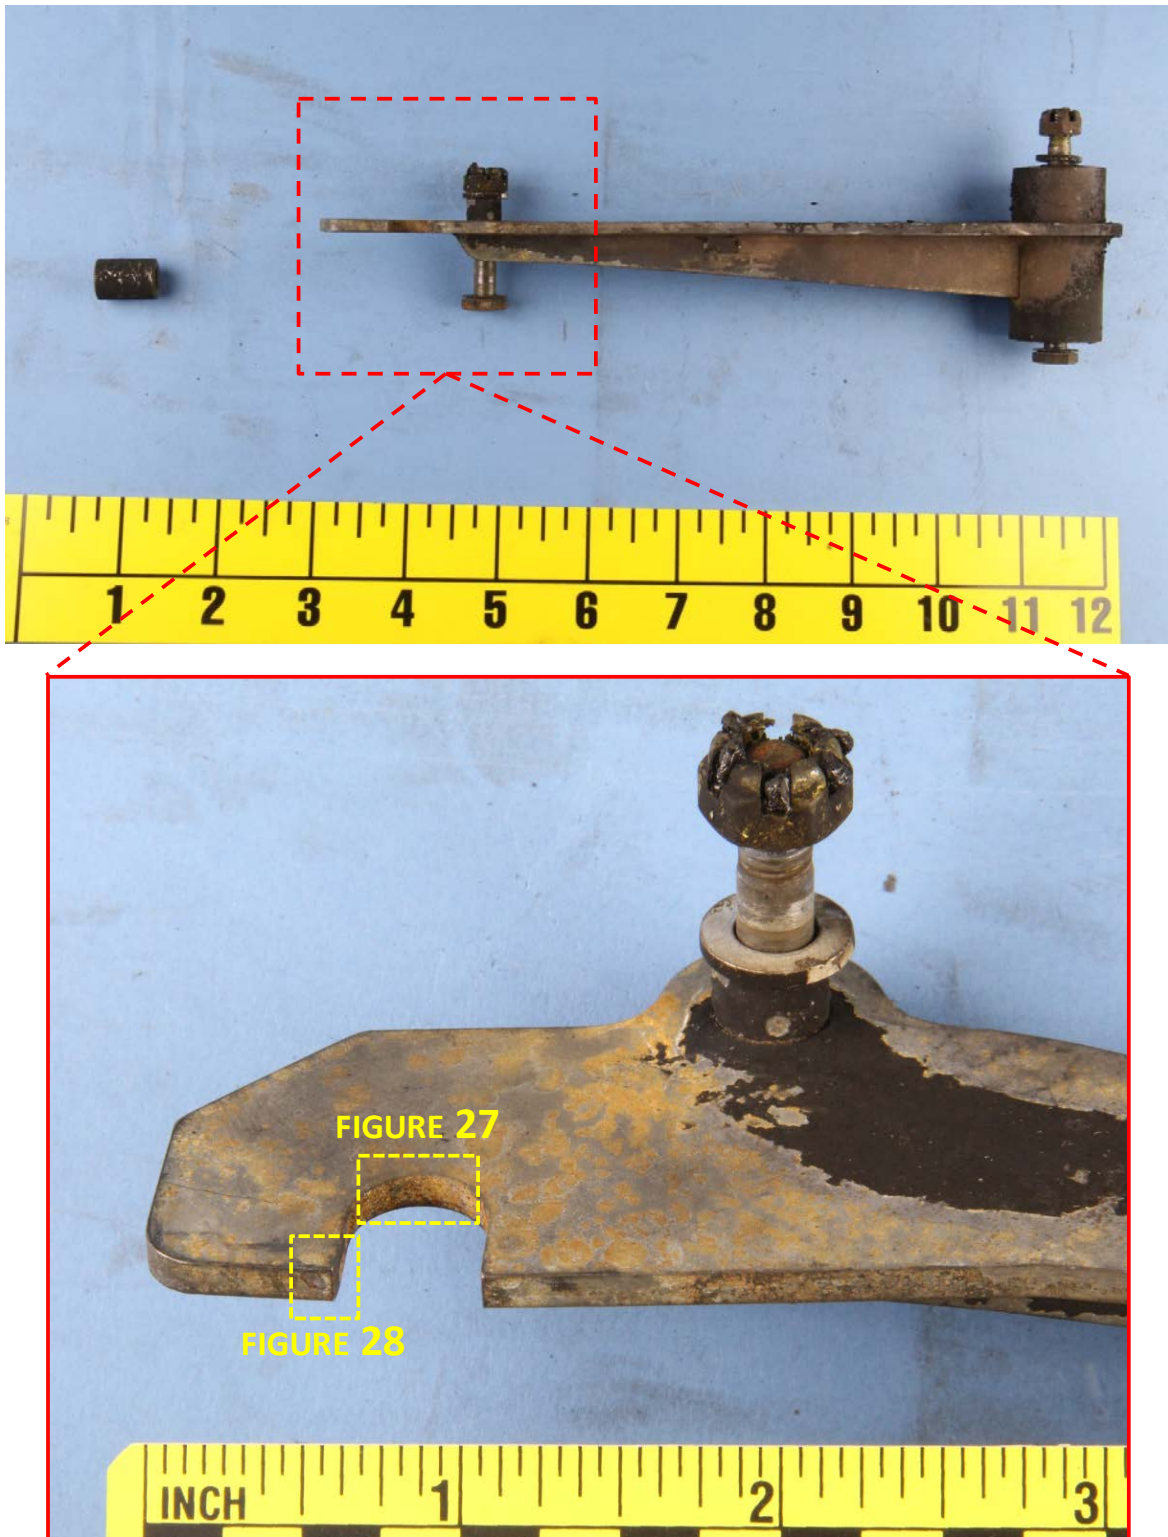
Figure 26 and Figure 27 show that all of the surfaces of the elevator hook, including within the slot, were covered in red/brown rust-like deposits consistent with corrosion. L-shaped areas with little to no corrosion deposits were observed on the ends of the slot, as seen on the representative end shown in Figure 28. Shiny, deformed areas were visible around the elevator hook slot edges adjacent to the L-shaped areas.

**Figure 26:** Overall photo of the elevator hook and roller (top), and close-up photo of the elevator hook slot (bottom).

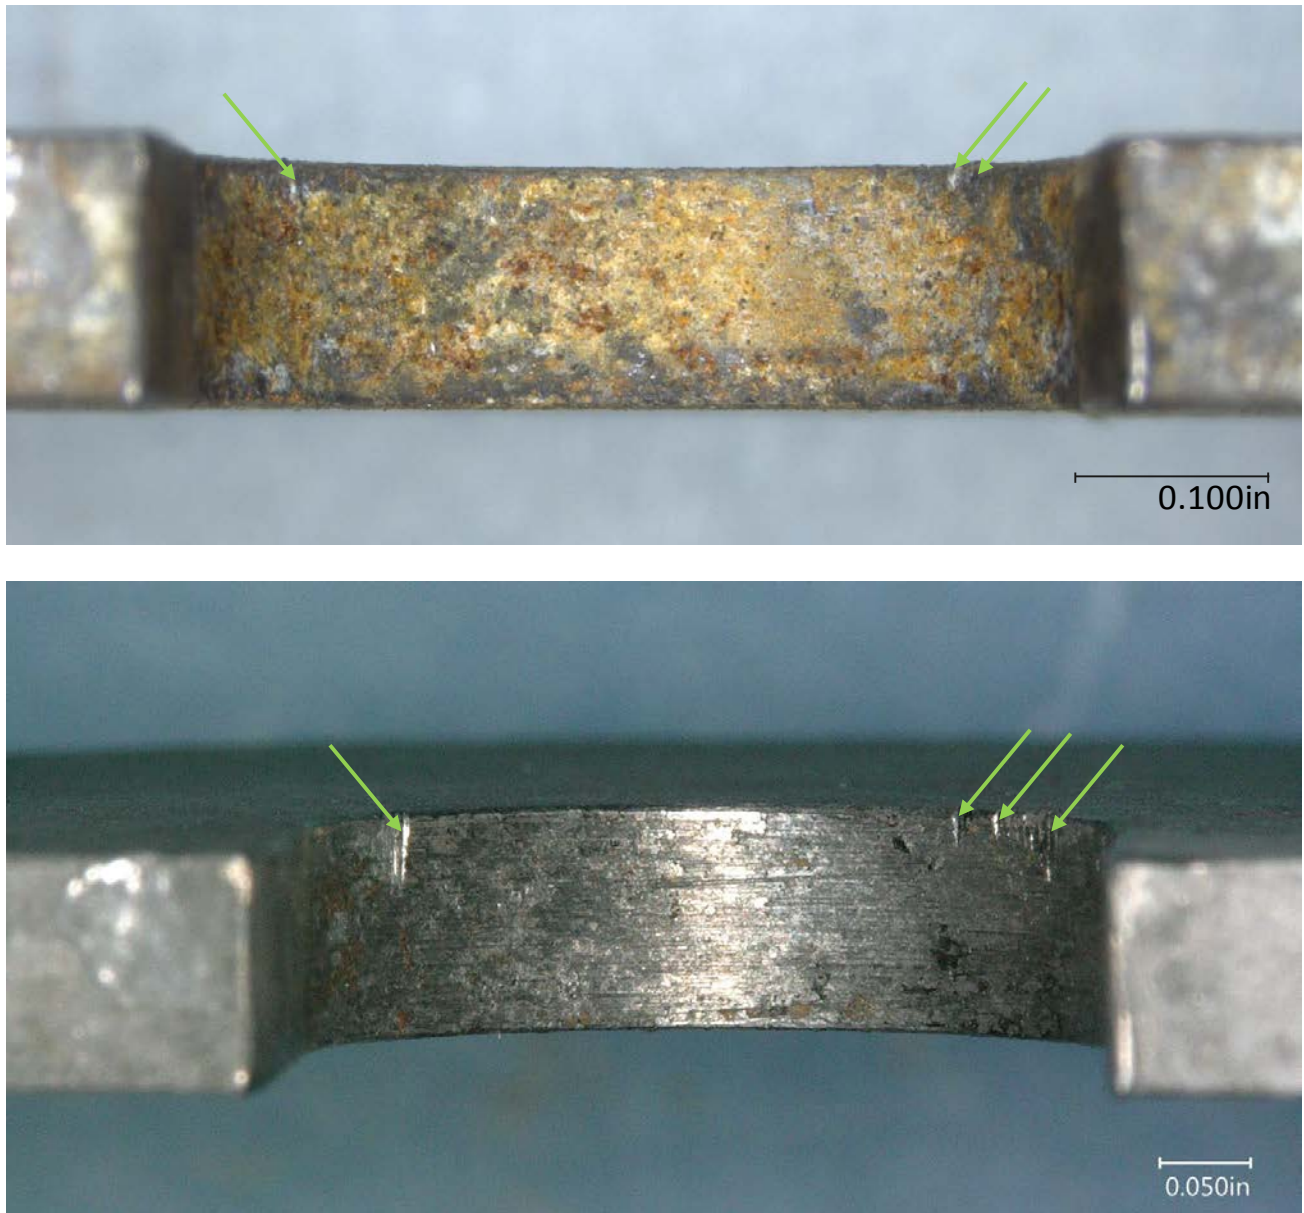
The elevator hook was cleaned using Evapo-Rust™ (Harris International Labs, Springdale, AR) and an acetone rinse. After cleaning, the L-shaped areas on the ends of the slot were observed to be consistent with burnished material. Linear marks were visible on the ends of the elevator hook slot and at the corners of the slot bottom in-line with the slot sides/flats, as indicated by the green arrows in Figure 27-Figure 29. The marks were observed as parallel to the edges of the slot ends. The shiny, deformed areas on the hook slot edge were revealed after cleaning to be material that had been rolled out of the slot ends adjacent to some of the linear marks. Circumferential lines consistent with machining were observed in the bottom of the elevator hook slot. No obvious deformation or witness marks were observed within the elevator hook slot.

**Figure 27:** Digital microscope photos of the elevator hook slot bottom before and after cleaning (top and bottom images, respectively). The green arrows point to linear marks observed on the slot surface.

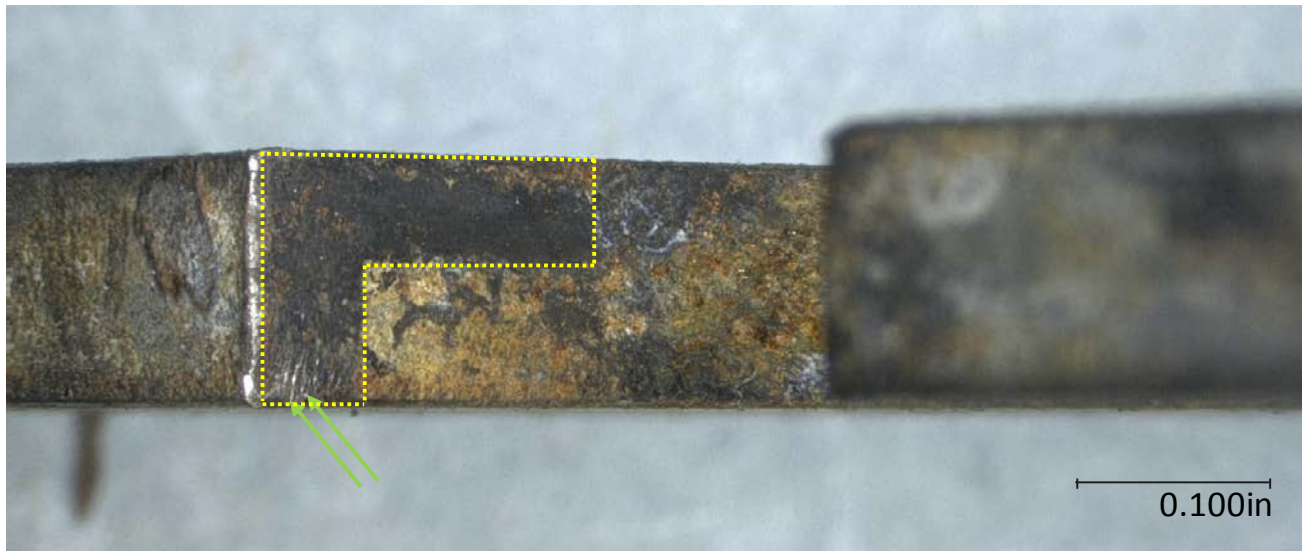
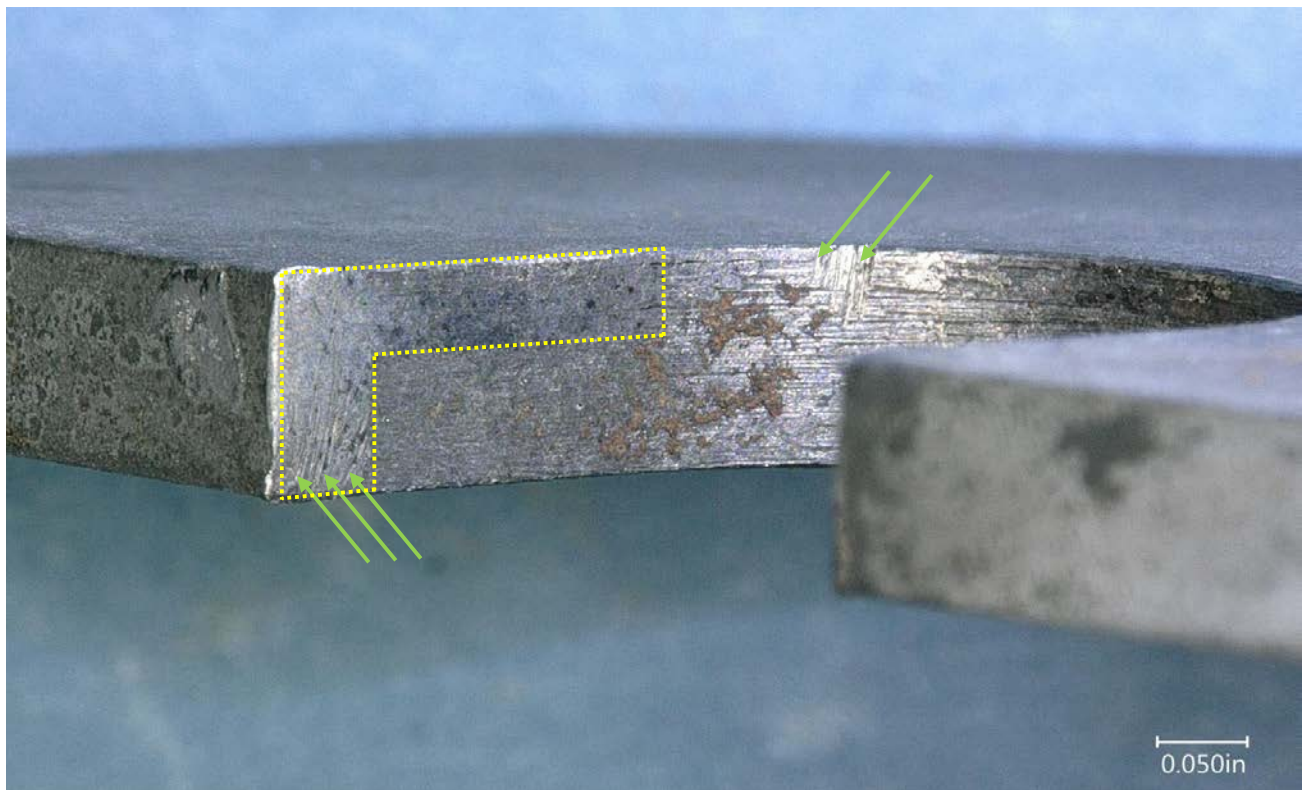
**Figure 28:** Digital microscope photos of one end of the elevator hook slot before and after cleaning (top and bottom images, respectively). The yellow dotted lines outline an L-shaped pattern visible on the surface of the slot end. The green arrows point to linear marks observed on the slot surface.

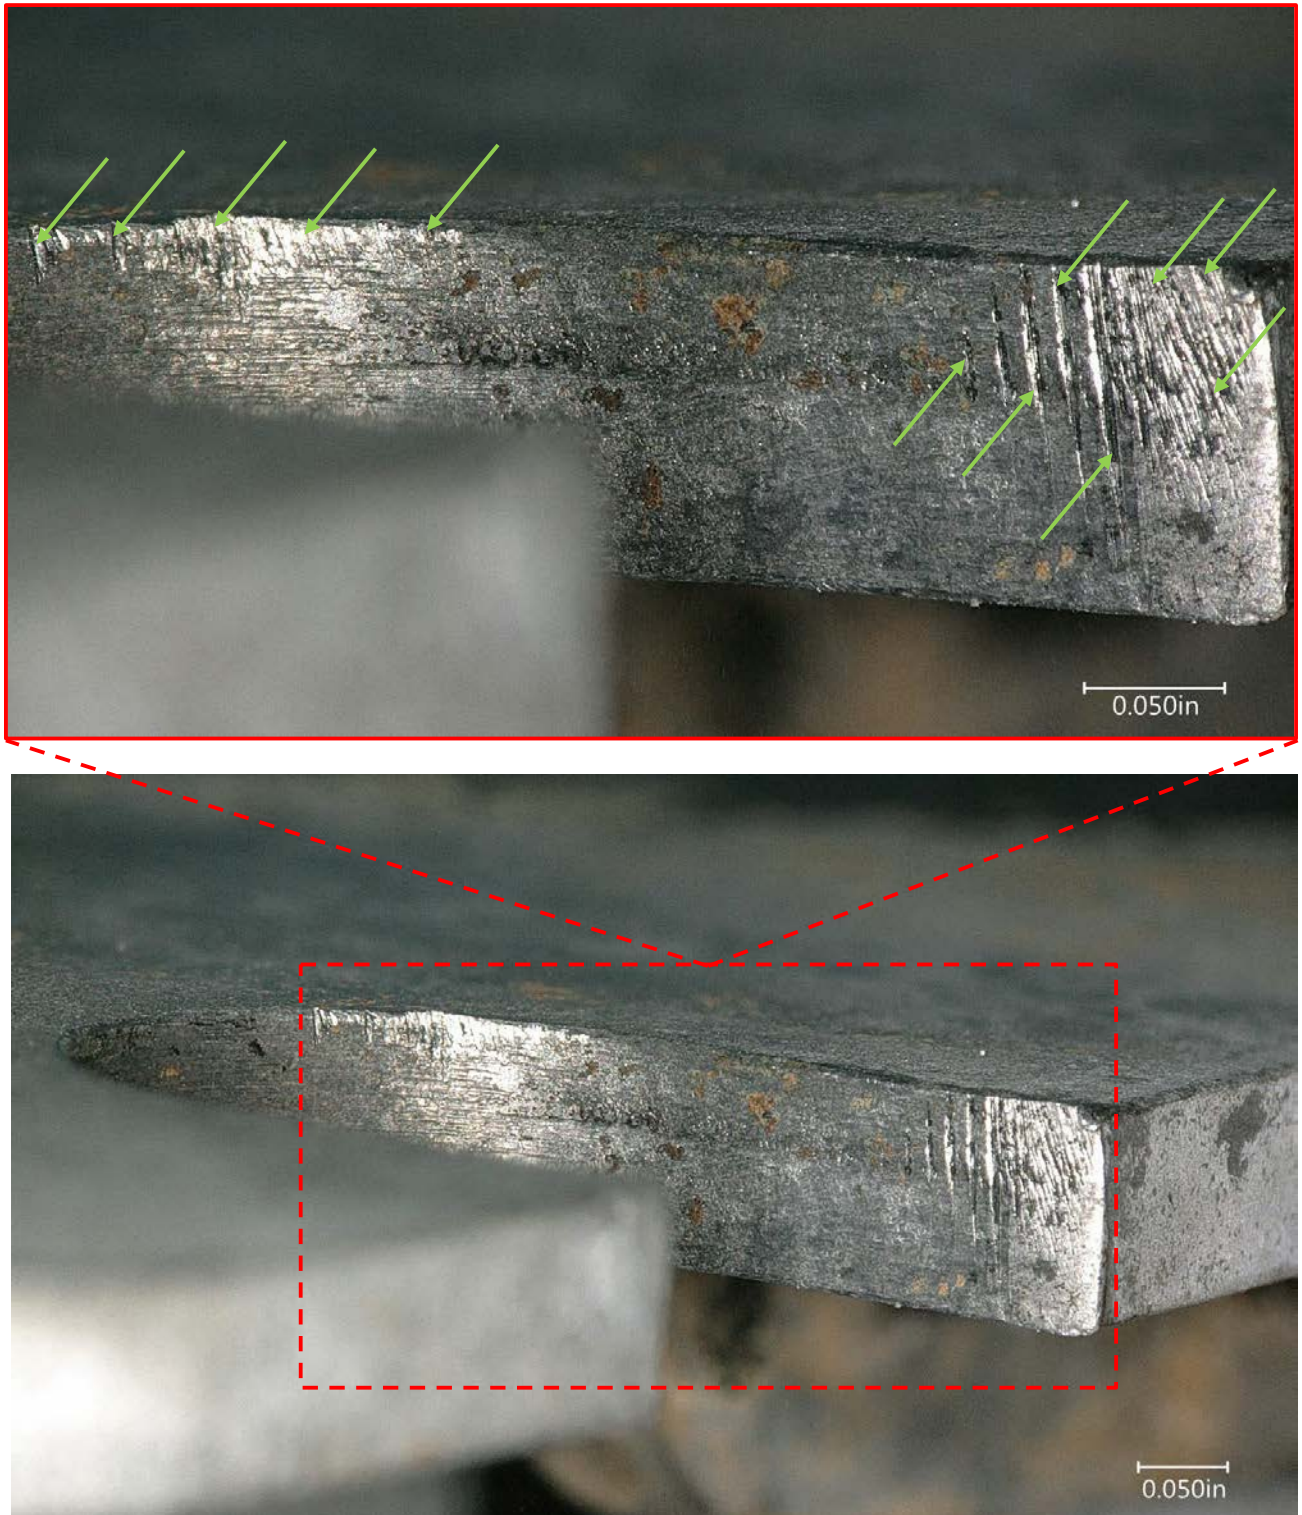
**Figure 29:** Digital microscope photos of the end of the elevator hook slot opposite the end shown in Figure 28. The green arrows point to linear marks observed on the slot surface.

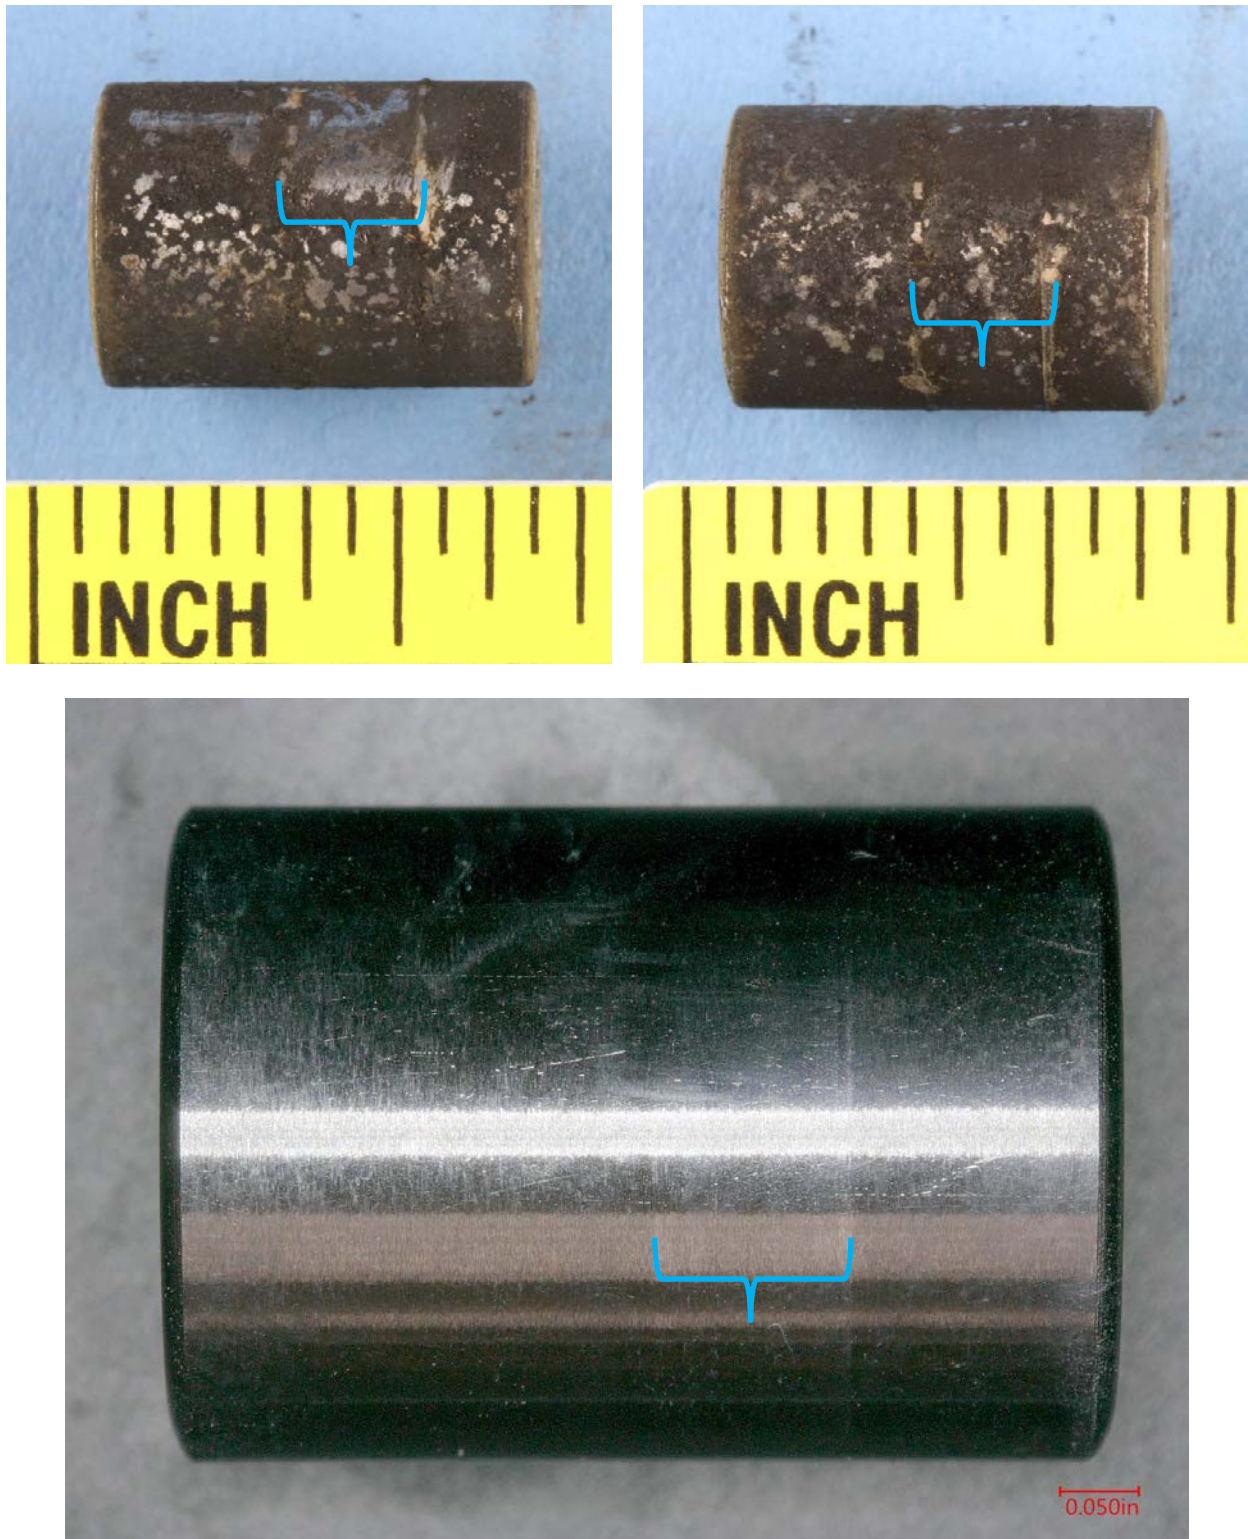
The elevator roller was covered in dark-colored deposits. The deposits were non-uniform and appeared to be heavier around one half of the roller circumference. Circumferential markings through the dark-colored deposits were observed around the OD of the roller, as indicated by the blue brackets in the top images of Figure 30.

The dark-colored deposits were cleaned from the roller surfaces using a sodium hydroxide solution. After cleaning, a shiny band, indicated by the blue bracket in the bottom image of Figure 30, was observed coinciding with the location of the circumferential markings through the dark-colored deposits. The shiny band was consistent with wear, and extended around the entire circumference of the roller. The band was located offset from the center of the roller width. The width of the band measured roughly the same as the width of the mating elevator hook slot.

**Figure 30:** Digital microscope photos showing the circumferential markings (blue brackets, top images) through the dark-colored deposits on the OD of the elevator roller. After cleaning, a circumferential band of wear (blue bracket, bottom image) was observed in the location of the markings.
