# NATIONAL TRANSPORTATION SAFETY BOARD

MATERIALS LABORATORY FACTUAL REPORT

Report No. 15-021

Place : Bedford, Massachusetts  
Date : May 31, 2014  
Vehicle : Gulfstream IV  
NTSB No. : ERA14MA271  
Investigator : Adam Huray (AS-40)

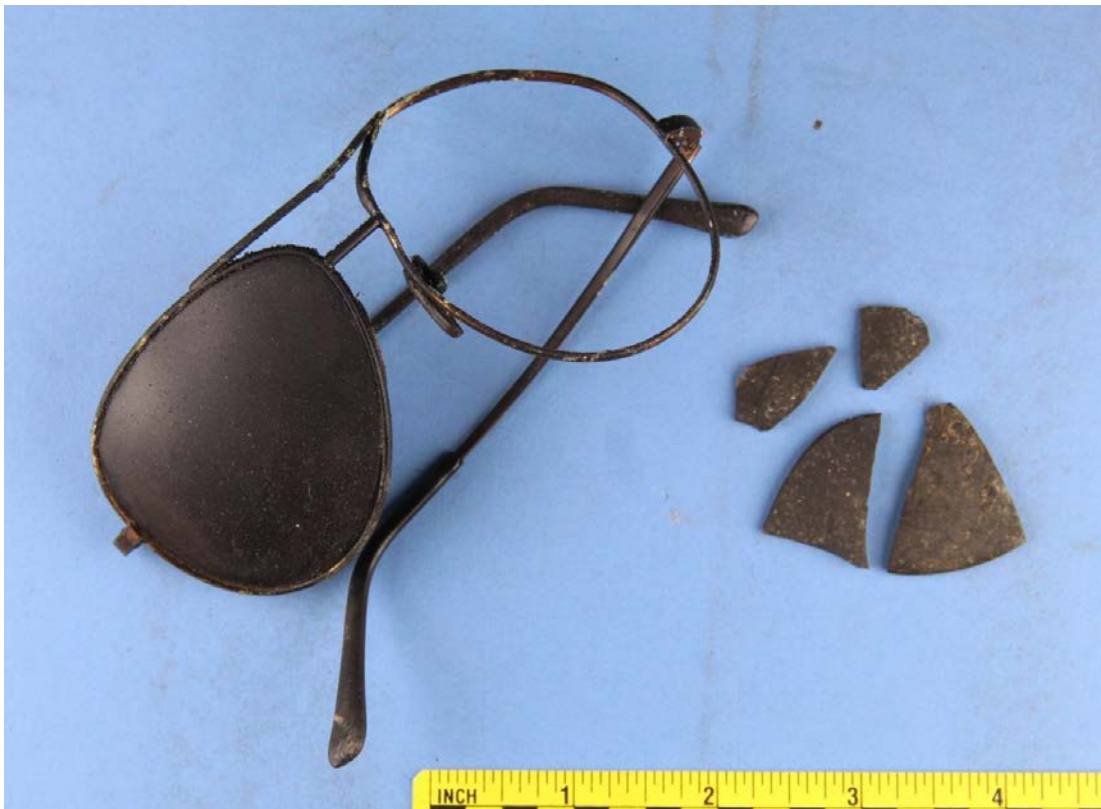
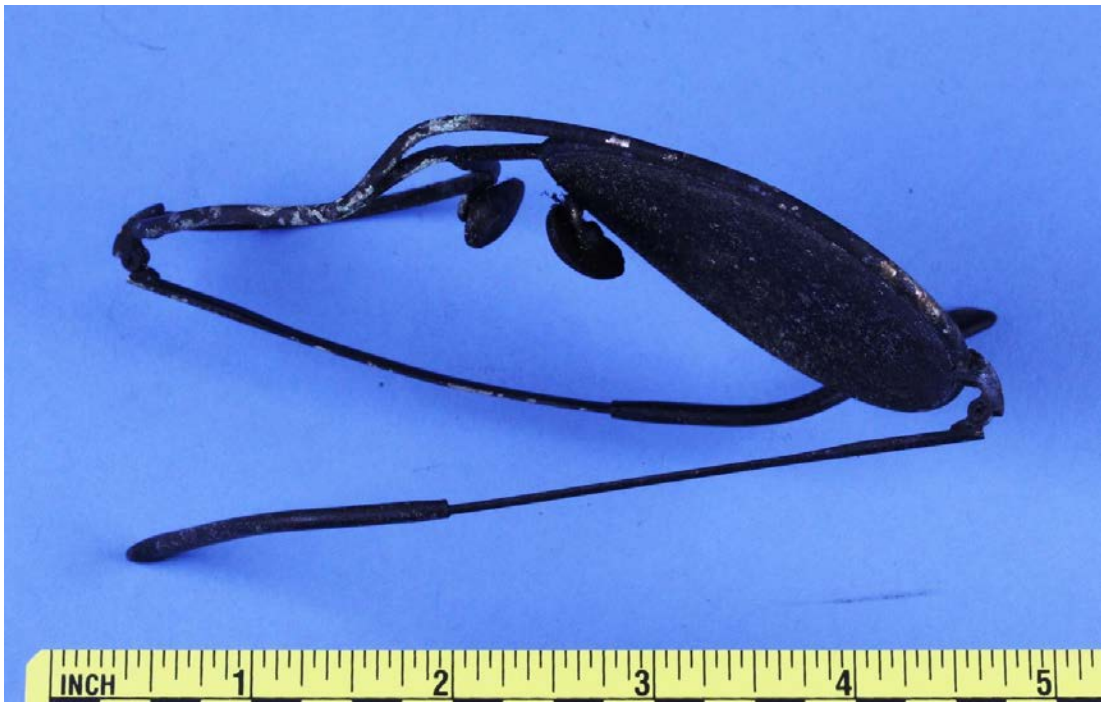
The sunglasses were submitted with the right lens still assembled inside the frames and the left lens missing. Broken pieces of the left lens were also submitted. It was reported that one of the pieces was further broken into two pieces during recovery. The sunglasses as-submitted are shown in Figure 31. The right lens and most of the exterior surfaces of the frame were covered in a black-colored substance consistent with soot; some areas on the interior surfaces of the frame, particularly near the nosepieces, did not appear to have soot. The following markings were visible on the inner surface of one of the stems: "SERENGETI" and "5134".

**Figure 31:** Overall photos of the sunglasses as-submitted.

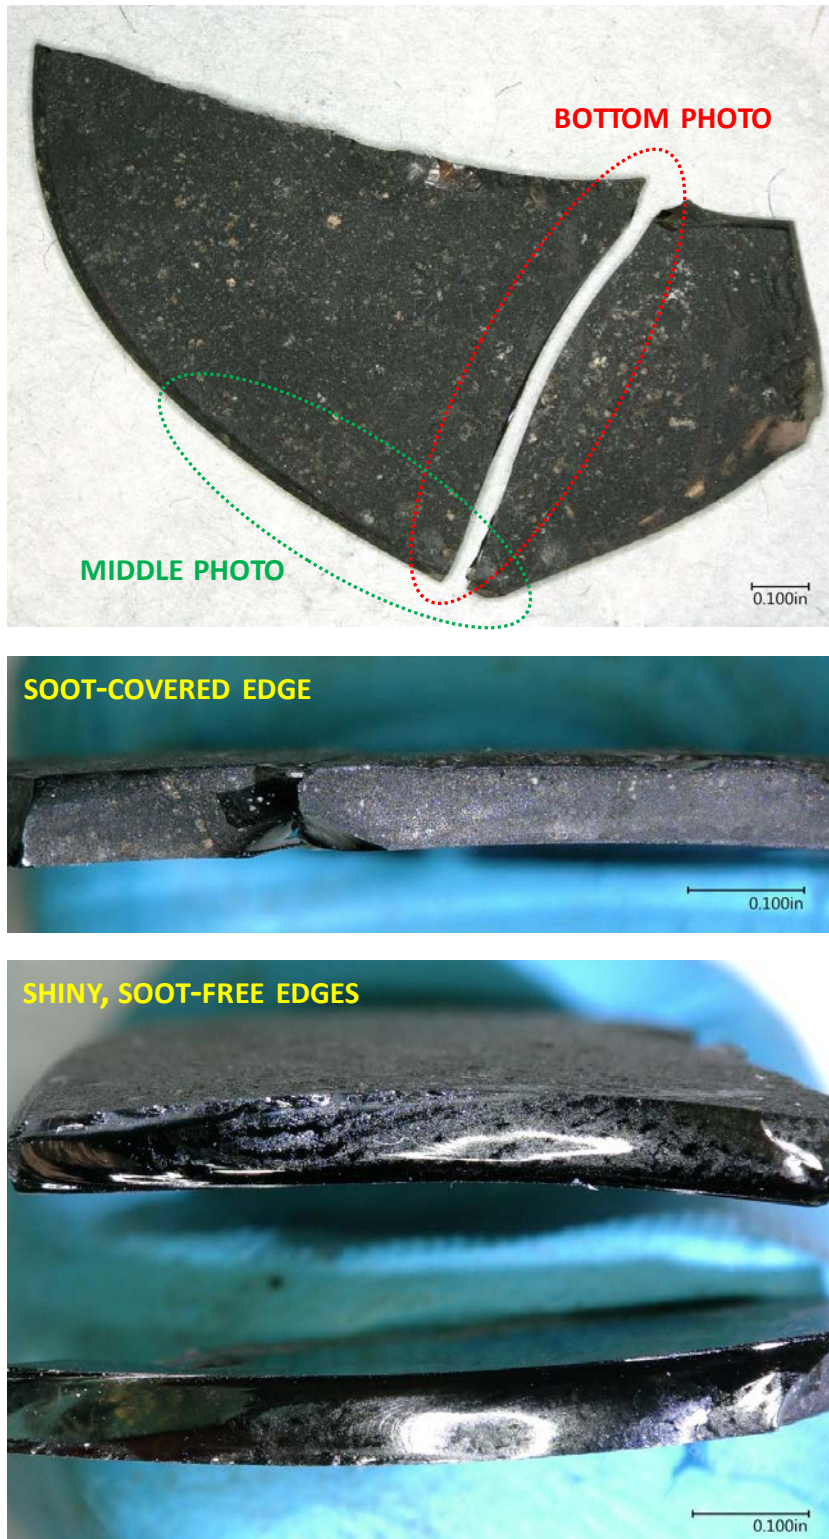
Soot was also observed on the broken pieces of the left lens. The soot was observed on the flats and most of the edges of the lens pieces. Two pieces had one shiny, soot-free edge that was noticeably different in appearance from the other edges, as shown in Figure 32.

**Figure 32:** Digital microscope photos of the sunglasses lens piece that was broken during recovery.

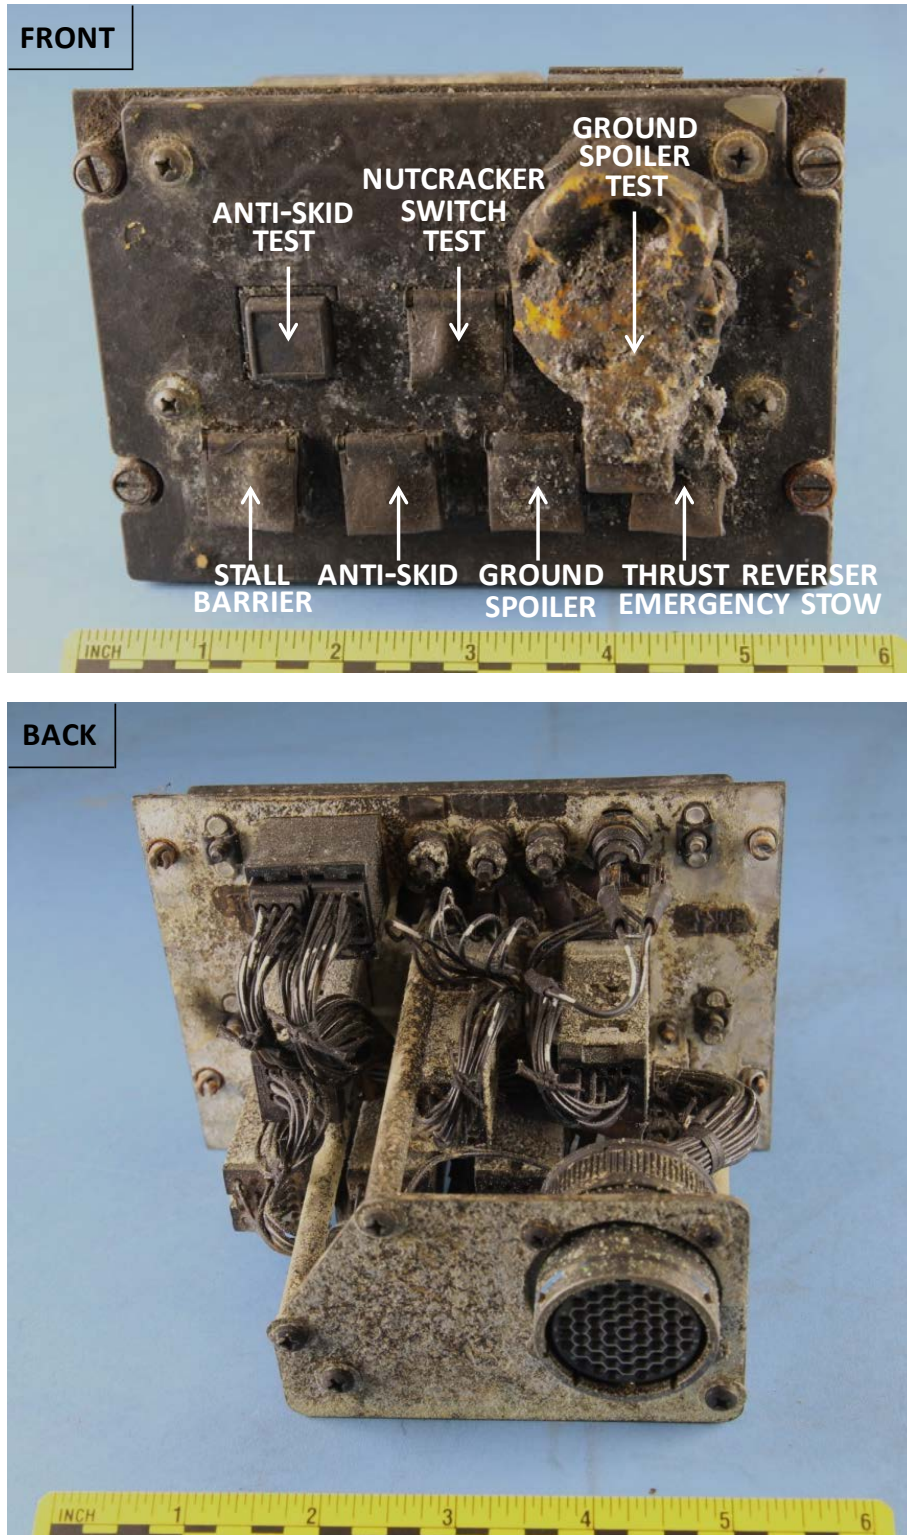
The pedestal switch panel was submitted with the following switches still assembled: Anti-Skid Test, Nutcracker Switch Test, Ground Spoiler Test, Thrust Reverser Emergency Stow, Ground Spoiler, Anti-Skid, and Stall Barrier. Portions of the front panel and switch covers were warped and melted, consistent with fire damage. All of the surfaces of the pedestal switch panel were covered in soot and debris consistent with fire suppression agents, as shown in Figure 33.

**Figure 33:** Overall photos of the pedestal switch panel.

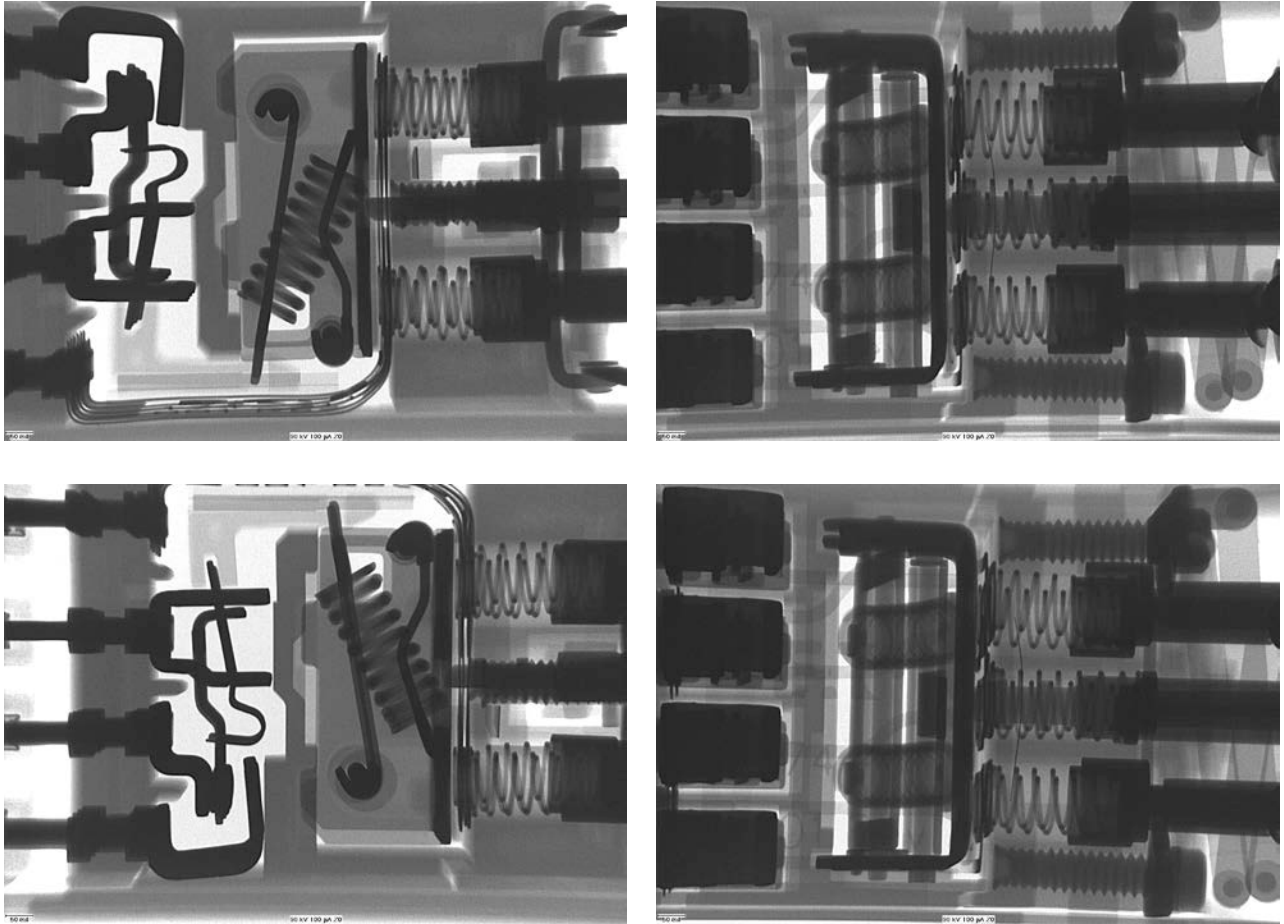
**Thrust Reverser Emergency Stow Switch from Incident Aircraft**

By comparing the positions of the incident switches to the exemplar switches in their known positions, it was determined that at the time of the incident the Thrust Reverser Emergency Stow, Ground Spoiler, and Anti-Skid switches were in the extended position, and the Stall Barrier switch was in the depressed position.

**Figure 34:** Radiographs of the 4 sides of the thrust reverser emergency stow switch from the incident aircraft.

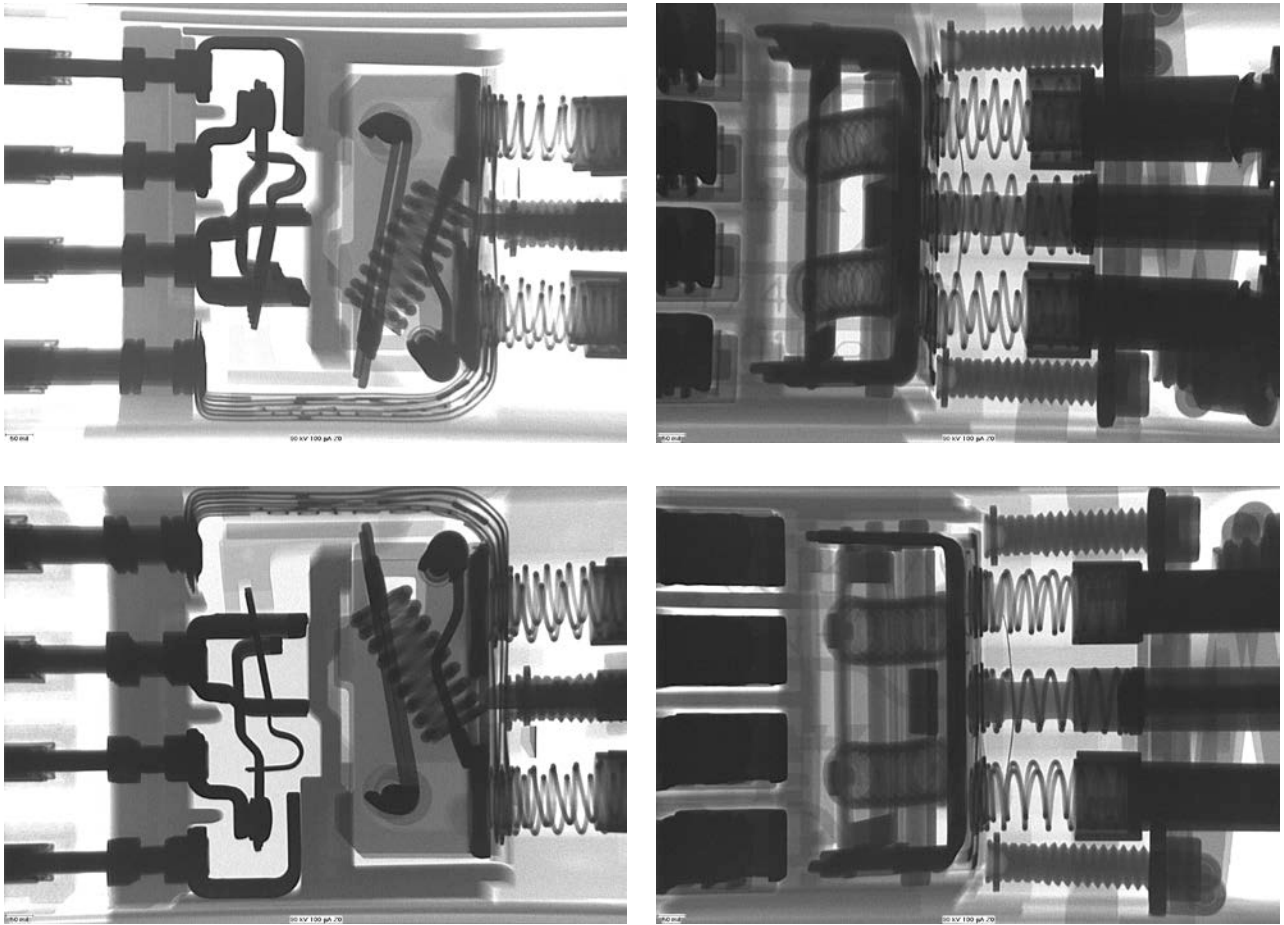
**Ground Spoiler Switch from Incident Aircraft**

**Figure 35:** Radiographs of the 4 sides of the ground spoiler switch from the incident aircraft.

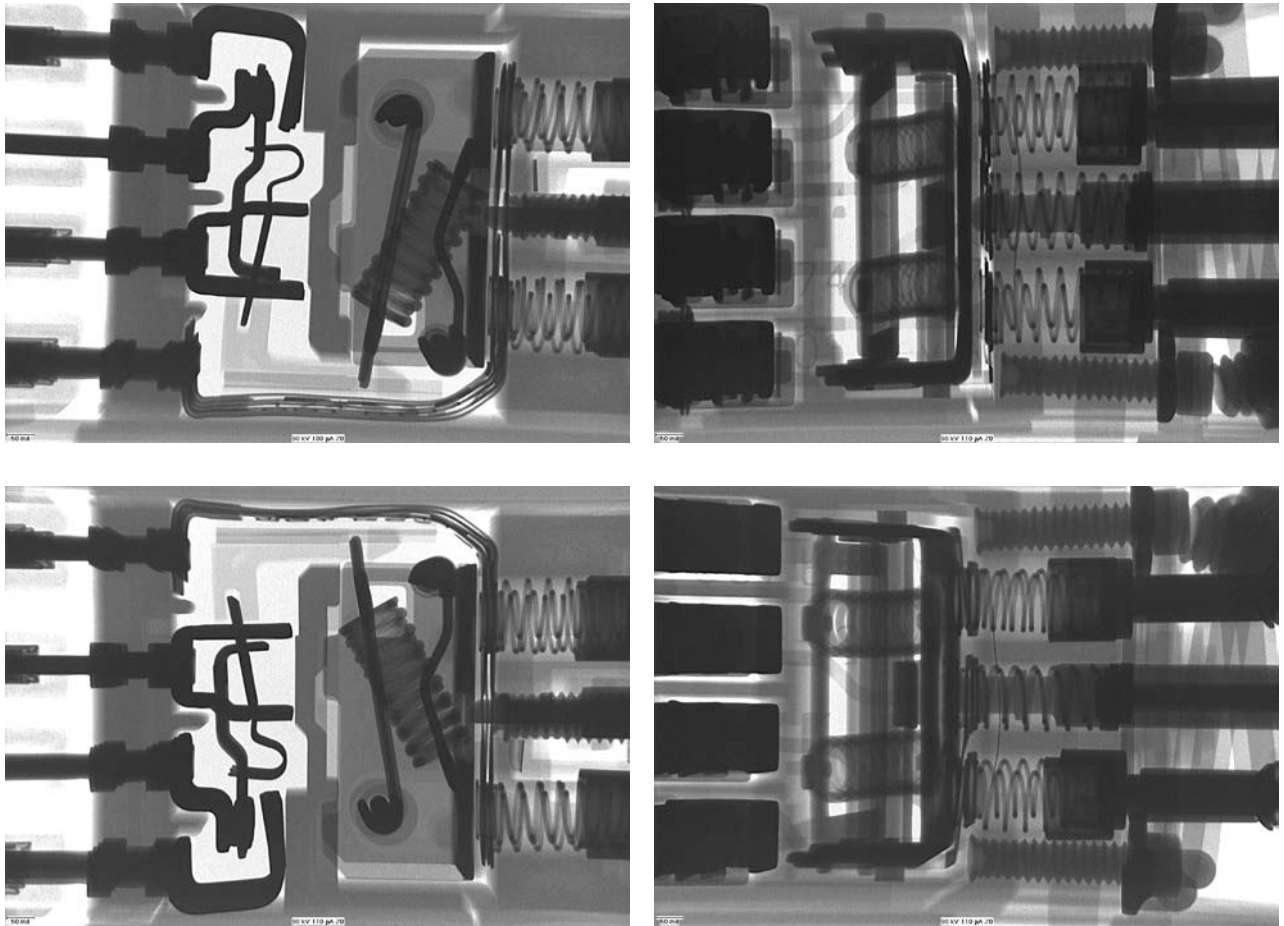
**Anti-Skid Switch from Incident Aircraft**

**Figure 36:** Radiographs of the 4 sides of the anti-skid switch from the incident aircraft.

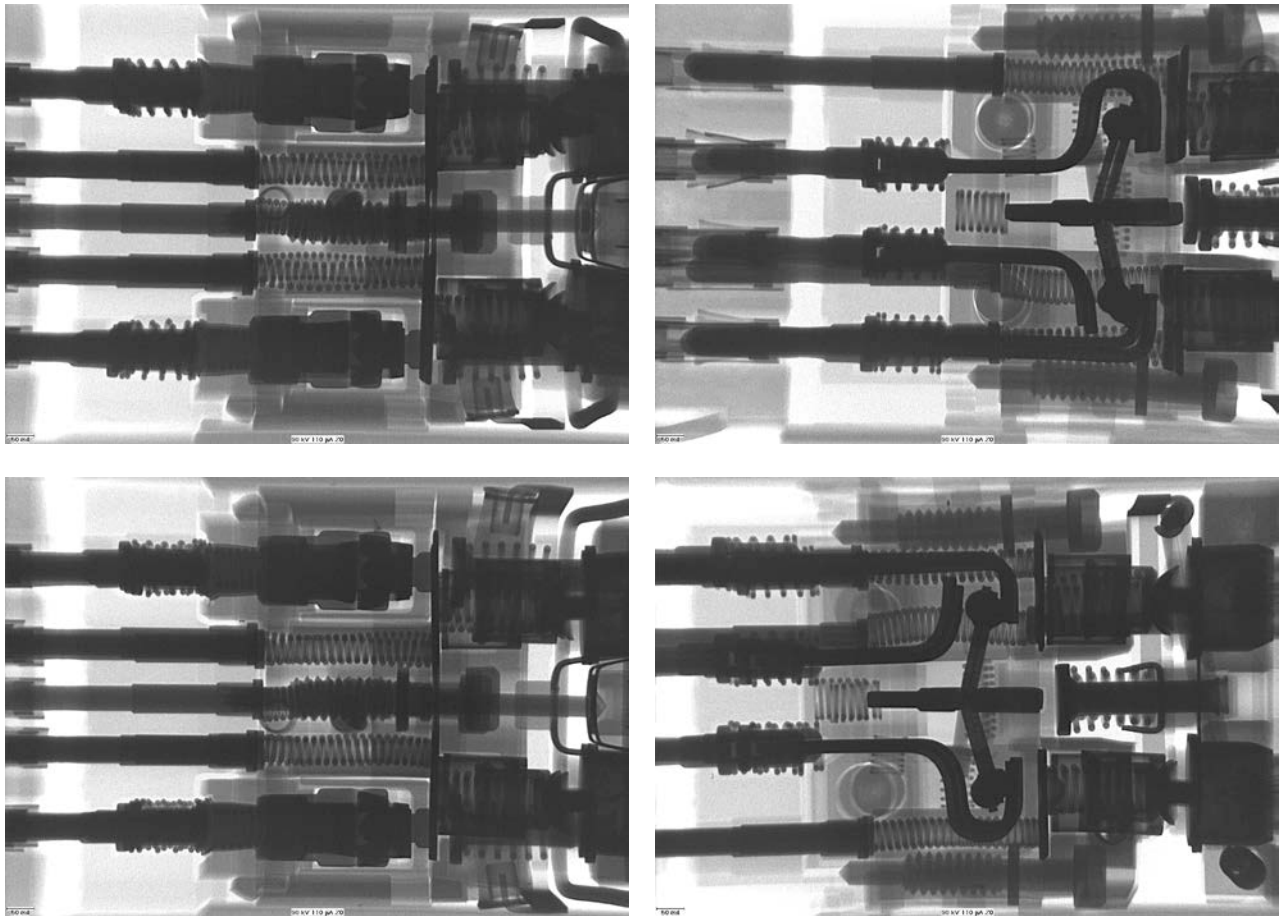
**Stall Barrier Switch from Incident Aircraft**

**Figure 37:** Radiographs of the 4 sides of the stall barrier switch from the incident aircraft.

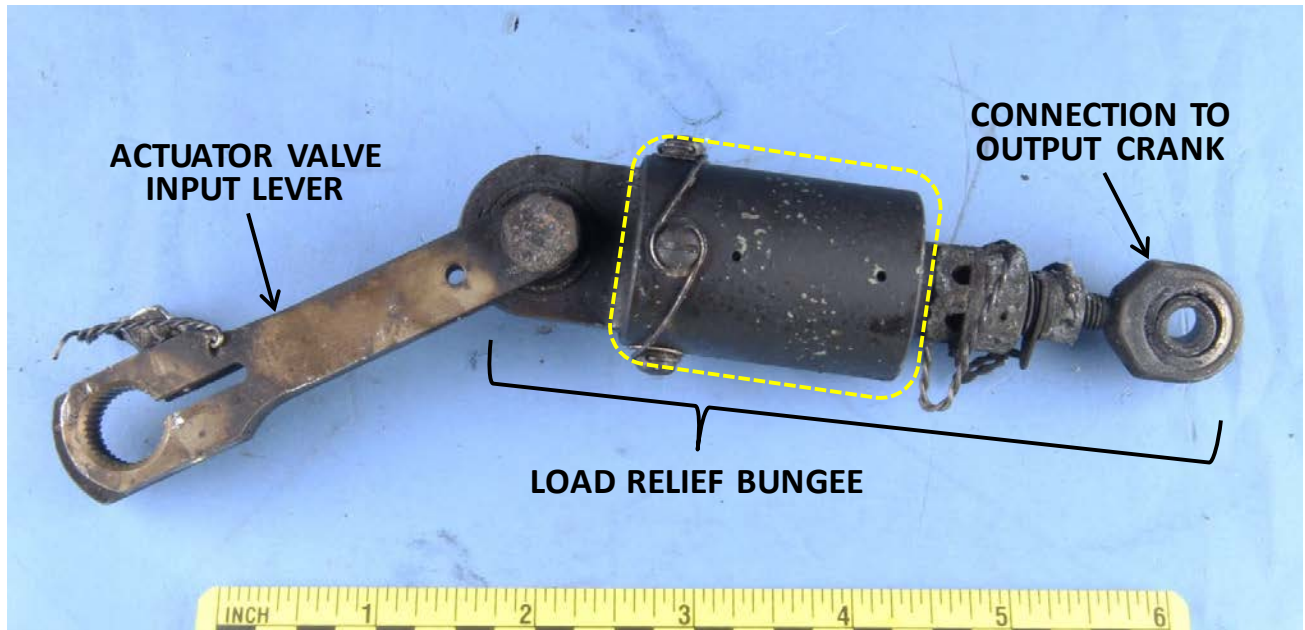
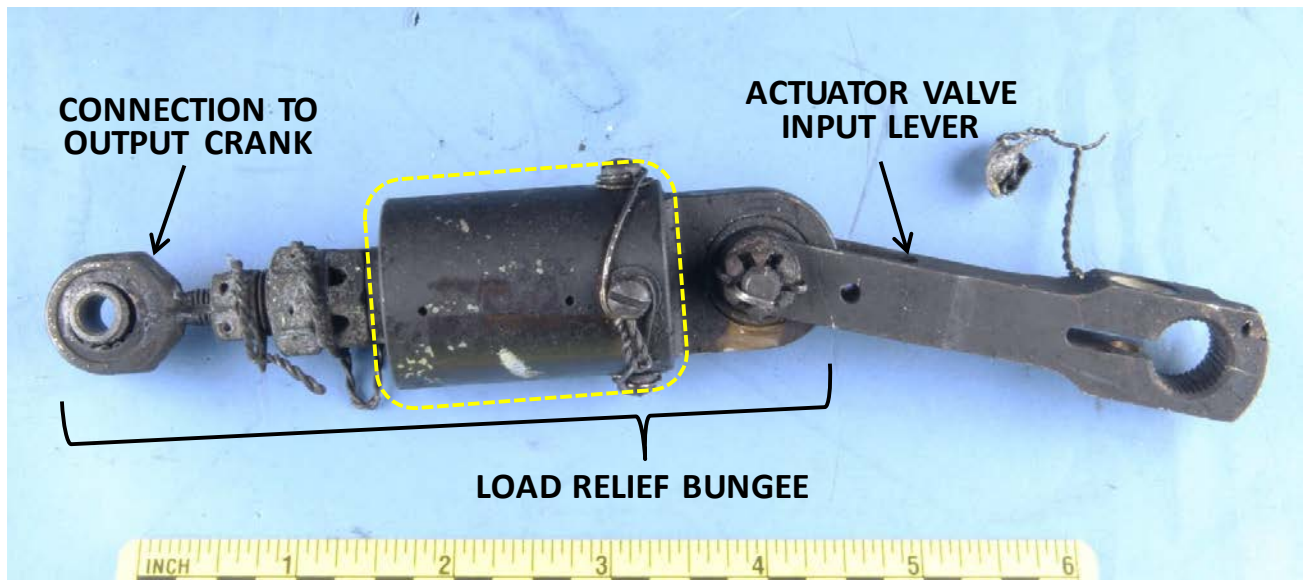
The elevator input bungee was submitted assembled, with most of the external surfaces coated in soot and corrosion deposits. The elevator input bungee is shown as-received in Figure 42.

**Figure 42:** Overall photos of the elevator input bungee. The chamber of the load relief bungee that contained the spring is encircled by the yellow dashed line.

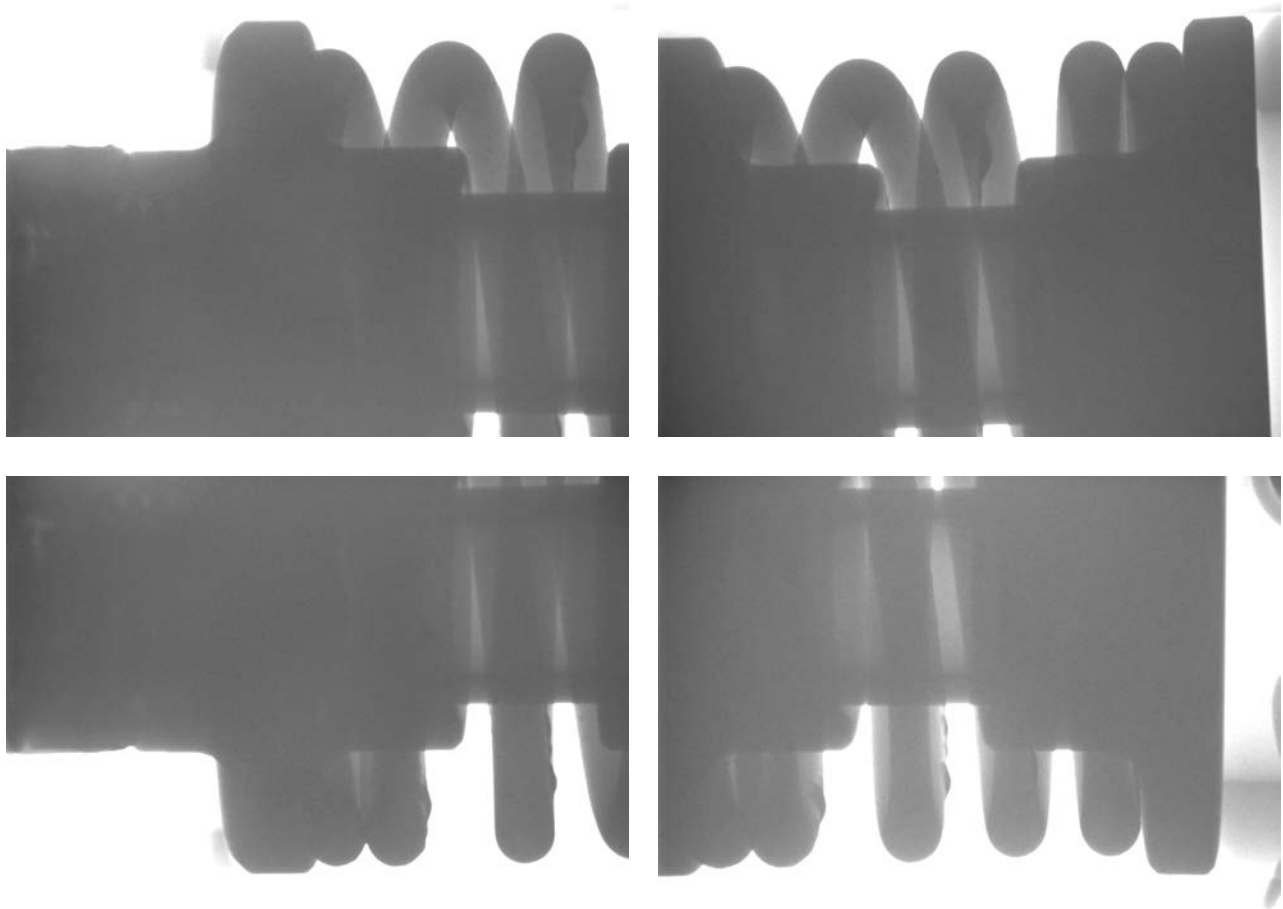
The spring within the chamber of the load relief bungee of the elevator input bungee was x-rayed. One side of the elevator input bungee was examined in the as-submitted position; the resulting radiographs are shown in Figure 43. The spring inside the load relief bungee chamber was compressed and released multiple times, then returned to neutral position, and the opposite side of the elevator input bungee was x-rayed. Radiographs of the opposite side of the elevator input bungee are shown in Figure 44. The spring inside the load relief bungee chamber of the elevator input bungee appeared intact in all of the radiographs, and no anomalies were observed.

**Figure 43:** Radiographs of one side of the spring inside the chamber of the load relief bungee on the elevator input bungee.

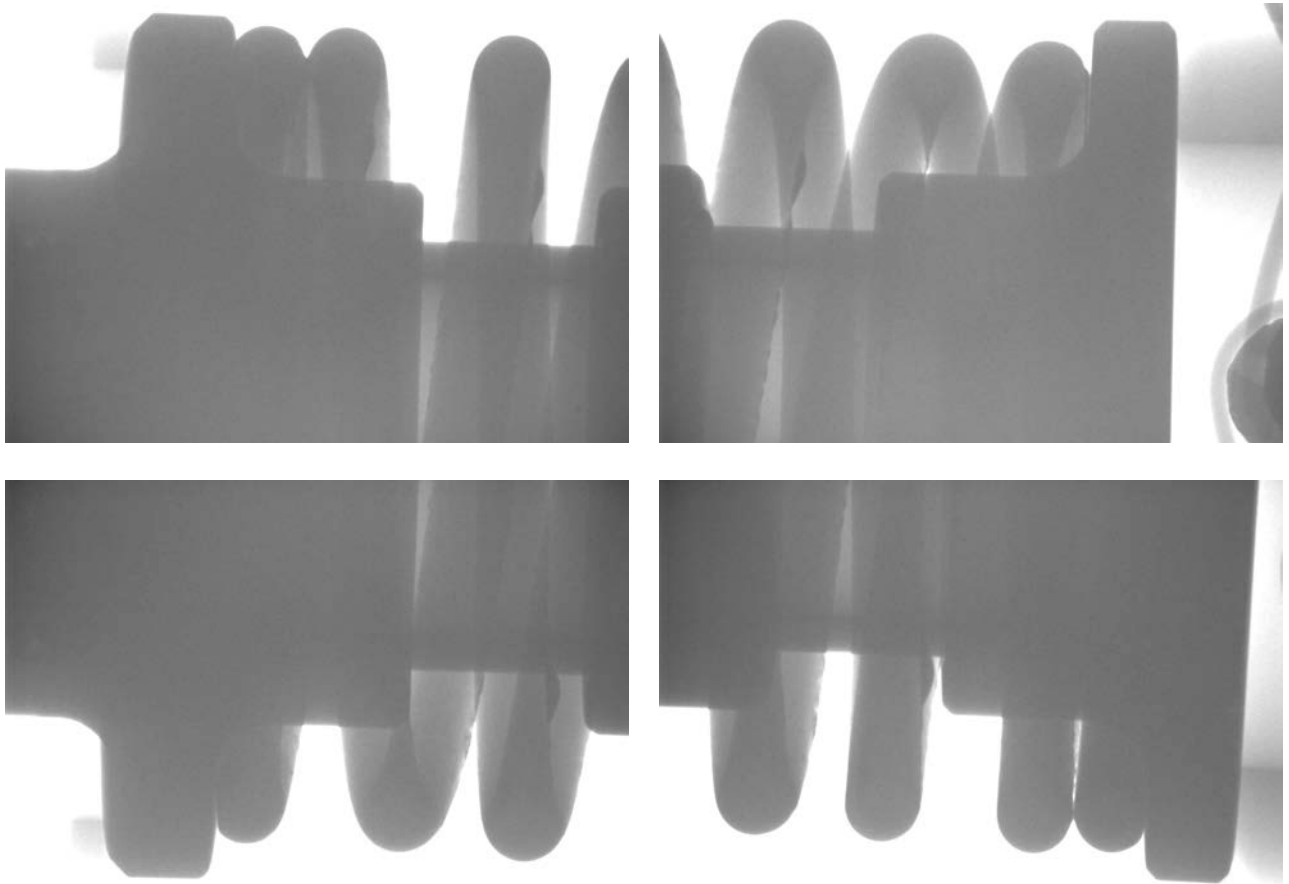
**Figure 44:** Radiographs of the side of the spring opposite the side shown in Figure 43 inside the chamber of the load relief bungee on the elevator input bungee.
