# NATIONAL TRANSPORTATION SAFETY BOARD

MATERIALS LABORATORY FACTUAL REPORT

Report No. 15-042

Place : Guntersville, Alabama  
Date : September 8, 2013  
Vehicle : Piper PA-32R-300  
NTSB No. : ERA13LA407  
Investigator : Timothy W. Monville, AS-ERA

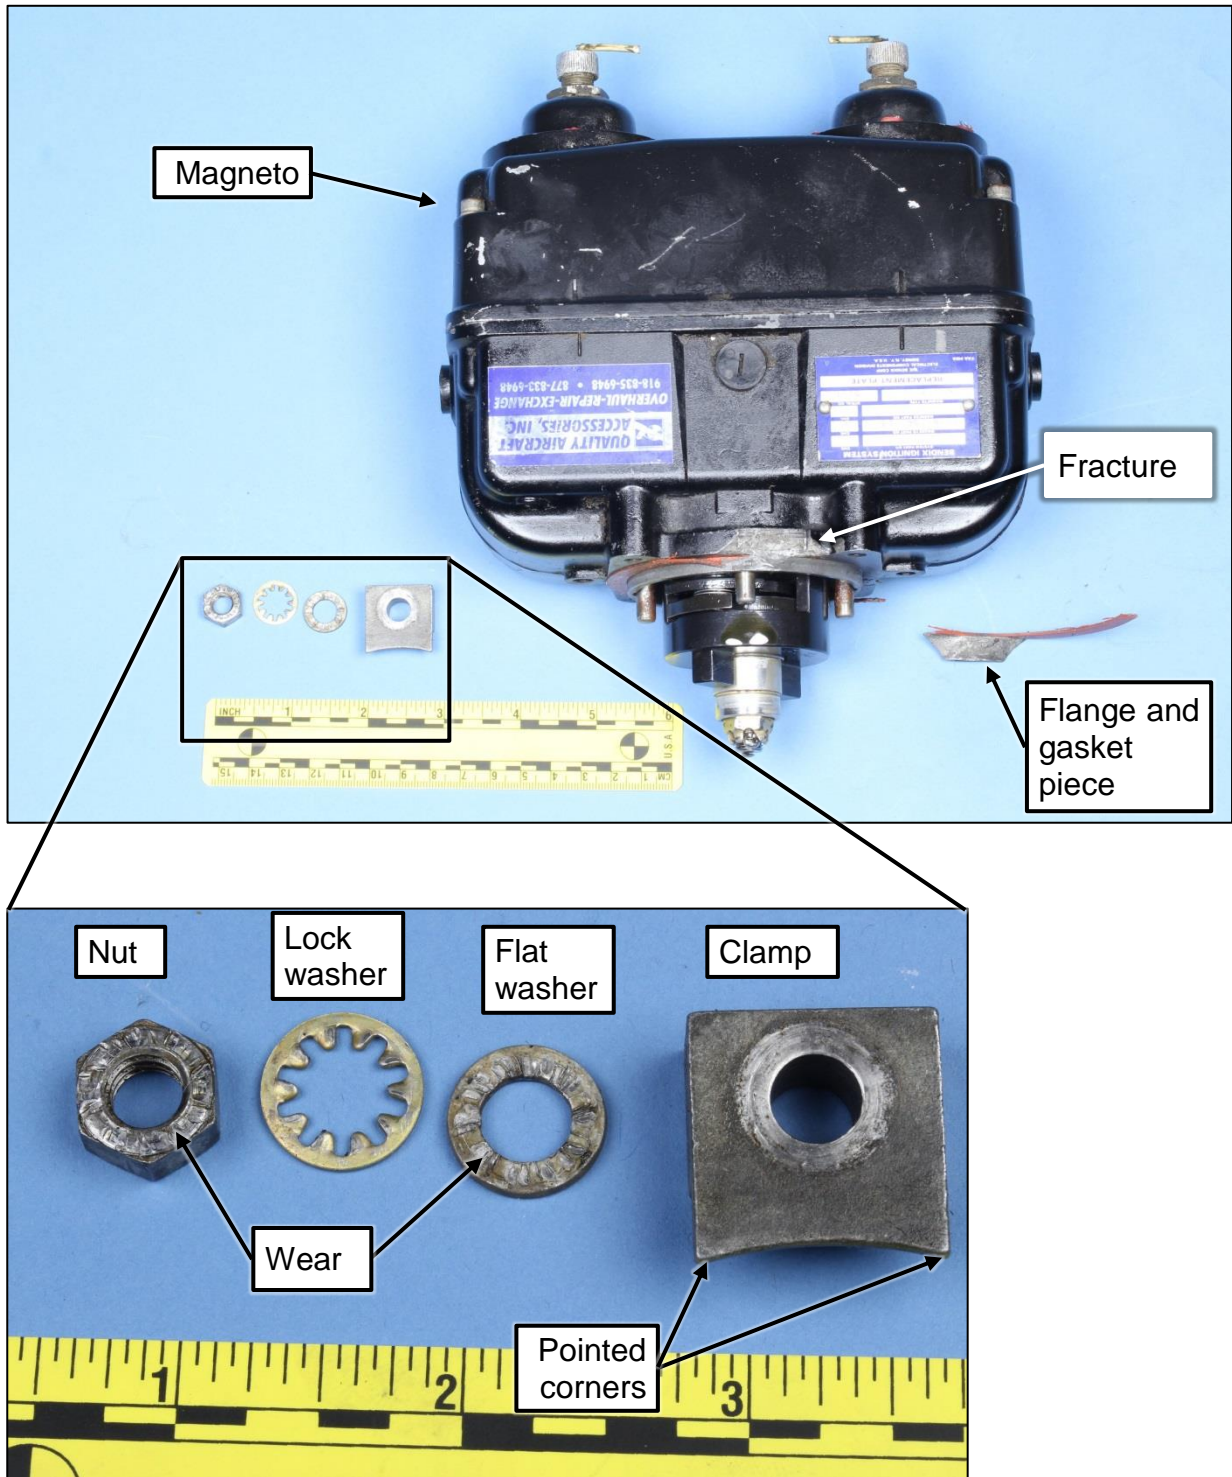
An overall view of the submitted dual magneto and attachment hardware is shown in figure 1. The attachment flange for the magneto was fractured at the upper side of the magneto as indicated in figure 1, and the fractured piece of the magneto flange is also shown. A piece of the magneto gasket remained adhered to the fractured flange piece. Hardware from the upper magneto attachment is also shown in figure 1, including a closer view. The NTSB investigator reported the hardware for the lower attachment point was missing and not recovered.

As shown in figure 1, the hardware installation for the upper magneto included a nut, a lock washer, a flat washer, and a clamp. Wear patterns corresponding to the teeth of the lock washer were observed on the faces of the nut and the flat washer as indicated in the lower image in figure 1. As shown in figure 2, no flat washer is included in the correct installation of the magneto in accordance with Lycoming SI 1508C.

Figure 1. Overall view of the magneto and attachment hardware as received (upper image) with a closer view of the attachment hardware (lower piece).

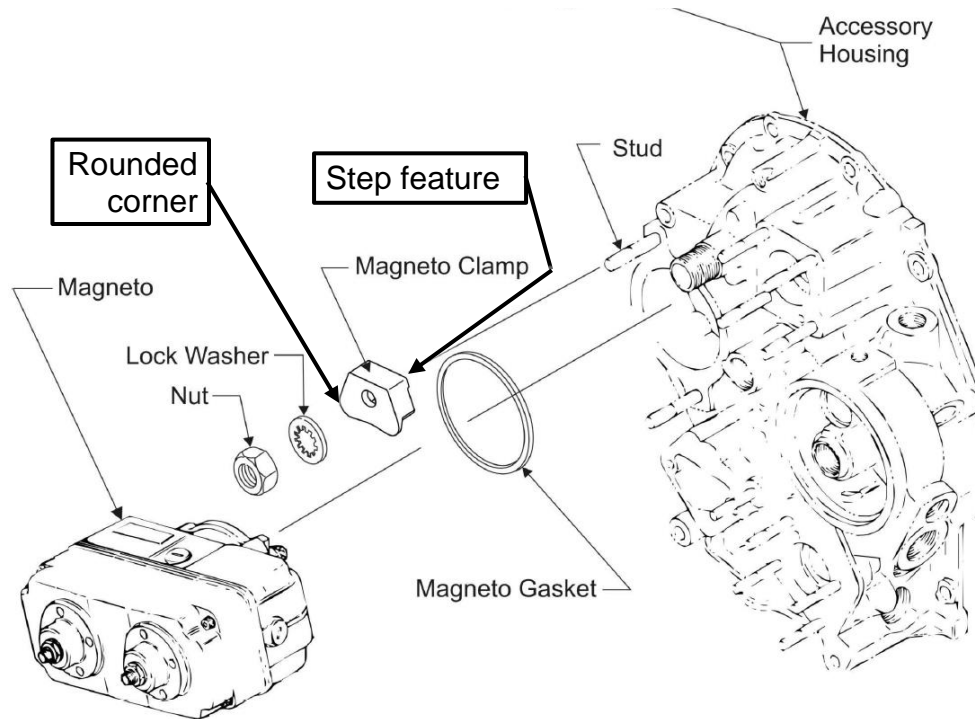
Lycoming Service Instruction (SI) 1508C, dated February 10, 2011, describes the attachment of magnetos on all Lycoming engines with dual magnetos. An illustration from Lycoming SI 1508C is captured in figure 2 of this report (with added annotations) showing the relative positions and shape of parts used in the magneto installation. The correct parts for attaching the magneto as described in SI 1508C are a nut (part number STD-1410), lock washer (part number STD-475), magneto clamp (part number 66M19385), and magneto gasket (part number LW-12681). Lycoming SI 1508C states that compliance with SI 1508C is mandatory and that failure to comply can cause loss of engine power. The time of compliance as stated in SI 1508C is at the next oil change, not to exceed 50 hours of engine operation or at each magneto timing check or service.

As shown in figure 2<sup>1</sup>, the correct magneto clamp part number 66M19385 has rounded corners, and the face that clamps against the accessory housing has a step feature at the outside portion of the clamp. The magneto clamp on the incident airplane had more pointed corners as indicated in figure 2 and had no step feature on the face that clamped to the accessory housing.

Figure 2. Illustration of the magneto installation from Lycoming Service Instruction No. 1508C with added annotations of clamp features.

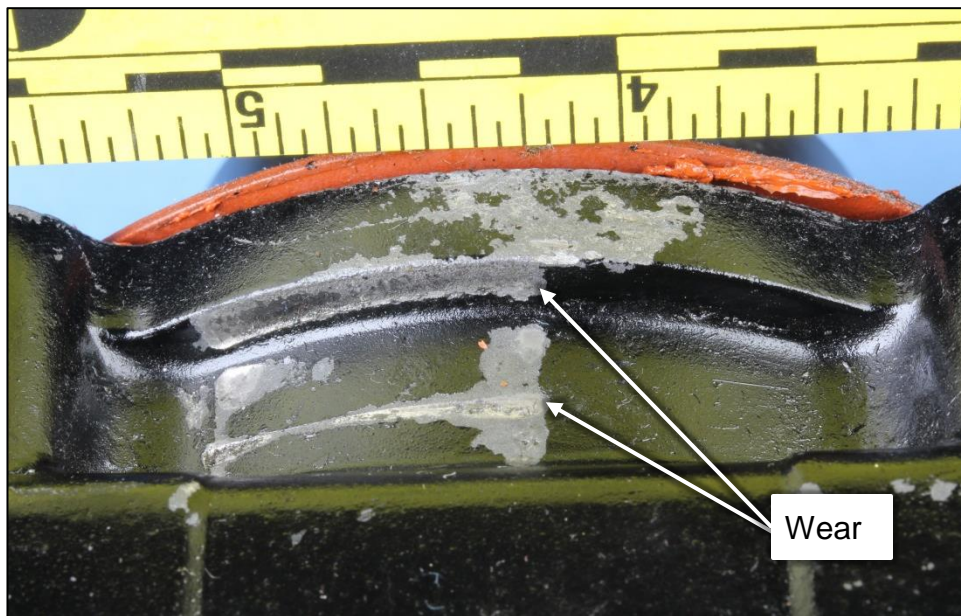
A view of the lower side of the magneto showing the attachment flange at the lower attachment point is shown in figure 3. Wear was observed on the clamping face of the magneto flange corresponding to contact with the attachment clamp. The wear was present across the width of the face from the edge of the flange inward to the fillet radius between the flange and the magneto body. As indicated in figure 3, wear was also observed on the magneto body adjacent to the clamping face.

Figure 3. View of the lower side of the magneto showing wear at the clamping face of the attachment flange and the adjacent surface.

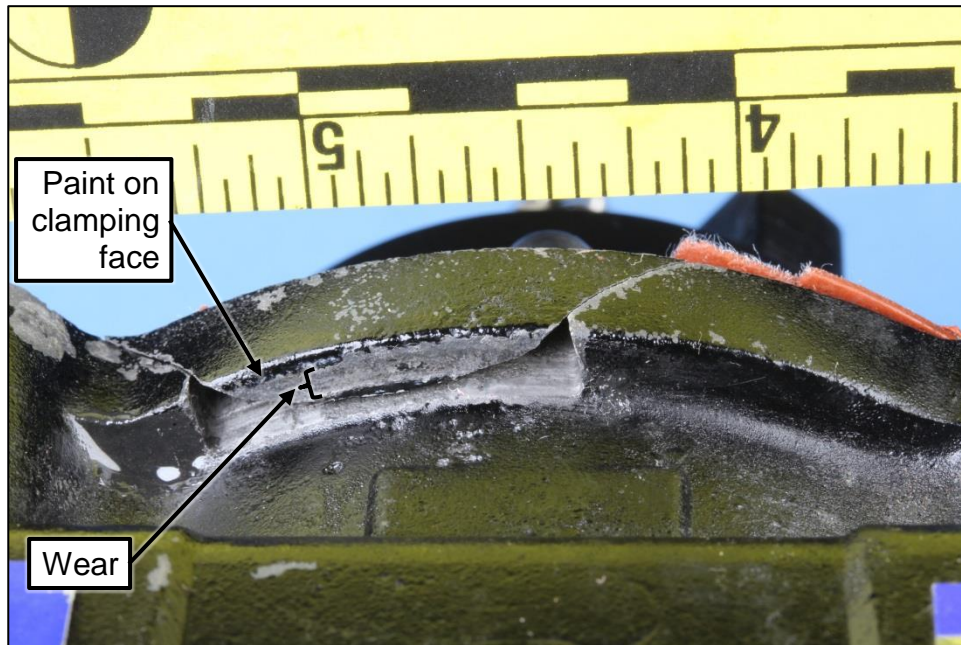
A view of the upper side of the magneto showing the fractured area of the attachment flange is shown in figure 4 with the mating sides of the fracture gently placed together. A band of wear was observed on the contact face of the flange as indicated with a bracket in figure 4. Paint remained present at the outer edge of the clamping face on the fractured piece, also as indicated in figure 4.

Figure 4. View of the upper side of the magneto showing the clamping face of the attachment flange.

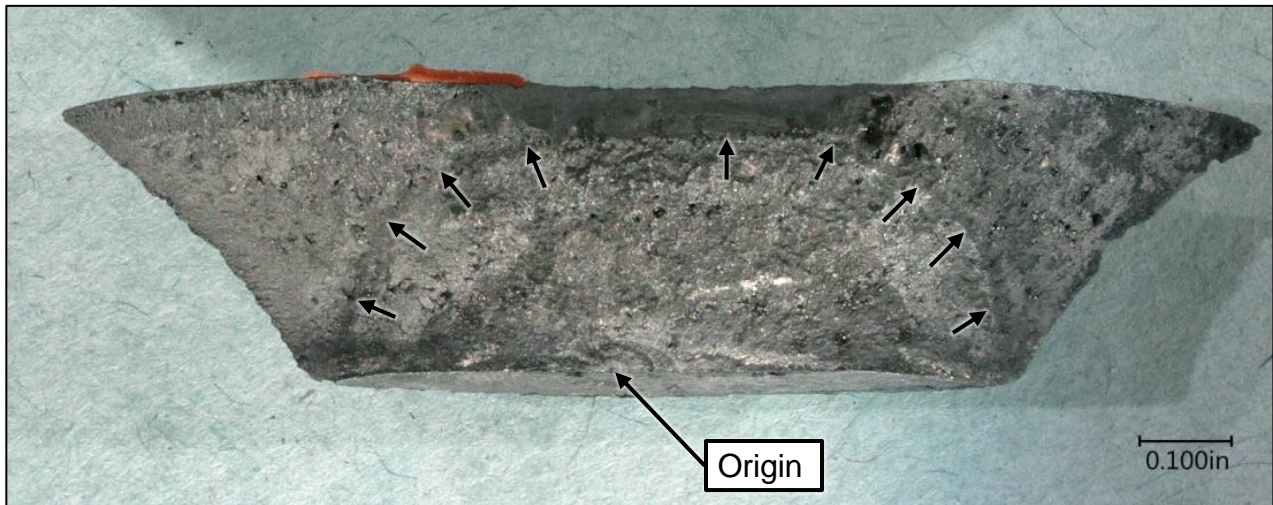
The fractured piece from the magneto flange was cleaned using soapy water and a soft-bristle brush. The fracture surface after cleaning is shown in figure 5. Concentric crack arrest lines emanated from an origin area near the middle of the fractured piece, features consistent with fatigue fracture. The fatigue origin and a crack arrest line on the fracture surface are indicated in figure 5.

Figure 5. Fracture surface on the fractured piece of the magneto attachment flange. The fatigue origin is indicated and unlabeled arrows indicate a crack arrest mark.
