NATIONAL TRANSPORTATION SAFETY BOARD

MATERIALS LABORATORY FACTUAL REPORT

Report No. 14-010

Place : Birdseye, Utah
Date : June 27, 2013
Vehicle : Cessna 172
NTSB No. : WPR13FA294
Investigator : Michael Huhn
AS-WPR

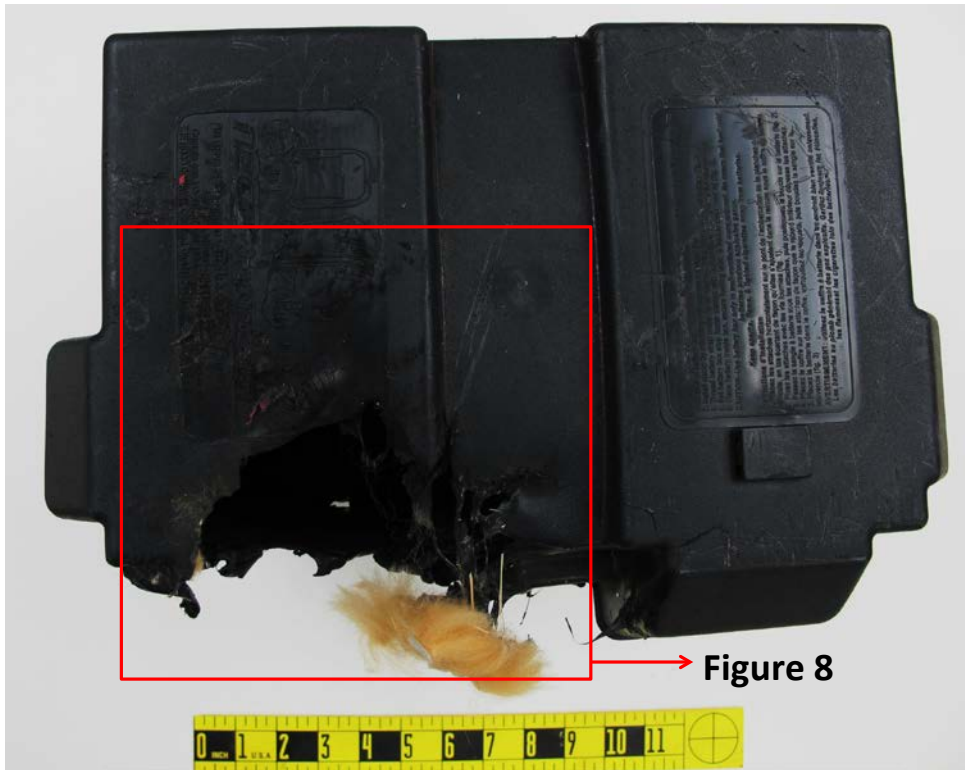
According to the manufacturer, the installation configuration for the power supply system consisted of the battery box serving as the base of the installation with the power distribution box sitting on top and all associated wiring running between bottom of the power distribution box and the top of the battery box. The wiring placement is in the area where the most significant thermal damage occurred. The battery box had extensive melting and missing material to the upper corner of the box and lid. This is shown in Figures 2-4.

Figure 2. Top view photograph of battery box.

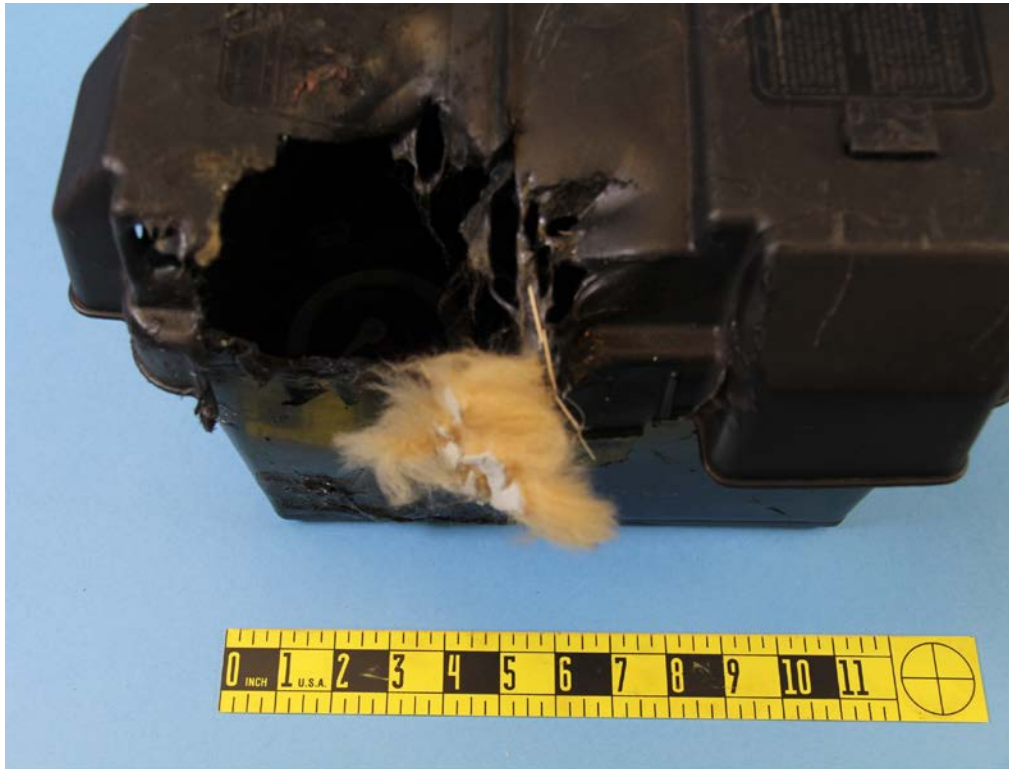
Figure 3. Close-up photograph of damaged battery box lid.

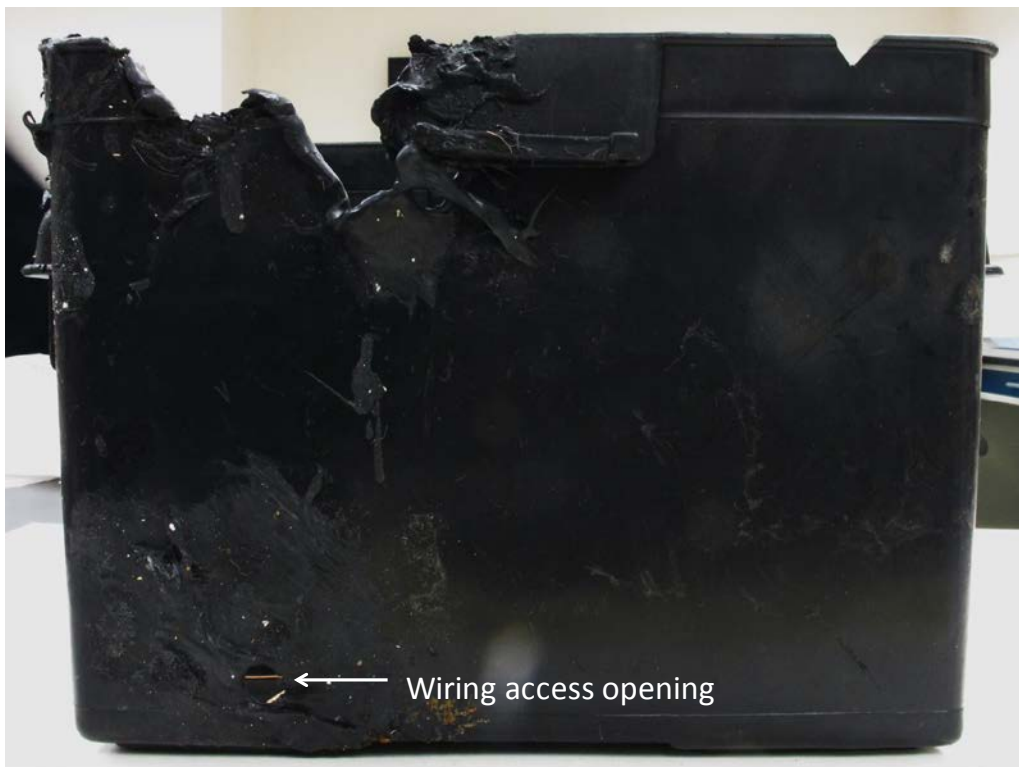
Figure 4. Photograph of battery box without lid.

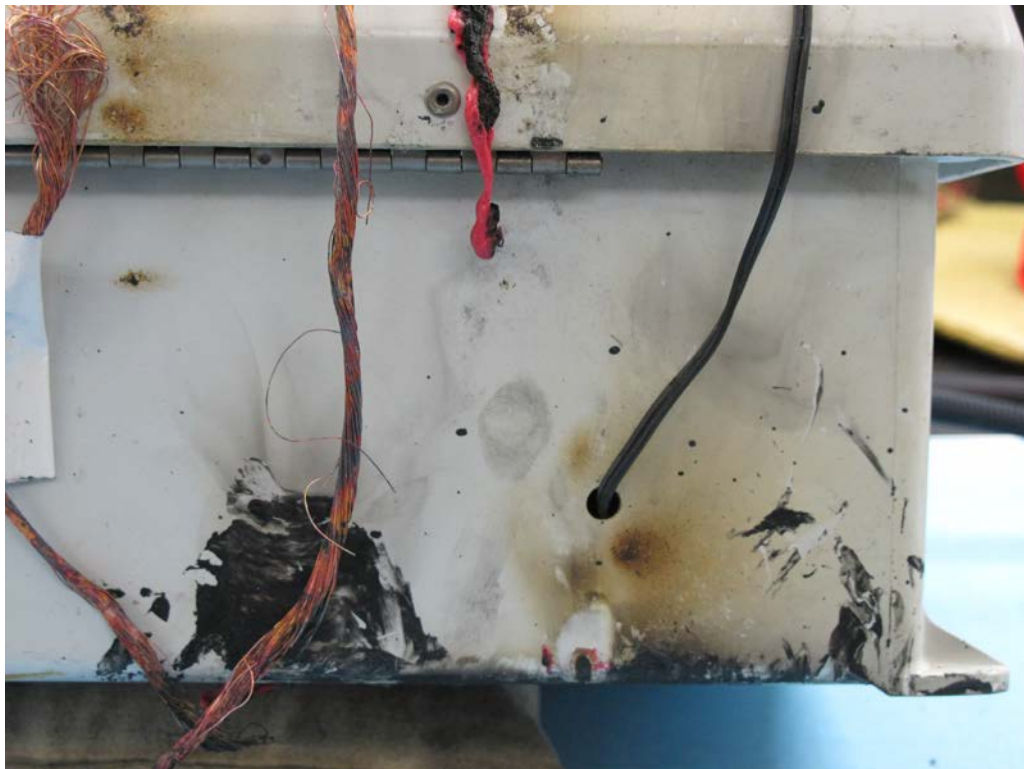
The configuration of the top of the power distribution box is shown in Figure 5. The power distribution box sustained sooting, paint discoloration, paint blistering and warping of the lower corner (sidewall and bottom) of the case as shown in Figures 6 and 7. The damage to the battery box corresponded to the damage on the lower corner of the power distribution box as shown in Figure 8. The interior of the distribution box had minimal

Figure 6. Photograph of lower corner of power distribution box.

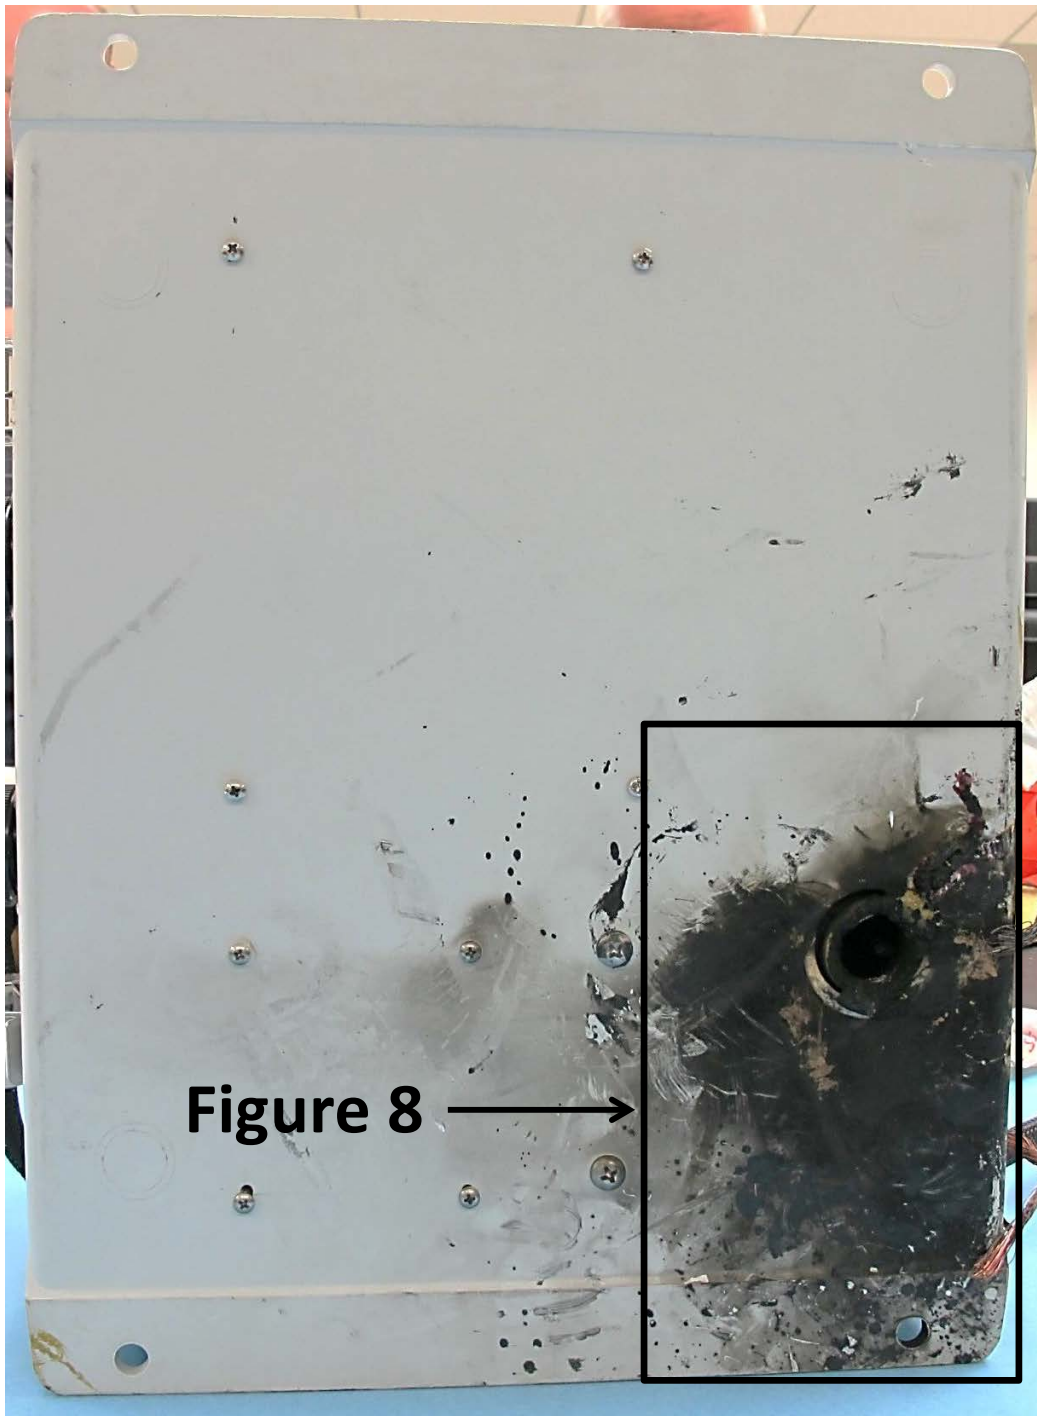
Figure 7. Photograph of bottom of power distribution box.

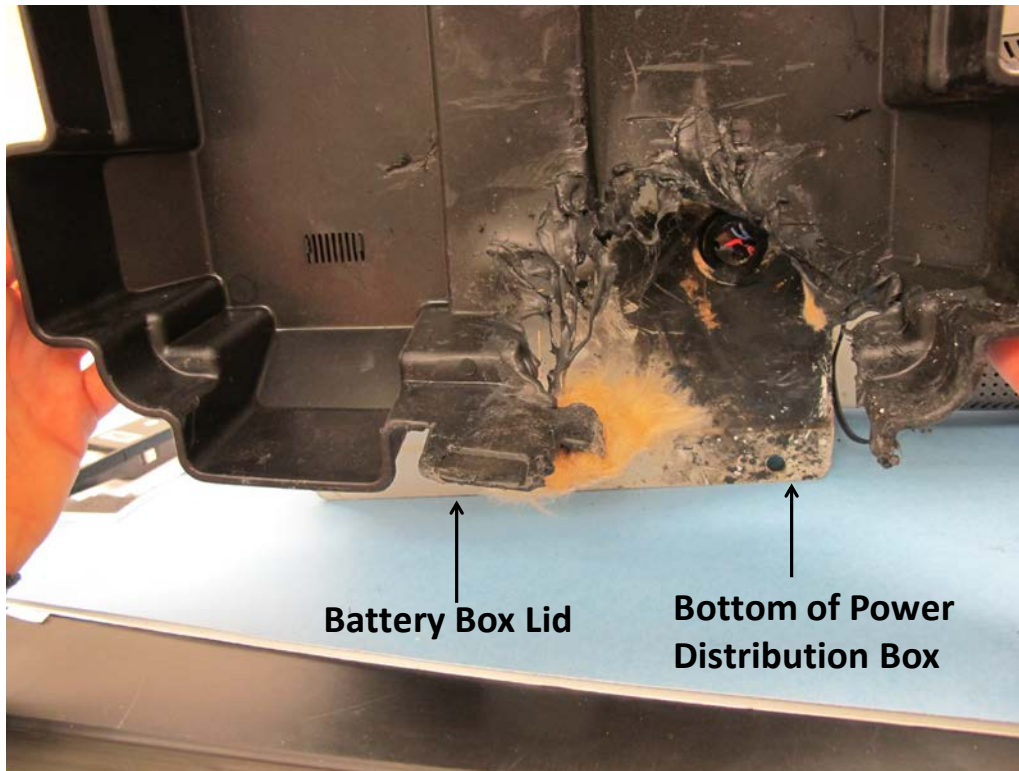
Figure 8. Photograph of damage to battery box lid and the bottom of the power distribution box.

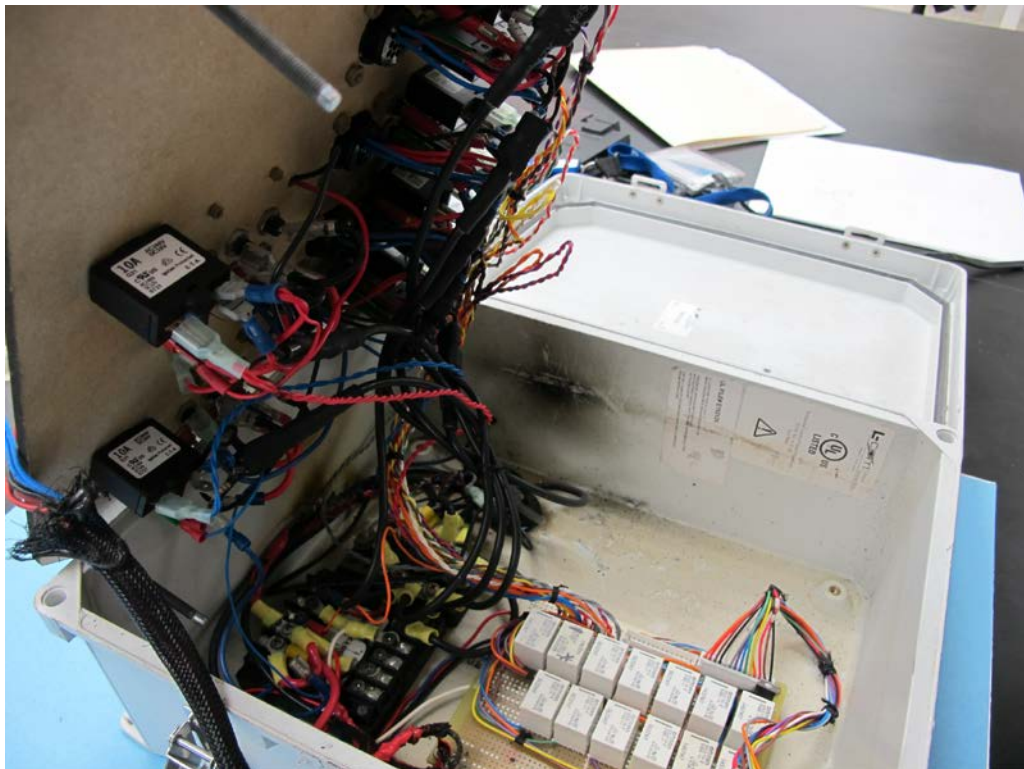
sooting and thermal damage as shown in Figure 9. The wiring that ran in between exhibited significant thermal damage in the forms of brittle and welded wire conductors, missing material and melted or missing wire insulation. Examples of the wire damage are shown in Figures 10 and 11.

Figure 9. Photograph of interior of power distribution box.

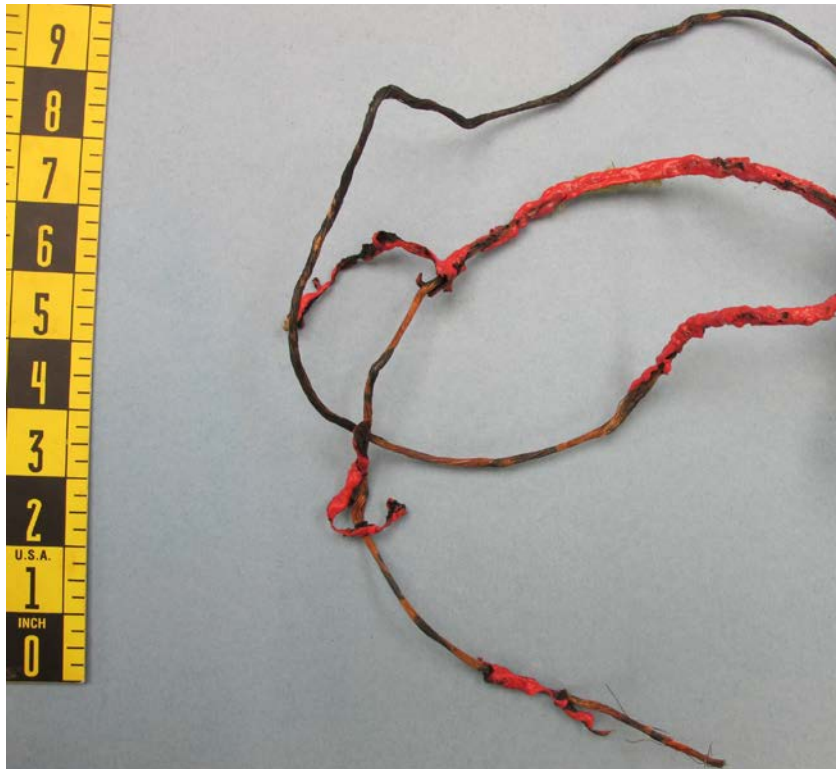
Additional testing by the airframe manufacturer was done to confirm the type of wire insulation present on the wire bundle. The wire insulation (both the red insulation and the black insulation) was found to be polyvinyl chloride. Thermal degradation (in air) of both wire insulation types was complete at approximately 1100°F with white smoke evolution between 455 and 660°F and again at 840-890°F. The wire insulation did not display a definite melting point (when tested between about 100 °F and 390 °F), but became soft at approximately 305°F. The complete report is attached at the end of this report.

Figure 10. Photograph of thermally damaged isolator wiring.

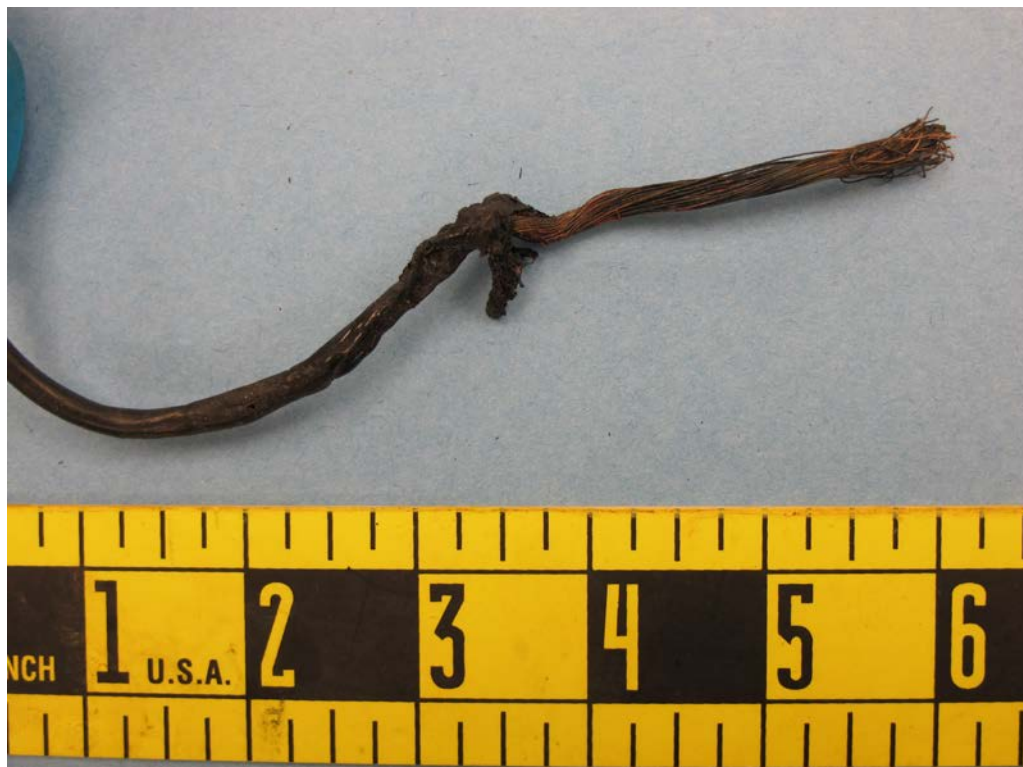
Figure 11. Close-up photograph of wiring damage.

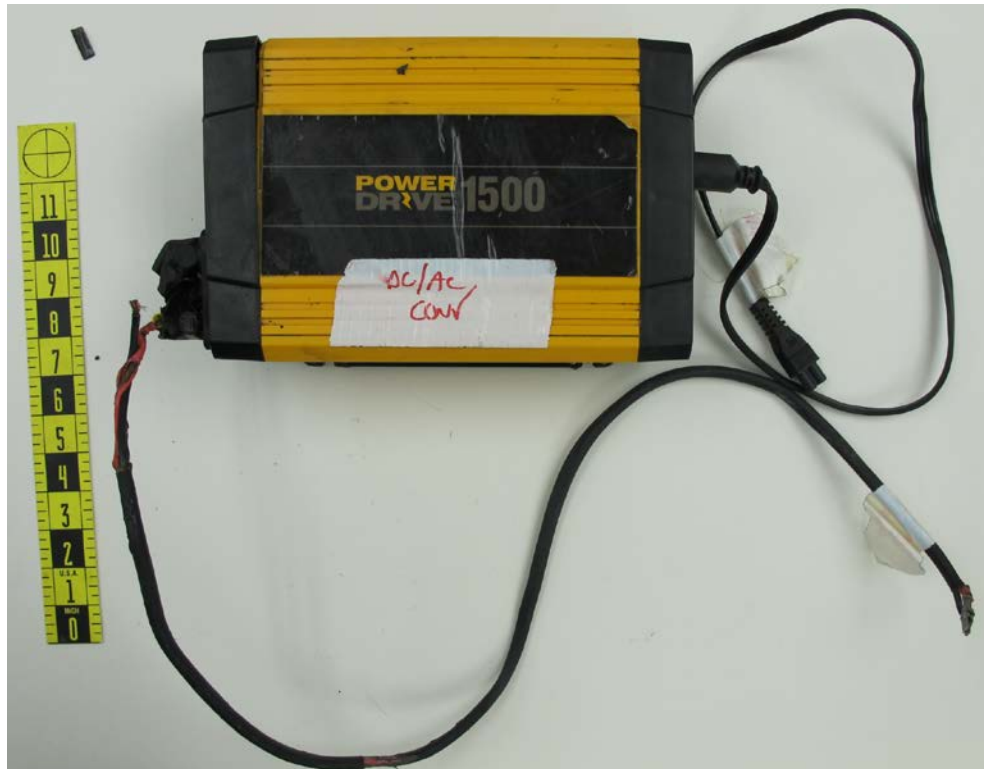
The inverter was found to be intact and undamaged as shown in Figure 12. The wiring attached to the inverter had some thermal damage at the interface. A functionality test was performed and the inverter operated as expected by the system manufacturer. The isolator was intact and had thermal damage to the exterior case as shown in Figure 13.

Figure 12. Photograph of the power inverter.

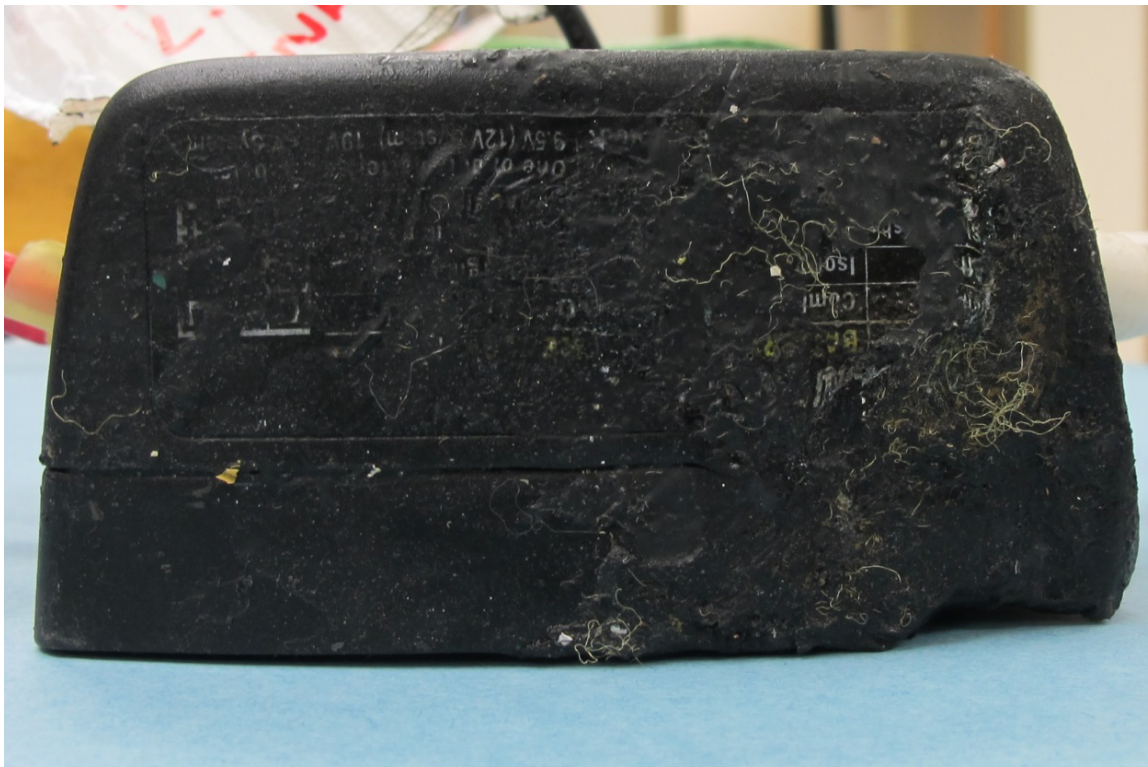
Figure 13. Photograph of the isolator unit.
