NATIONAL TRANSPORTATION SAFETY BOARD

MATERIALS LABORATORY FACTUAL REPORT

Report No. 15-037

Place : Brunswick, GA
Date : March 24, 2015
Vehicle : Piper PA-44-180, N923RS
NTSB No. : ERA14FA168
Investigator : Shawn Etcher, AS-ERA

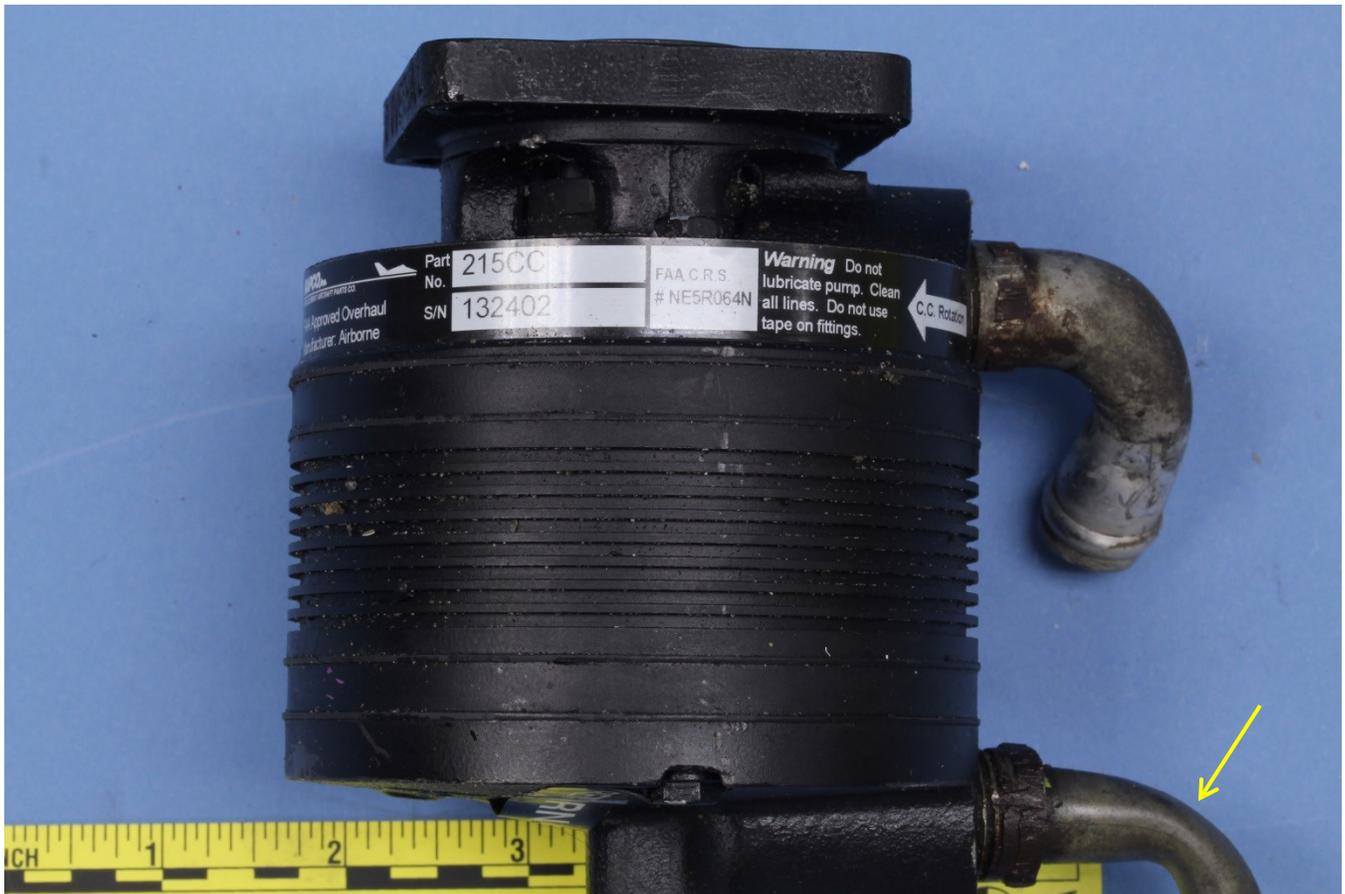
The left vacuum pump is shown in Figure 1, as received. The pump exhibited no external damage to the housing (see Figure 1 and Figure 2). However, the outlet side tube exhibited buckling on the inside on the elbow, consistent with bending forces towards that direction. When handled or moved, the pump exhibited a rattling sound from the inside.

Figure 1 – The left vacuum pump, as received, showing the serial and part number markings on the side. The arrow denotes the partially collapsed outlet tube, consistent with excessive bending stresses.

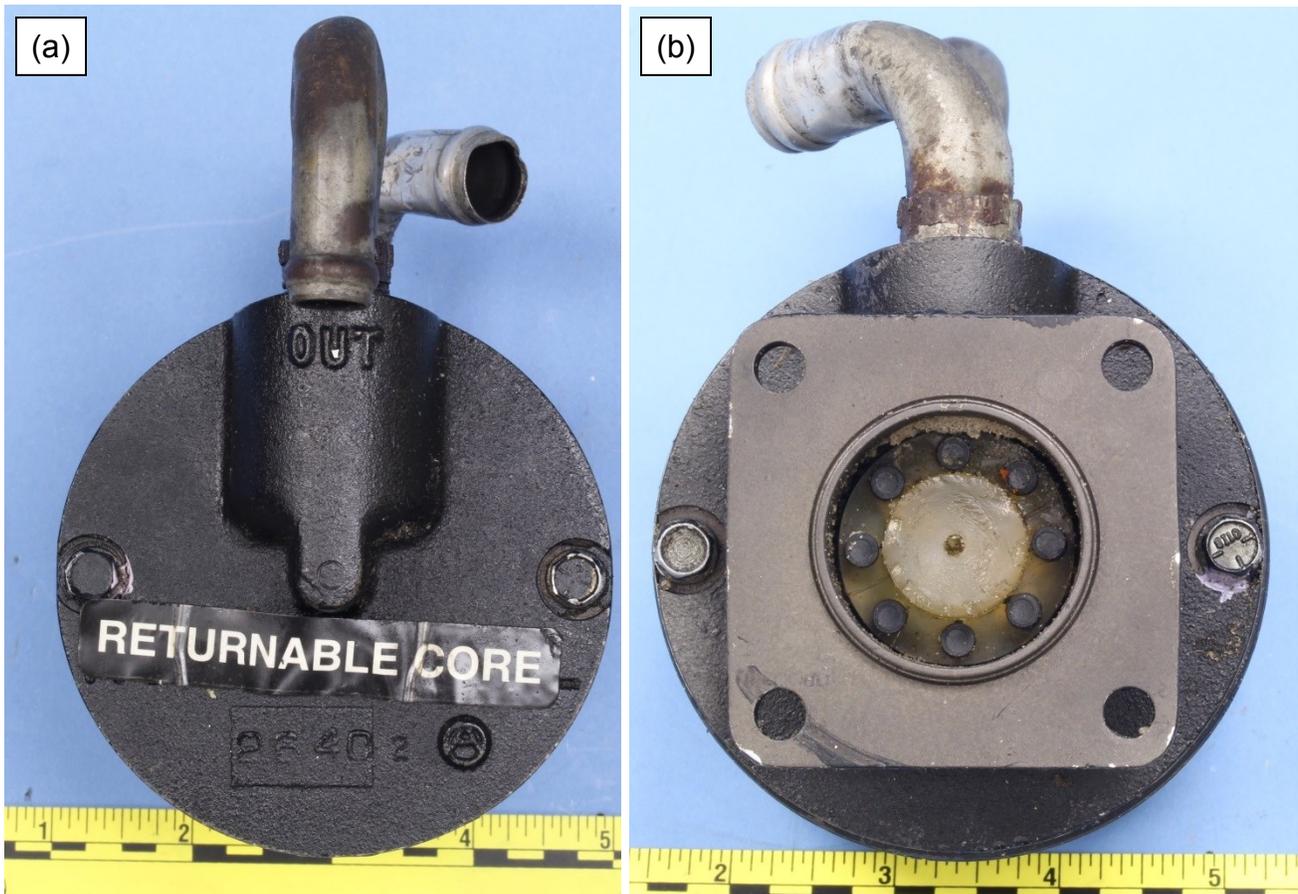
Figure 2 – The left vacuum pump, as received, shows (a) the outlet side and (b) the drive side.

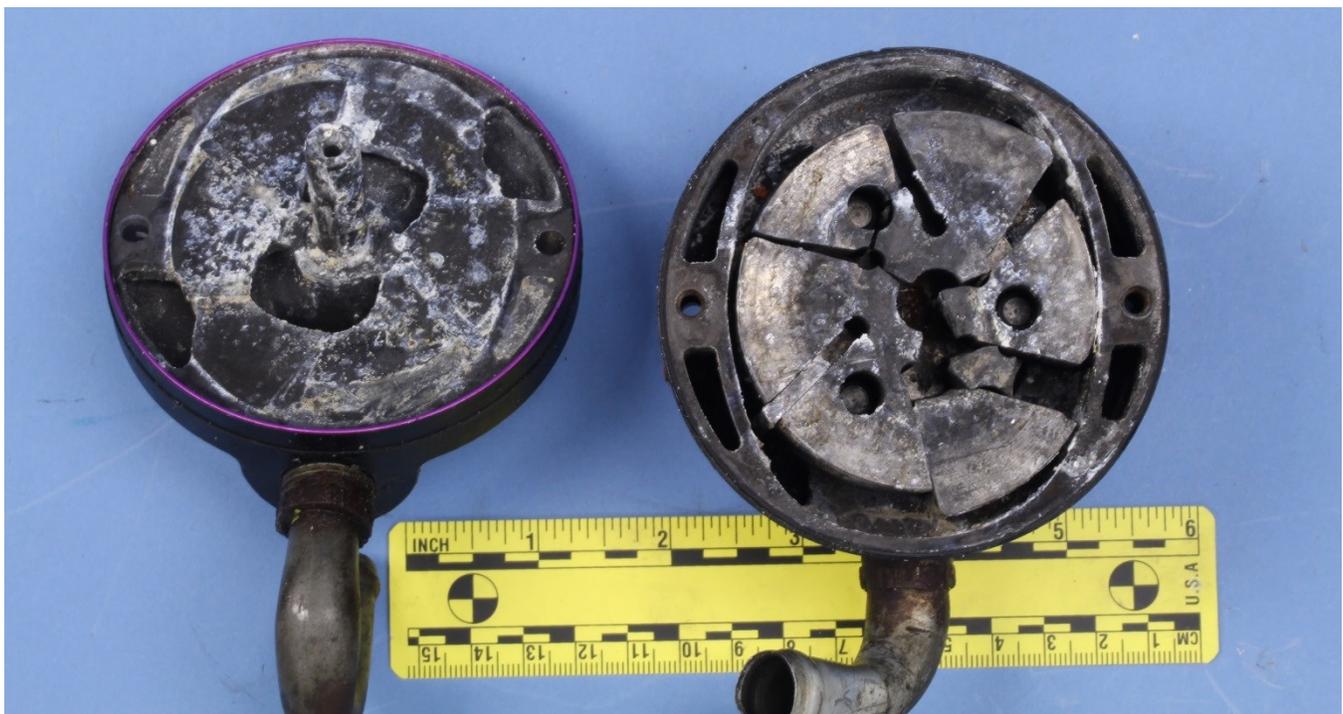
The pump was disassembled to reveal the condition of the internal components (see Figure 3). The interior of the pump contained a white brittle material on most of the drive end surfaces. This material was consistent with salt deposits from evaporated salt or brackish water that infiltrated the pump after the accident. Upon opening the pump housing, the rotor was found fractured in multiple locations (see Figure 4). The pieces of the rotor were carefully reassembled, as shown Figure 5. The rotor flanges and slots were labeled 1 through 6, clockwise, for the purposes of this report. Cracks were apparent on the rotor at slots numbered 1, 3, 4, and 5. A transverse crack was present across the hole on rotor flange #2.

Figure 3 – The interior of the left vacuum pump after removing the outlet side housing cover.

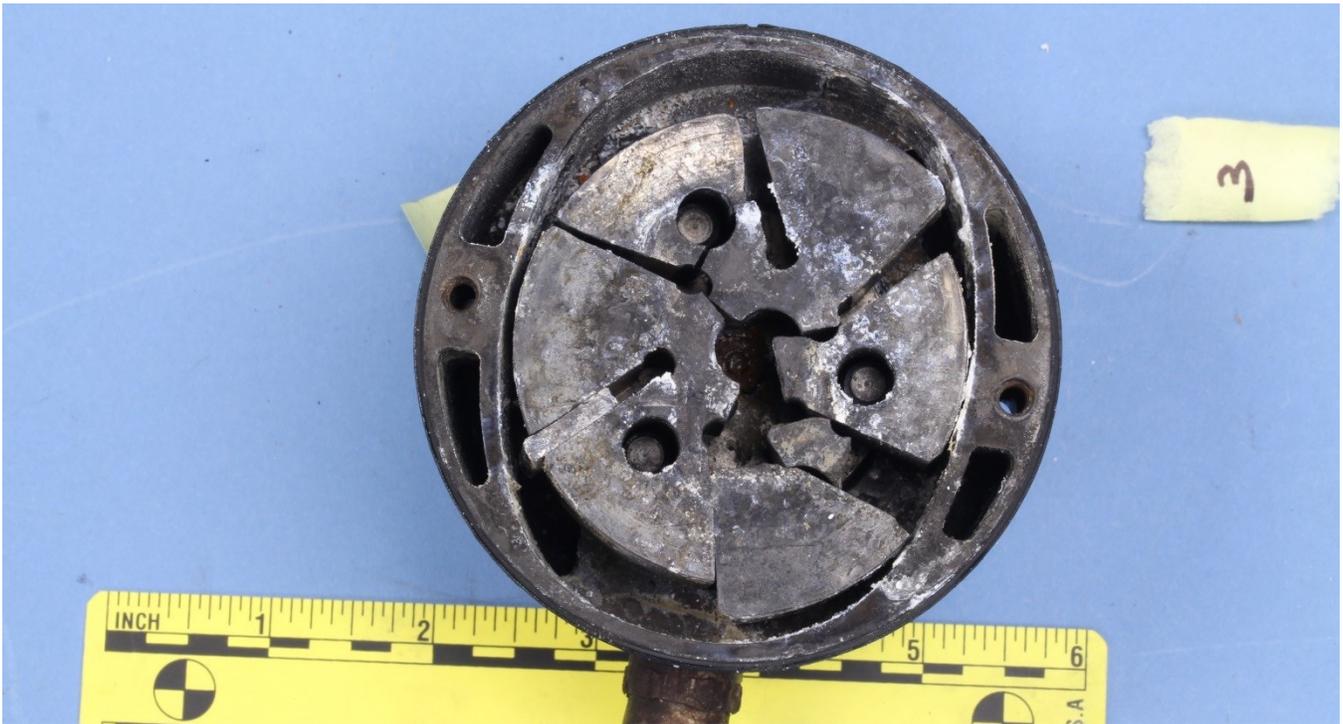
Figure 4 – Closer view of the left vacuum pump rotor, after removal of the outlet housing cover. The rotor had fractured in multiple locations.

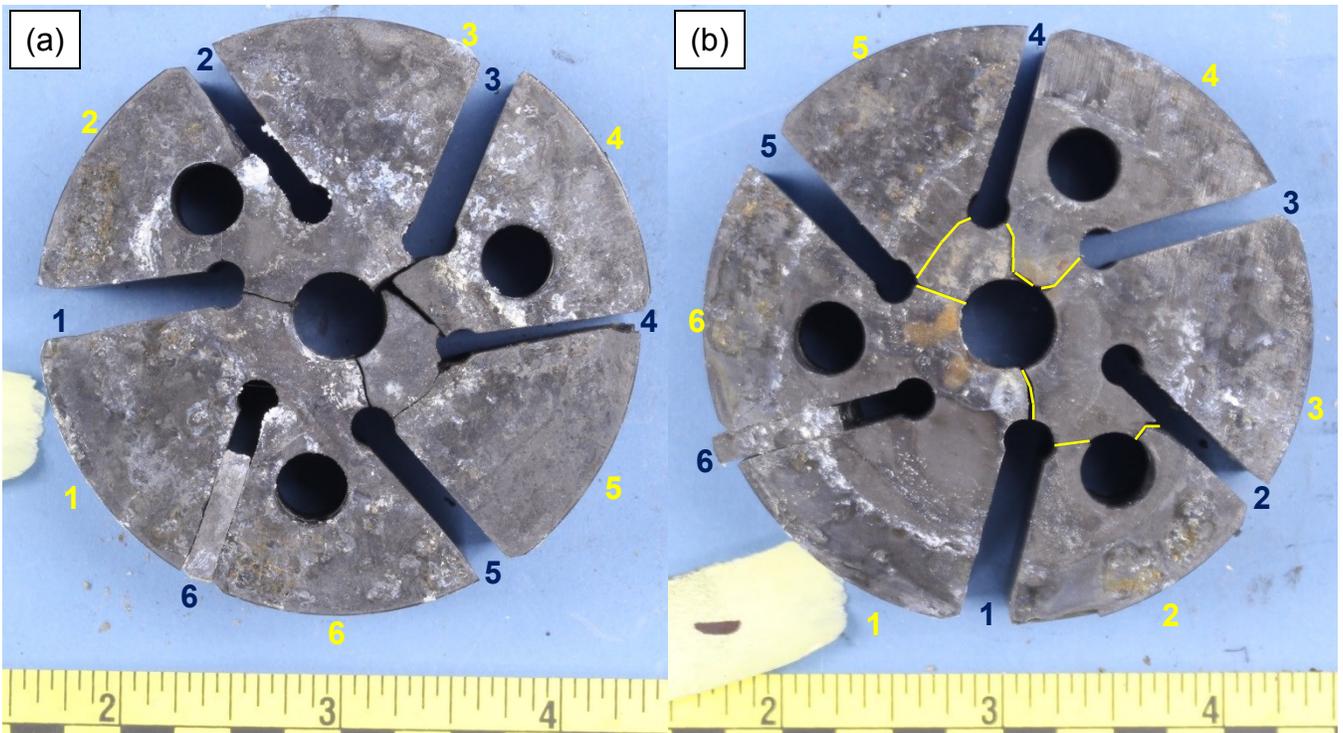
Figure 5 – The fractured rotor from the left vacuum pump, after removal from the housing from (a) the outlet side and (b) the opposite drive side. The rotor prongs are labeled 1 – 6 in yellow, and the vane slots are labeled 1 – 6 in dark blue (vane 6 was still in slot 6). The fracture locations are highlighted with the cracks in yellow.

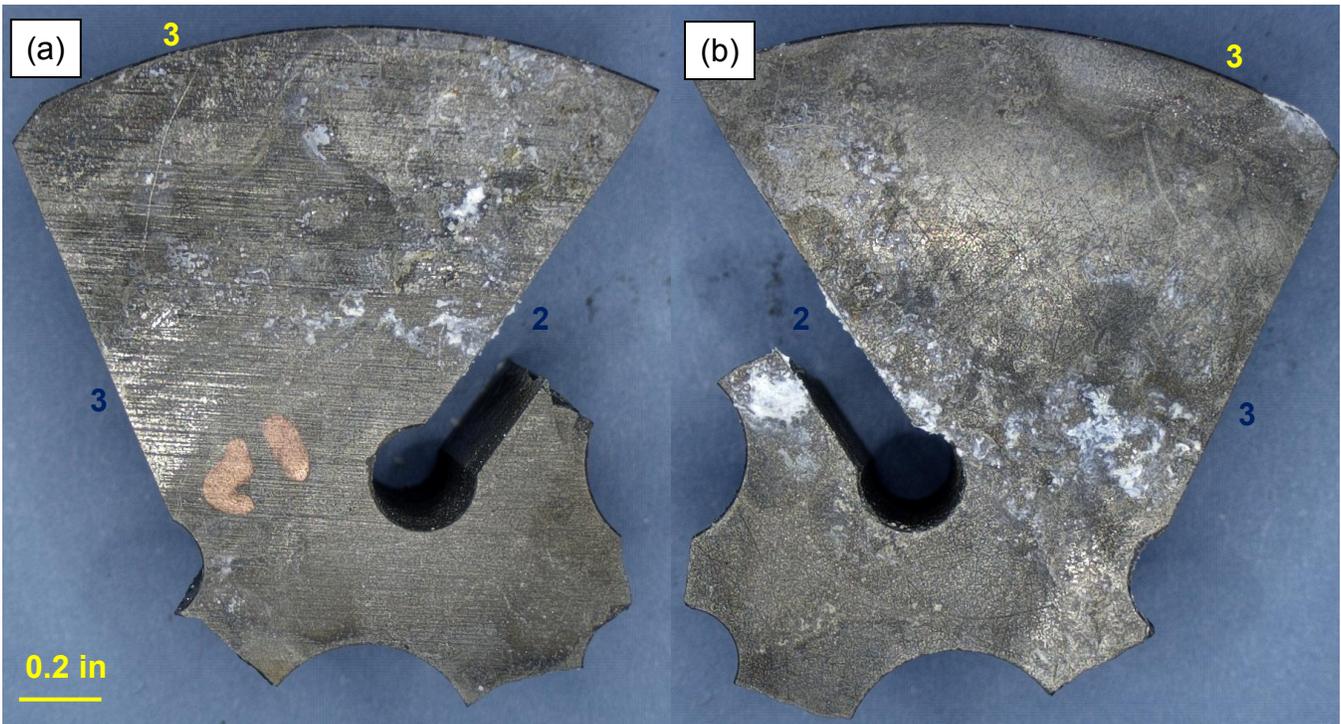
The forward (inlet flange end) and aft (discharge flange end) faces of the rotor were examined for wear marks indicative of rotor motion in contact with the housing. As exemplified in Figure 6, these rotor faces exhibited dents and wear consistent with non-rotational or stationary contact with adjacent components (the housing).

Figure 6 – The (a) drive side and (b) outlet side faces of the left pump rotor, showing longitudinal wear marks.

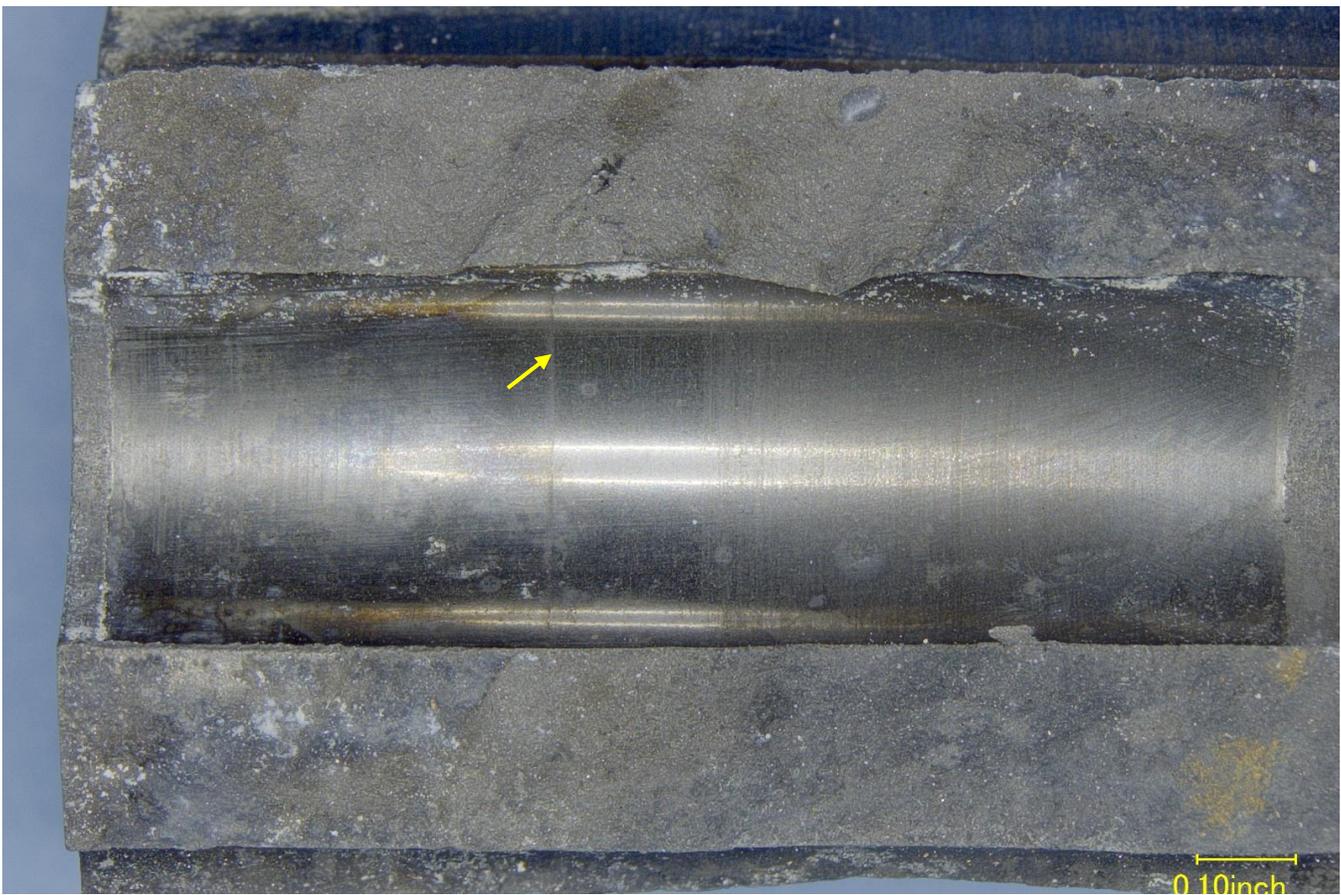
Circumferential score marks were observed on the interior surface of the rotor center hole (Figure 7). The location of a prominent score mark in Figure 7 (arrow) was located at a location on the rotor fracture surface consistent with the fracture initiation on this fragment. The interior surface also exhibited longitudinal and angled wear marks.

Figure 7 – The inside bore of the left pump rotor fragment 3, showing circumferential and curving longitudinal wear marks on the bore. A notable wear mark was present (arrow).

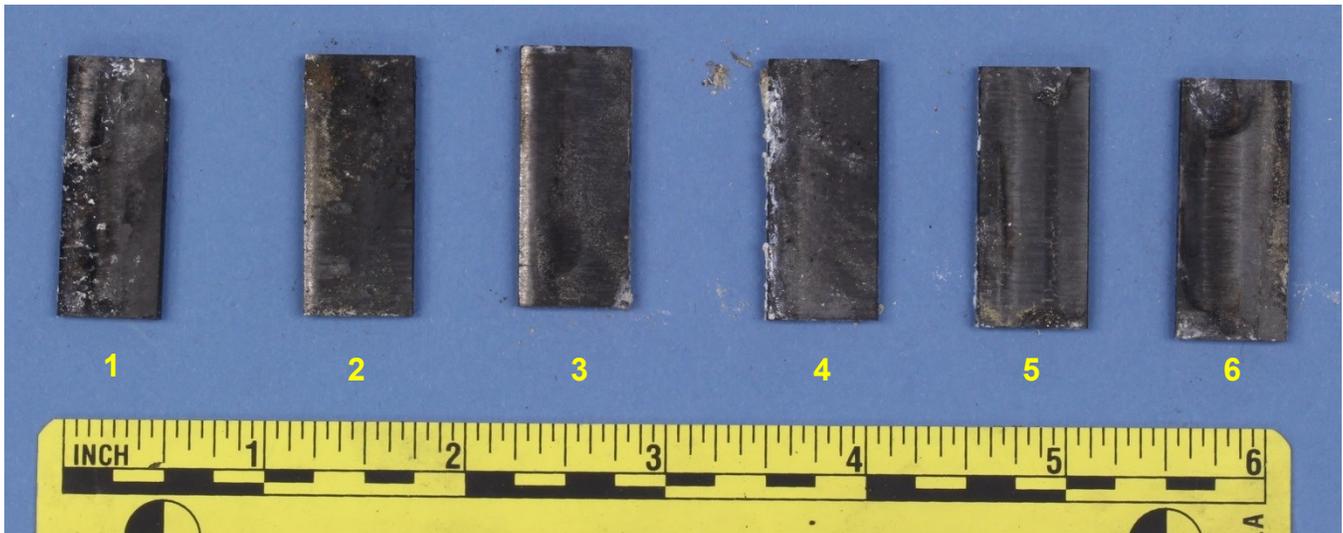
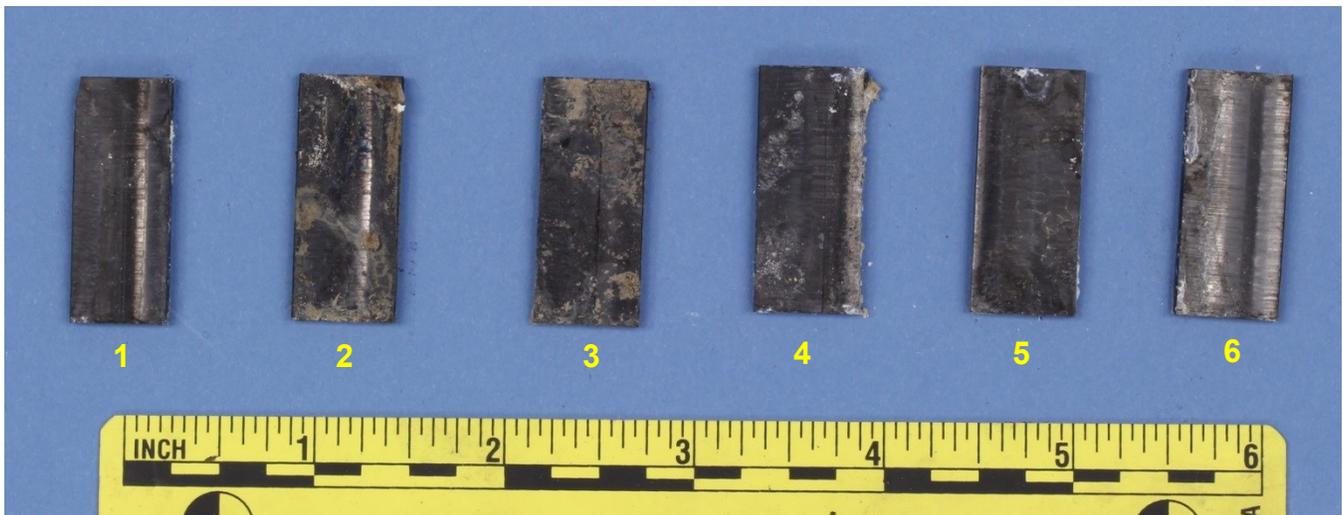
The vanes were removed from the pump housing and rotor slots, and they are illustrated in Figure 8 and Figure 9. All of the vanes were intact—none had cracked or fractured. The widths of the vanes recovered from this pump were measured using digital calipers and are listed in Table I. Horizontal and vertical sliding marks were present on the faces of the vanes. These marks were consistent with similar marks on the inside faces of the rotor vane slots. The horizontal marks were consistent with sliding of the vanes that occurred during rotational operation of the rotor. Each of the vanes exhibited one flat vertical face and one rounded vertical face.

Figure 8 – The vanes from the left pump, after removal. The vanes were labeled 1 through 6 for the purposes of this report, and correspond to the slots clockwise of the rotor prongs labeled in Figure 4.

Figure 9 – The left pump vanes, after removal, showing the opposite faces from that shown in Figure 8.

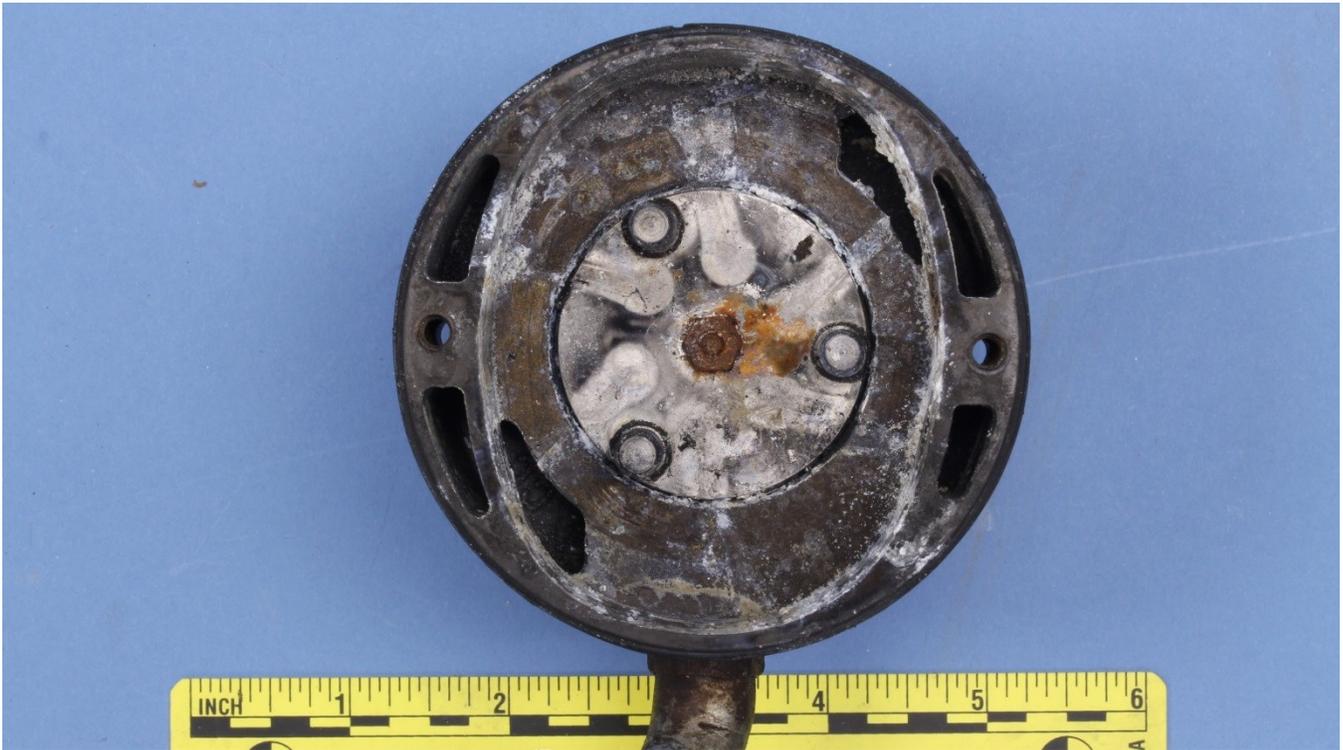
The interior of the drive end pump housing is shown in Figure 10. This surface exhibited the white brittle material consistent with salt deposits found on the opposite interior of the pump. The pattern of the white material was consistent with the resting position of the rotor and vanes after the airplane accident and recovery.

Figure 10 – The inside face of the drive side housing cover, after removal of the interior rotor and vanes.

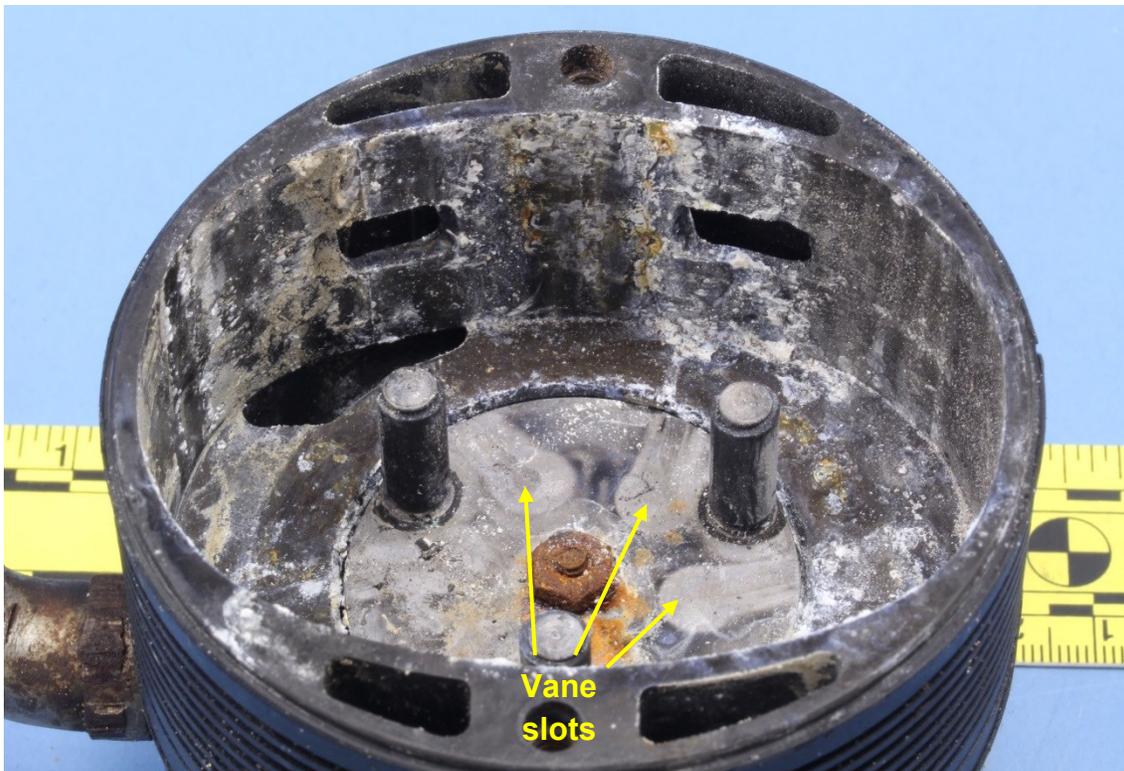
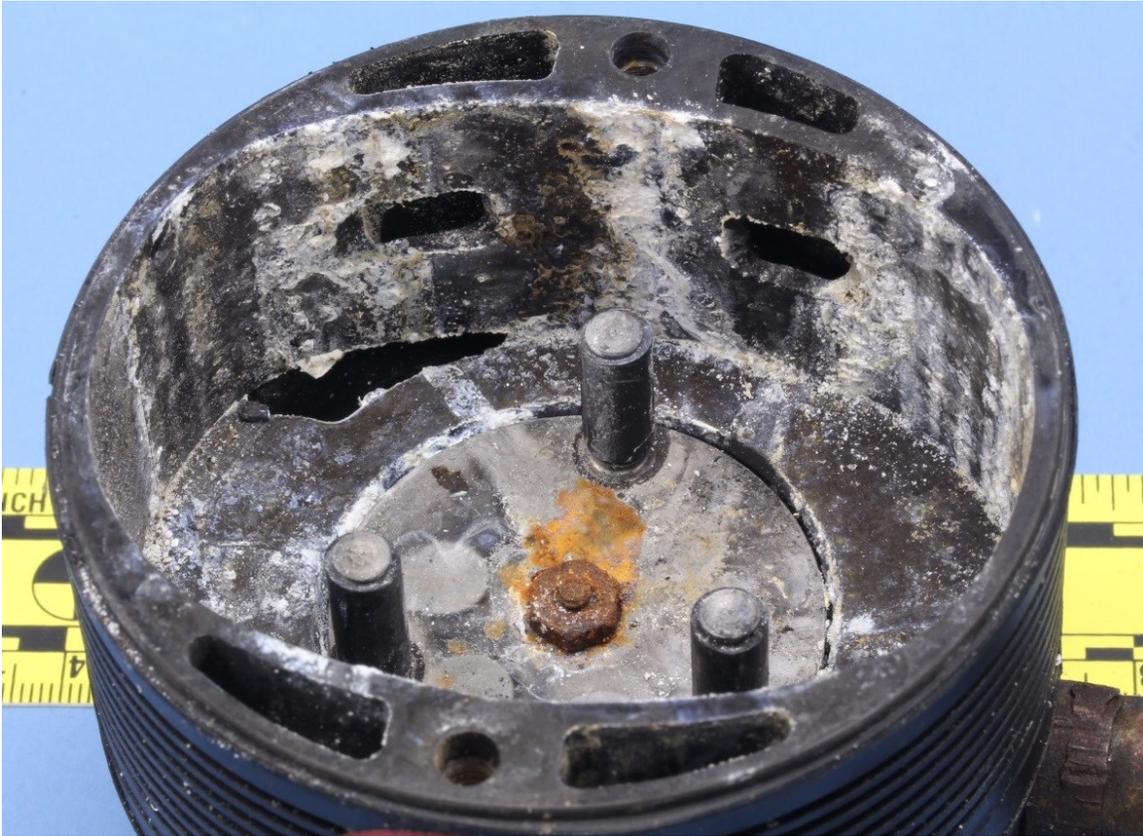
The interior of the circular housing is illustrated in Figure 11 and Figure 12. These surfaces also show the white deposits found on the other interior surfaces. These deposits were most prevalent at regular positions consistent with the rest position of the vane slots in the rotor. Circumferential wear marks, consistent with contact during rotation, were present.

Figure 11 – The interior surface of the left pump housing, after removal of the rotor and vanes. The witness marks showing the locations of the vane slots are labeled on the figure.

Figure 12 – The interior surface of the left pump housing, after removal of the rotor and vanes, opposite Figure 11.

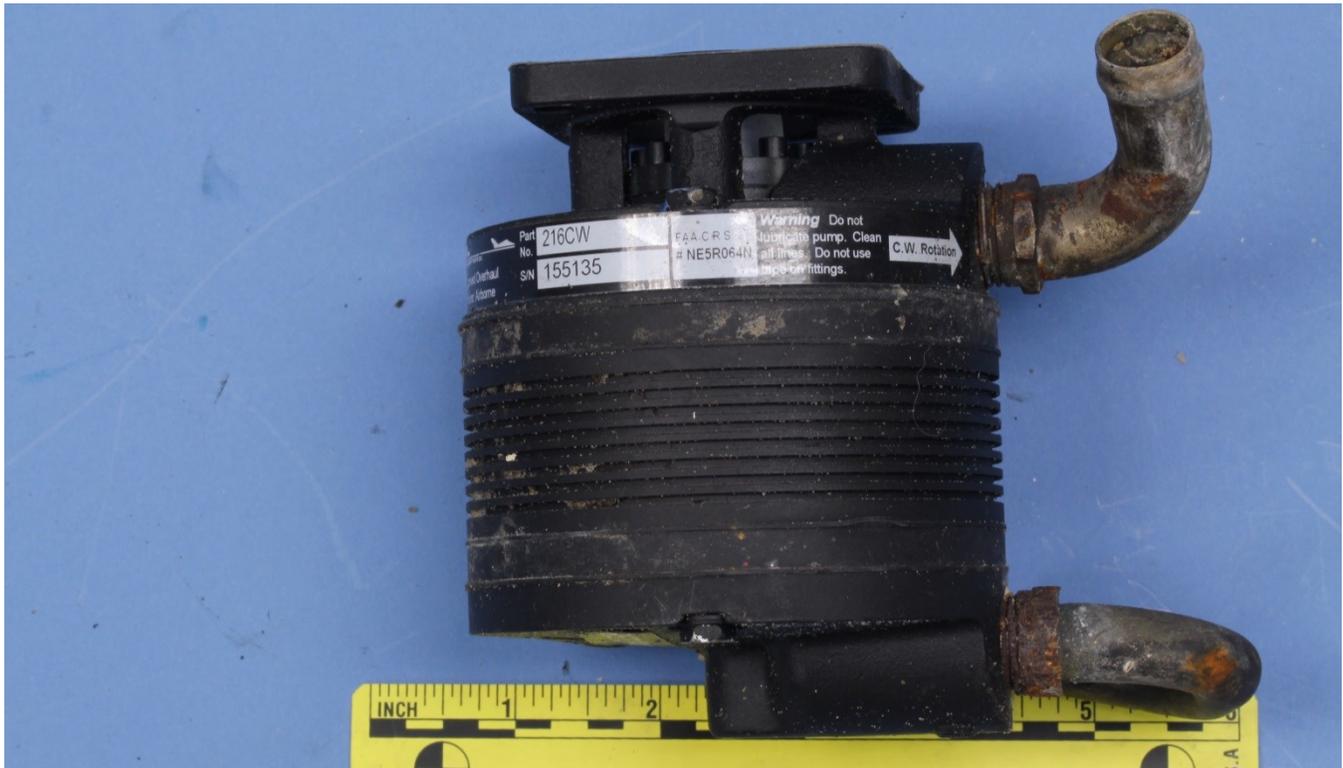
The right vacuum pump is shown in Figure 13, as received. The pump exhibited no external damage to the housing (see Figure 14). The drive-side coupling end could not be turned. The fracture surface of the plastic coupling exhibited rotational river patterns, consistent with overstress fracture in torsion.

Figure 13 – The right vacuum pump, as received, showing the part and serial numbers.

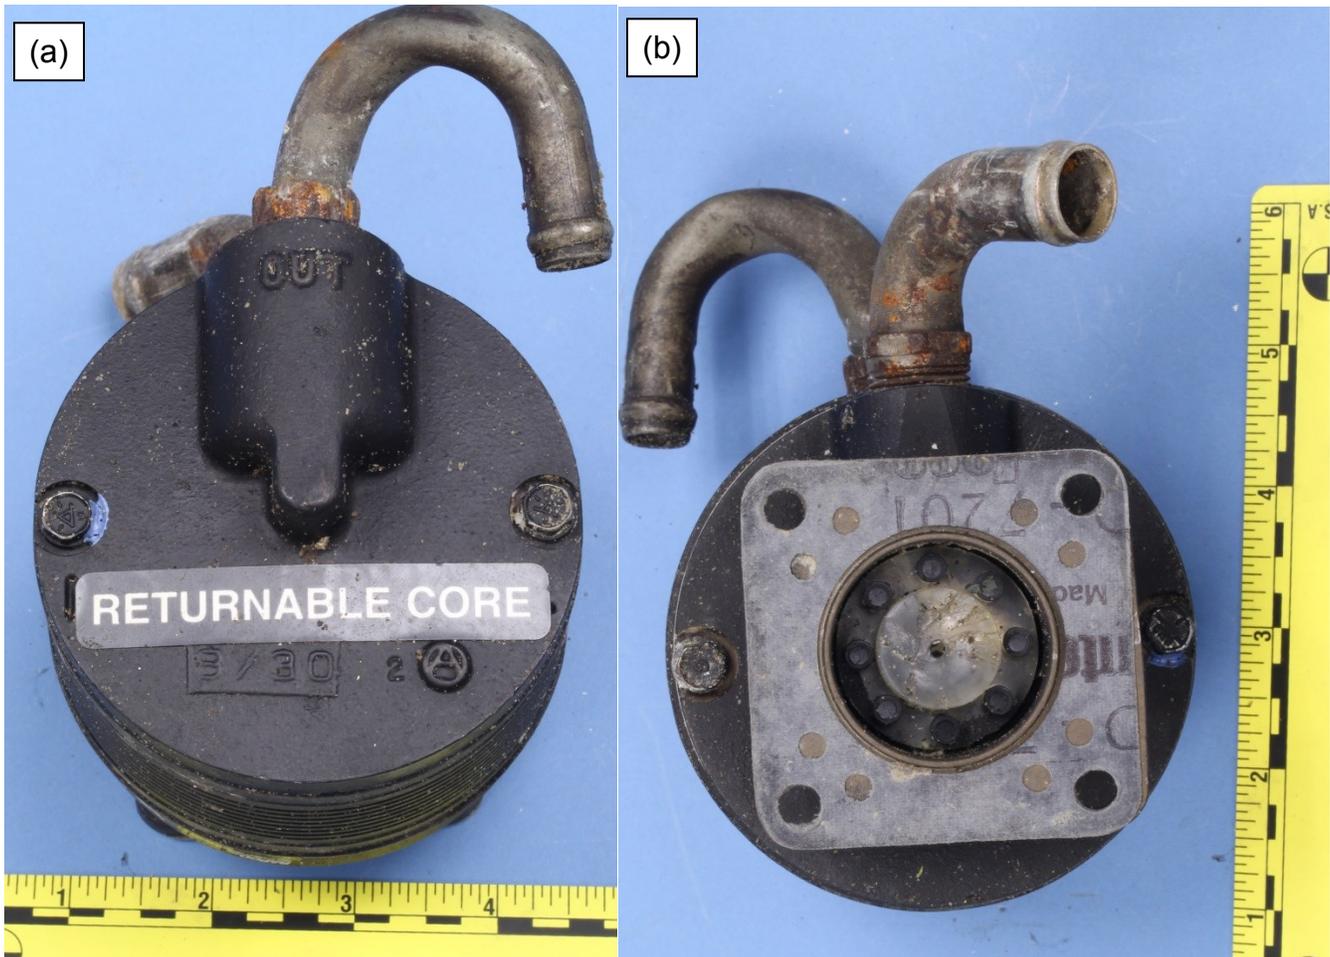
Figure 14 – The right vacuum pump, as received, showing (a) the outlet side and (b) the drive side.

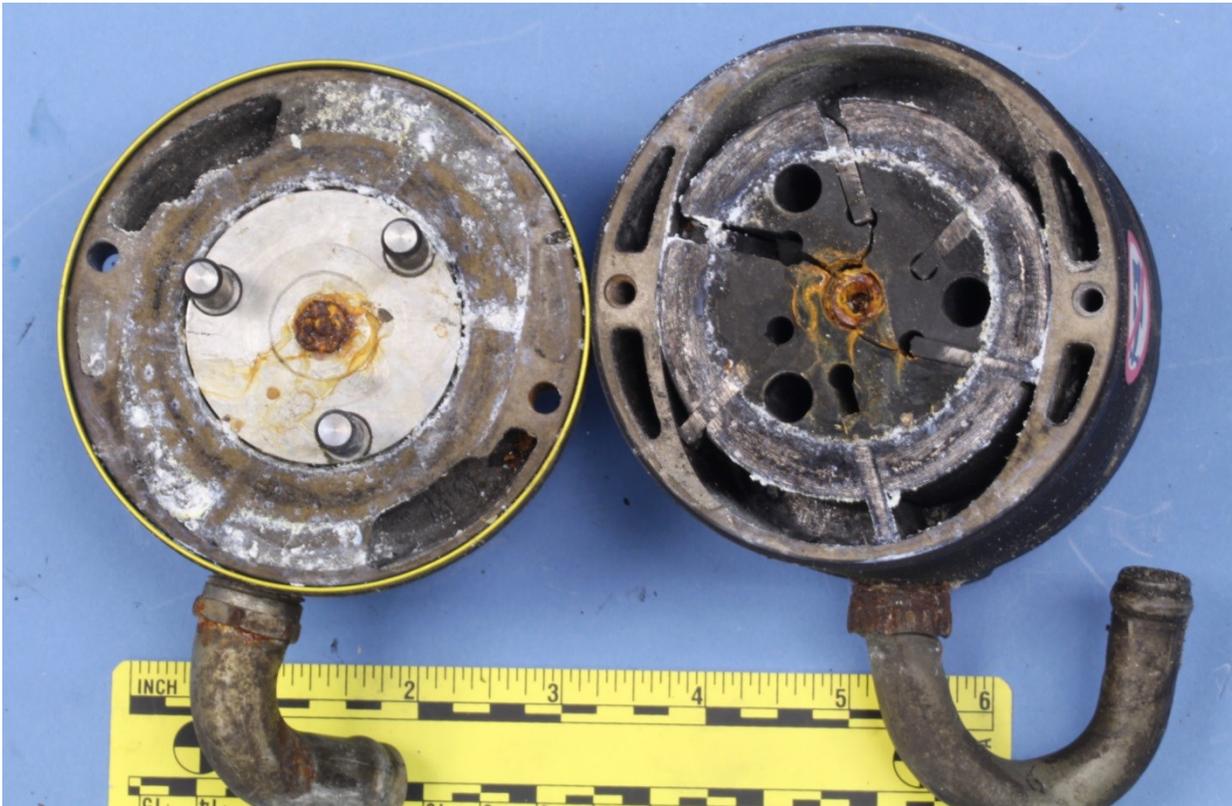
The pump was disassembled to reveal the condition of the internal components (see Figure 15). Similar to the left pump interior, a white brittle material was found on most of the interior surfaces. The rotor was wedged in position with the interior housing surfaces, even though it had fractured in multiple locations. The rotor and forward housing interior exhibited orange-colored oxidation that was consistent with rust found on the interior nut.

Figure 15 – The interior of the right vacuum pump after removing the outlet side housing cover.

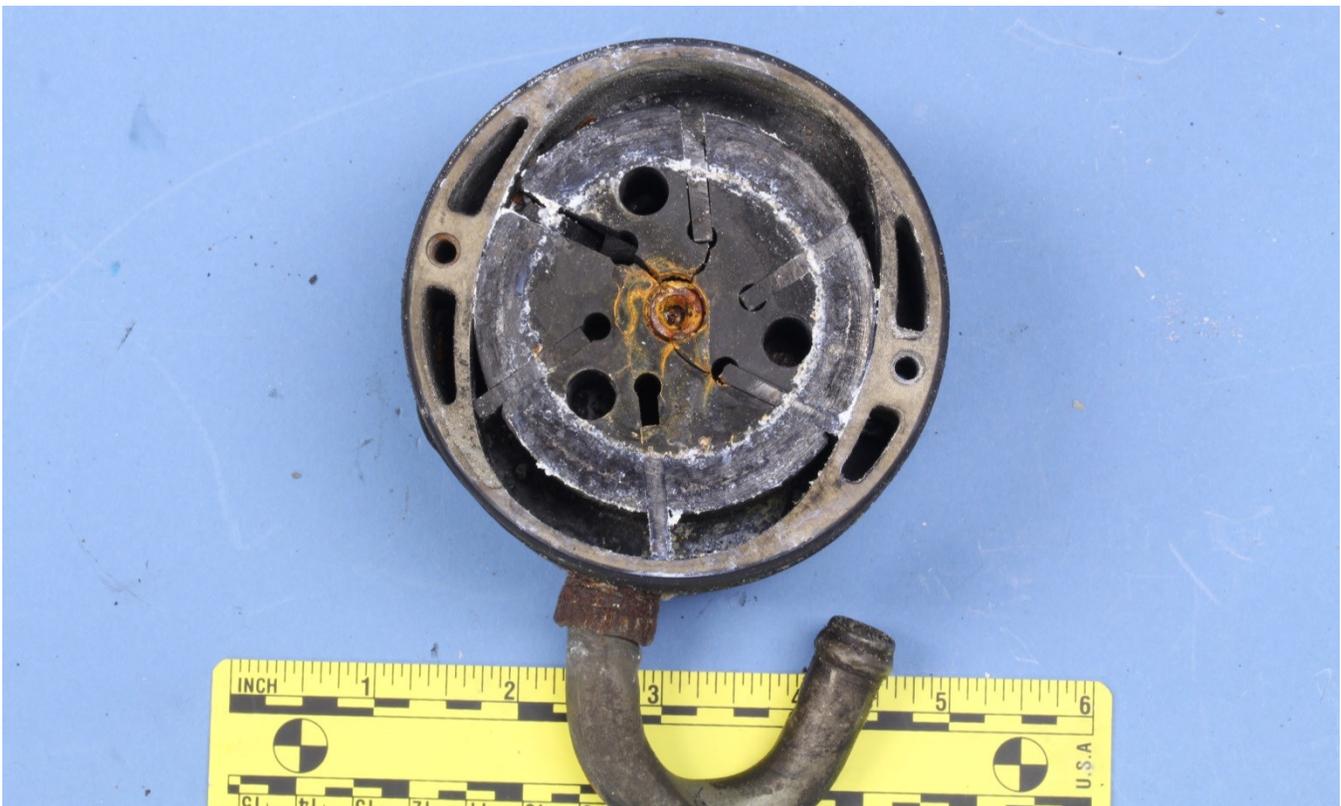
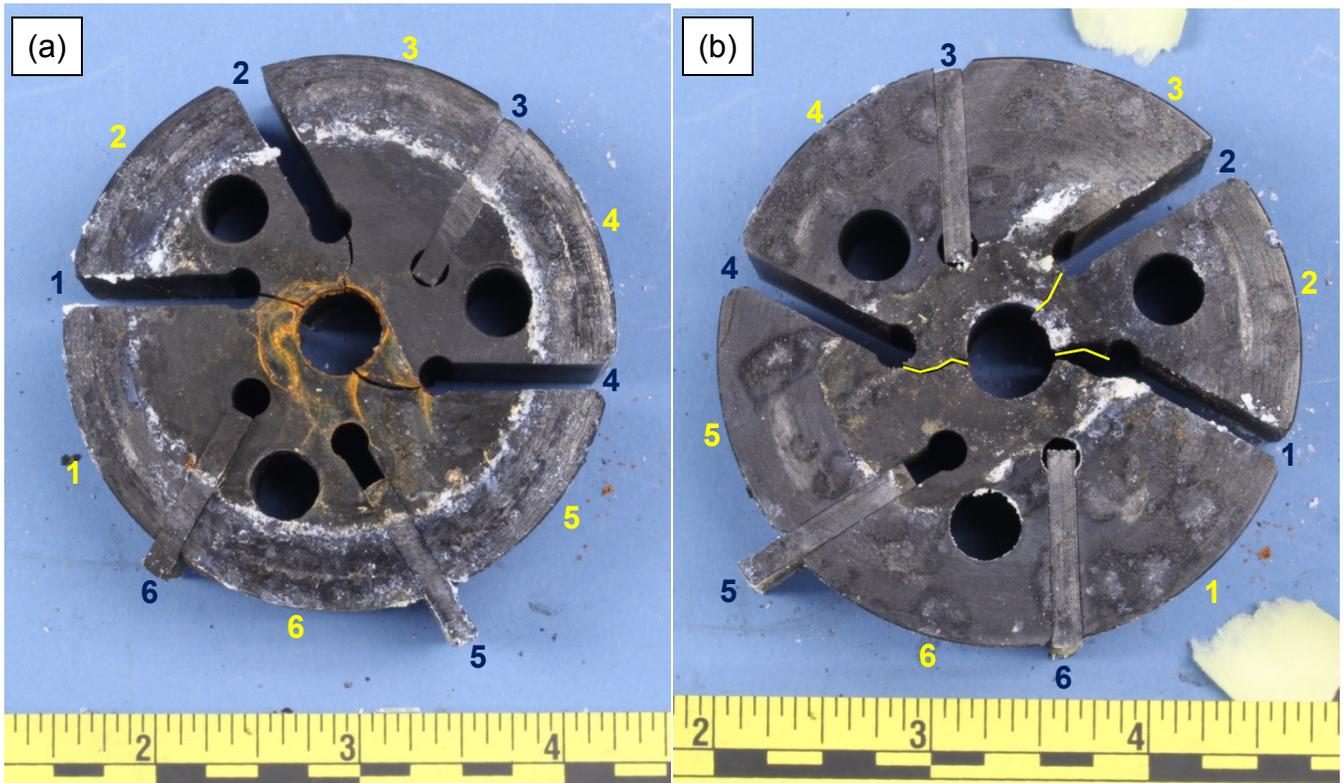
Figure 16 shows the multiple fracture locations of the rotor, found upon opening. The pieces of the rotor were reassembled as shown Figure 17. As with the left pump, the rotor flanges and slots were labeled 1 through 6 clockwise for the purposes of this report. Upon opening, cracks were found on the rotor at slots numbered 1, 2, and 4.

Figure 16 – Closer view of the right vacuum pump rotor, after removal of the outlet housing cover. The rotor had fractured in multiple locations. The rotor prongs are labeled 1 through 6 for the purpose of this report.

Figure 17 – The fractured rotor from the right vacuum pump, after removal from the housing from (a) the outlet side and (b) the opposite drive side. The fracture locations are highlighted with the primary cracks in yellow.

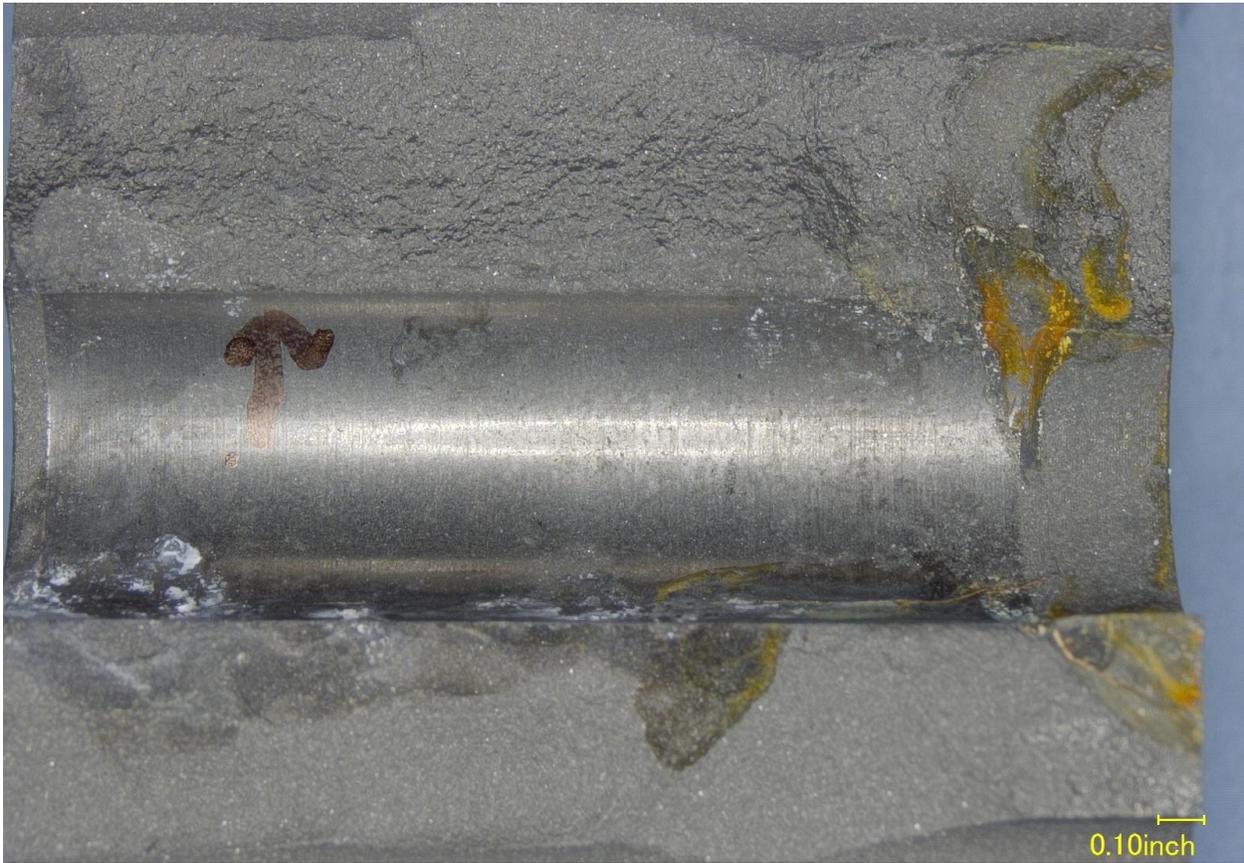
Circumferential score marks were observed on the interior surface of the rotor center hole (Figure 18). The fracture surfaces of the rotor were consistent with brittle overstress fracture. The patterns of the fracture surfaces adjacent to the center bore were consistent with multiple crack initiation locations. However, no indications of progressive fracture were observed.

Figure 18 – The fracture surfaces of the rotor interior.

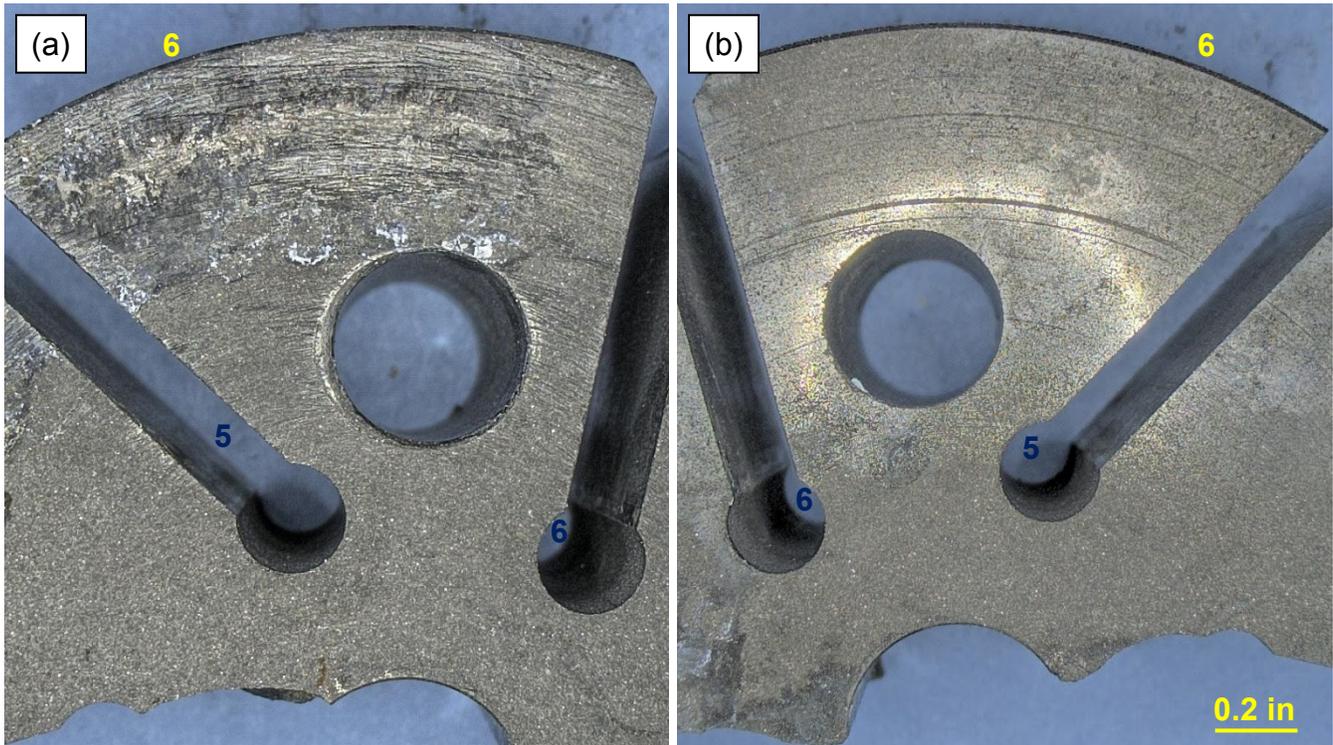
The faces of a portion of the right pump rotor are illustrated in Figure 19. These faces exhibited primarily circumferential wear marks. The outlet side exhibited some chatter and salt deposition (see Figure 19a). No indications of longitudinal contact with the mating surfaces were observed.

Figure 19 – The faces of the right pump rotor, showing rotational wear marks on (a) the outlet side and (b) the drive side.

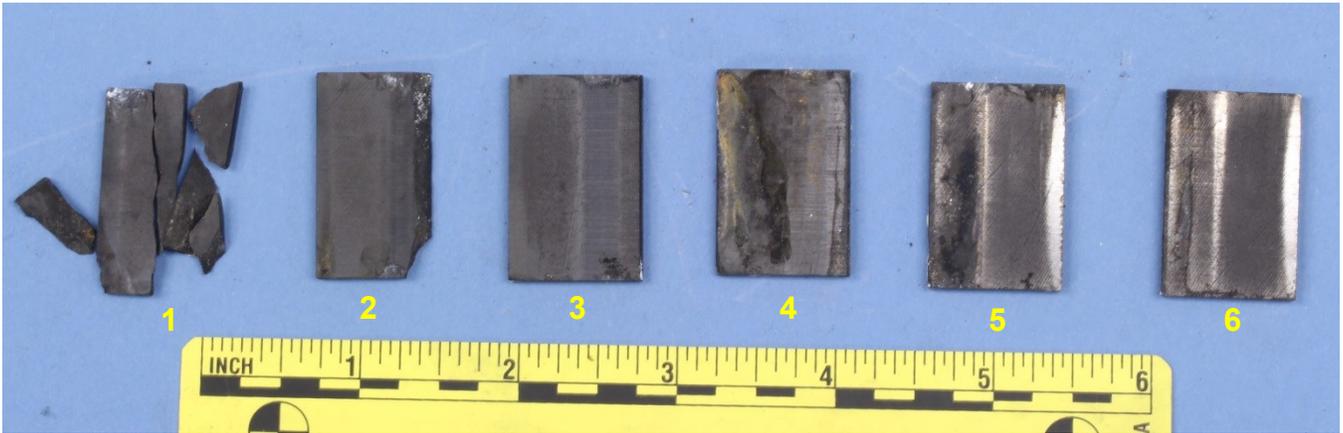
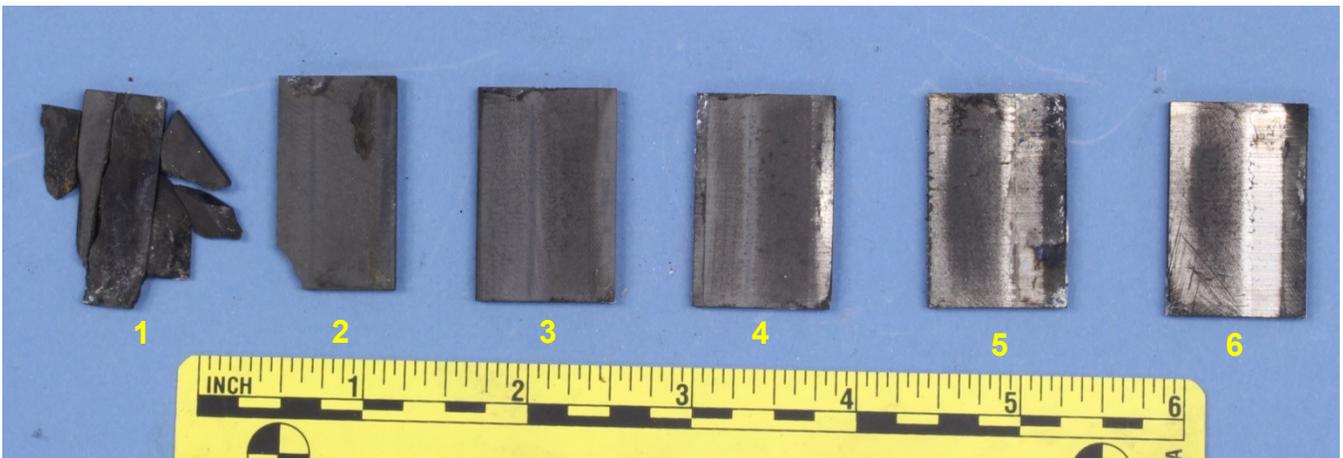
The vanes were removed from the pump housing and rotor slots, as illustrated in Figure 20 and Figure 21. The widths of the vanes recovered from this pump were again measured and listed in Table I. Vanes 1 and 2 were cracked in multiple locations, and Vane 1 had shattered completely. As such, the widths of these two vanes were not measured. The dimensions of these vanes were not consistent with those of the left pump.

Horizontal and vertical sliding marks were present on the faces of the vanes. These marks were consistent with similar marks on the machined inside faces of the rotor pieces. The horizontal marks were consistent with sliding of the vanes that occurred during rotational operation of the rotor. Each of the vanes exhibited one flat vertical face and one rounded vertical face.

Figure 20 – The vanes from the right pump, after removal. The vanes were labeled 1 through 6 for the purposes of this report, and correspond to the slots clockwise of the rotor prongs labeled in Figure 16.

Figure 21 – The right pump vanes, after removal, shown opposite side that in Figure 20.
