NATIONAL TRANSPORTATION SAFETY BOARD

MATERIALS LABORATORY FACTUAL REPORT

Report No. 15-037

Place : Brunswick, GA
Date : March 24, 2015
Vehicle : Piper PA-44-180, N923RS
NTSB No. : ERA14FA168
Investigator : Shawn Etcher, AS-ERA

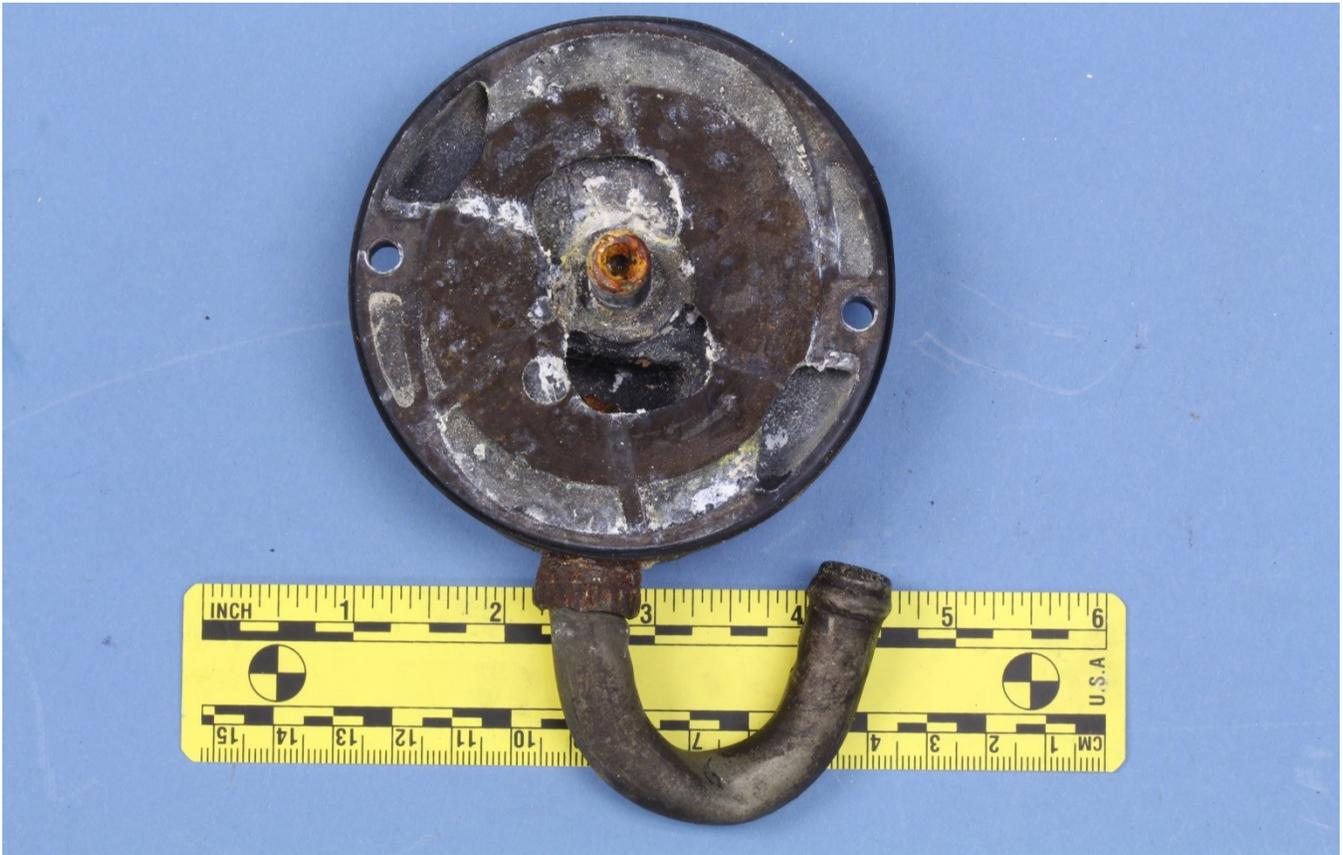
The interior of the drive end pump housing is shown in Figure 22. This surface exhibited the white brittle material consistent with salt deposits found on the opposite interior of the pump. The pattern of the white material was consistent with the resting position of the rotor and vanes in the pump.

Figure 22 – The inside face of the drive side housing cover, after removal of the interior rotor and vanes from the right pump.

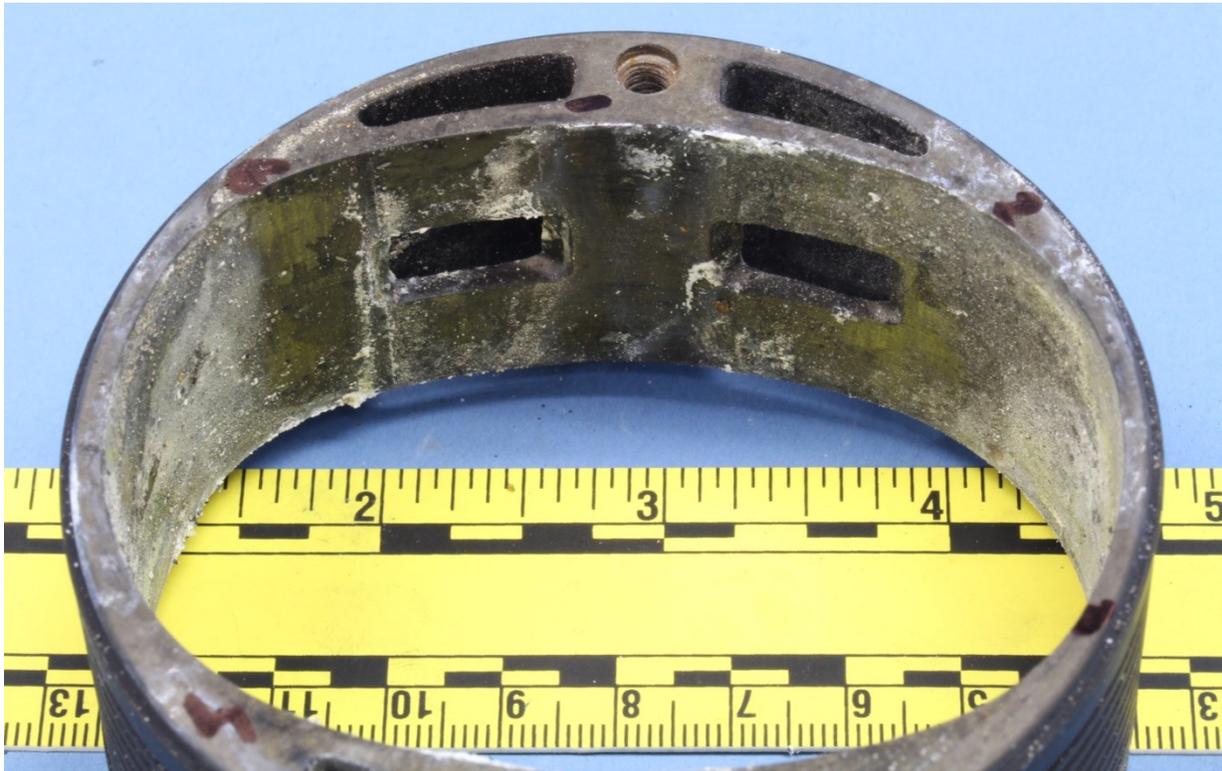
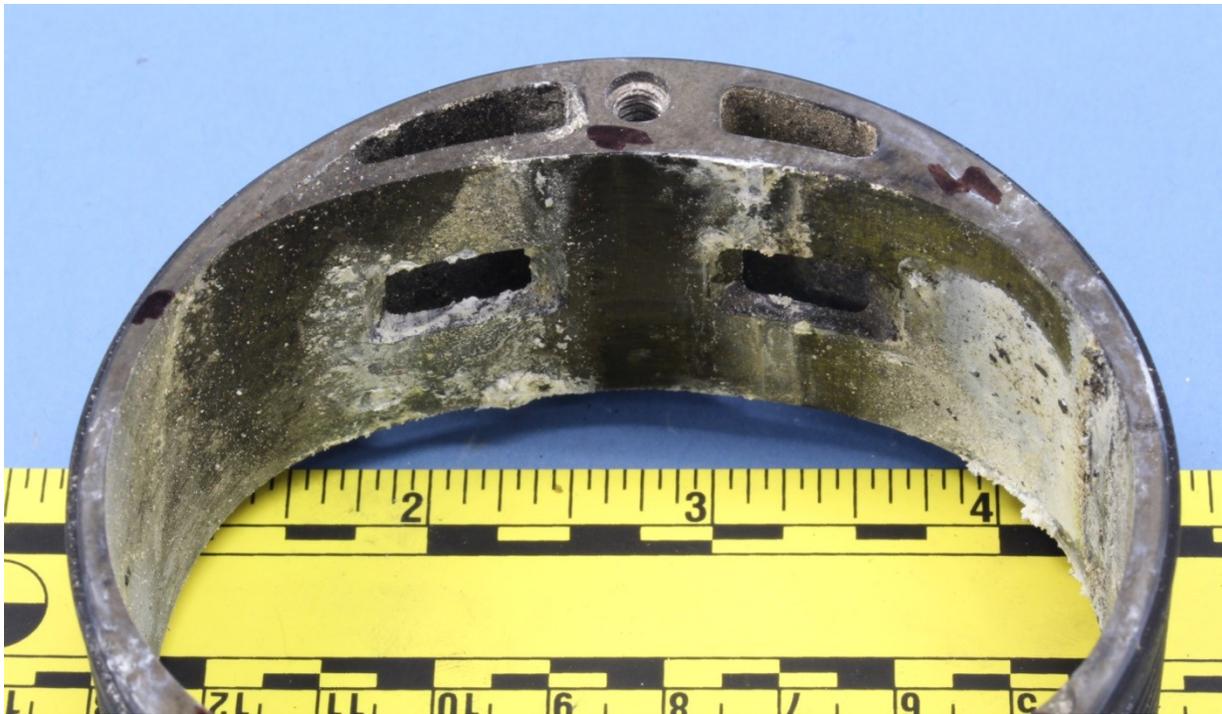
The interior of the circular housing is illustrated in Figure 23 and Figure 24. These surfaces show the white deposits found on the other interior surfaces. These deposits were most prevalent at regular positions consistent with the rest position of the vane slots in the rotor. Scraping was present on the inside wall of the housing, predominantly at the location of the #1 vane slot. This was the location of the crushed vane (#1) and a crack in the rotor.

Figure 23 – The interior surface of the right pump housing, after removal of the rotor and vanes.

Figure 24 – The interior surface of the right pump housing, after removal of the rotor and vanes, opposite Figure 23.
