NATIONAL TRANSPORTATION SAFETY BOARD

MATERIALS LABORATORY FACTUAL REPORT

Report No. 15-077

Place : Anchorage, Alaska
Date : March 14, 2015
Vehicle : Eurocopter AS350-B2
NTSB No. : ANC15LA015
Investigator : Shaun Williams

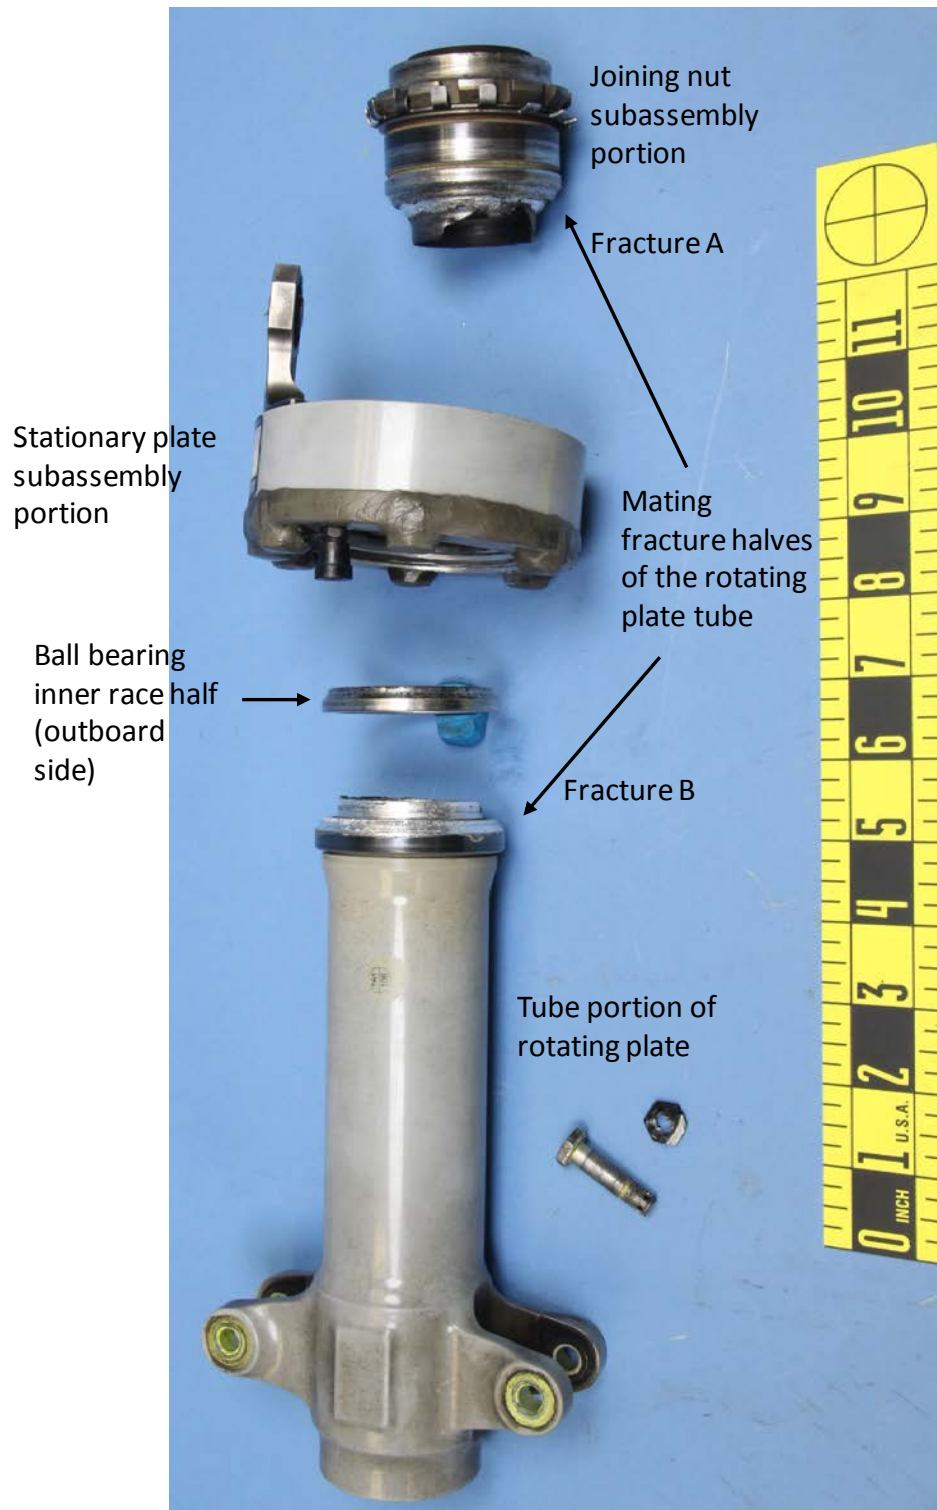
The tube portion of the rotating plate fractured where the stationary plate assembly is located as shown in Figure 1. Both halves of the tube fracture surfaces are shown in Figures 7 and 8. Examined under a 5X to 50X stereo zoom microscope, the fracture surface in Figure 7 (see also Figure 1 Fracture B) was damaged over about 50% of the surface and the undamaged areas exhibited features consistent with overstress fracture. The bearing inner half-race seating surfaces exhibited galling and adhesive wear scars. The mating bearing inner half-race is shown in Figure 5.

Figure 1 As-received pieces of the rotating and stationary plate assembly. Depicted in approximate order of assembly.

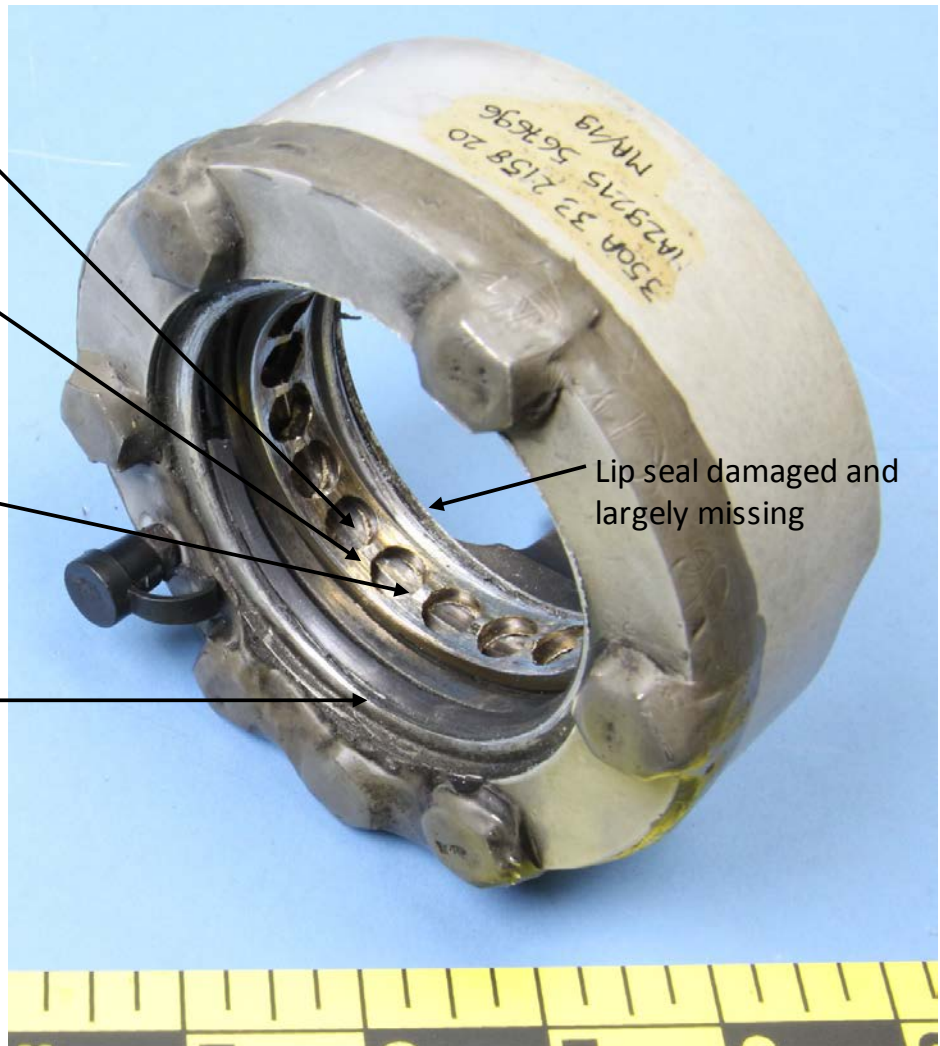
Pieces from the stationary plate subassembly are shown in Figure 3. The single and double lip seals are damaged and much of the seal material is missing. The outer ball bearing raceway surfaces exhibit galling scars consistent with sliding contact. The inner surfaces of the ball cage exhibit adhesive wear scars around the circumference. The ball pockets of the cage retained accumulated wear debris. A cotton swab was wiped along the circumference of the raceway of the outer ball bearing race in order to collect any grease residue. Fourier transform infrared spectroscopy analysis of the cotton swab revealed that no grease was detected¹.

Outer bearing race exhibited galling wear scars consistent with sliding contact

Inner surface of ball cage exhibited adhesive wear scars consistent with sliding contact

Ball pockets exhibited accumulated wear debris

Lip seal damaged and largely missing

Figure 3 Photograph of a portion of the stationary plate for the tail rotor drive assembly is shown. Damage observations are annotated in the image.

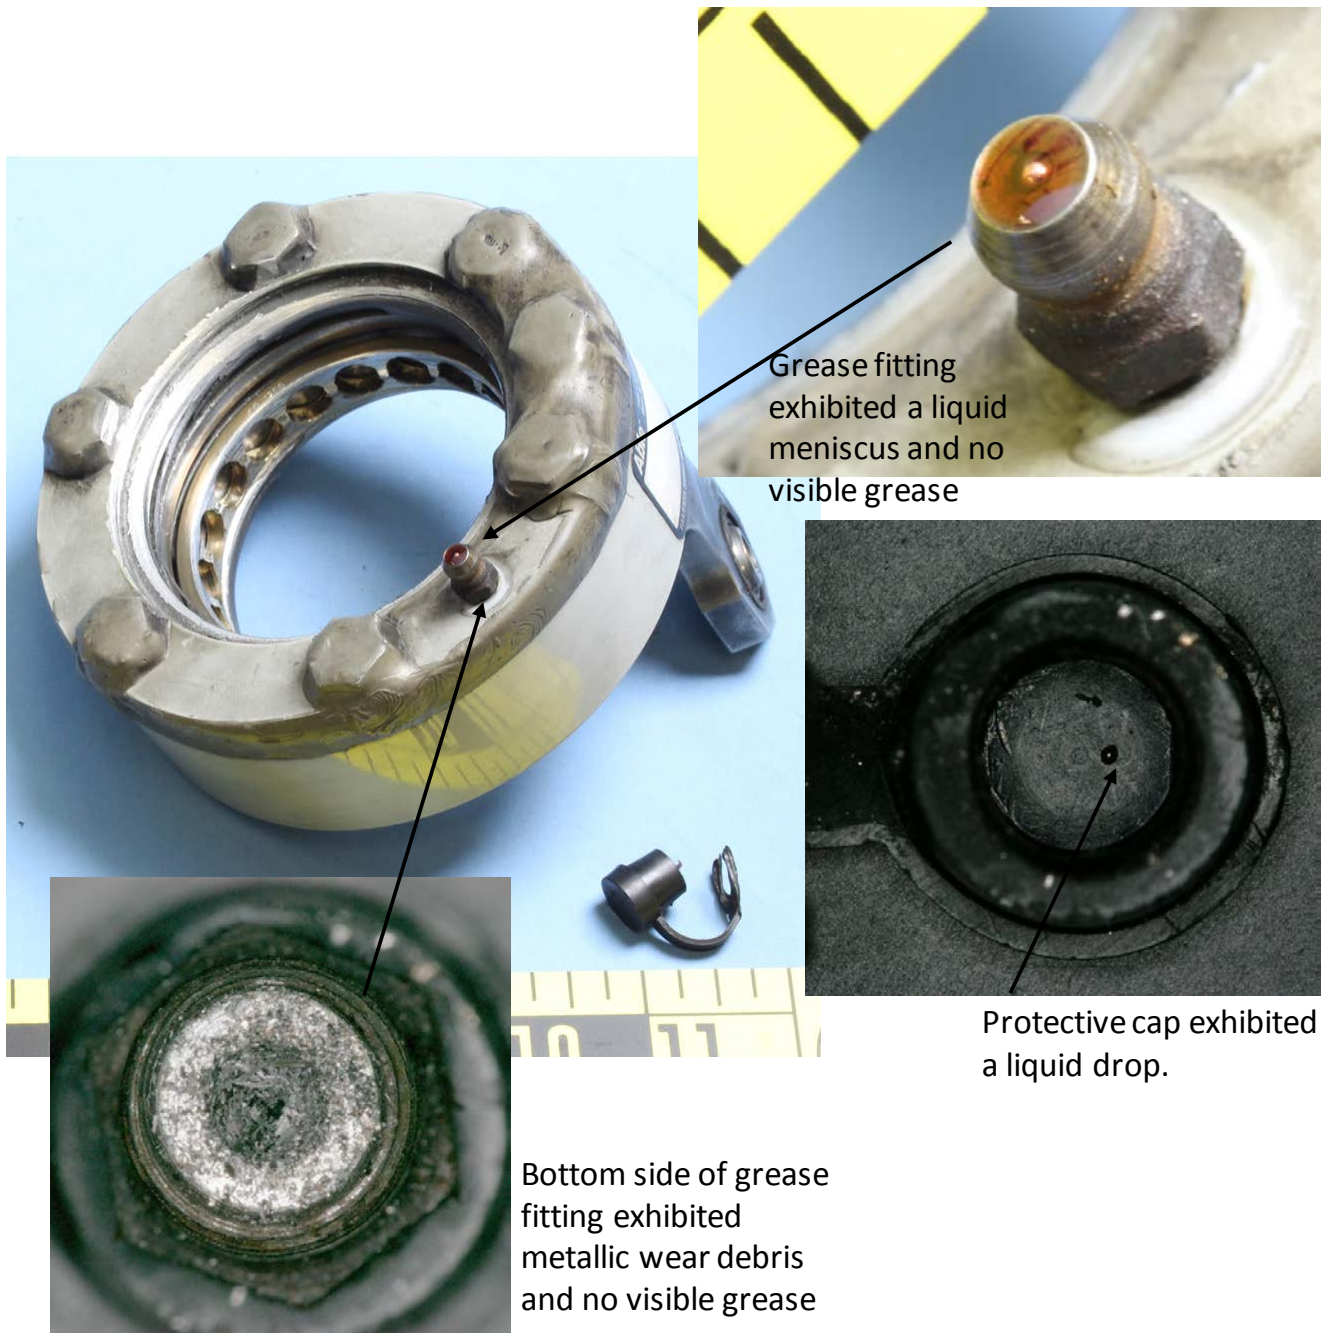
The protective cap was removed from the grease fitting as depicted in Figure 4. As indicated in the figure, sessile drops of liquid were discovered on the inlet portion of the grease fitting and on the inside surface of the protective cap. A cotton swab was used to sample a sessile drop. Fourier transform infrared spectroscopy analysis of the cotton swab revealed that no grease was detected. As documented in the figure, the grease fitting was removed from the stationary plate housing. The bottom (outlet side) of the grease fitting was covered with accumulated wear debris. A cotton swab was

used to sample this surface. Fourier transform infrared spectroscopy analysis of the cotton swab revealed that no grease was detected.

Figure 4 Portion of the stationary plate assembly depicting the presence of a liquid meniscus on the inlet portion of the grease fitting and metallic wear debris accumulated on the outlet portion of the grease fitting.

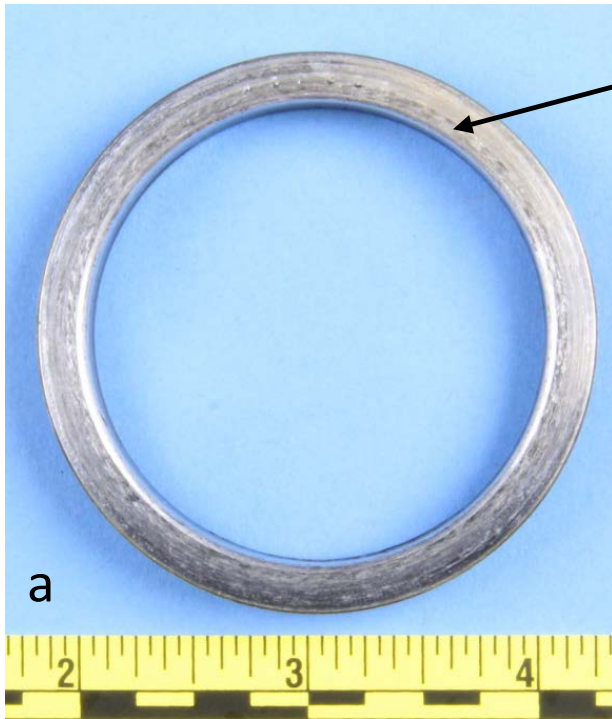
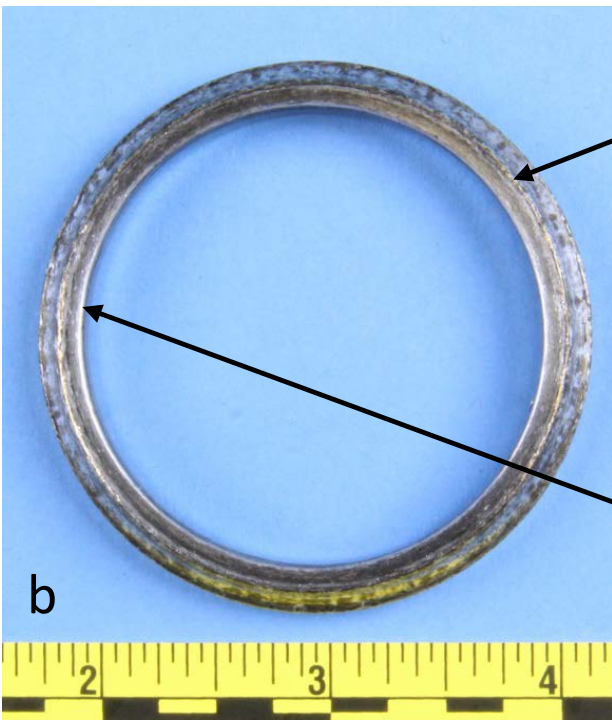
The ball bearing inner half-race from the outboard side of the assembly identified in Figure 1 is shown at closer views in Figure 5. The bearing half-race was examined under a 5X to 50X stereo zoom microscope. The raceway exhibited galling scars consistent with sliding contact. The inside diameter and edge surfaces of the inner half-race was covered with a deposit of tribo-transferred aluminum. The edge surface was also marked with serial numbers under the deposited aluminum. A sodium hydroxide solution was applied to the edge of the bearing race half to dissolve the deposited aluminum (see Figure 6). Two letter/number strings were revealed after cleaning as shown in Figure 6: NR 7842 and AG 2358. After cleaning in sodium hydroxide, the NR 7842 letter/number string was etched with 4% nital metallurgical etchant for enhancement.

Edge of inner half-race covered with tribo-transferred aluminum

This surface was also marked with serial numbers under the deposited aluminum (see Figure 6)

Inner bearing half-race raceway exhibited galling scars consistent with sliding contact

Inside diameter surface of the inner half-race covered with tribo-transferred aluminum

Figure 5 Images of the edge and raceway of one half of the inner bearing half-race (see Figure 1).

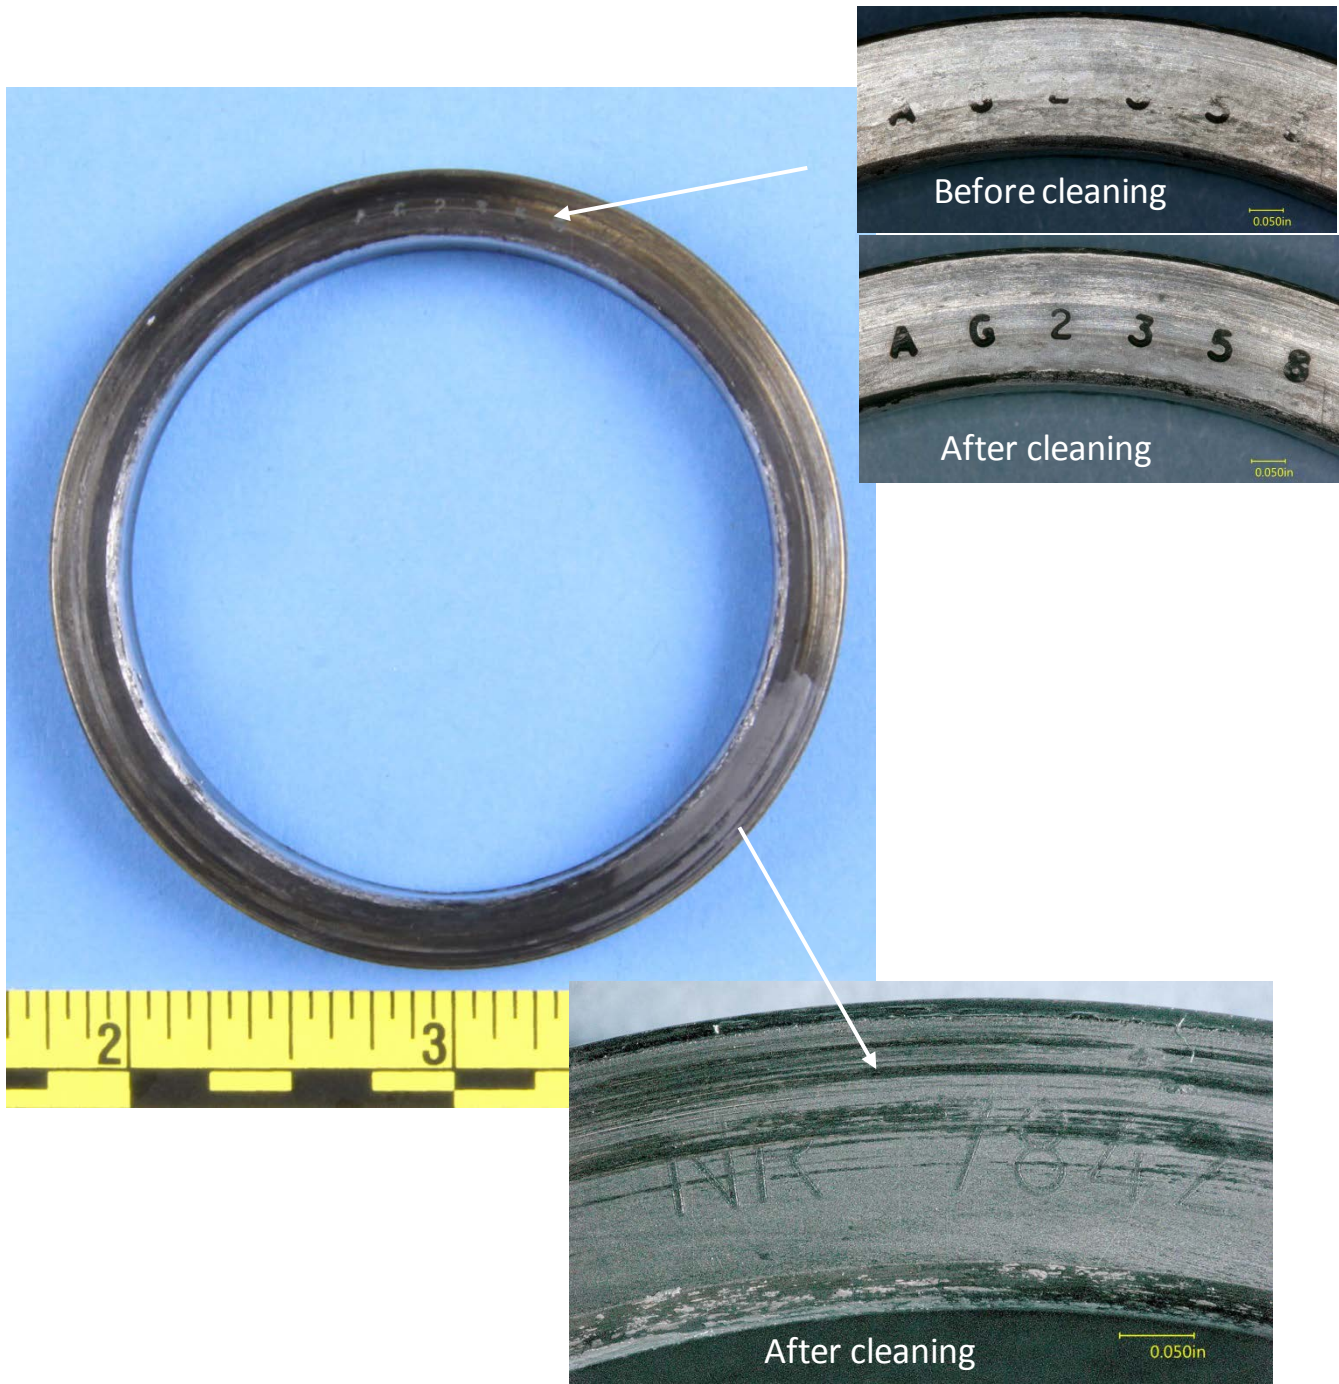
Figure 6 Images of the edge of the inner bearing half-race shown in Figure 5. The edge has been cleaned to reveal serial numbers.

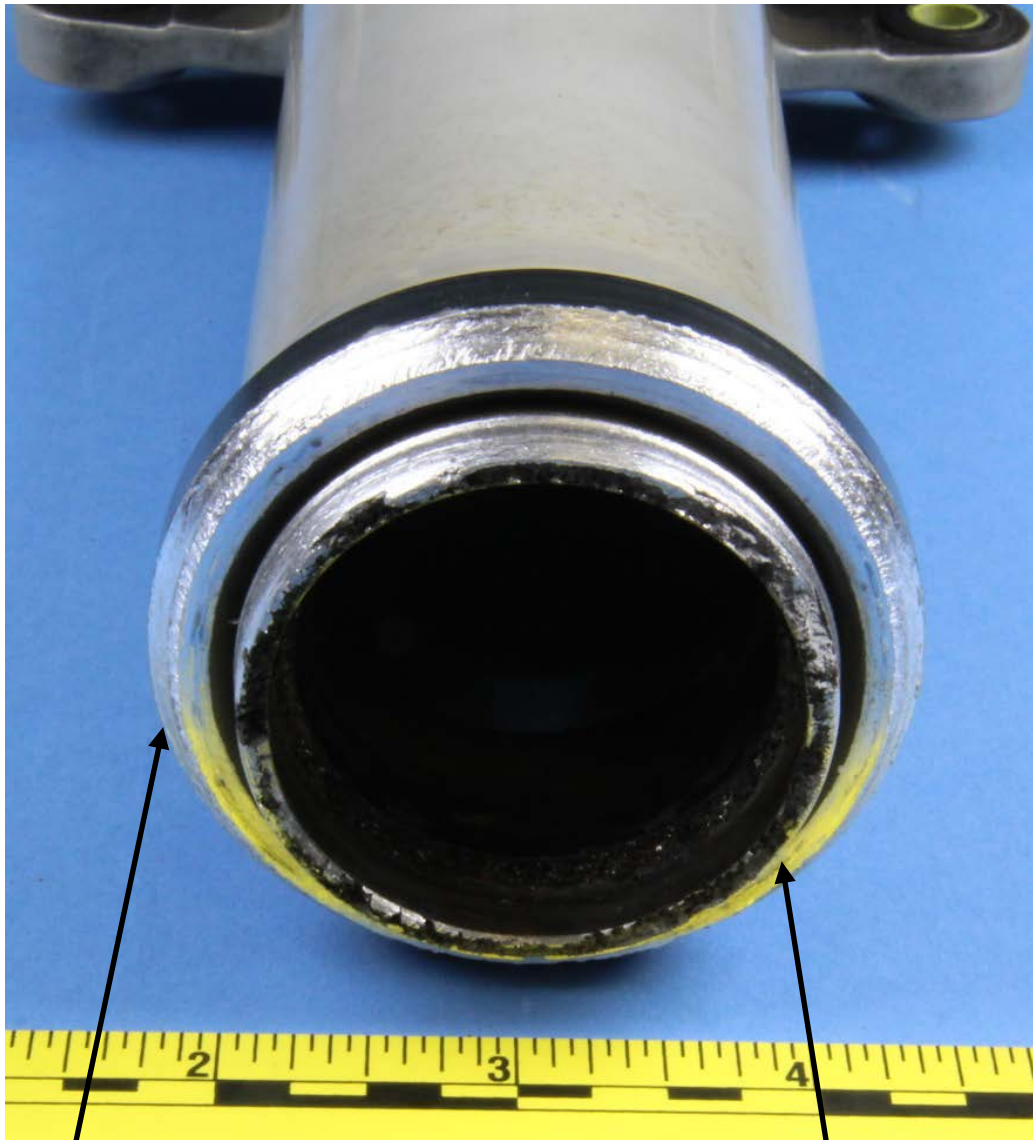
Outer diameter of the rotating plate tube exhibited adhesive wear and galling scars.

Fracture surface exhibited features consistent with overstress fracture.

Figure 7 Image of the tube portion of the rotating plate (see Figure 1).

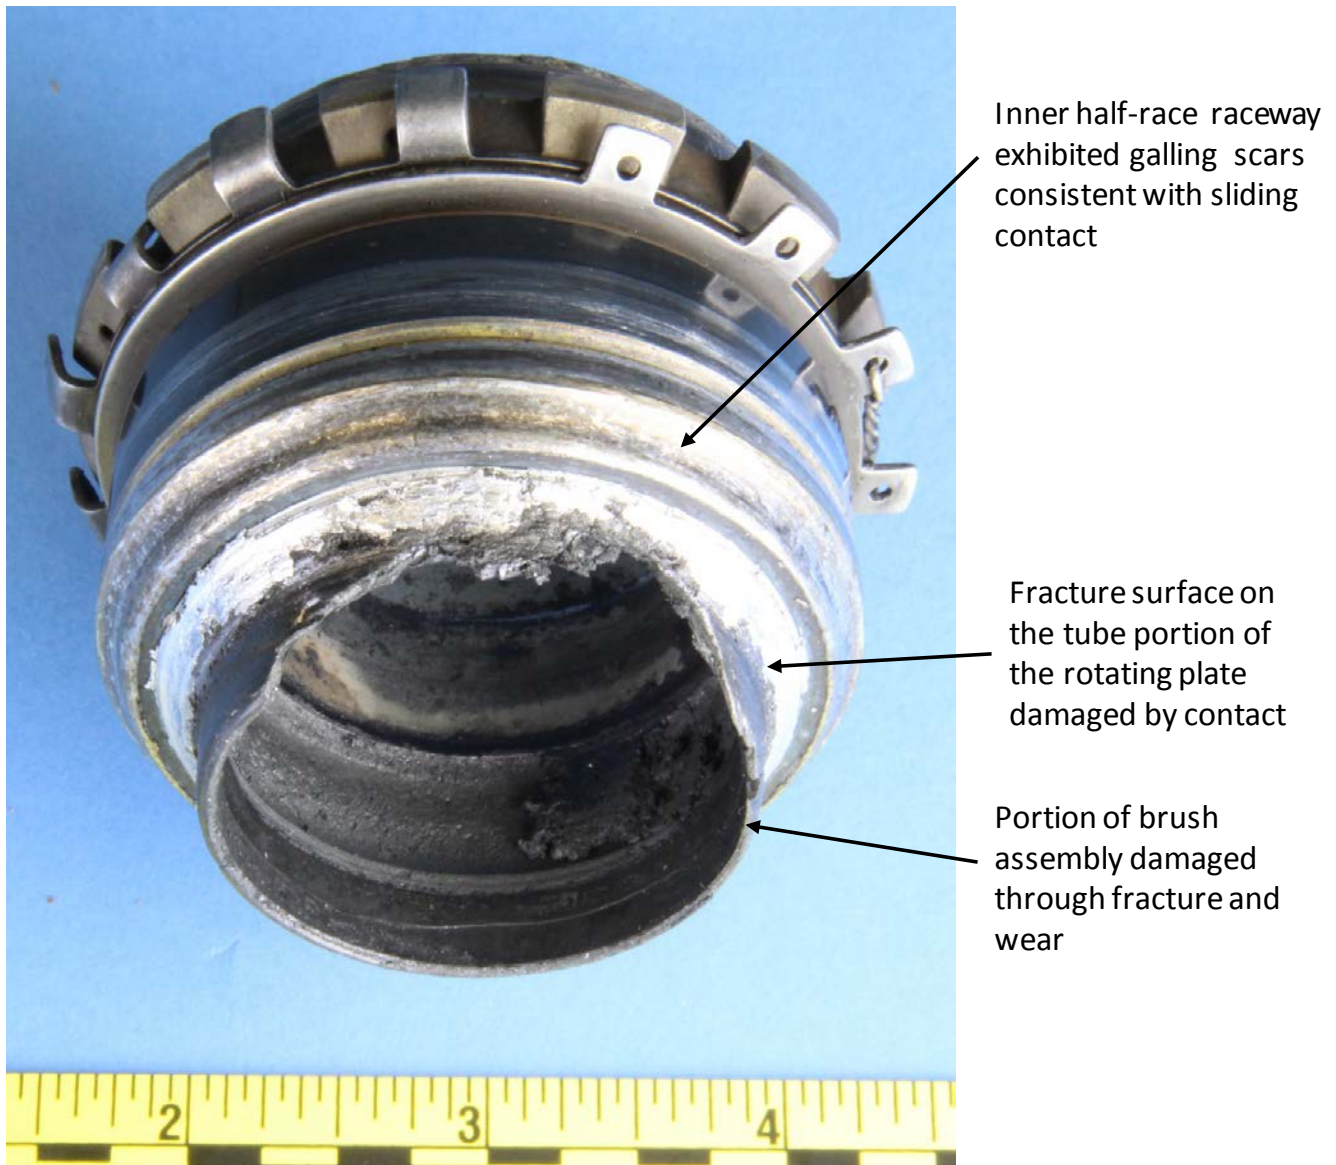
As identified in Figure 1, the portion of the rotating plate that contained the joining nut separated from the assembly as shown in Figure 8. The other half of the inner bearing half-race remained with the joining nut portion. Examined under a 5X to 50X stereo zoom microscope, the raceway surface of the inner bearing half-race exhibited galling scars consistent with sliding contact. The fracture surface of the tube portion of the rotating plate was damaged over 100% of the surface. The internal brush assembly was partially worn or fractured.

Figure 8 Image of the joining nut subassembly portion of the rotating plate (see Figure 1).
