NATIONAL TRANSPORTATION SAFETY BOARD

MATERIALS LABORATORY FACTUAL REPORT

Report No. 15-025

Place : Summerfield, FL
Date : April 6, 2014
Vehicle : Van's RV-7, N57DC
NTSB No. : ERA14FA182
Investigator : Dennis Diaz, AS-ERA

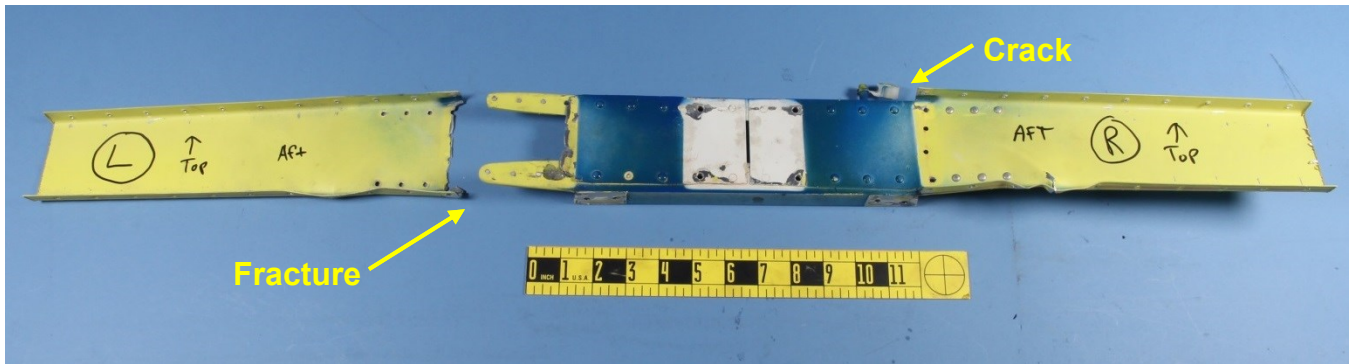
A section of the horizontal stabilizer spar was submitted to the NTSB Materials Laboratory for further examination. Figure 1 shows the fractured halves of the submitted horizontal stabilizer spar section. The spar had fractured on the left side (aft looking forward), perpendicular to the direction of the part. The fracture was located along four rivet holes in the spar, all of which exhibited elongation in the part direction. There was also an "L-shaped" crack on the right side of the assembly, approximately 0.25 inches long, which had terminated at a rivet hole.

Figure 1 – The section of the horizontal stabilizer spar, as received (aft looking forward). The fractured section is annotated on the left.

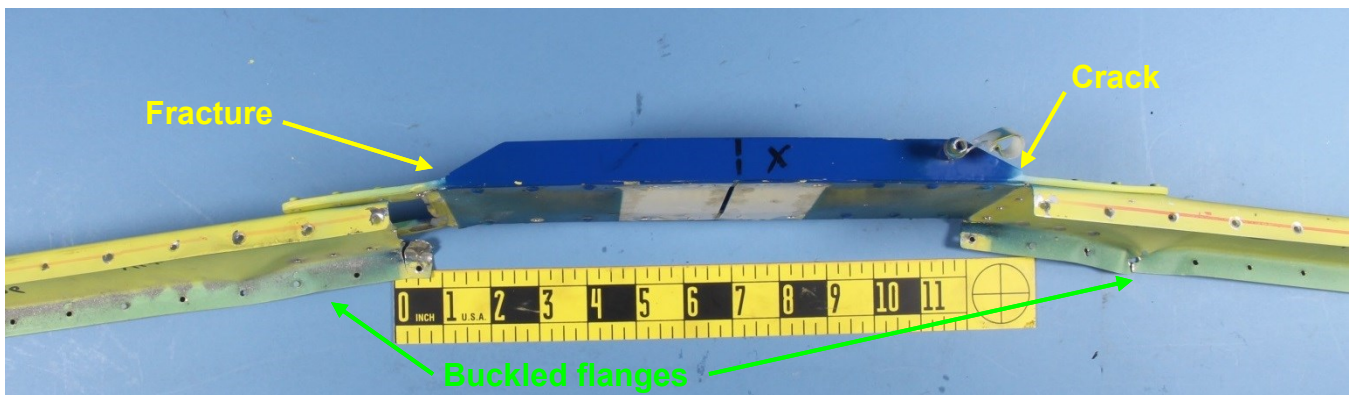
As shown in Figure 2, there was out-of-plane buckling on the spar outboard of the fracture and crack on the spar section. This buckling was located at two tears on the lower portion of the right side of spar. This was consistent with damage incurred to the part at ground impact. No indications of wear or corrosion were observed on the submitted spar section.

Figure 2 – The spar section halves, as view from above. Areas of buckling are denoted on both sides.

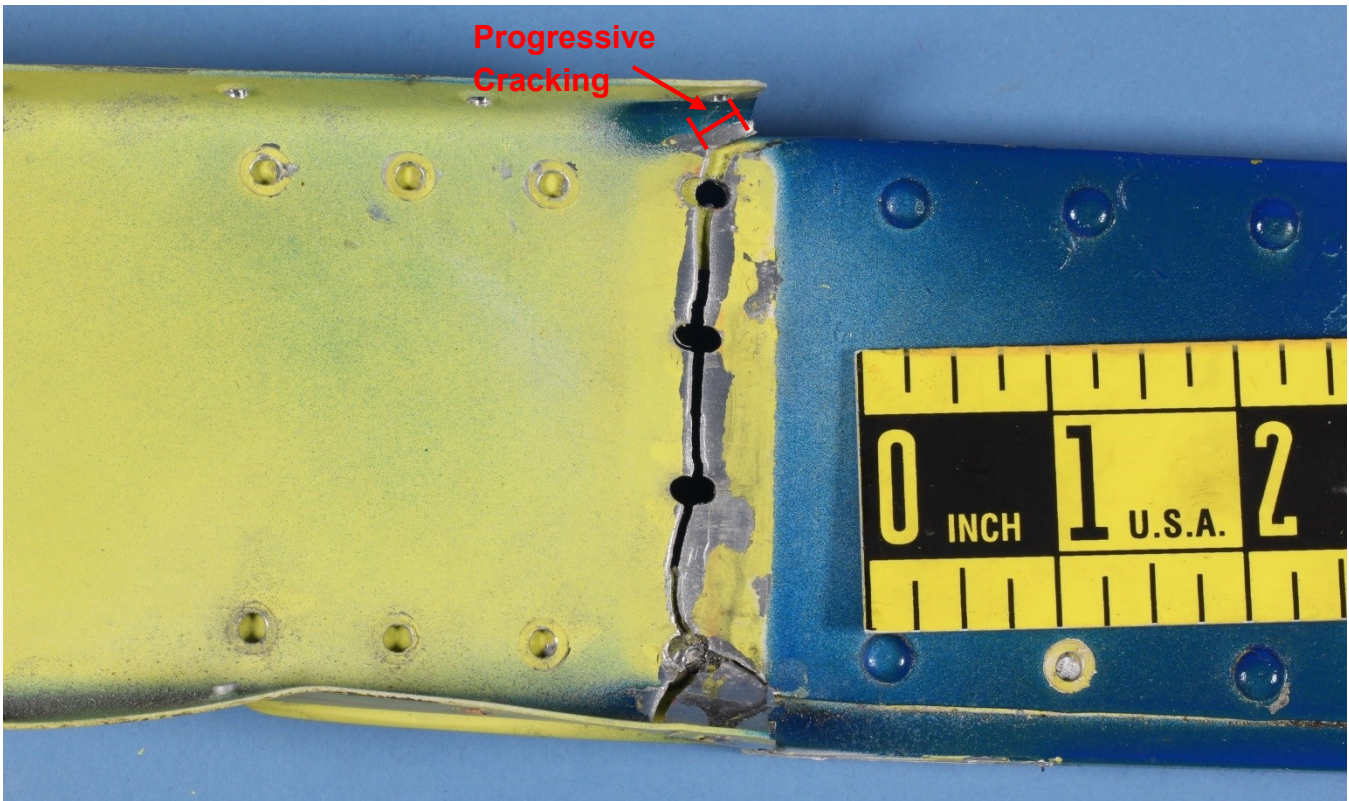
Figure 3 and Figure 4 illustrate closer views of the left side fracture and right side crack, respectively. Small portions of the fracture and crack exhibited features consistent with progressive cracking. Figure 5 and Figure 6 illustrate these progressive cracking regions (Figure 6 shows the right side crack after backcutting and intentionally opening the crack in the laboratory). These thumbnail-shaped areas were generally flat perpendicular to the part direction, and they exhibited crack arrest and ratchet marks. The progressive portion of the right side crack was approximately 0.15 inch long, and the progressive portion of the left side fracture was approximately 0.25 inch long.

The remaining portions of the fracture and crack exhibited a rougher texture and a general 45° slant. These features were consistent with overstress failure.

Figure 3 – The fractured halves of the spar, positioned to show their relative positions at fracture (aft looking forward). The small area of progressive fracture is labeled on the top of the figure.

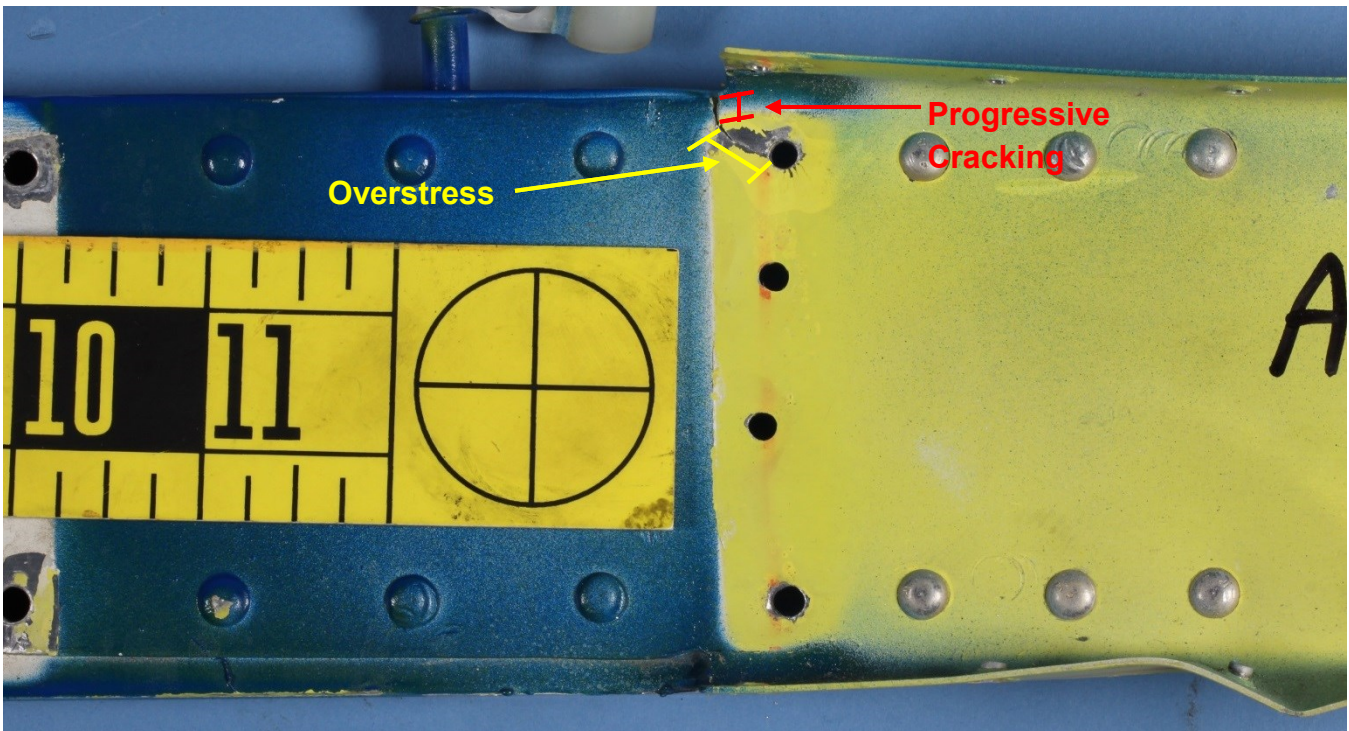
Figure 4 – The small upper crack on the right side of the spar section, as received (aft looking forward). The area of progressive fracture is labeled on the top of the figure.

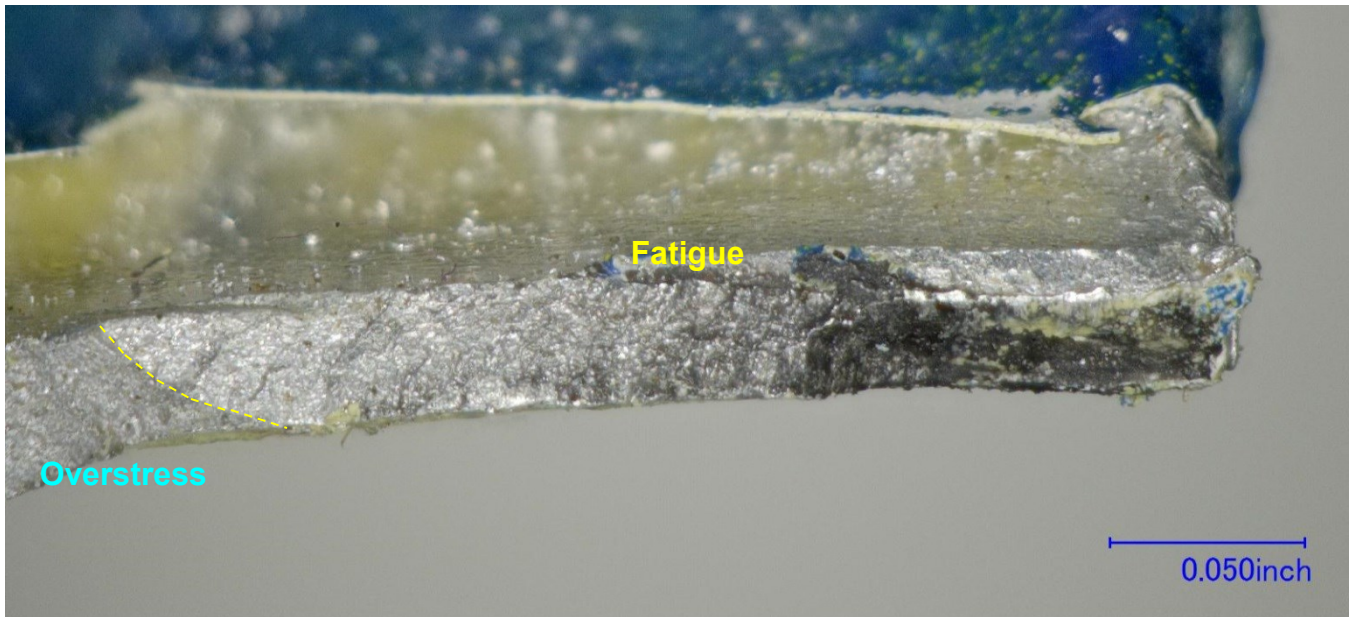
Figure 5 – The progressive portion of the fracture surface on the left side of the spar section.

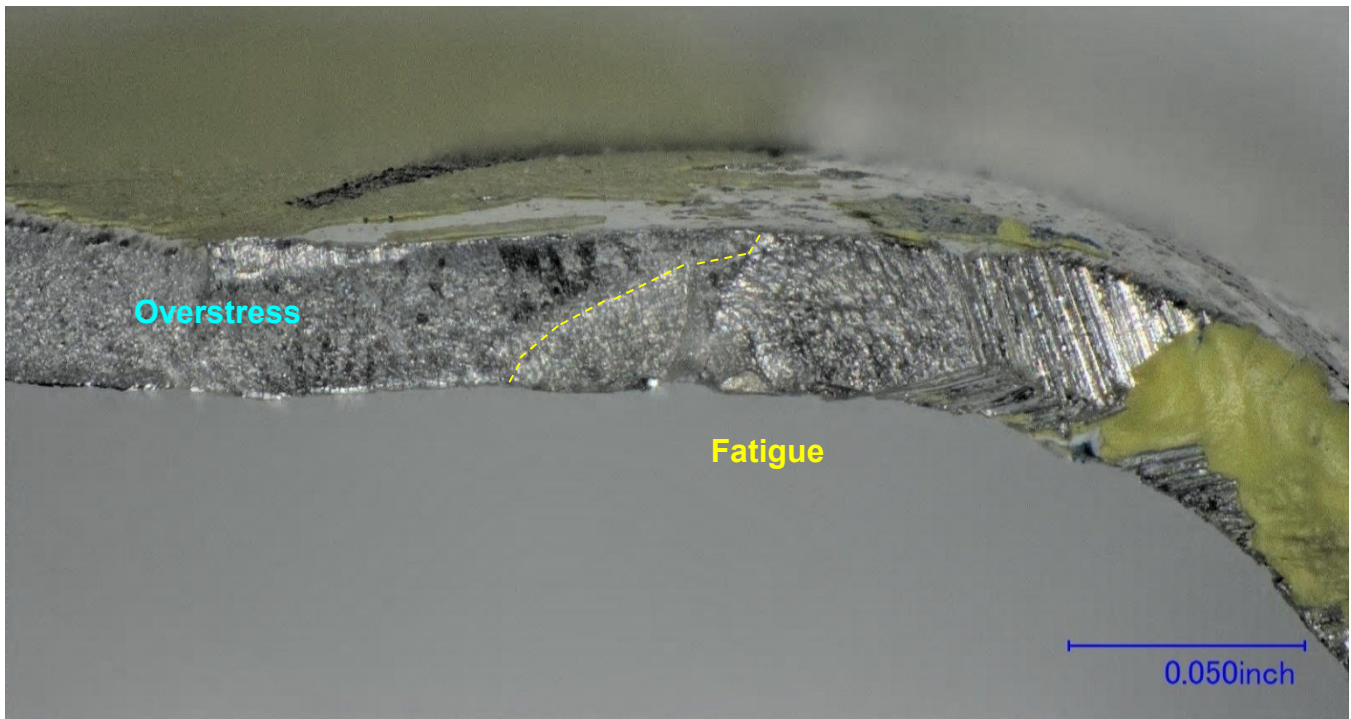
Figure 6 – The progressive portion of the crack on the right side of the spar section, after intentional crack opening.

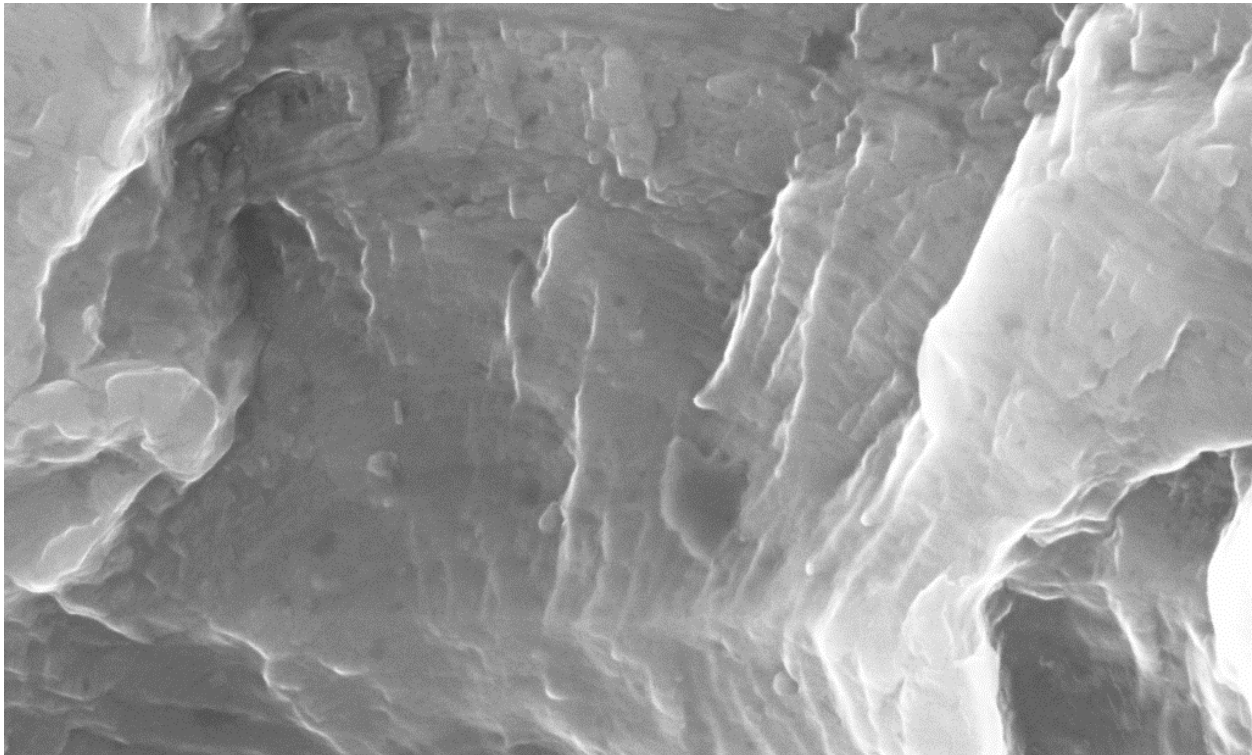
The fractures were examined using a scanning electron microscope. Figure 7 illustrates the progressive region of the fracture surface, displaying fatigue striations consistent with fatigue cracking. The remainder of the fracture surface exhibited dimple rupture, consistent with failure from overstress (see Figure 8). The thumbnail portion of the opened crack also exhibited fatigue striations, as shown in Figure 9.

Figure 7 – Secondary electron (SE) micrograph of fatigue striations on the spar section fracture surface.

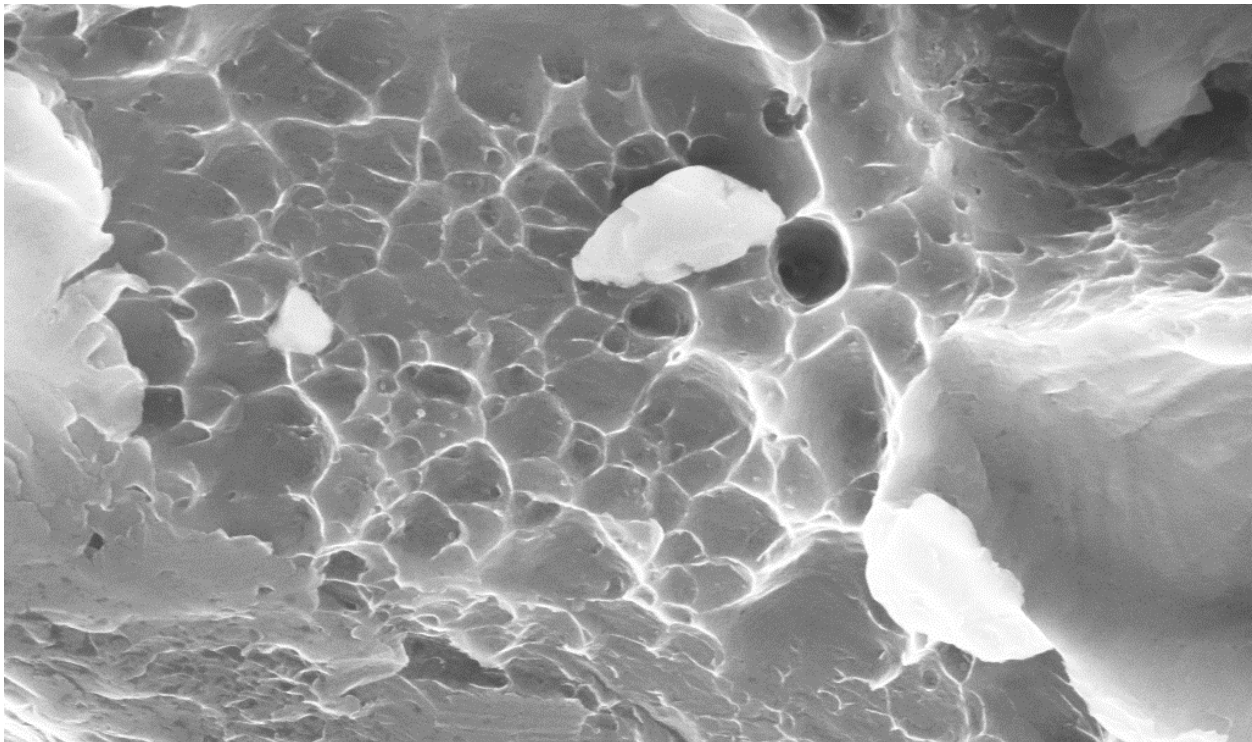
Figure 8 – SE micrograph of dimple rupture on the spar section fracture surface.

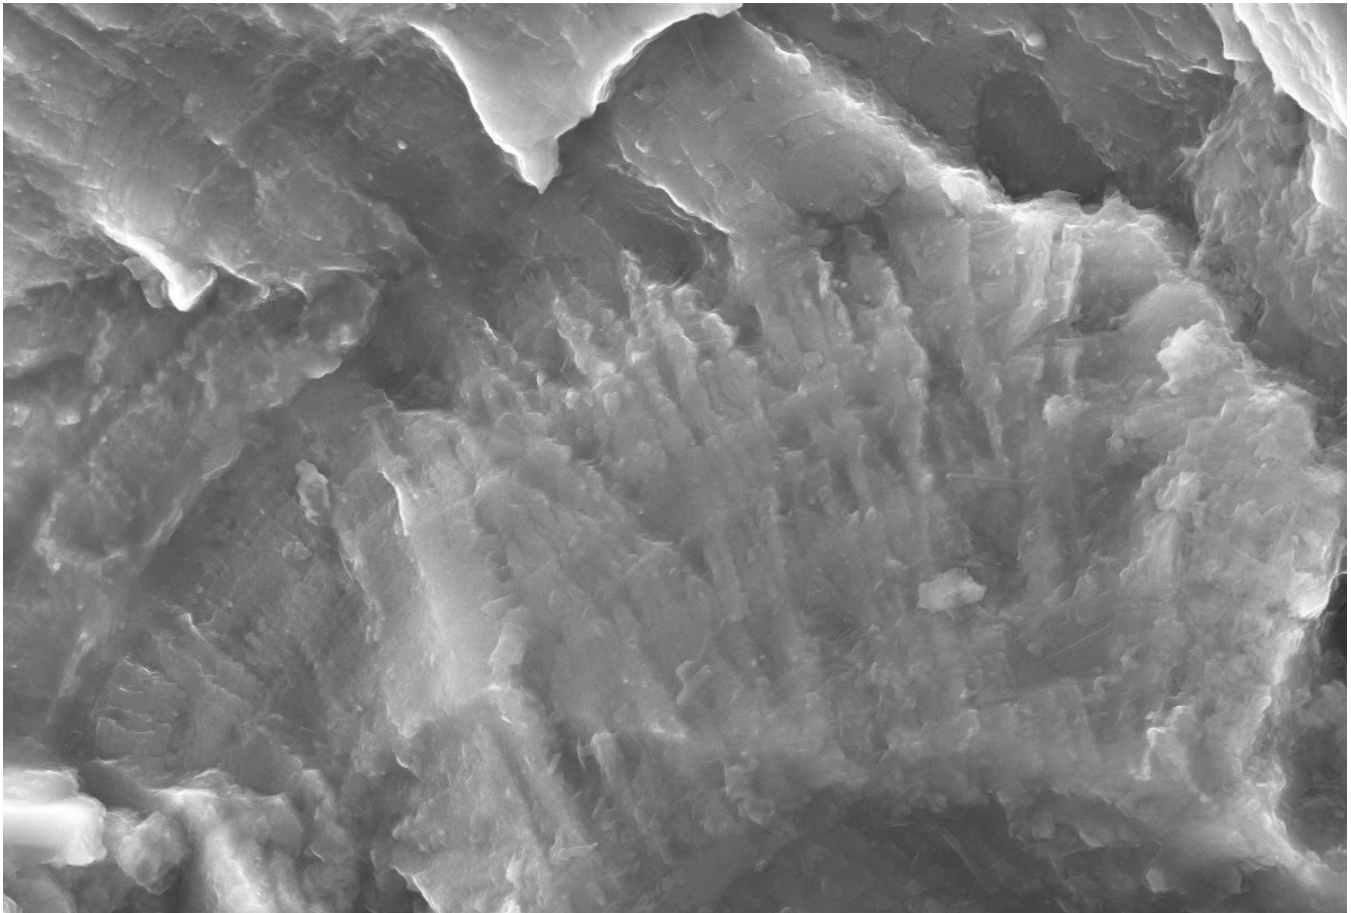
Figure 9 – SE micrograph of fatigue striations on the crack on the right side of the spar.
