NATIONAL TRANSPORTATION SAFETY BOARD

MATERIALS LABORATORY FACTUAL REPORT

Report No. 15-096

Place : Lolo Pass, Idaho
Date : July 28, 2014
Vehicle : Lancair Legacy, N29MM
NTSB No. : WPR14FA316
Investigator : Albert Nixon, AS-WPR

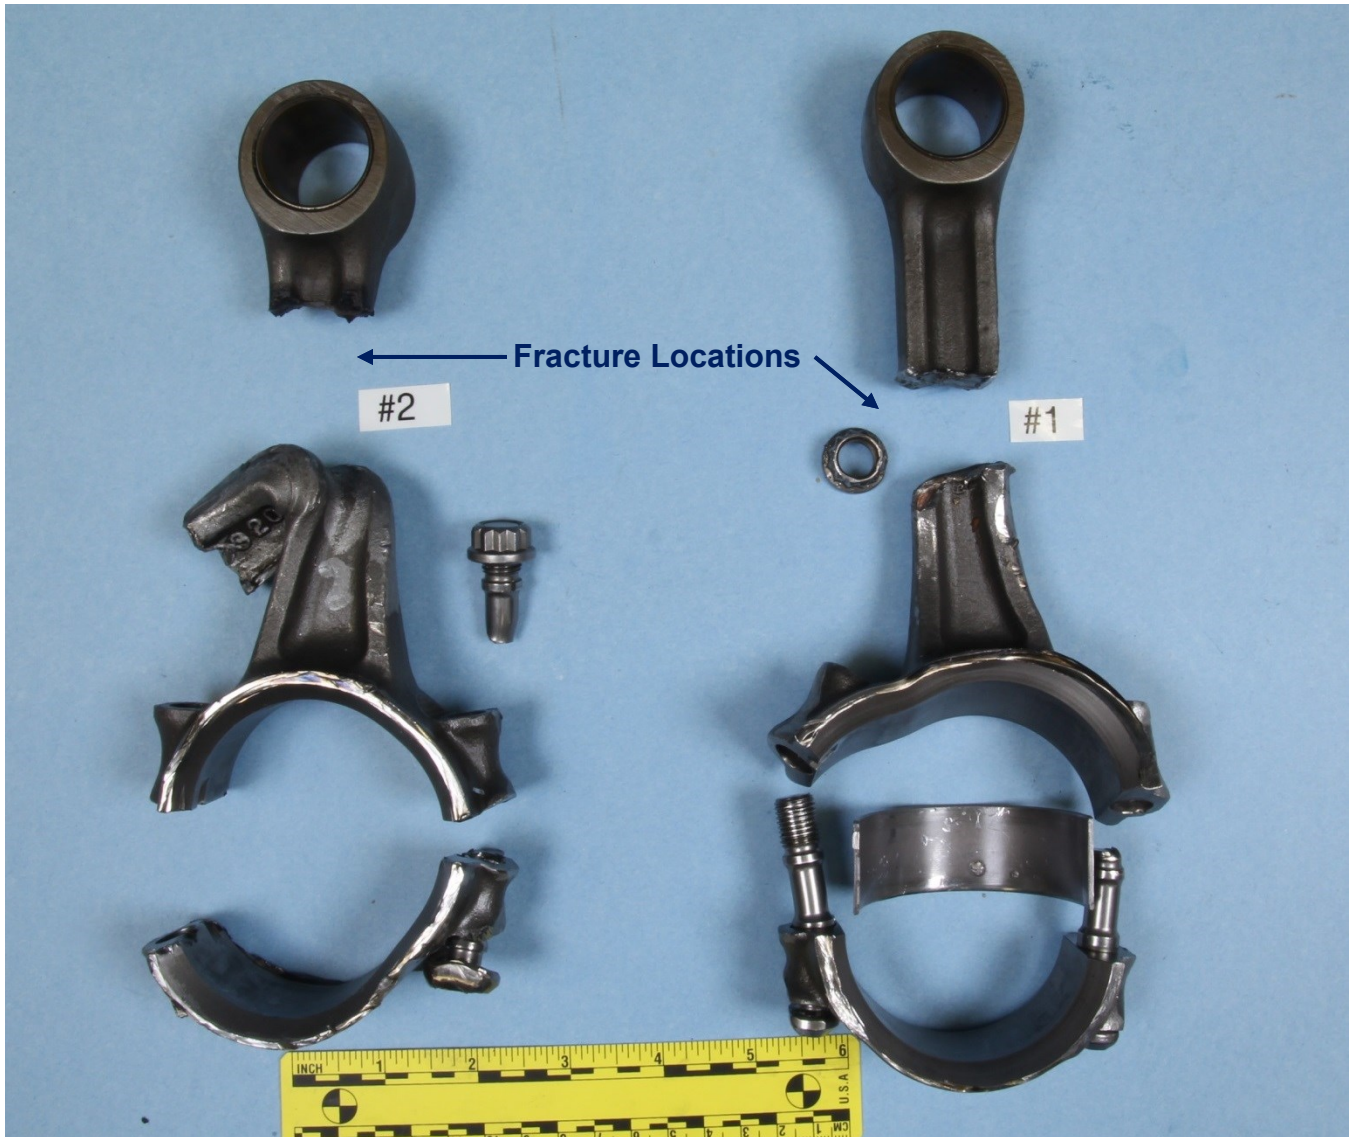
Figure 1 illustrates the two connecting rod assemblies, as received. Both connecting rods had been substantially damaged—both had fractured along the I-beam shafts, with a portion of the #2 connecting rod shaft having bent backward in an approximately 45° angle. Both assemblies exhibited impact batter, consistent with post fracture damage. The #2 rod cap was deformed, and the remaining rod bolt had fractured (the other bolt was missing).

Figure 1 – The #1 and #2 connecting rod assemblies, as received.

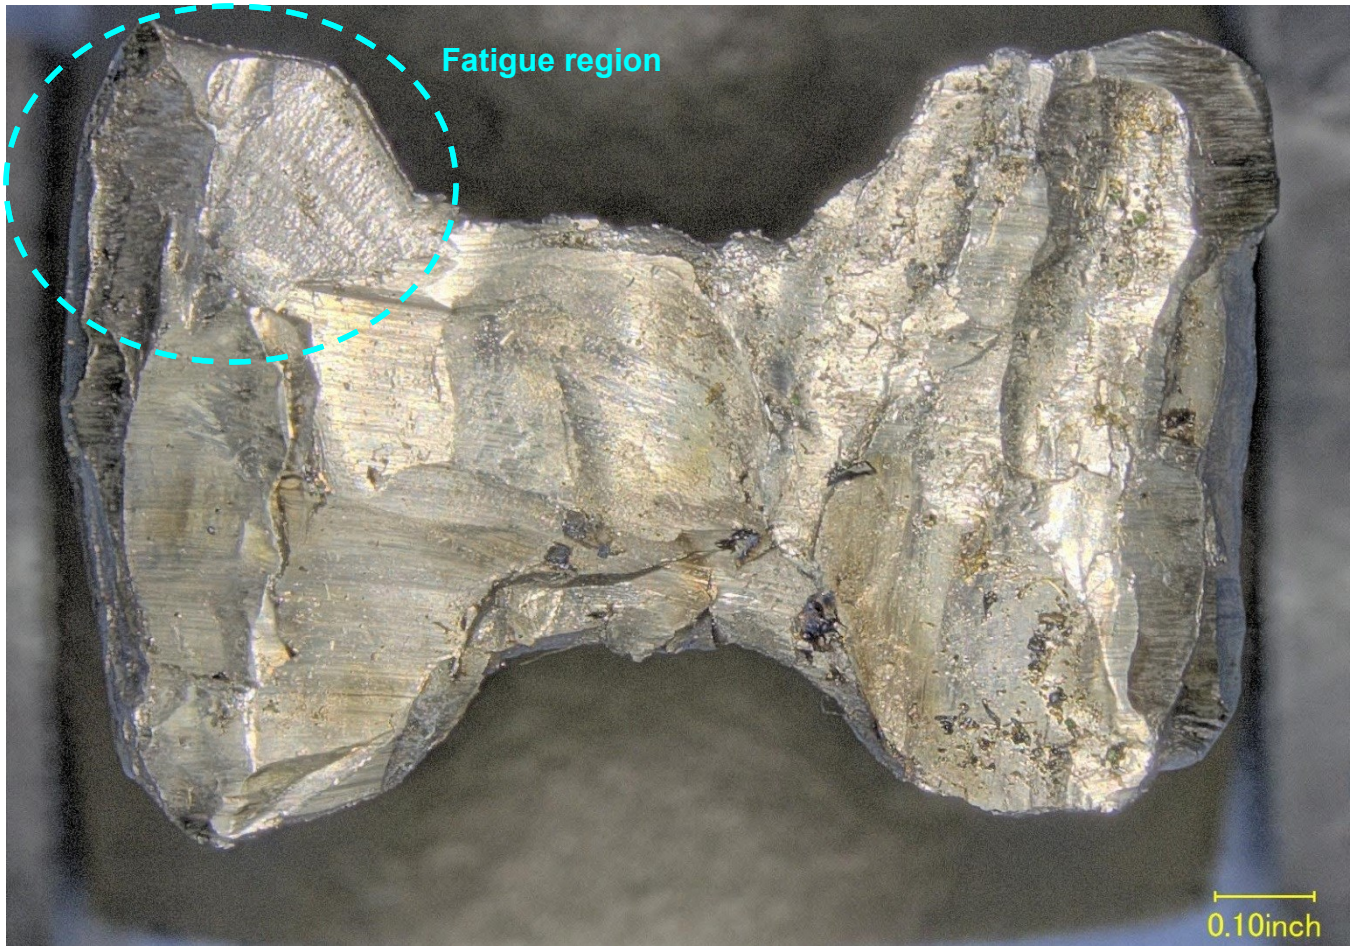
Figure 2 illustrates the fracture surface of the #1 connecting rod shaft from the piston pin end. The majority of the fracture surface had been obliterated by smearing, consistent with post-fracture damage. A portion of the fracture surface (upper left in Figure 2) exhibited features consistent with crack arrest marks.

Figure 2 – The fracture surface of the #1 connecting rod in the shank, from the piston pin end.

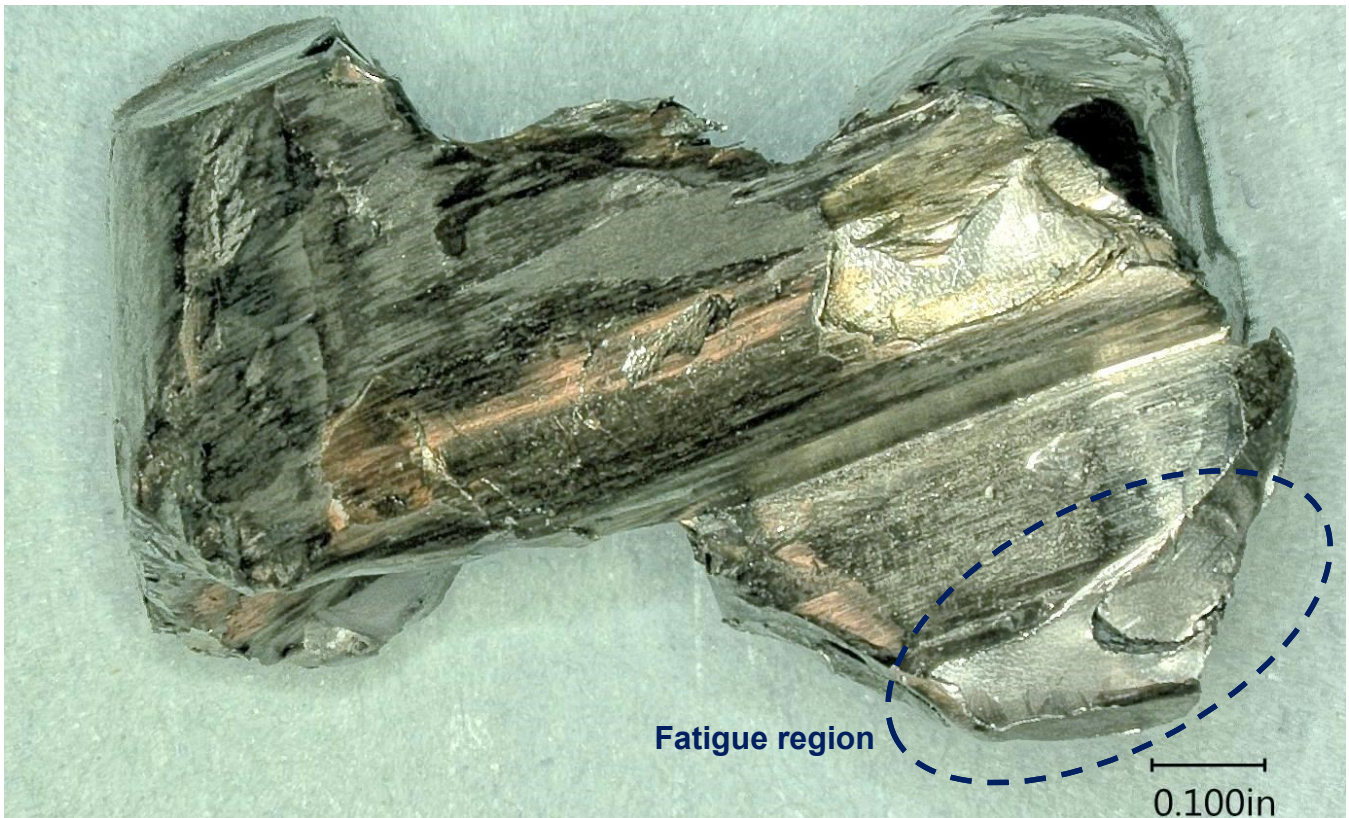
The mating fracture surface, shown in Figure 3, was also heavily smeared and damaged. A portion of the fracture surface (lower right of Figure 3) exhibited crack arrest marks. This area is magnified in Figure 4 and Figure 5. The morphology of the crack arrest marks were consistent with progressive fracture that initiated at or near the rod shaft surface and progressed inward (arrows in Figure 5). The circular tear in this region in Figure 4 and Figure 5 was consistent with subsequent post-fracture damage.

Figure 3 - The fracture surface of the #1 connecting rod in the shank, from the crank end. The area in the lower right is magnified in Figure 4.

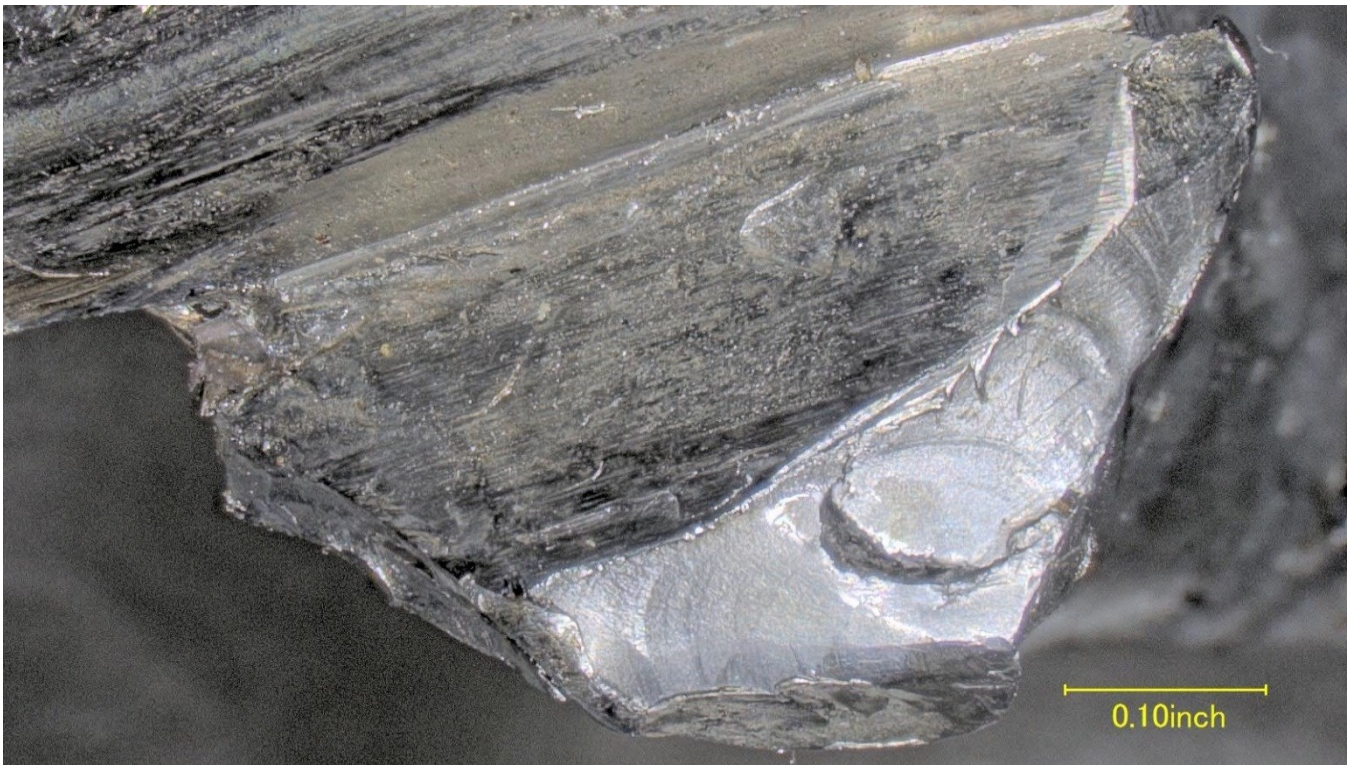
Figure 4 – Closer view of the #1 rod fracture surface from the crank end, showing crack arrest marks (lower right).

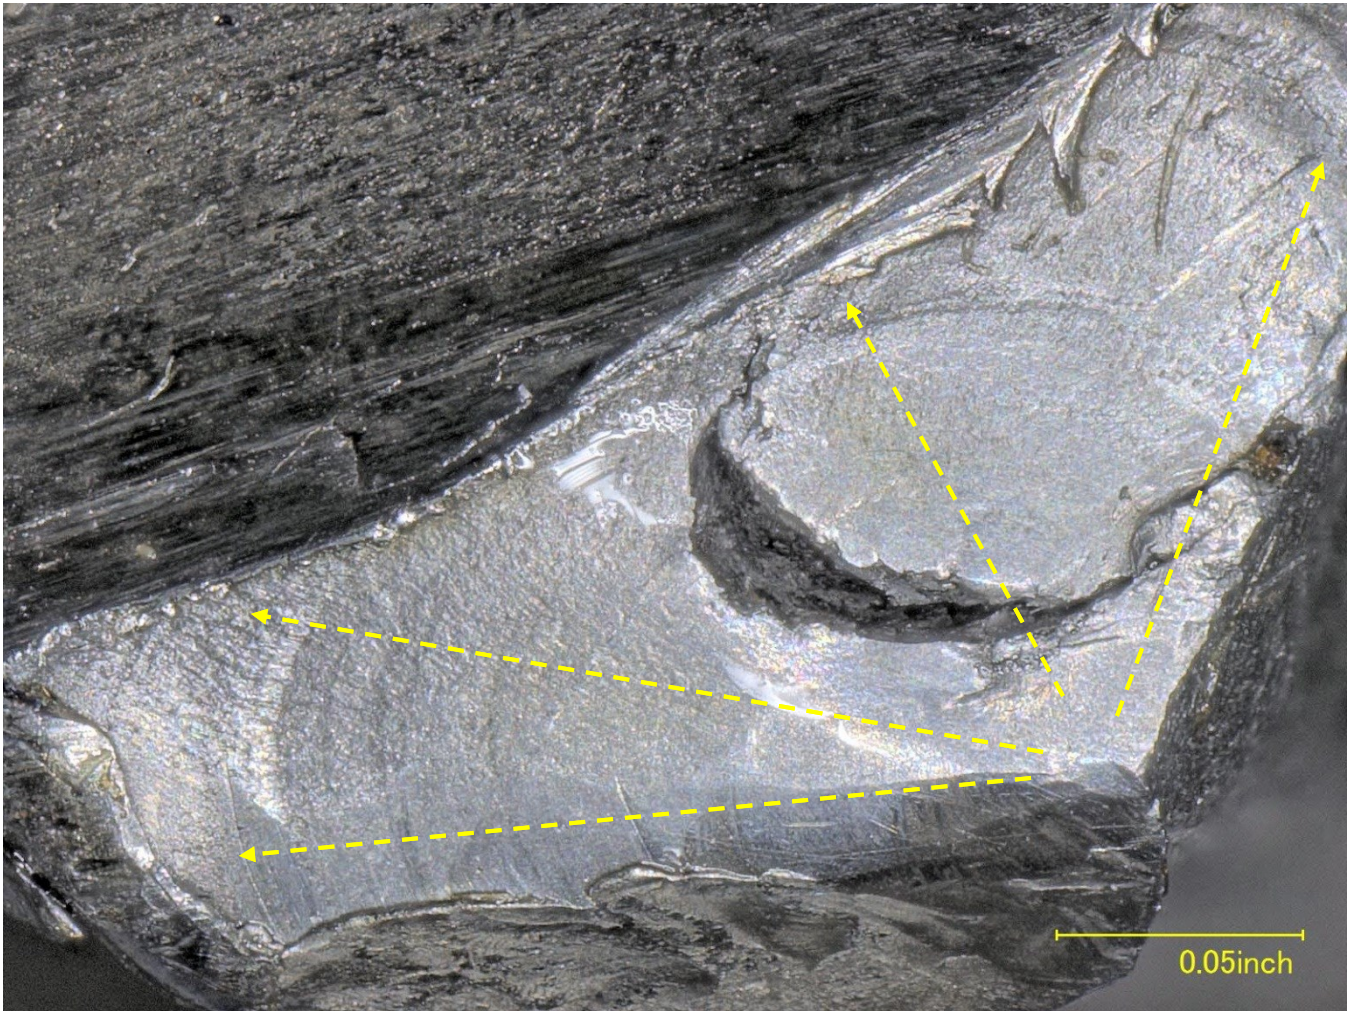
Figure 5 – Closer view of the progressive fracture from the #1 connecting rod shown in Figure 4.

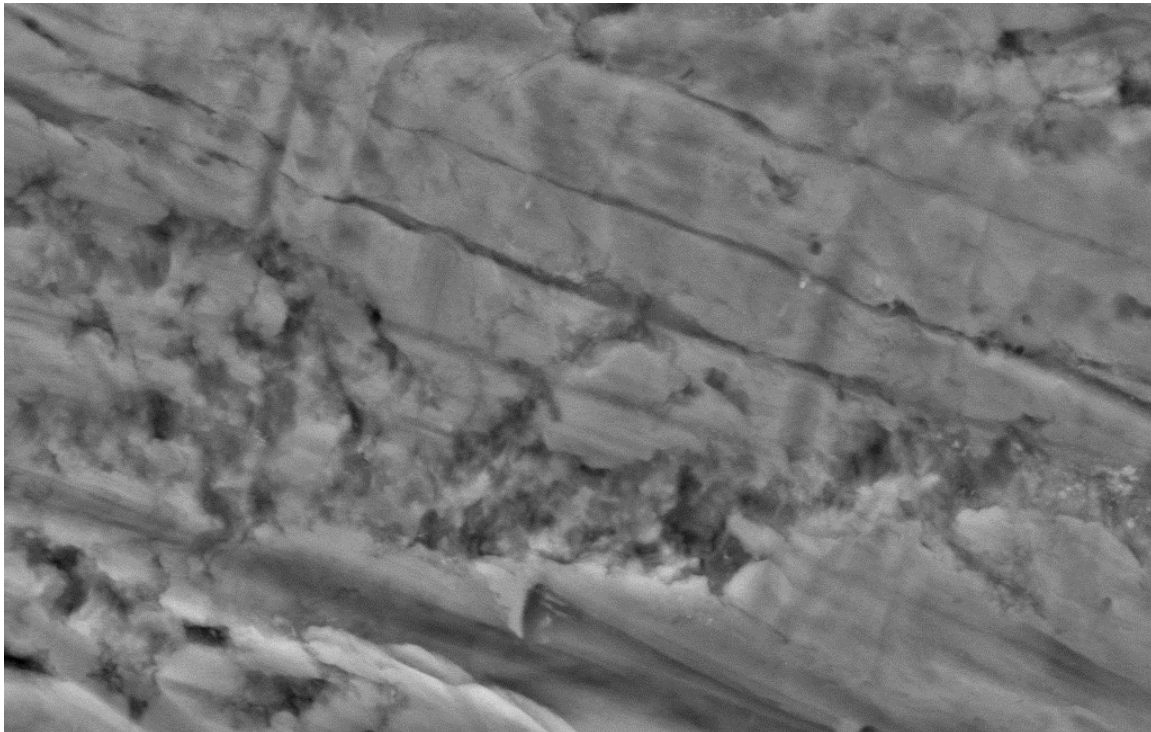
This portion of the fracture surface was examined in a scanning electron microscope (SEM). Figure 6 and Figure 7 illustrate typical areas in the progressive region of the #1 connecting rod fracture surface. This region exhibited striations consistent with fatigue crack propagation. Examination of the crack initiation site revealed no additional features, due to the extensive post-fracture damage in the region.

Figure 6 – Backscattered electron (BE) micrograph of fatigue striations in the progressive fracture region of the #1 connecting rod fracture surface from Figure 5.

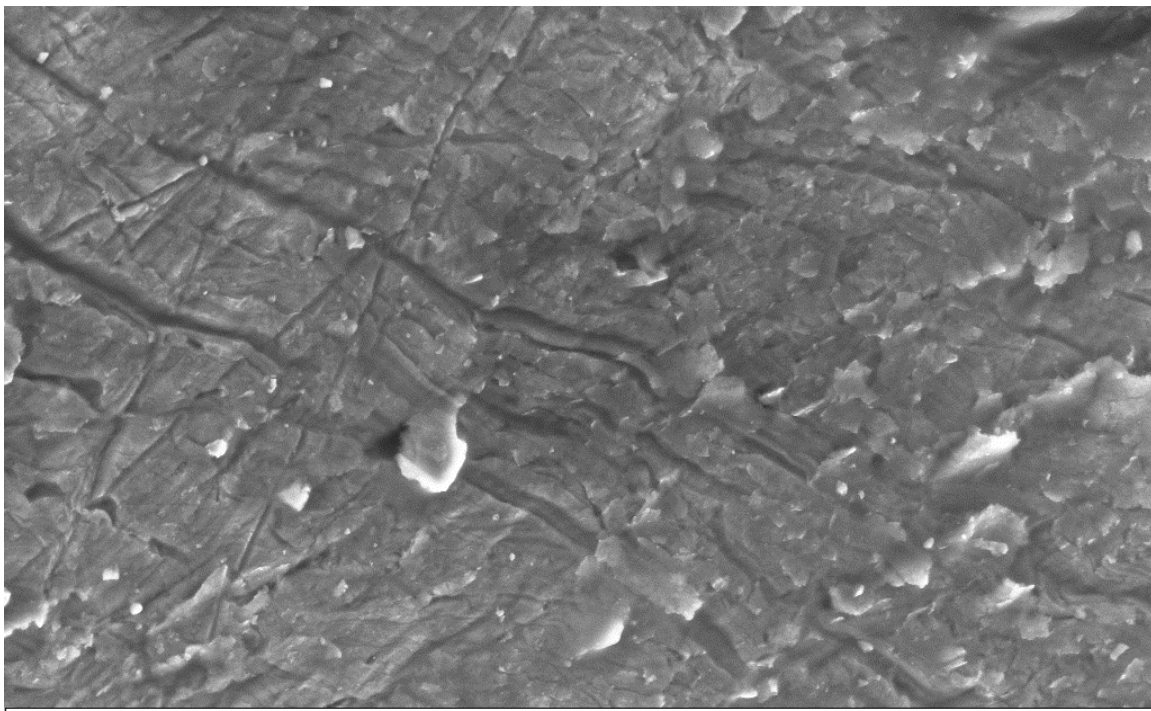
Figure 7 – Secondary electron (SE) micrograph of fatigue striations on the #1 connecting rod fracture surface.

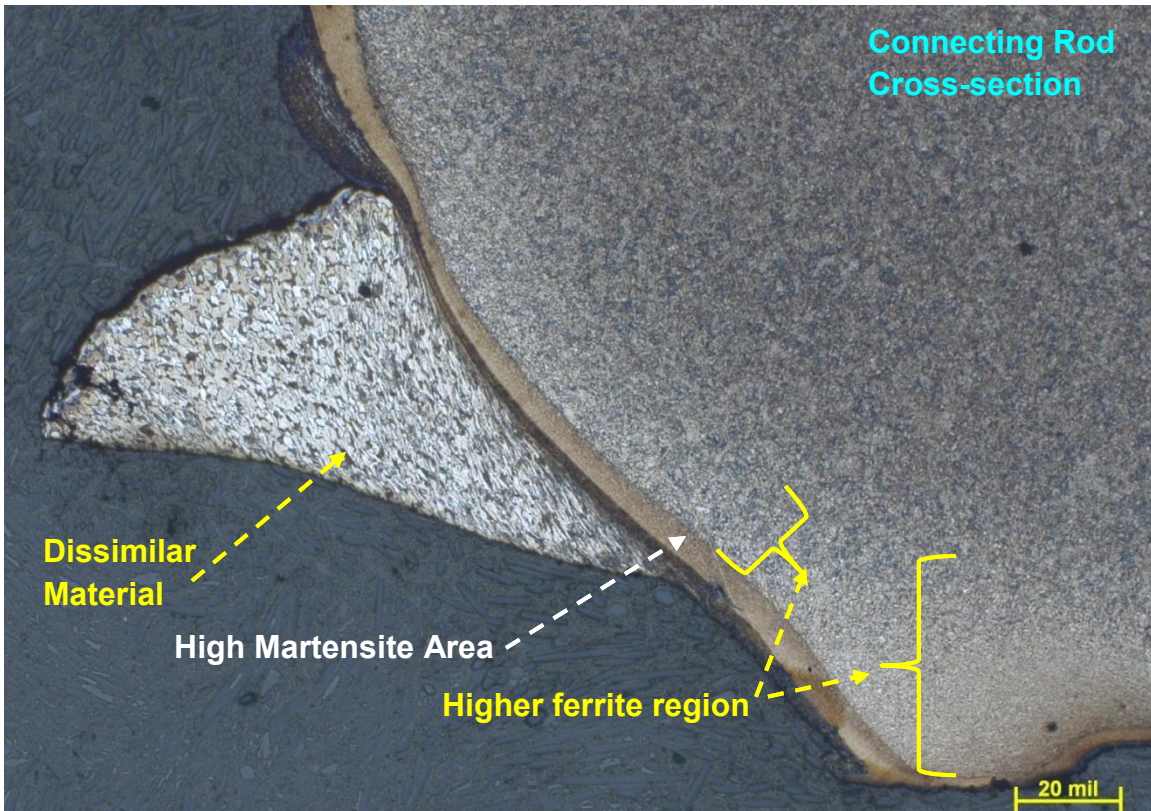
The #1 connecting rod was sectioned just below the fracture surface on the crankshaft side. This cross section was mounted, polished, and etched to examine the microstructure. Figure 8 and Figure 9 show one area of note, located just below the fatigue crack initiation site. The majority of the interior rod shaft microstructure exhibited features consistent with tempered martensite.² However, as shown in both figures, the surface of the rod shaft exhibited a tempered martensite microstructure containing more ferrite (lighter phase), and a darker-colored surface layer, consistent with fine untempered martensite and a highly deformed layer.³ The untempered martensite was consistent with local high heating and rapid quenching. These features were consistent with a high friction area, consistent with contact between the connecting rod shaft and the dissimilar material shown

Figure 8 – Optical metallograph of a corner of the #1 connecting rod shaft cross-section, showing deposited foreign material joined to the rod (etched 2% Nital).

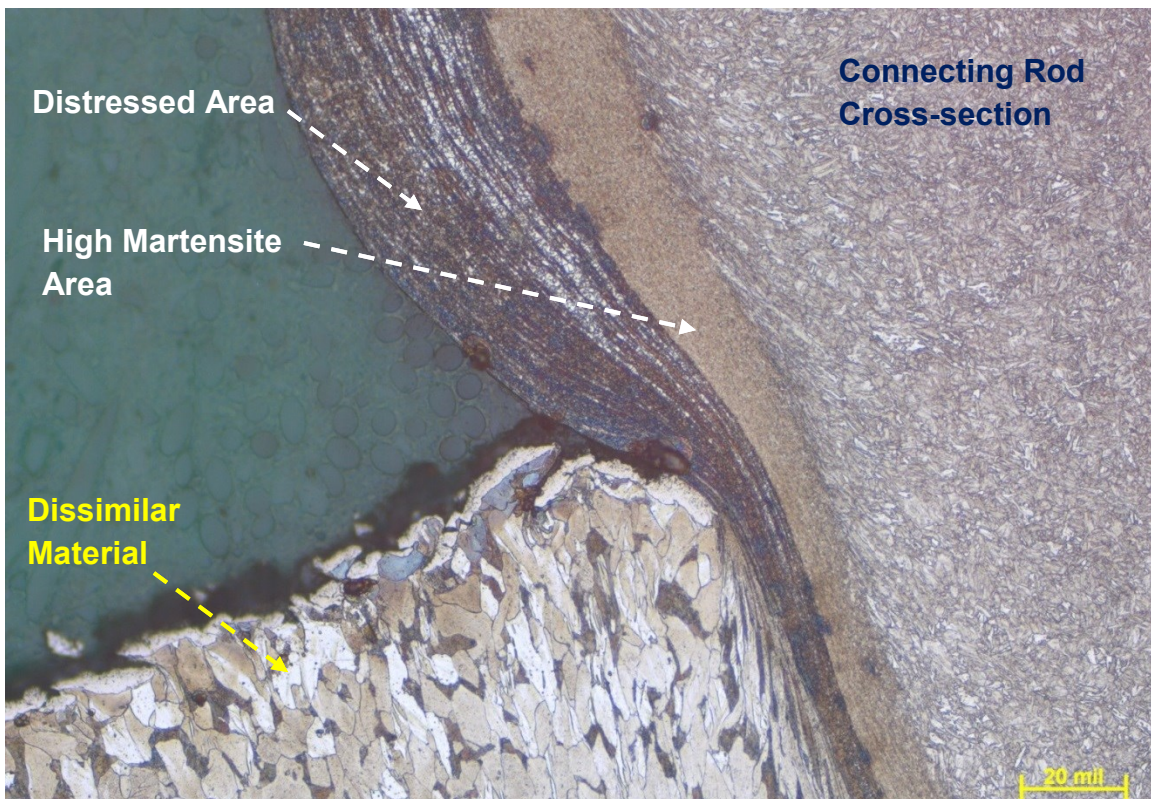
in Figure 9. Away from this area, corrosion pits were also observed on the surface of the shaft cross section, away from the area shown in Figure 8.

Attached to the shaft surface was a separate material, exhibiting a pearlite/ferrite microstructure consistent with many carbon steels.⁴ The microstructure of this material was noticeably different from the shaft material, and was collocated with smeared material present on the shaft rail face in this location. Inspection of the chemical composition of this material using energy dispersive x-ray spectroscopy (EDS) revealed a low-alloy carbon steel composition. Inspection of the shaft cross-section using EDS and x-ray fluorescence (XRF) found it to be consistent with a type 43XX-series alloy steel.

Figure 9 – Closer view of Figure 8, showing the foreign material, attached to the distressed surface layers of the #1 connecting rod (etched 2% Nital).

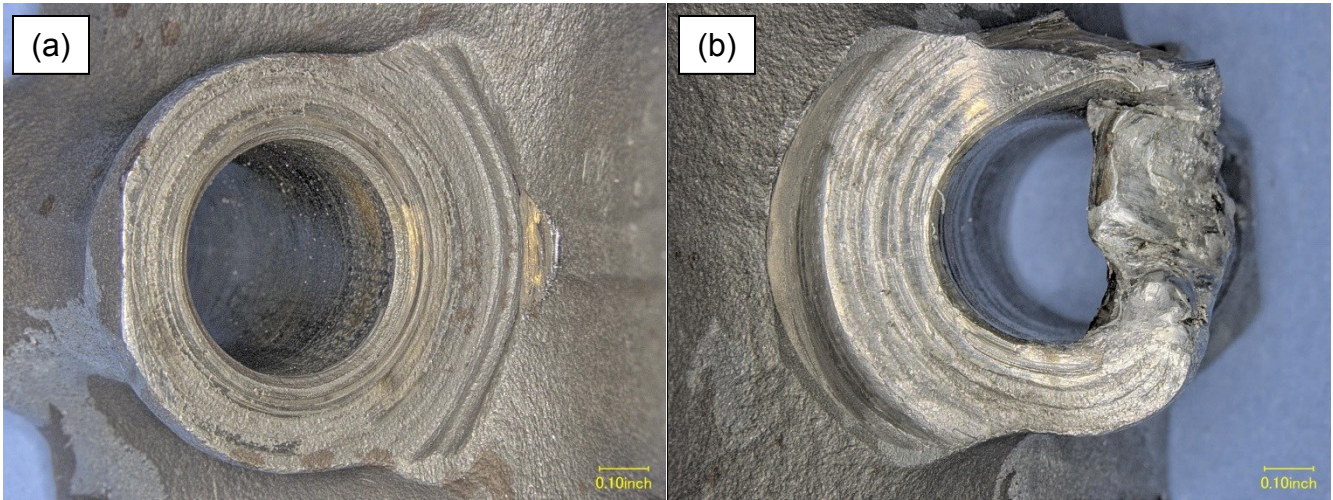
The bolt holes of the #1 connecting rod yoke and the rod cap were examined. Figure 10 illustrates the bolt holes from the #1 rod yoke side (Figure 10b was the location of the fractured bolt). Both surfaces shown in Figure 10 exhibited circumferential wear marks. However, the wear pattern in Figure 10a was more severe, with visible gouging and smearing marks (see Figure 11). Inside the bolt holes, there were no indications of deep wear or excessive contact. The circumferential wear marks inside the bolt holes were consistent with normal service conditions. There were no visible longitudinal wear marks present in the bolt holes.

Figure 10 – The bolt holes from the #1 connecting rod yoke.

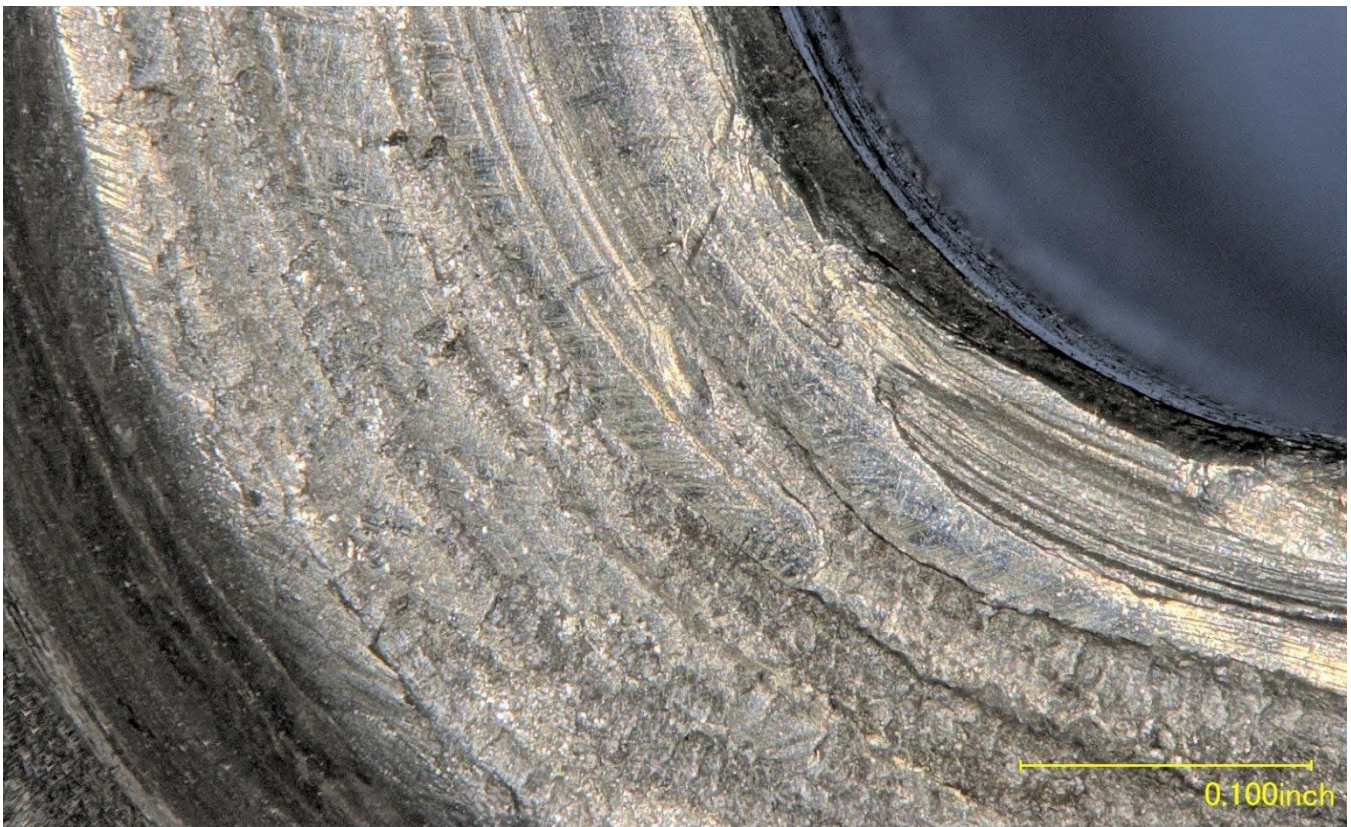
Figure 11 – Closer view of Figure 10a, showing gouging and smearing on the rod surface.

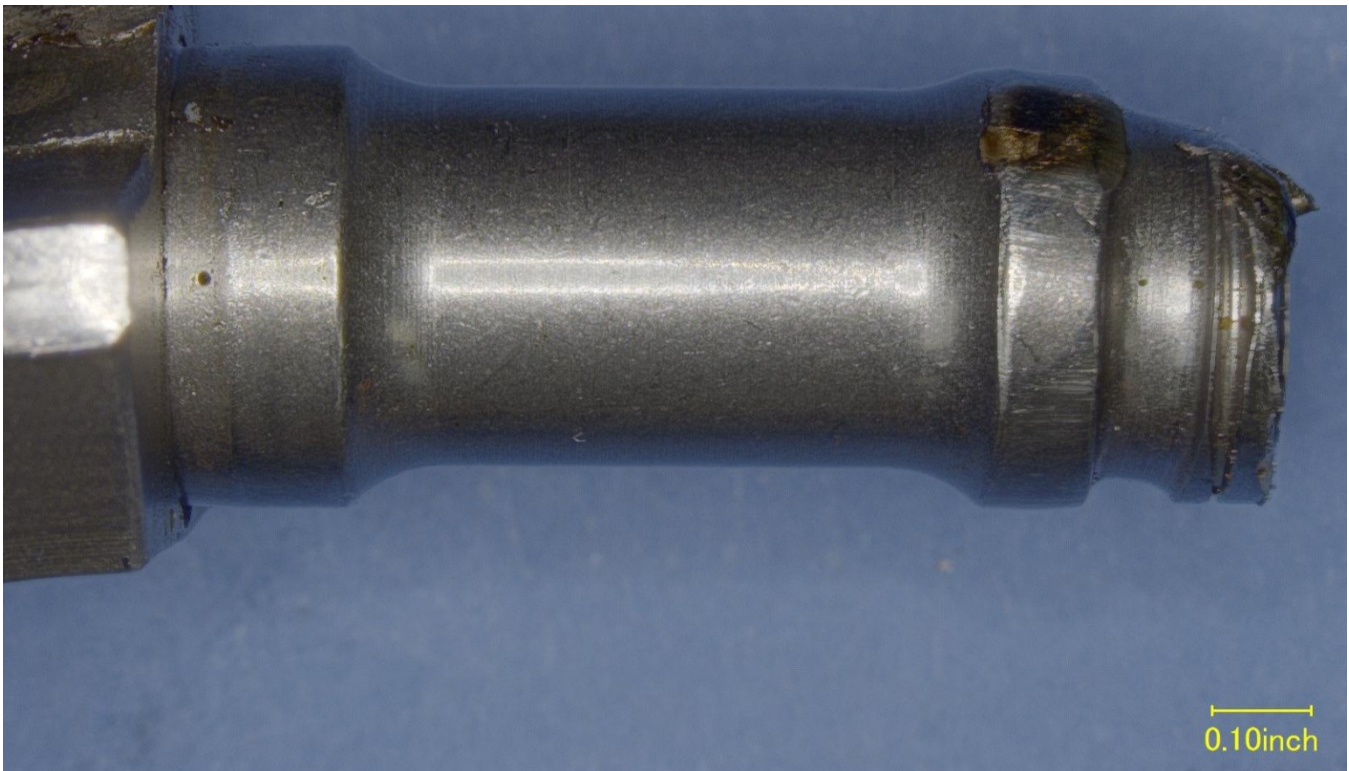
Figure 12 shows the fracture bolt that was present in the bolt hole in Figure 10a. The bolt had been bent towards the fracture surface, with indications of local necking deformation adjacent the fracture surface. The fracture surface, shown in Figure 13, exhibited a reflective luster with a relatively rough texture. Examination in the SEM revealed dimple rupture, consistent with overstress failure of the bolt (see Figure 14).

Figure 12 – The #1 connecting rod yoke bolt (positioned on the right in Figure 1), as viewed from the side.

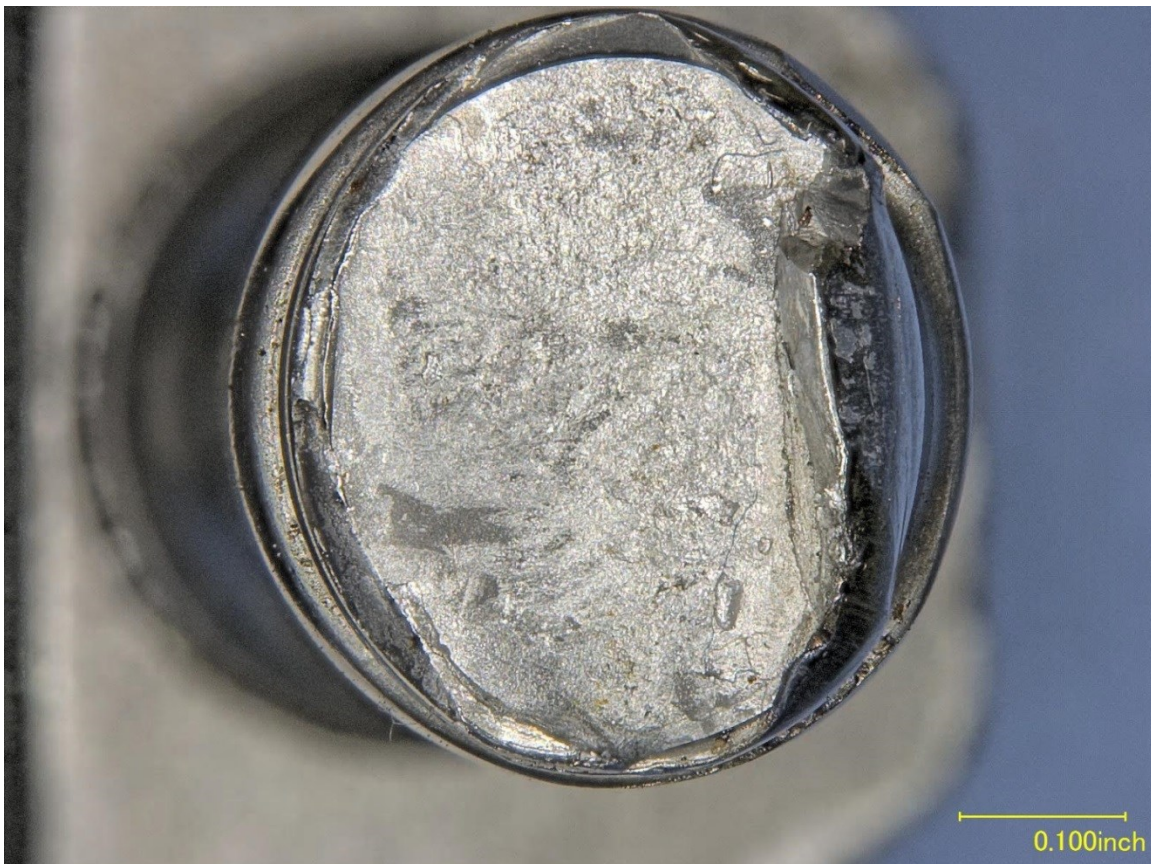
Figure 13 – The fracture surface of the #1 rod yoke bolt, shown in Figure 12.

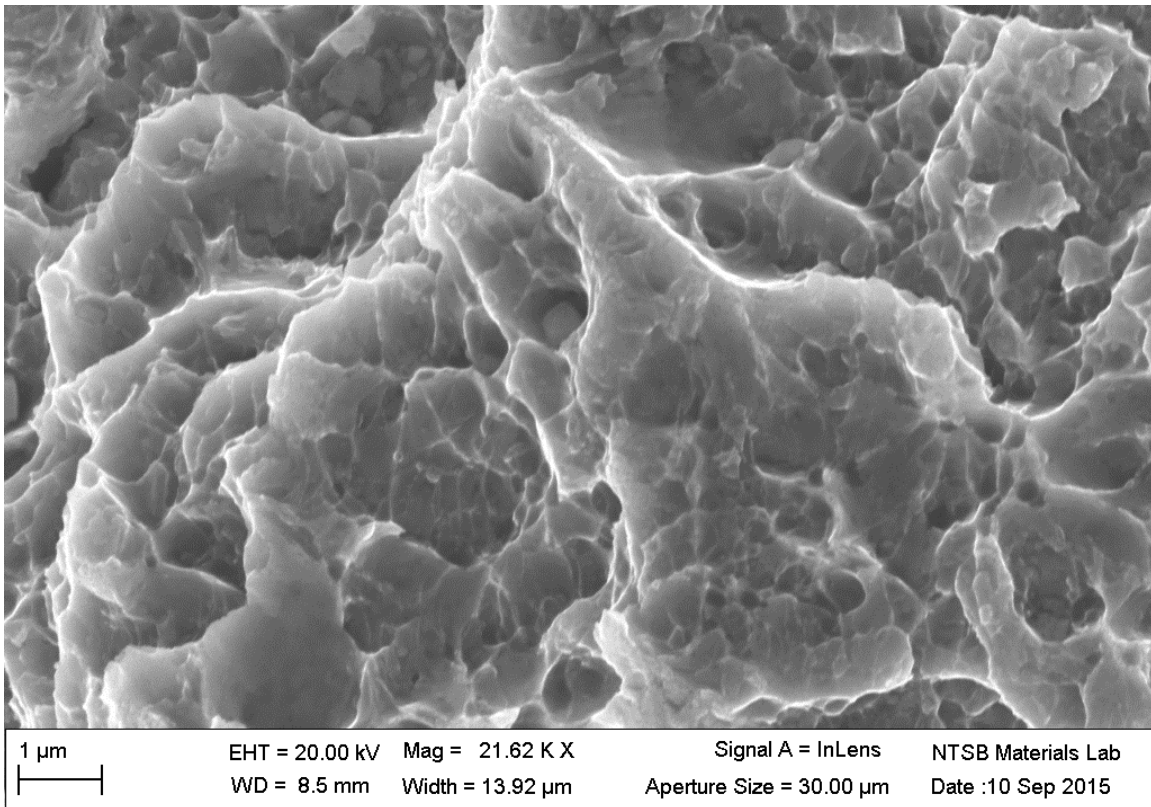
Figure 14 – SE micrograph of the #1 bolt fracture surface, showing dimple rupture consistent with overstress.

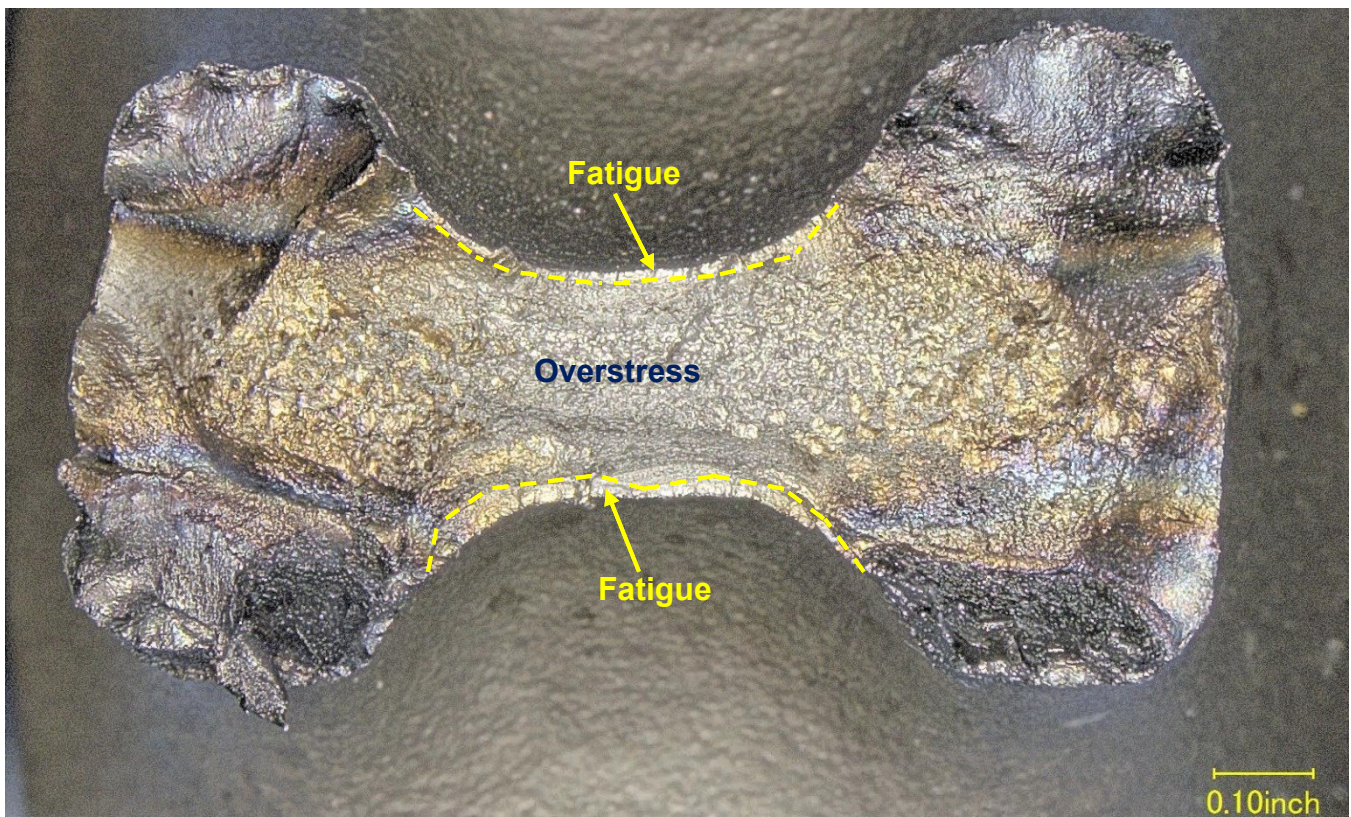
The fracture surface of the #2 connecting rod is illustrated in Figure 15. The fracture surface showed indications of heat tinting on the fracture surface. The fracture surface showed small regions with features consistent with progressive failure. Portions of the fracture surface close to the surface exhibited crack arrest marks, consistent with progressive fracture.

Figure 15 – The #2 connecting rod fracture surface, from the crankshaft side.

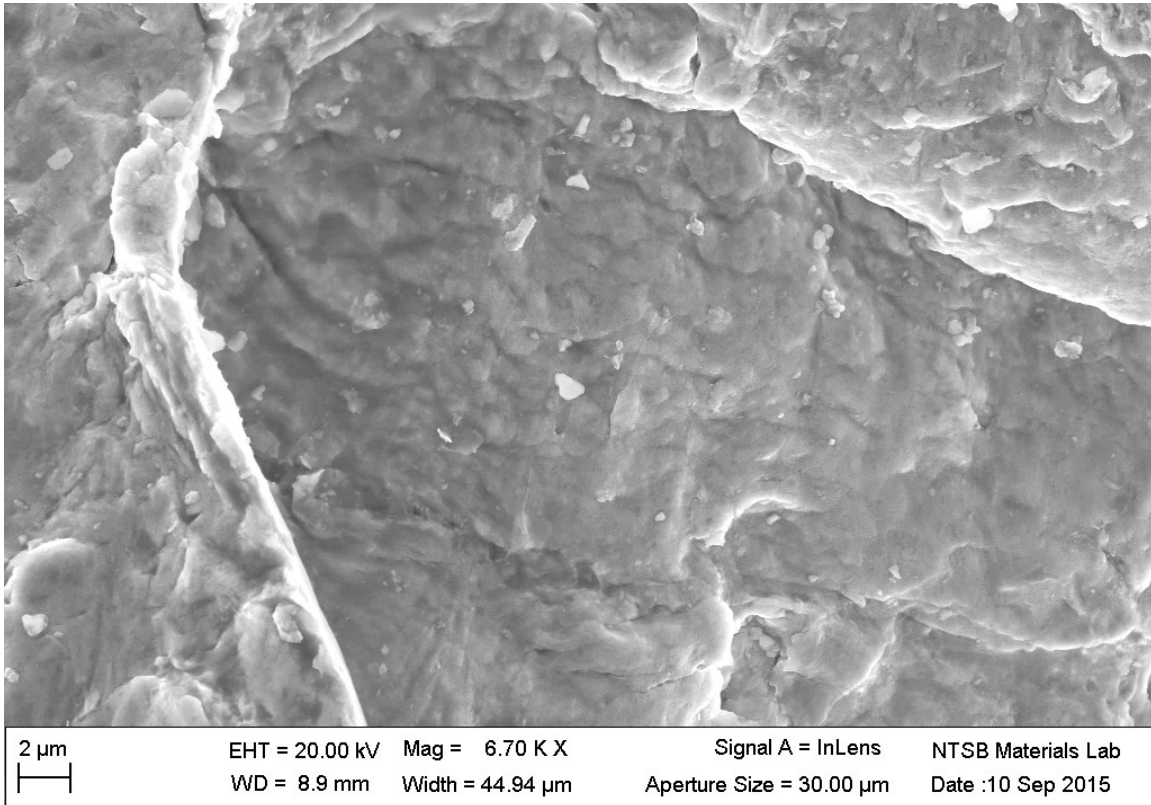
Examination of the progressive portions of the fracture surface using SEM revealed faint fatigue striations (see Figure 16). The remainder of the fracture surface exhibited dimple rupture, consistent with overstress failure, as shown in Figure 17. Examination of the surface of the #2 connecting rod shaft in the fatigue regions of the fracture surface

Figure 16 – SE micrograph of fatigue striations in the thumbnail crack portions of the #2 connecting rod fracture surface.

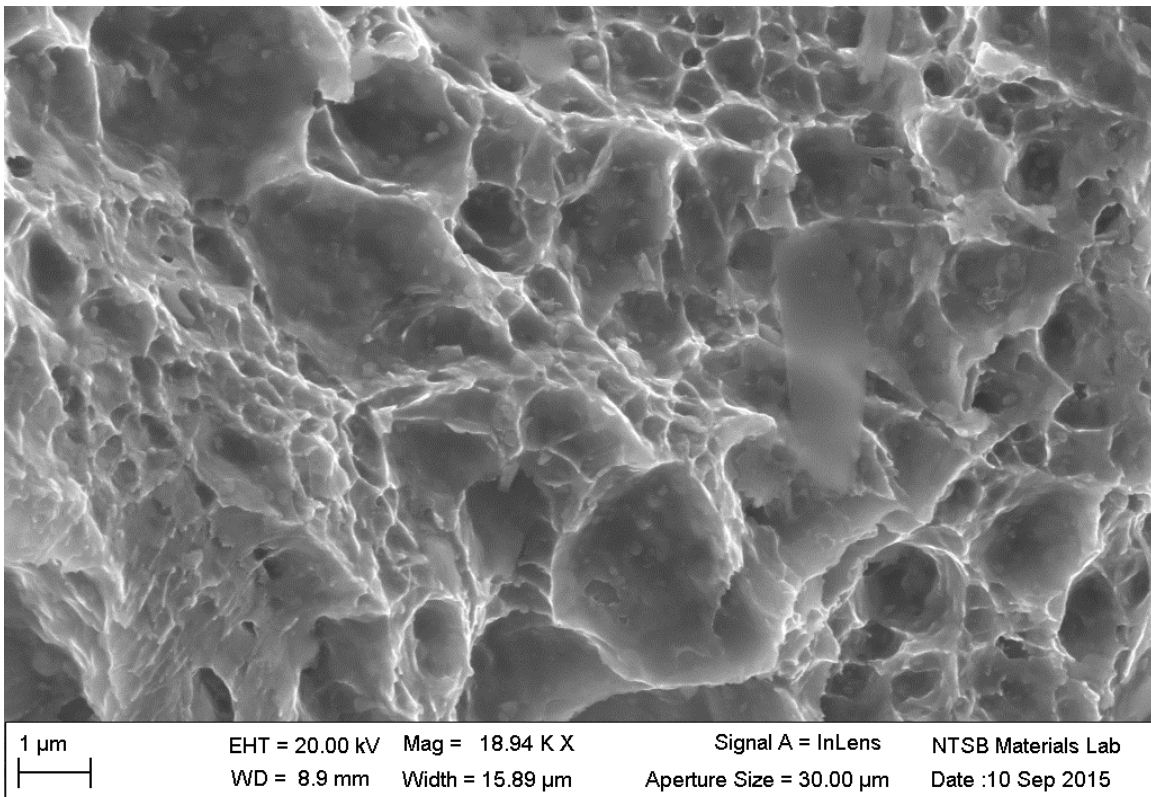
Figure 17 – SE micrograph of dimple rupture features present over most of the inner portions of the #2 connecting rod fracture surface.

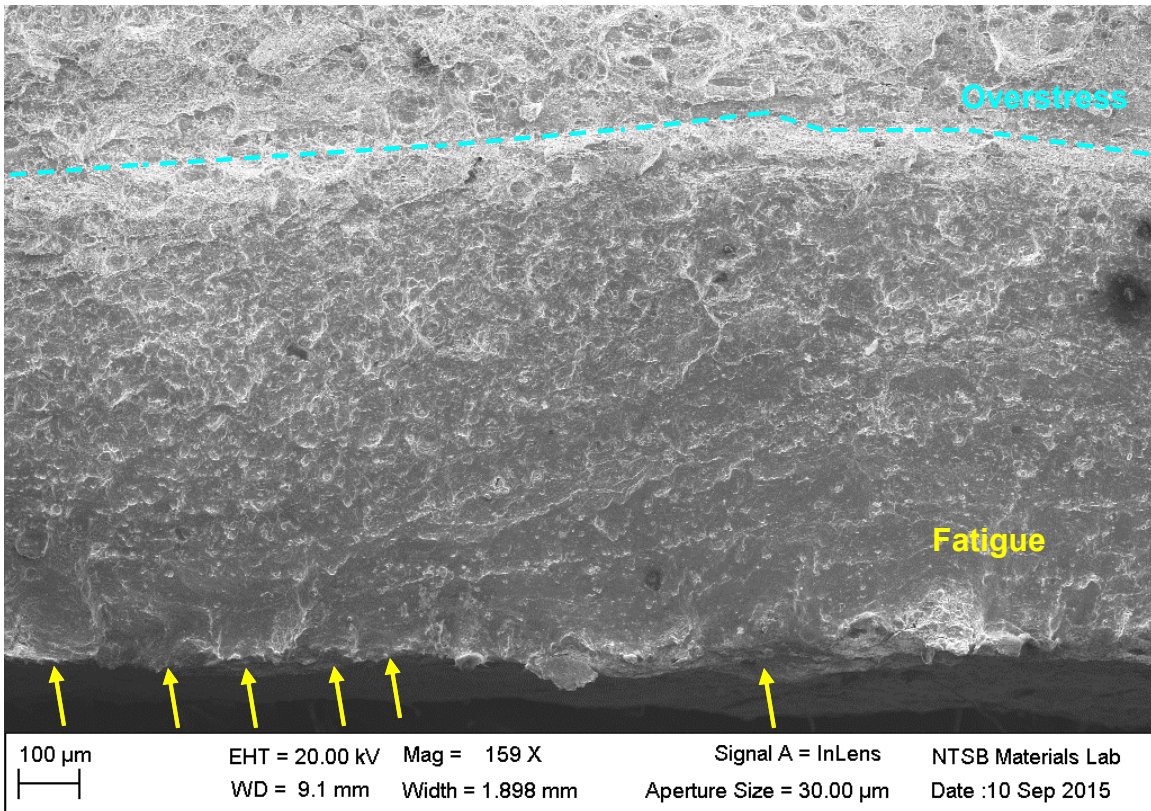
revealed multiple crack initiation sites (see Figure 18). These sites were free of any material artifacts such as inclusions, pores, or corrosion pits.

Figure 18 – SE micrograph of the fatigue region, showing multiple crack initiation sites (arrows) on the #2 rod surface.

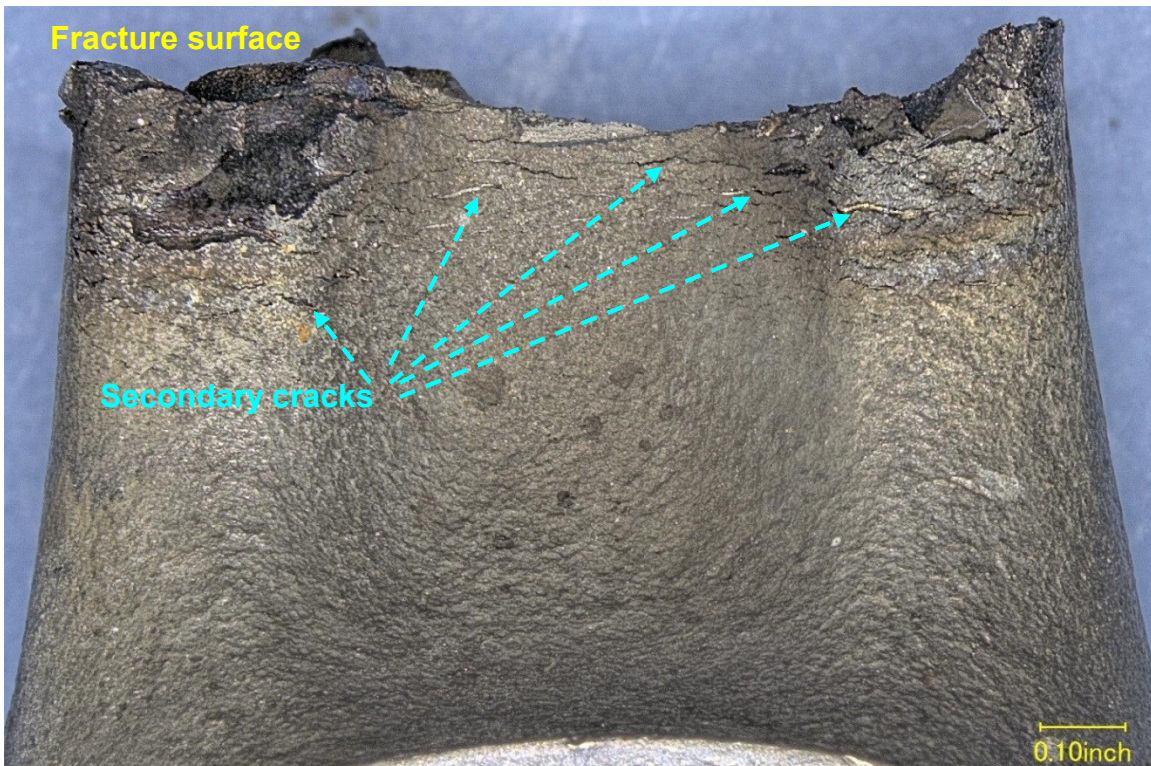
Below the fracture surface on the side of the shaft of the #2 connecting rod were areas of multiple secondary cracks. These cracks were oriented parallel to the fracture surface, as shown in Figure 19. Figure 20 shows a closer view one of these secondary cracks. The features inside the secondary cracks were consistent with fatigue striations propagating inward.

Figure 19 – The #2 connecting rod shaft near the fracture surface, from the side, showing secondary cracks below the fracture surface.

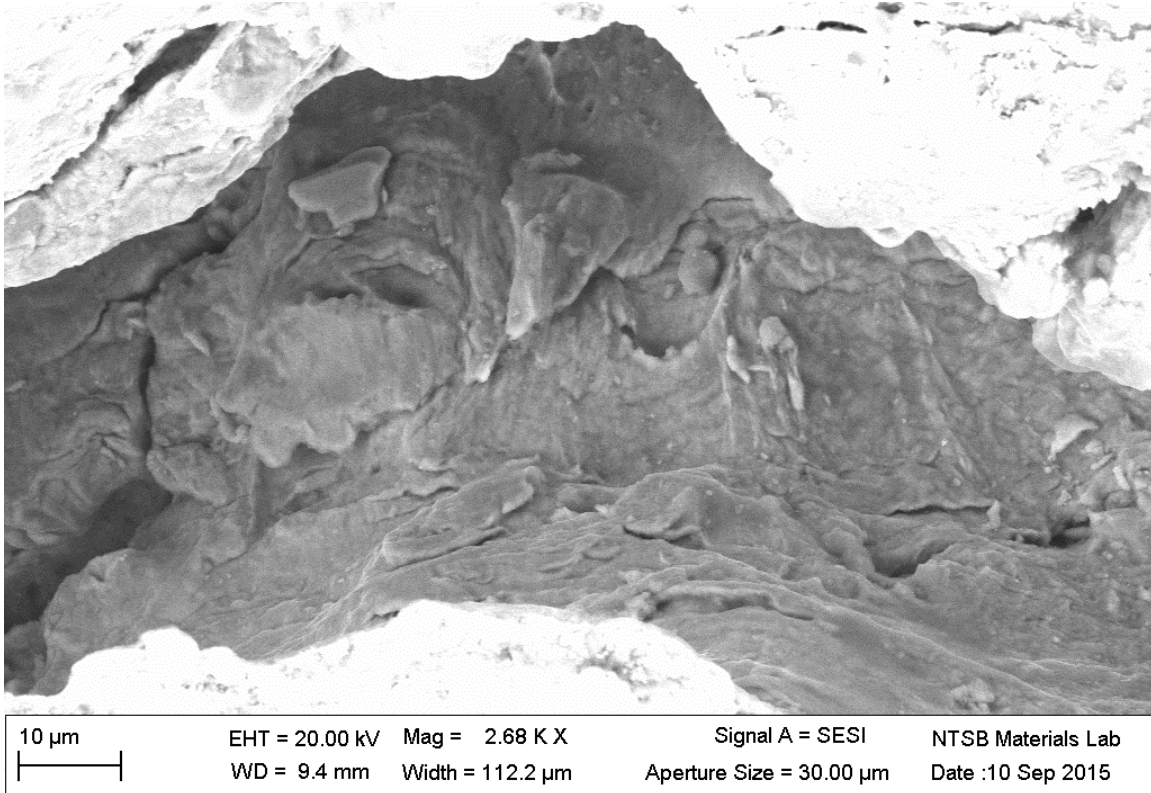
Figure 20 – SE micrograph of faint fatigue striations in the secondary cracks along the shaft of the #2 connecting rod (shown in Figure 19).
