NATIONAL TRANSPORTATION SAFETY BOARD

MATERIALS LABORATORY FACTUAL REPORT

Report No. 15-096

Place : Lolo Pass, Idaho
Date : July 28, 2014
Vehicle : Lancair Legacy, N29MM
NTSB No. : WPR14FA316
Investigator : Albert Nixon, AS-WPR

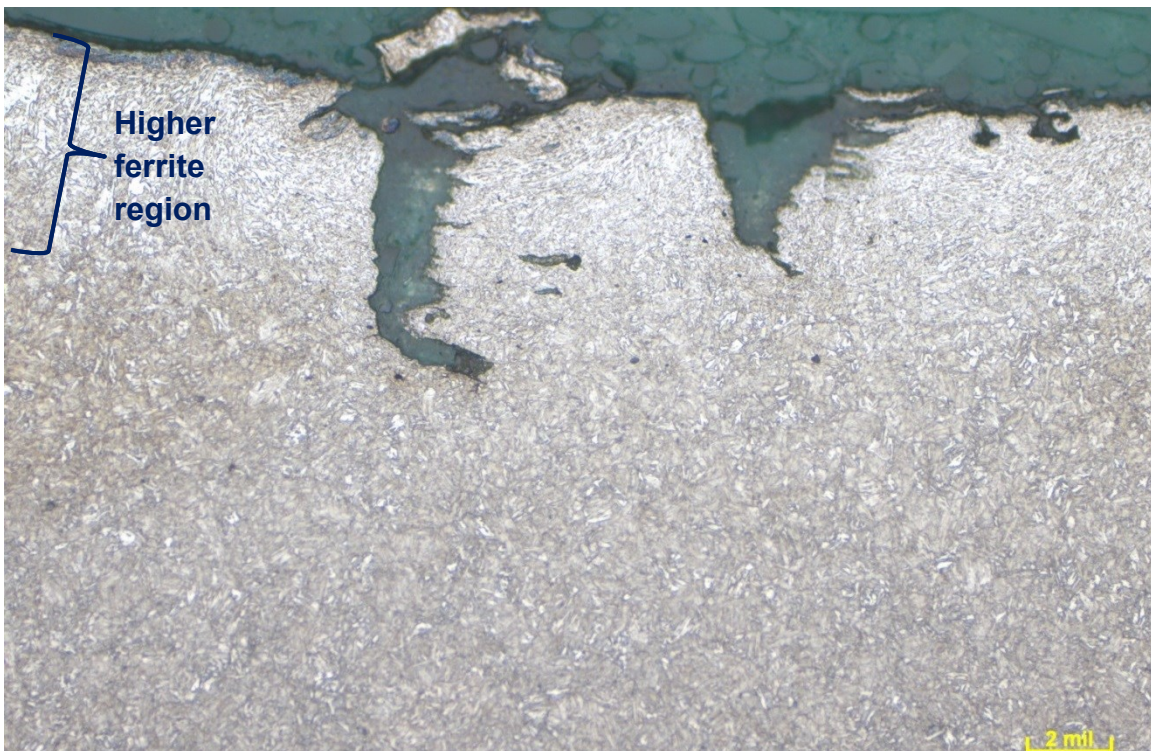
Figure 21 illustrates a cross-section of the #2 connecting rod, parallel to the grain direction (perpendicular to the secondary crack and fracture surface). Two of the smaller secondary cracks were present in this cross section. The microstructure was consistent with tempered martensite, particularly towards the interior. Closer to the surface, the rod microstructure contained more ferrite (lighter colored phase).

Figure 21 – Optical metallograph of a cross-section of the #2 connecting rod shaft, sectioned through two of the secondary cracks shown in Figure 19 and Figure 20 (etched 2% Nital).

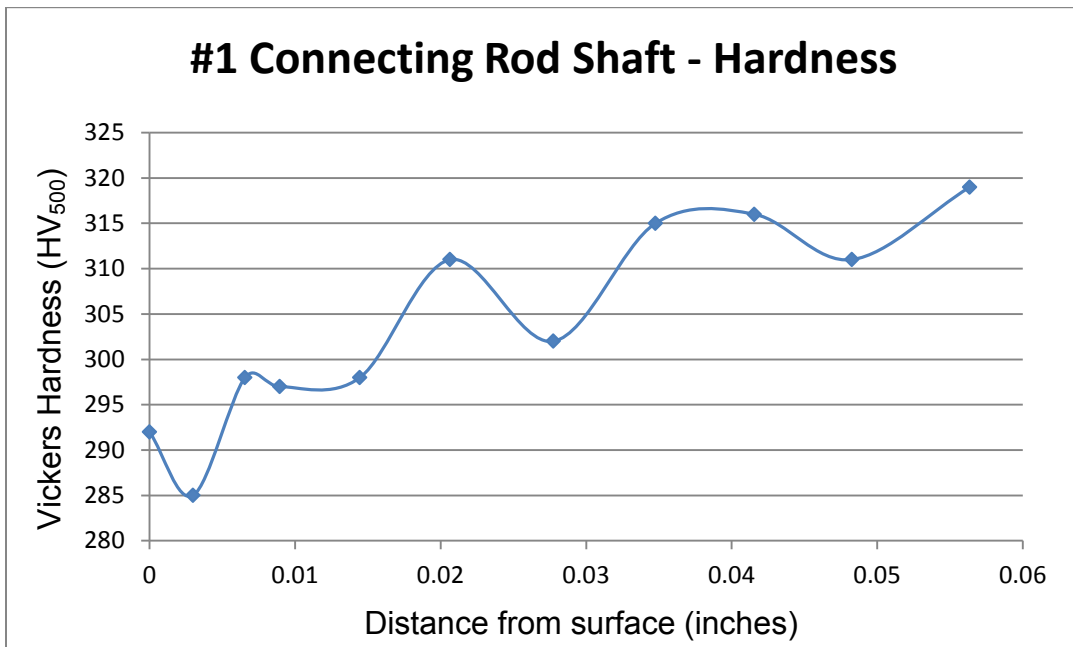
The hardness results indicated that the rod shafts exhibited lower hardness towards the surface. The average hardness towards the interior of the #1 and #2 connecting rod shafts averaged 32 HRC (315 HV₅₀₀) and 30 HRC (303 HV₅₀₀), respectively. This hardness decreased approximately 10% and 25% towards the surface on the #1 and #2 shaft surfaces. The lower hardness measurements were primarily present up to depths of 0.03 inches, which corresponded with the higher ferrite illustrated in Figure 8 and Figure 21. These characteristics were consistent with partial surface decarburization of the connecting rod shafts.⁶

Figure 22 – Chart showing the hardness (HV₅₀₀) from the surface to the interior of connecting rod #1.

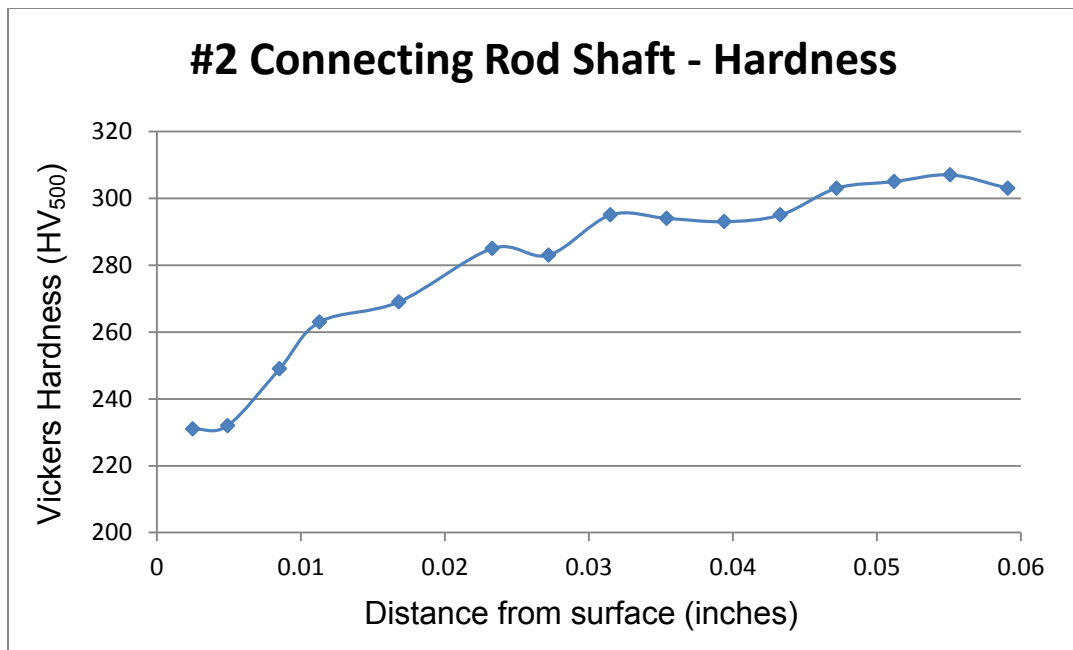
Figure 23 – Chart showing the hardness (HV₅₀₀) from the surface to the interior of connecting rod #2.
