**MATERIALS LABORATORY GROUP CHAIRMAN'S  
FACTUAL REPORT**

**HWY15MH006**

MATERIALS LABORATORY FACTUAL REPORT

Report No. 15-093

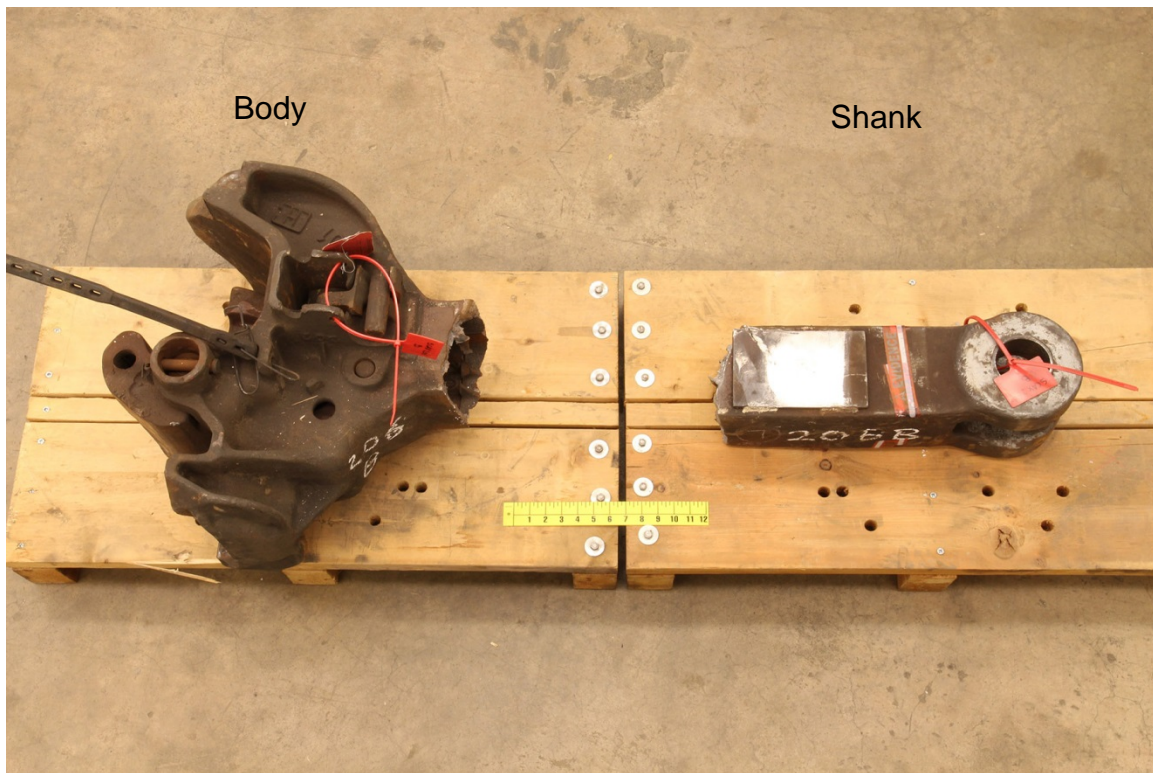
The as-received coupler is shown in figure 1. The coupler was fractured through the shank approximately 2 inch from the body. There were no indications of left/right bending deformation in the shank, as shown in figure 2a. In contrast, when viewed from the side, the lower portion of the shank exhibited downward plastic bending deformation, as indicated in figure 2b. The deformation pattern was consistent with the fracture starting in the upper portion of the shank and ending in the lower portion of the shank.

**Figure 1:** Image of the underside of the fractured B-end coupler. The coupler was fractured through the shank approximately 2 inch from the body.

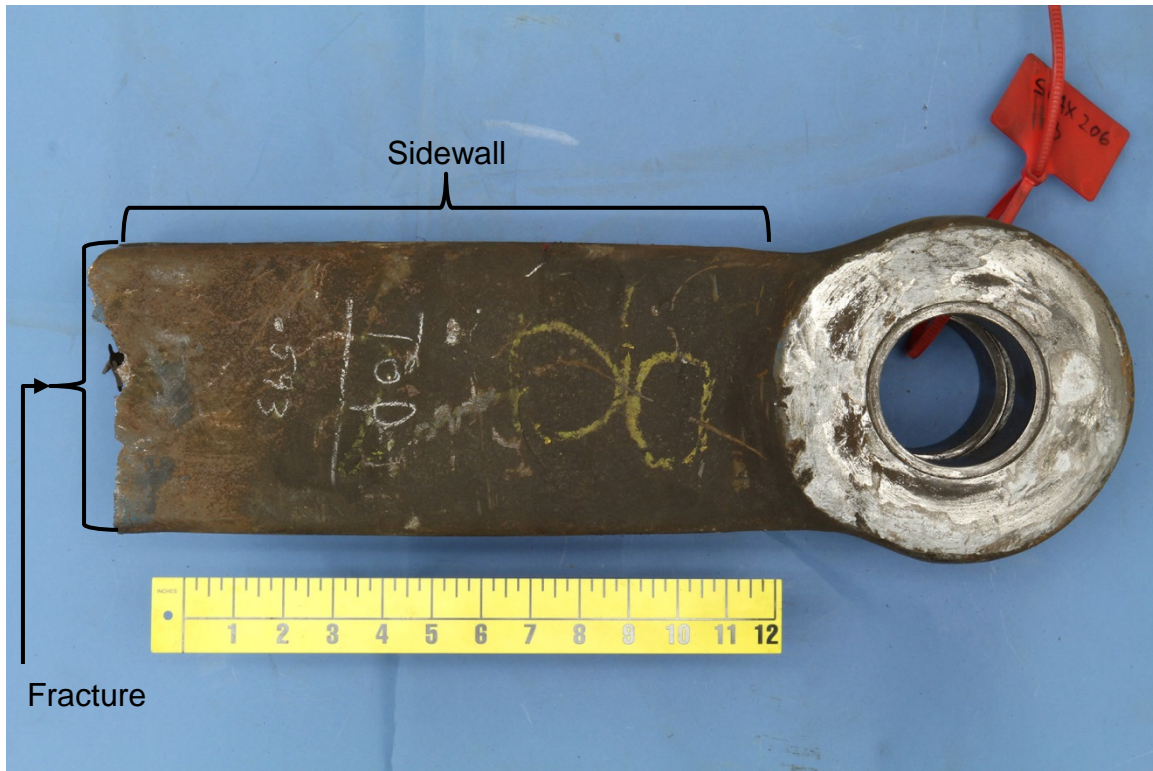
**Figure 2:** a) Top down view of the fractured coupler shank and b) side view of coupler shank.

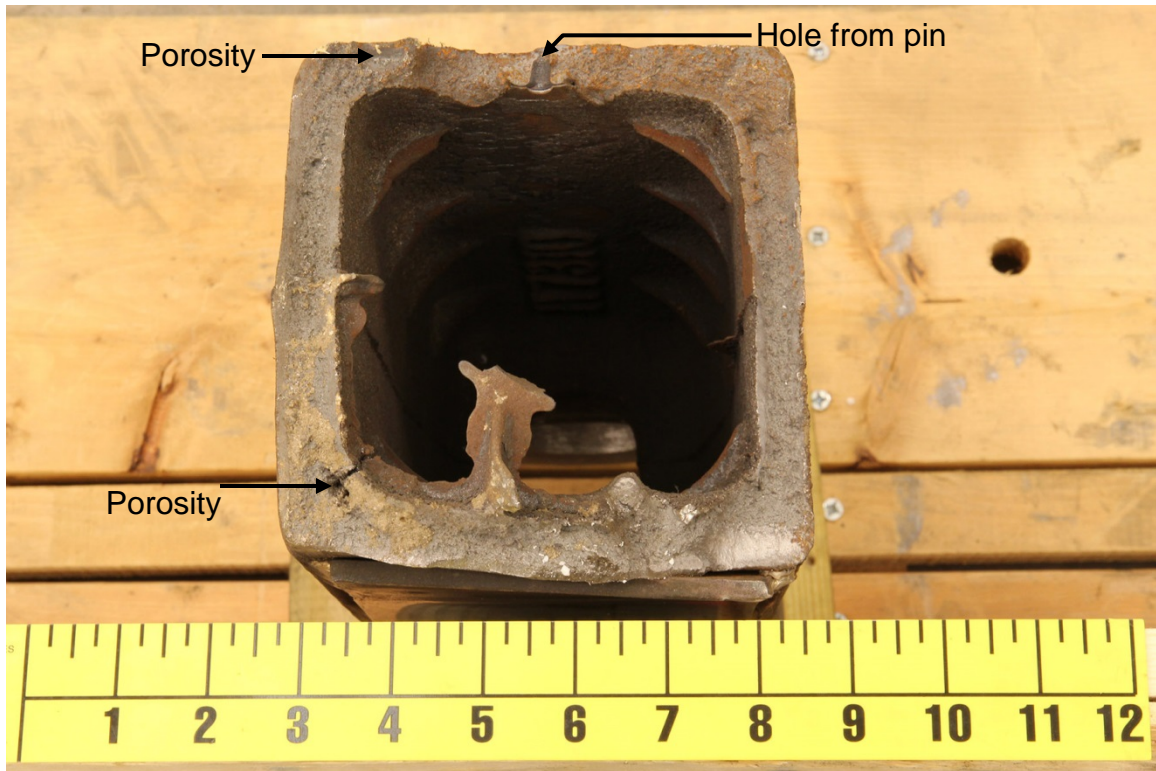
Examination of the fracture surfaces indicated that there was a pin embedded in the casting on the coupler body-side of the fracture on the top side of the coupler. On the mating shank-side of the fracture there was a matching cylindrical hole in the top center of the fracture, as indicated in figures 3a and 3b. Two additional porosity features

were identified on the fracture and are also indicated in figure 3a. The cross sectional area of the porosity features was approximately 0.10 inch<sup>2</sup> and 0.13 inch<sup>2</sup> as measured on a calibrated image. Remnant gate stubs were visible on the inside of the shank rising approximately 1 inch to 1.5 inch above the inside surface, as seen in figures 3a and 3b.

**Figure 3:** Images of the mating coupler fracture surfaces: a) shank-side fracture surface and b) body-side fracture surface.

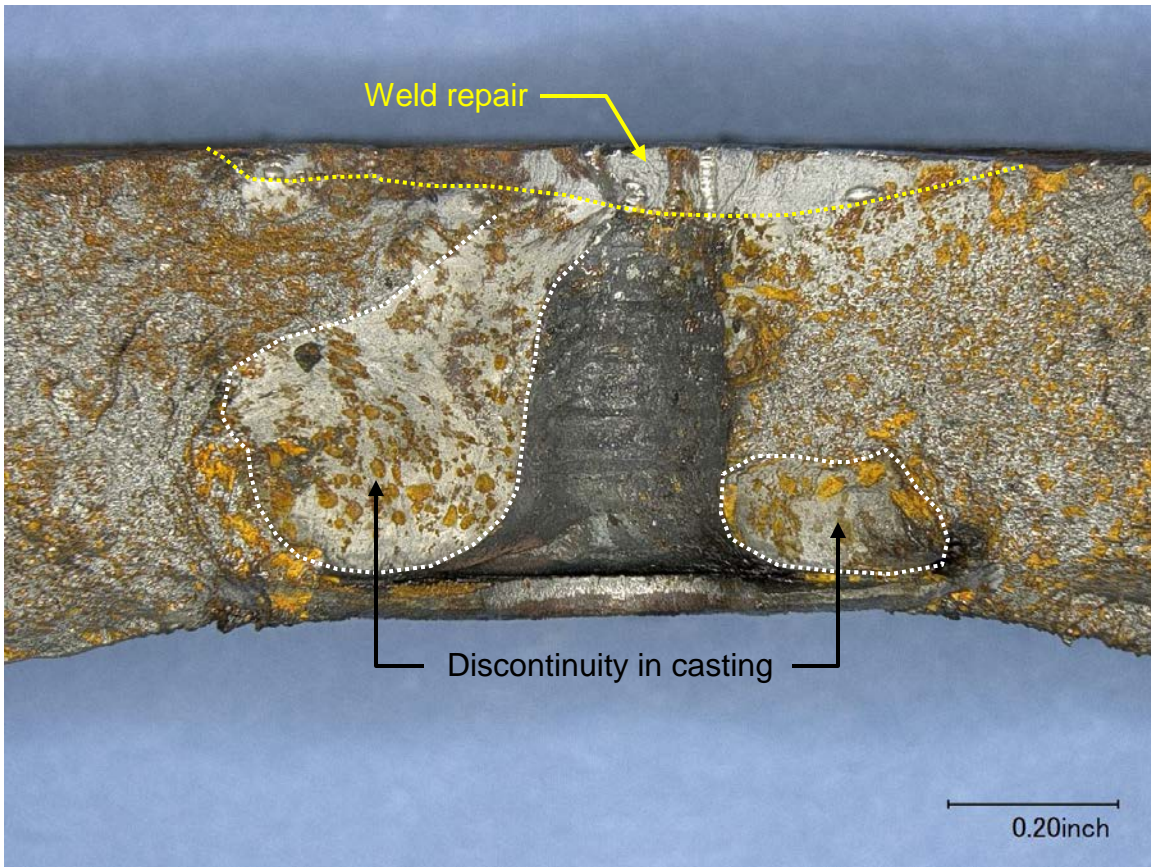
The fracture around the casting pin hole is shown in greater detail in figure 4. There were two casting discontinuities, one on either side of the hole as indicated by the white dotted lines. The discontinuity on the right side of the image was entirely subsurface. The discontinuity on the left side of the image tapered toward a point as it approached the outer surface but did not reach the surface. Instead, it ended at a surface weld repair, as indicated in figure 4 by the yellow dotted line. The weld repair was identified by a change in the appearance of the fracture and the presence of small gas porosity, consistent with an arc welding procedure. There were no preexisting cracks emanating out of the discontinuities or the surface repair weld. Outside of the discontinuities the fracture had a rough appearance, indicative of an overstress fracture. The combined cross sectional area of the pin hole and the discontinuities was approximately 0.24 inch<sup>2</sup>, as measured on a calibrated image.

**Figure 4:** Higher magnification image of the pin hole in the shank. Discontinuities in the casting are outlined with white dotted lines and a weld repair is indicated by a yellow dotted line.
