NATIONAL TRANSPORTATION SAFETY BOARD

MATERIALS LABORATORY FACTUAL REPORT

Report No. 17-050

Place : Graettinger, Iowa
Date : March 10, 2017
Vehicle : Union Pacific Ethanol Unit Train, UEGKOT-09
NTSB No. : DCA17MR007
Investigator : Michael Hiller, RPH-10

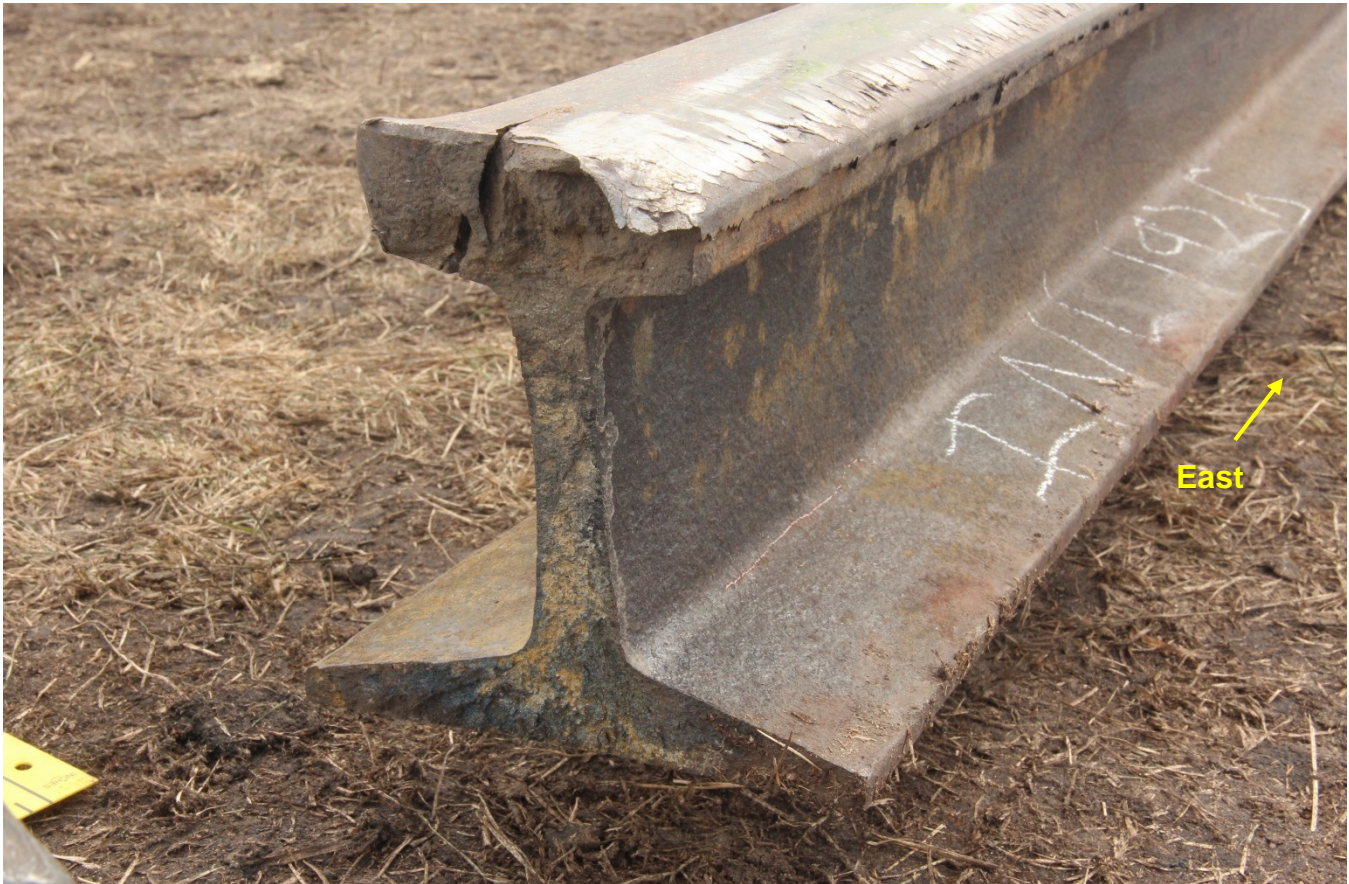
Rail batter, as shown in Figure 7, is indicative of rail-wheel impact that occurs after a rail has broken. In the Table I and Table II, the rail batter is described either receiving batter or leaving batter (RB and LB, respectively), and is classified as heavy or minimal, depending on the relative depth and length of damage. Figure 7 also shows head checking (HC) on the gage side.⁴ The head checking was severe enough that it developed into flakes on the gage side of the head.⁵ Figure 8 shows another example of head checking and surface flaking, consistent with rolling contact fatigue due to wheel-rail interaction.

Figure 7 – The west-facing fracture surface of 20N, showing heavy rail batter, head checking, and flaking.

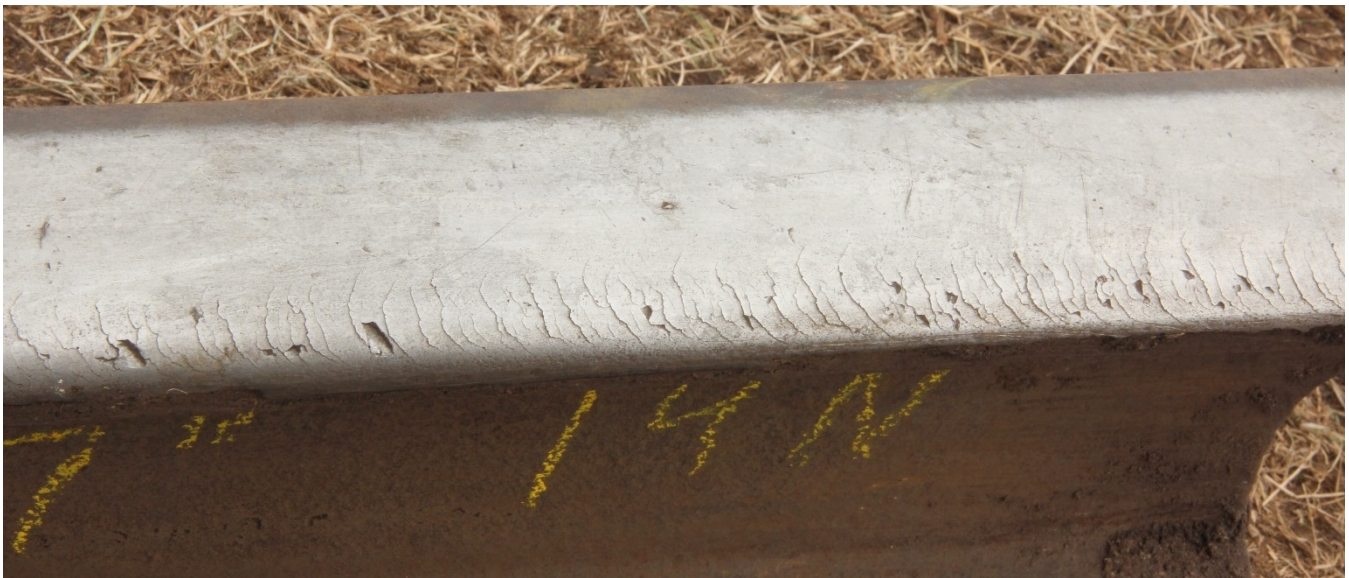
Figure 8 – Closer view of rolling contact fatigue on the gage side of 14N rail section.

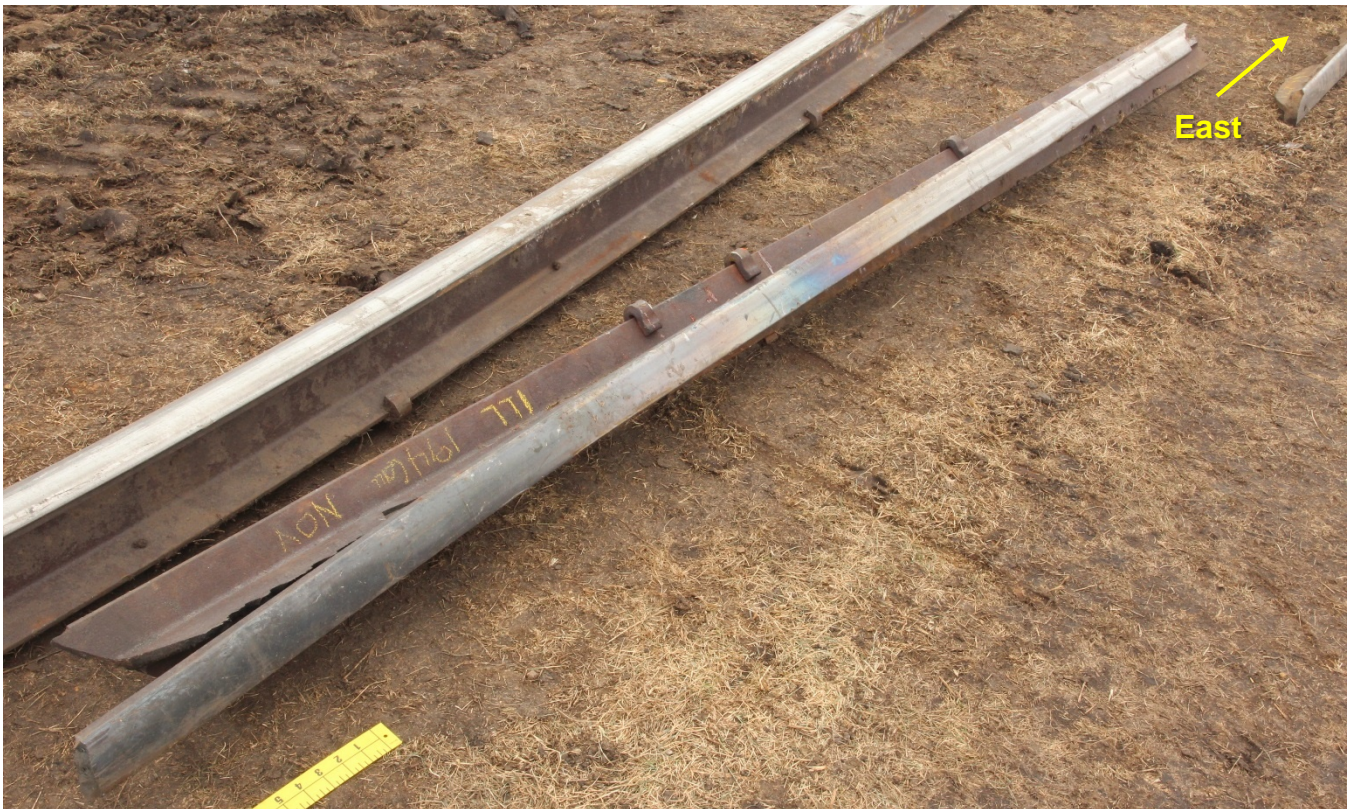
The west side of the rail piece 4S exhibited a split web (see Figure 9). A split web is a fracture parallel to the rolling direction of the rail located along the web. In this case, the

fracture was saw-toothed, consistent with overstress failure in shear across a thin wall. This piece was also a “plug rail,” in that it was installed after the last full installation of the track at the accident site.

Figure 9 – Rail piece 4S located where the plug rail and weld was located.

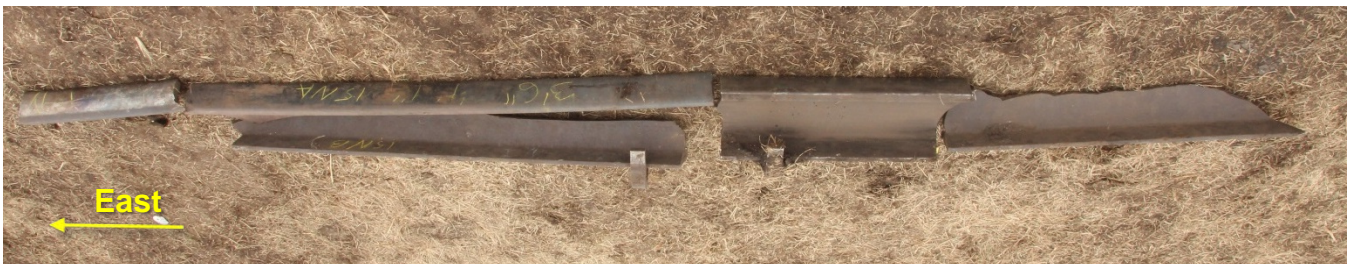
Figure 10 shows multiple pieces that separated due to a compound fractures. Fractures for these pieces were oriented in the transverse and longitudinal directions, present in the head, web, and base of the rail.

Figure 10 – From right to left, pieces 14N through 16N recovered on scene.

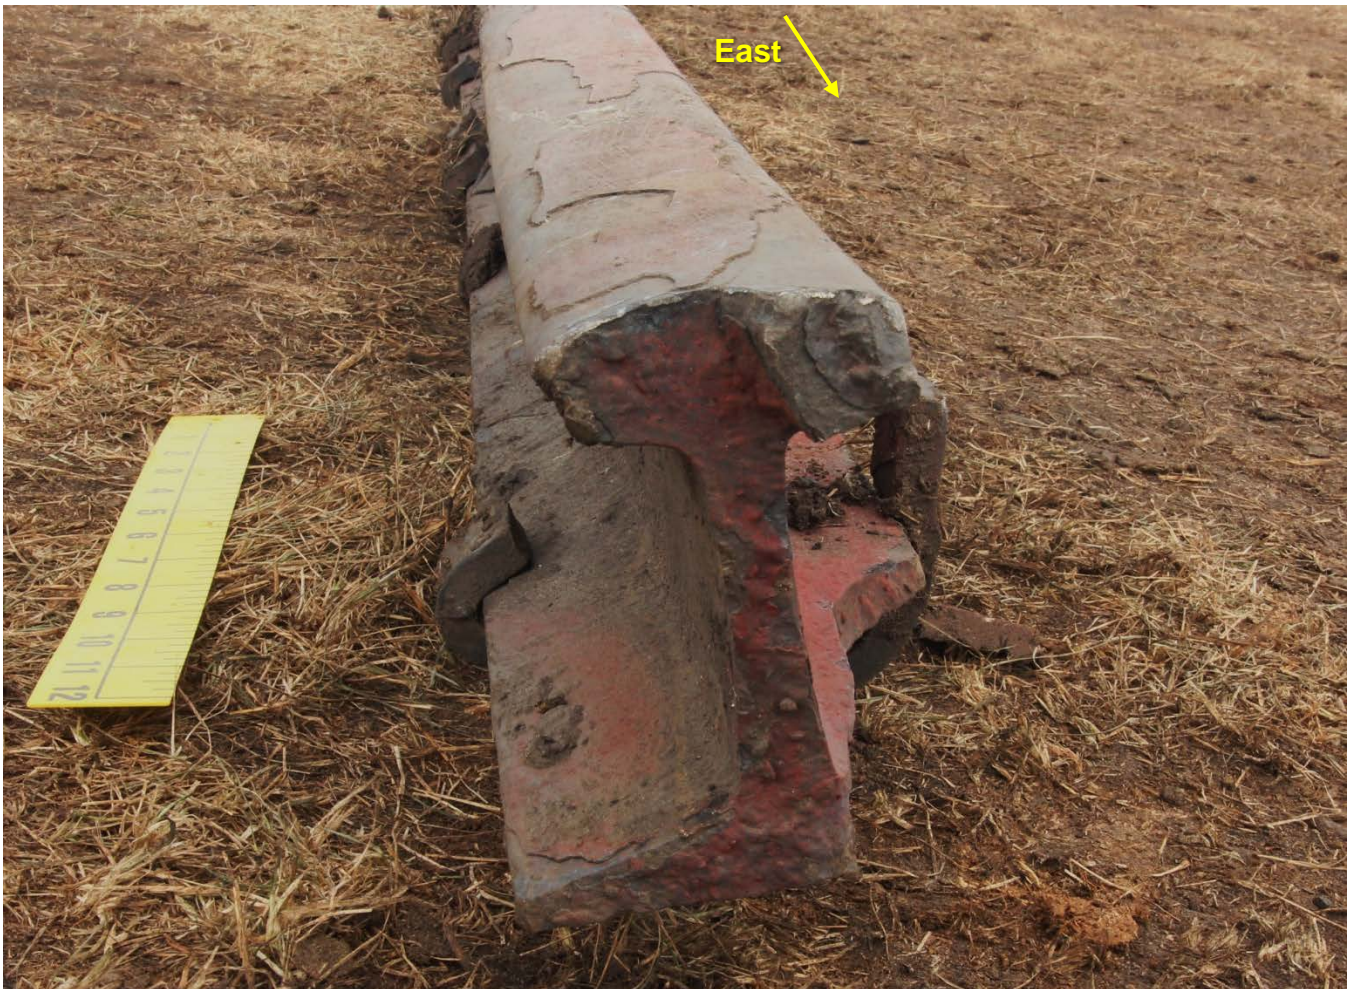
Figure 11 shows a piece that exhibited a reddish-orange colored compounds. As there were no coatings on the rail, and as the compounds were also present on the fracture surfaces, the material was consistent with post-derailment contamination. The likely source would be the fire-fighting compounds used during the post-accident pool fire of released ethanol. These compounds would not have been present during or a factor in the derailment.

Figure 11 – The east-facing fracture surface of 18N, showing orange-colored residue on the running surface and fracture surface.

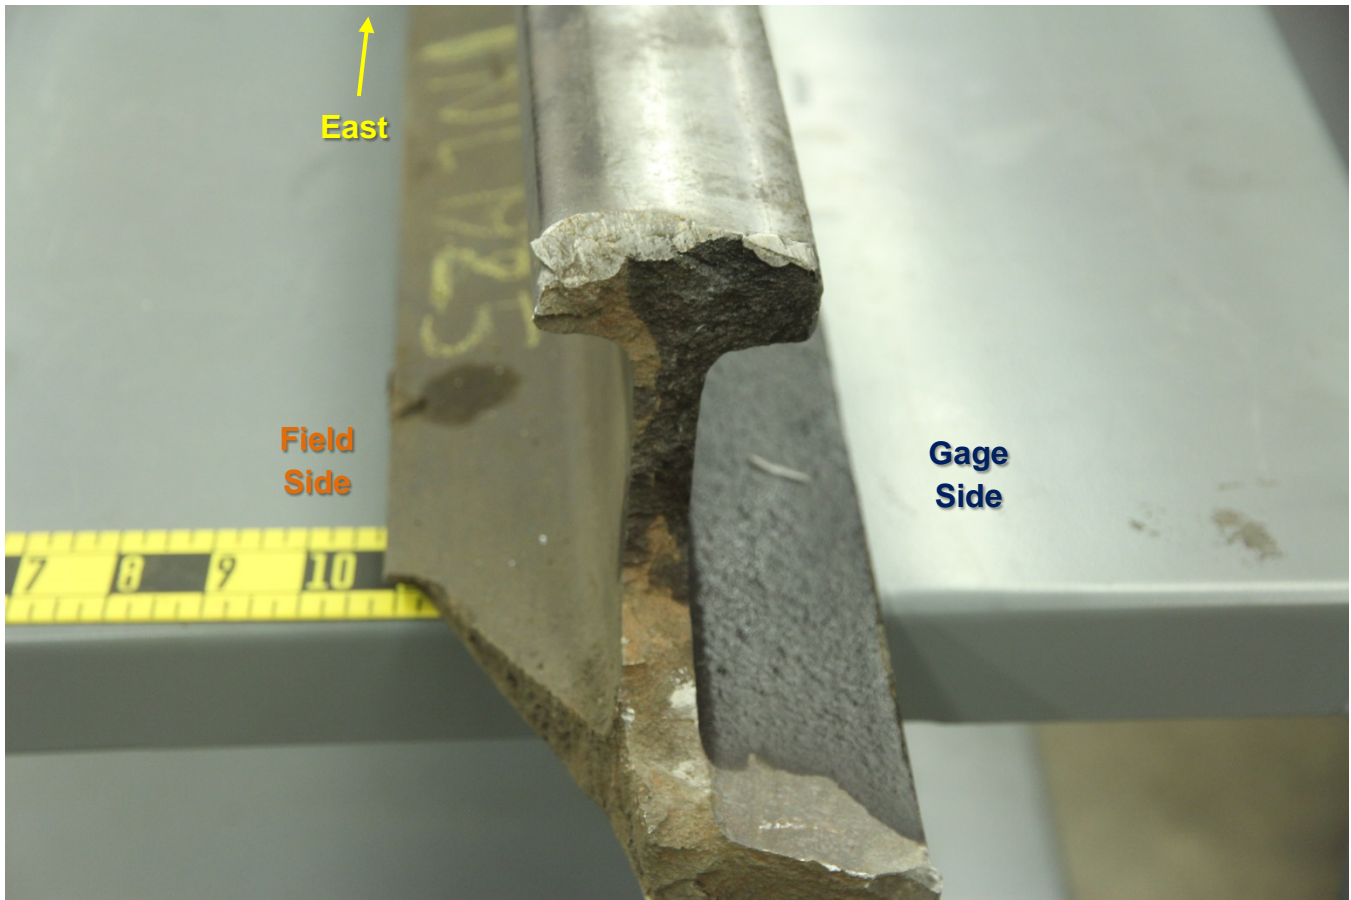
Of note on this rail piece was the presence of rail batter on the field side of the head (Figure 19). This batter was consistent with wheel-rail contact on the west rail face after fracture. Figure 21 shows repeating dimpled chatter marks on the gage side of the rail. These marks were consistent with repeated wheel flange impacts on the gage side of the rail head.

Figure 19 – The west-facing fracture face of the 12N rail fragment.

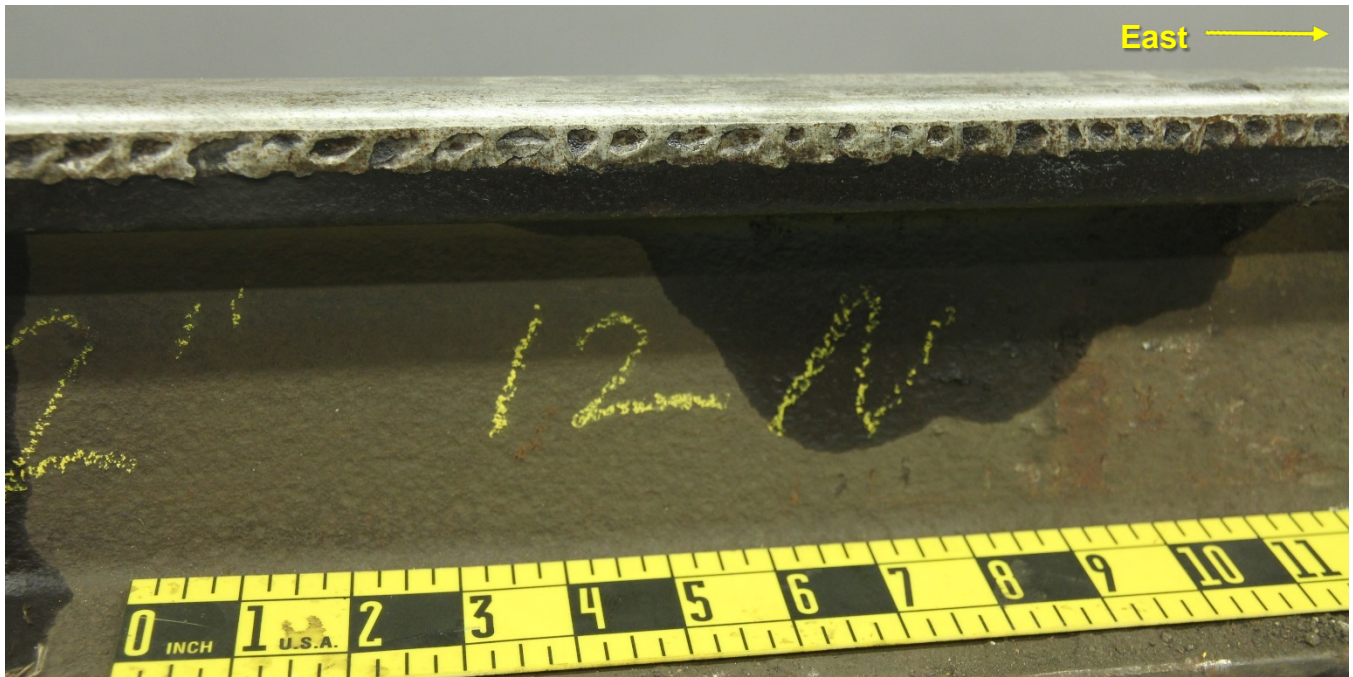
Figure 21 – Closer view of the gage side of the 12N rail fragment, showing side batter from wheel interaction. East is to the right.

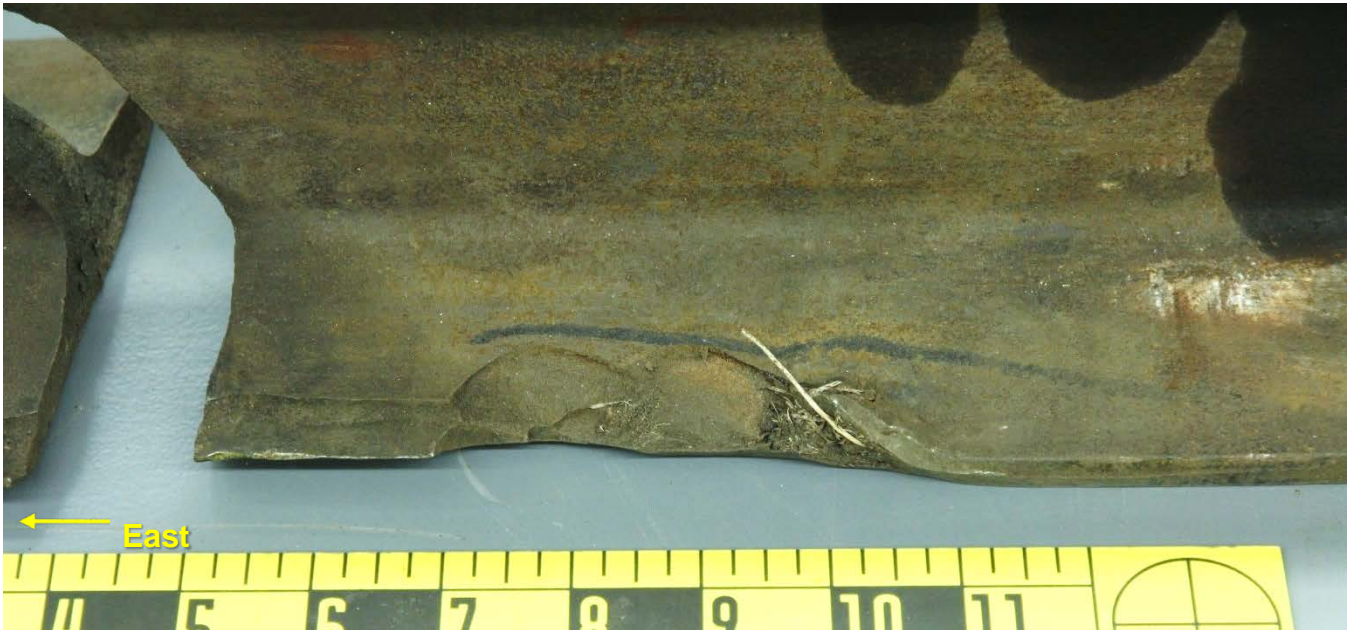
Figure 24 shows some chipping on the base of 10N. This chipping was consistent with the location of a rail anchor, where the derailment forces pulled the base away from the anchor. Figure 25 shows gage side chatter and deformation on 10N. However, there were no visual indications of more severe damage consistent with extensive rolling contact fatigue or head wear (Figure 26 and Figure 27).

Figure 24 – Chipped piece of the field side base the 10N rail fragment.

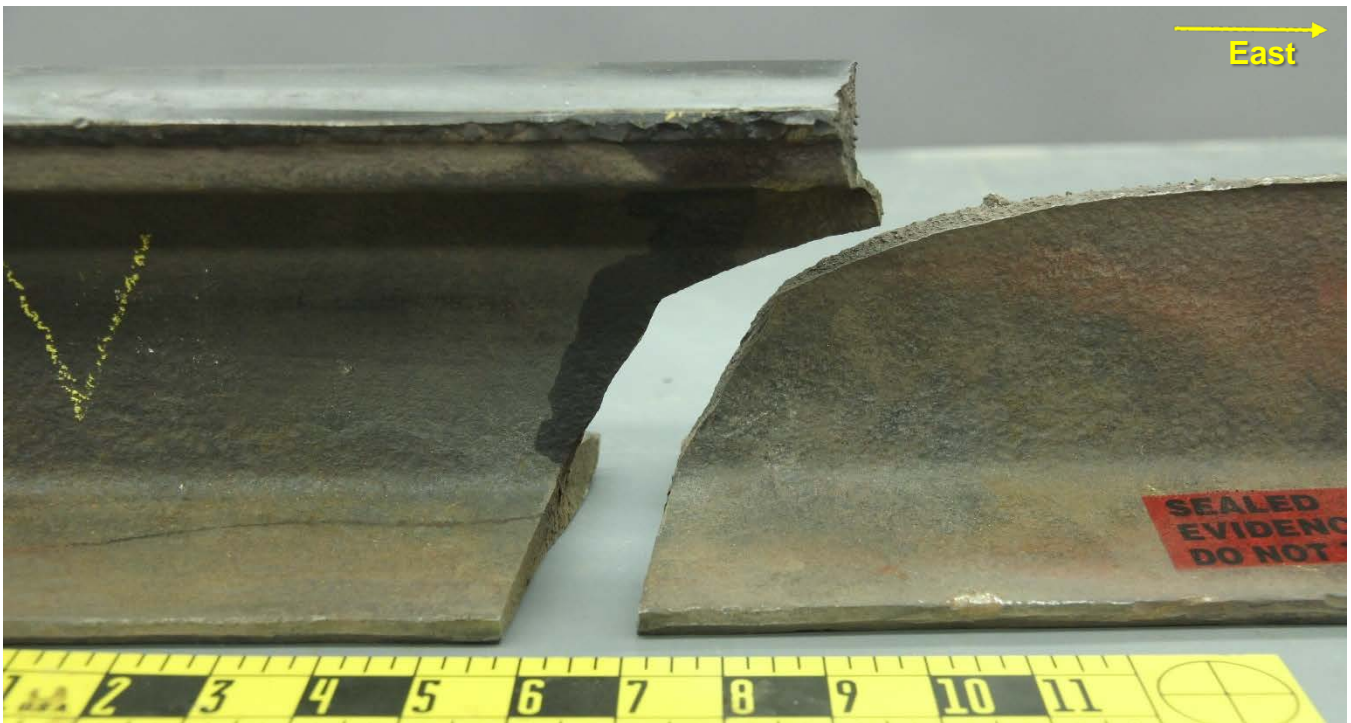
Figure 25 – Closer view of the mating fractures between the 10N and 11N fragments, from the gage side.

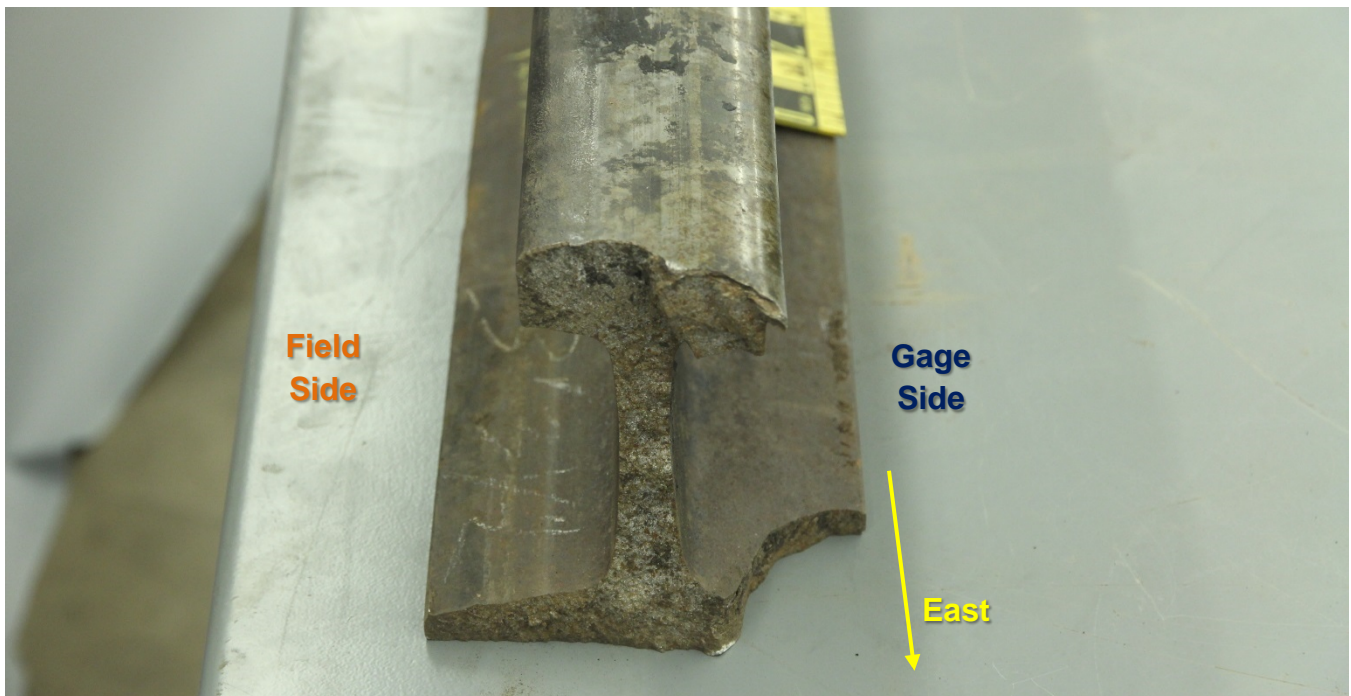
Figure 28 through Figure 32 highlight rail fragment 10S. This rail fragment measured 3 feet, 4 inches. As shown in Figure 28, Figure 29, and Figure 31, the west-facing fracture surface was a compound fracture that exhibited longitudinal and transverse orientations in the head, web, and base. The east-facing fracture surface, though, was more flat and transverse oriented, with features consistent with overstress fracture (Figure 30).

Figure 30 – The east-facing fracture surface of the 10S rail fragment.

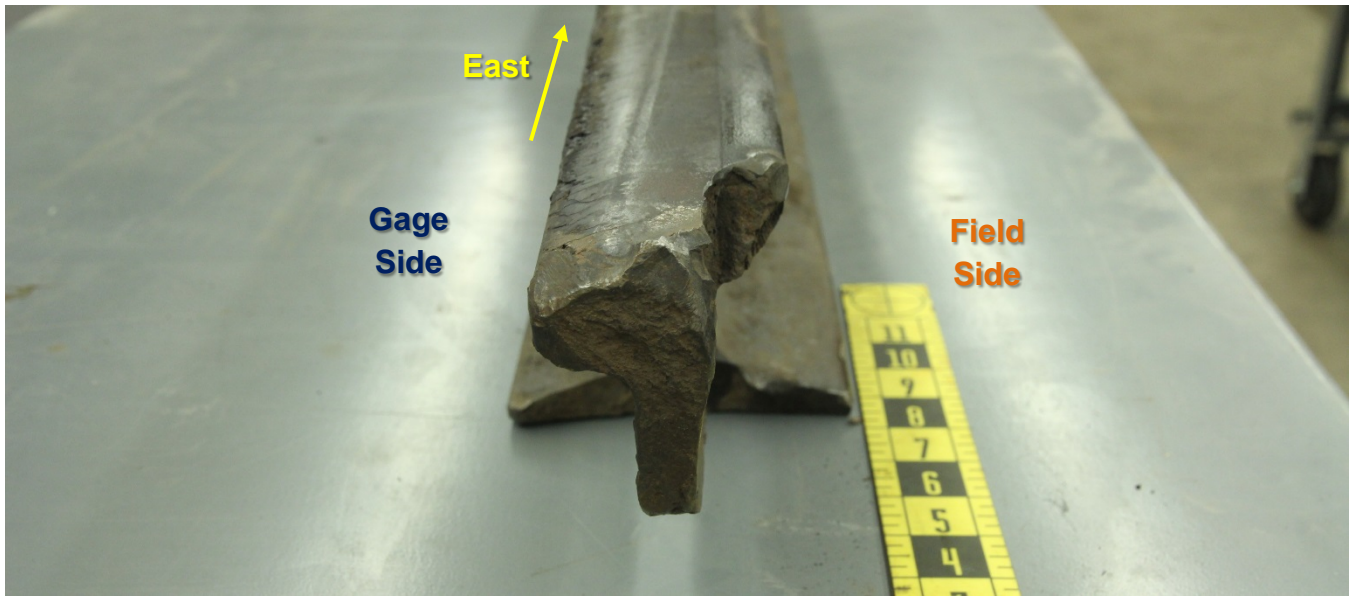
Figure 31 – The west-facing fracture surface of the 10S rail fragment.

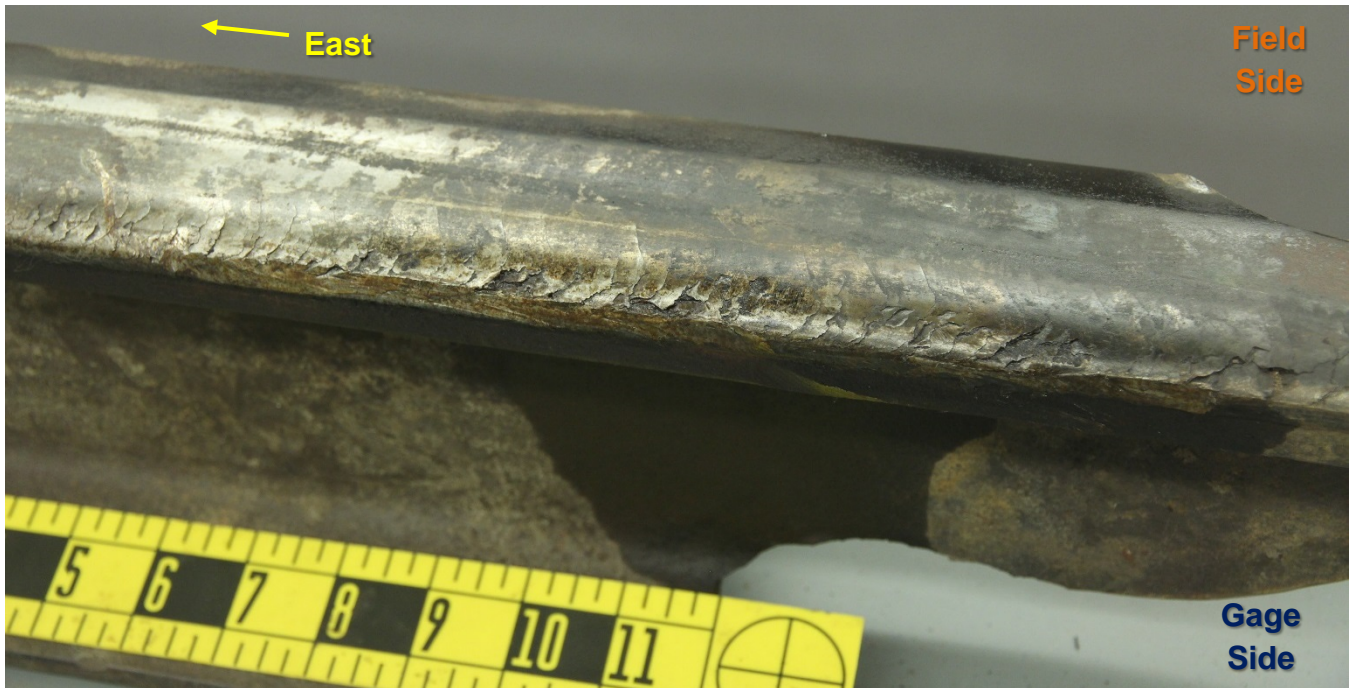
Figure 32 – Closer view of head checking and shelling on the gage side of the 10S fragment.

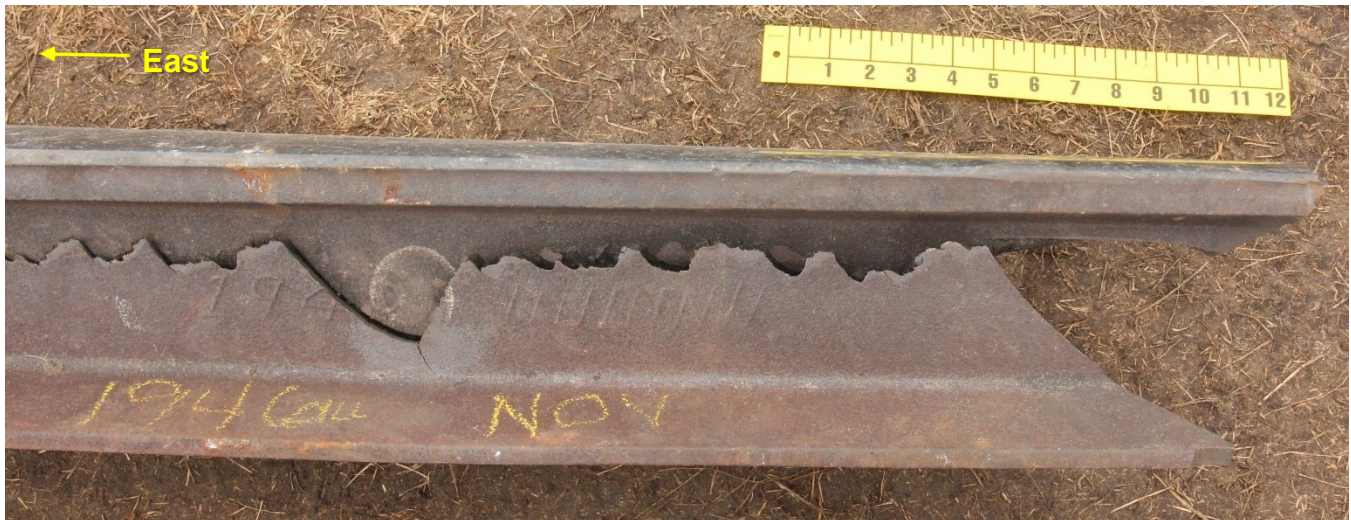
Figure 33 and Figure 34 highlight two major features of rail piece 4S, which measured 9 feet, 4 inches. Figure 33 shows a sawtooth fracture in the web near the west-facing fracture surface. No head batter was observed on this fracture surface. The head portion was generally deformed outward or toward the field side, while the base was generally deformed toward the gage side. These features were consistent with a shear overstress fracture through the web, which would be consistent with derailment forces directed toward the south side of the track. The markings on the rail indicated it was manufactured in November of 1946 by U.S. Steel (Illinois Facility).⁹

Figure 33 – The gage side of the west-facing fracture of the 4S rail piece, showing a sawtooth fracture in the web (on-scene photo).

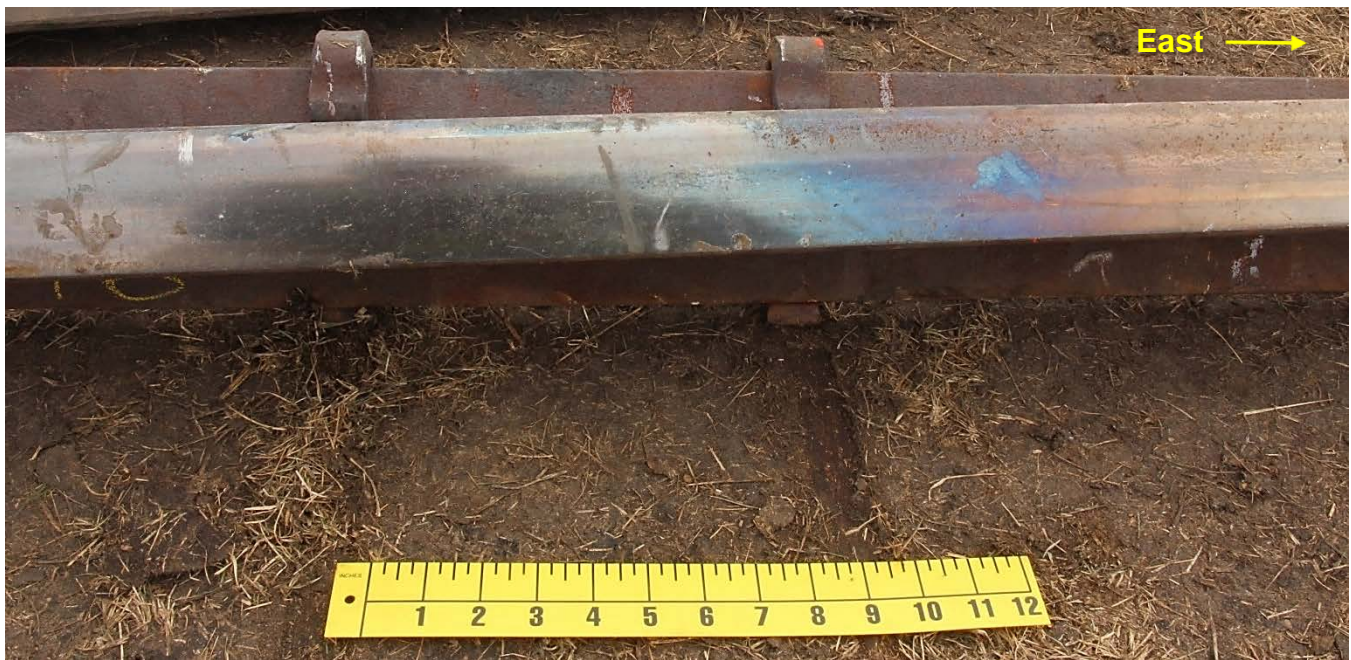
Figure 34 – The middle of the 4S rail piece, showing heat tinting on the head surface (on-scene photo).

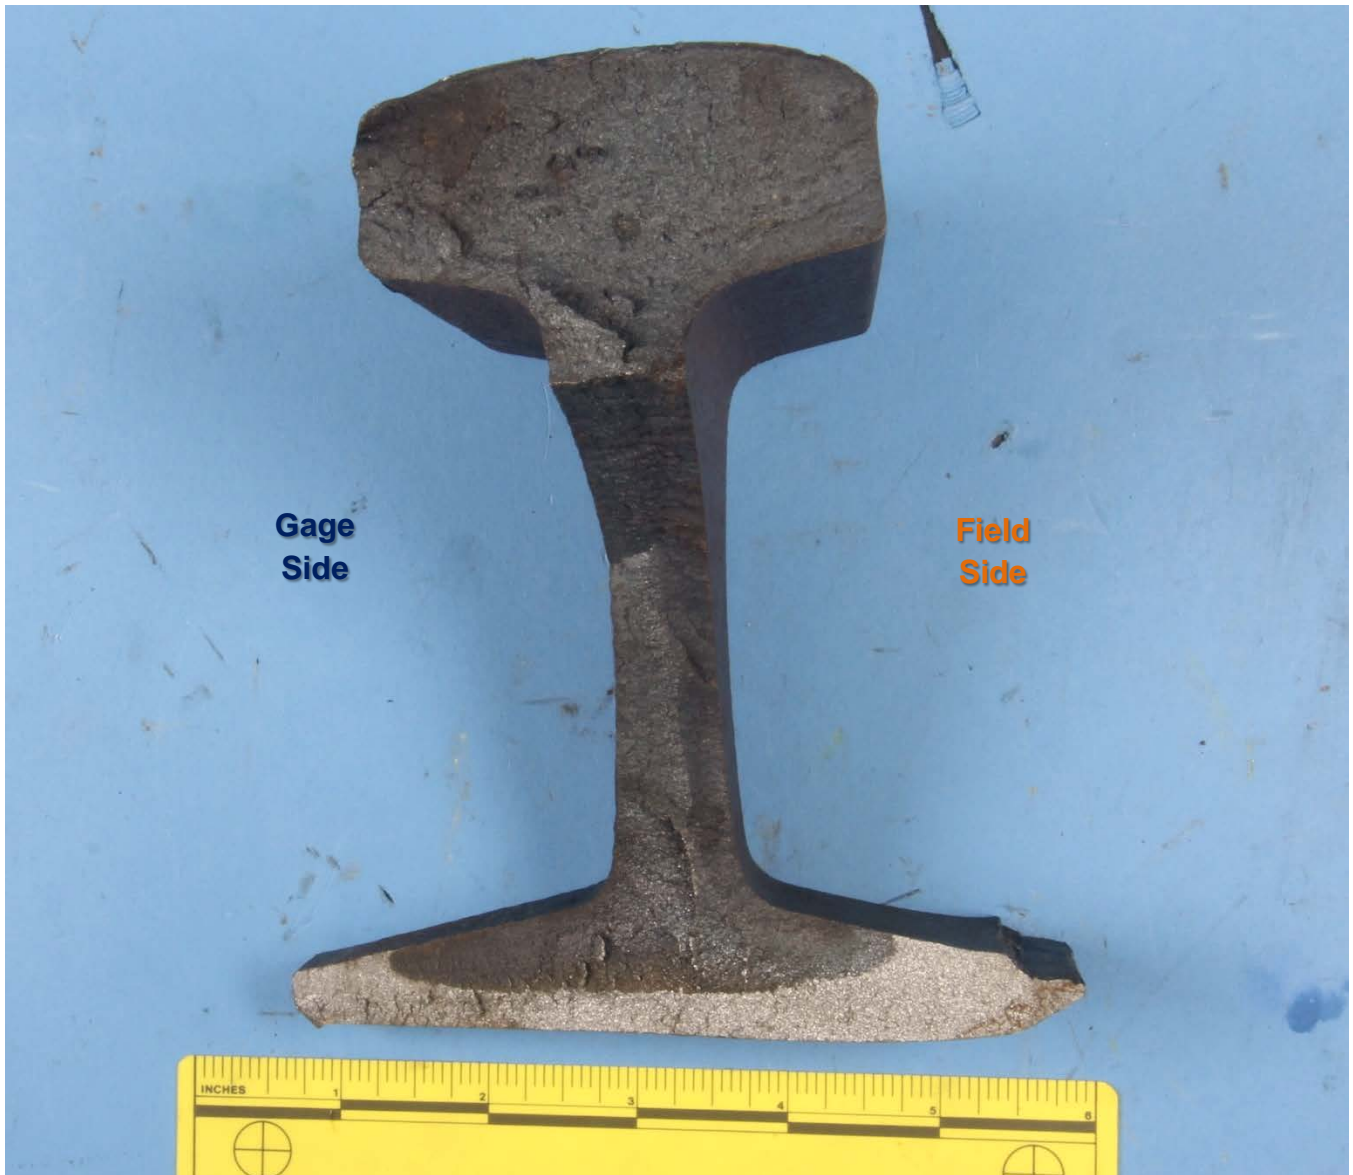
The east-facing fracture surface of fragment 10N is shown in Figure 35 and Figure 36, before and after cleaning, respectively. Fragment 11N, which mated with 10N, consisted only of the base and part of the web (Figure 37). Pieces 10N and 11N exhibited features typically consistent with pre-existing fracture, such as discoloration and a general curved thumbnail shape. However, later examination using a scanning electron microscope (SEM) showed that the fracture features on these pieces were inconsistent with pre-existing or progressive failure modes (Section 3.3).

The fracture surface features in the web of the fracture surfaces of both pieces extended into the base. These fracture features were inconsistent with having originated in the head of the rail. Rather, the features suggest that this fracture initiated in the web, approximately 2.75 inches from the bottom of the base, on the gage side. There were no discernible visible material or mechanical defects noted on the gage side of the web.

Figure 36 – The east-facing 10N fracture surface in Figure 35, after cleaning.

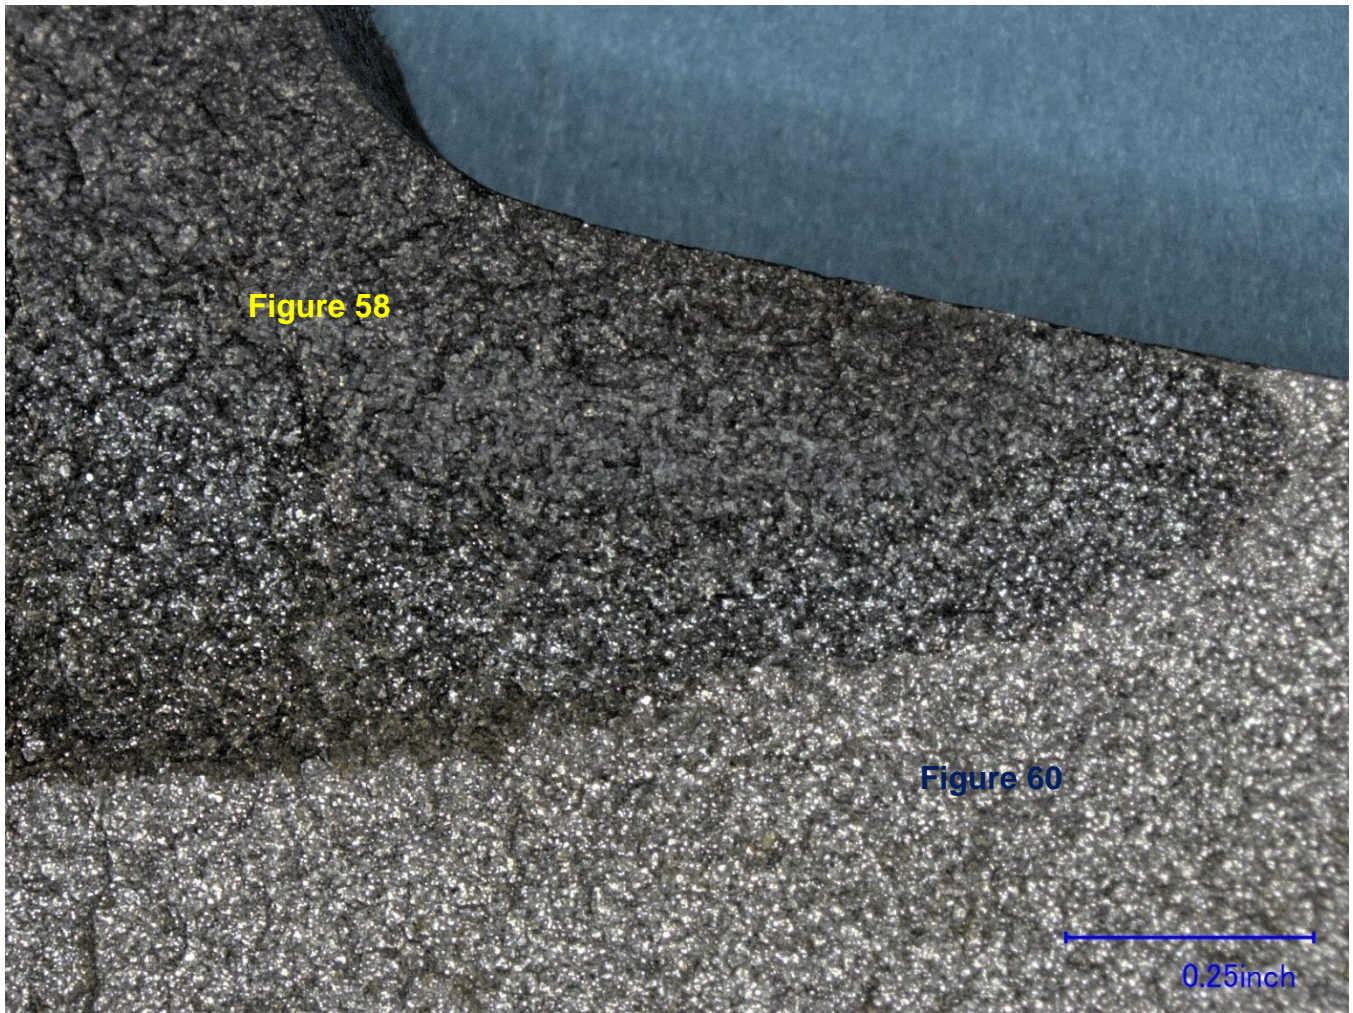
Figure 40 shows the edge of the discoloration difference on the 10N fracture surface, located at the web to base transition. This figure shows the location of SEM micrographs taken on this fracture surface, shown later in Figure 58 and Figure 60.

Figure 40 – The gage side of the 10N fracture surface web to base transition, showing the different colored regions of the fracture surface.

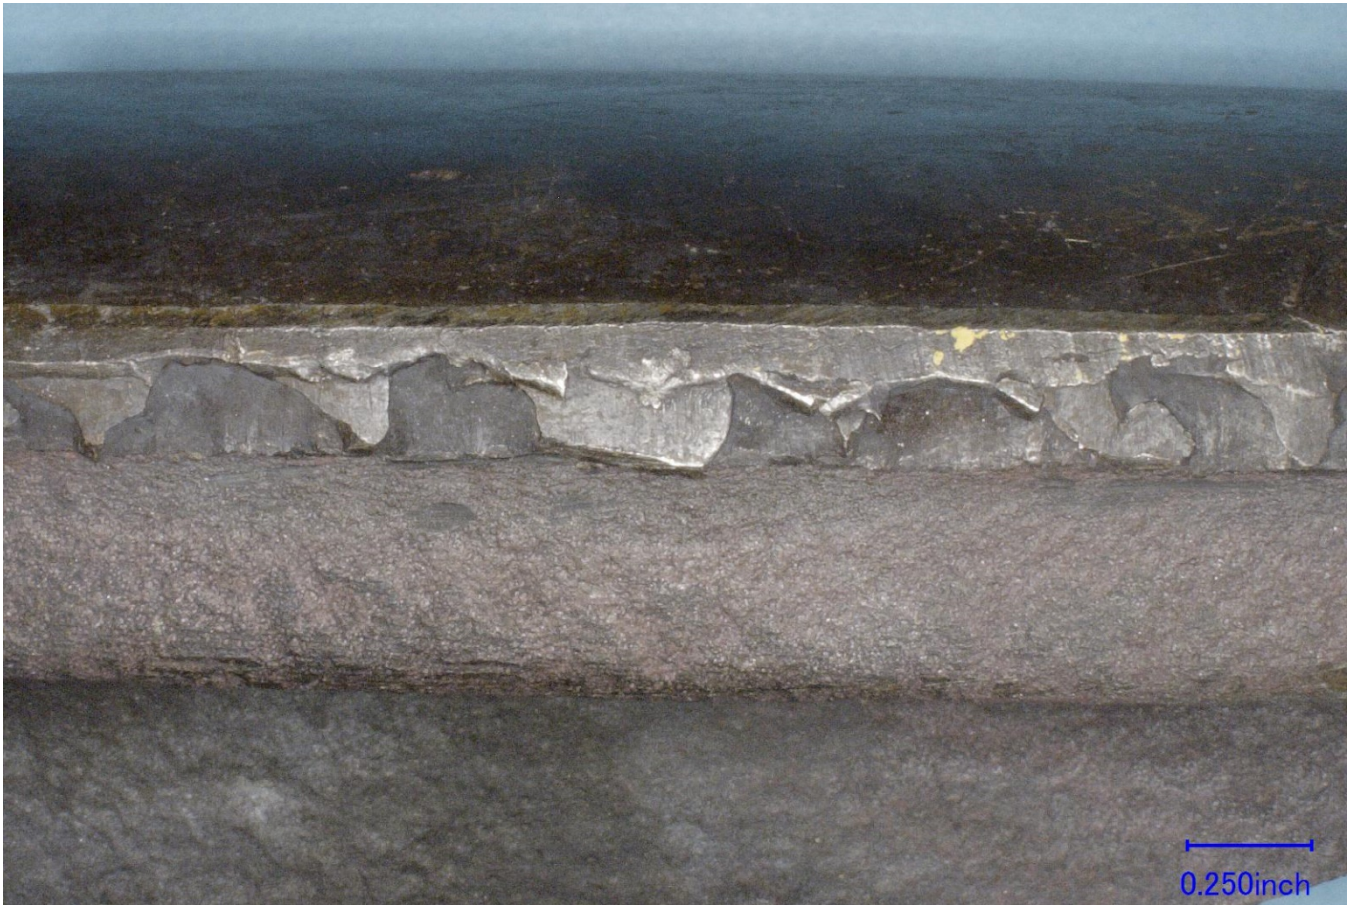
Figure 41 – The gage side of the 10N segment, showing batter consistent with wheel interaction.

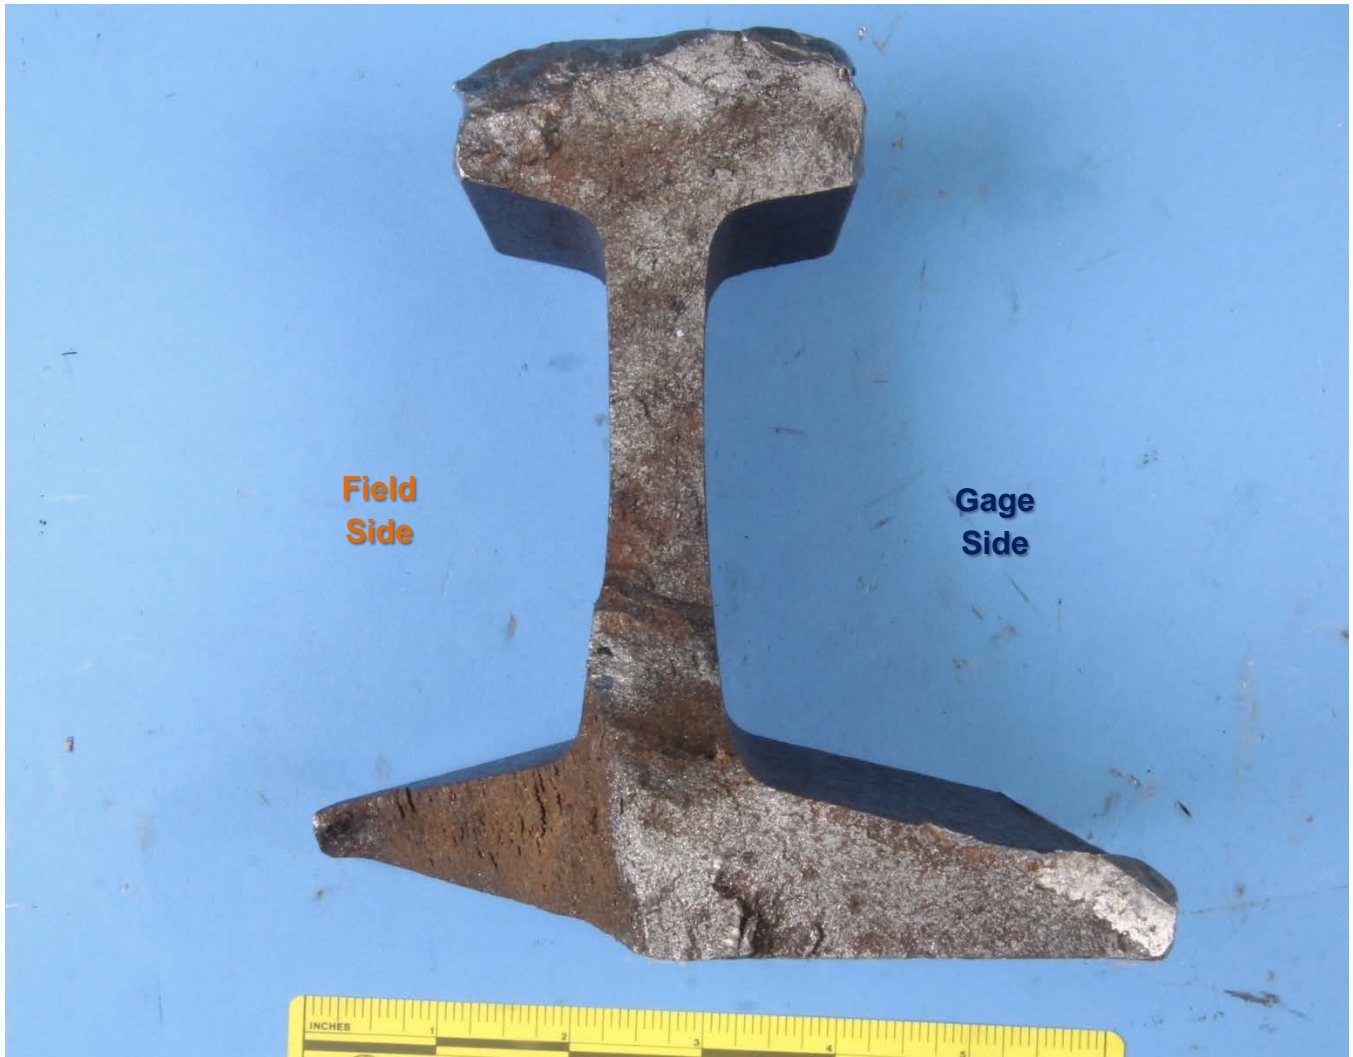
Figure 42 and Figure 43 show the east-facing fracture surface of rail piece 12N, before and after cleaning, respectively. The cleaned fracture surface exhibited features that were consistent throughout. The gage side of the rail piece exhibited corrugated dimpling, consistent with repeated sliding contact with an adjacent wheel. The fracture surface features of fragment 12N were consistent with overstress.

Figure 43 – The east-facing fracture surface on 12N in Figure 42, after cleaning.

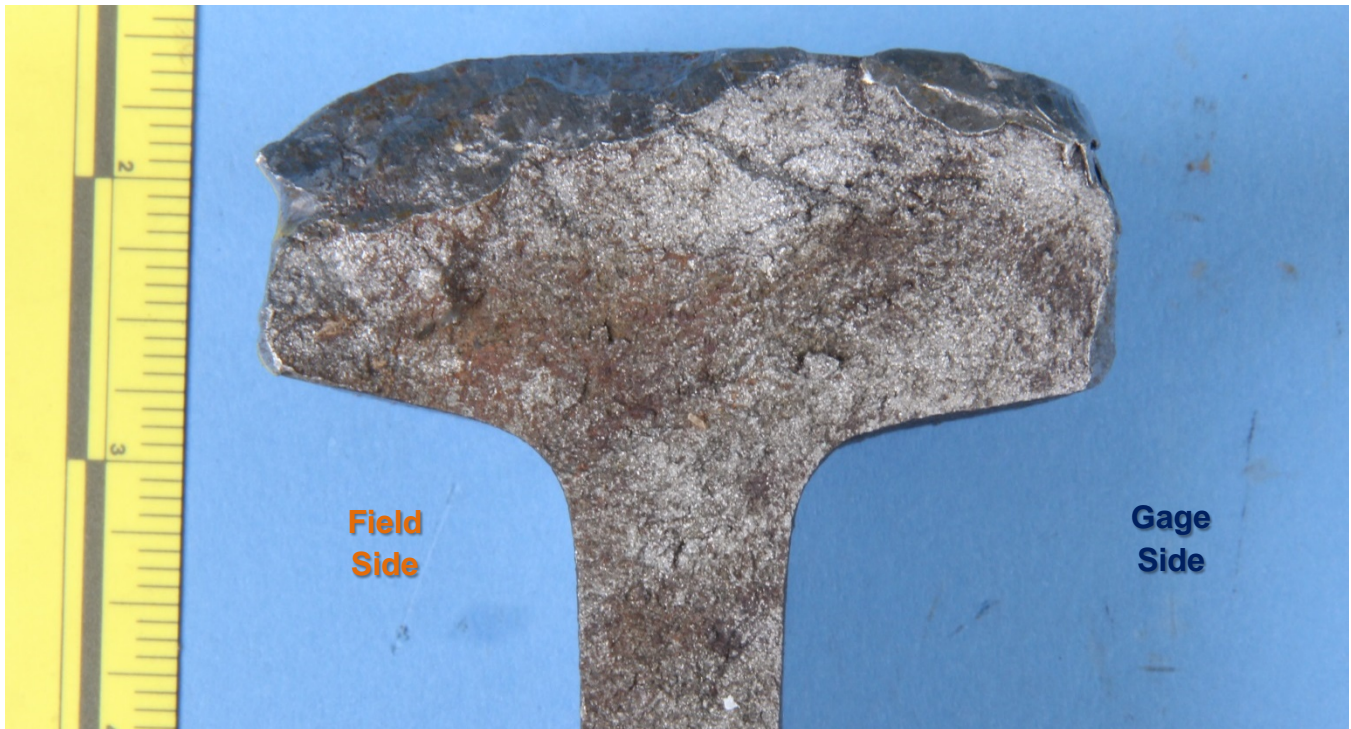
Figure 44 – Closer view of the 12N fracture head from Figure 42 after cleaning, showing surface batter.
