NATIONAL TRANSPORTATION SAFETY BOARD

MATERIALS LABORATORY FACTUAL REPORT

Report No. 17-050

Place : Graettinger, Iowa
Date : March 10, 2017
Vehicle : Union Pacific Ethanol Unit Train, UEGKOT-09
NTSB No. : DCA17MR007
Investigator : Michael Hiller, RPH-10

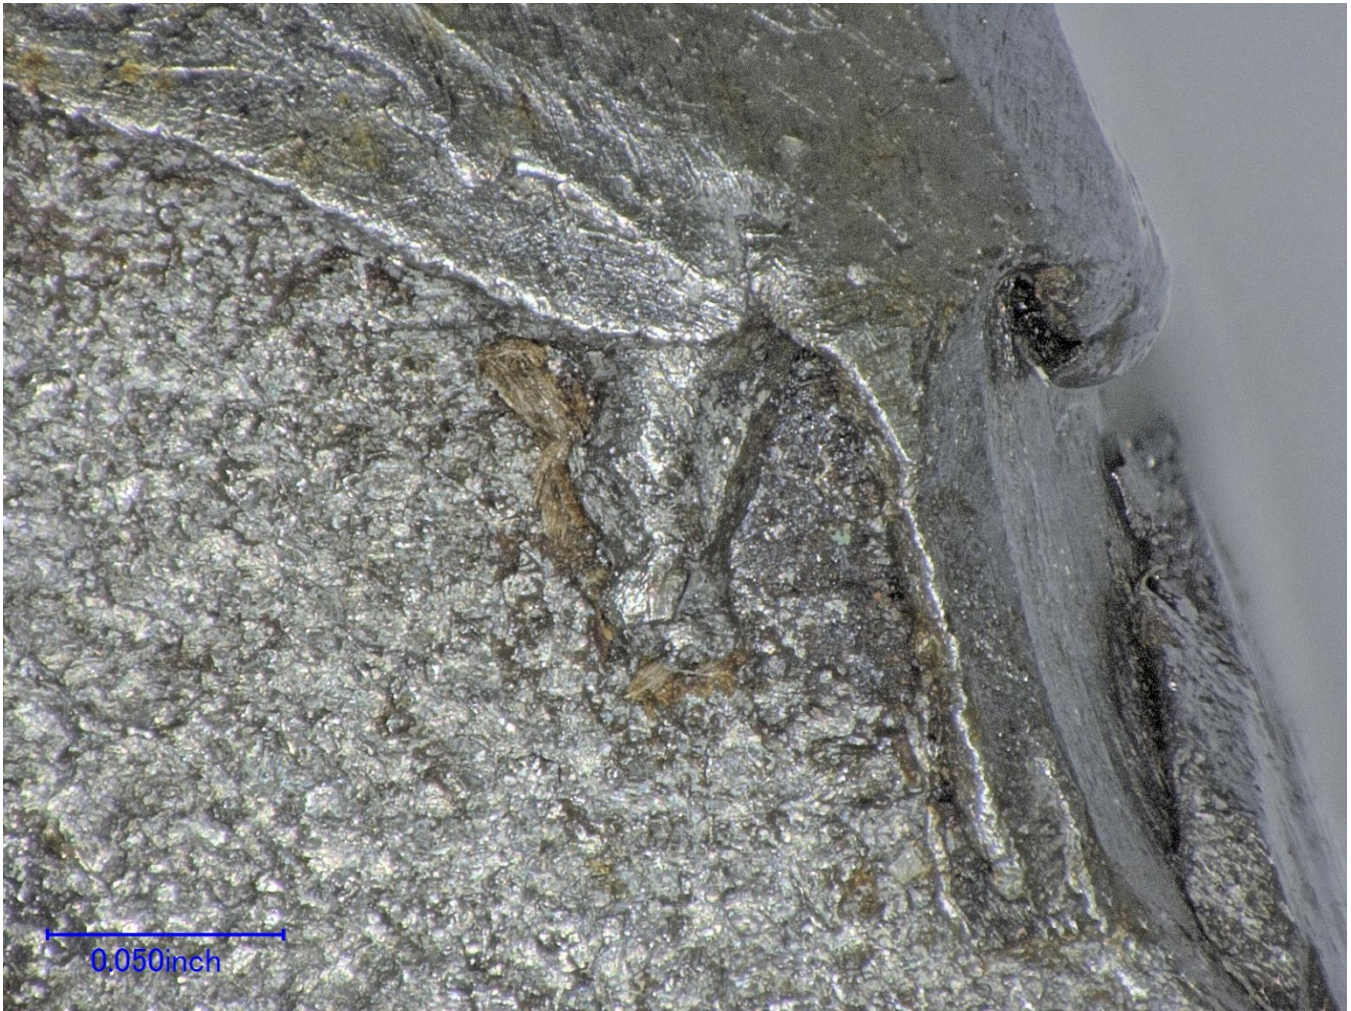
Of note was the batter and deformation on the gage side corner of the head of 12N (see Figure 45 and Figure 46). The radial lines of the head fracture surface were consistent with fracture initiation in this region. A closer view in Figure 47 shows some local deformation on the gage side of this region. However, later examination using a SEM did not reveal features that would have been consistent with pre-existing damage, such as progressive cracking.

The area highlighted on the gage corner of 12N, shown in Figure 46, was examined using a SEM. This region revealed cleavage features consistent with those in Figure 58 through Figure 62. No features consistent with other fracture modes or pre-existing cracking were observed in the gage corner of the 12N fracture surface.

Figure 46 – Closer view of the gage corner in the 12N head fracture surface (shown in Figure 45).

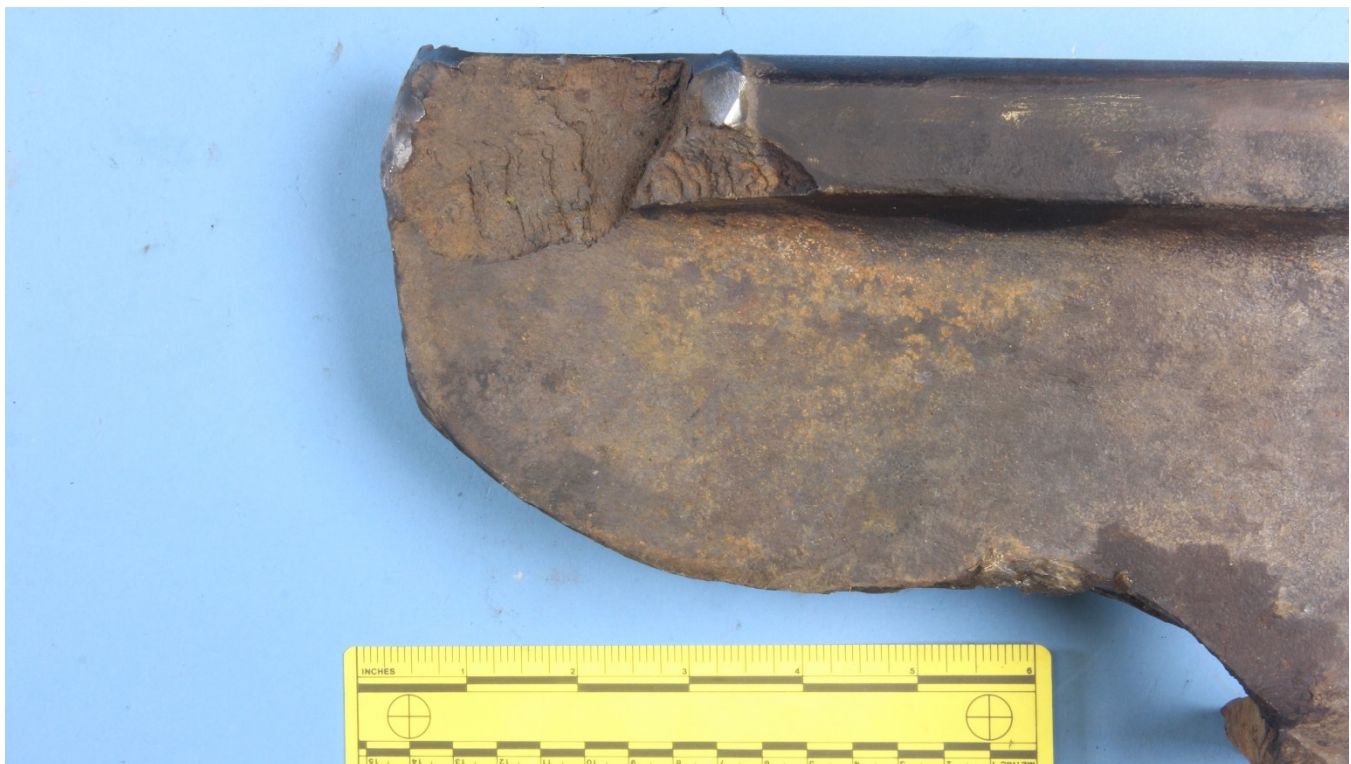
The sectioned west-facing fracture surface of piece 10S is shown in Figure 49. This fragment exhibited a fracture surface on the west-facing side of the rail consisting of transverse and vertical components (Figure 50). Head batter was also present on this fracture. This batter was consistent with the running direction of the train (towards the east). The undamaged fracture surfaces on this fragment were all consistent with overstress. There were no indications of pre-existing cracks on the batter-free portions of the fracture surface.

Figure 50 – Vertical fracture features on the field side of the east-facing 10S rail fragment fracture.

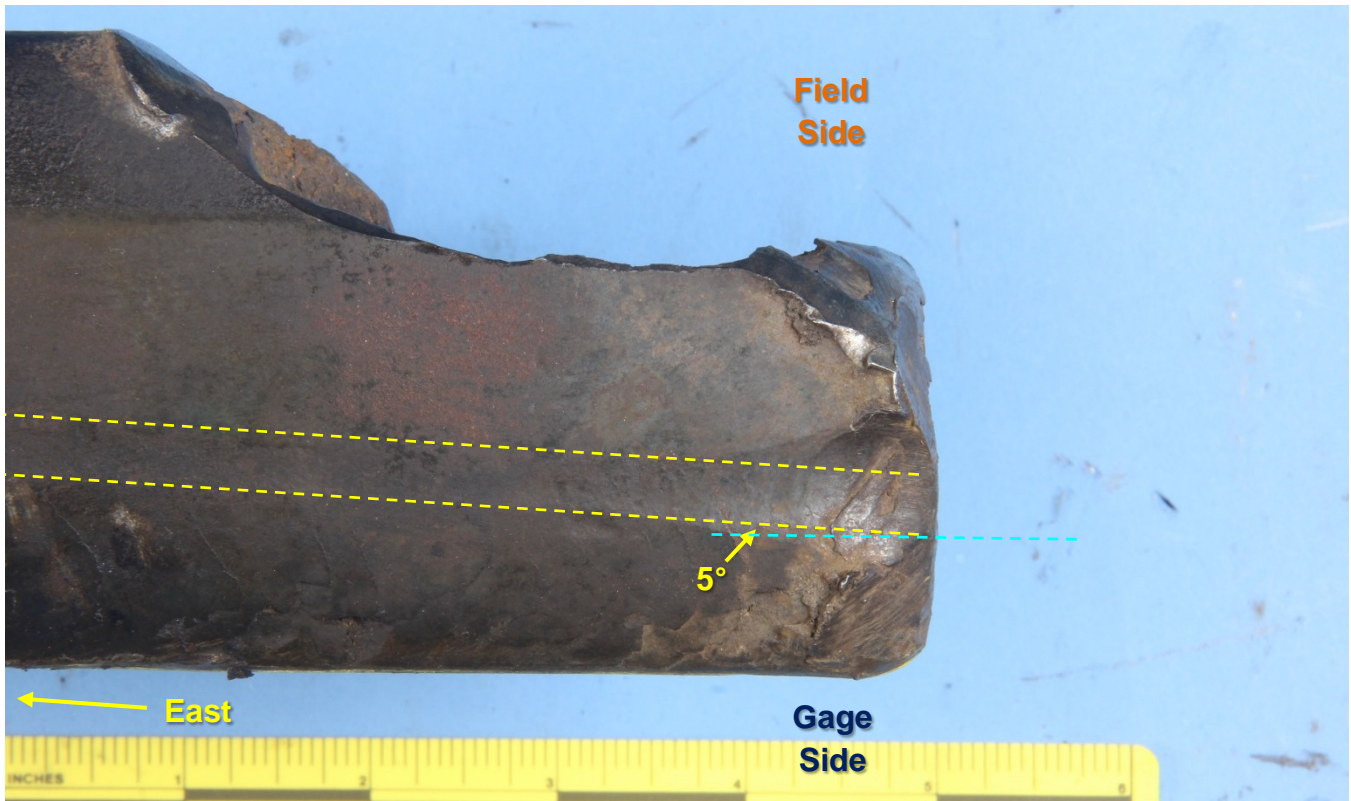
Of note on the 10S east-facing fracture was head batter. The batter was present on much of this fracture face, although it was generally angled facing the field side. The orientation of the angled batter was generally parallel to the deviation marks on the running surface of the head (upper portion of Figure 31). In addition, as shown in Figure 32, the gage side of the head exhibited features consistent with rolling contact fatigue. Head checking, flaking, and shelling were all present on this rail fragment. These features are described more in Section 3.2.2 of this report.

Figure 51 – Top view of the east-facing fracture surface of the 10S rail section. The dashed lines represent the 5° deviation toward the field side.

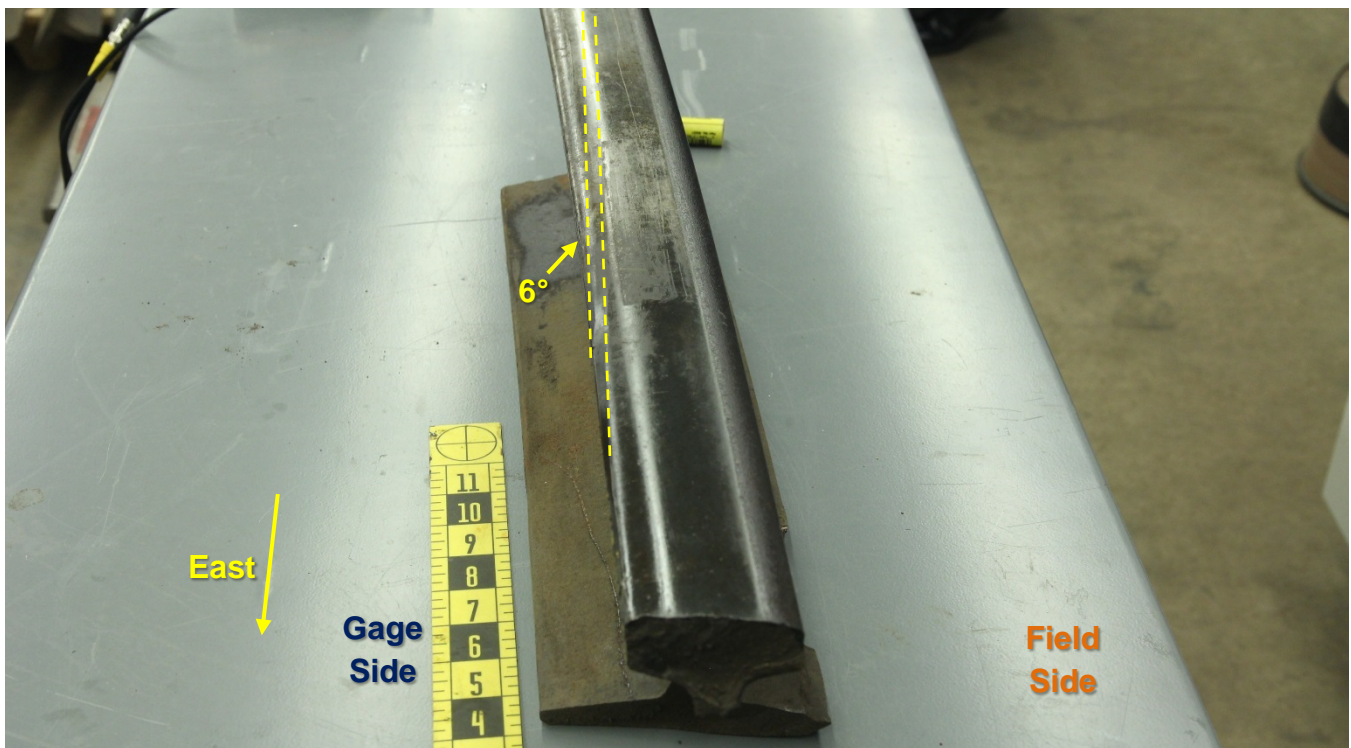
Figure 52 – The east-facing end of the 10N rail fragment. A wheel deviation mark was present on the head running surface, with the angle of departure labeled.

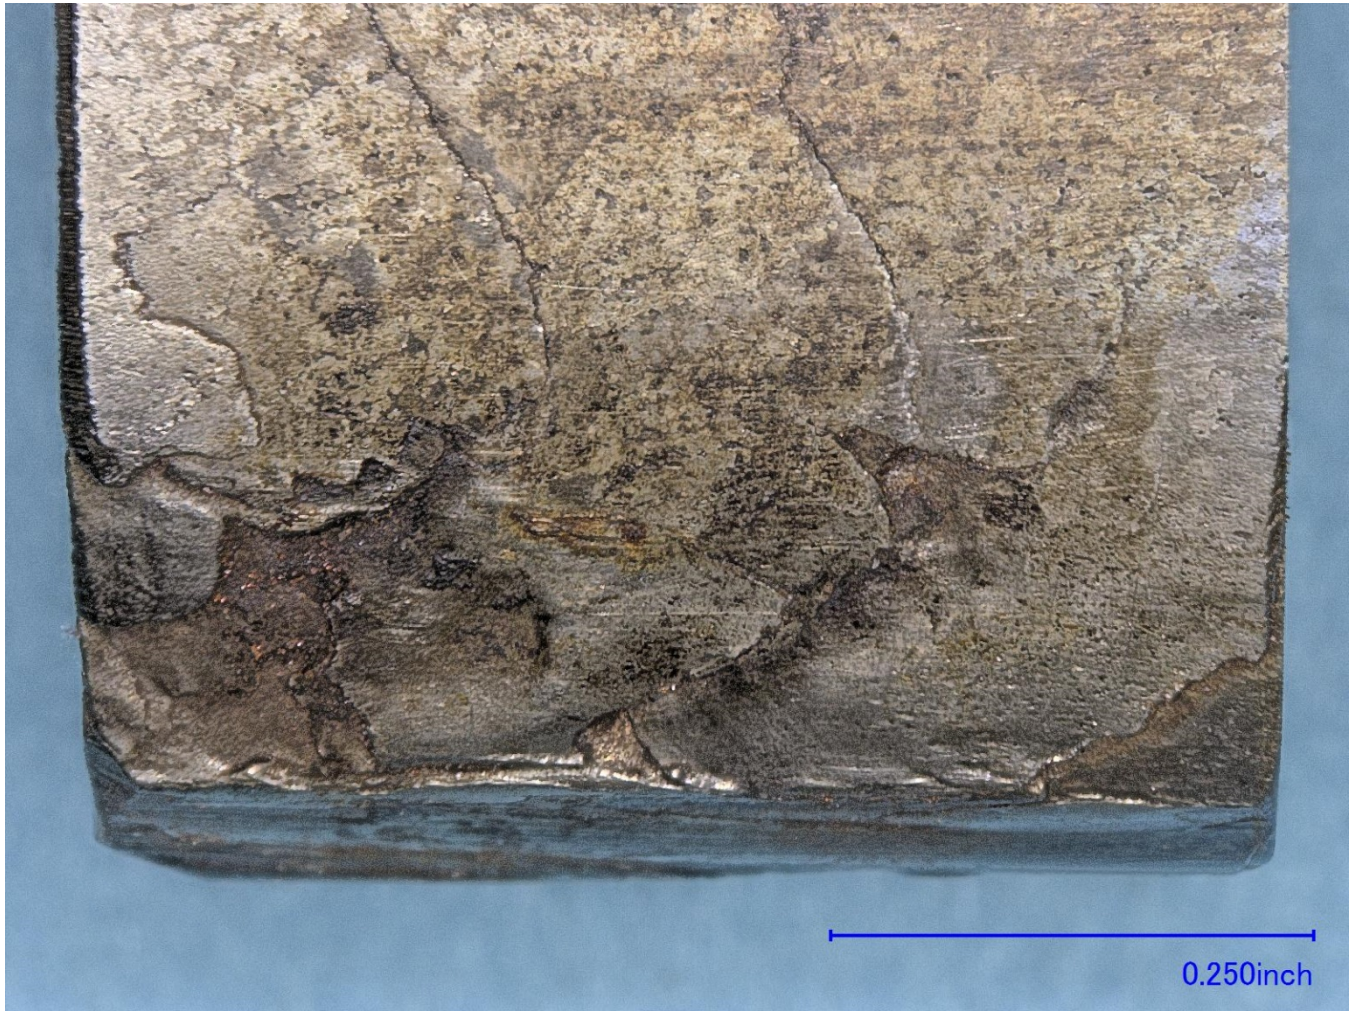
Sections of the 10S piece show the head checking and later shelling damage on the gage side of the 10S piece (Figure 53). A pronounced shell near a battered portion of the gage side is shown in Figure 54. This region was cross-sectioned and examined using optical metallography, as detailed in Section 3.4.

Figure 53 – Closer view of shell cracks of the gage side of the 10S piece.

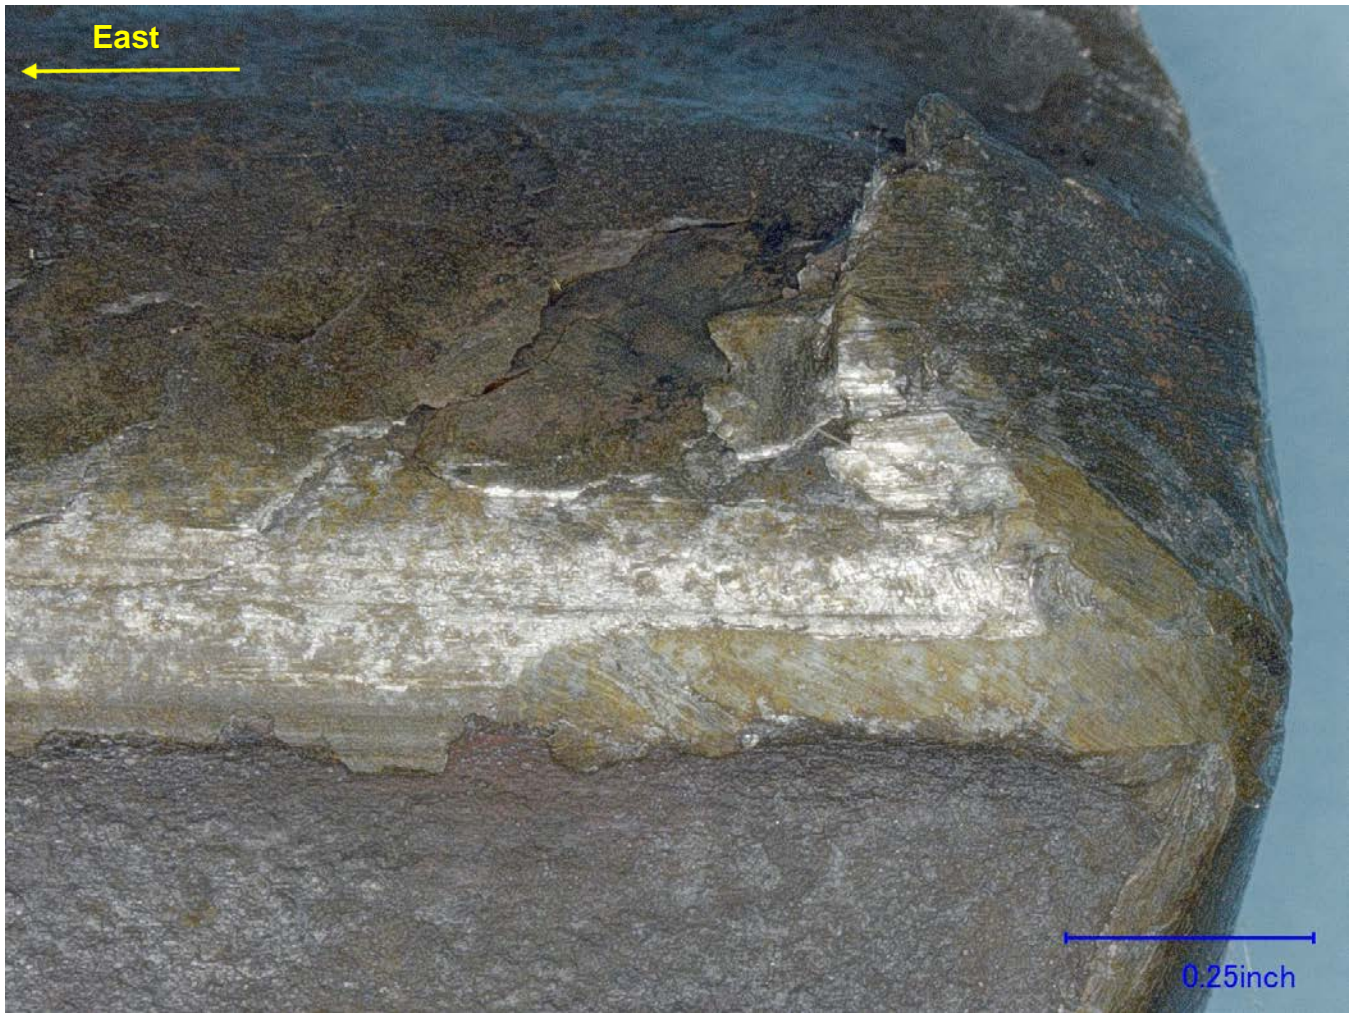
Figure 54 – The gage side of the 10S fragment, showing the shelling damage and the fracture surface batter.

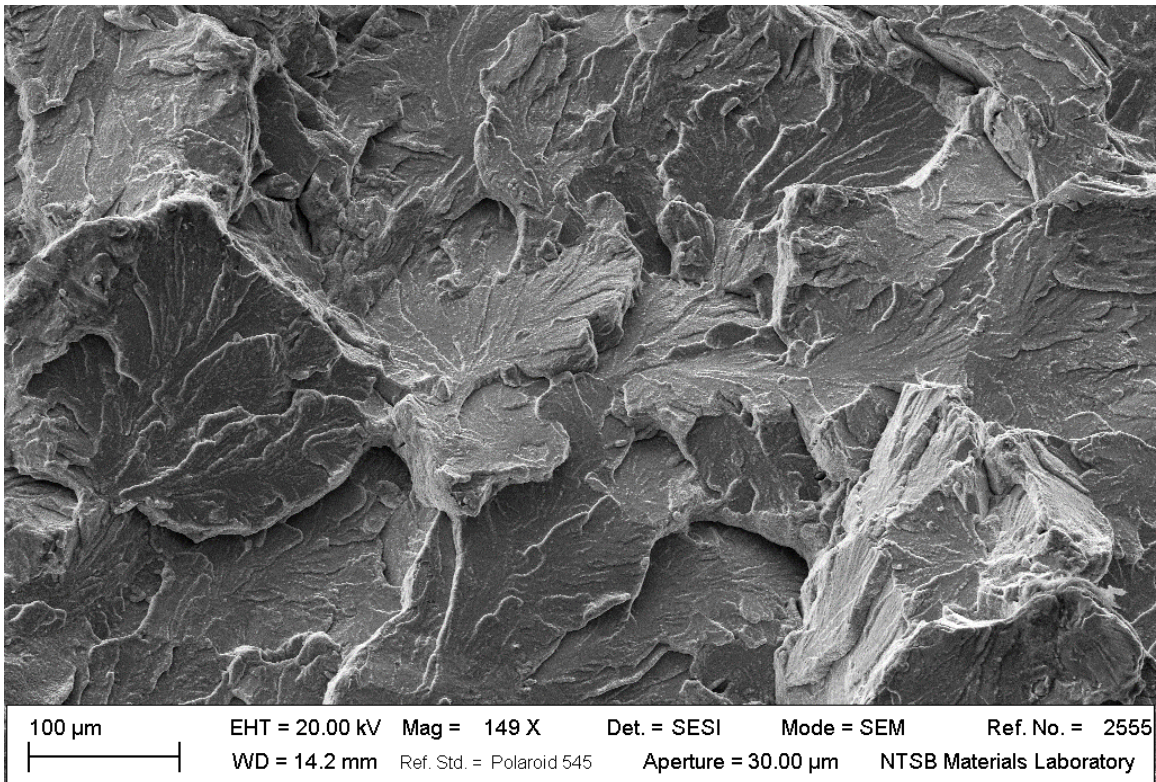
Some of the fracture surfaces from the rail pieces were inspected using a scanning electron microscope. Two regions of the fracture surface of 10N were examined, as shown in Figure 40. A typical area of the fracture surface from the darker-colored portion of 10N is illustrated in Figure 58. This portion of the fracture surface exhibited cleavage facets, consistent with overstress fracture of a less ductile metal alloy.¹⁰ At higher magnifications, the cleavage facets exhibited observable rounding (Figure 59). This rounding was consistent with surface oxidation, typical of fractured steels exposed to air, particularly at elevated temperatures.

Figure 58 – Secondary electron (SE) micrograph of cleavage facets on the dark part of the fracture surface of 10N.

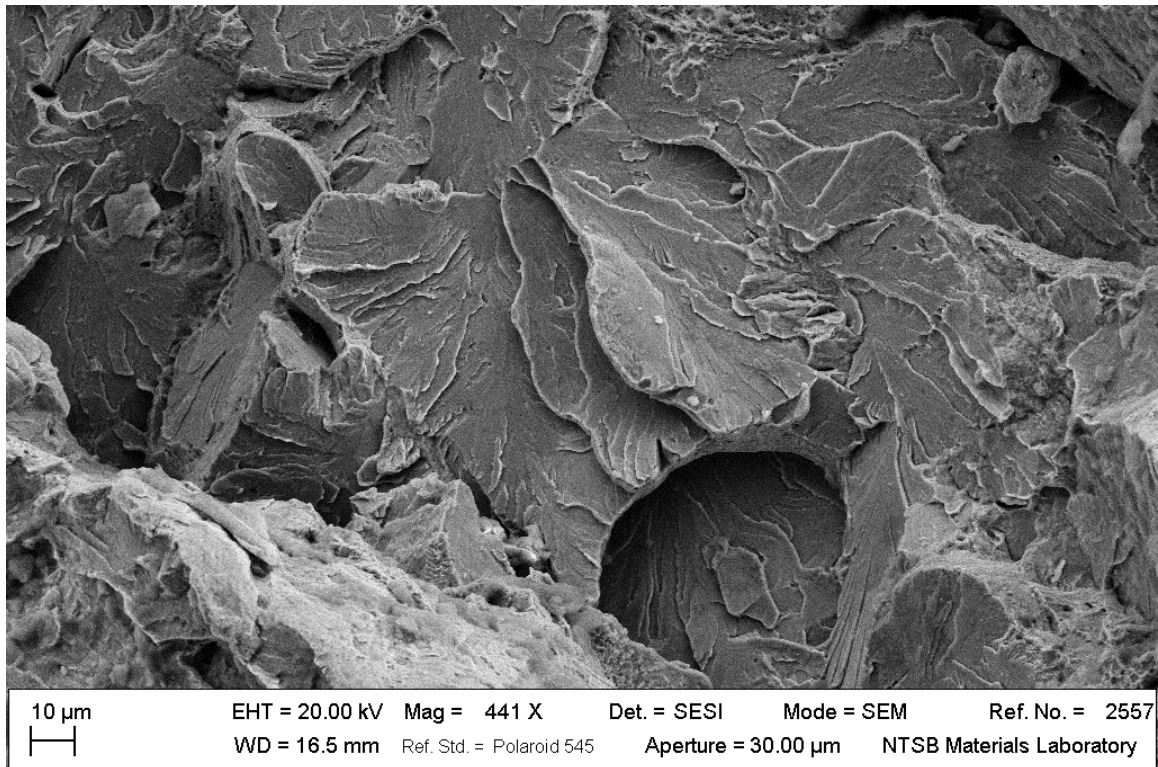
A typical area of the shinier portion of the 10N fracture surface (outside the darker region) is illustrated in Figure 60. This region exhibited cleavage fracture features, consistent with SEM examination of the darker portion of the 10N fracture surface. A closer view of the features in Figure 60 revealed a banded arrangement (see Figure 61). Closer examination of these features found them to be consistent with lamellae in the pearlitic microstructure, typical of carbon steel (see Figure 62). No features consistent with other fracture modes were observed. This chemical composition of the 10N fracture surface was inspected using energy dispersive x-ray spectroscopy (EDS). The composition was found to be consistent with a carbon steel.

Figure 60 – SE micrograph of the shiny portions of the 10N fracture surface.

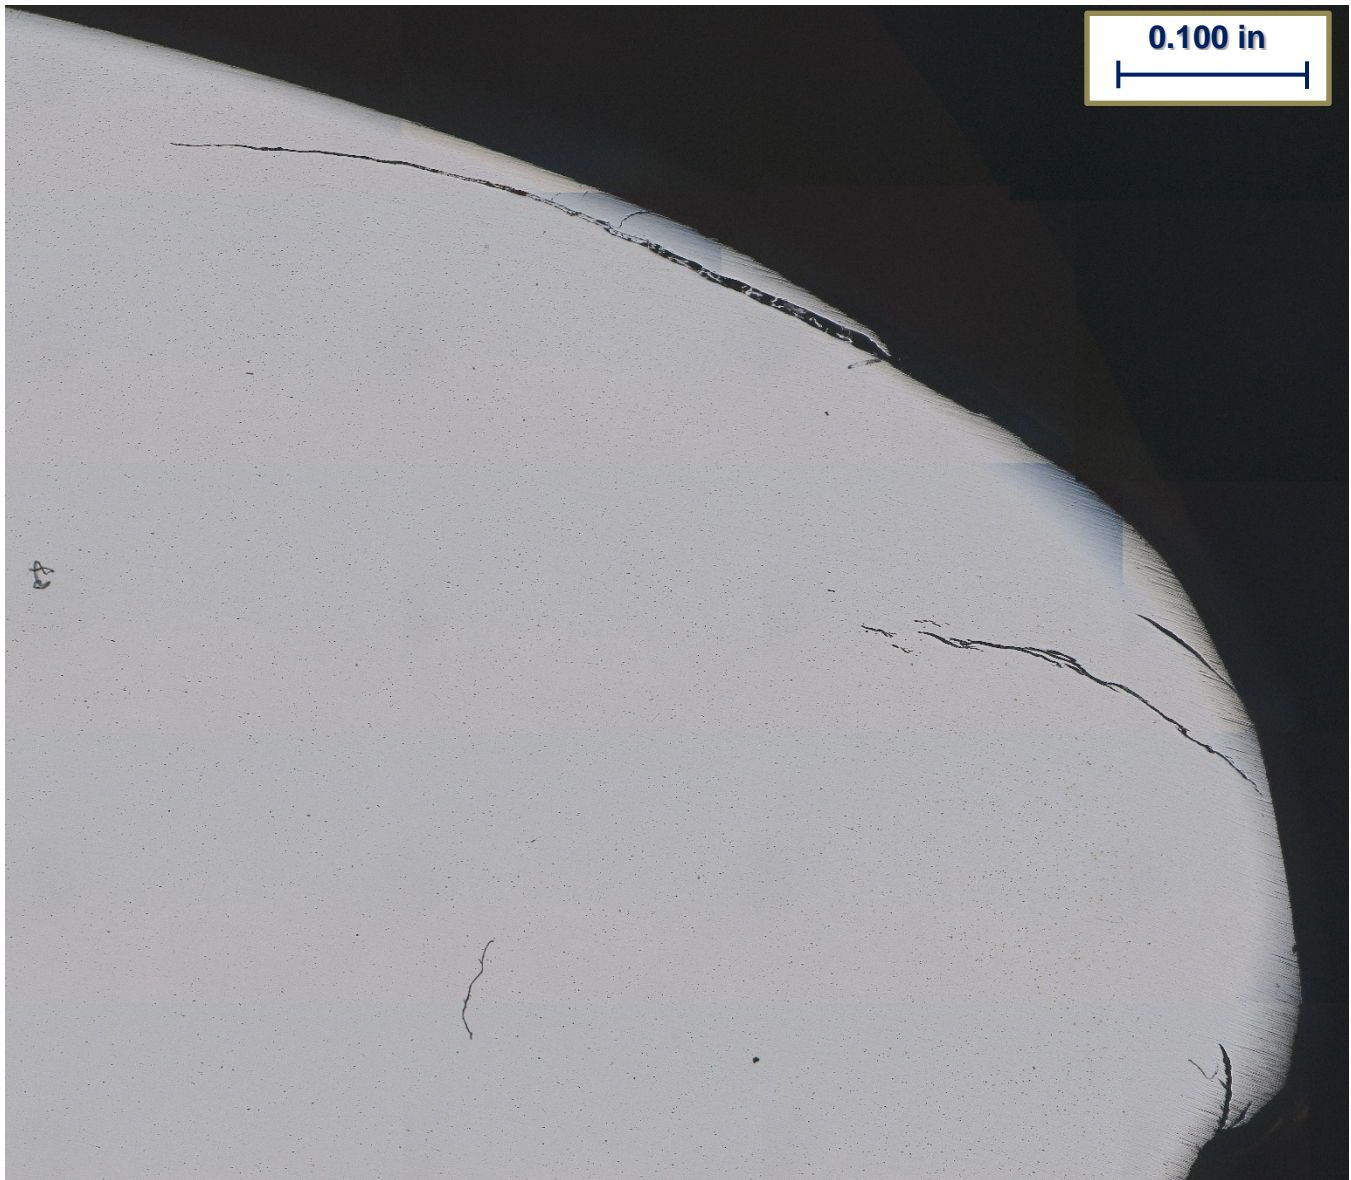
The head of the 10S cross section was ground and polished to 0.3 μm . The gage side of the polished cross section is shown in Figure 63. This cross section illustrated a sub-surface shell crack. The shell crack was present at a depth of 0.150 inches below the running surface, and extended 0.449 inches from the gage side into the head. Other smaller cracks were present on the gage side.

Figure 63 – Bright-field (BF) optical micrograph of a cross section of the 10S head, facing west, as-polished. The gage side is on the right. (~20X).

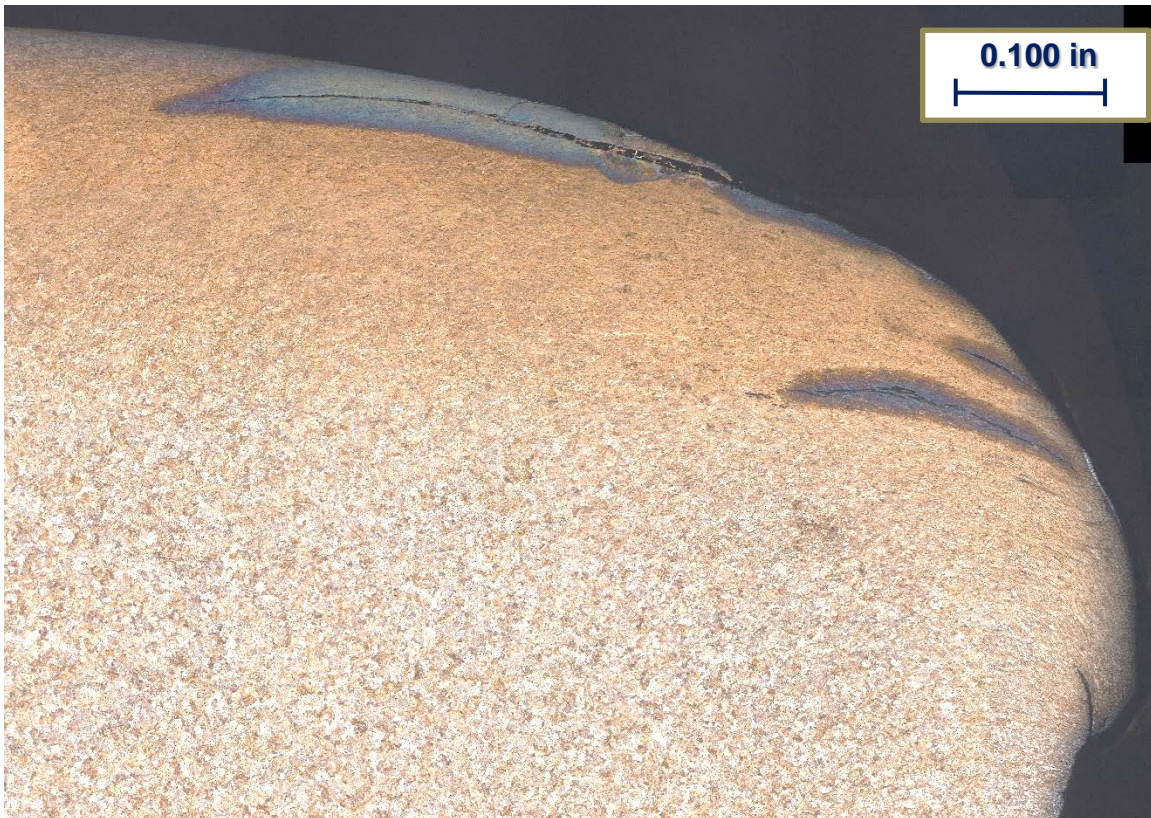
Figure 64 shows the same cross section, after etching with 2% Nital. The overall grain size was visibly smaller near the running surface, where the subsurface cracks were also present. Figure 66 shows a typical area of the rail microstructure, away from the running surface. The microstructure consisted of pearlite and ferrite, consistent with a typical microstructure for a near-eutectoid carbon steel.

Figure 64 – Bright-field optical micrograph of a cross section of the 10S head, facing west. The gage side is on the right (~20X, etched 2% Nital).

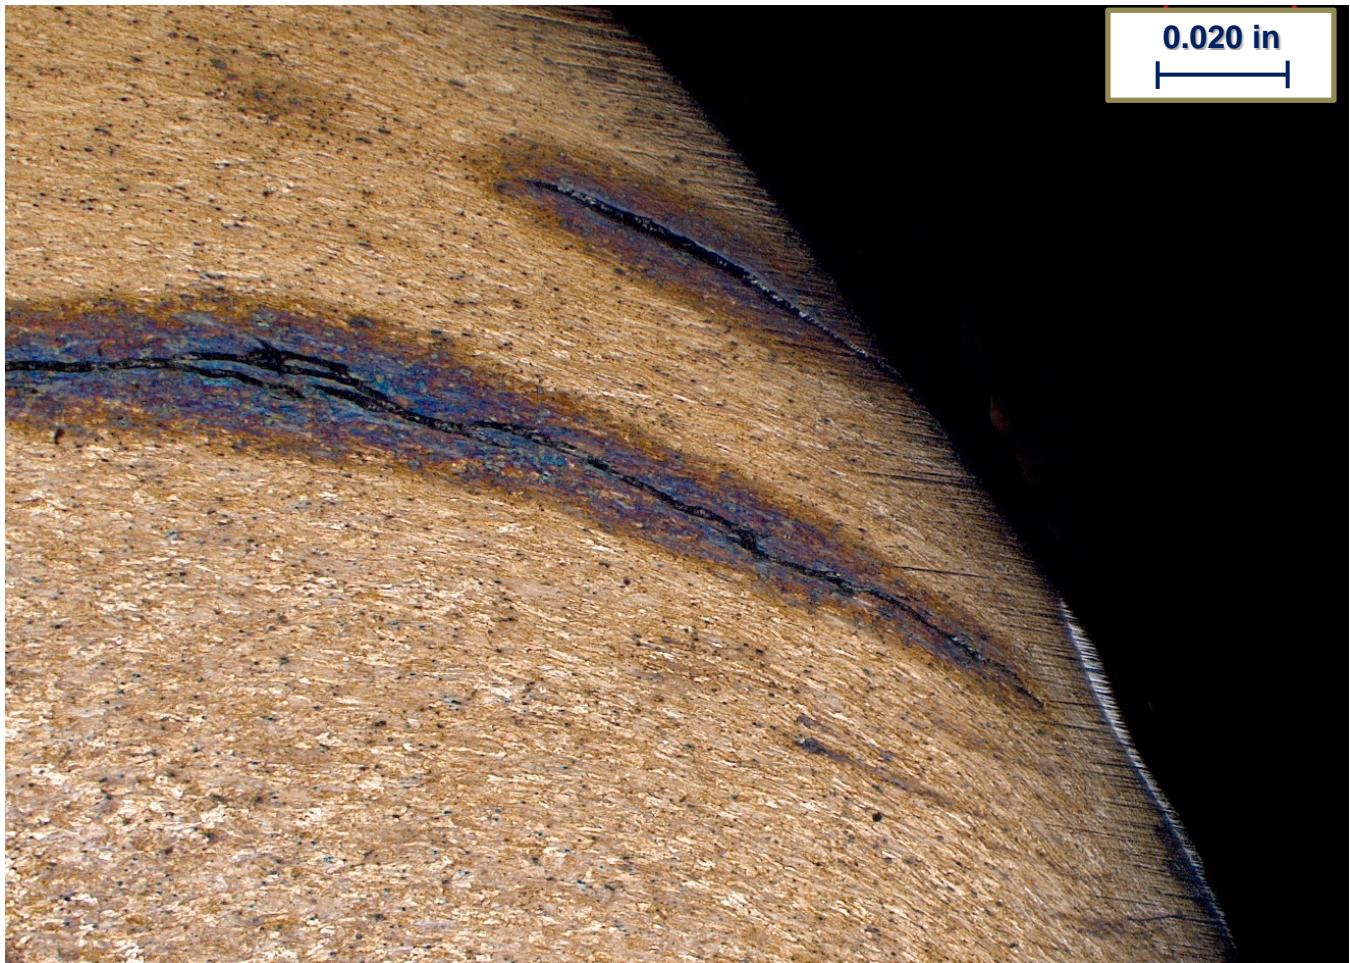
Figure 67 shows a region closer to the running surface of the head. The microstructure, while still comprised of pearlite, also exhibited a compressed and flattened grain structure. This grain texture was generally parallel to the internal shell cracks present in the gage corner of the head cross section. The right side of the figure exhibited some white-colored material. This was consistent with untempered martensite, which would be consistent with a portion of the steel experiencing temperatures above 770°C (1418 °F), and then rapidly cooled. It should be noted the dark blue regions adjacent to the shell cracks in Figure 67 were etch stain artifacts from etchant flowing into the openings.

Figure 67 – BF micrograph of the 10S head cross section near the running surface, showing a more compressed grain structure and internal cracks (~500X, etched 2% Nital).
