NATIONAL TRANSPORTATION SAFETY BOARD

MATERIALS LABORATORY FACTUAL REPORT

Report No. 17-089

Place : East Haven, Connecticut
Date : February 22, 2017
Vehicle : Piper PA 38, 112
NTSB No. : ERA17FA112
Investigator : Robert Gretz

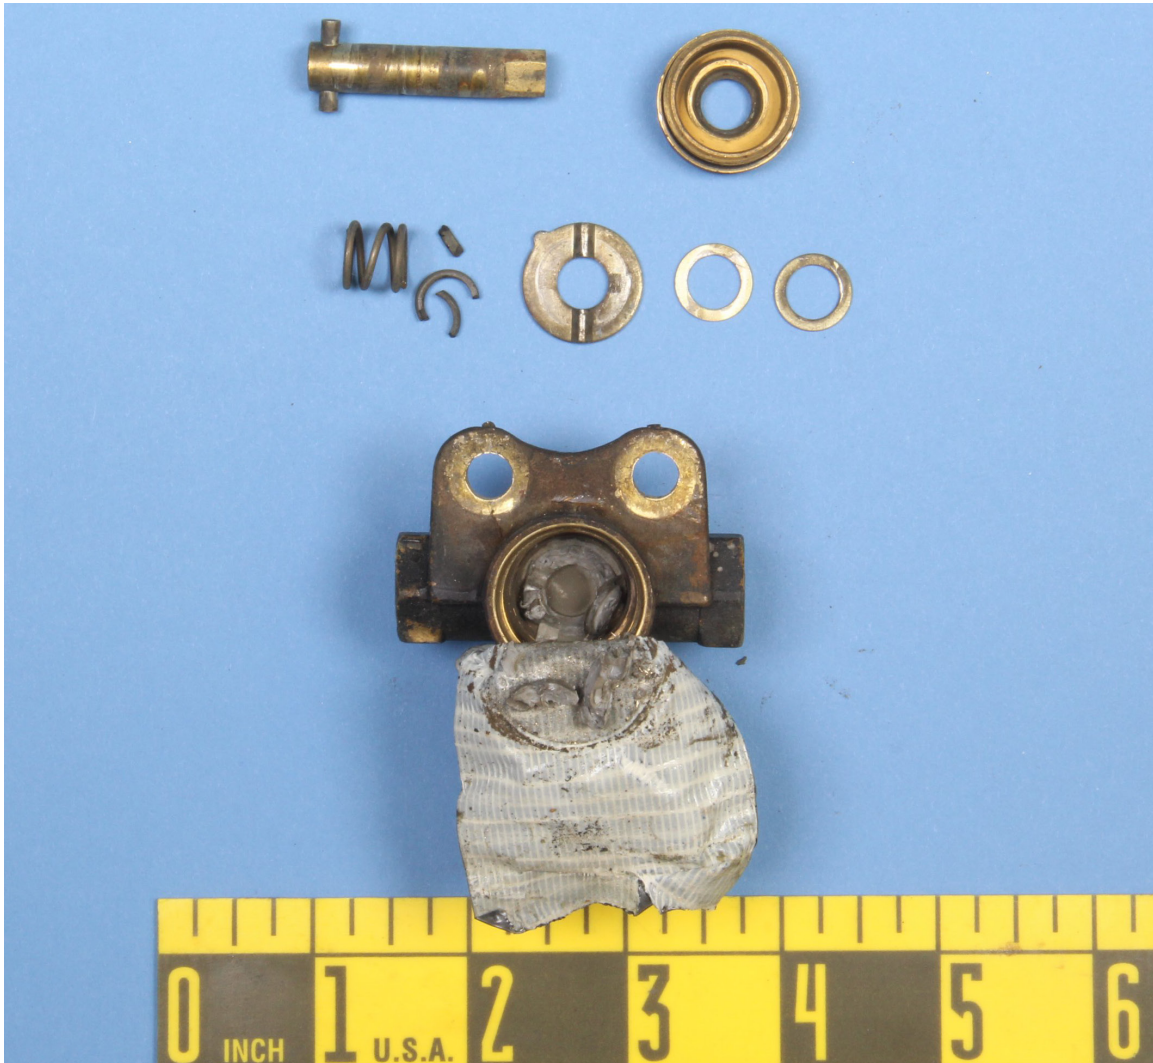
The fuel selector valve from the accident aircraft was submitted to the Materials Laboratory for examination. An as received photograph is shown in Figure 1.

Figure 1. Overall photograph of fuel selector valve at intake.

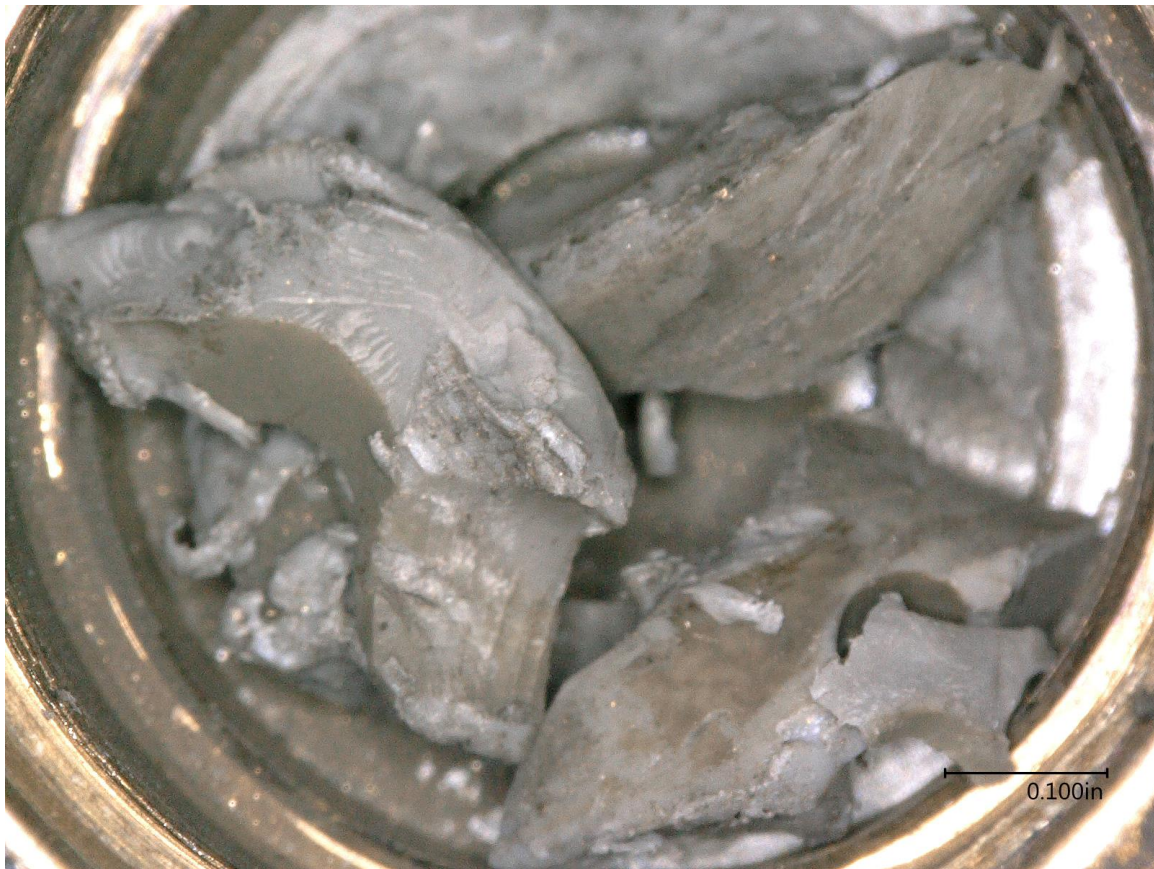
The fuel selector valve was received partially disassembled. The metallic shaft was free from the insert. The top portion (above the pin insertions) of the polymeric inset was fractured into multiple pieces as shown in Figure 2. The lower portion was still present within the metallic body of the valve as shown in Figure 3. The lower portion could not be rotated within the valve body.

Figure 2. Photograph of fragments of top portion of polymeric inset.

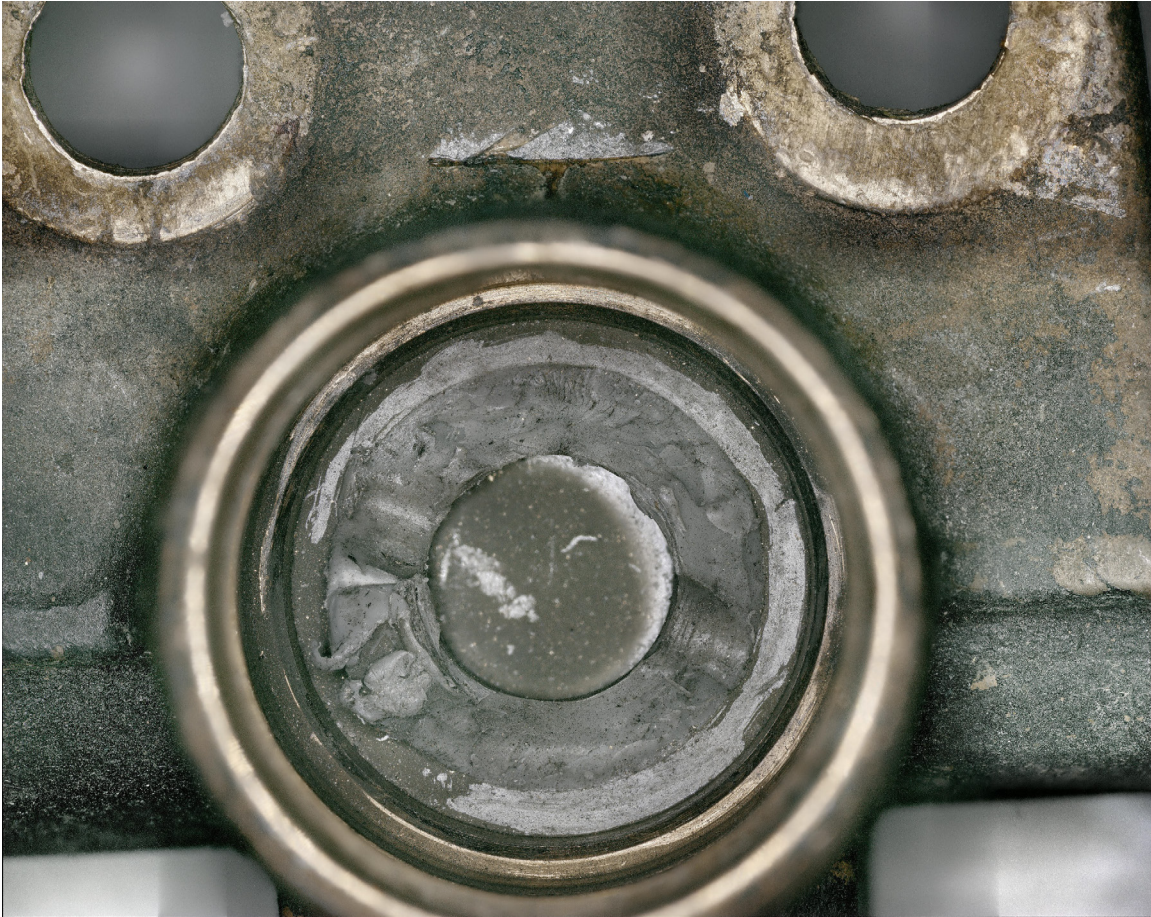
Figure 3. Photograph of lower portion of inset in valve housing.

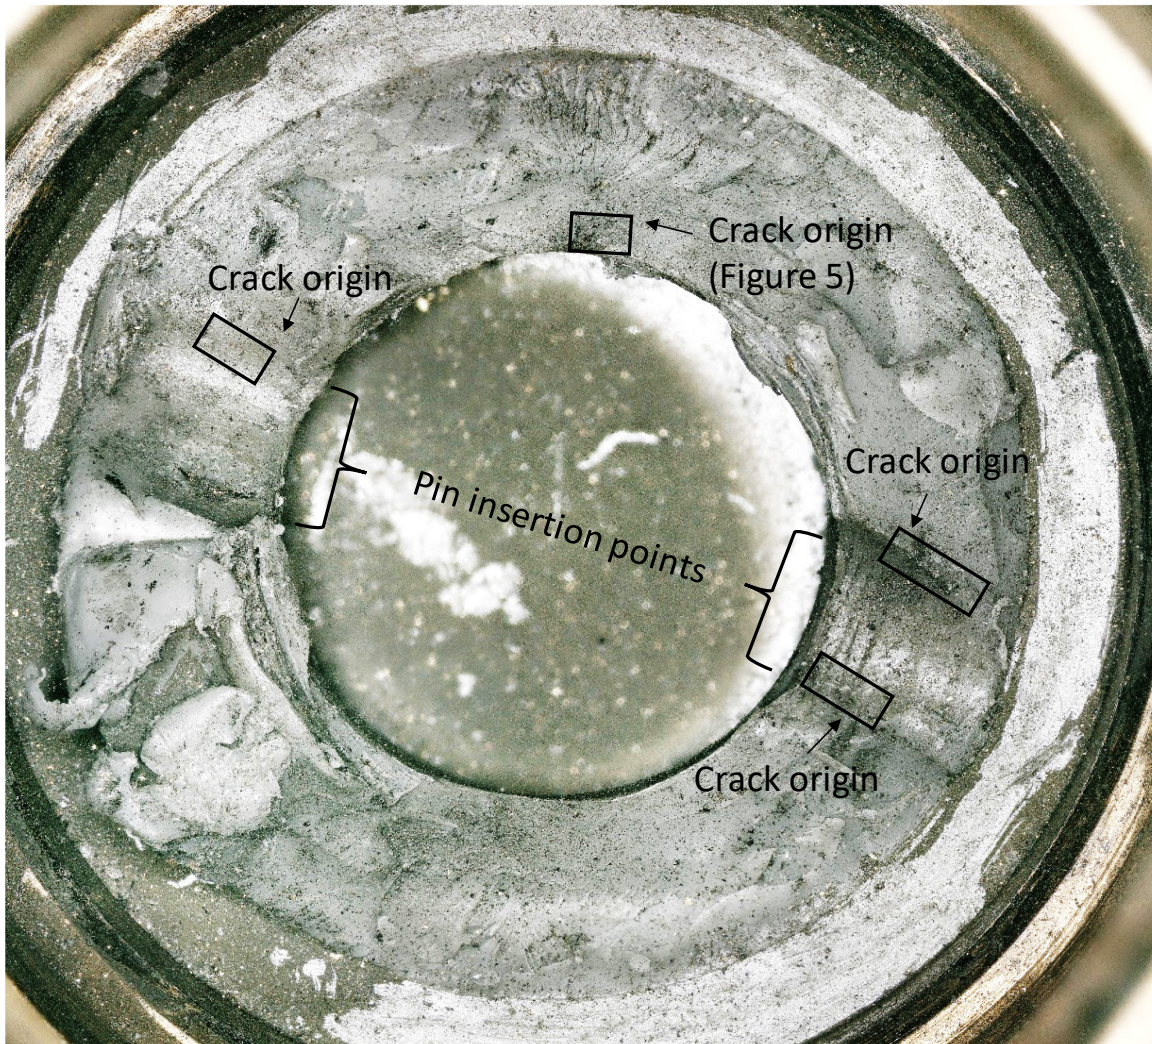
The upper surface of the intact portion exhibited multiple points of crack origin included origins in the area of the pin insertions. These areas are characterized by smooth, featureless areas. This is shown in Figure 4. Ridges on the fracture indicated fast crack propagation through the full thickness of the insert. An example of this is shown in Figure 5. In addition, there were several large smeared features that ended with shear lips. The fracture features shown on the surface of the lower insert portion were consistent with rotational ductile overstress.

Figure 4. Photograph of fracture face on lower portion of inset.

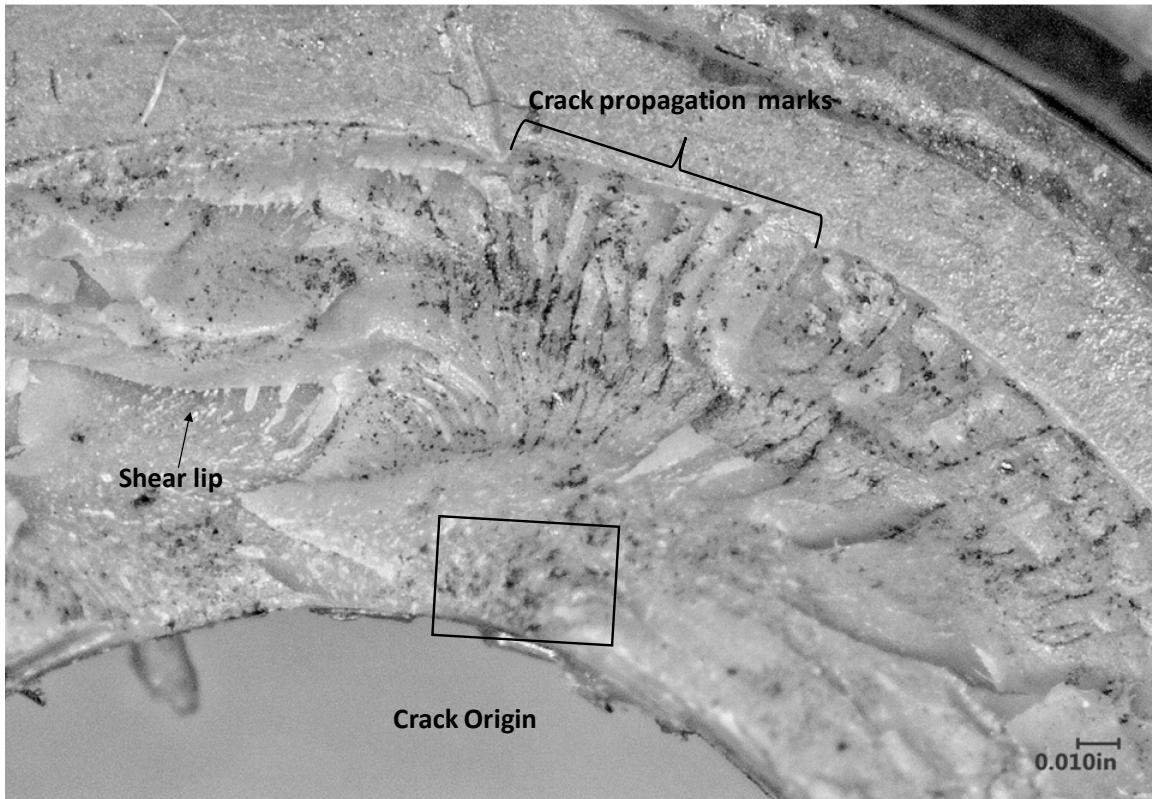
Figure 5. Close-up photograph of one of the crack origin areas on the lower inset portion.

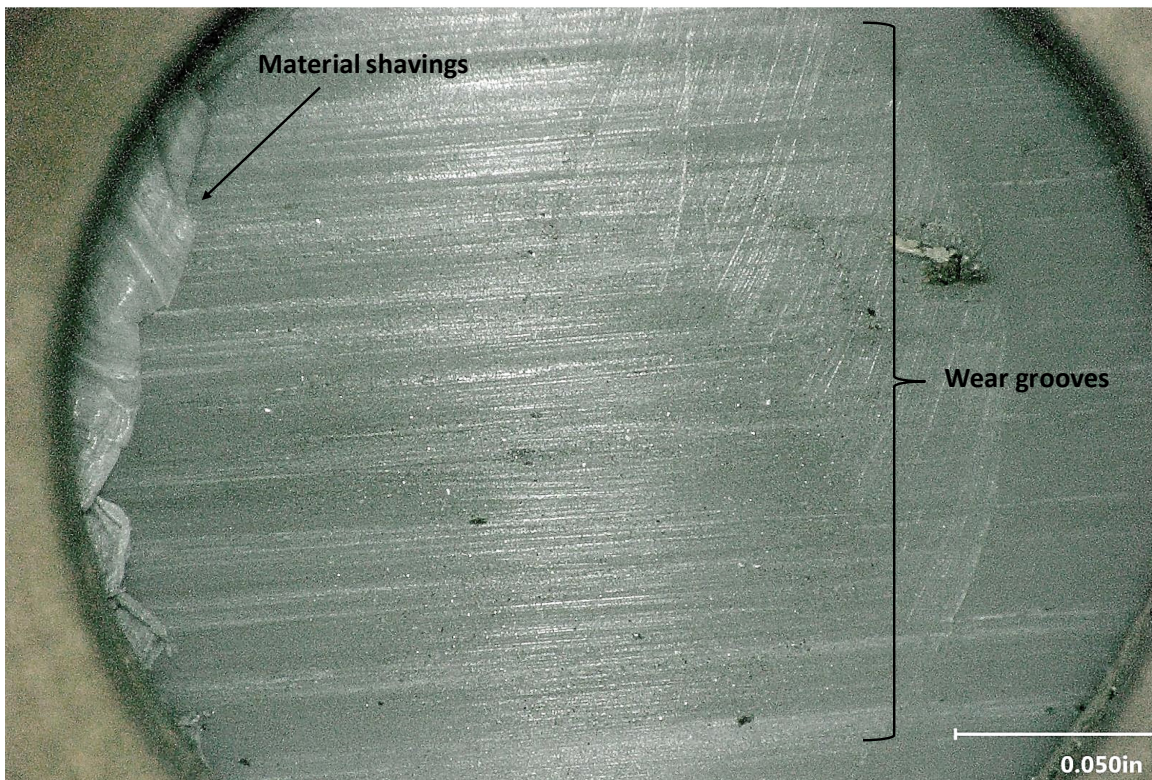
There was also the presence of abrasive wear on the outer portion of the insert due to contact with burs on the valve housing. The presence of grooves on the surface of the insert as well

as the presence of insert material shavings are indicative of this type of wear as shown in Figure 6.

Figure 6. Close-up photograph of abrasive wear on side of insert.
