NATIONAL TRANSPORTATION SAFETY BOARD

MATERIALS LABORATORY FACTUAL REPORT

Report No. 18-031

Place : Honolulu, HI
Date : February 13, 2018
Vehicle : Boeing 777 (United Airlines)
NTSB No. : DCA18IA092
Investigator : Jim Hookey (AS-40)

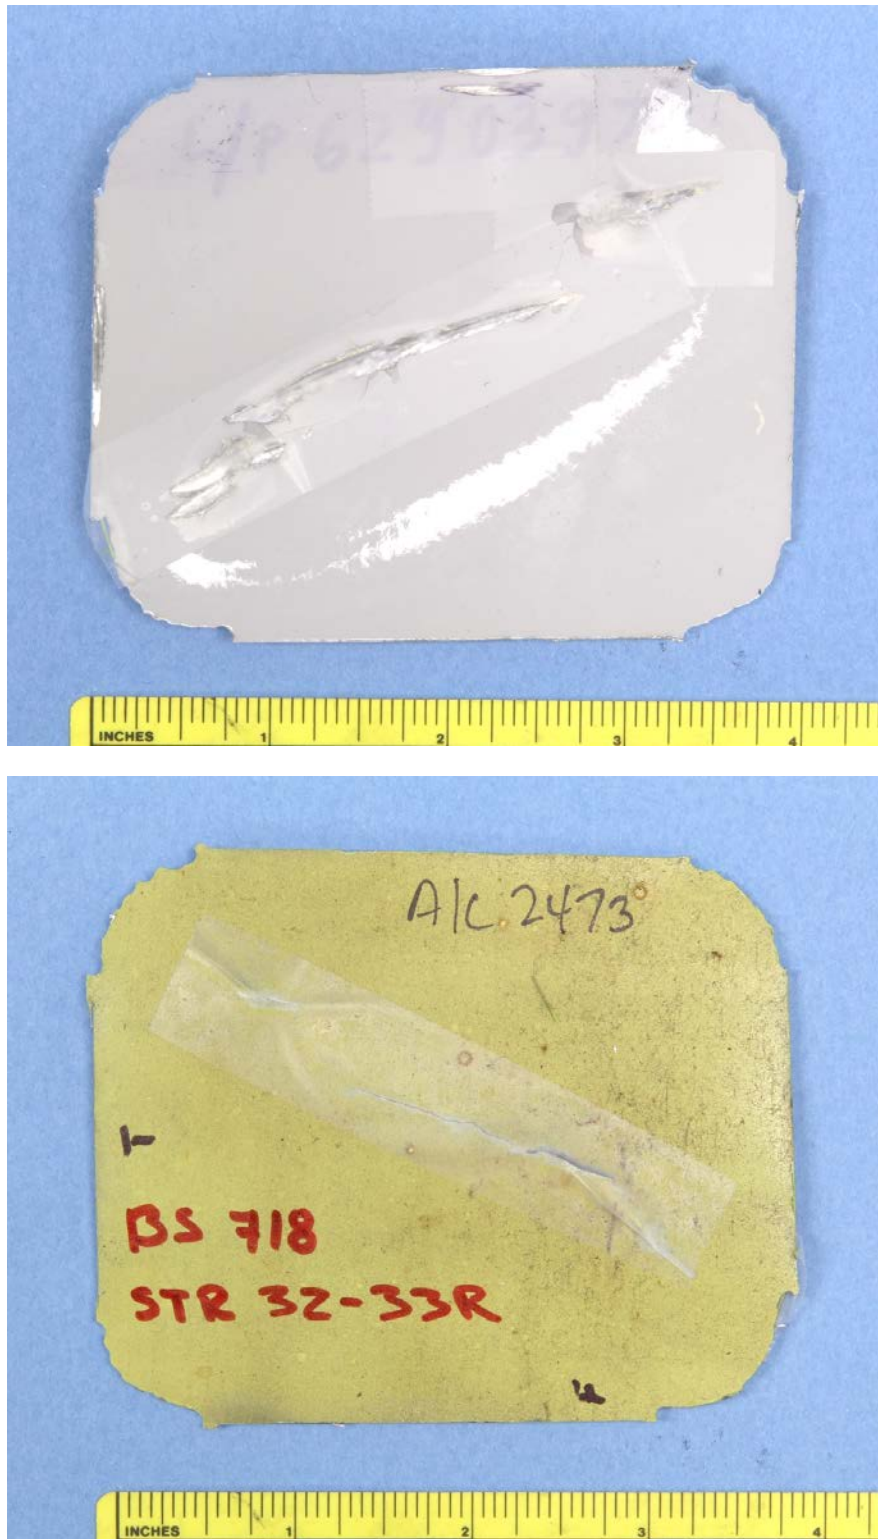
A fan blade separation resulted in damage to the inlet, engine cowl, and surrounding aircraft structure. Several areas on the fuselage had impact marks from debris that had exited the engine during the event. Two pieces of fuselage were excised and sent to the Materials Laboratory for analysis. The pieces are shown in Figure 1 thru Figure 3. One piece consisted of only fuselage (Figure 1), while the other piece had fuselage skin still attached to a portion of stringer substructure (Figure 2 and Figure 3). The stringer had separated along the longitudinal rib, as indicated by the red arrows in Figure 2.

Figure 1: Overall photos of the unattached piece of fuselage. The top photo shows impact marks on the painted external surface of the piece.

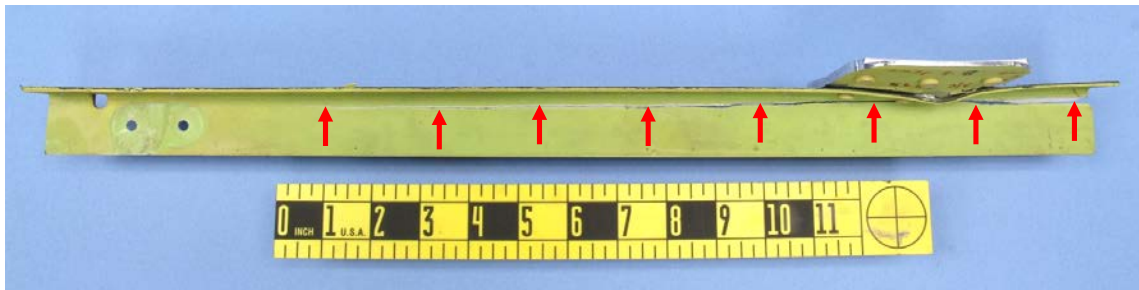
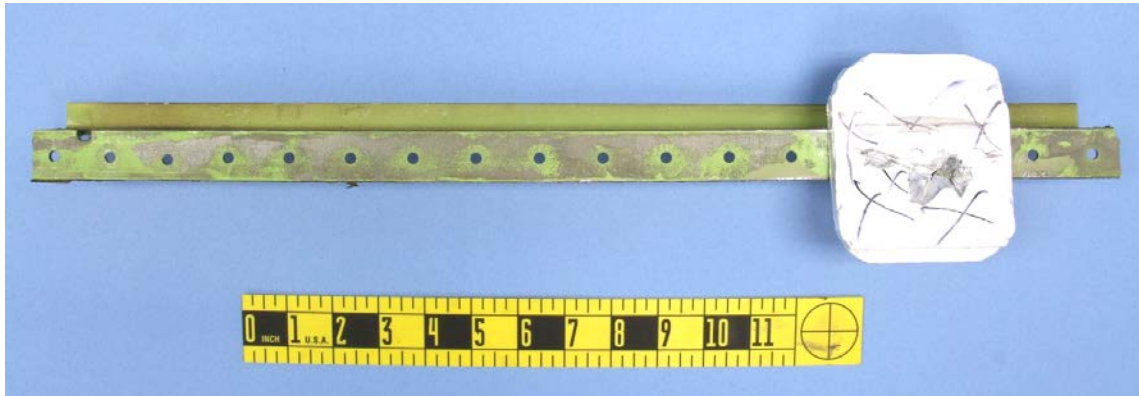
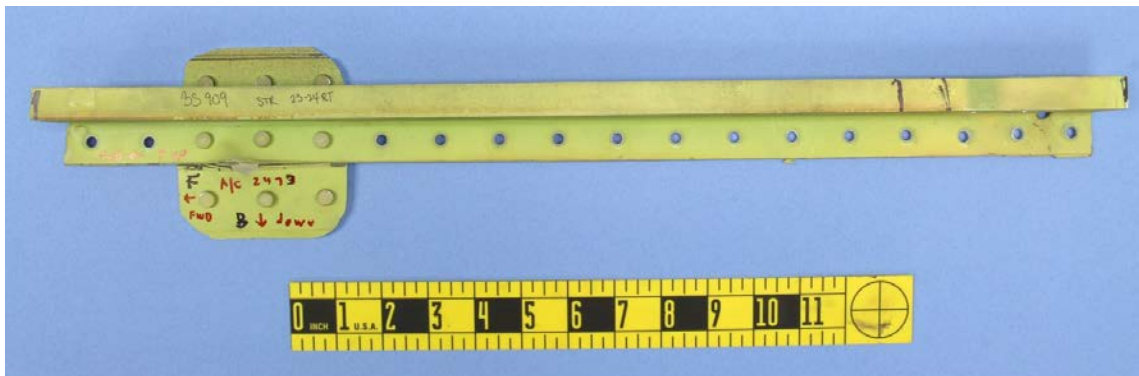
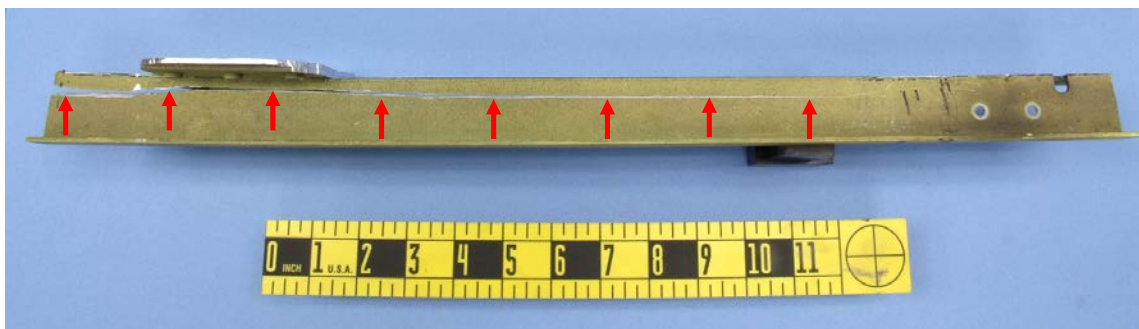
Figure 2: Overall photos of the piece of fuselage still attached to the stringer. The red arrows point to a separation in the rib of the stringer.

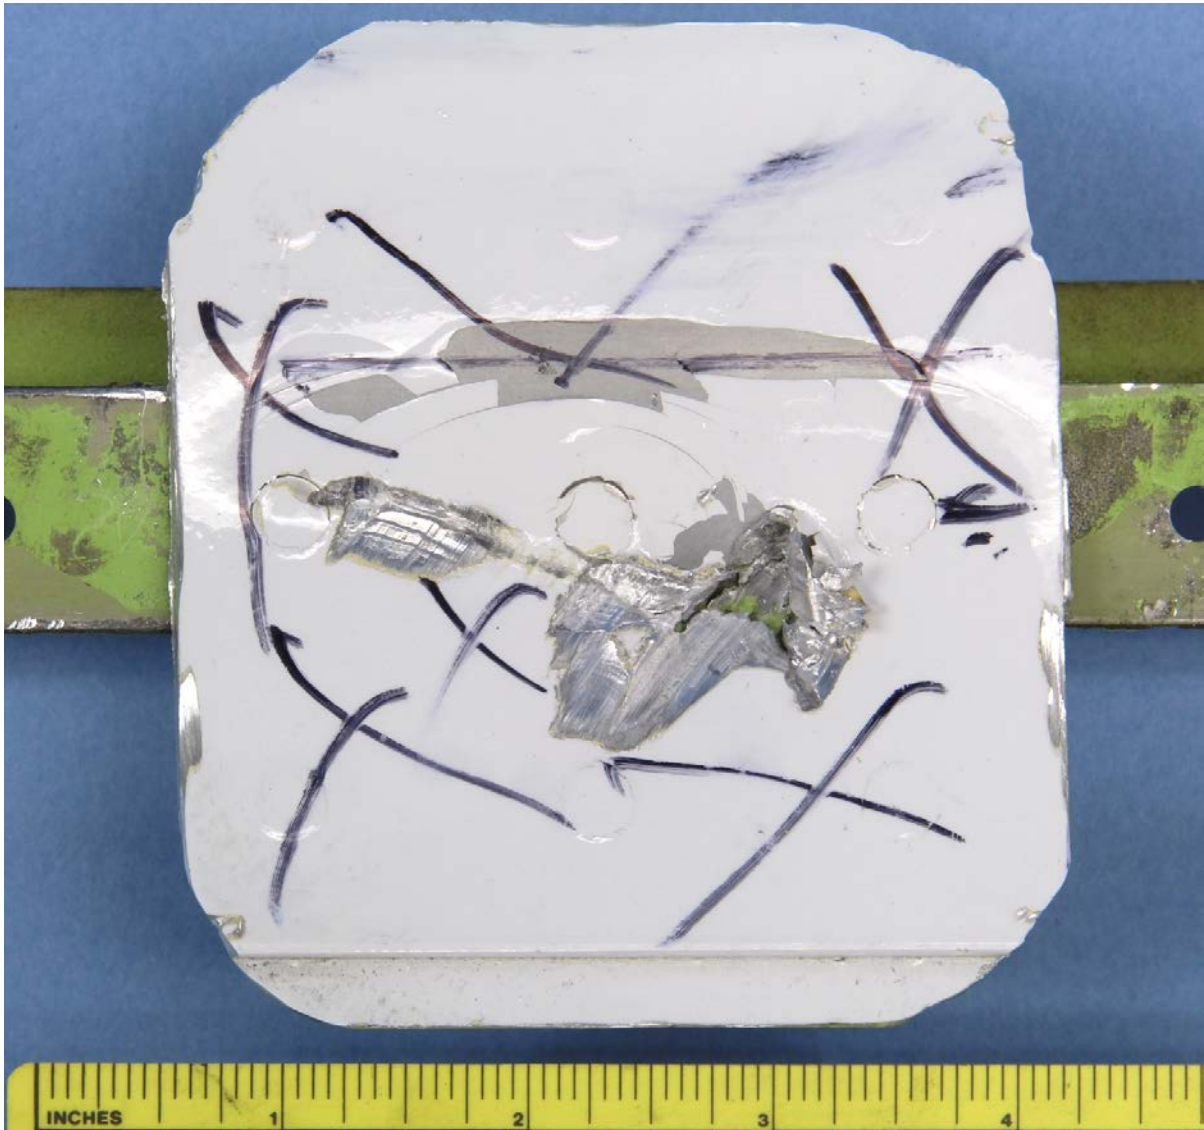
Figure 3: Close-up photo of the piece of fuselage still attached to the stringer. Impact marks were visible on the painted external surface of the piece.

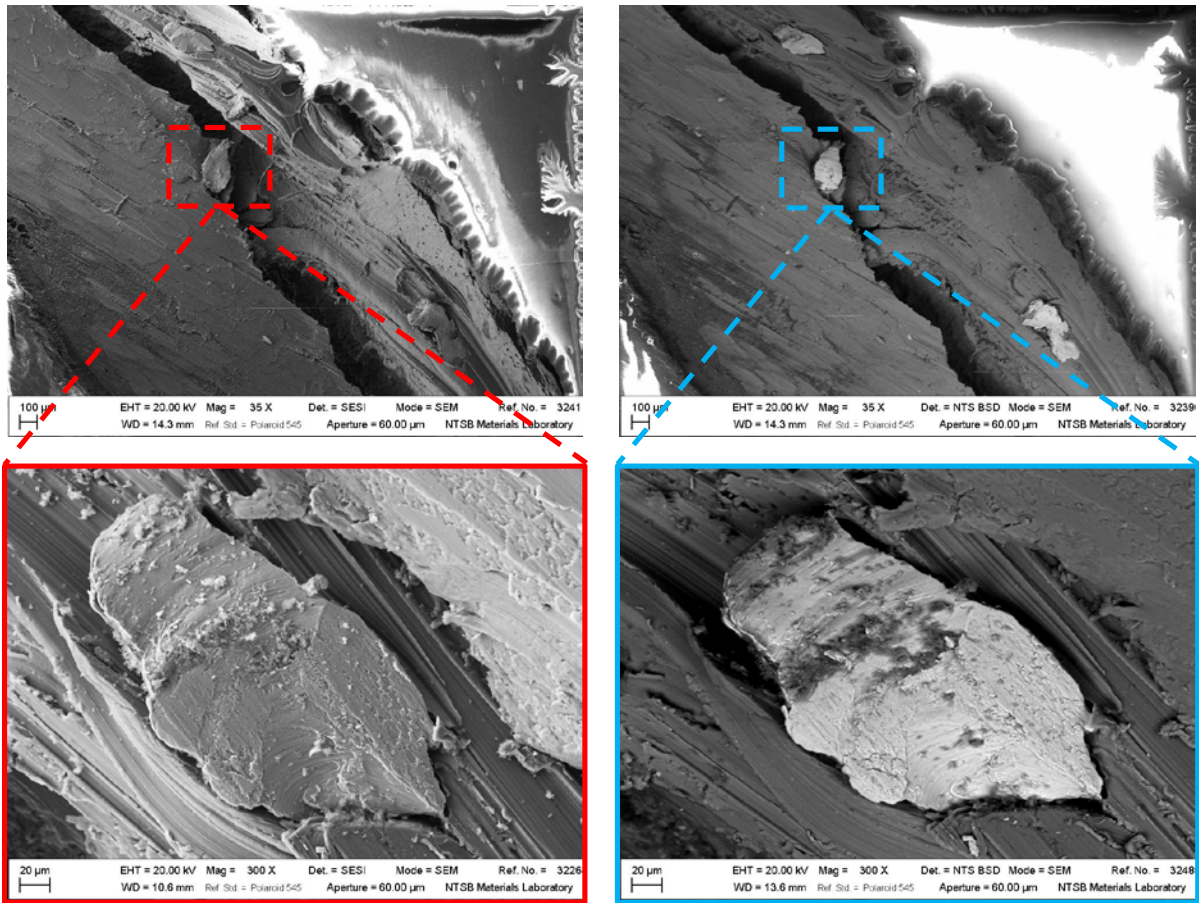
Both pieces had multiple gouges and embedded particles in their surfaces. The embedded particles had a distinctly different appearance than the fuselage skin when viewed using backscattered electron (BSE) imaging. SEM images of exemplar embedded particles in the unattached fuselage piece and the fuselage piece attached to the stringer are shown in Figure 4 and Figure 6.

Figure 4: Secondary electron (left) and BSE (right) SEM images of an exemplar embedded particle in the surface of the unattached piece of fuselage.

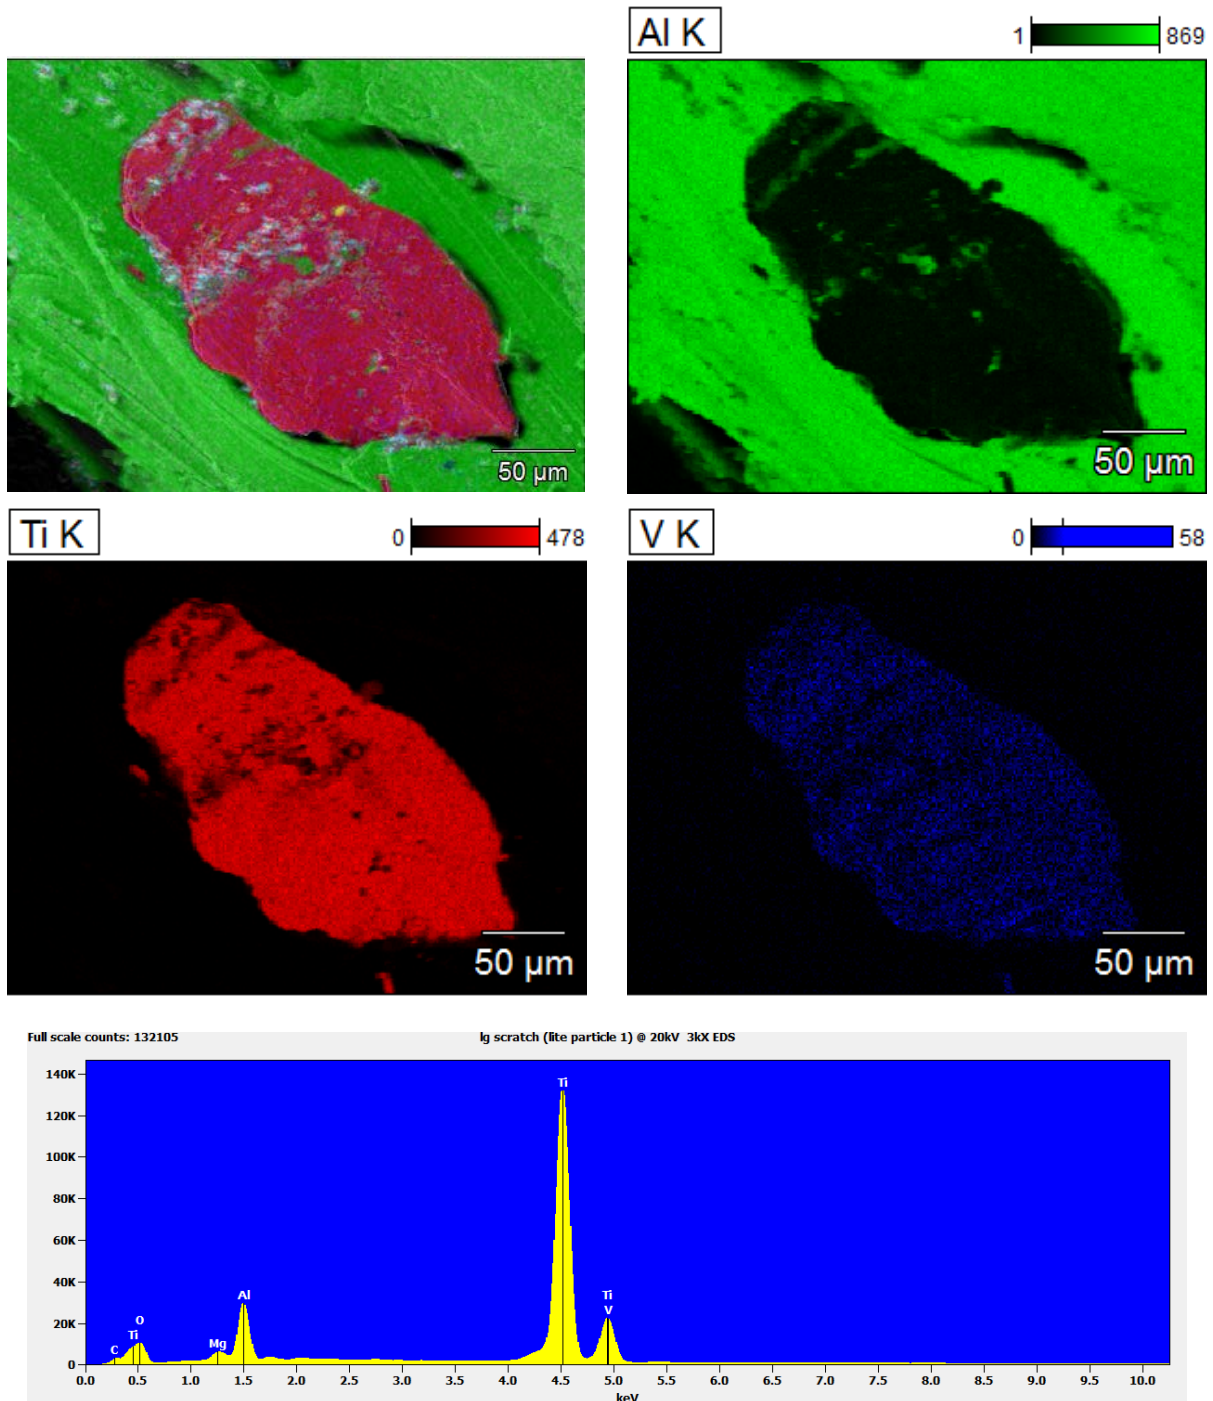
EDS elemental maps of the embedded particles showed they were rich in titanium and vanadium, and had less aluminum when compared to the surrounding fuselage skin. EDS spectra of the embedded particles were consistent with Ti-6-4 titanium alloy. The corresponding EDS elemental dot maps and EDS spectra of the exemplar embedded particles are shown in Figure 5 and Figure 7.

The separated fan blade was made from Ti-6-4 titanium alloy, while the fuselage skin was made from an aluminum alloy.

Figure 5: EDS elemental dots maps of the exemplar embedded particle in the surface of the unattached piece of fuselage from Figure 4 are shown in the top 4 images. Clockwise from the top right the images show the presence of aluminum, vanadium, and titanium, and the top left image is a composite of the 3 elements. The bottom image shows the EDS spectrum of the embedded particle, which was consistent with Ti-6-4 titanium alloy.

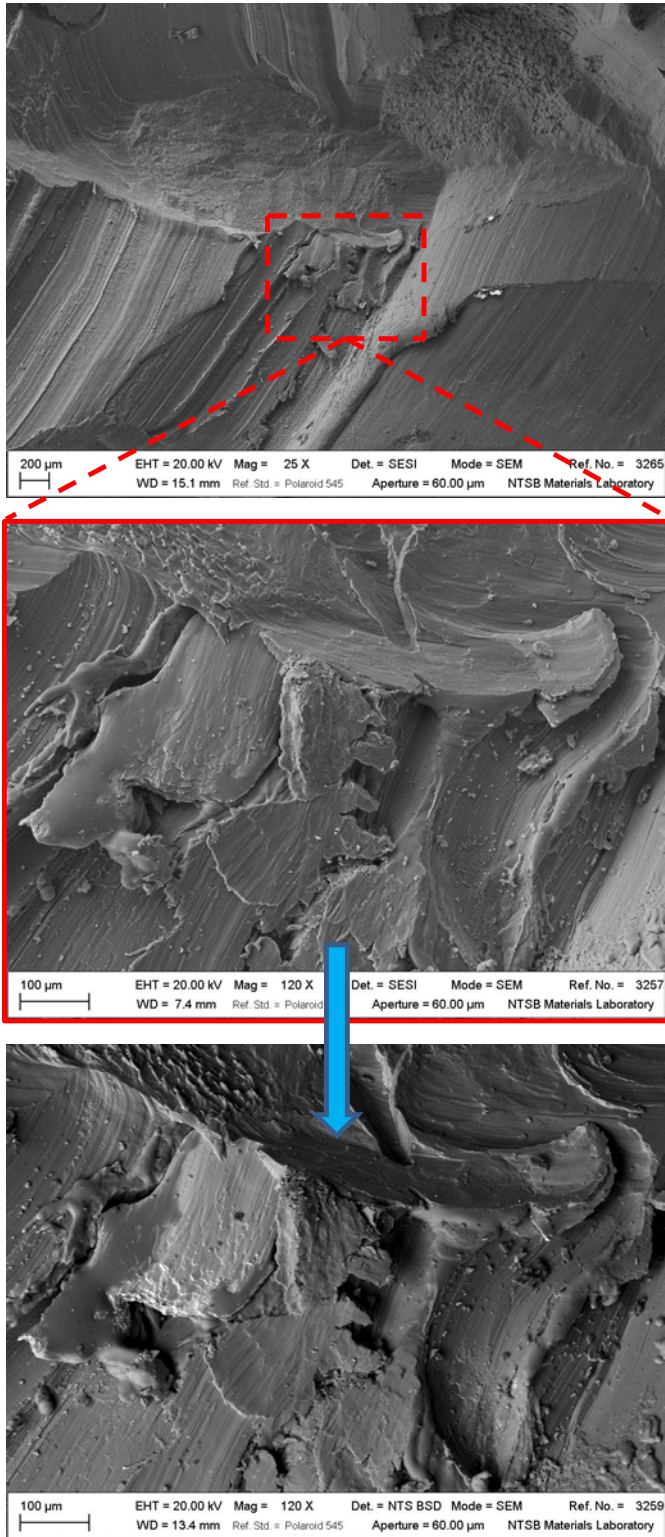
Figure 6: Secondary electron (top and middle) and BSE (bottom) SEM images of an exemplar embedded particle in the surface of the piece of fuselage still attached to the stringer.

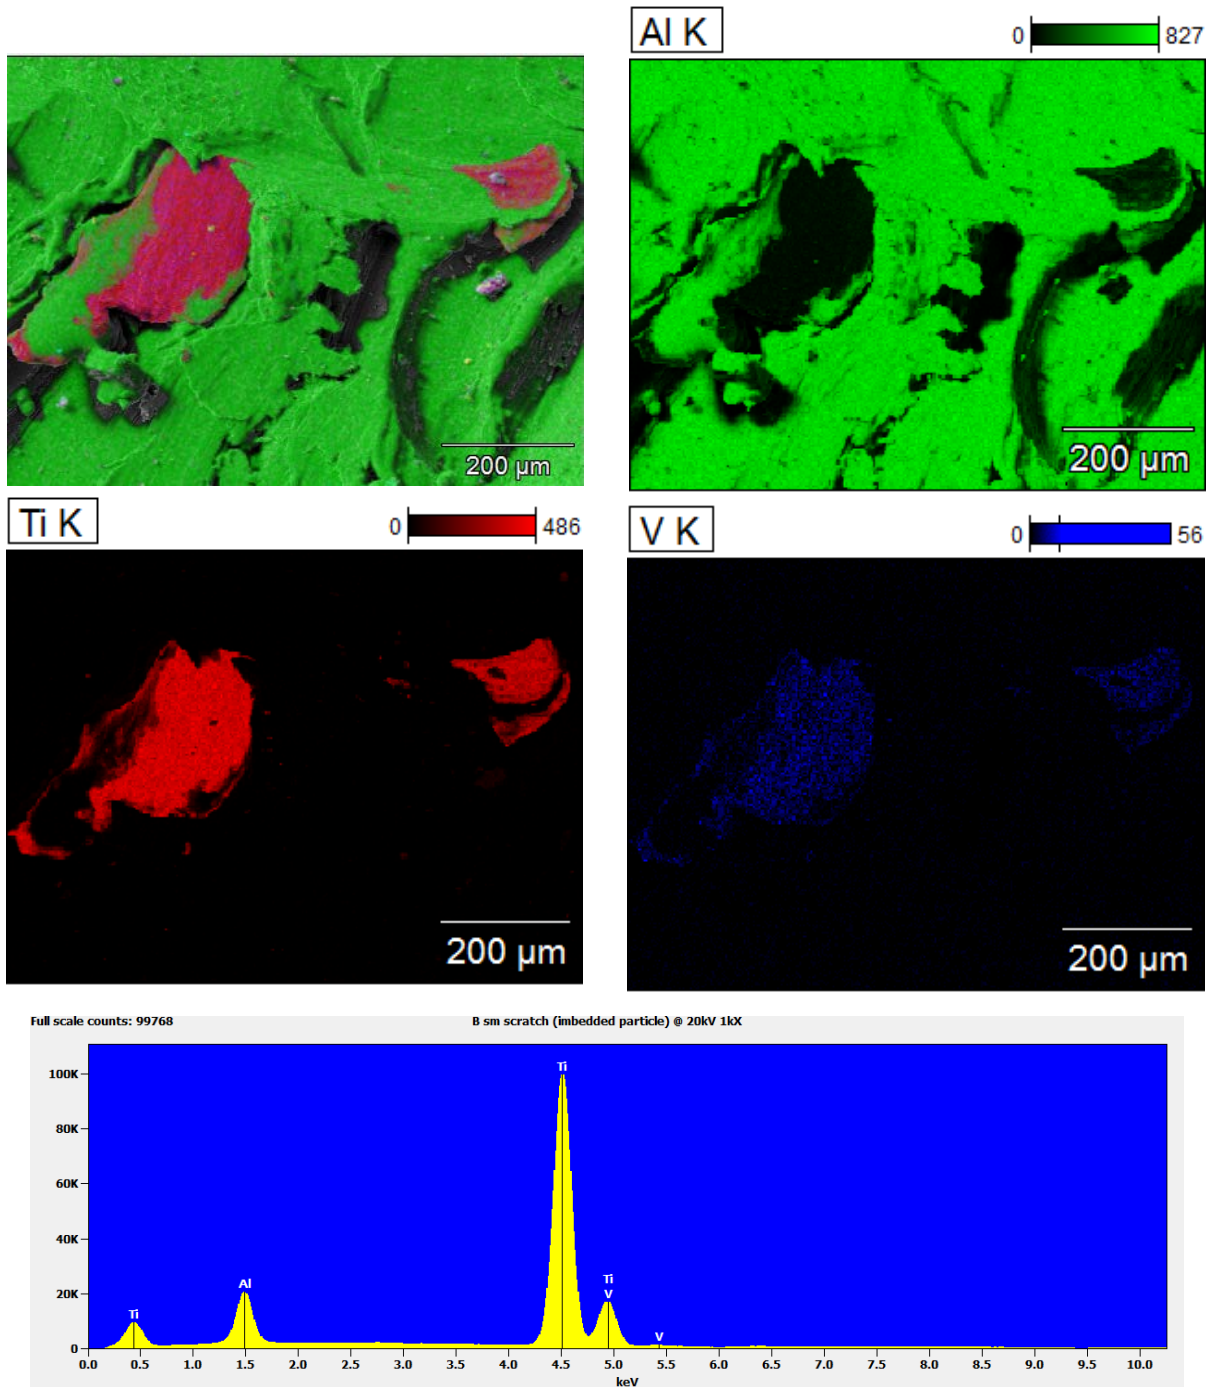
Figure 7: EDS elemental dots maps of the exemplar embedded particle in the surface of the piece of fuselage still attached to the stringer from Figure 6 are shown in the top 4 images. Clockwise from the top right the images show the presence of aluminum, vanadium, and titanium, and the top left image is a composite of the 3 elements. The bottom image shows the EDS spectrum of the embedded particle, which was consistent with Ti-6-4 titanium alloy.
