NATIONAL TRANSPORTATION SAFETY BOARD

MATERIALS LABORATORY FACTUAL REPORT

Report No. 19-070

Place : Adrian, Michigan
Date : January 13, 2019
Vehicle : Piper PA-32R-300, N8892E
NTSB No. : CEN19LA066
Investigator : Mitchell Gallo, AS-CEN

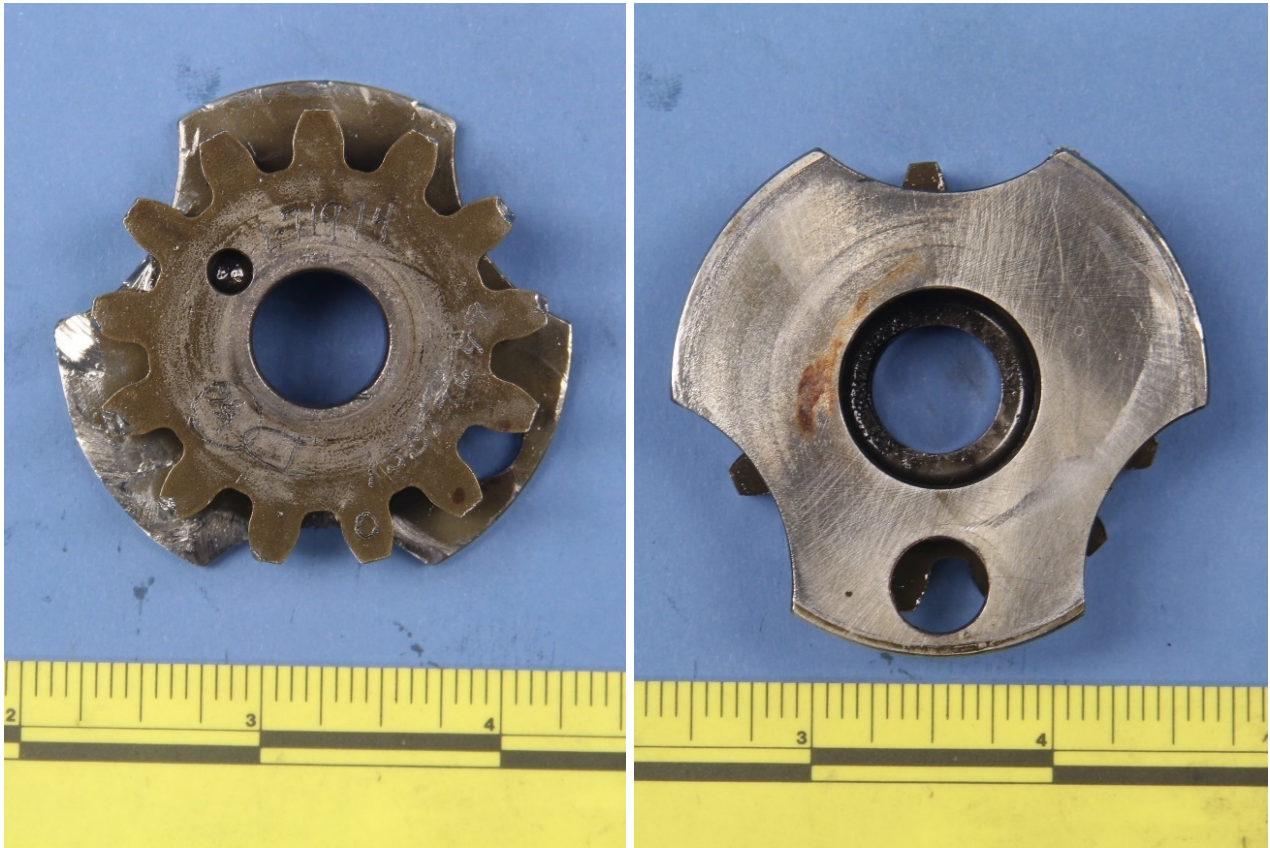
Figure 1 shows the gear from the engine, as received. The gear face is shown in Figure 1a and the backing plate face is shown in Figure 1b. As shown in Figures 2 and 3, the gear face displayed vibroetched markings. The markings stated, "L-71974" and "13519649".

Figure 1 – The crankshaft gear, viewed from opposite faces, as received.

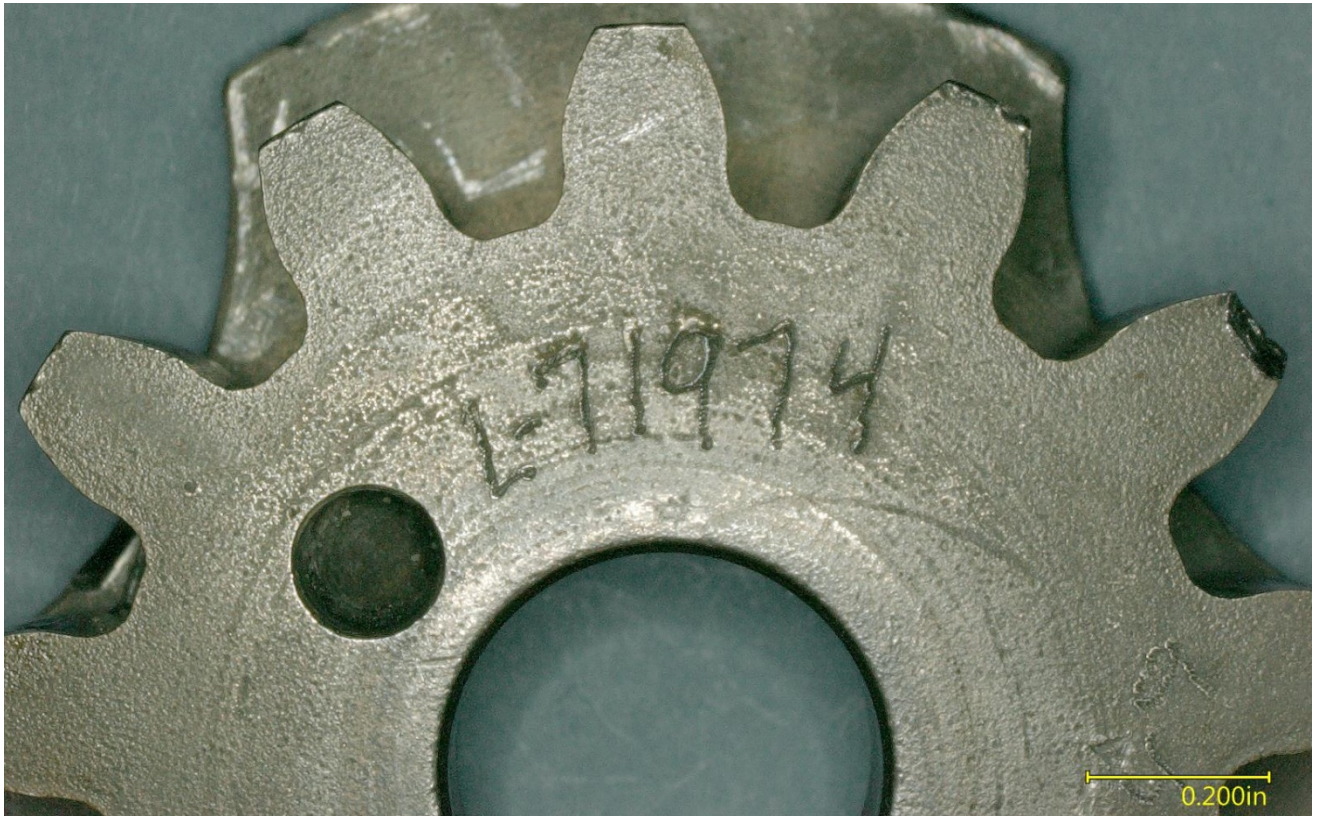
Figure 2 – The markings on the face of the gear side of the crankshaft gear.

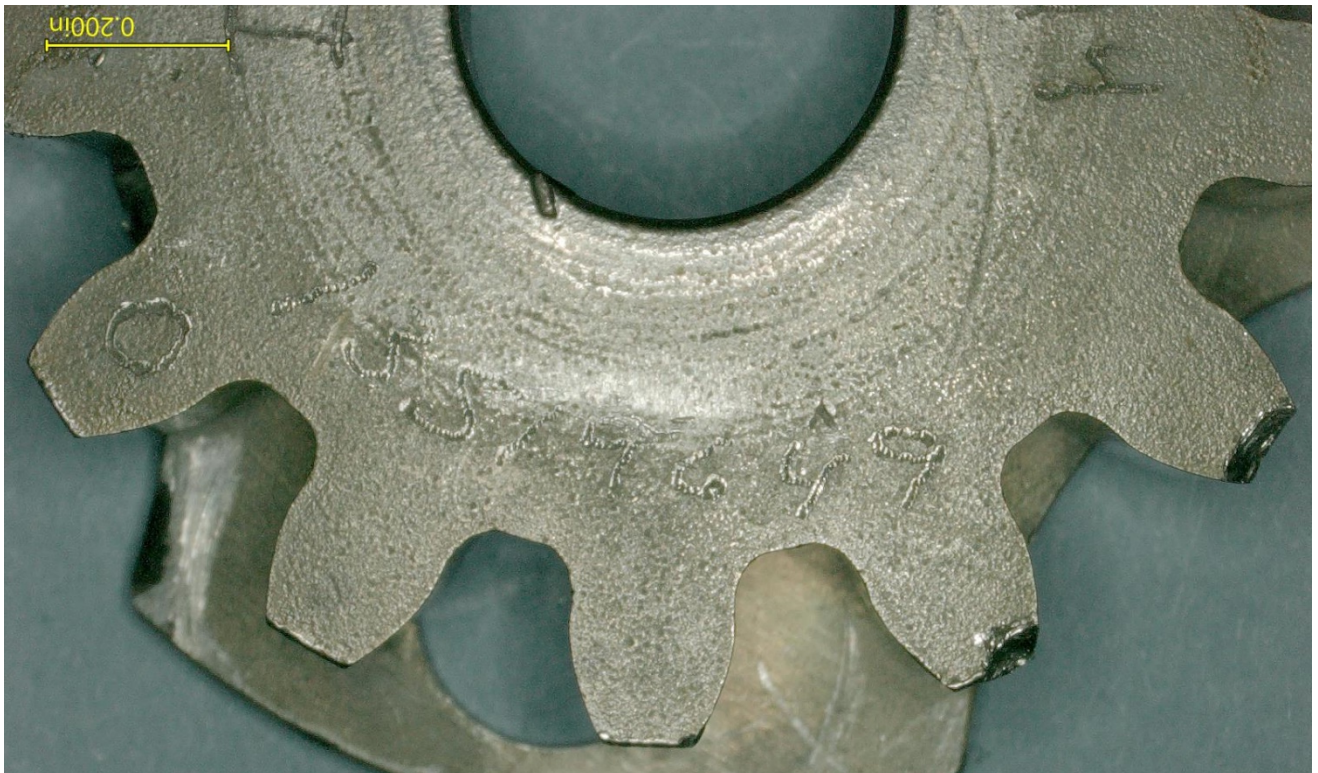
Figure 3 – Vibroetched markings on the gear face, 180° opposite of those in Figure 2.

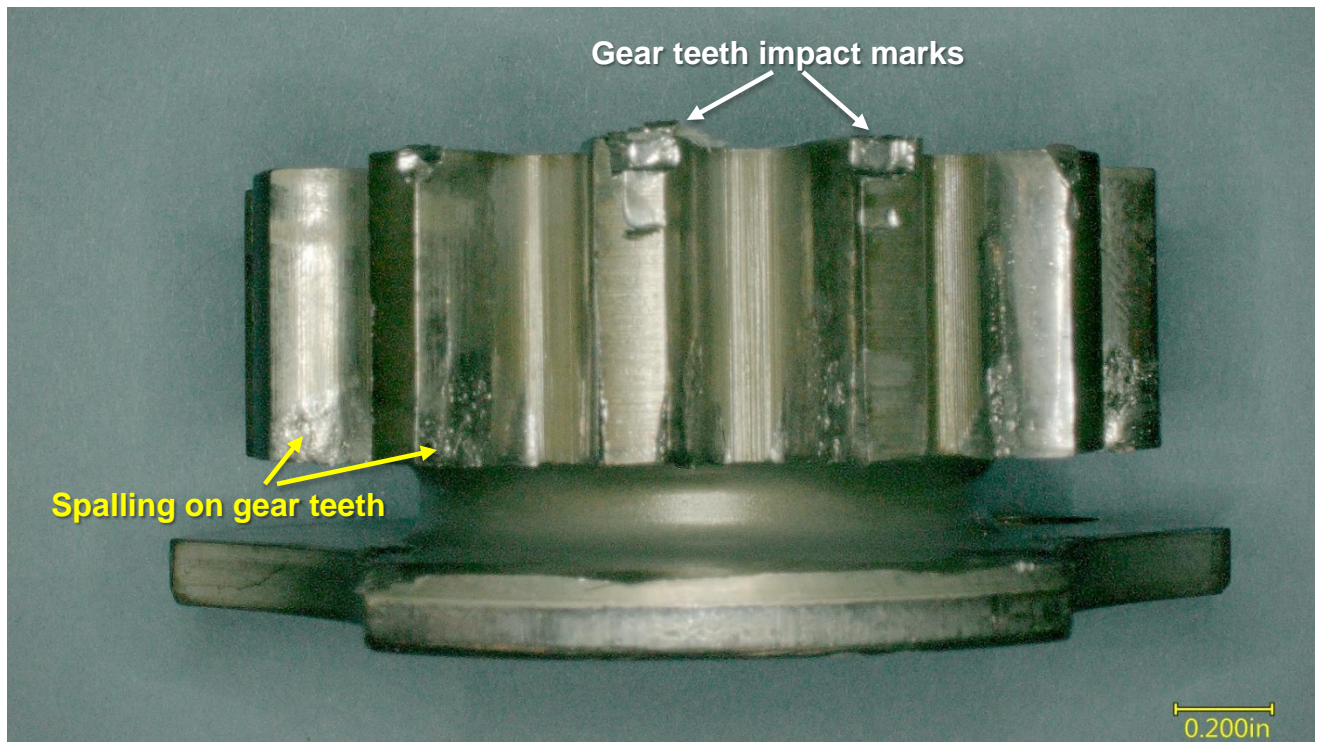
The gear teeth exhibited damage consistent with impact and wear with an adjacent geared component. These included rectangular-shaped impact marks, shown in Figure 3. The impact marks were located on the edge of top lands of several teeth (upwards in Figure 4). Most of the faces of the gear teeth exhibited pock marks and missing material, as shown in Figures 5 and 6. This missing material was located above the flanks on the faces, which was consistent with locations where surfaces contact between geared components. These features were consistent with spalling wear of the gear.

Figure 4 – View of the gear from the teeth side, showing rectangular impact marks from an adjacent geared component.

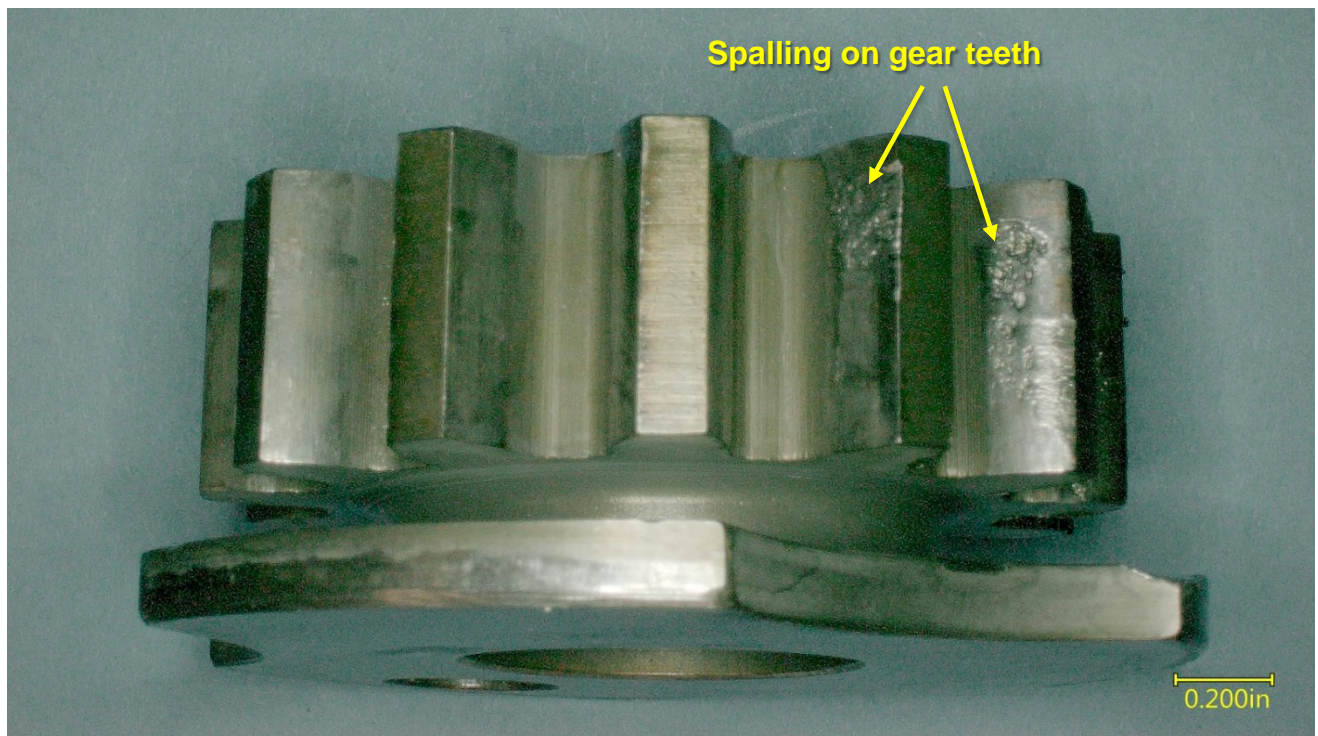
Figure 5 – View of the gear teeth, rotated approximately 90° from Figure 4, showing spalling on the teeth contact faces (arrows).

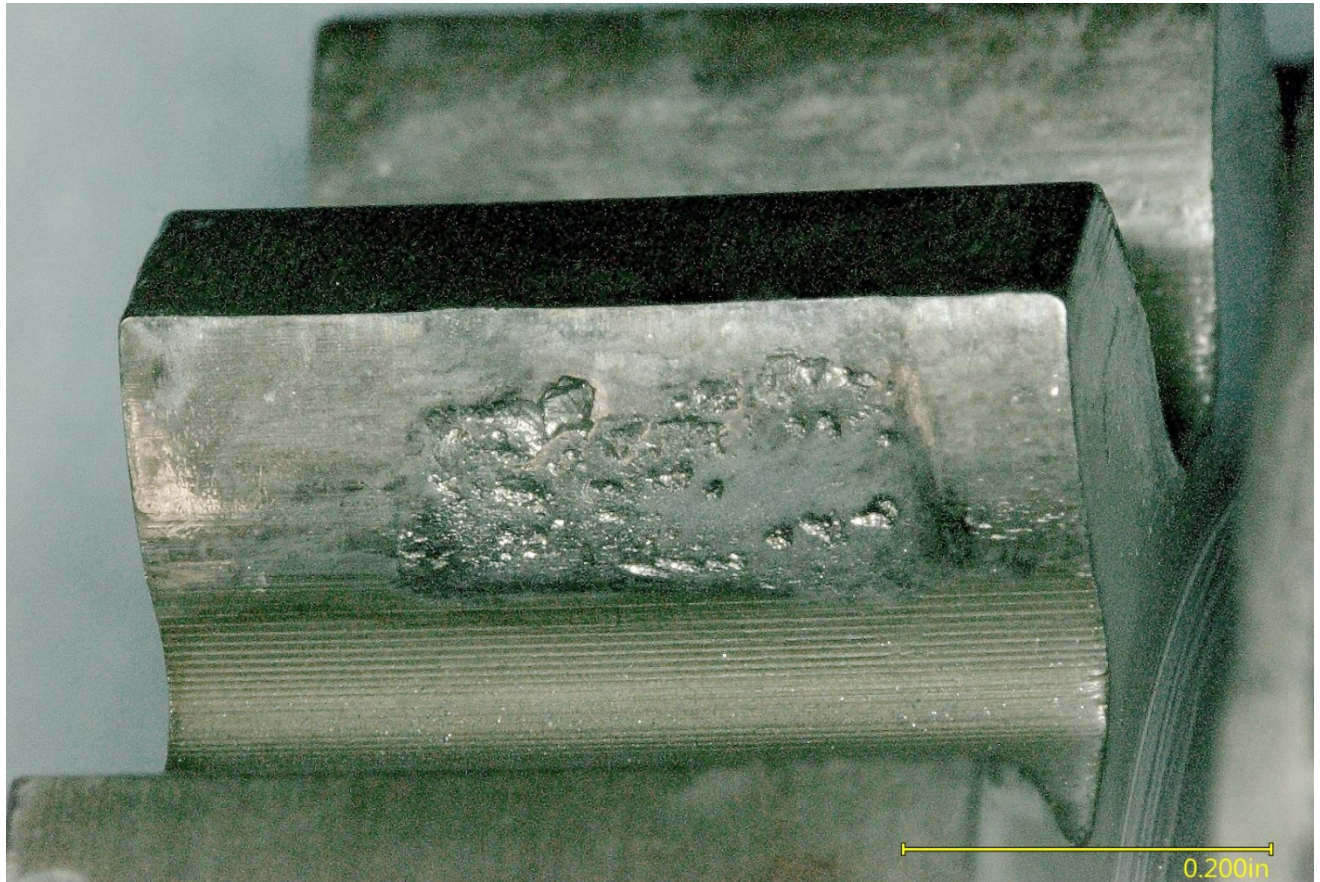
Figure 6 – Closer view of the spalling on a gear tooth face.

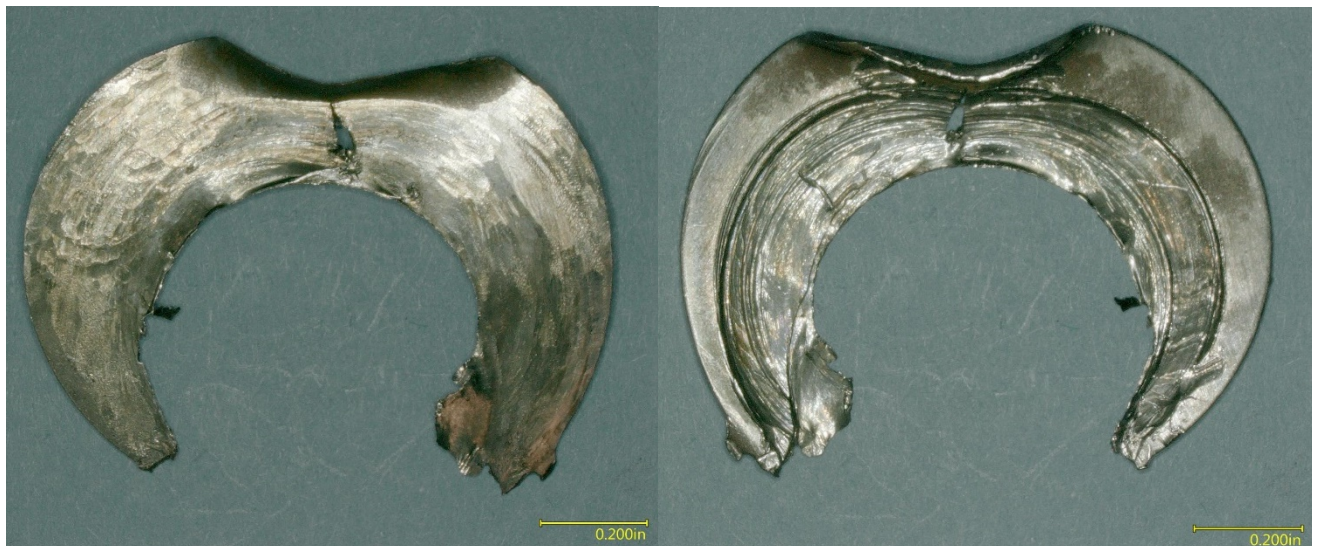
Figure 7 illustrates the submitted spacer from both sides. Overall, the shape of the spacer remnant was a U-shape. The bottom portion of the spacer was missing. The upper portion in the figures had been bent over from one side to the other. The face displayed in Figure 7b exhibited circular impressions, consistent with batter marks. These features were consistent with repeated impacts with an adjacent component.

Figure 7 – Deformed spacer, viewed from (left) the flatter and (right) the reverse side, as received.

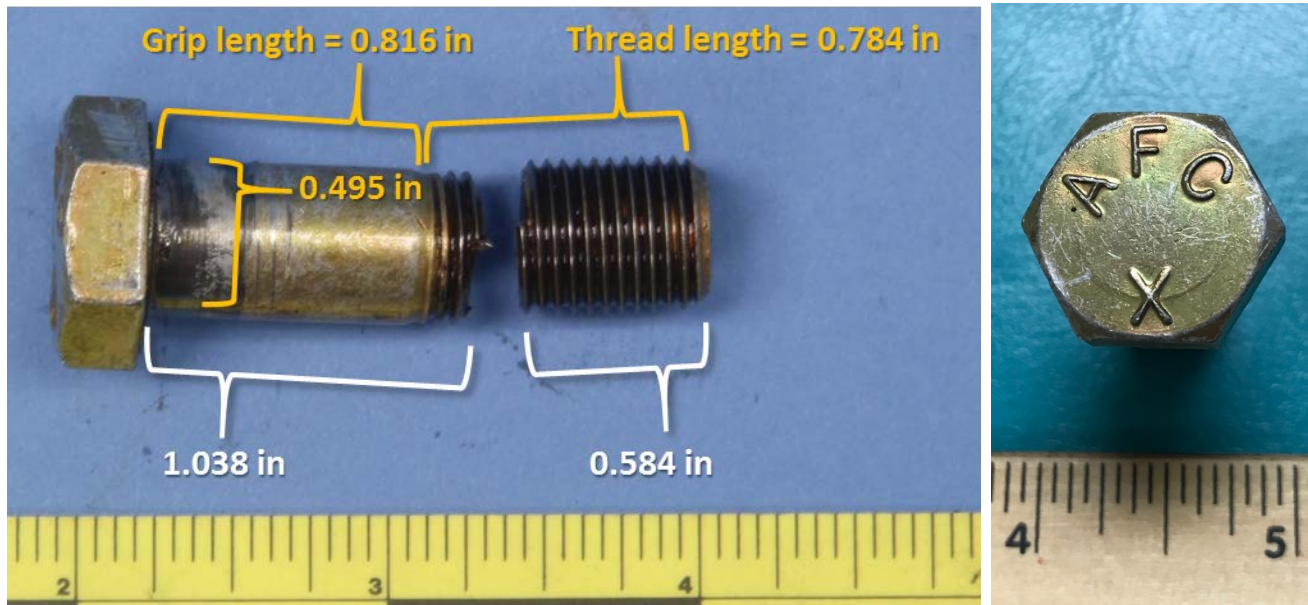
Figure 8 shows the two halves of the fractured crankshaft bolt, as received. The figure is annotated to show several measurements. The grip length, or length from under the head to the threaded transition, was 0.816 inches. The thread length was 0.784 inches, with the total length being 1.910 inches long. The shank diameter was 0.495 inches. The head of the bolt exhibited raised markings, "A F C" with an "X" on the bottom (see Figure 8, right side).

According to the dimensions for both AN8-14 and AN8-14A bolts, the grip length total length should be 1.59375 inches, the grip length should be 0.8125 inches, the threaded length should be a minimum 0.781 inches, and the diameter should be 0.500 inches in diameter. The (A) designation on the bolt part number indicates there should be no drilled hole in the shank. The fractured bolt measurements were consistent with the above dimensions and contained no drilled hole in the shank. Therefore, the submitted bolt was consistent with an AN8-14A.

Figure 8 – View of the two fractured halves of the crankshaft bolt, as received on the left figure. The top of the bolt head is shown on the right figure.

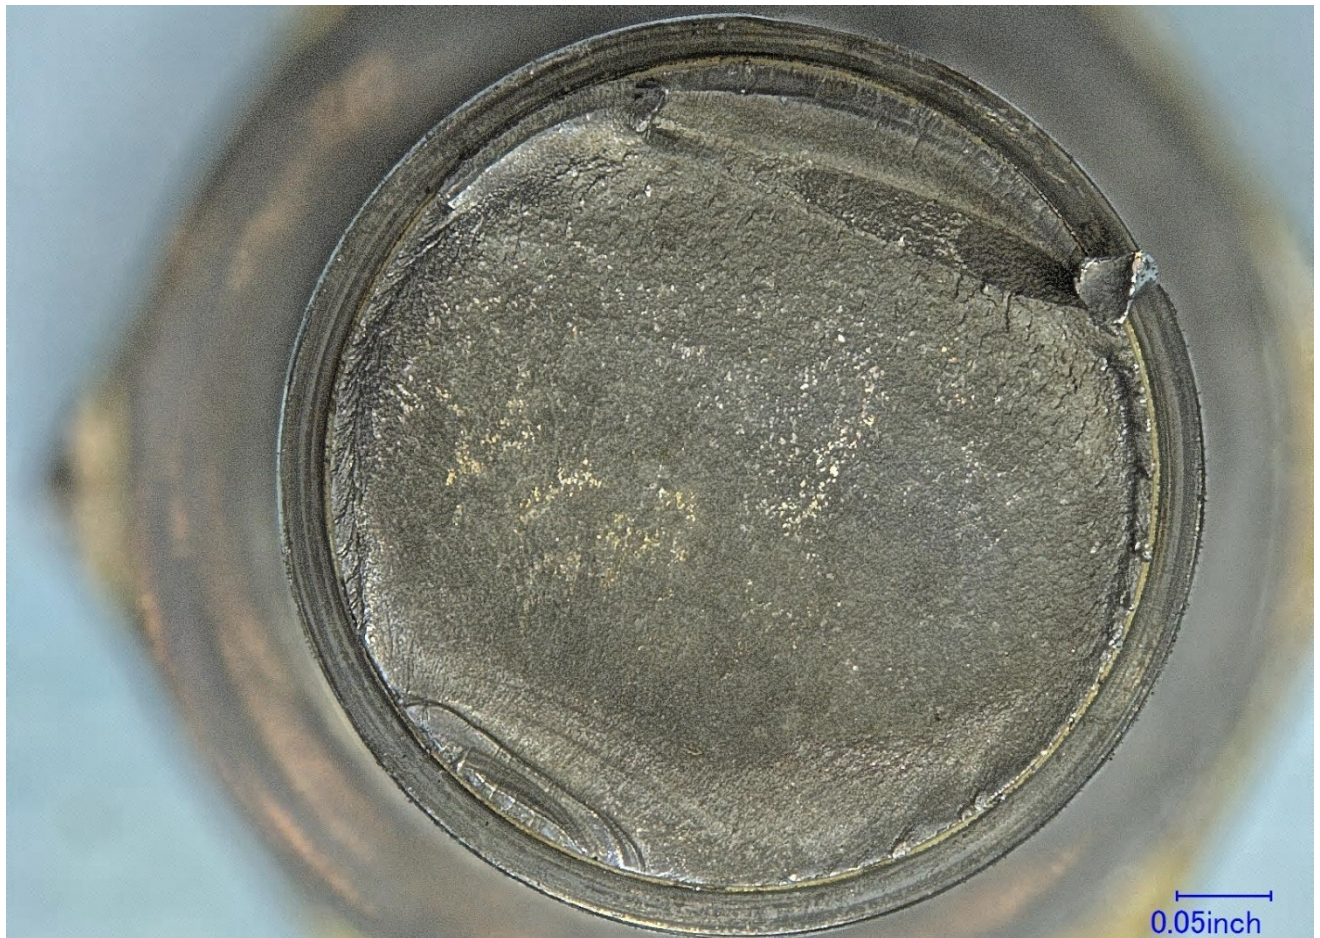
The bolt had fractured 1.038 inches below the bolt head. The fracture surface is shown in Figure 9. Examination using visual and scanning electron microscopy (SEM) found features consistent with fatigue crack propagation and subsequent overstress. These regions on the fracture surface are annotated in Figure 10. As shown in Figures 9 through 12, there were two smaller thumbnail cracks present on opposite 180° sides of the fracture surface. Figure 11 shows the thumbnail crack feature of the larger crack—this crack was located near the bottom of a thread root.

Figure 9 – The bolt shank fracture surface, showing crack arrest and ratchet marks.

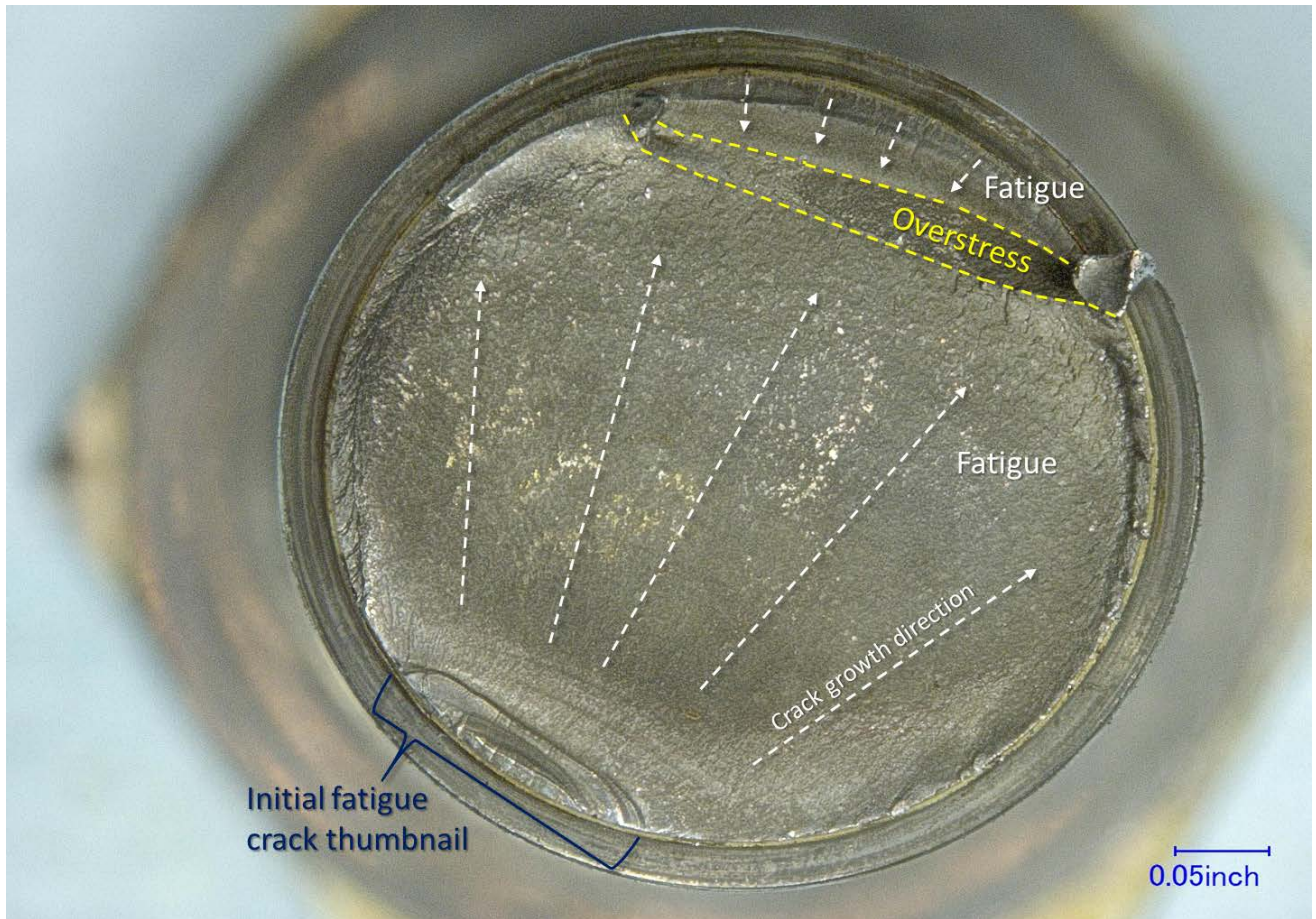
The above bolt features were consistent with fatigue cracking that initiated at multiple sites near the bottom of a thread root. These smaller cracks coalesced and propagated inward through more than half the crack section of the bolt. The bolt began to cycle under reverse bending, which initiated fatigue cracking at multiple sites along the thread root on the opposite side. Once both cracks had propagated inward to the extent present on the fracture surfaces, the remaining cross section of the bolt fractured from overstress.

Figure 10 – The bolt fracture surface, annotated to show the different fracture regions on the surface.

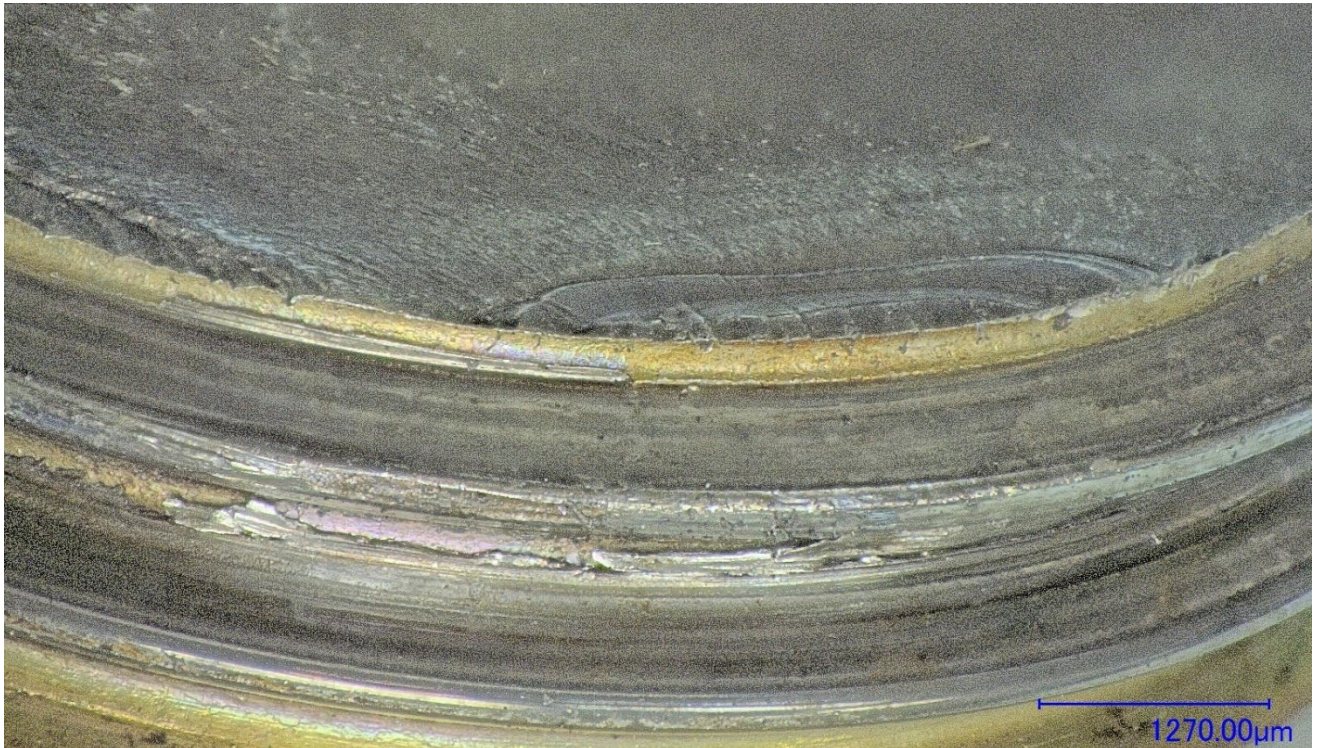
As shown by the ratchet marks in Figure 11 and 13, both fatigue cracks exhibited multiple crack initiation sites. Figure 17 shows some of these initiation sites, with intermediate ratchet marks. As illustrated in Figure 18, there were no features consistent with material or mechanical defects, such as corrosion pits, pores, and voids.

Figure 11 – Angled view of the initial thumbnail on the fatigue crack of the bolt fracture.

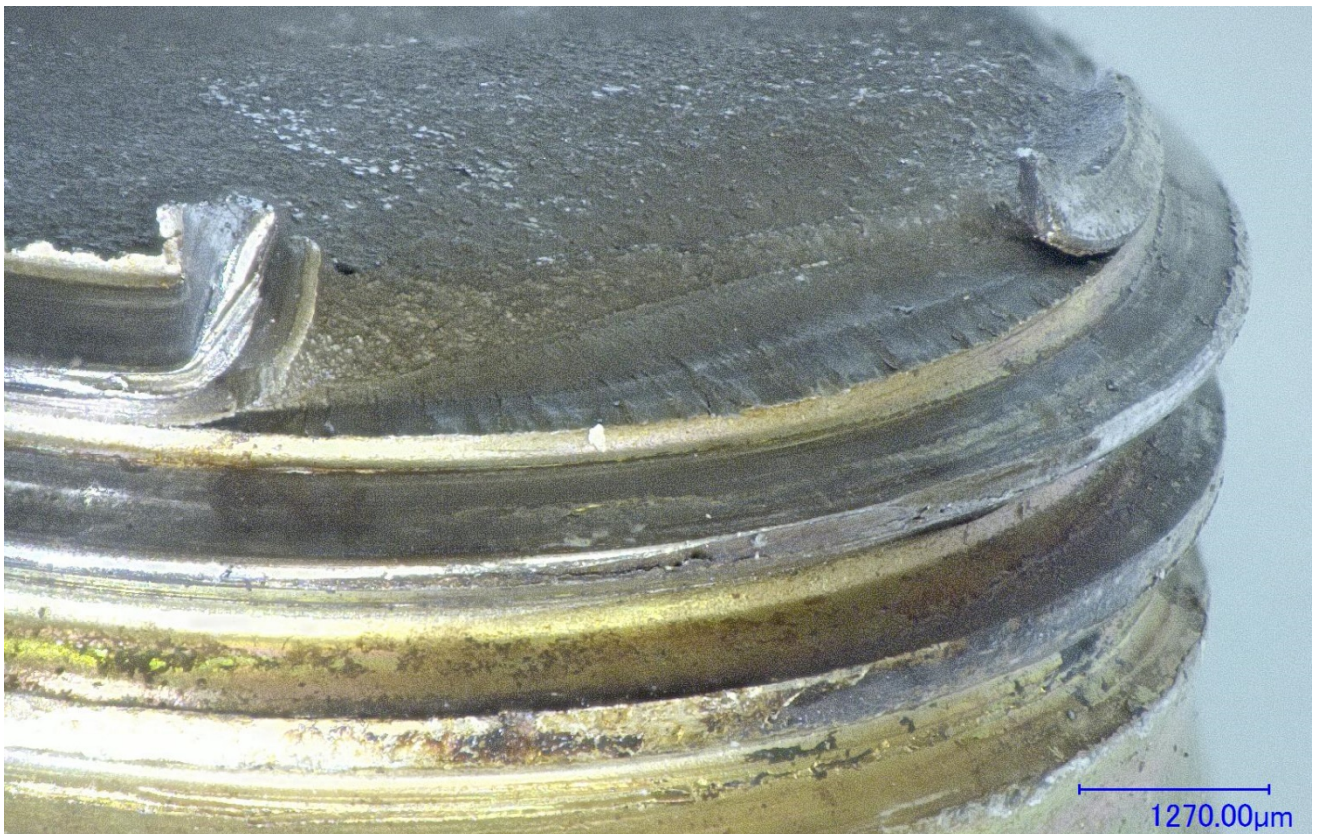
Figure 12 and Figure 13 show the smaller thumbnail crack side, at an angled and planar view, respectively. As illustrated in the figures, the smaller thumbnail crack exhibited crack arrest marks and ratchet marks, consistent with crack initiation at the thread root and propagation inward.

Figure 12 – Angled view of the smaller thumbnail crack and the overstress region on the bolt.

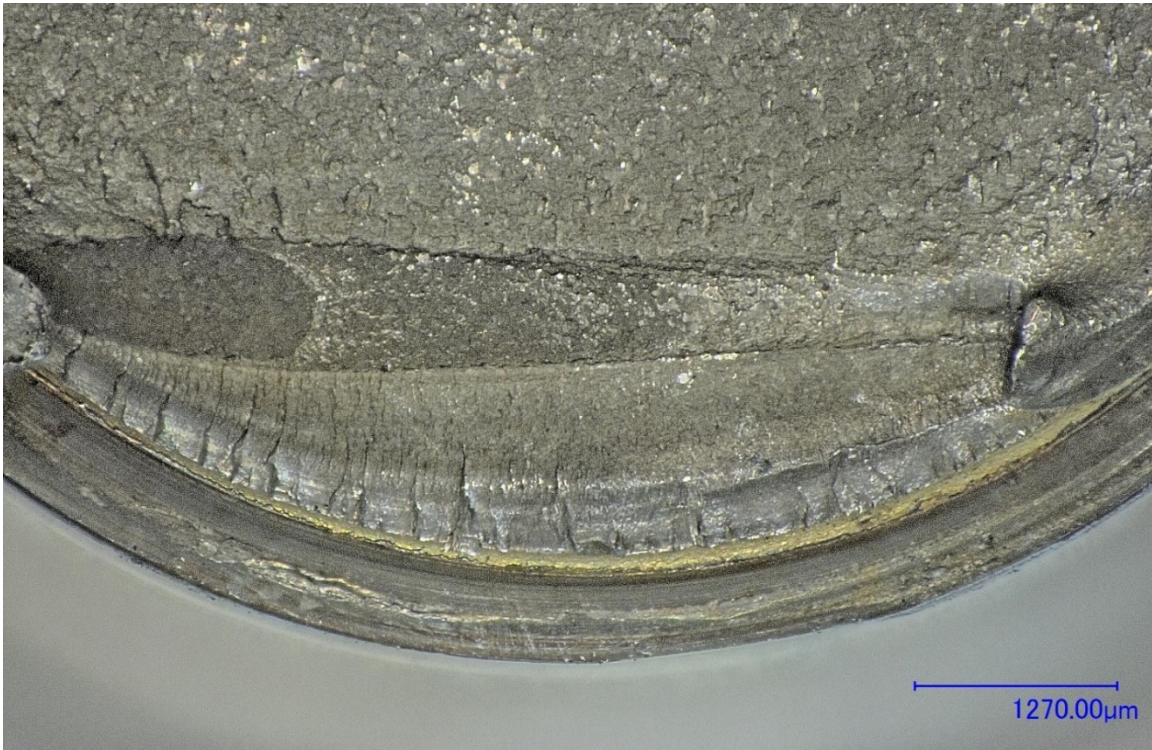
Figure 13 – View of the area of overstress and the smaller fatigue crack on the fractured bolt.

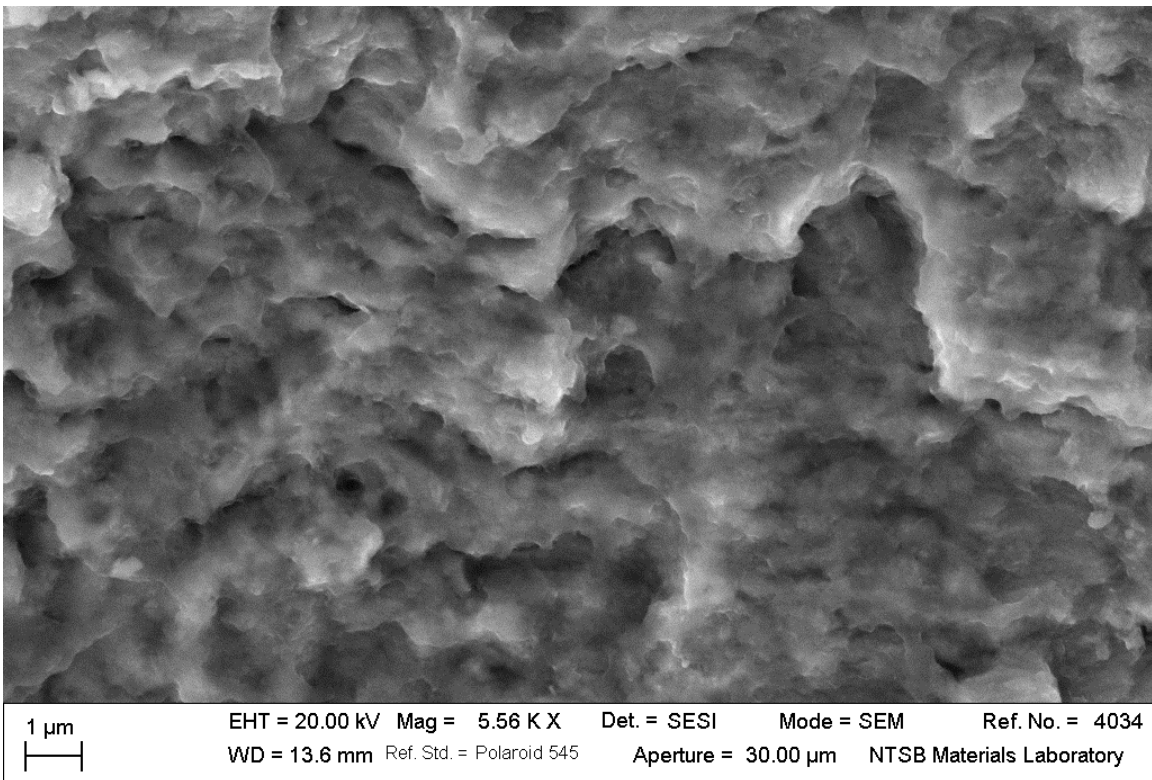
Figure 14 shows a typical area of the larger fatigue crack in the initial thumbnail area. The figure shows fatigue striations, consistent with fatigue crack propagation. Figure 15 shows a typical area of the fatigue crack in the larger, flatter area. This region also exhibited fatigue striations. The smaller opposite thumbnail crack also exhibited fatigue

Figure 14 – Secondary electron (SE) micrograph of fatigue striations near in the initial thumbnail area of the bolt fracture surface.

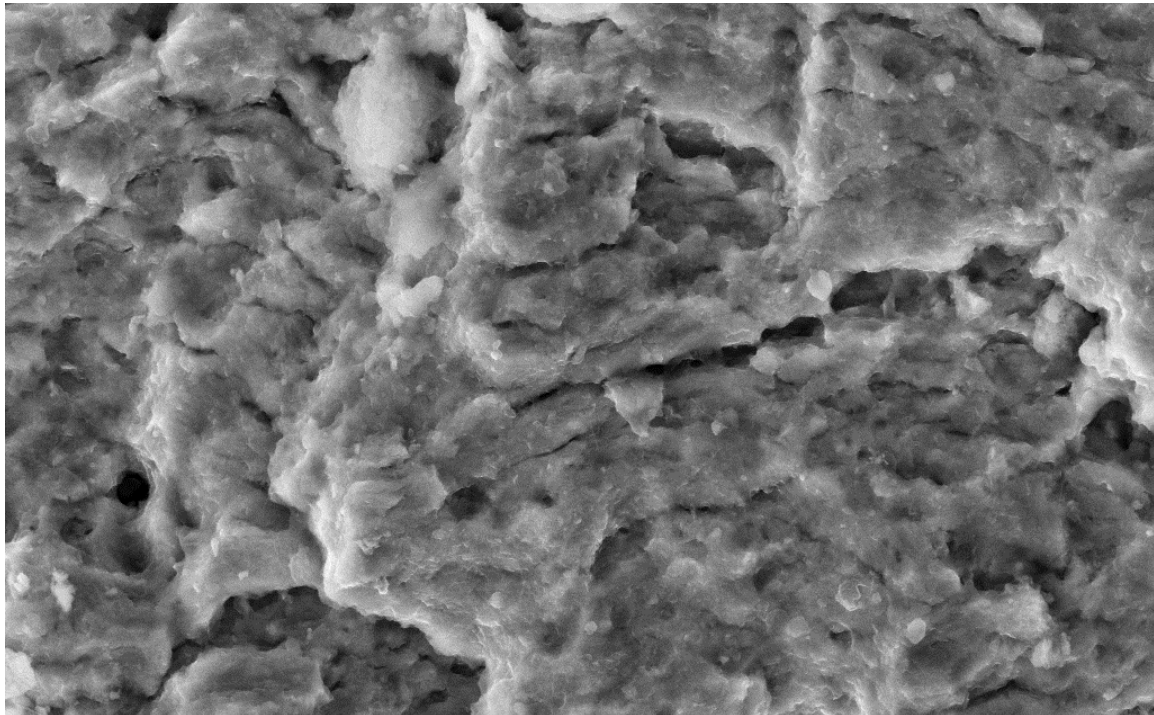
Figure 15 – SE micrograph of fatigue striations at the end of the large fatigue crack on the bolt fracture surface.

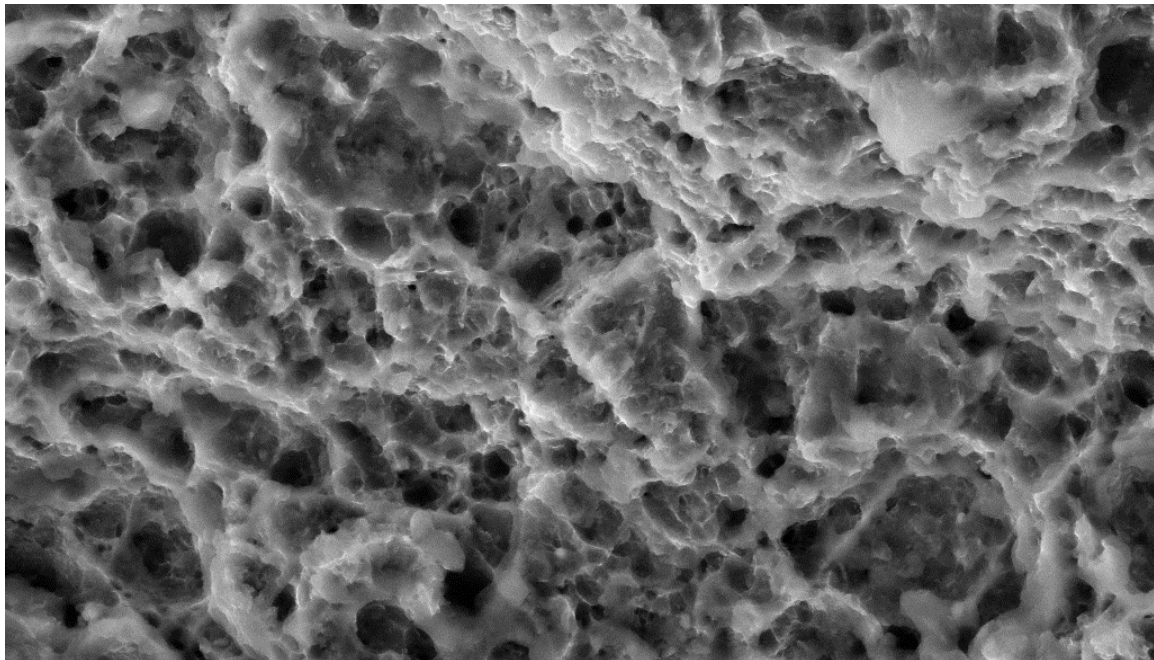
striations. In both thumbnail cracks, the striations were oriented consistent with the propagation from the outside surface inward. The small middle region exhibited dimple rupture, as shown in Figure 16. These features were consistent with subsequent overstress.

Figure 16 – SE micrograph of dimple rupture in the overstress area on the bolt fracture surface.

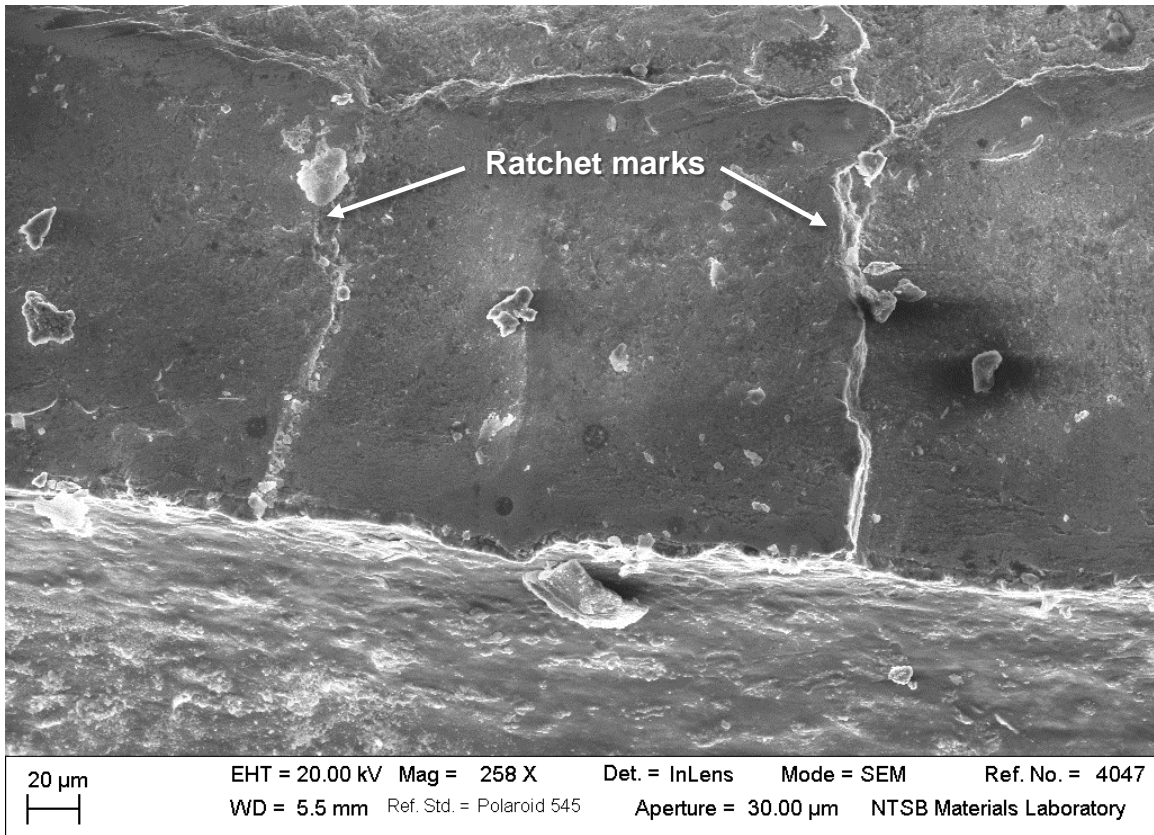
Figure 17 – SE micrograph of multiple crack initiation sites, with ratchet marks highlighted.

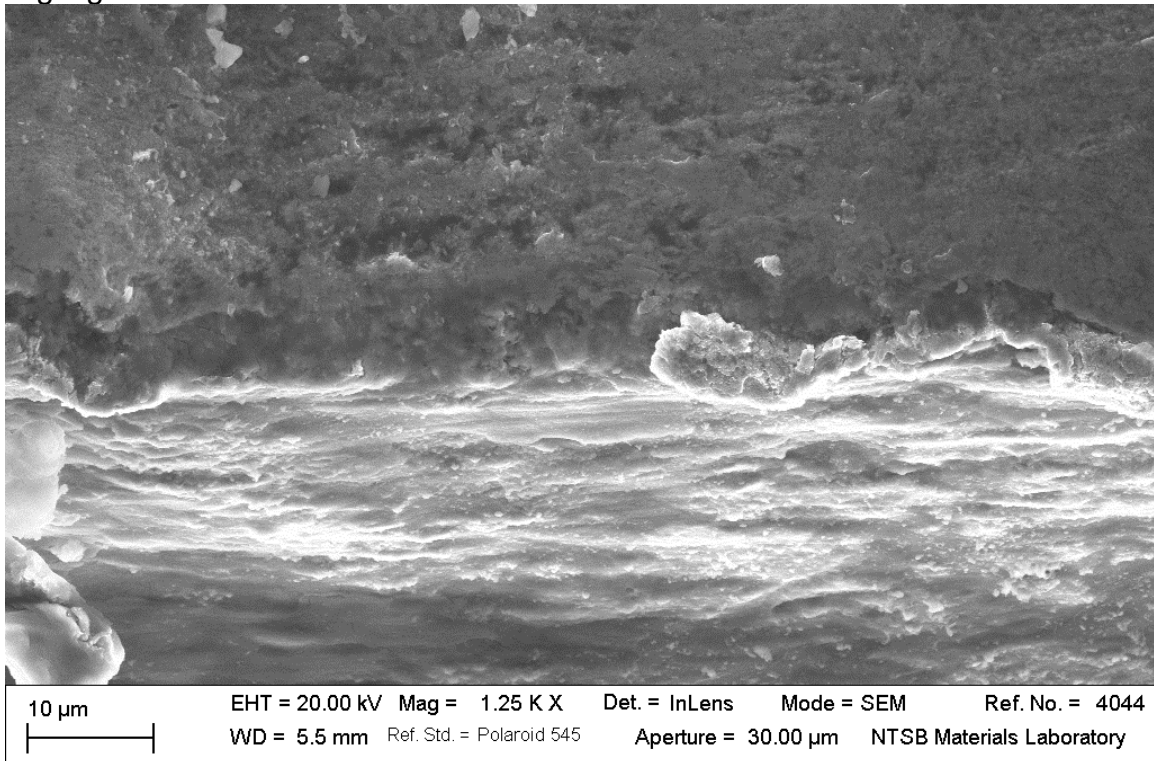
Figure 18 – SE micrograph of the middle initiation site in Figure 17.

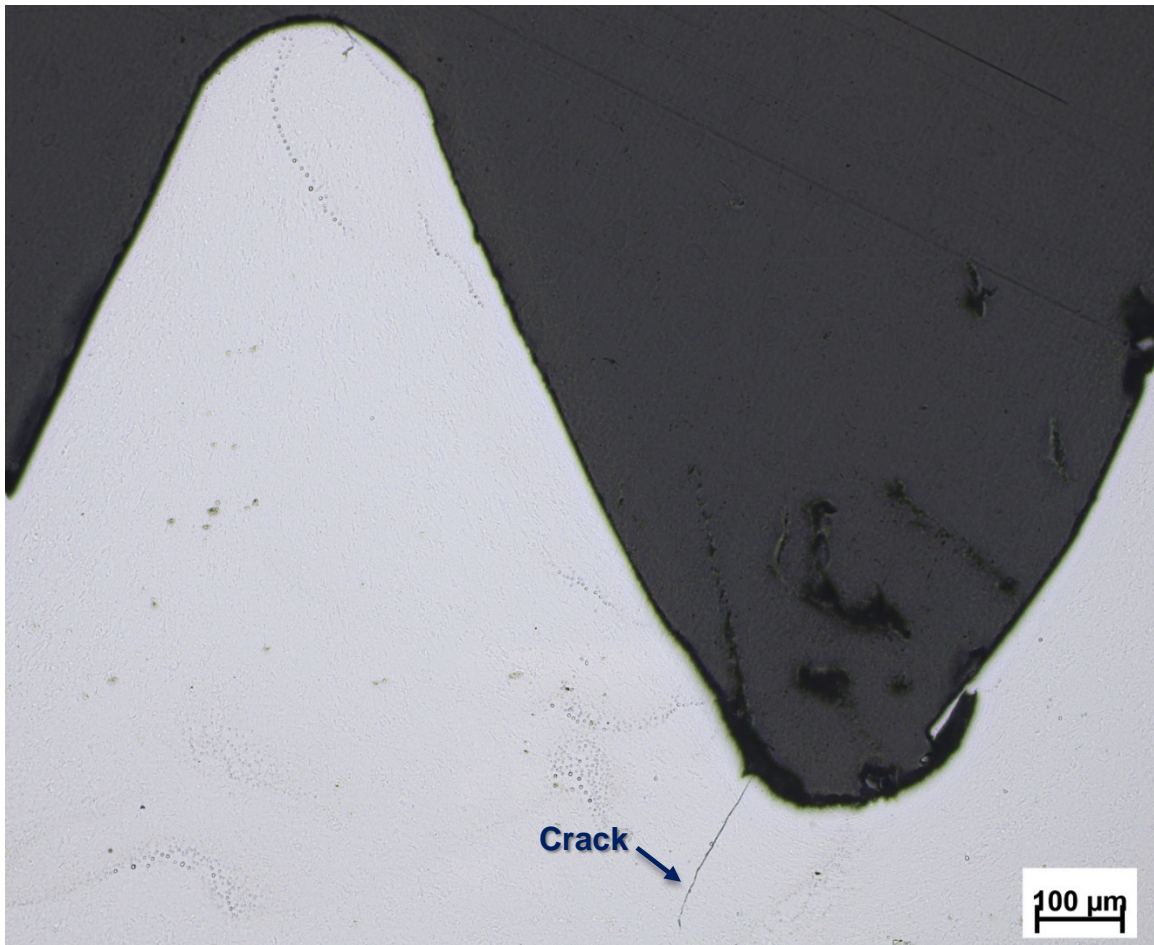
The threaded portion of the fractured bolt was sectioned, mounted, and polished. Figure 19 shows a thread root and two teeth adjacent to the fracture surface (off figure to the right in Figure 19). A small crack was present emanating inward from the thread root. Figure 20 shows the same thread root after etching with a 2% Nital solution.² The root exhibited grain flow around the radius, which was consistent with rolled threads.

Figure 19 – Bright-field (BF) optical micrograph of a cross-section of the threaded bolt section, near the fracture surface. A small crack was present in the thread root (arrow) (~100X, as polished).

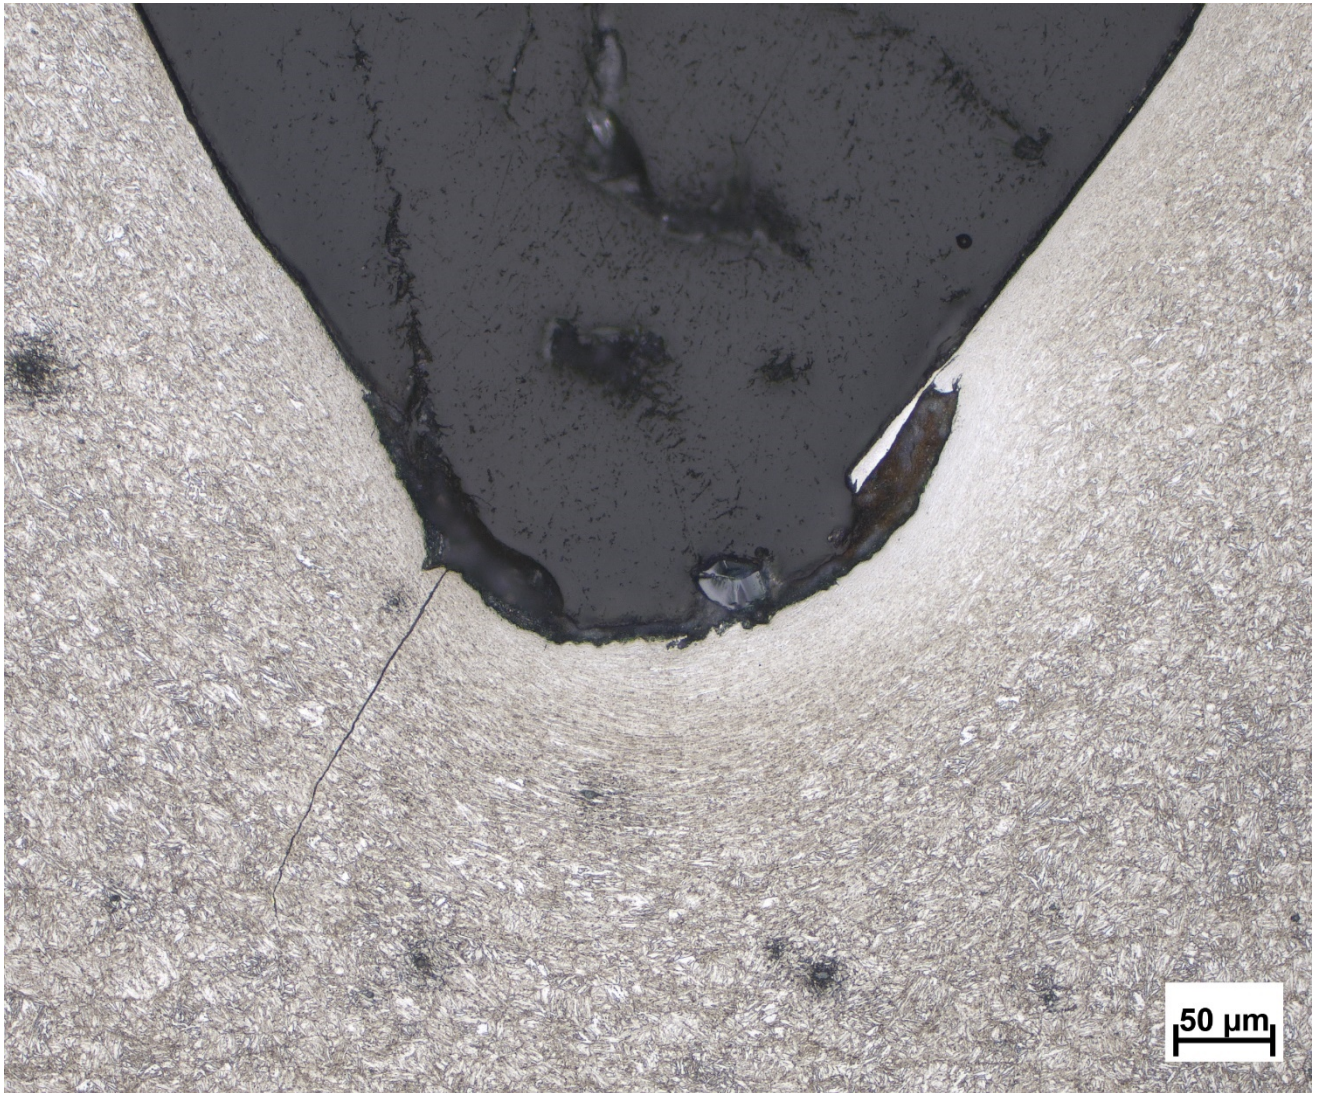
Figure 20 – BF micrograph of cracked thread root adjacent the fracture surface in Figure 19, showing grain flow around the thread and the crack (~200X, etched 2% Nital).
