NATIONAL TRANSPORTATION SAFETY BOARD

MATERIALS LABORATORY FACTUAL REPORT

Report No. 19-070

Place : Adrian, Michigan
Date : January 13, 2019
Vehicle : Piper PA-32R-300, N8892E
NTSB No. : CEN19LA066
Investigator : Mitchell Gallo, AS-CEN

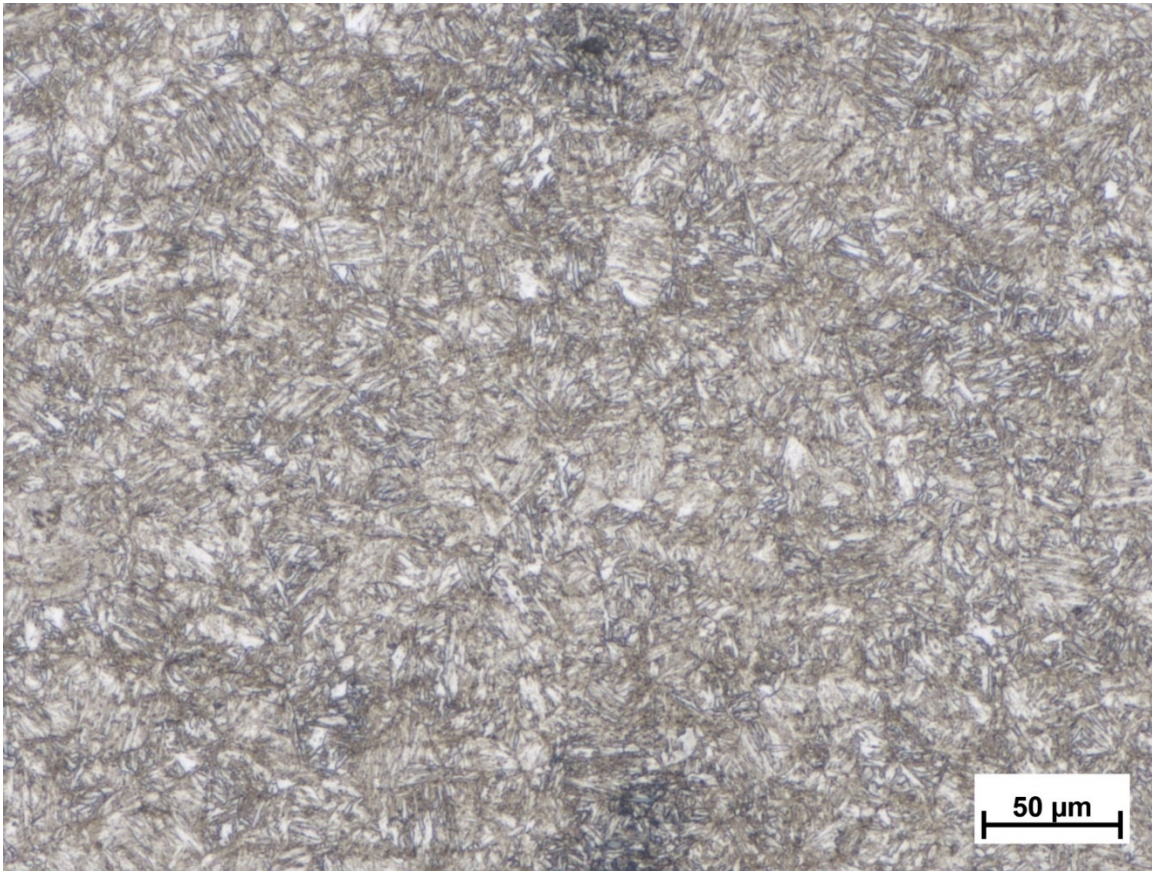
The composition of the bolt was examined using energy dispersive spectroscopy (EDS). The composition was consistent with an alloy steel. Figure 21 shows a typical area of the bolt microstructure. The microstructure was consistent with tempered martensite. The hardness of the core of the bolt was inspected using microindentation hardness per ASTM E384.³ The hardness for the part averaged 31 HRC (308 HK₅₀₀), which exceeded a stated minimum of 26 HRC. These data were consistent with the alloy and microstructure observed.

Figure 21 – BF optical micrograph of a typical area of the bolt microstructure, showing tempered martensite (~500X, etched 2% Nital).
