# NATIONAL TRANSPORTATION SAFETY BOARD

MATERIALS LABORATORY FACTUAL REPORT

Report No. 20-010

Place : Newmarket, Virginia  
Date : December 15, 2019  
Vehicle : Piper PA-18A, N1984A  
NTSB No. : ERA20LA055  
Investigator : Brian Rayner, AS-ERA

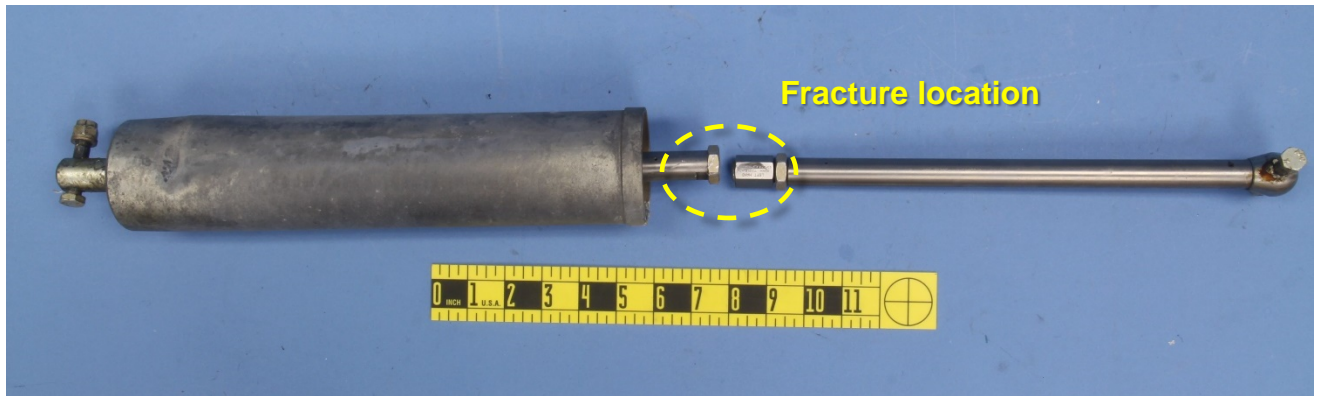
Figure 1 shows the parts from the dampener assembly, as received. This assembly consisted of a dampening piston system, contained inside a housing, and a piston rod. The rod had fractured at a thread root, as annotated in Figure 1. The markings on the side of the rod stated, "BAR 18-9A-11.6 FAA-PMA". The housing of the dampener exhibited inward denting and buckling, as exemplified in Figure 2. This damage was consistent with an impact with an adjacent component or a ground object.

Figure 1 – Fractured dampener assembly, as received. The piston had fractured at the circled location.

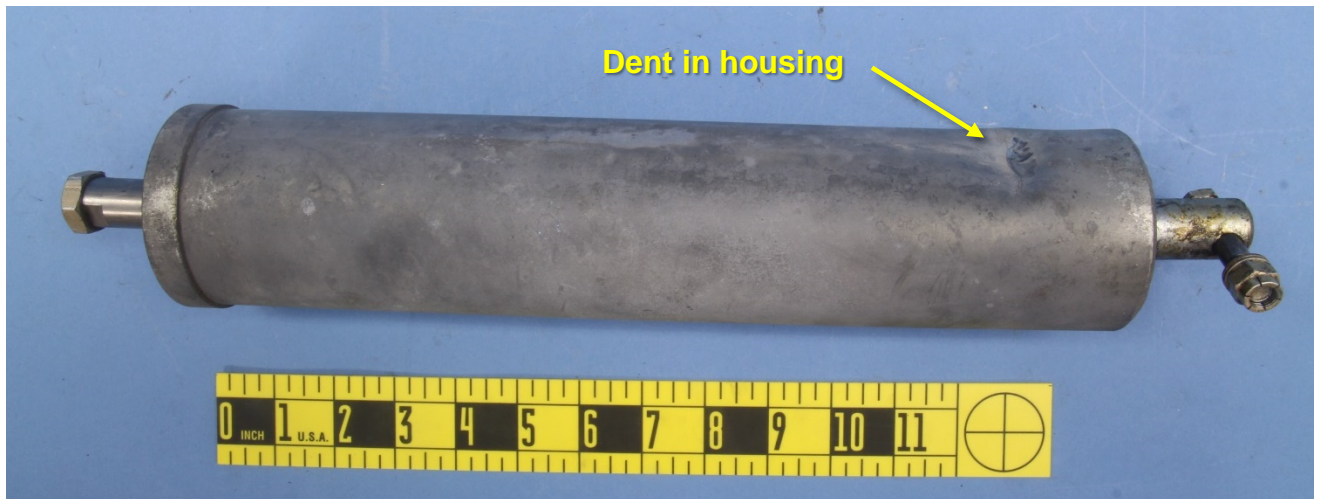
Figure 2 – Closer view of the dampener housing showing a dent in the surface opposite the fracture region (left side).

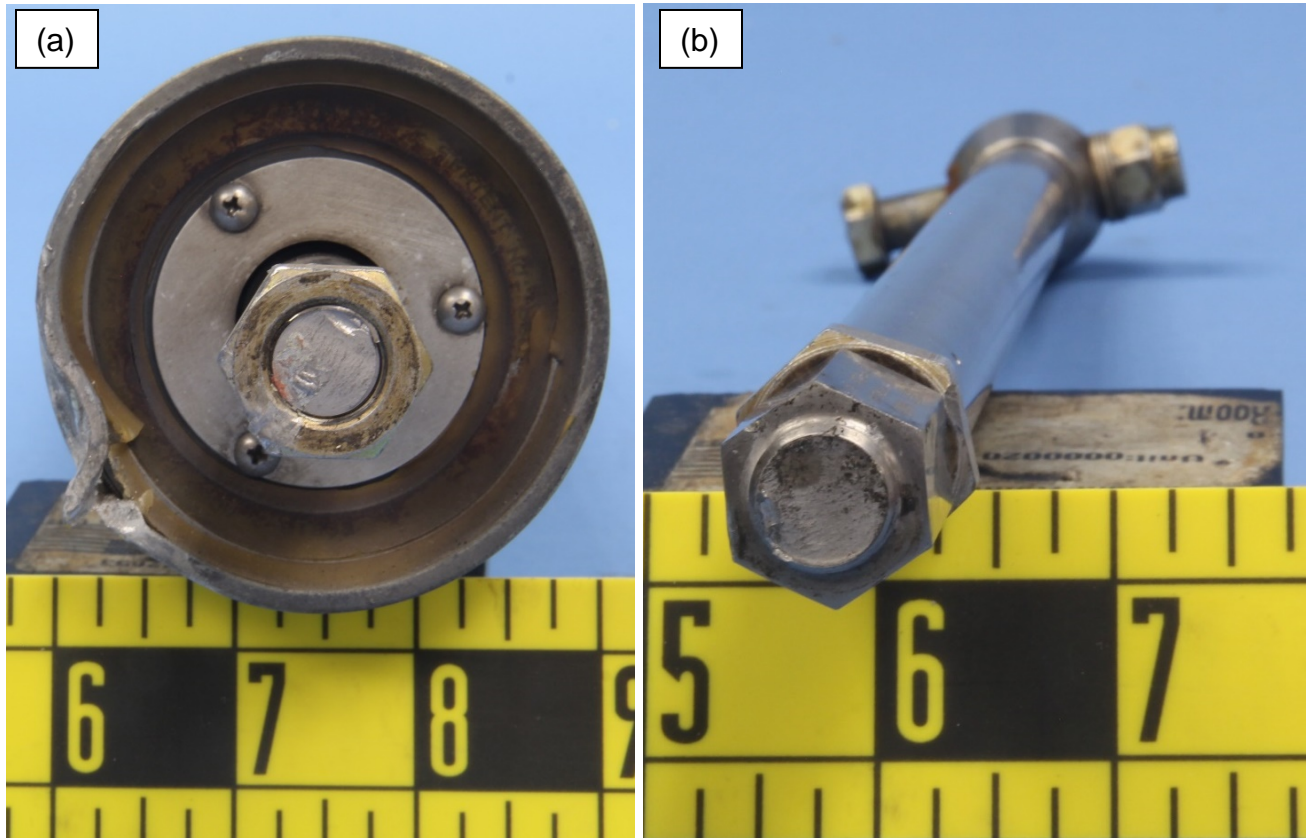
The piston rod to the dampener had fractured along a thread root next to the hexagonal collar. The markings on the side of the rod stated, "LEFT HAND, MAX THREAD, ½" FROM NUT." Figure 3 shows the mating sides of the fracture surface, from the dampener side and the rod side. The rod side fracture surface was sectioned away from the rod for closer examination.

Figure 3 – Fracture surface of the dampener piston from (a) the assembly side and (b) the piston rod side.

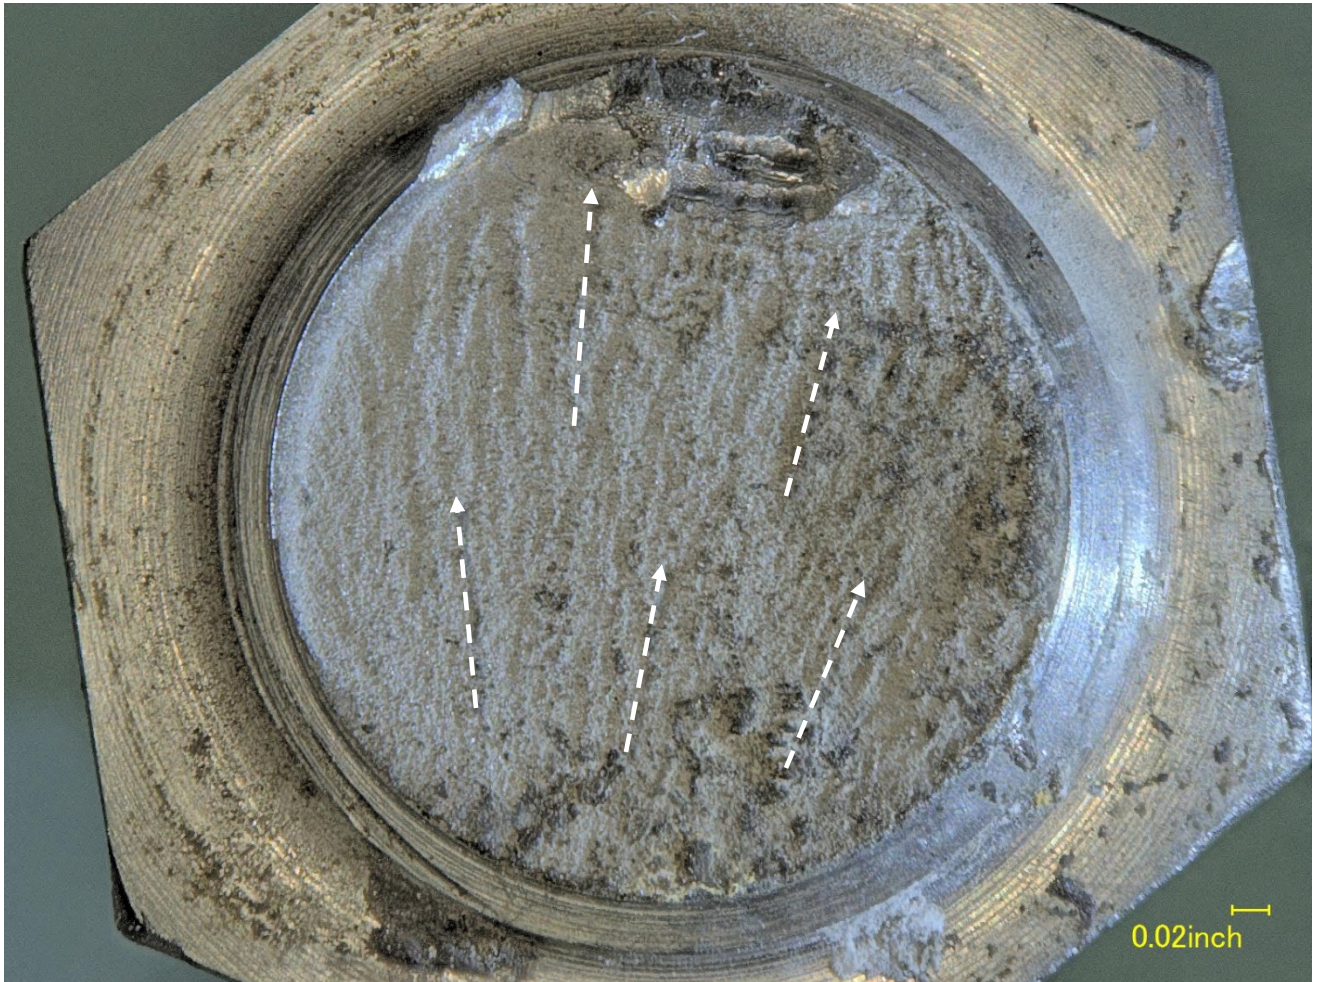
Figure 4 shows the rod side fracture surface, viewed with direct and oblique lighting. The fracture surface exhibited a rough, tortuous texture and a dull, gray luster. There were river patterns that were consistent with fracture from one side of the rod towards the other. Figure 4 is annotated to show this general fracture direction, from the lower side in the

figure towards the upper side. The upper side exhibited smoother and shinier regions locally. These shiny features were consistent with smearing, a type of post-fracture damage on this section of the fracture surface.

The opposite end of the fracture surface is shown in Figure 8. This area had been damaged by post-fracture smearing. The undamaged areas were examined closer, as typified in Figure 9. These fracture features, exhibiting dimpled rupture, were consistent with overstress fracture. No indications of pre-existing fracture features, such as corrosion or fatigue striations, were found. The fracture features of the rod were consistent with a tensile overstress and bending in the direction depicted in Figure 4.

Figure 4 – Closer view of the rod side fracture surface from Figure 3b. The arrows denote the general fracture direction.

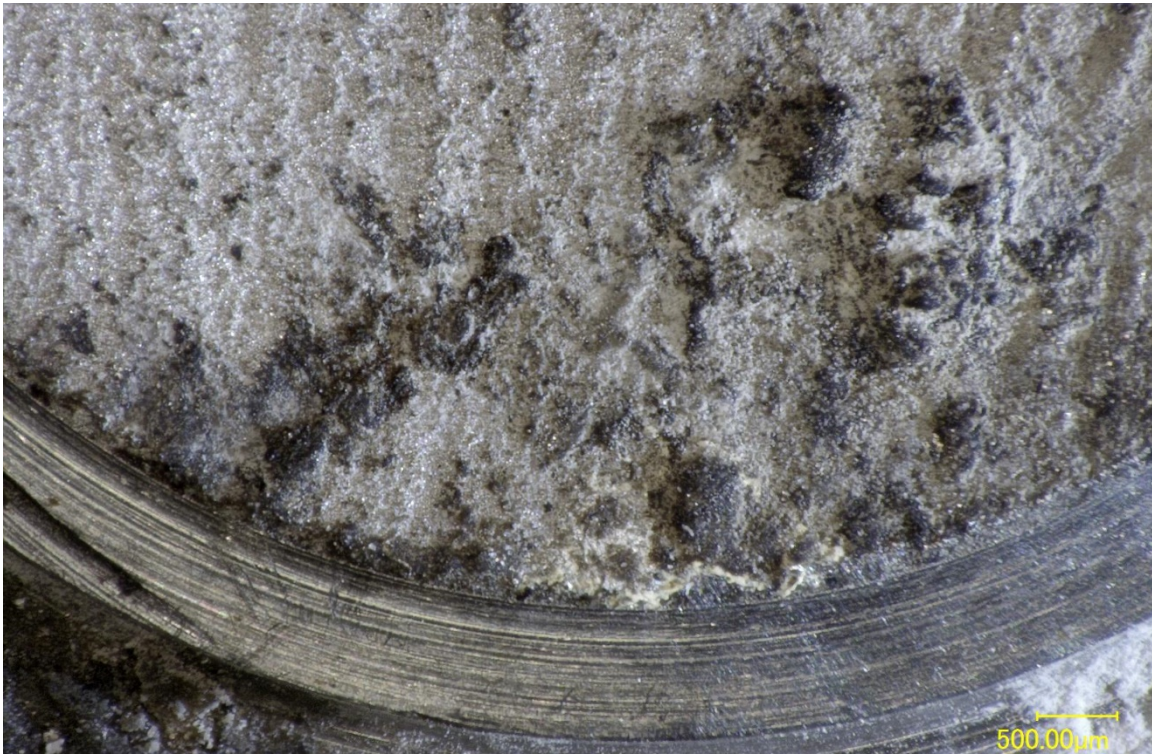
The initial regions of the rod fracture are shown closer in Figure 5. As shown in the figure, river pattern features were consistent with fracture beginning at a thread root on the rod surface. The fracture surface was examined using a scanning electron microscope (SEM). Figure 6 shows a general view of this initial side of the fracture surface. The darker areas were consistent with non-conductive material, typical of post-fracture contamination of the surface. An area of the fracture surface that was not contaminated (yellow box in Figure 6) region was examined closer, as illustrated in Figure 7. The fracture features in this region were typical of the rest of the fracture surface. This region exhibited dimpled rupture, consistent with overstress fracture.

Figure 5 – Closer view of the lower portion of Figure 4, showing the the region the fracture originated.

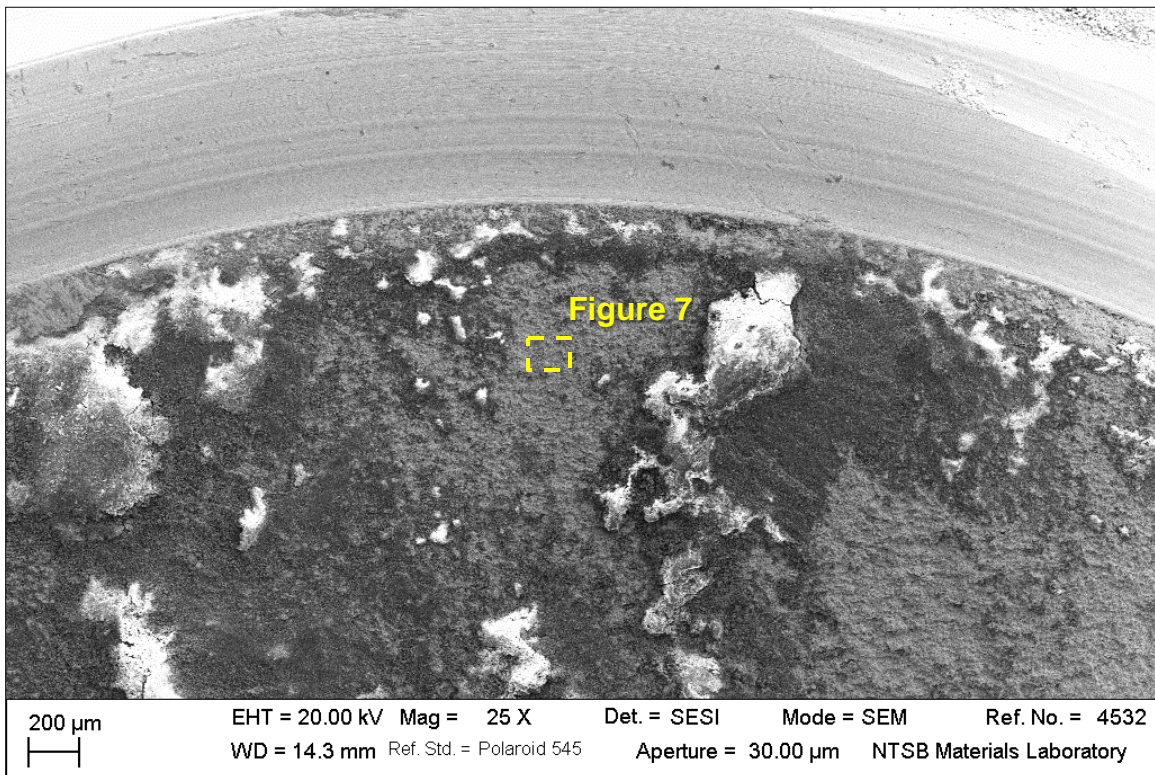
Figure 6 – Secondary electron (SE) micrograph of the fracture initiation area on the dampener rod fracture (viewed reversed from Figure 5).

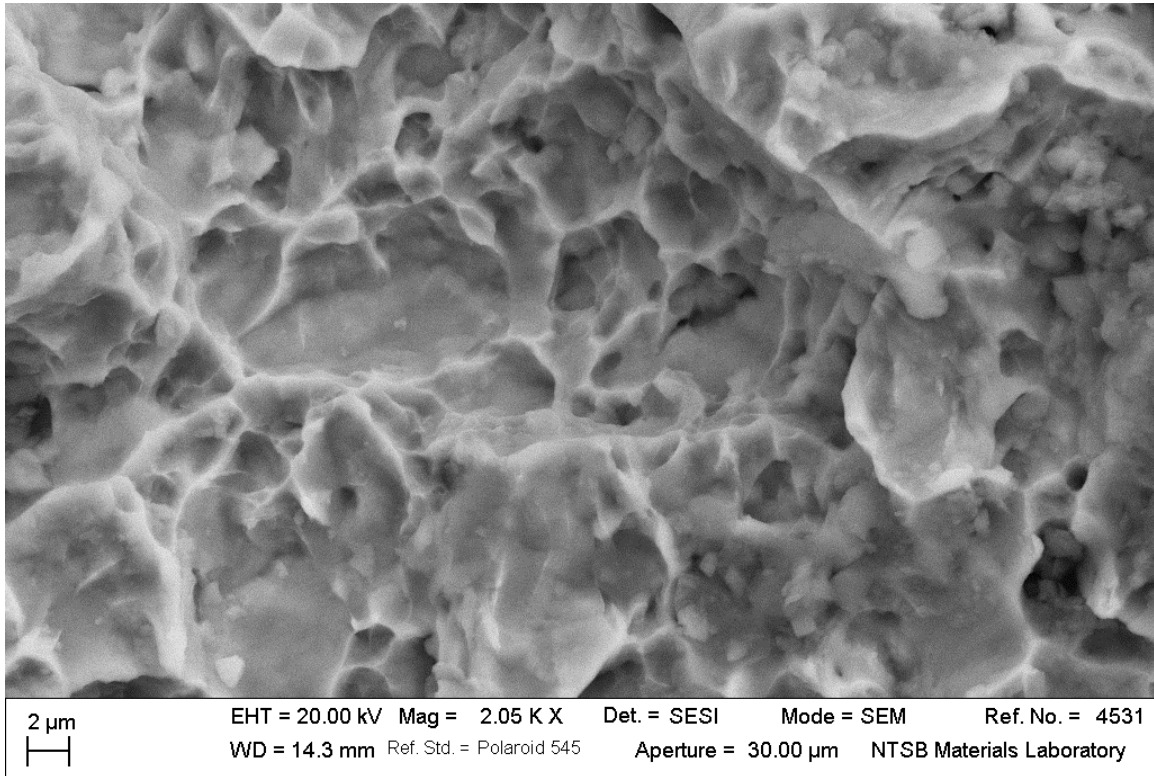
Figure 7 – SE micrograph of dimpled rupture on the boxed area in Figure 6.

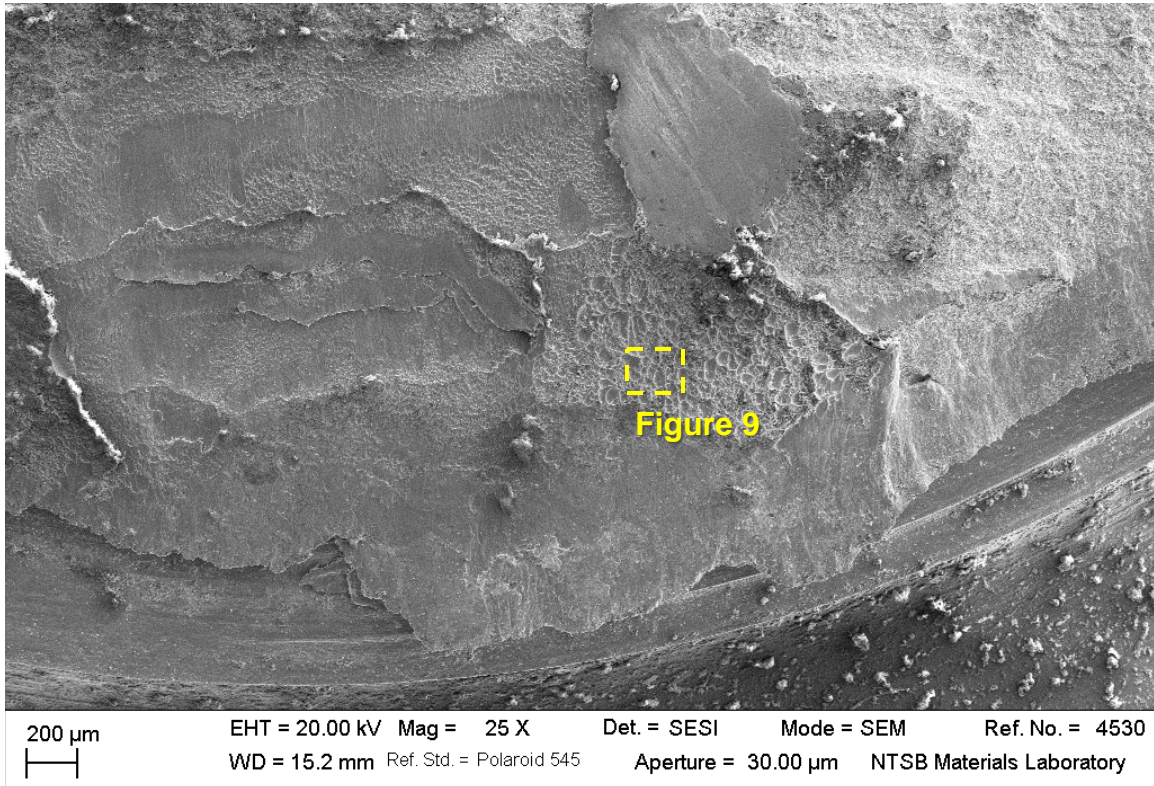
Figure 8 – SE micrograph of the smeared area on the top of Figure 4.

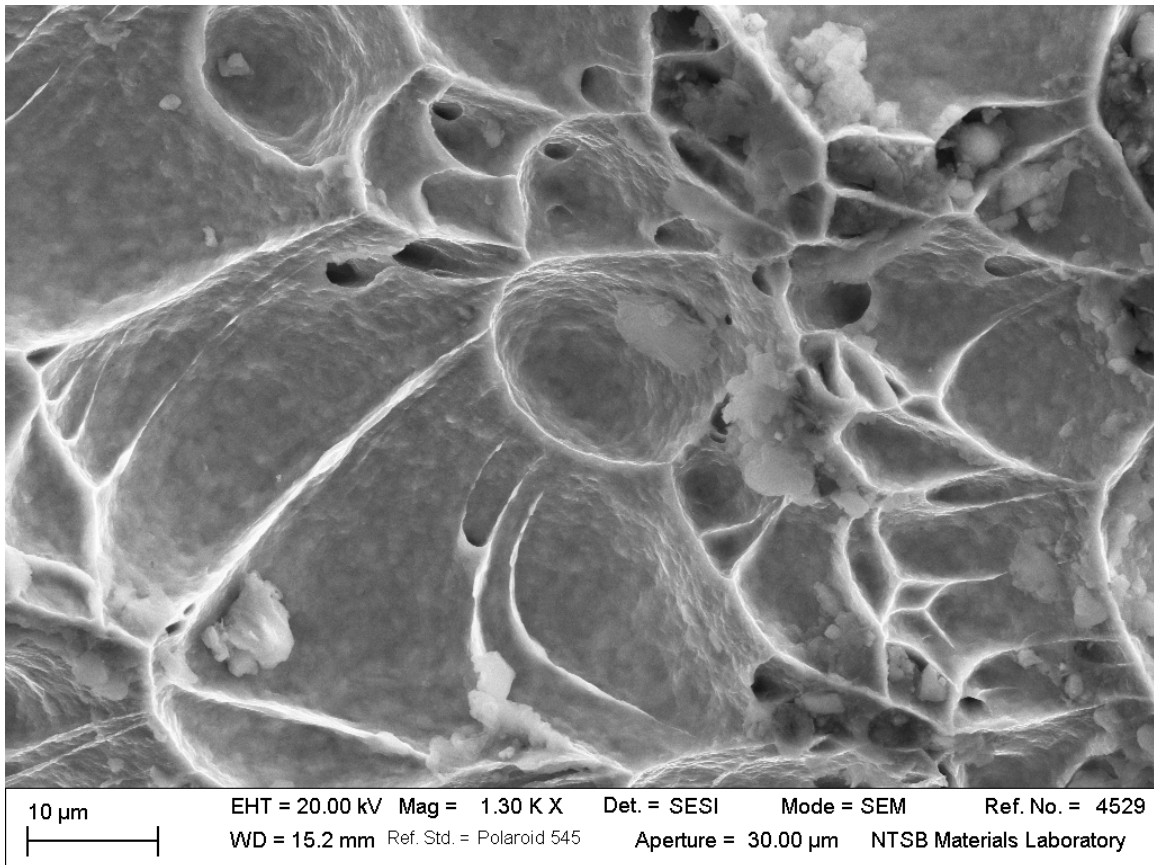
Figure 9 – SE micrograph of dimpled rupture from the boxed area in Figure 8.

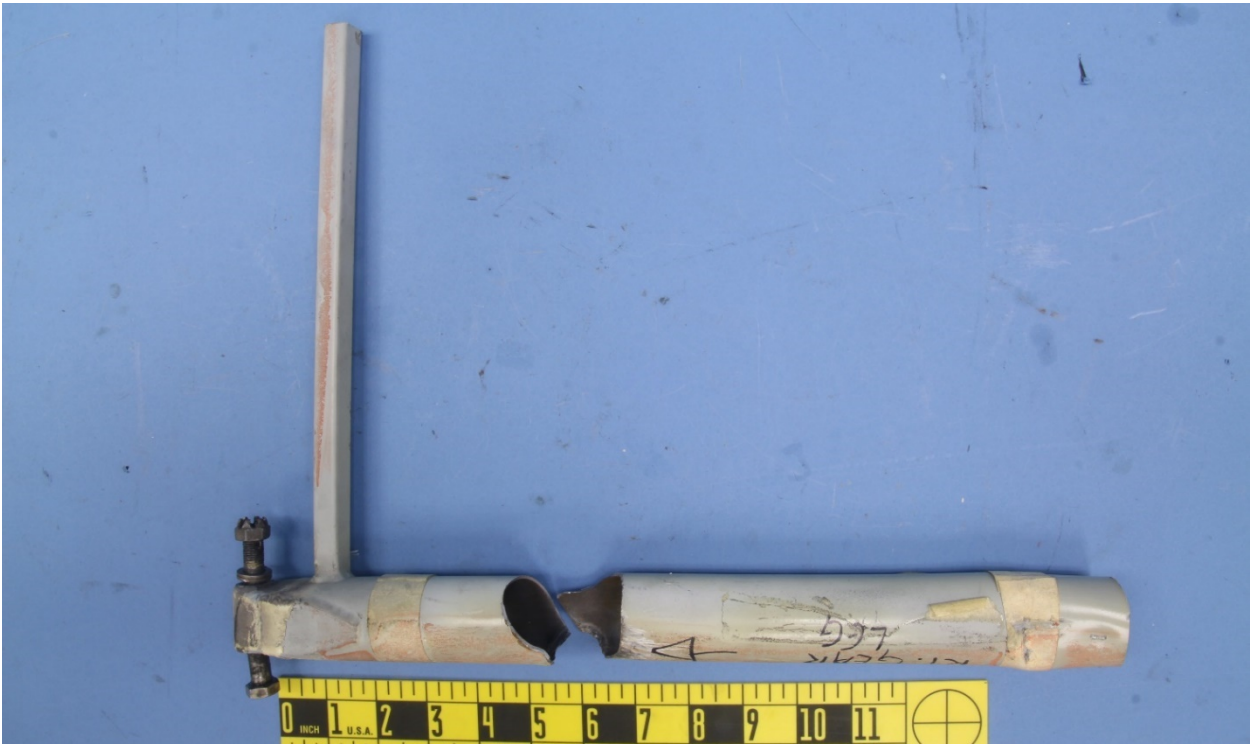
The mating fragments of the landing gear arm are shown in Figures 10 and 11, placed in their approximate respective positions at the time of the fracture. As shown in Figure 11, there was a faint red paint stripe along the length of the cylindrical tube portion of the arm. This and other markings were used to position the fragments near their mating positions.

Figure 10 – The fragments of the landing gear arm, positioned near their pre-fracture places.

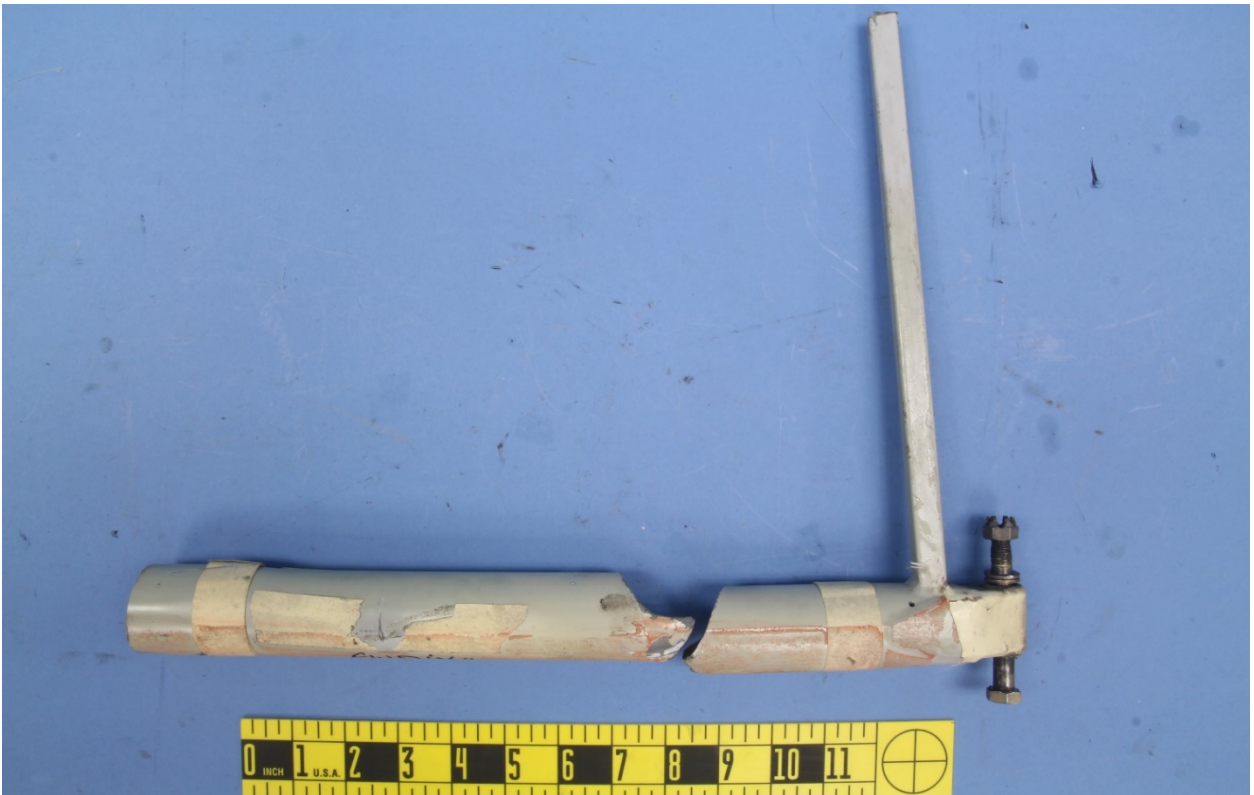
Figure 11 – The repositioned landing gear arm fragments, shown opposite those in Figure 10.

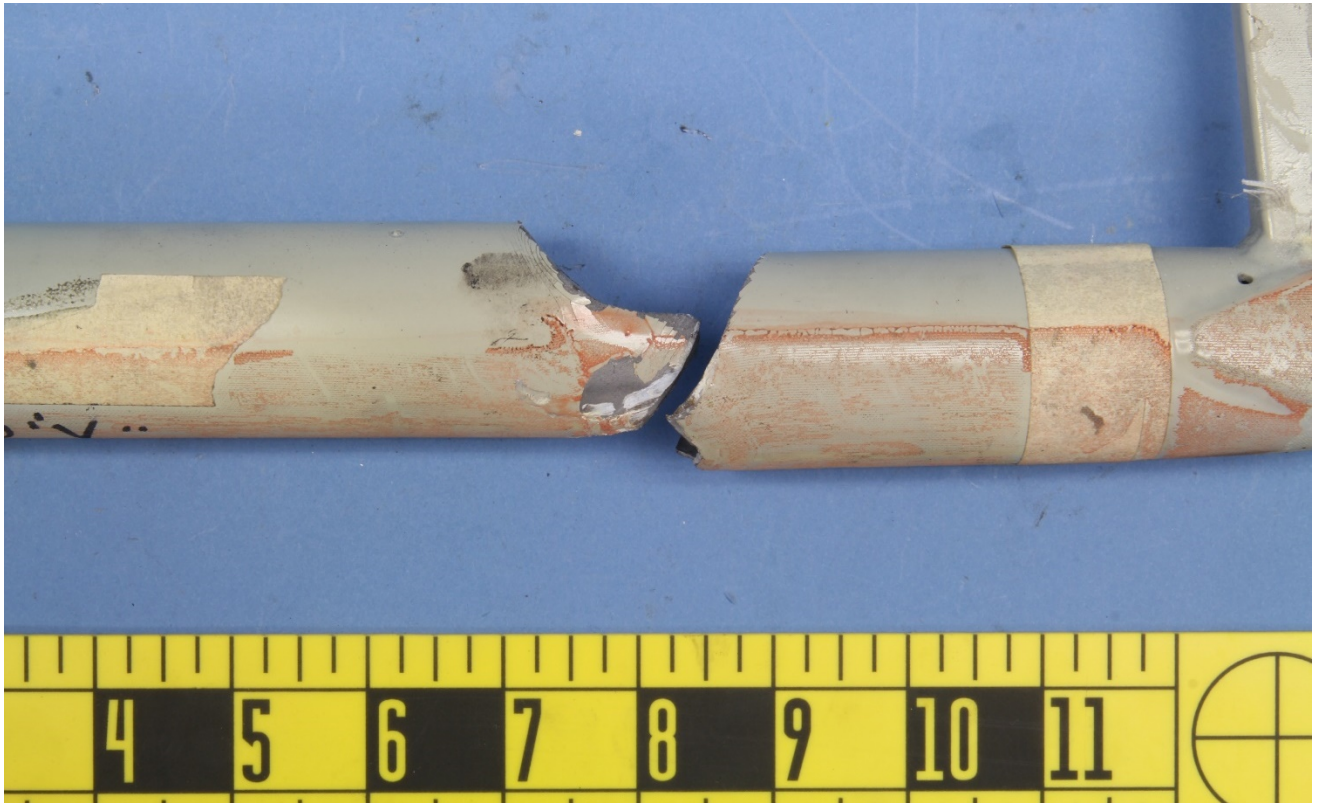
As shown in closer views in Figures 12 and 13, the fractured sides only mated along a small, 0.5-inch, portion of the fracture surface. This was consistent with another fractured piece or pieces of the arm assembly which were not received by the Materials Laboratory.

Figure 12 – The mating fracture surfaces of the arm fragments, viewed from the outer surface.

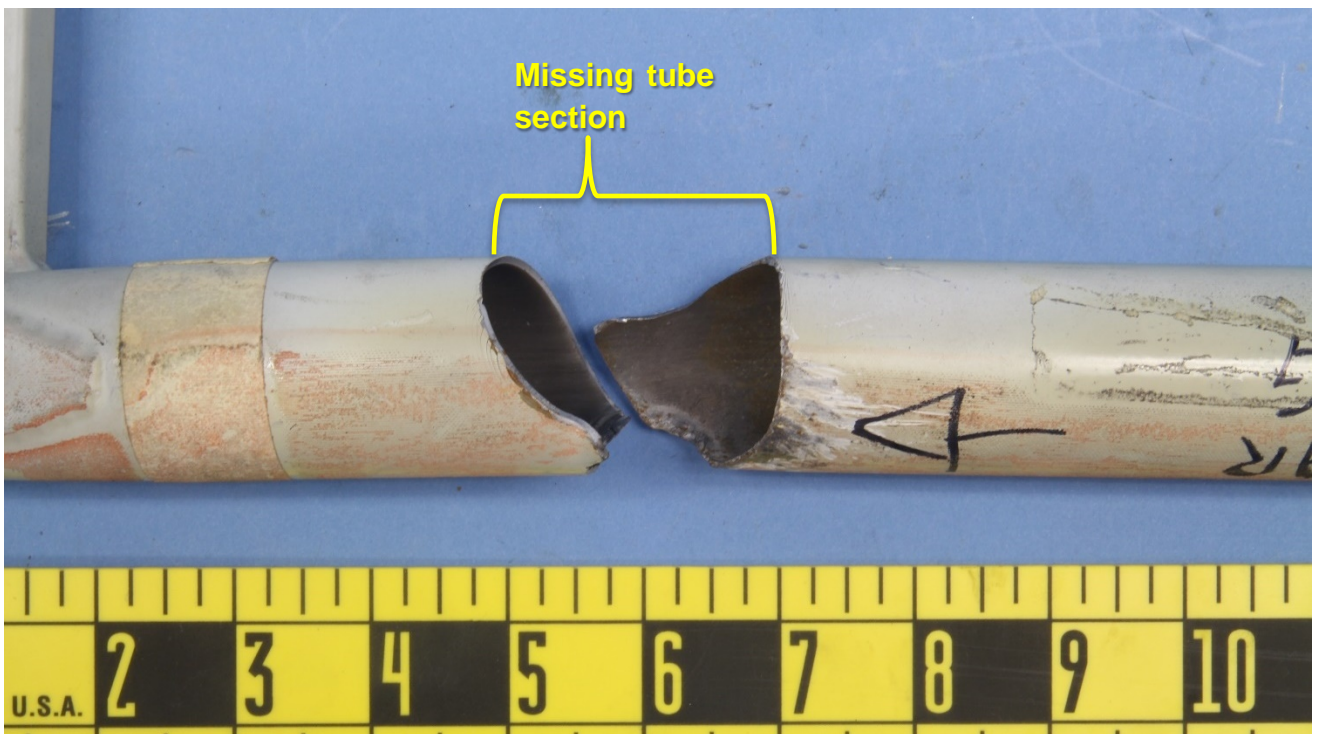
Figure 13 – The mating arm fractures, viewed opposite Figure 12 from inside, showing the missing material.

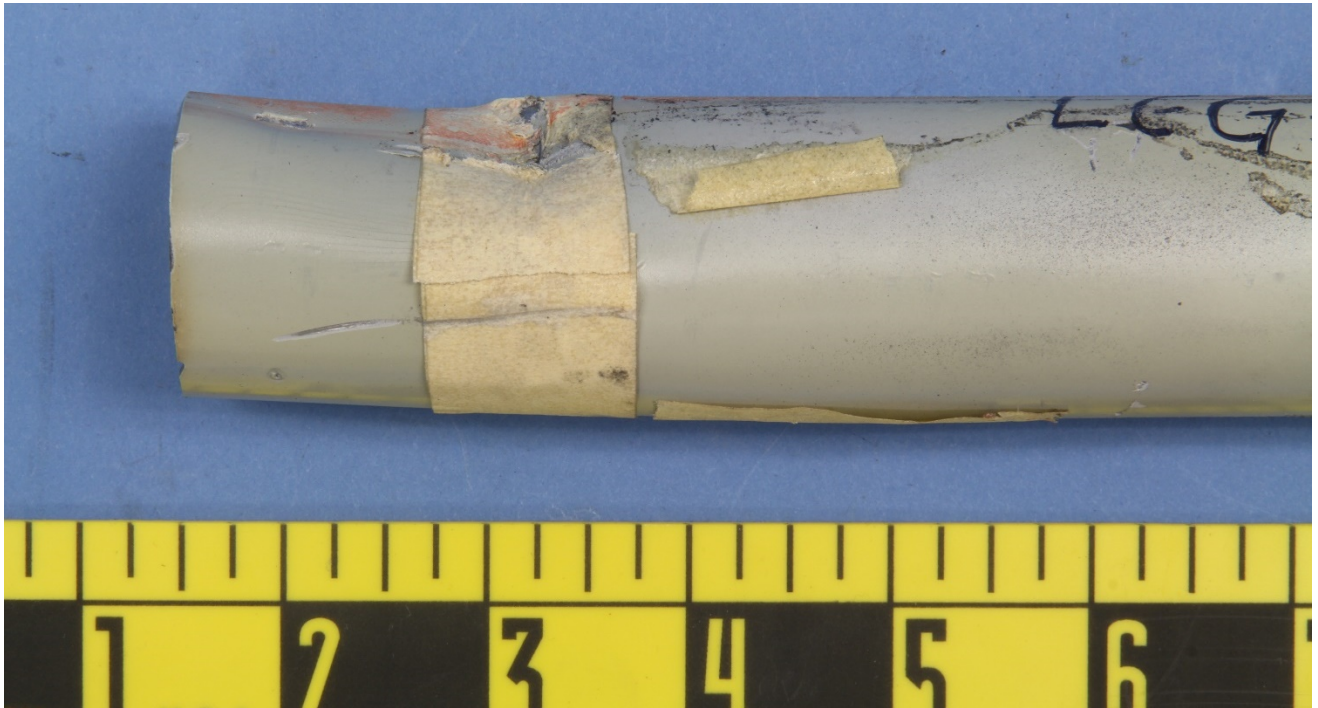
Besides the fracture, other damage was noted on the arm assembly fragments. Much of the paint near the fracture exhibited spalling and cracking. There were indications of sliding and impact marks, such as shown in Figure 14.

Figure 14 – A dent in one of the arm fragment near a sectioned portion.

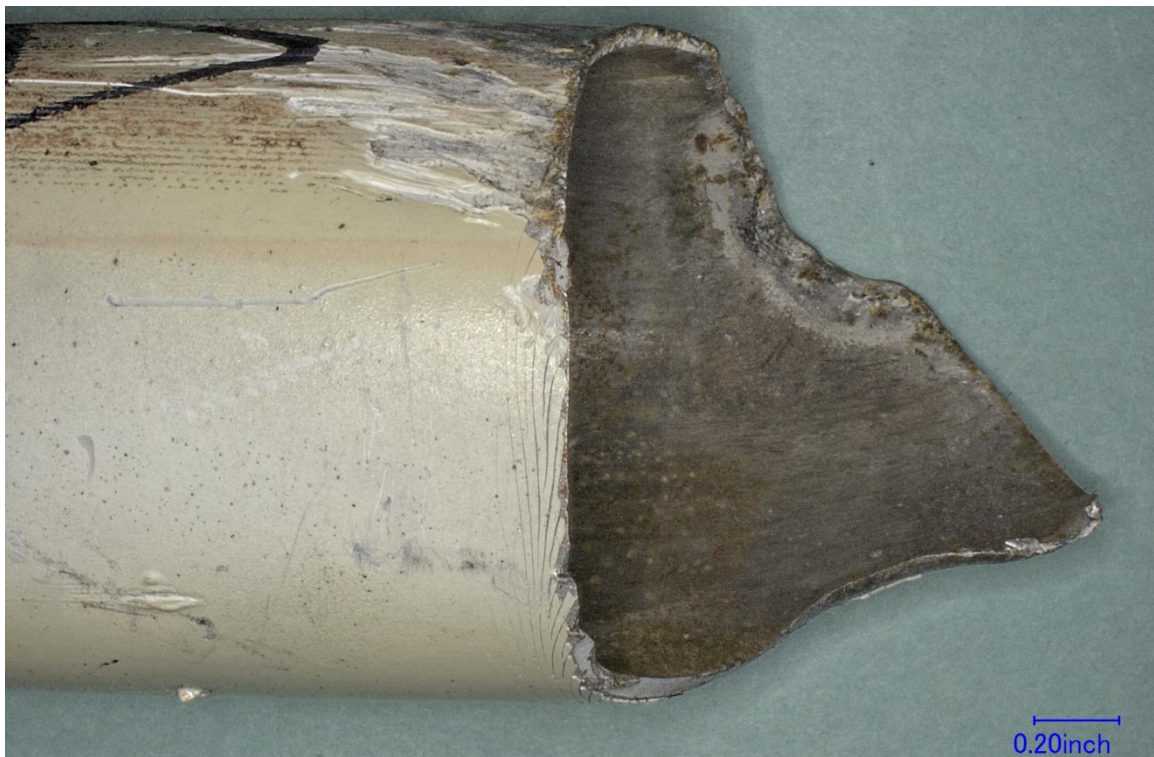
Figure 15 through 17 show closer views of the mating fracture surfaces of the arm. These fracture surfaces exhibited a general 45° slanted orientation, except on one section that protruded outward. This protrusion exhibited localized thinning, or necking, of material adjacent to the fracture surface. The paint in this area had fractured, and the orientation

Figure 15 – Closer view of the inner surface of the right arm fragment in Figure 13.

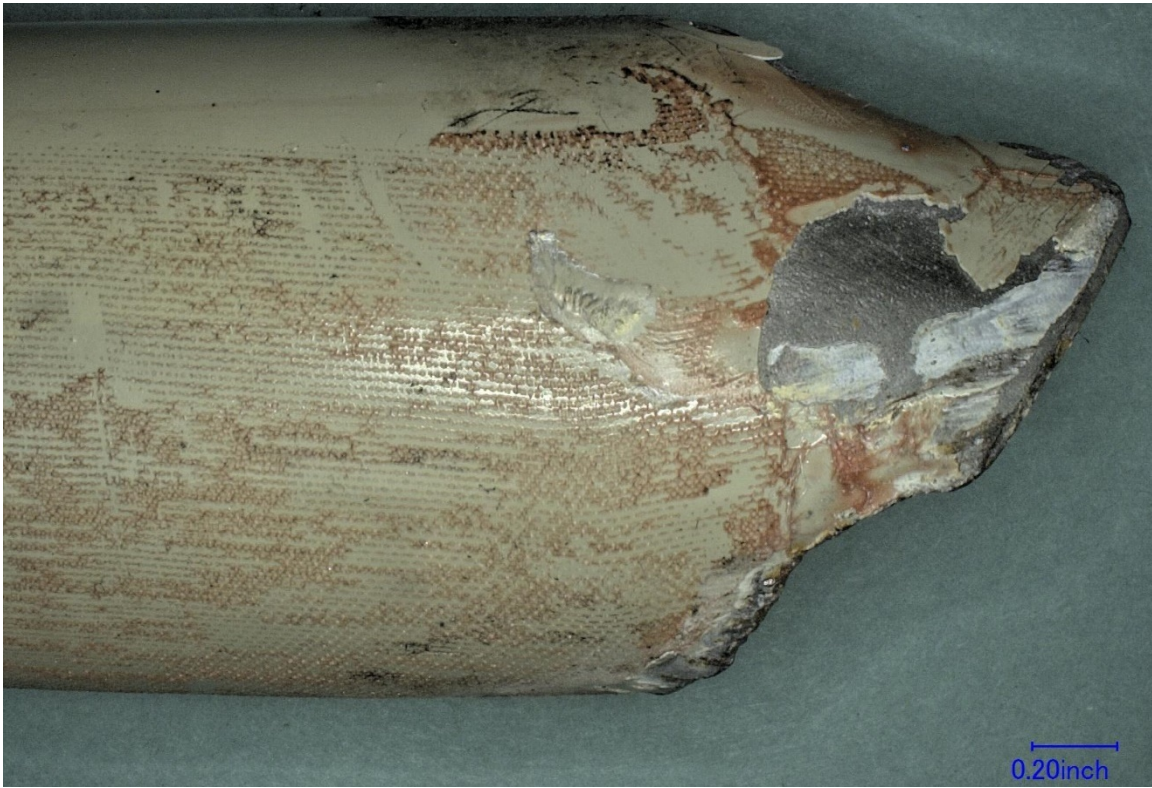
Figure 16 – Closer view of the outer surface of the right arm fragment in Figure 13.

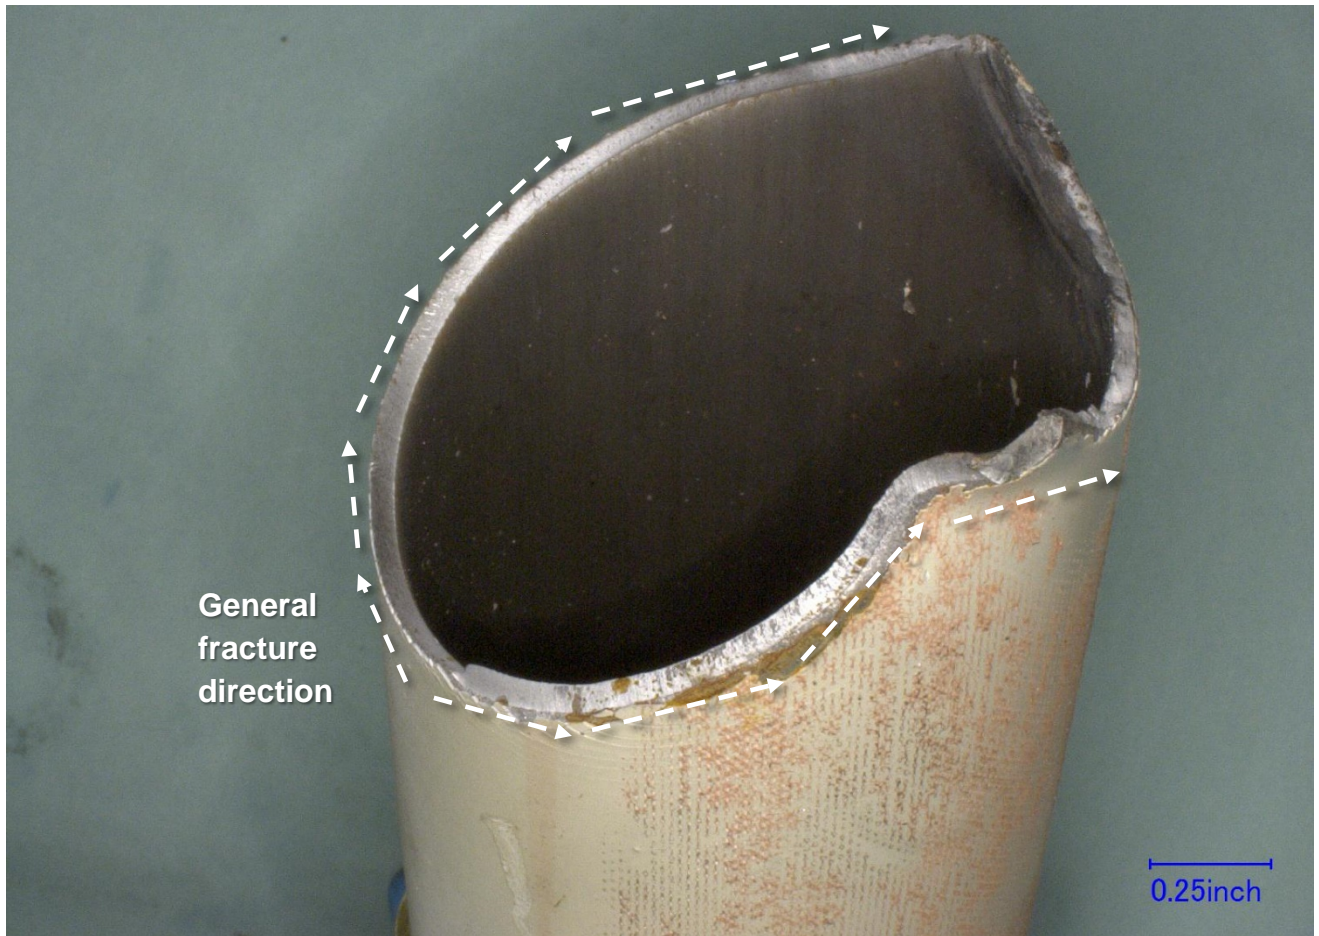
The fracture surface exhibited a dull luster and rough texture. In general, the fracture surface exhibited river patterns that were consistent with fracture from the lower slanted sides toward the elongated and necked side. All these features were consistent with the arm having fractured from overstress, in the direction as annotated in Figure 17. There were no indications of pre-existing defects or cracking in the arm. The fracture pattern was consistent with overstress fracture in tension, which then also bent outward at the end of the fracture (right side of Figure 17).

Figure 17 – View of the fracture surface of the left arm fragment in Figure 13, annotated to show the general fracture direction.

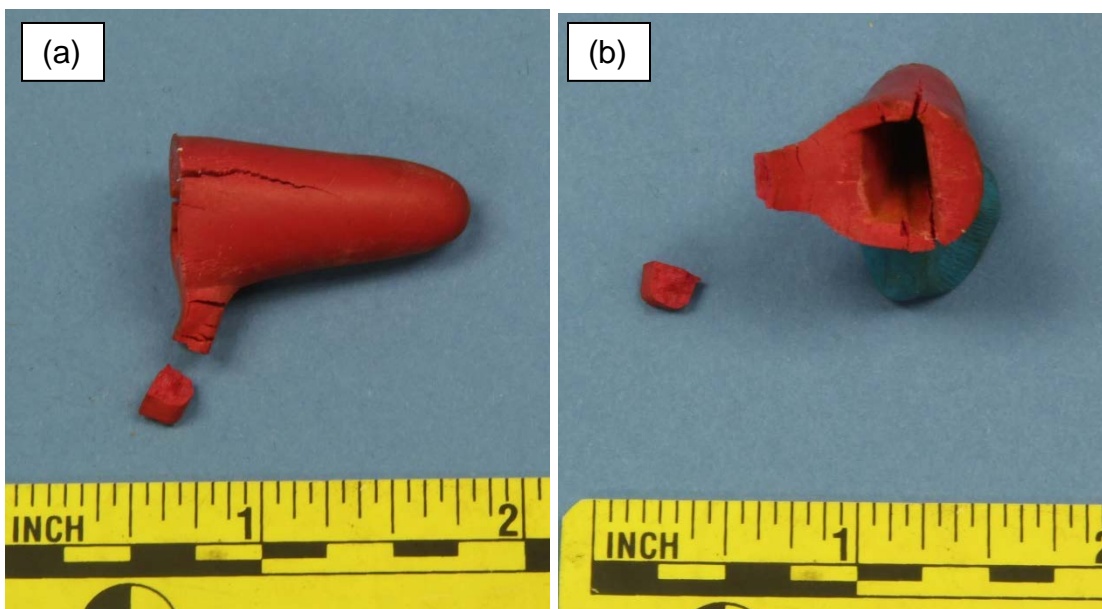
A small protruding red rubber cover was also submitted, as depicted in Figure 18. The cover had fractured about the fitting hole, as shown in Figure 18b. This piece exhibited an orangish-red color, and had cracked or split from the rectangular hole on the mating end.

Figure 18 – View of the rubber cover from (a) the side and (b) the mating end.
