NATIONAL TRANSPORTATION SAFETY BOARD

MATERIALS LABORATORY FACTUAL REPORT

Report No. 17-081

Place : Medford, New Jersey
Date : September 8, 2017
Vehicle : Schweizer 269C1, N204HF
NTSB No. : ERA17FA317
Investigator : Brian Rayner, ASI-ERA

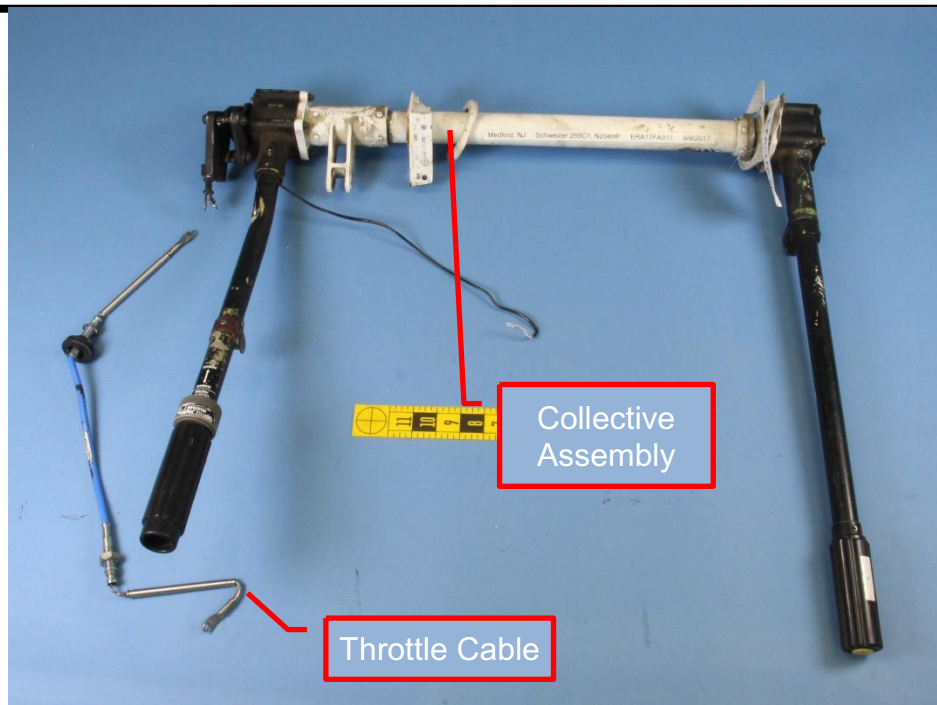
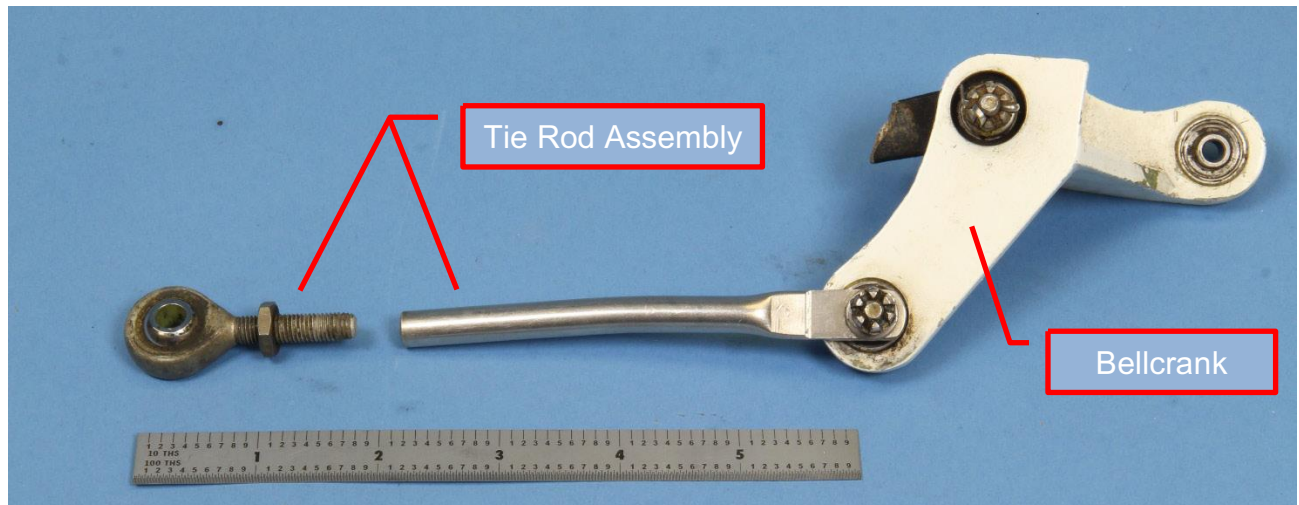
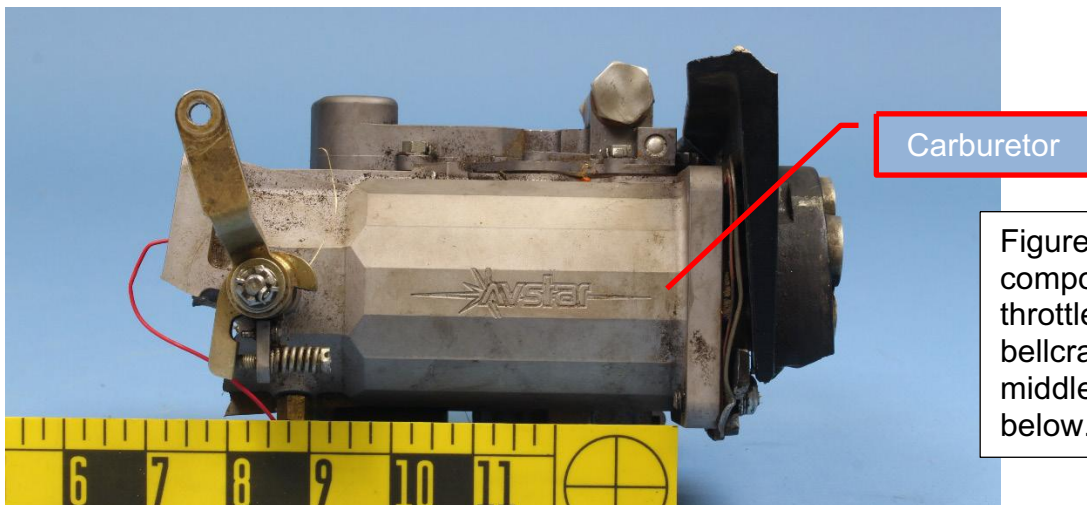
The as-received components are displayed in figure 1. The collective and throttle assembly with throttle cable are in the upper view. The right collective lever was bent upward with mechanical damage and denting at the fulcrum of the bend and the throttle cable was bent and distorted as shown. The carburetor linkage is displayed in the middle view with the support structure for the bellcrank assembly fractured and the tie rod separated. The throttle arm side of the carburetor is shown below.

Figure 1. The as-received components, collective and throttle cable at top, the bellcrank and tie rod in the middle and the carburetor below.

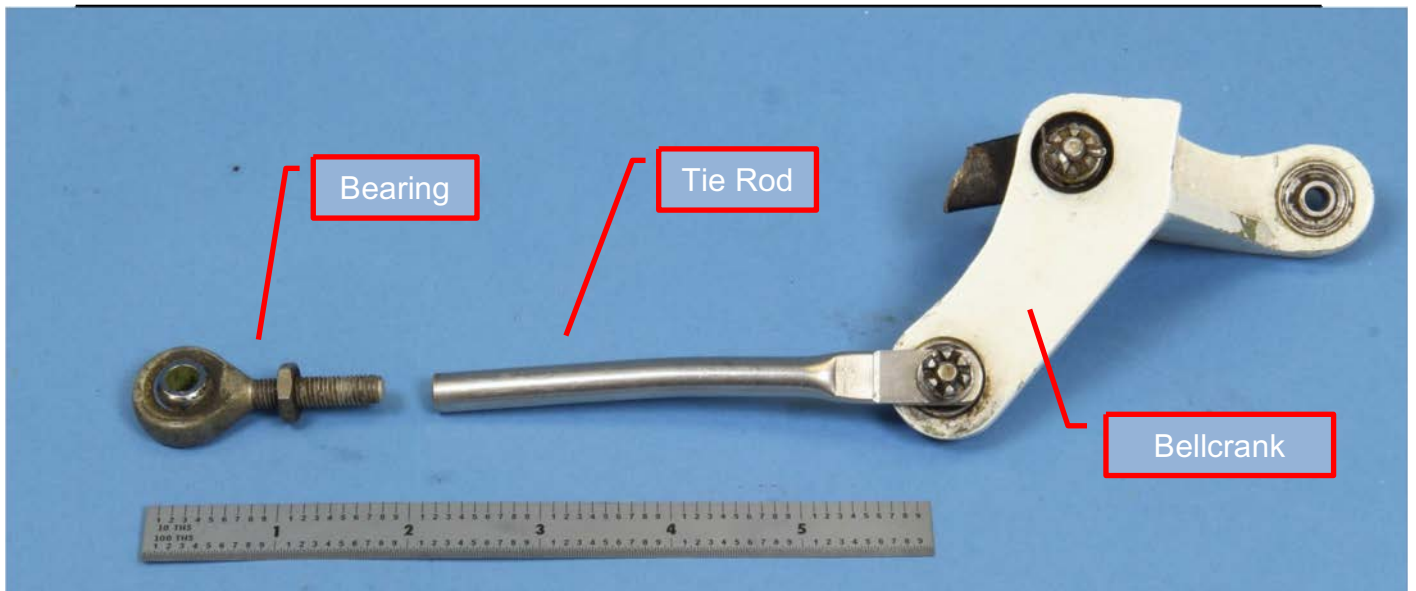
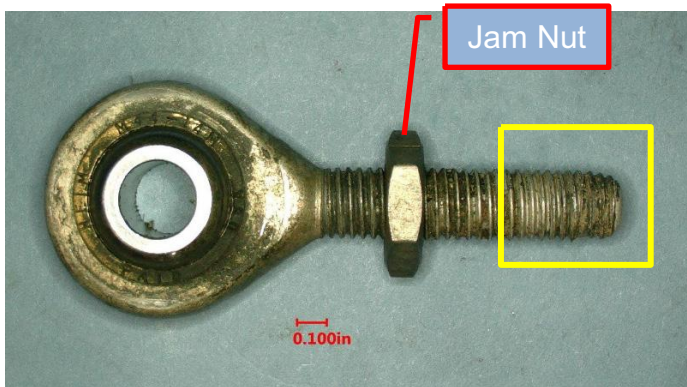
The bellcrank and tie rod assemblies are displayed in the upper view of figure 2. The tie rod assembly was received separated at the threaded joint. The components were unbolted from the carburetor throttle arm and the throttle cable prior to receipt in the materials laboratory. The tie rod assembly consisted of an internally threaded rod attached to the bellcrank and an externally threaded rod end bearing and jam nut attached to the throttle arm. The tie rod was separated at the threaded joint between the two pieces. The rod end was received with the jam nut at the location shown. This was reported to be the location found at the accident scene.

Magnified examinations of the bearing threads uncovered mechanical damage to the three end threads boxed area in the middle view and shown at higher magnification in the lower view of figure 2. The damage was consistent with thread to thread wear. The wear showed a distinct pattern with material removed (red arrows) from the bearing side flanks of the lower threads (as shown) and the opposite flanks (bellcrank side) of the upper threads.

Figure 2. The carburetor throttle linkage with separated tie rod assembly at top. Left view shows the rod end bearing with thread damage. The boxed area is displayed below at higher magnification showing the pattern of wear (red arrows) damage.

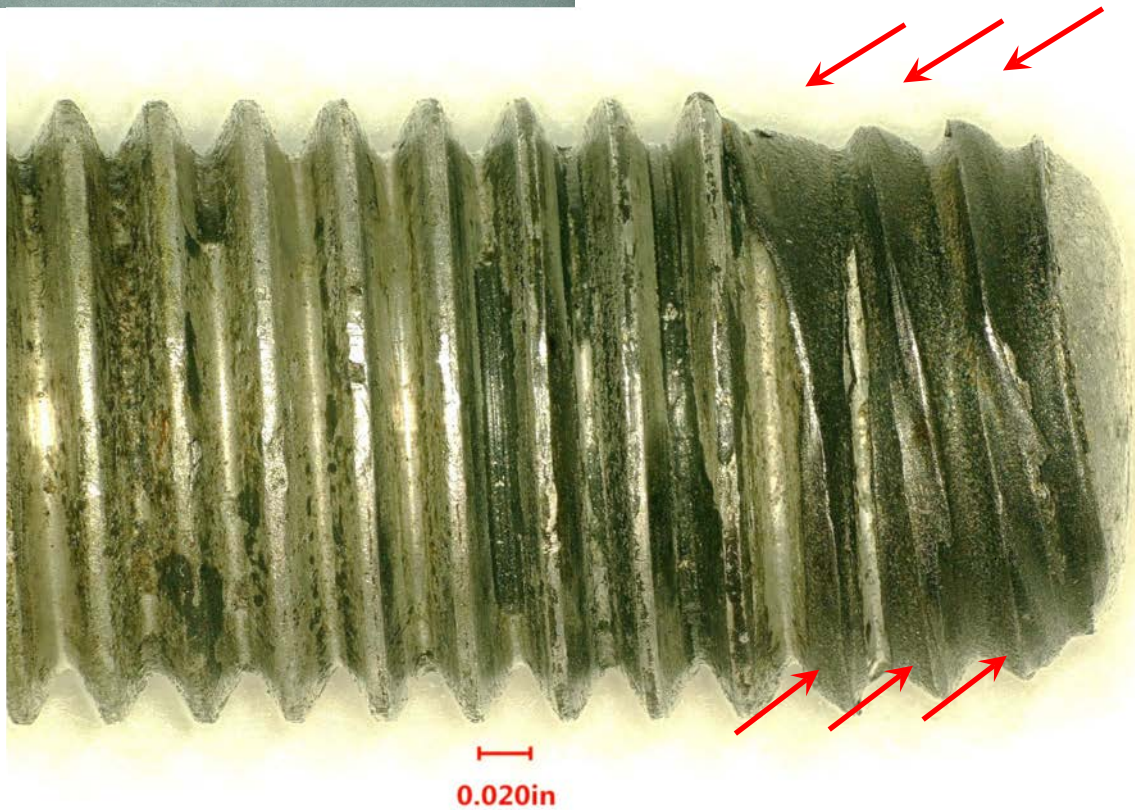
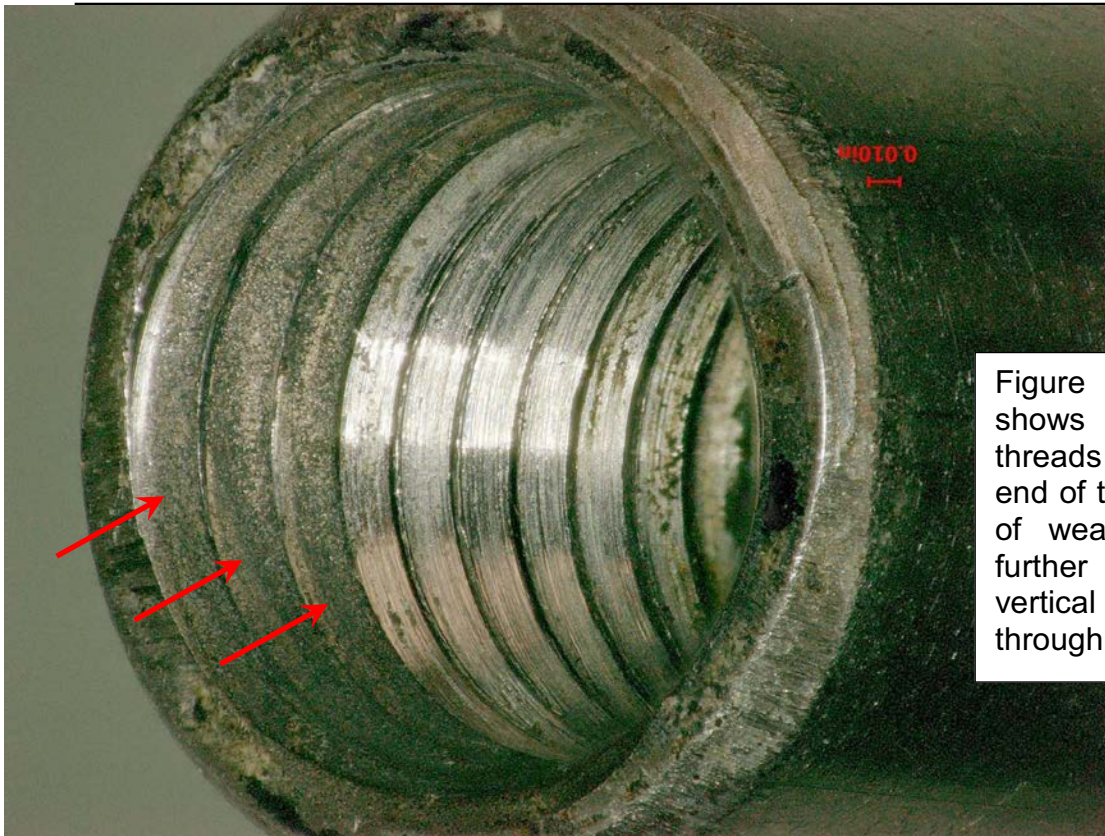
Visual examination of the internal threads in the rod revealed cellulose material imbedded into the threads. After brush cleaning, damage was visible to the three end threads as shown in the upper view of figure 3. The damage left the thread flanks pock marked and reduced in size consistent with vibratory thread to thread wear. These three threads correspond to the three worn threads on the bearing fitting. Threads further inside the rod were bright and shiny and undamaged.

The end of the rod was abrasively cut on a vertical plane to reveal the damaged threads as shown in the lower view of figure 3. Magnified examinations of the damaged threads showed a similar pattern of wear to the bearing threads. For half of the rod circumference the wear (red arrows) was on one flank of the threads and on the opposite flank on the other half of the circumference.

The pattern of thread wear was consistent with bending contact with the mating threads of the bearing and rod. The remaining threads on the bearing were relatively undamaged and without clearly define contact patterns.

Figure 3. Upper view shows the three worn threads (red arrows) at the end of the rod. The pattern of wear (red arrows) is further evident on the vertical cross section through the threads below.

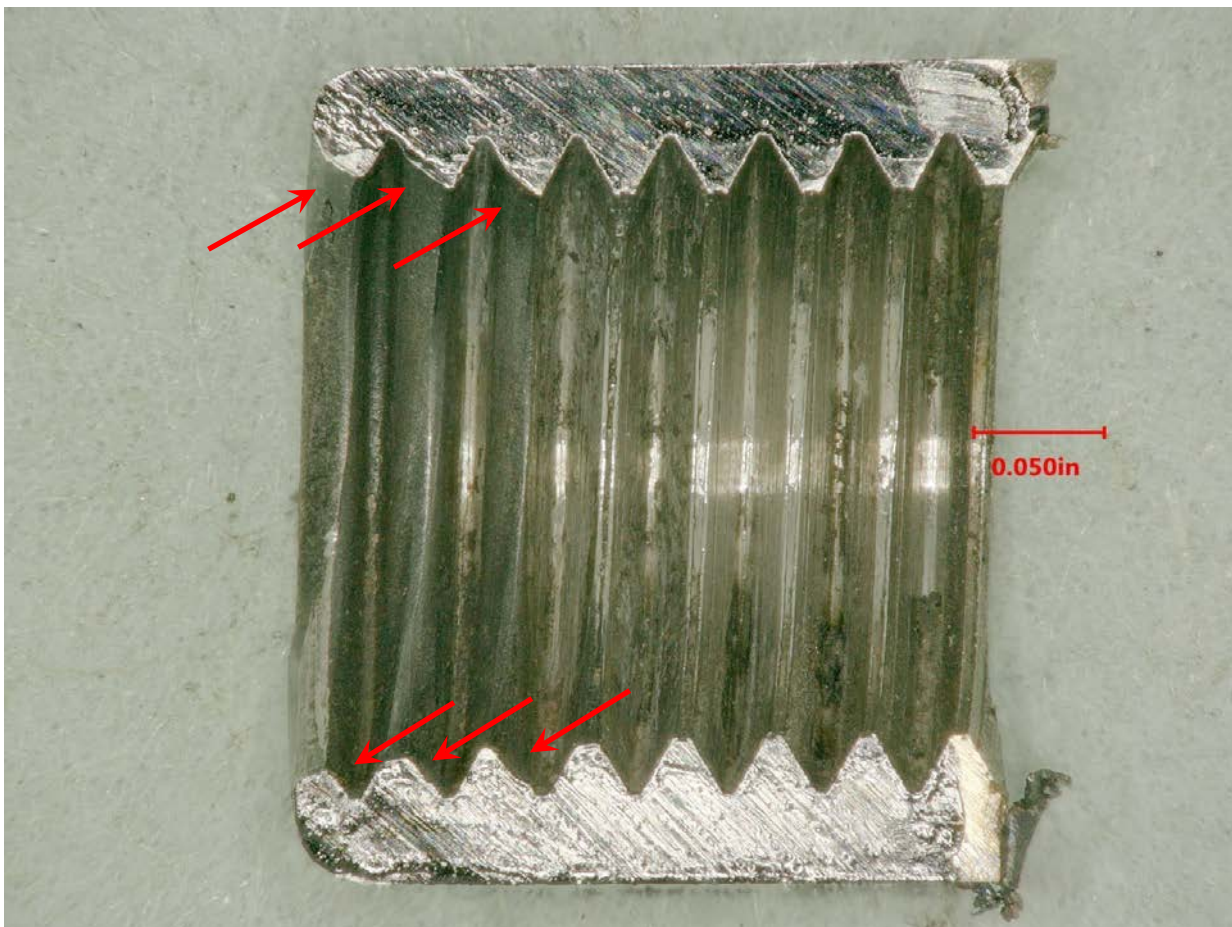
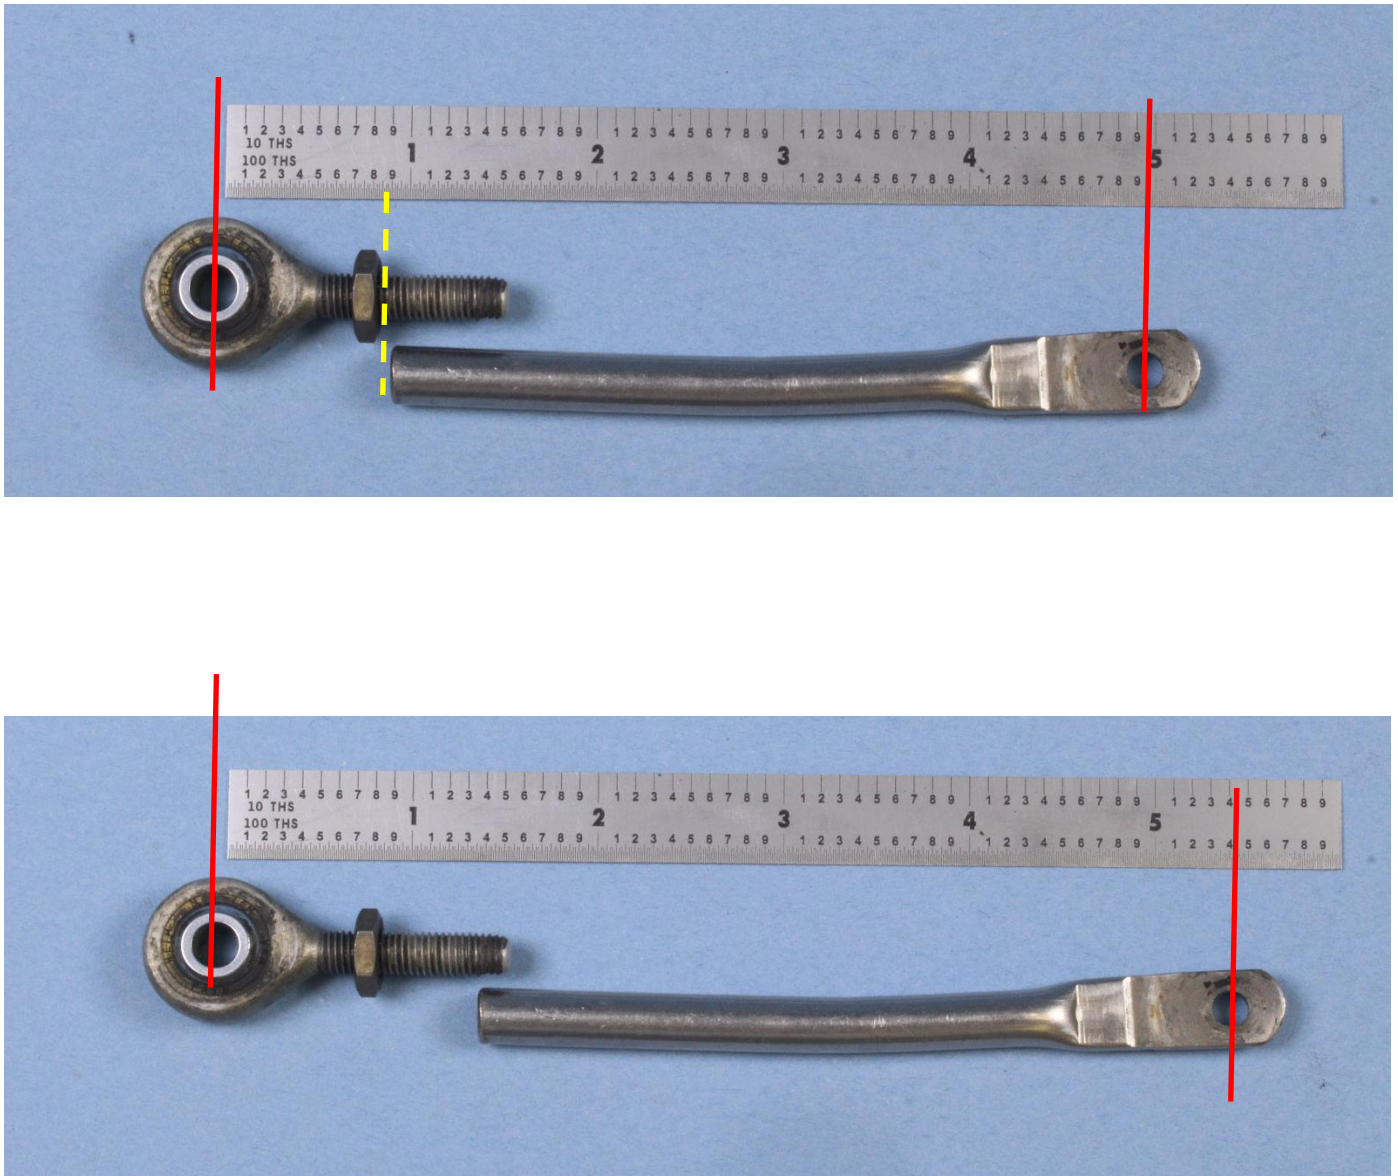
The engineering drawing, 269A8416, and maintenance documents¹ both specify the eye to eye center length of the tie rod assembly as 4.97 inch +/- 0.02 inch. This length is depicted in the upper view of figure 4 and results in about 16 or 17 engaged threads. When the tie rod is installed on the throttle arm and the bellcrank, the rod and bearing cannot rotate relative to each other. The as-received position of the jam nut was about two threads past the end of the rod when at about 4.97 inches, as shown.

The thread wear found on both the bearing and rod however was consistent with about three threads engaged between the two components. This is depicted in the lower view of figure 4 and results in a tie rod length of about 5.5 inches or about 0.5 inch longer than specified.

Figure 4. The upper view shows the relative thread engagement when the tie rod is adjusted to approximately the eye to eye length specified by the engineer drawing and maintenance documents, $4.97 \pm .020$ inches. The lower view shows the overlap when only the three damaged threads are engaged. With an eye to eye distance of about 5.5 inches.

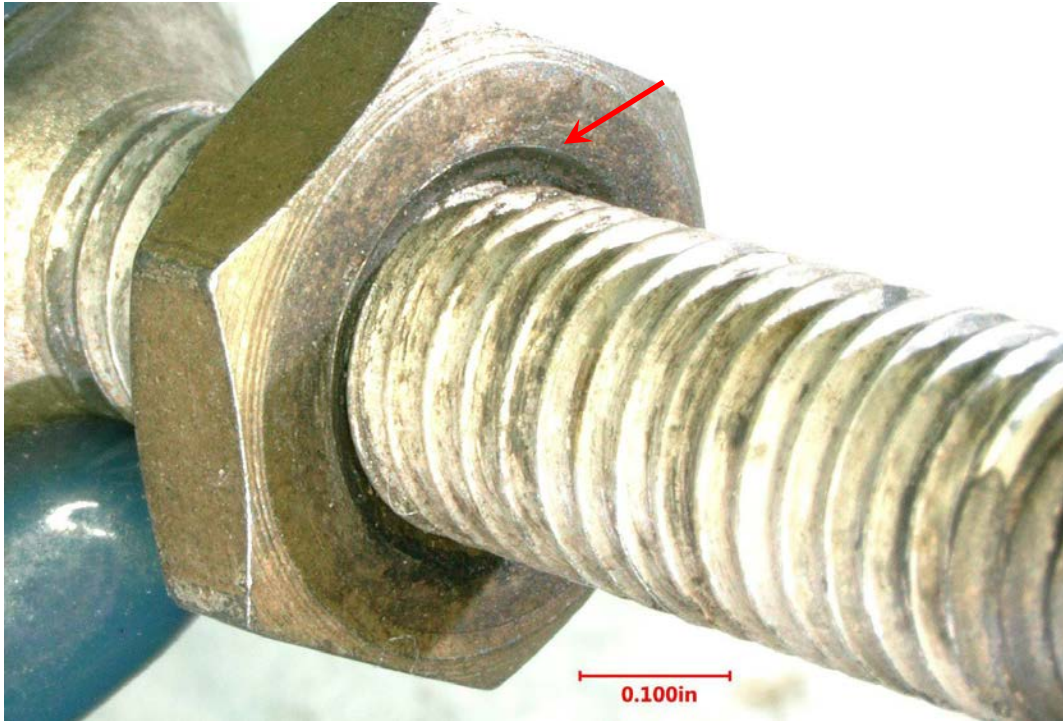
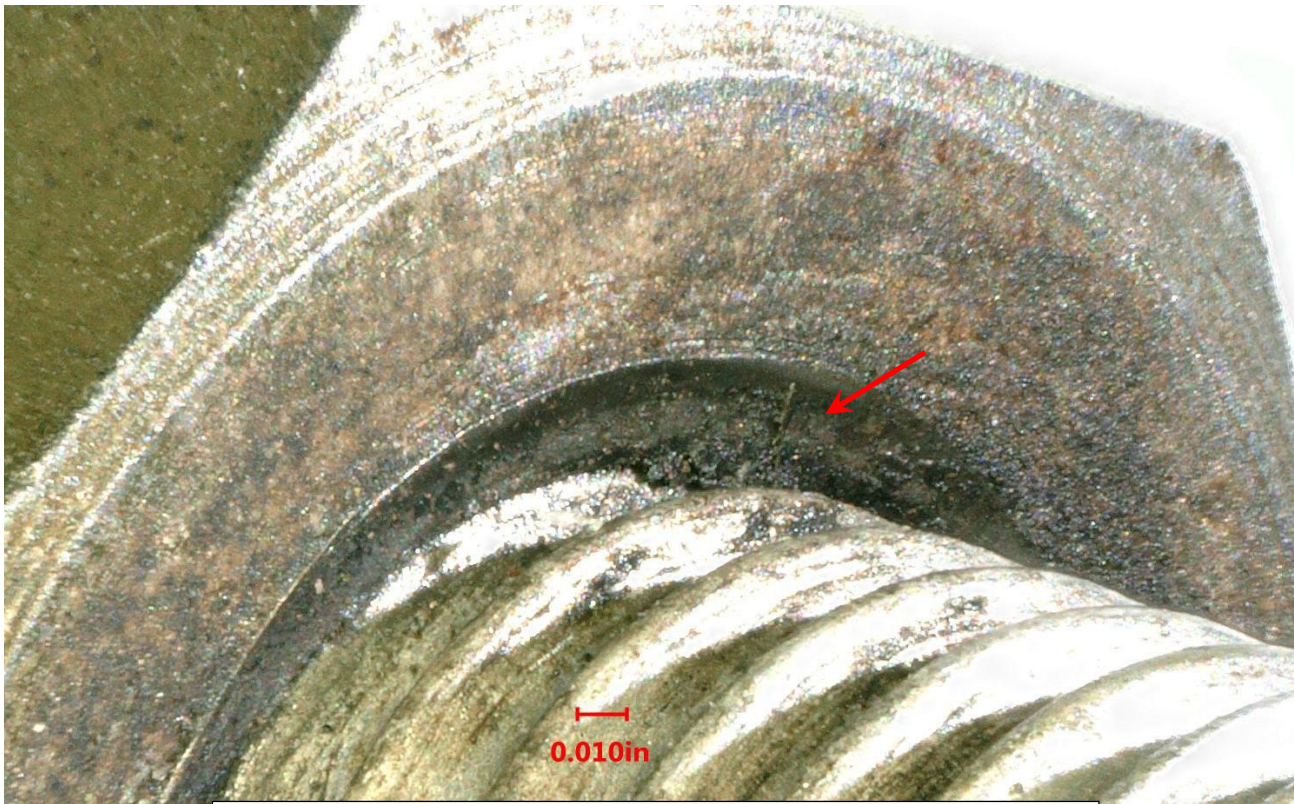
Examinations of the jam nut uncovered an arc of wear damage to the bellcrank side washer face as shown in the two views of figure 5. The arc of wear covered about 217 degrees of the nut adjacent to the internal nut threads. A similar arc of wear was found on the end of the rod. The size and location of the wear on the nut corresponds to the size and location of a wear pattern found on the end of the rod as shown in figure 6.

Figure 5. Two optical views showing the arc of wear, red arrow, on the rod side of the jam nut.

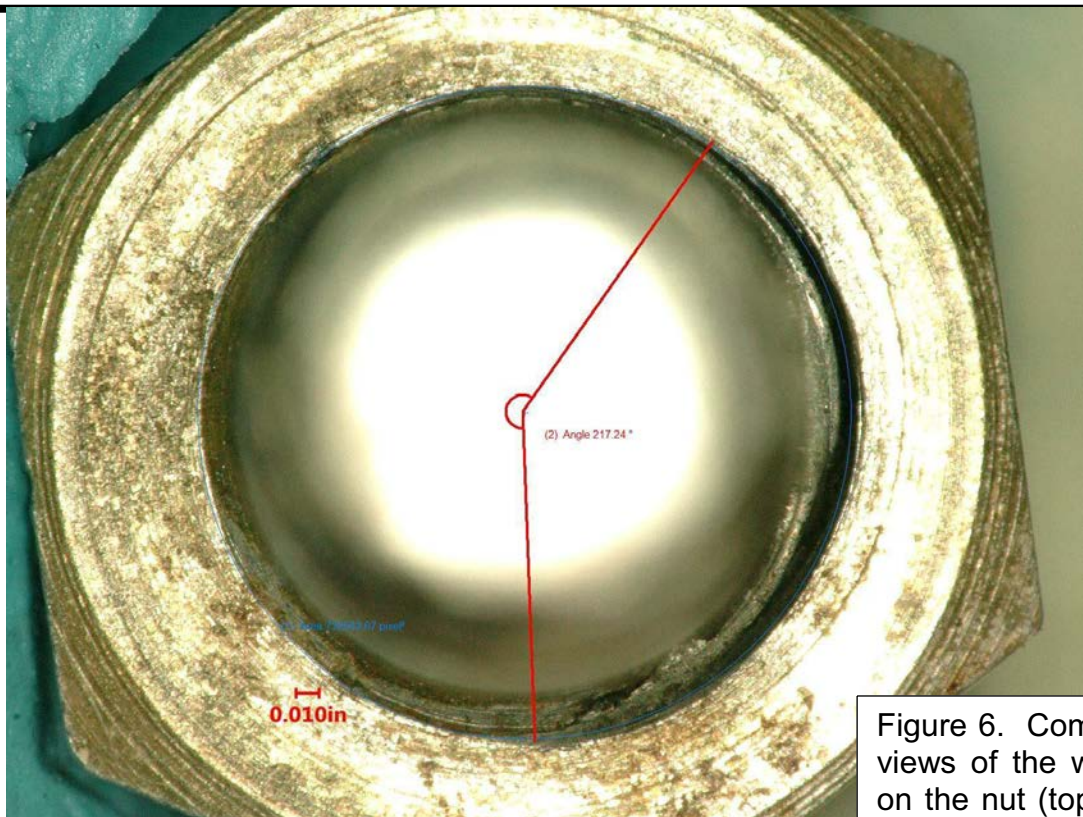
Figure 6. Comparison views of the wear arc on the nut (top) to the wear area on the end of the rod, dashed blue area below.

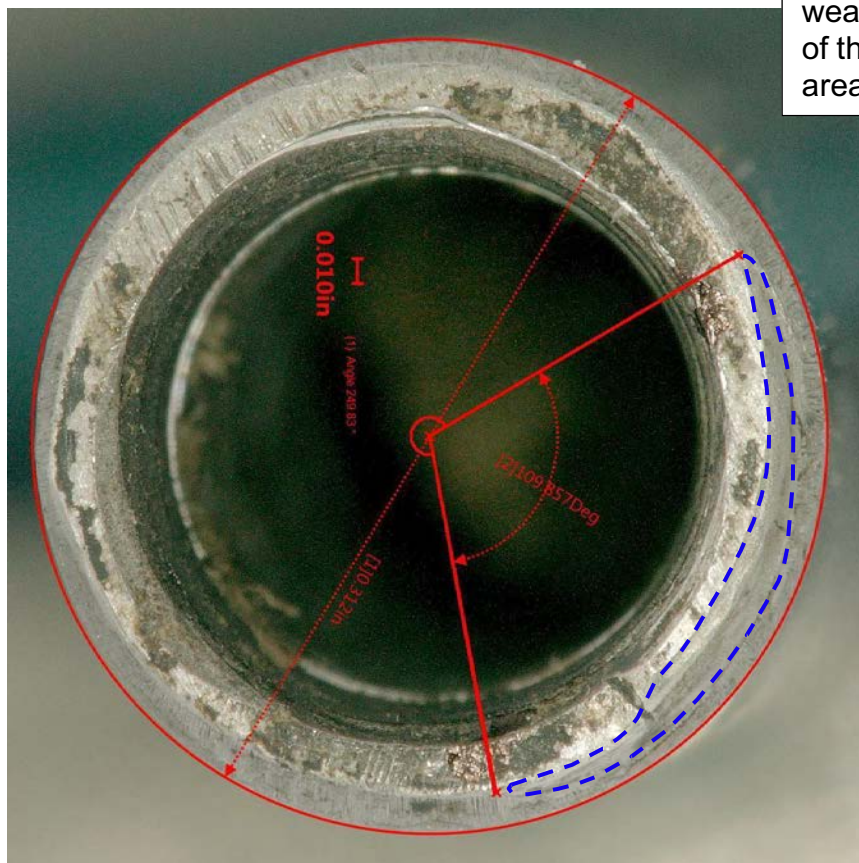
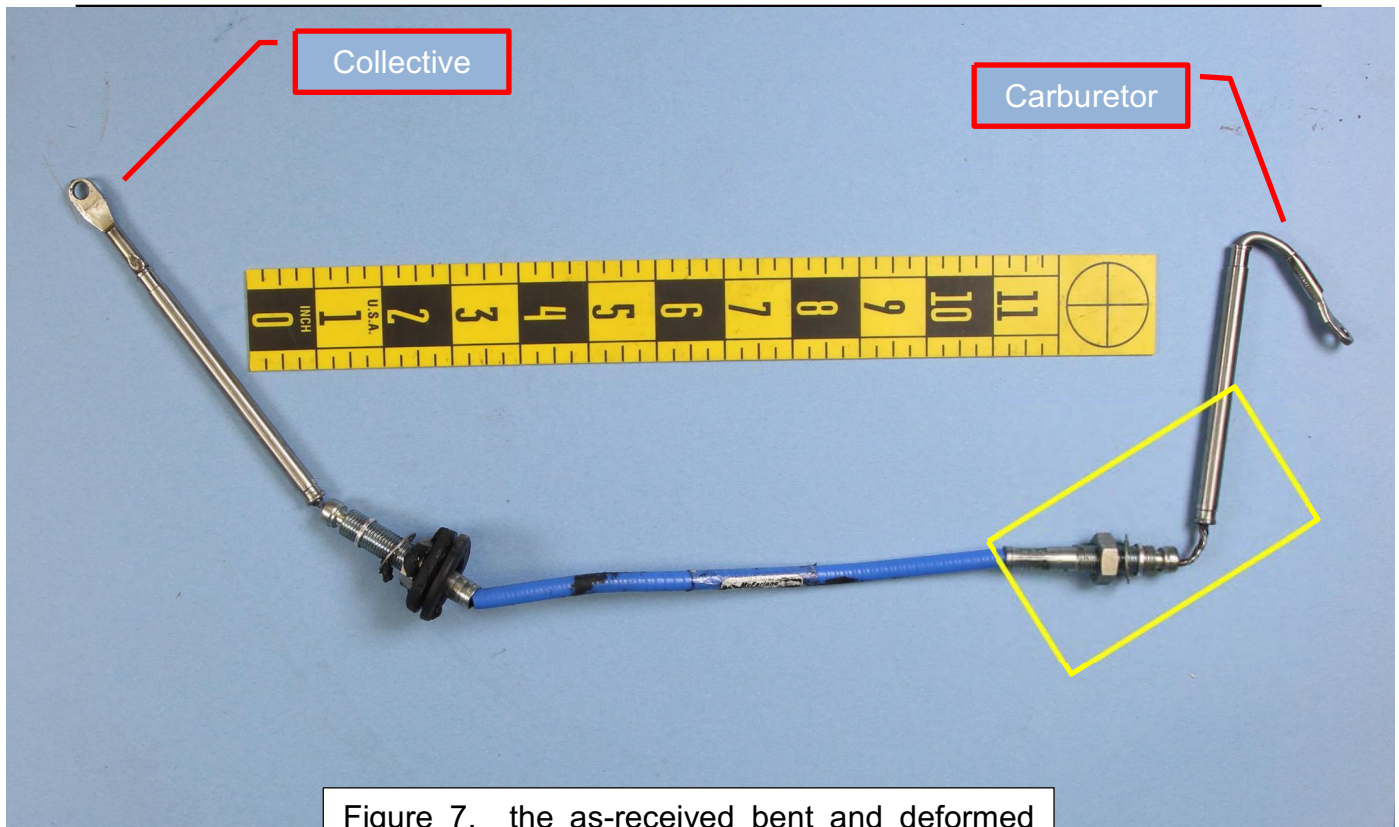
The as-received throttle control cable assembly is shown in the upper view of figure 7. The assembly was deformed and kinked as shown with both support tubes separated from their respective swivel fittings. The carburetor side cable end, that connects to the bellcrank, was bent more than 90 degrees and the stranded inner cable was kinked and bent about 90 degrees, yellow box upper view. The exposed strands of the cable were spread apart (bird caged), as shown in the lower view of figure 7. The cable assembly was labeled "McFarlane custom Lot# 45481". It was reported to be a copy of the original assembly p/n 269A8410.

Figure 7. the as-received bent and deformed throttle cable above with the bent yellow boxed area show at higher magnification below.

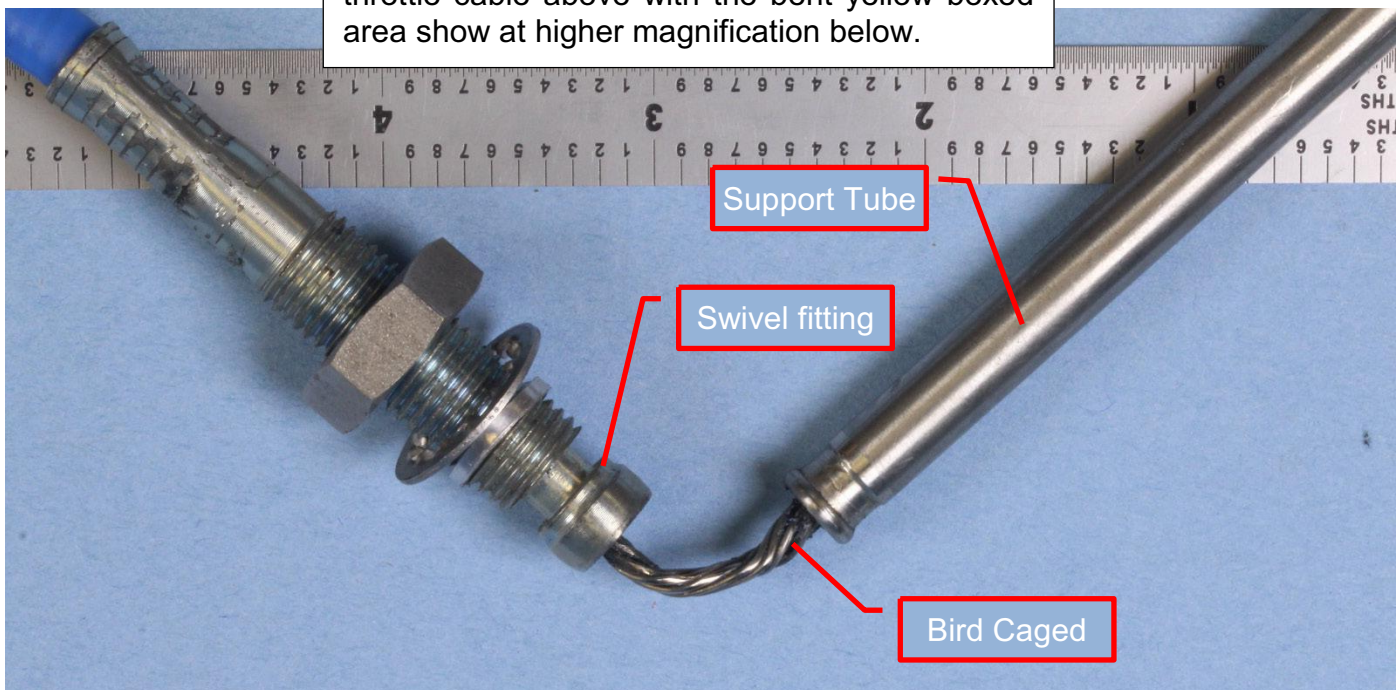
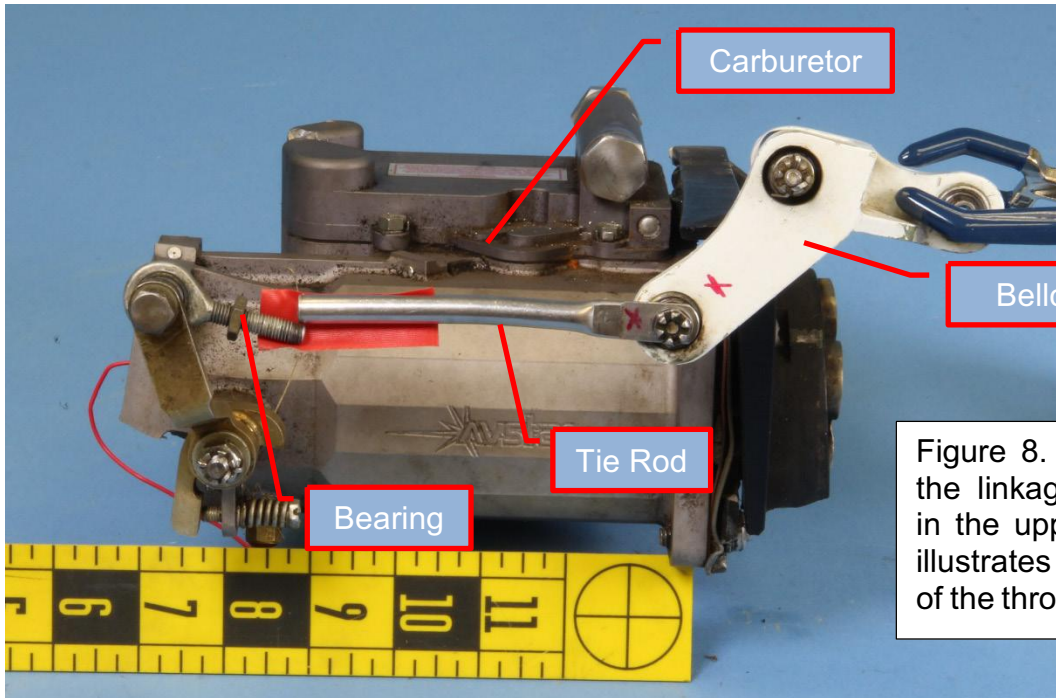
The carburetor is displayed in the upper view of figure 8 with the bellcrank and tie rod pieces positioned in their approximate original positions. The mounting structure for the bellcrank was fractured and deformed. The inlet and outlet flanges of the carburetor were also distorted and fractured. The throttle arm and idle stop screw appeared intact and undistorted. The maintenance documents indicated that with the throttle arm at idle (against the stop) The arm should be at approximately 17 degrees from vertical. The angle of the arm was photographically measured using three different reference lines on the carburetor. All three measurements were within 1 degree of 17 as depicted in the lower view of figure 8.

Figure 8. The carburetor with the linkage roughly positioned in the upper view. Lower view illustrates the 17 degree angle of the throttle arm at idle setting.
