NATIONAL TRANSPORTATION SAFETY BOARD

MATERIALS LABORATORY FIRE FACTUAL REPORT

Report No. 17-066

Place : McKinleyville, California
Date : July 29, 2016
Vehicle : Piper PA-31T
NTSB No. : WPR16FA153
Investigator : Brice Banning
IIC/AS-ANC

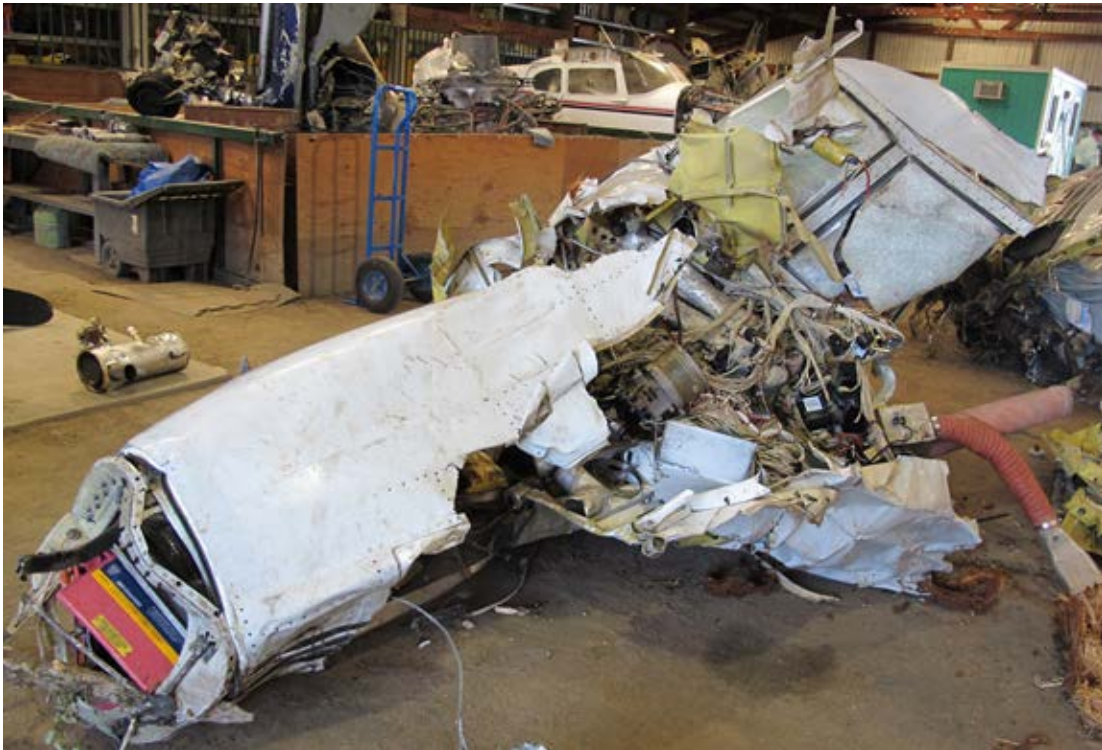
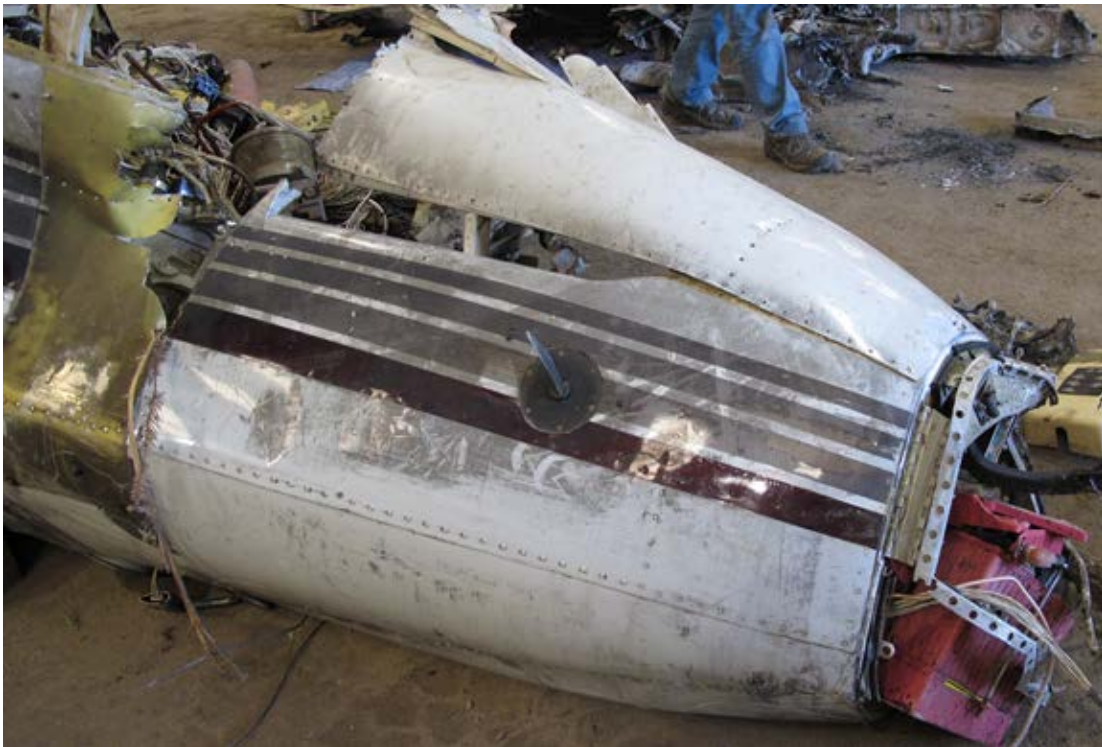
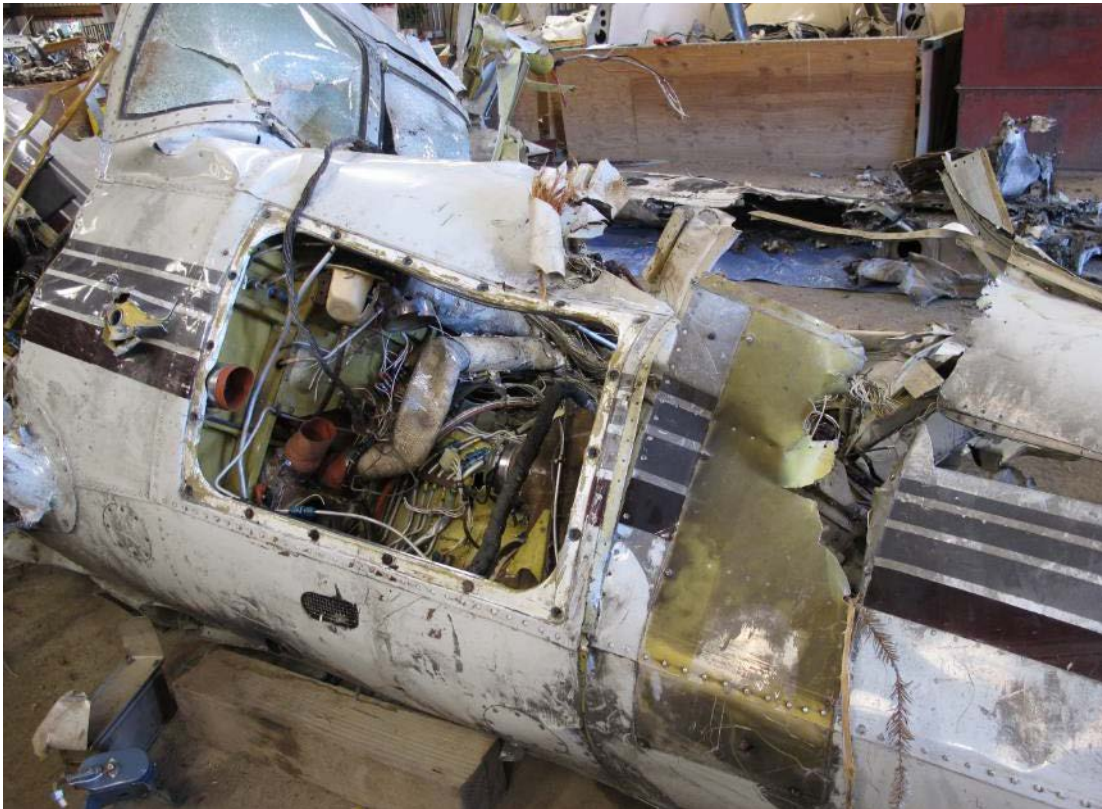
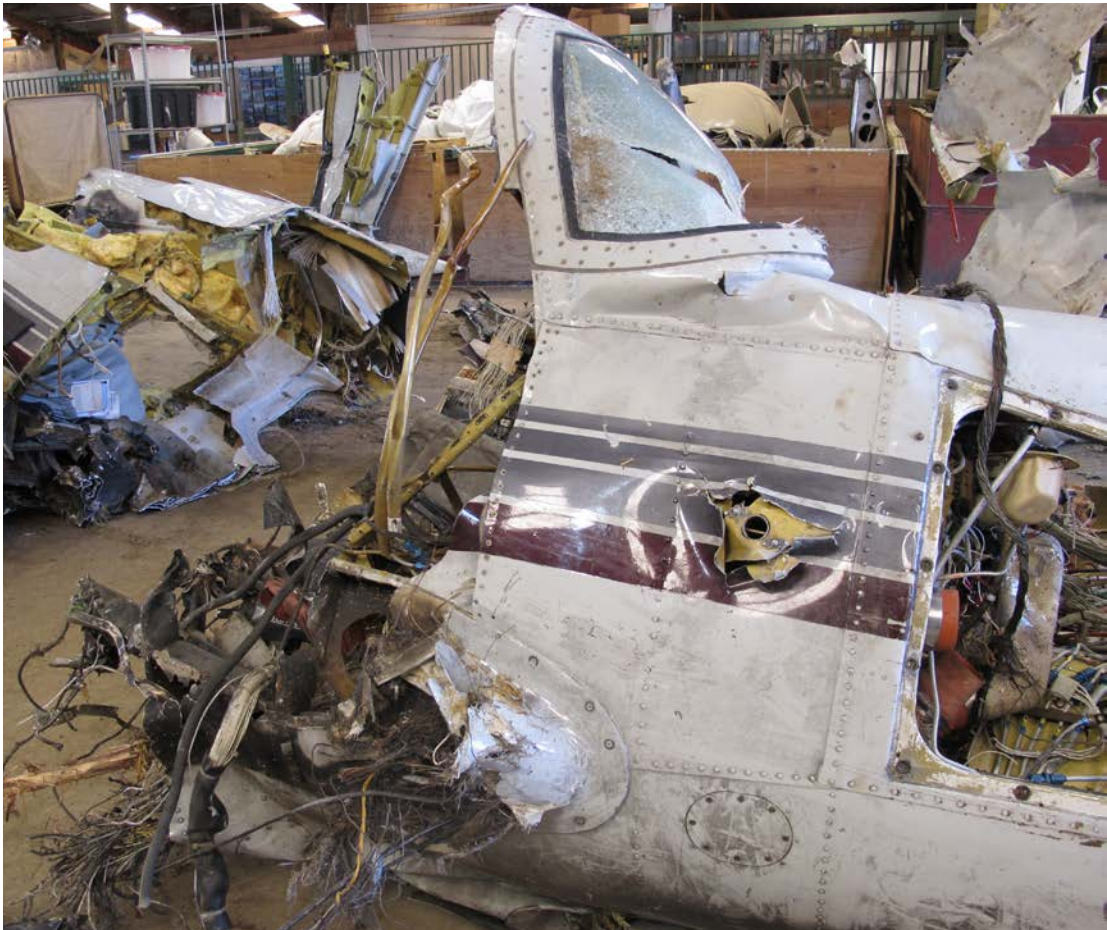
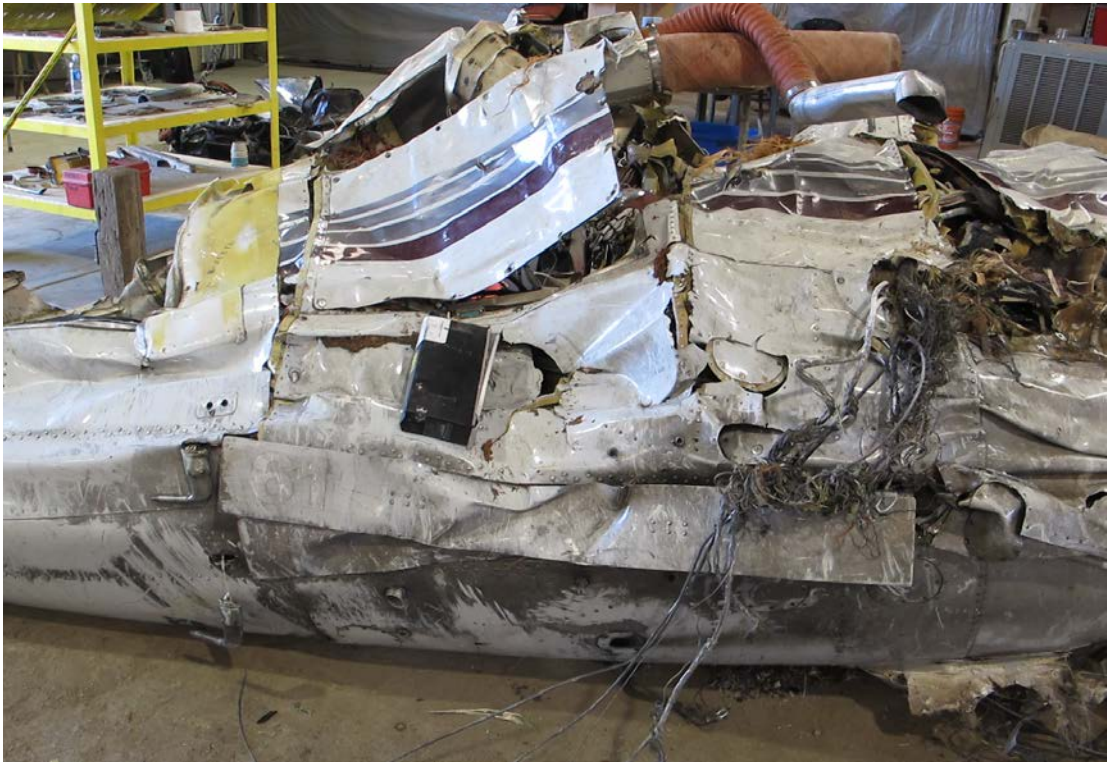
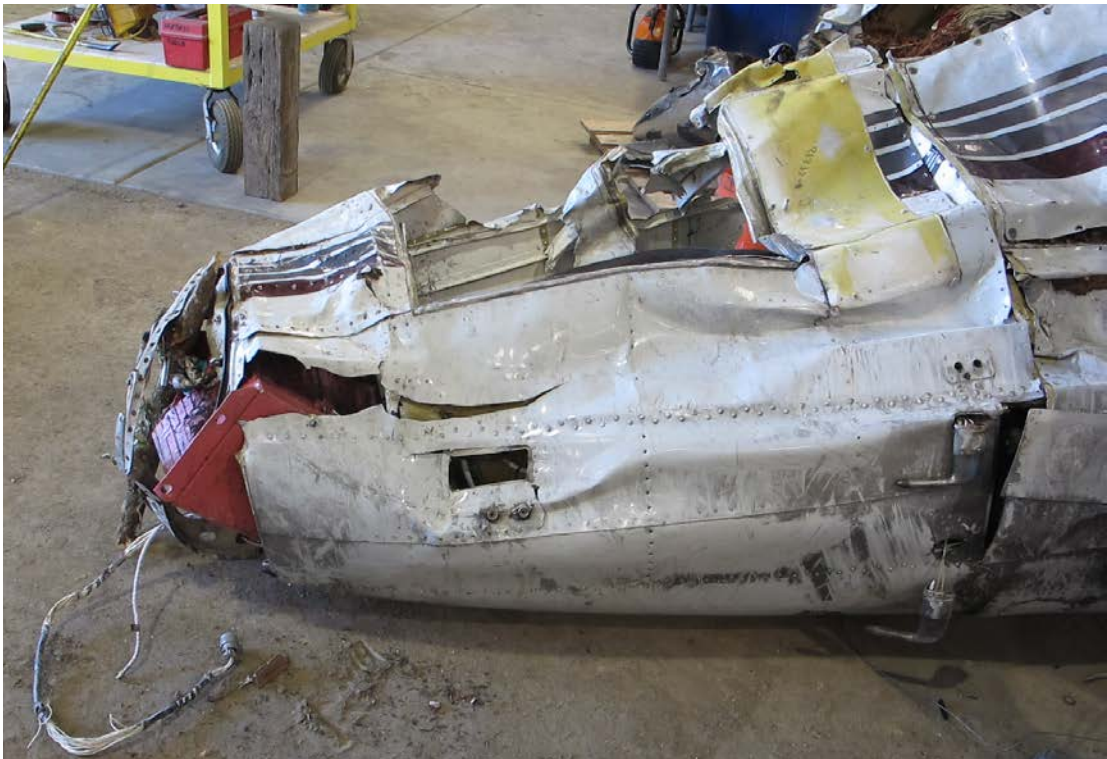
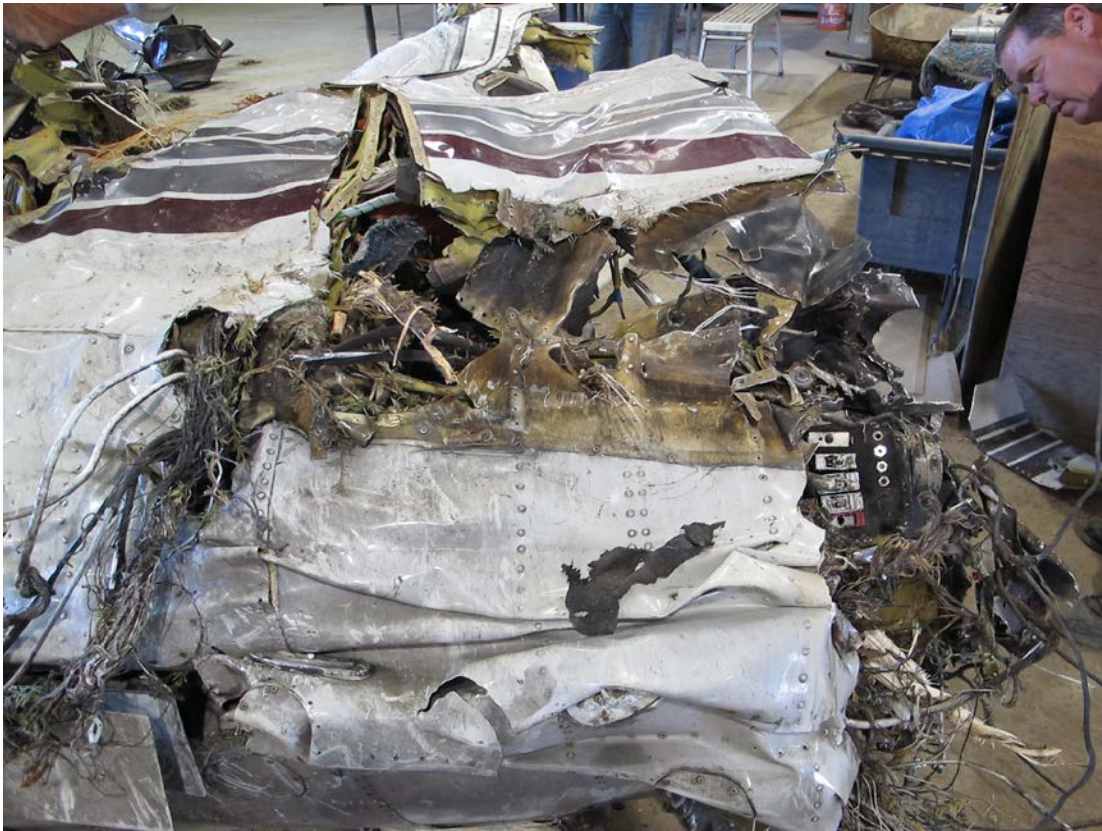
The cockpit section consisted of the entire fuselage from the nosecone to the forward edge of the wing spar (which was located just aft of the cockpit seats). There was an even, lightly adhered coating of light soot over the entire fuselage exterior skin with several small areas (below the right wing root and along the lower right belly area) with heavier soot deposit. There was no sign of thermal damage to the exterior paint in this area. These fire signatures are shown in Figures 1-7.

Figure 1. Overall photograph of front of aircraft

Figure 2. Photograph of right nosecone area of aircraft.

Figure 3. Photograph of right side forward of the cockpit.

Figure 4. Right side of cockpit exterior.

Figure 5. Photograph of right side under cockpit.

Figure 6. Photograph of left nosecone area of aircraft.

Figure 7. Photograph of left exterior side of cockpit.

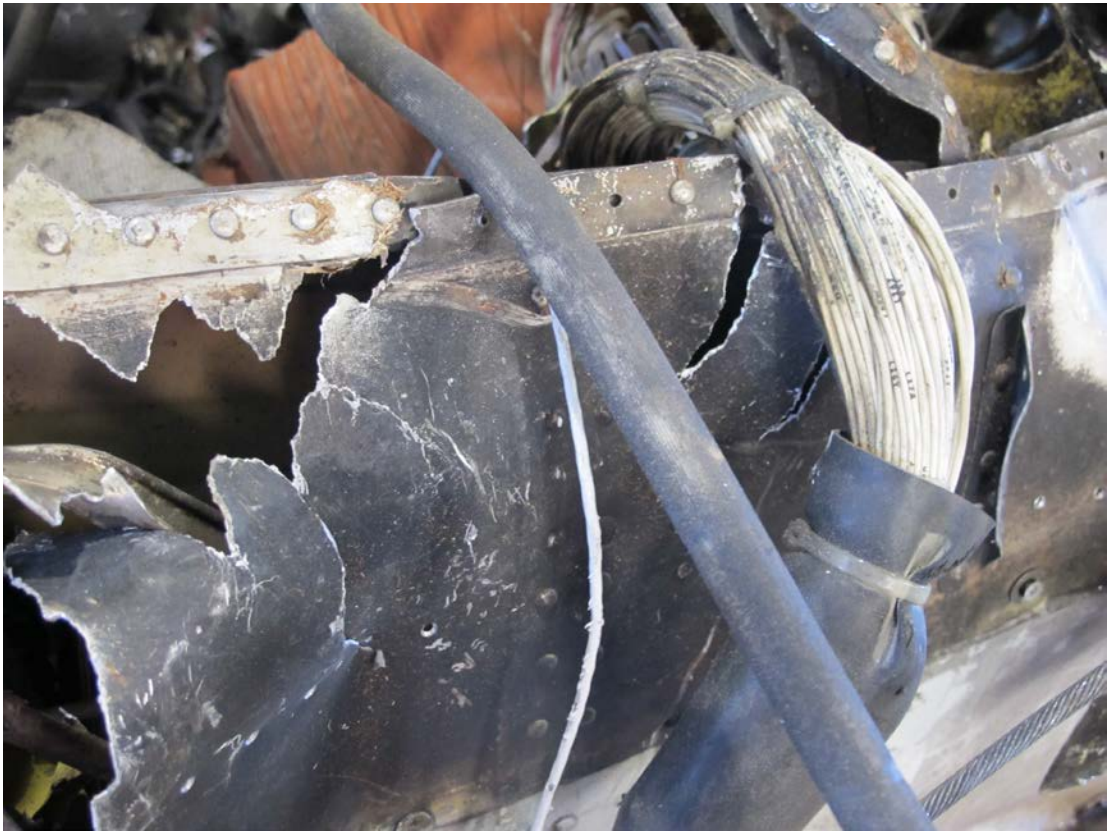
There was some localized damage to the outboard side of the fuselage skin at the right wing root. There is a small area of clean burn as well as some thermal related tearing as shown in Figure 8. The inboard side exhibited no thermal damage.

Figure 8. Closeup photograph of thermal tearing on right wing root.

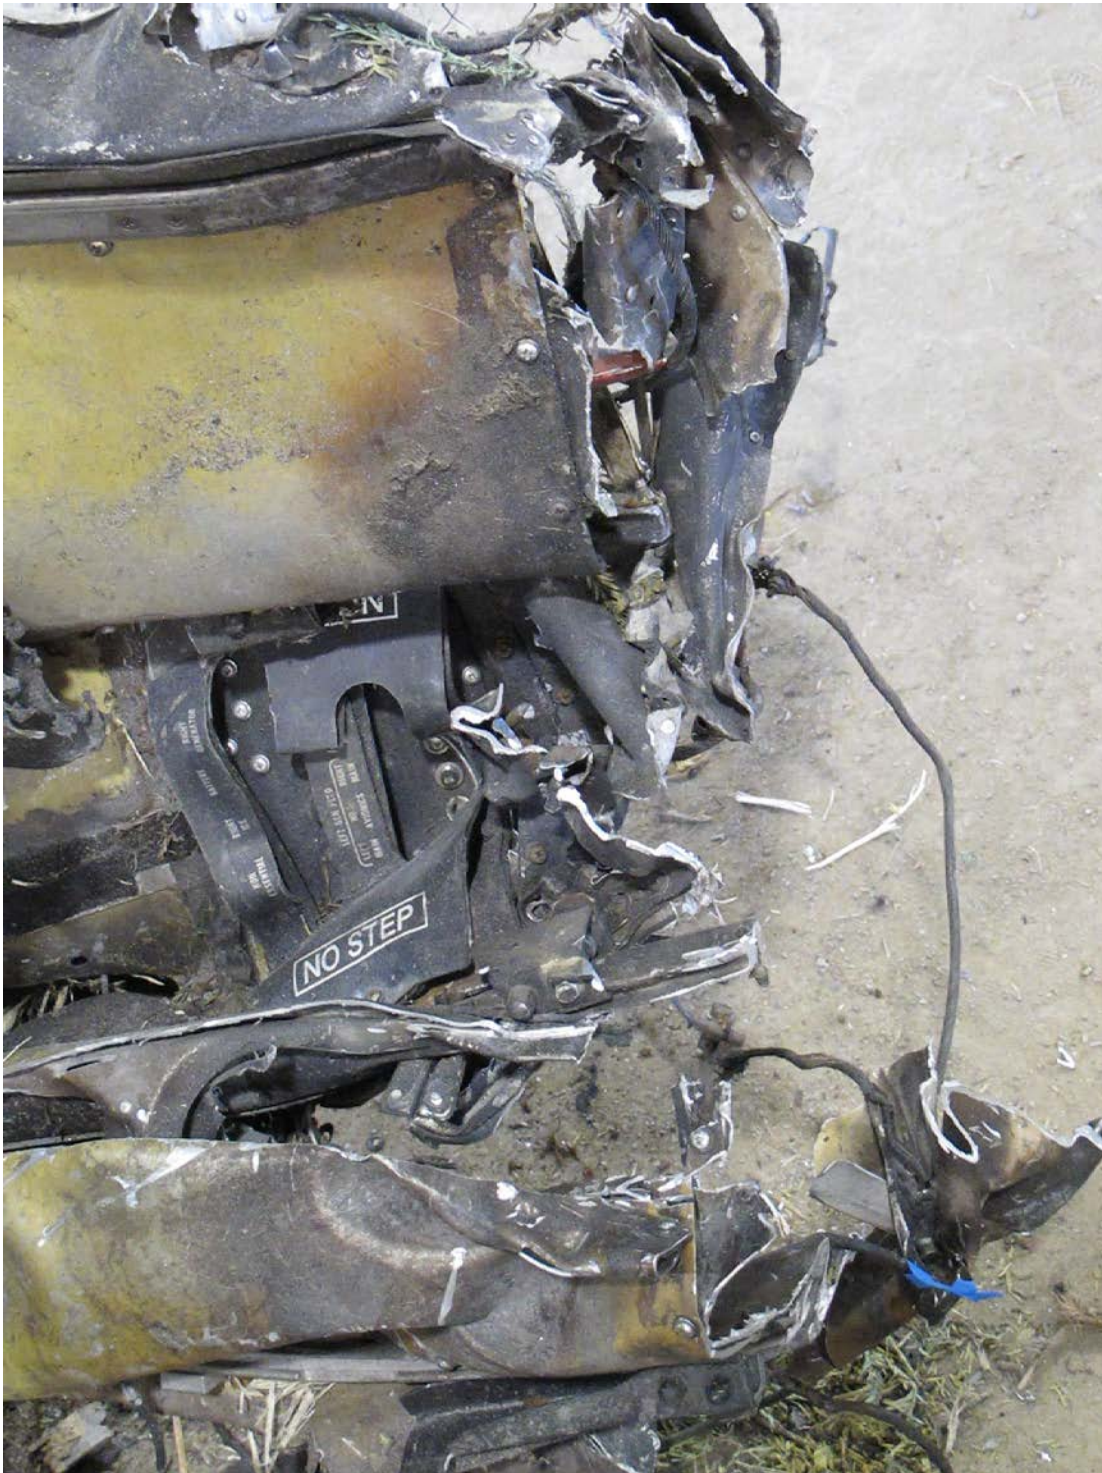
The thermal damage to this area was limited to the floor area between the two forward seats near the main bus tie circuit breaker panel and extended to the forward edge of the wing spar. All exposed surfaces were heavily sooted. There was some localized melting and thermal related tearing of aluminum structure as shown in Figure 9. The primer paint on the floor panels under the right aft corner of the pilot (left) seat and left aft corner of the co-pilot

Figure 9. Overall photograph of main bus tie circuit breaker panel and surrounding structure.

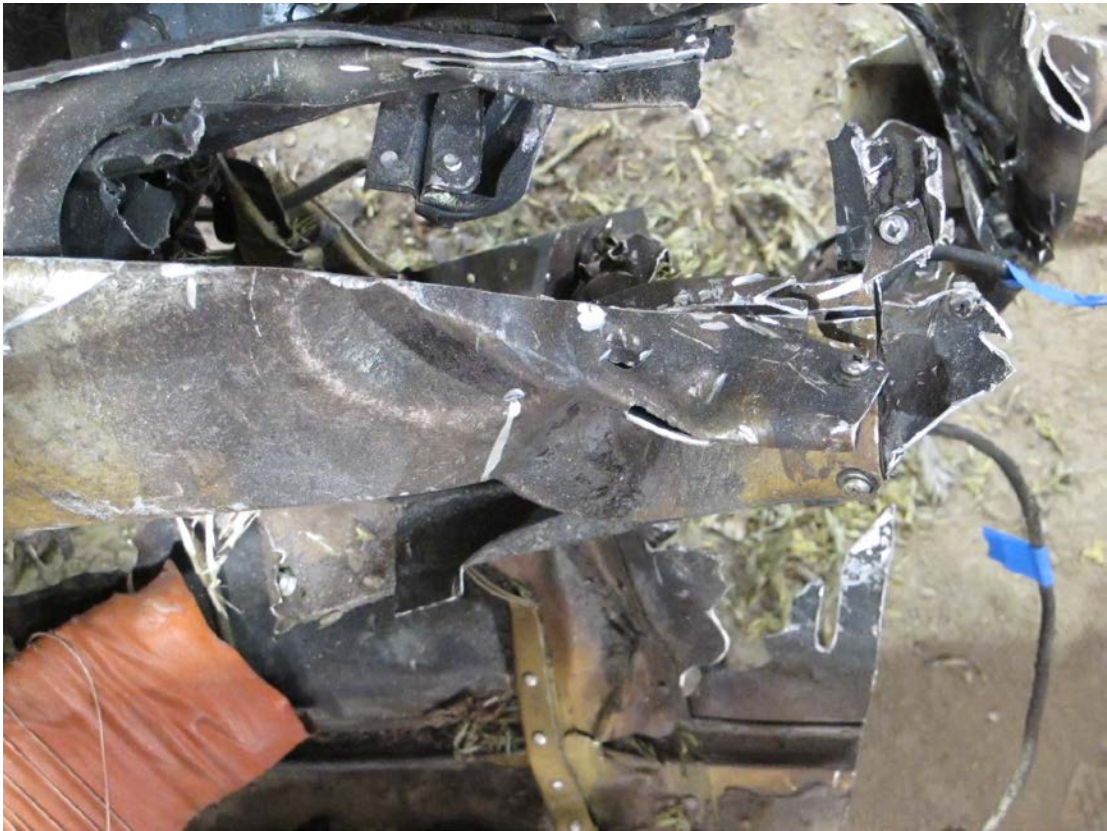
(right) seat was discolored dark brown as shown in Figure 10. A stringer in this location exhibited broomstrawing as shown in Figure 11¹.

Figure 10. Photograph of thermal damage to aircraft structure near main bus tie circuit breaker panel.

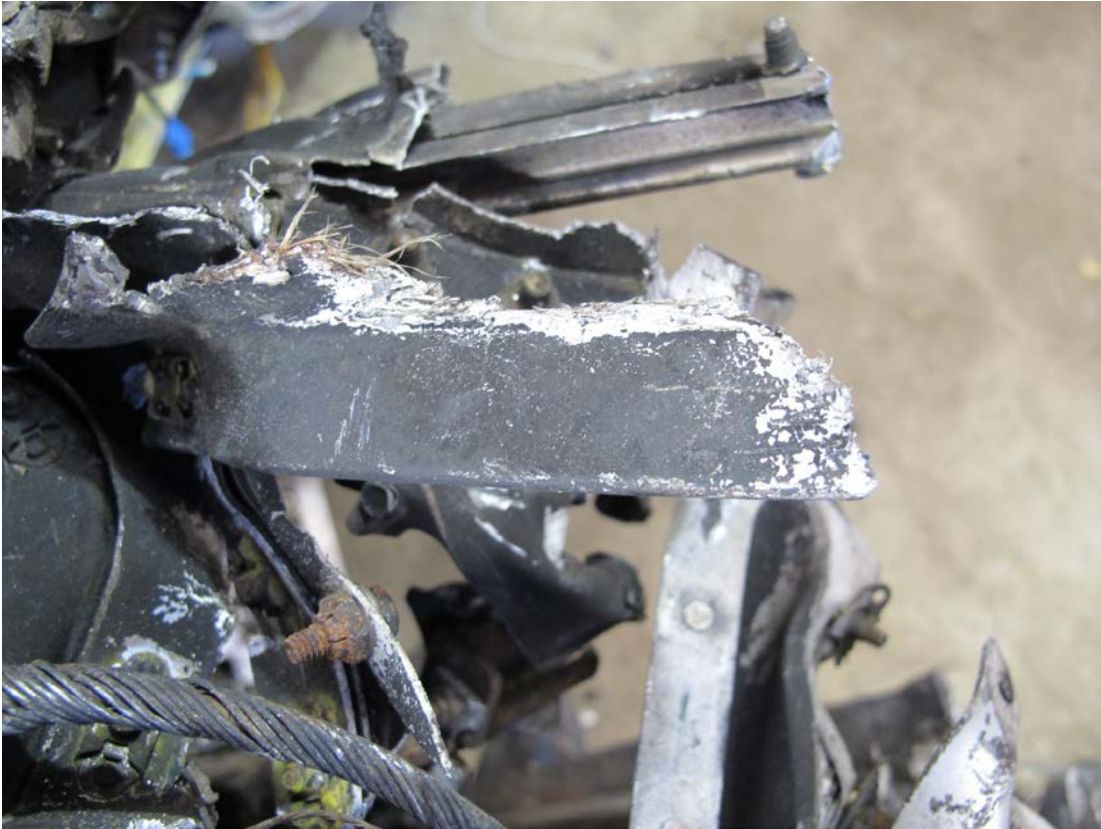
¹ A fire signature where a near-molten aluminum component subjected to a shock loading (e.g., impact) can take on the physical appearance of broomstraw or feather-like appearance.

Figure 11. Closeup of broomstraw on structure near main bus tie circuit breaker panel.

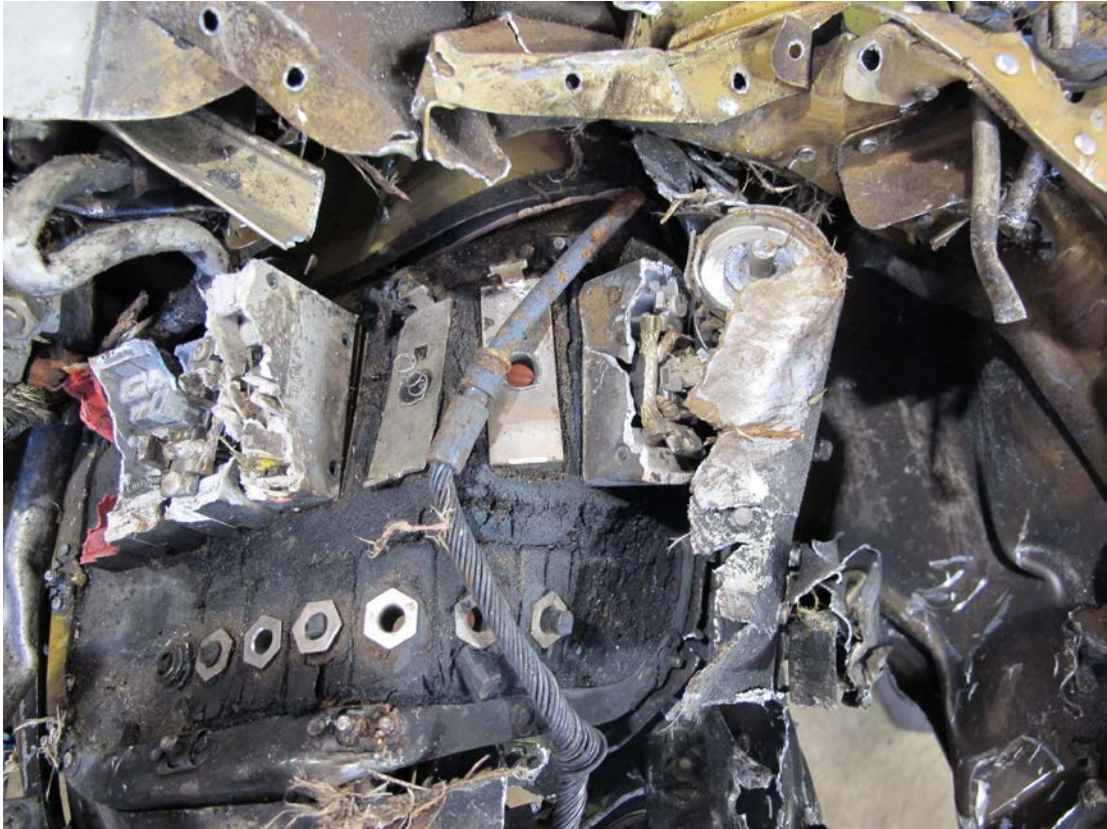
The main bus tie circuit breaker panel (located in the floor in this location) was partially missing as shown in Figure 13. The remaining breakers were heavily sooted on the aft end. One breaker was thermally discolored. There were areas of charring on the backside of the panel. The low voltage circuit breaker panel (located forward of this location in the instrument panel) was present but exhibited no thermal damage.

Figure 13. Photograph of underside of main bus tie circuit breaker panel.

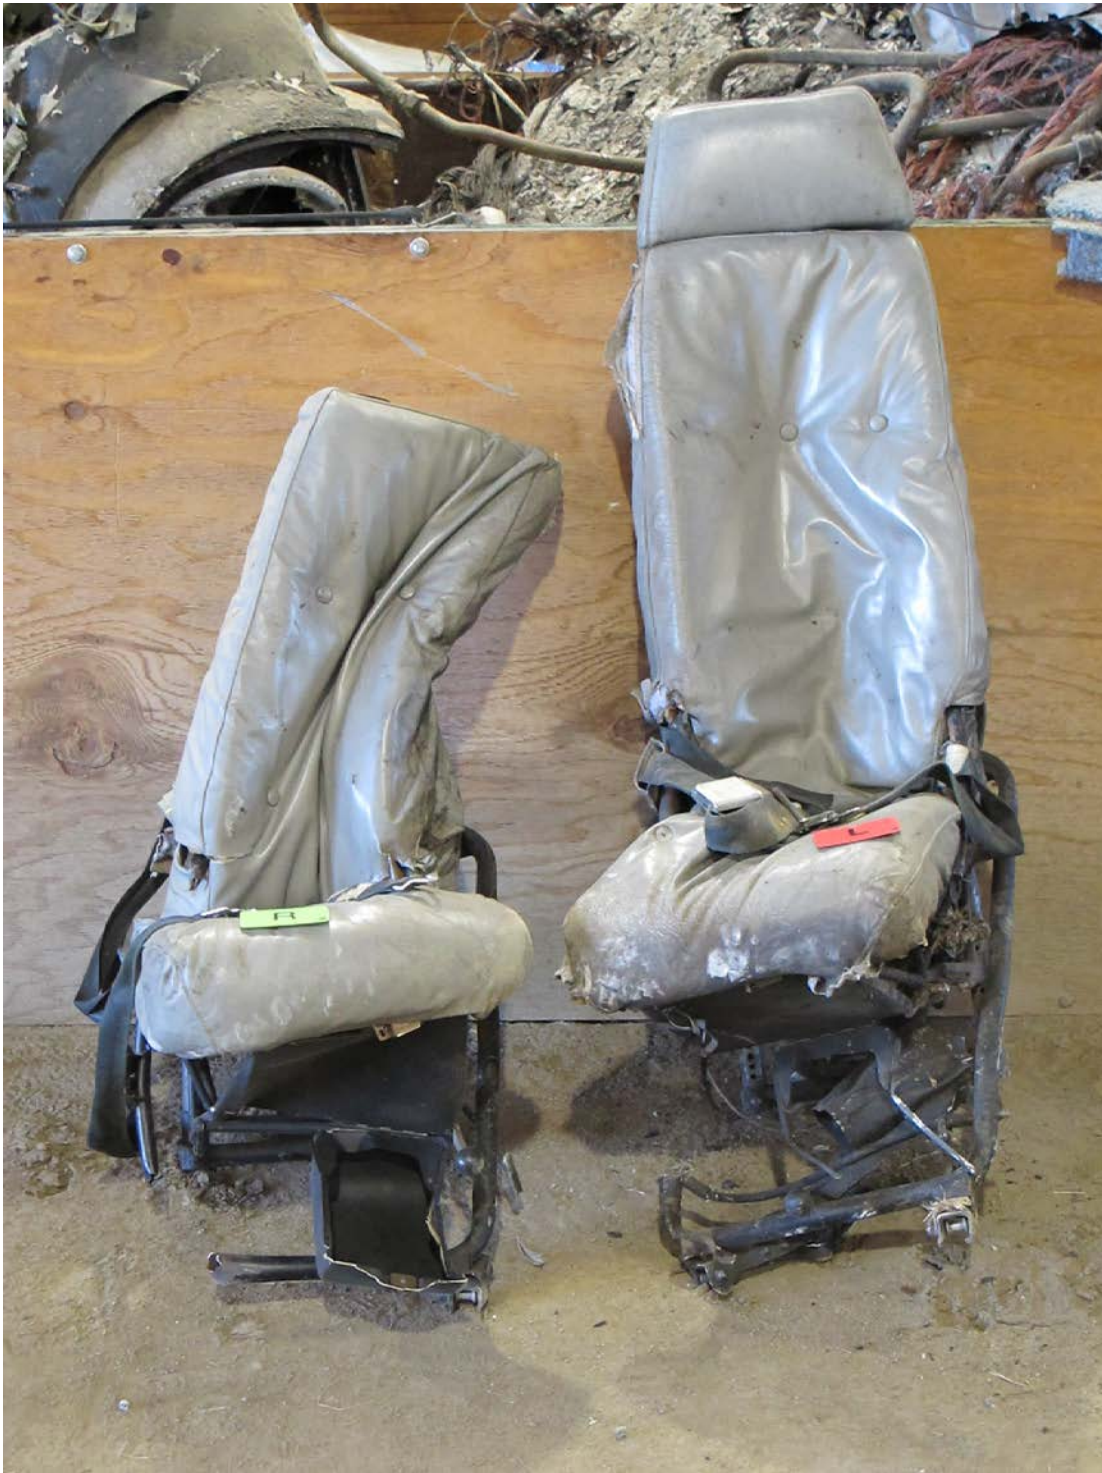
The left and right forward seats exhibited light thermal discoloration and some thermal related shrinking on the inboard edges as shown in Figure 14. The seat frames had some thermal discoloration on the rear inboard legs.

Figure 14. Photograph of cockpit seats.

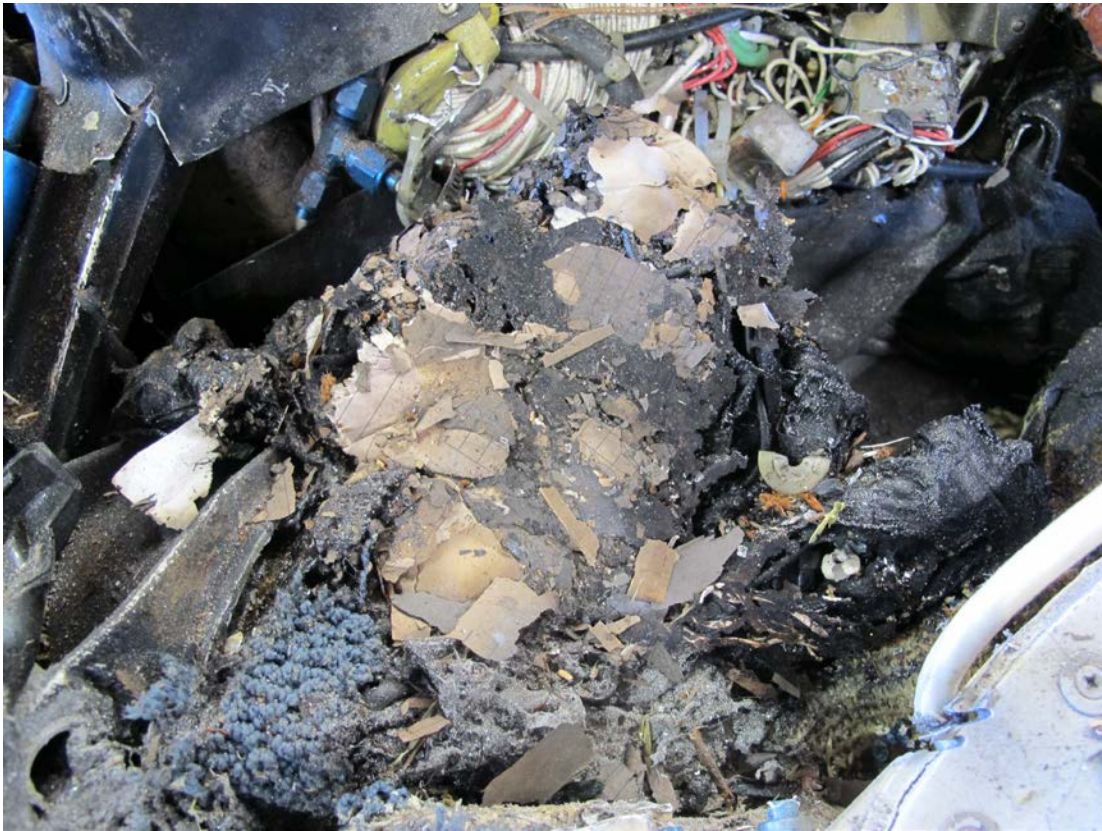
The carpet around the rudder pedal was charred as shown in Figure 15. Personal items and notebooks located in the center area of the floor also were thermally discolored and charred.

Figure 15. Photograph of damaged cockpit carpet and floor mats.

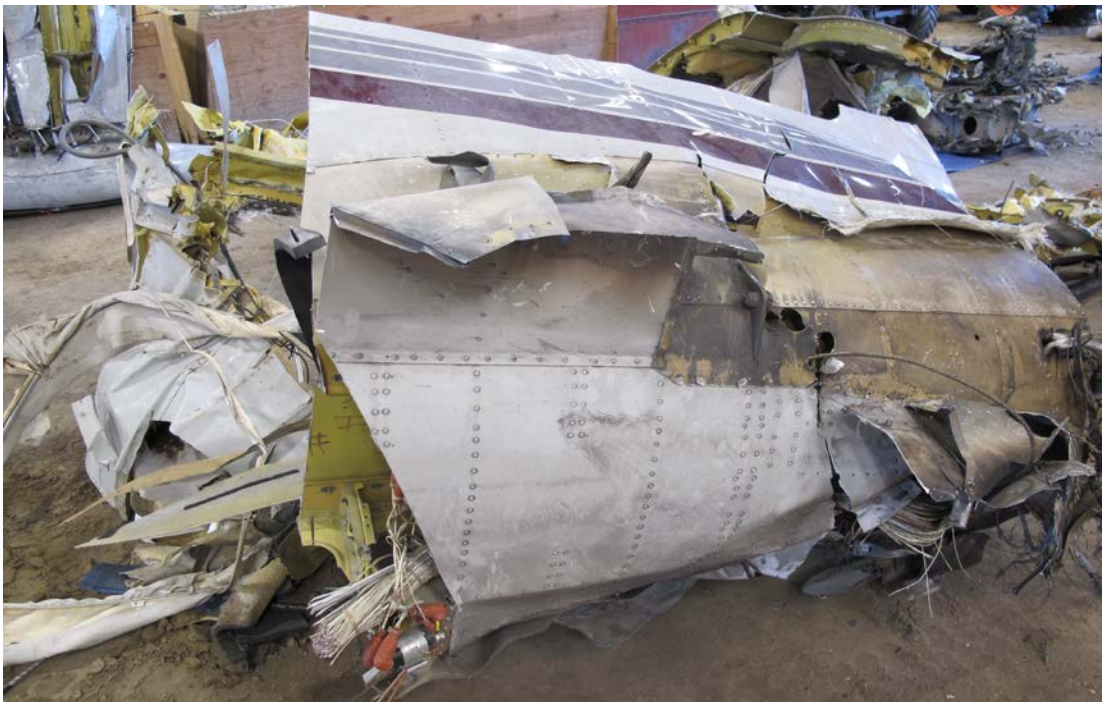
The passenger/EMS section of the cabin exhibited little fire/thermal related damage. There was a light coating of soot on the exterior of the fuselage skin as shown in Figure 16. The cabin interior was undamaged. The wiring bundles located in the floor of this section were intact and most did not exhibit thermal damage. One bundle was damaged by fire. All the insulation was missing from all the wire conductors and the bare wire conductors were discolored and oxidized. The fuel cross-tie lines were located midline under the floor of this

Figure 16. Photograph of right side of passenger/EMS section of aircraft.

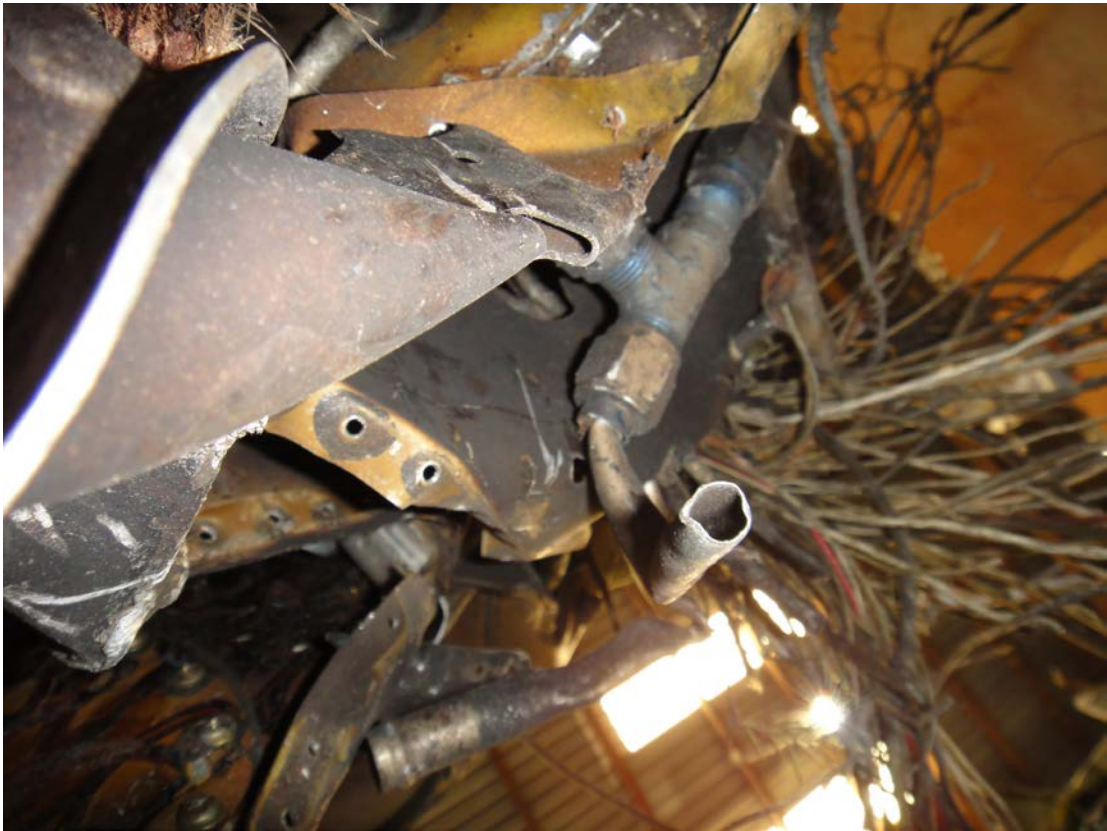
section as shown in Figure 17. As stated above, this fitting was removed from the aircraft for further examination.

Figure 17. Closeup photograph of fuel crosstie lines at wing spar.

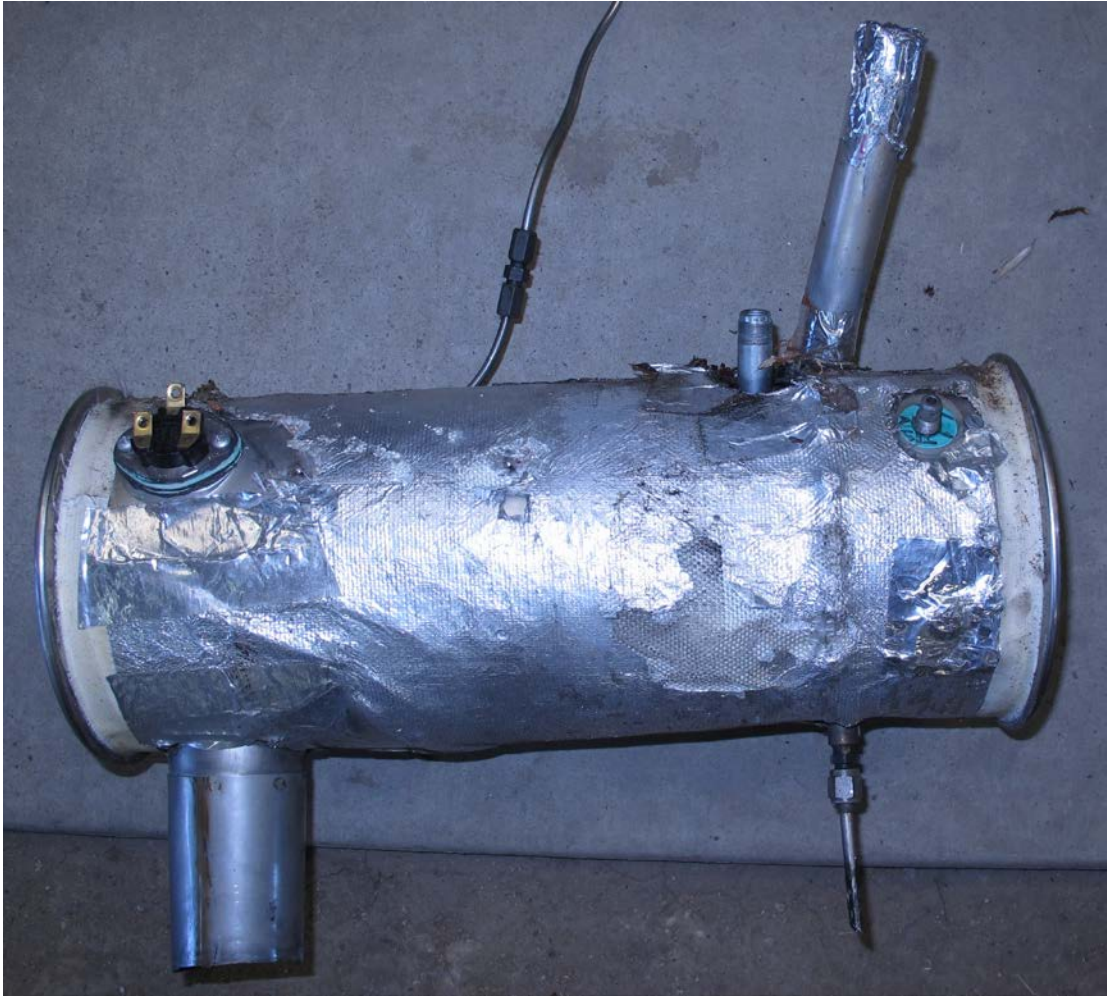
The cabin heater was removed from the nosecone for examination. The heater exhibited no thermal damage and appeared intact as shown in Figure 18. All the ducting for the heater was examined and no sooting was present.

Figure 18. Photograph of cabin heater.

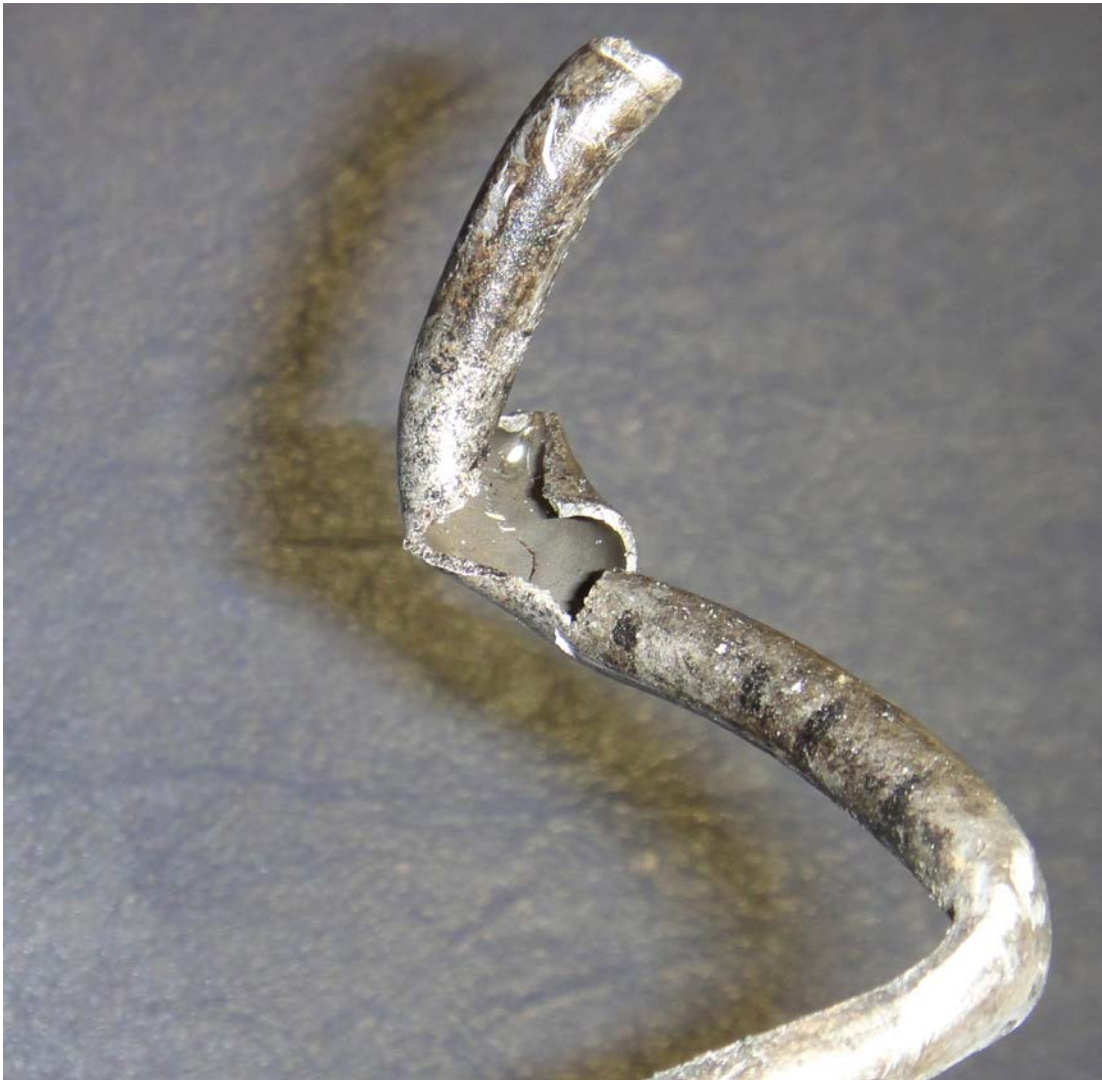
The fuel line for the heater was examined. The line was intact to the forward edge of the wing spar. There was a hole in the line in this location but no visible sign of thermal related damage as shown in Figure 19. The line had a full diameter fracture several inches aft from the hole in the line. Fuel was still present in the line.

Figure 19. Closeup photograph of hole in cabin heater fuel supply line.

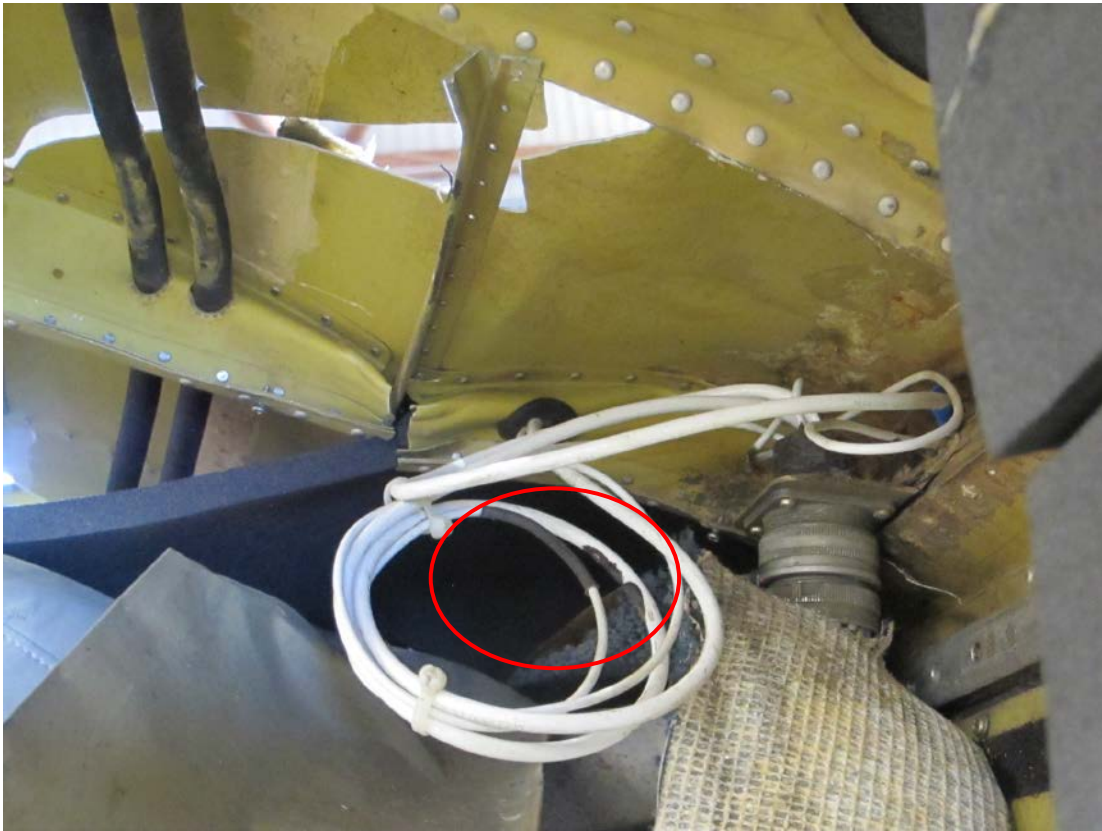
The LifePort system's electrical service wiring located in the passenger section was examined³. Apart from two small, isolated thermal discoloration patterns on the surface of the insulation, shown in Figure 20, there was no thermal related damage to any of the wiring for the system in this area. The system panel, as shown in Figure 21, was also undamaged by fire.

Figure 20. Photograph of thermal damage (circled in red) to LifePort wiring.

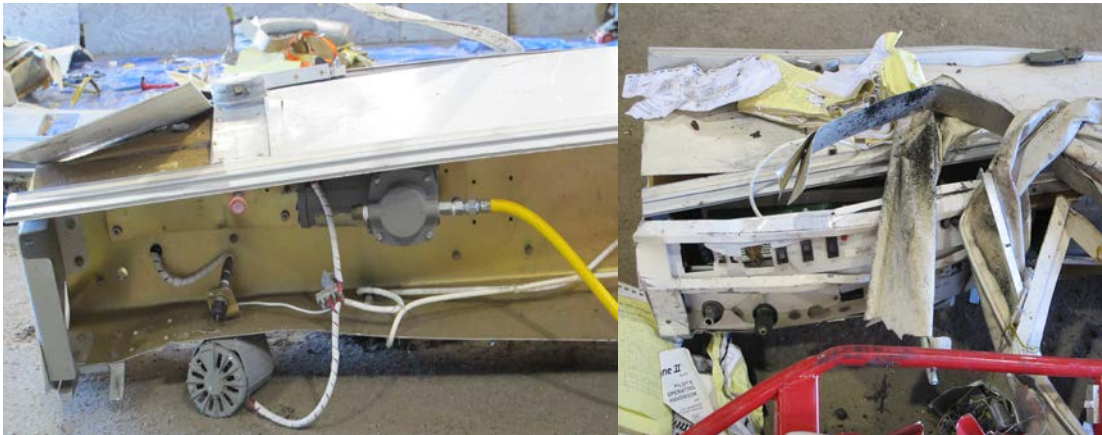
Figure 21. Photograph of LifePort panel (interior on left, exterior on right).

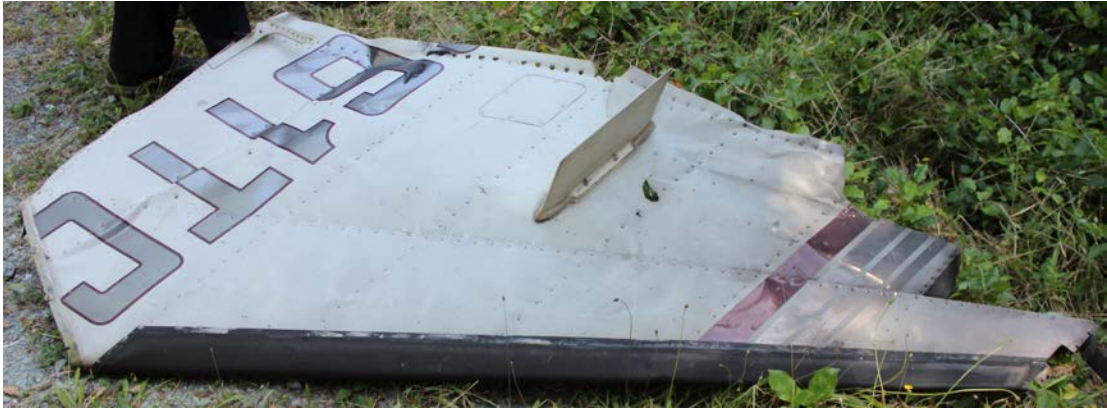
The pieces of recovered empennage including the vertical stabilizer were covered with a light coating of soot but were otherwise undamaged by fire as shown in Figure 22.

Figure 22. On scene photograph of section of vertical stabilizer.

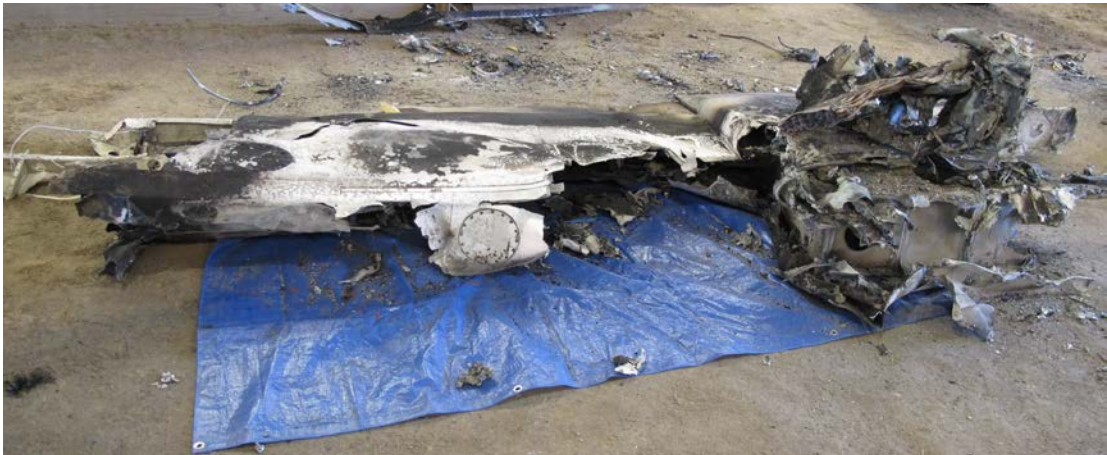
As shown in Figure 23, the section of wing that runs from the wing root to the engine nacelle was heavily damaged in a postcrash fire. The wing tip section including the tip tank was sooted but undamaged by fire as shown in Figure 24.

Figure 23. Photograph of remaining right wing structure.

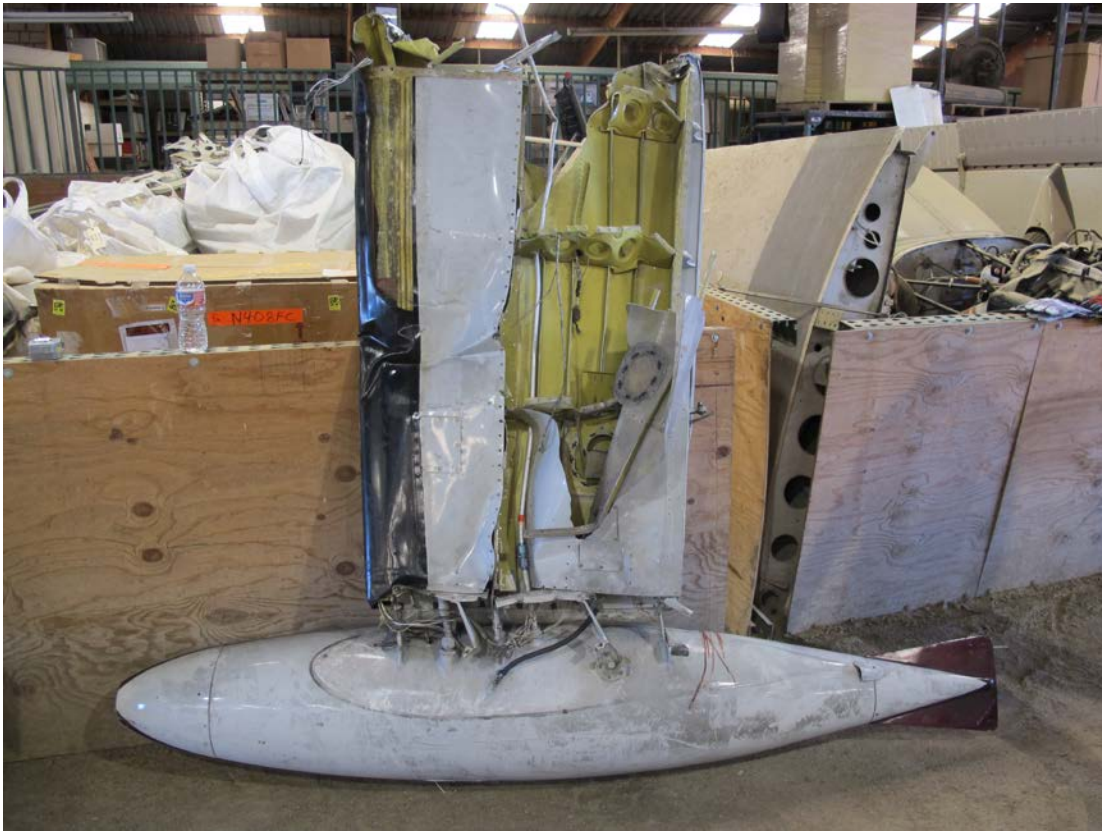
Figure 24. Photograph of right wing tip tank.
