NATIONAL TRANSPORTATION SAFETY BOARD

MATERIALS LABORATORY FIRE FACTUAL REPORT

Report No. 17-066

Place : McKinleyville, California
Date : July 29, 2016
Vehicle : Piper PA-31T
NTSB No. : WPR16FA153
Investigator : Brice Banning
IIC/AS-ANC

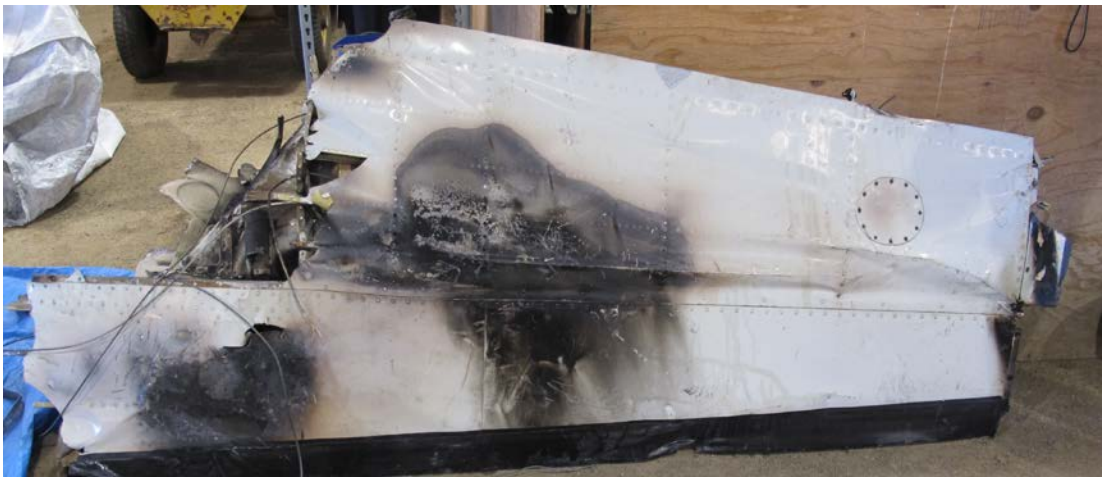
The section of wing that runs from the wing root to the engine nacelle was heavily damaged in a postcrash fire as shown in Figure 25. The wing tip section had two oval-shaped burn patterns on the upper and lower wing skin. The interior compartment exhibited melting at several lightening holes and discolored primer paint as shown in Figure 26. The internal fuel lines and the tip tank were missing.

Figure 25. Photograph of thermal damage to left wing.

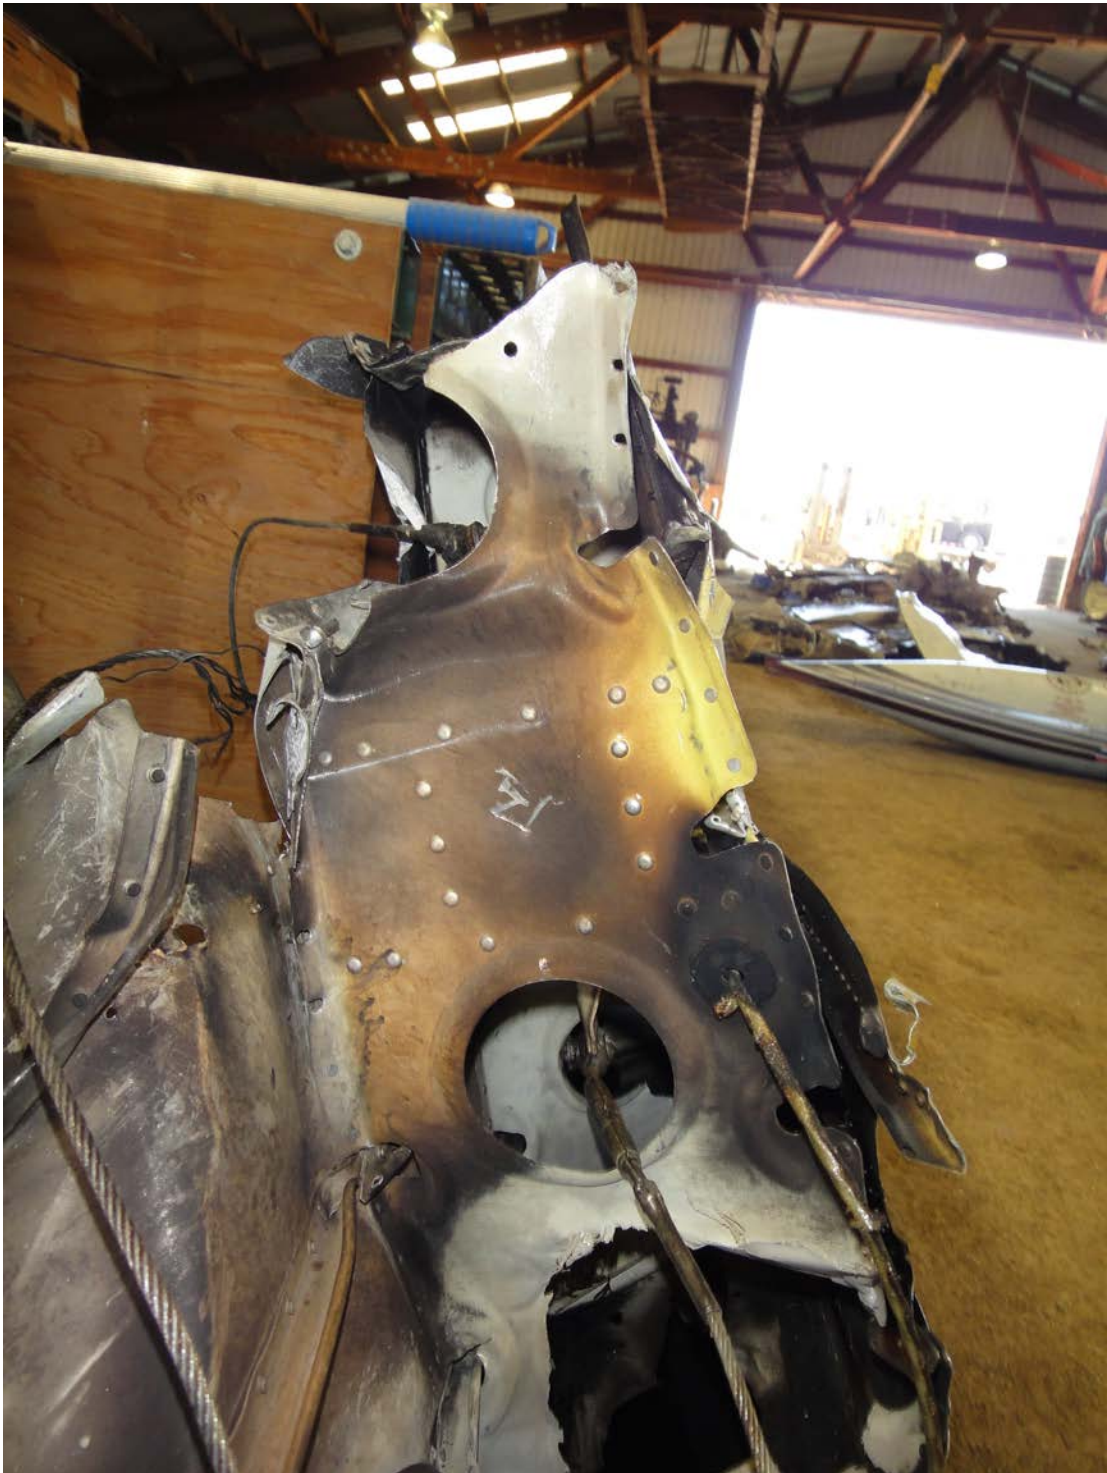
Figure 26. Photograph of thermal damage to interior of left wing fuel bay.

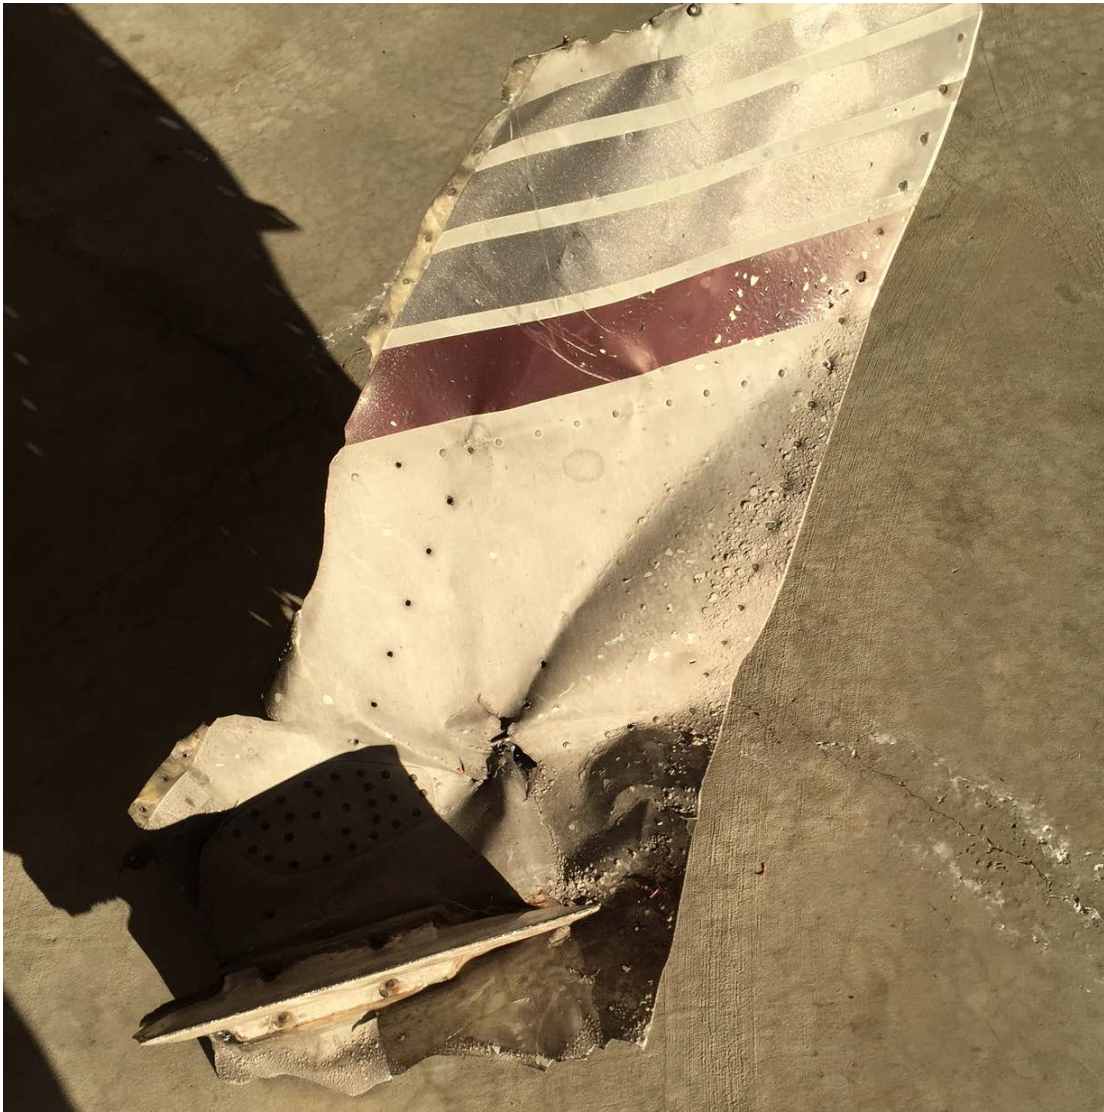
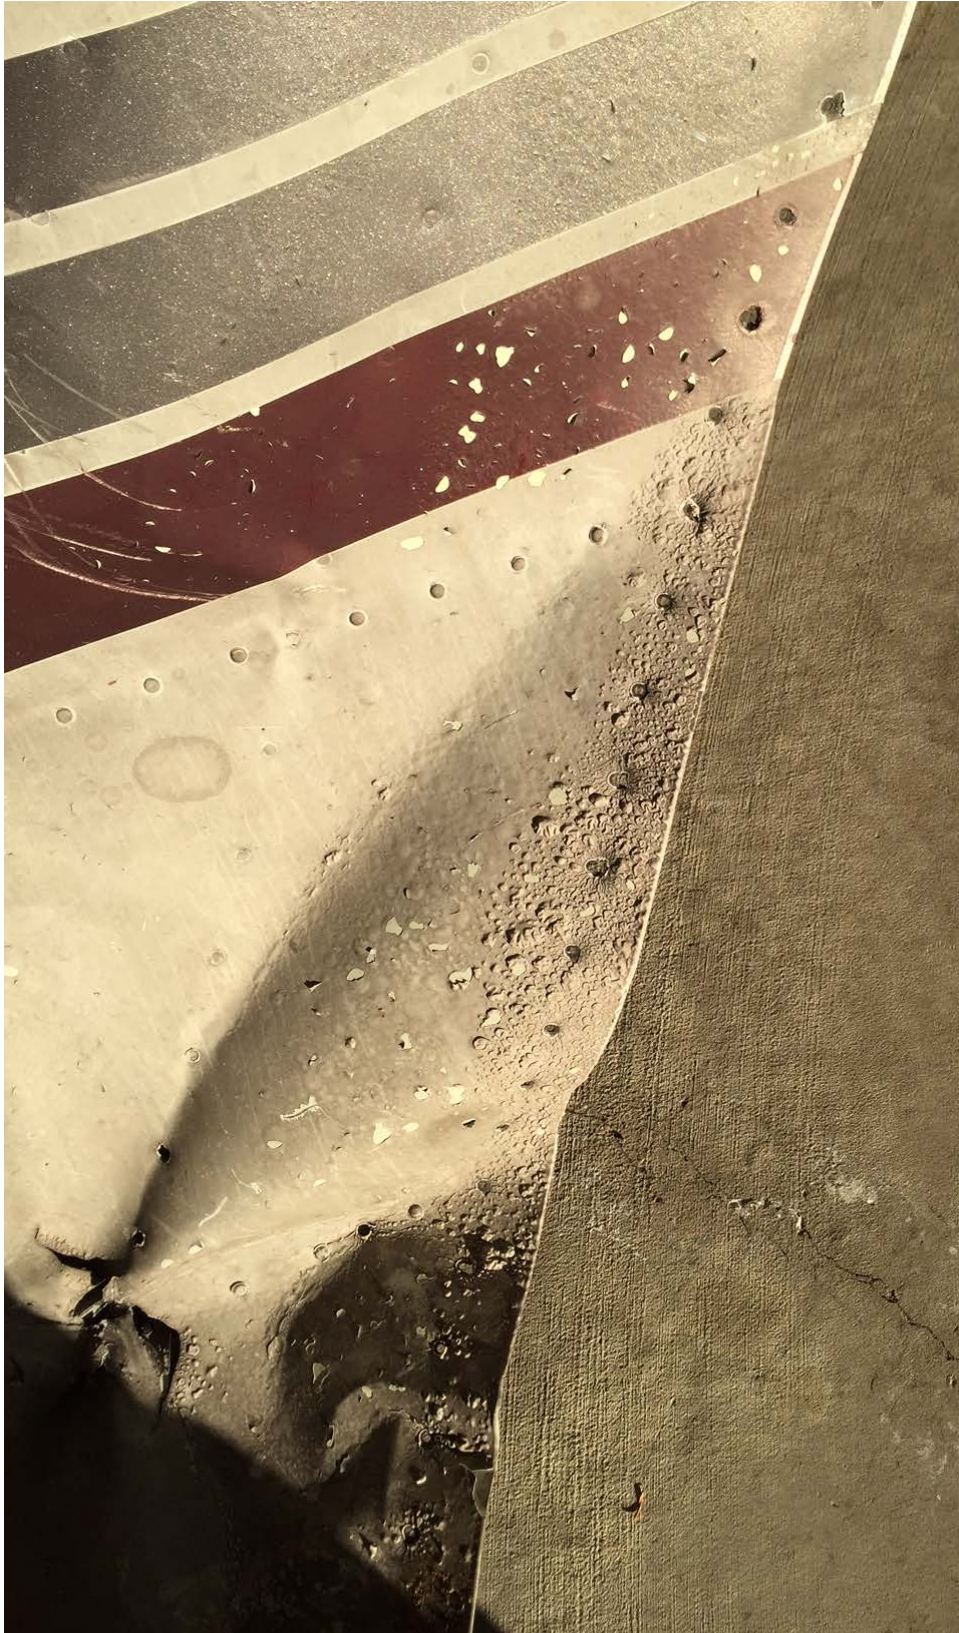
A small section of the left side of the vertical stabilizer was found several months after the original wreckage was recovered, shown in Figures 27 and 28. The section had some localized thermal damage and sooting on the lower edge. Some blistering of the exterior paint was present in the damaged area and along the right edge of the piece directly above the damaged area.

Figure 27. Overall photograph of recovered portion of the vertical stabilizer-left side.

Figure 28. Closeup of thermal damage of left side section of vertical stabilizer.
