# NATIONAL TRANSPORTATION SAFETY BOARD

MATERIALS LABORATORY FACTUAL REPORT

Report No. 15-127

Place : Frisco, Colorado  
Date : July 3, 2015  
Vehicle : Airbus Helicopter AS 350B3e  
NTSB No. : CEN15MA290  
Investigator : Jennifer Rodi

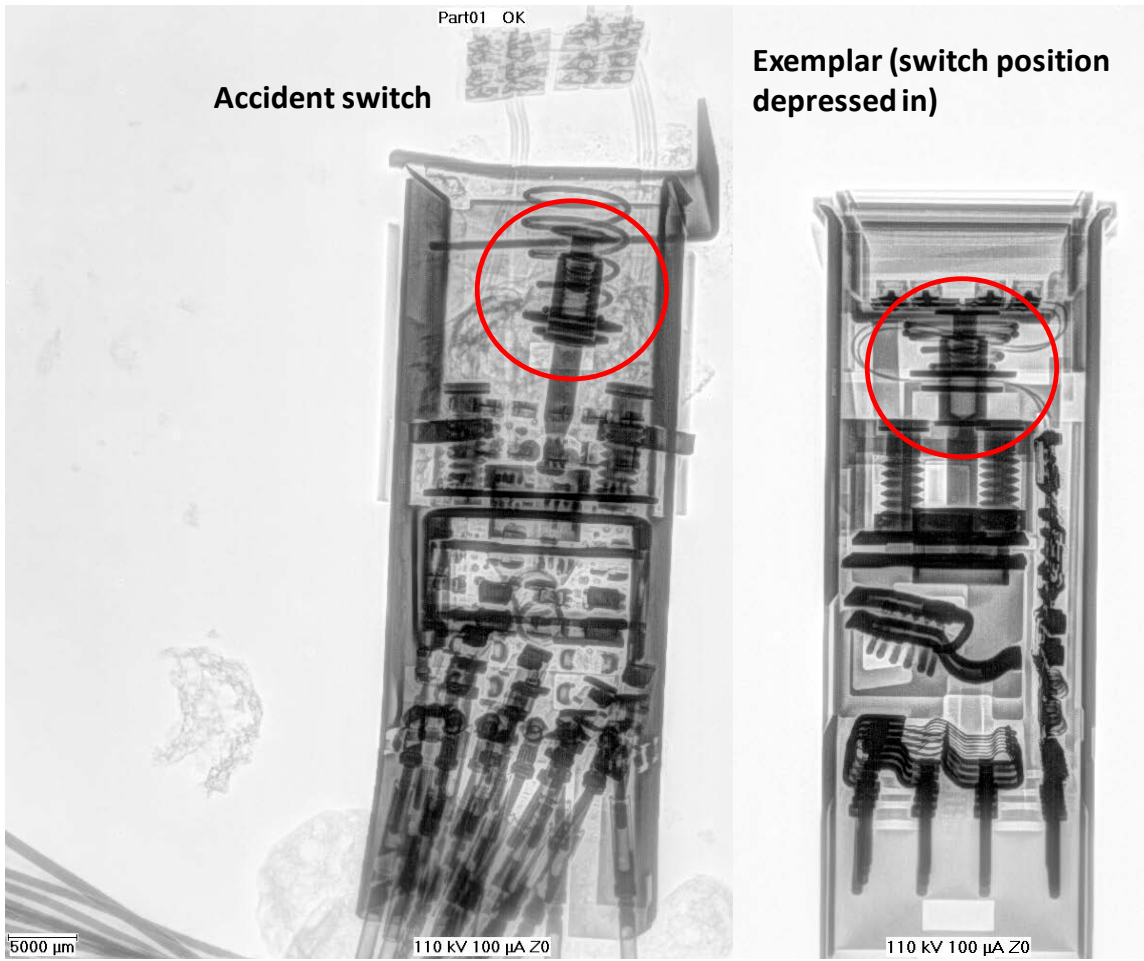
When compared to both switch positions on the known switch radiograph, the accident ACCU TEST switch position did not match either position of the known switch as shown in Figure 1. In addition, the accident switch springs no longer appear to be under compression which is necessary to hold the switch in its selected position. Therefore, the accident switch appears to be too damaged for determination of switch position.

**Figure 1. Radiograph of exemplar and accident ACCU TEST switch.**

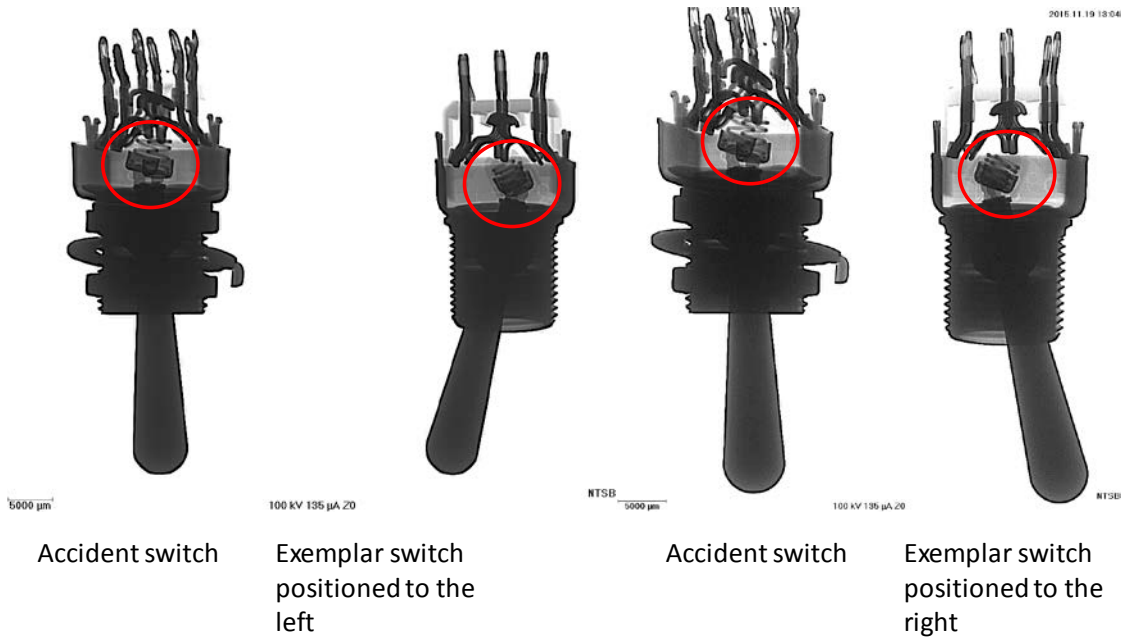
One of the accident toggle switches was identified as the yaw hydraulic isolation switch due to its resemblance to the exemplar switch. The toggle lever on the accident switch had been pushed into the body of the switch. The radiograph shows the spring that holds the toggle lever into place is no longer in place (under compression) as shown in Figure 2. When compared to the radiograph of the exemplar toggle switch, the contact positions for the accident toggle do not match either position on the exemplar. Therefore, the accident yaw hydraulic isolation switch appears to be too damaged for determination of switch position.

**Figure 2. Radiograph of exemplar and accident yaw hydraulic isolation switch.**

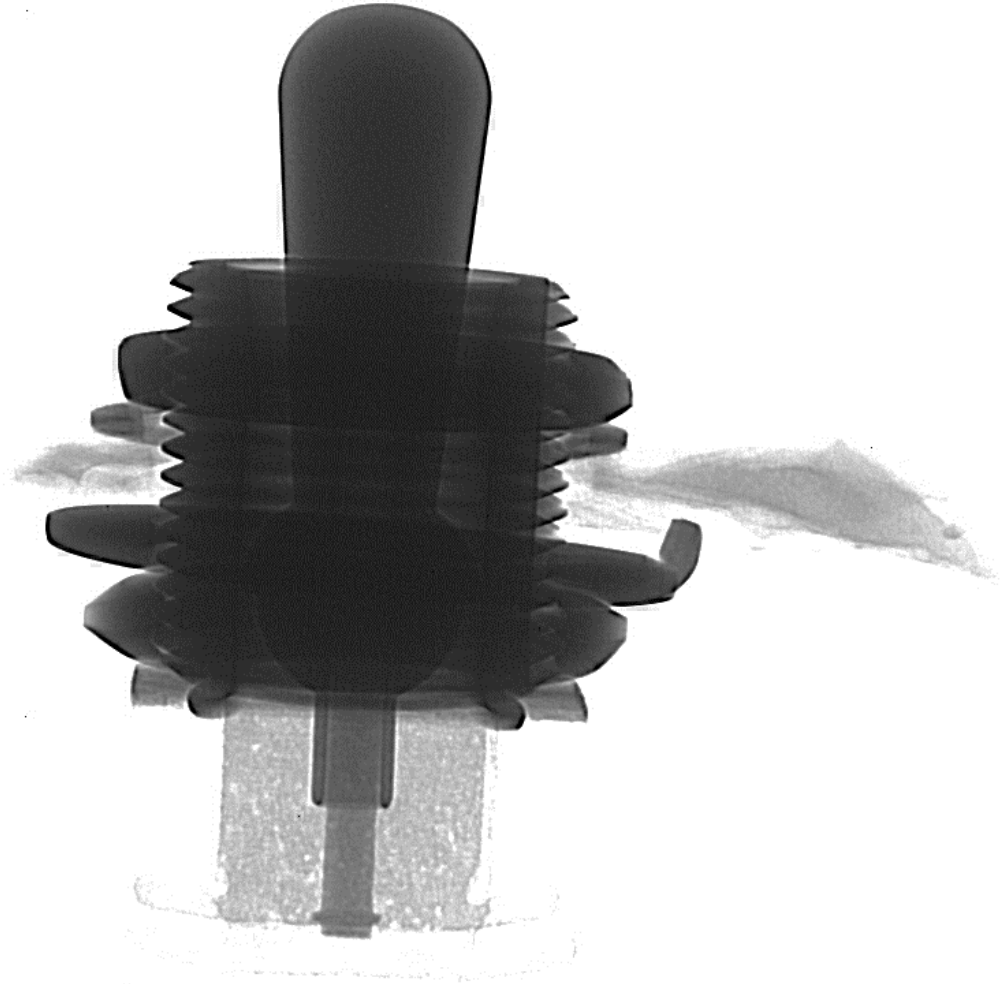
A single toggle switch unidentified switch that had separated from the rest of the damaged collective was examined by x-ray. The radiograph is shown in Figure 3. The switch is missing most of the internal toggle mechanism with only the switch body and toggle lever present. Due to the amount of damage, the position of the switch could not be determined.

**Figure 3. Radiograph of single unidentified collective switch.**

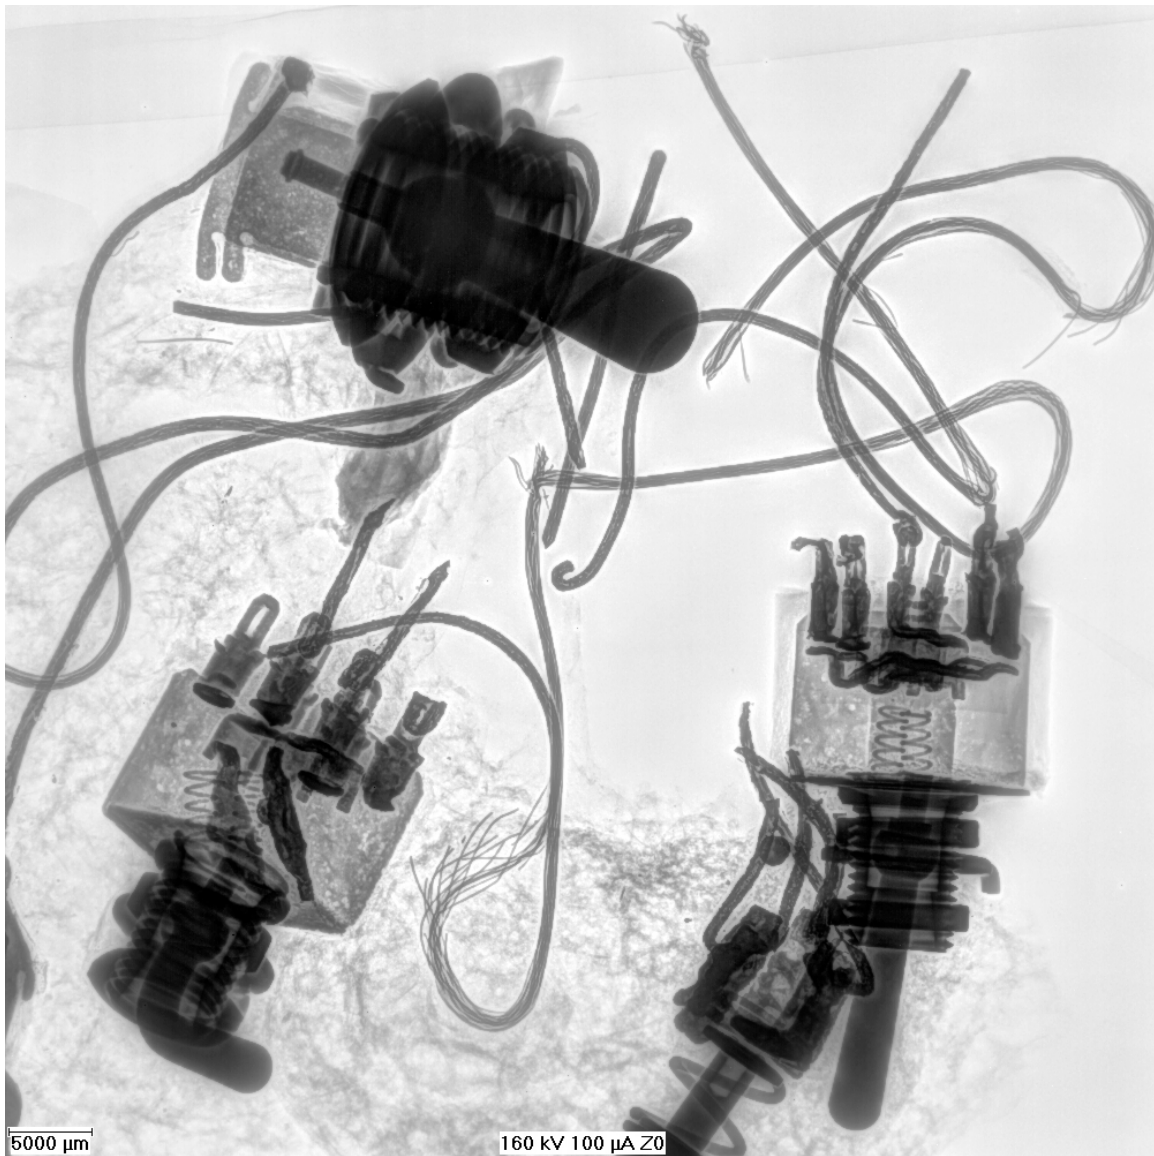
The remaining four collective switches (toggle switches) were found encapsulated within melted plastic of the damaged collective. The remains of the damaged collective were examined by x-ray to visualize the contacts on the switches inside. The radiograph is shown in Figure 4. It was not possible to determine the original switch position on the collective and orientation of these switches due to movement that occurred during the melting of the collective. In addition, the switches are heavily damaged by impact and fire. Therefore, switch position for these switches could not be determined.

**Figure 4. Radiograph of switches within damaged remnants of the collective.**
