NATIONAL TRANSPORTATION SAFETY BOARD

MATERIALS LABORATORY FACTUAL REPORT

Report No. 12-125

Place : Nashua, NH
Date : 11/9/2011
Vehicle : Vans RV-8
NTSB No. : ERA12LA069
Investigator : Jose Obregon

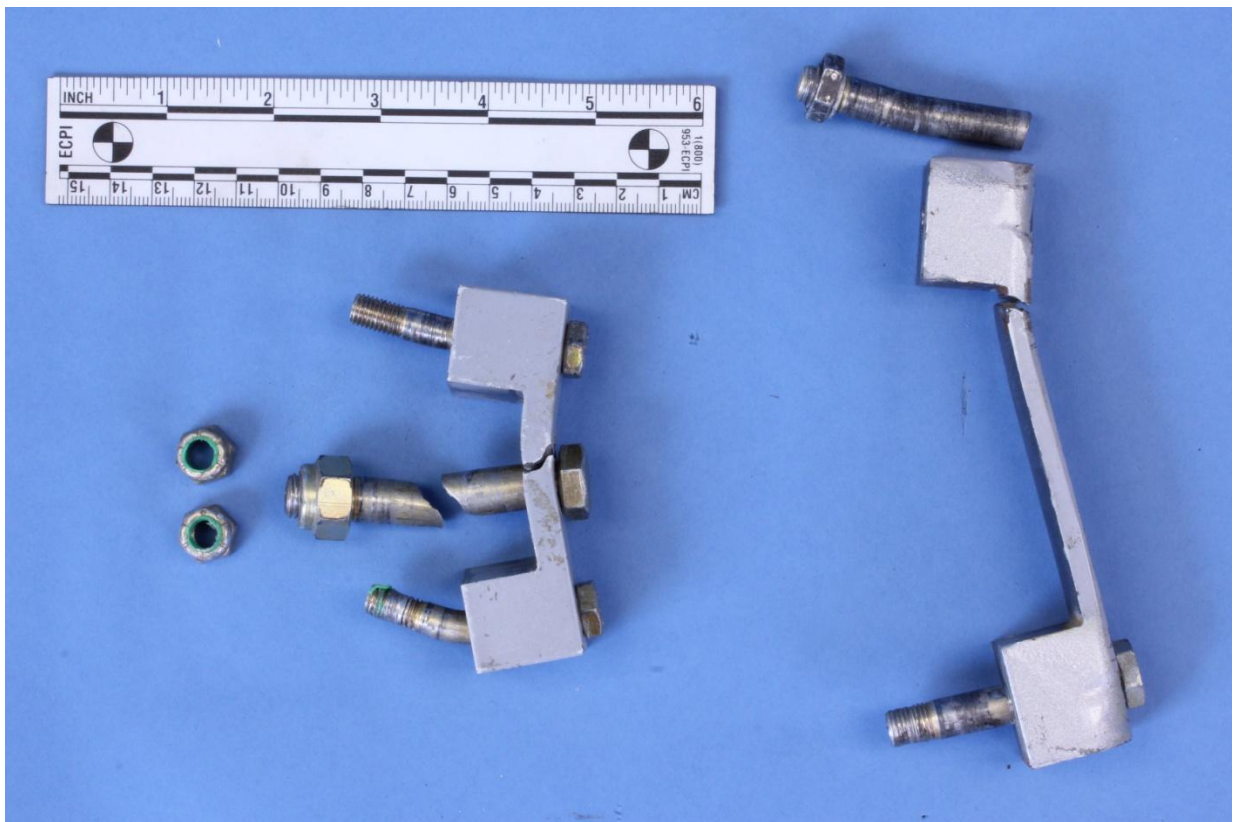
The parts submitted for examination were portions of the outboard and inboard landing gear spring brackets and portions of their fasteners (figure 1)

Figure 1: Landing gear spring brackets and hardware as received.

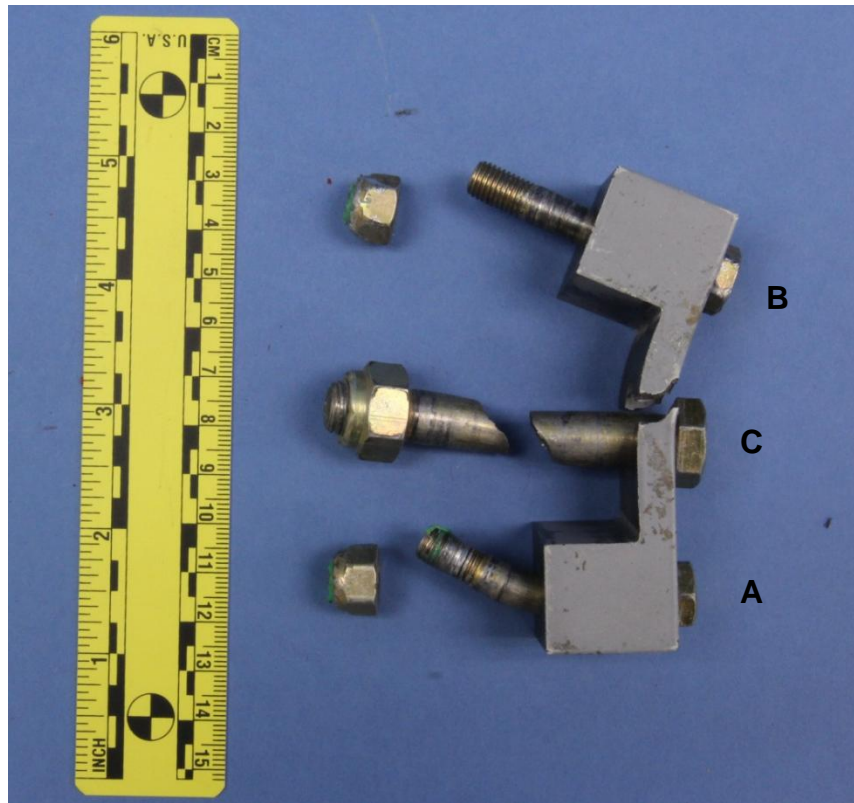
The inboard landing gear spring bracket was designed with three through holes for its fasteners. The bracket was fractured and plastically deformed in the area of the bolt hole for the middle fastener labeled "C" in figure 2. The fracture surfaces of the bracket exhibited shear lips throughout consistent with an overstress failure. No evidence of preexisting corrosion was observed on the fracture surfaces. The two fasteners at the opposing ends of the bracket (labeled A and B in figure 2) had sustained plastic deformation consistent with cantilever bending. The bolt at position "A" had substantially more plastic deformation than the bolt at position "B". Additionally, the bolt at position "A" had striped threads consistent with an overload failure. The threads on the bolt at position "B" remained intact. The bolt labeled "C" in figure 2, going through the midsection of the inboard landing gear bracket, did not exhibit as much plastic deformation as the bolts at positions "A" and "B". Bolt "C" fractured through the middle of the shank portion of the bolt leaving shear lips on the fracture surfaces with respect its axis. The fracture surfaces of bolt "C" are consistent with an overload fracture. The plastic deformation and fracture surfaces associated with the inboard bracket and hardware are consistent with a failure due to overload.

Figure 2: Inboard landing gear spring bracket and hardware.

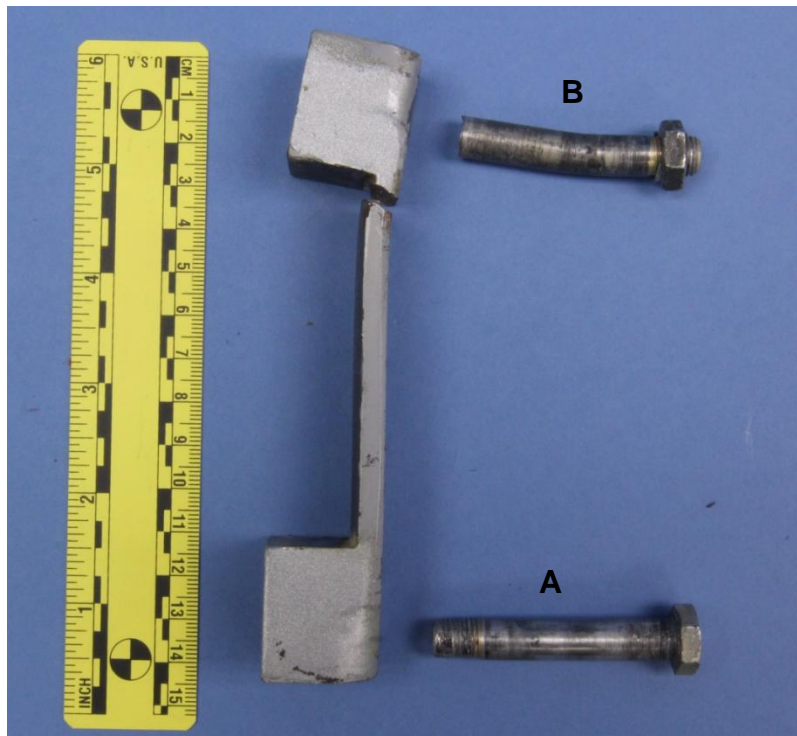
The outboard landing gear spring bracket had two holes at opposing ends for its fasteners (figure 3). The bracket had fractured near the end about $\frac{3}{4}$ inch inboard of the bolt hole for the bolt labeled "B" in figure 3. The bracket exhibited plastic deformation and shear lips on the fracture surfaces consistent with an overload failure. No evidence

of preexisting corrosion was observed on the bracket's fracture surfaces. The bolt at position labeled "A" in figure 3 had stripped threads consistent with an overload failure. The bolt at position "B" (this bolt is oriented backwards in the photo from how it was installed) had to have its head cut off with an abrasive cutting wheel during recovery. This bolt exhibited substantial plastic deformation but the threads remained intact. The plastic deformation and fracture surfaces of the outboard landing gear spring bracket and hardware are consistent with an overload failure.

Figure 3: Outboard landing gear spring bracket and hardware.
