NATIONAL TRANSPORTATION SAFETY BOARD

MATERIALS LABORATORY FACTUAL REPORT

Report No. 16-100

Place : Silver Spring, Maryland
Date : August 10, 2016
Vehicle : Washington Gas service pipe and gas regulators
NTSB No. : DCA16FP003
Investigator : Ravindra Chhatre O-RPH

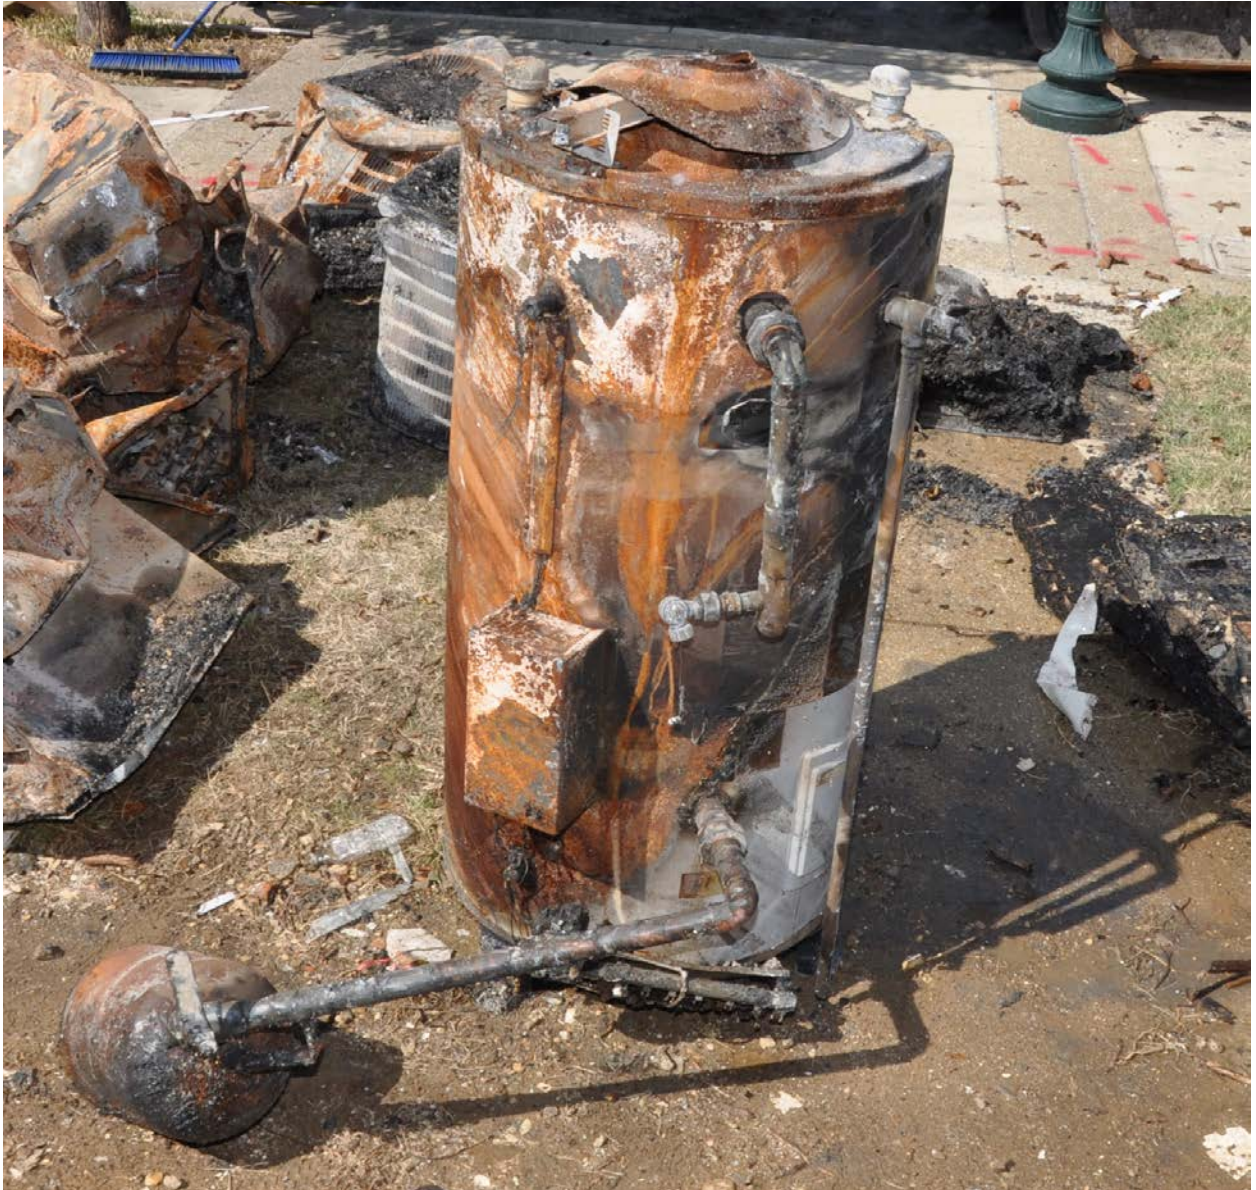
The hot water heater from the accident location was retained by on-scene investigators. It was examined by a fire investigator from the NTSB Materials Laboratory to assess the condition of the heater. The hot water heater was examined after it was removed from the accident scene. The heater is shown in Figure 1.

Figure 1. Overall photograph of hot water heater on-scene.

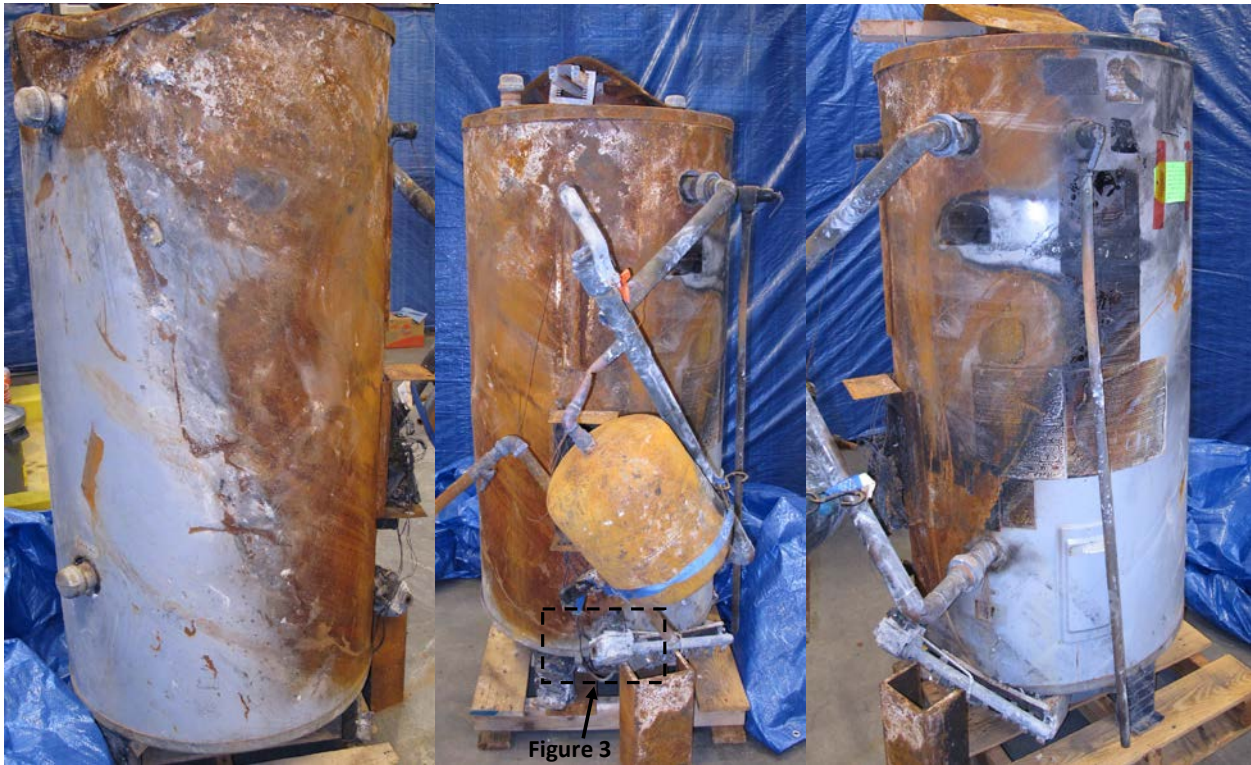
The unit was found intact in the building debris. There is a U-shaped pattern of thermal damage covering nearly half of the outer surface of the heater. The thermal damage was located above the thermostat/controller unit of the heater unit as shown in Figure 2. The data and installation/operation instruction labels on the outside of the unit were illegible due to thermal damage. Some gouges and scuff marks were present in various locations on the exterior surface. The side of the unit opposite the location of the thermostat/controller had a large area that appeared undamaged by heat. There is no evidence of bulging or significant deformation on the outer cylinder of the heater unit. The gas controller located at the bottom of the heater unit was thermally damaged as shown in Figure 3. Due to the amount of damage, the position of the selector knob could not be determined.

Figure 2. Overall view of thermal damage to exterior of water heater.

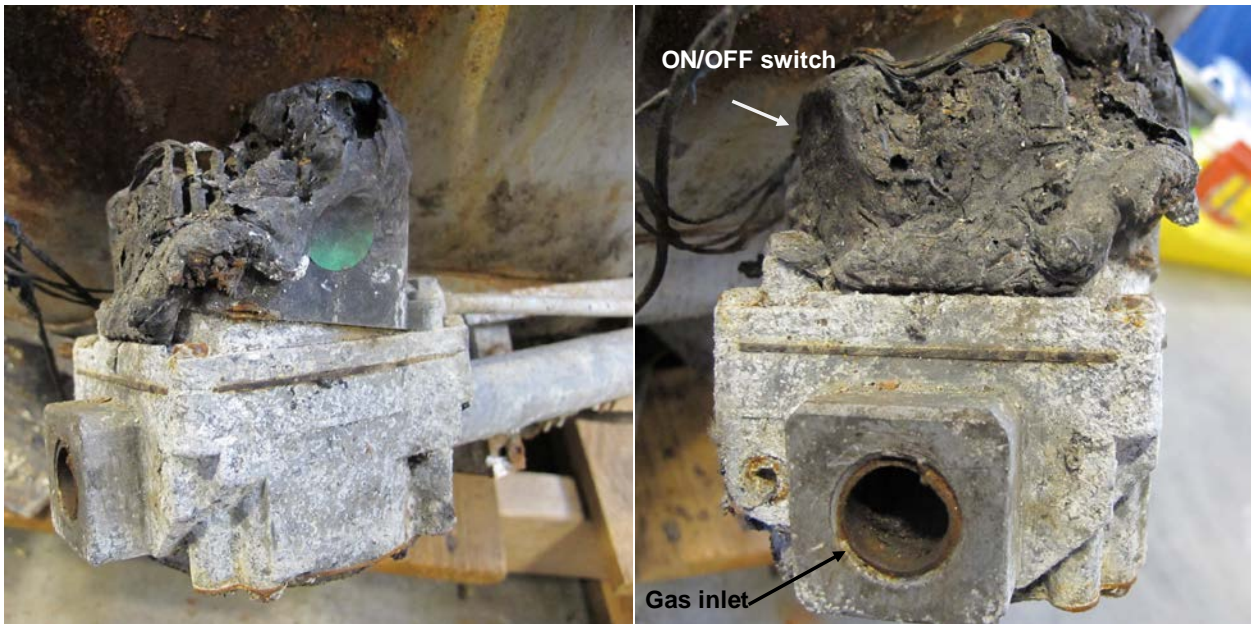
Figure 3. Gas controller for water heater.

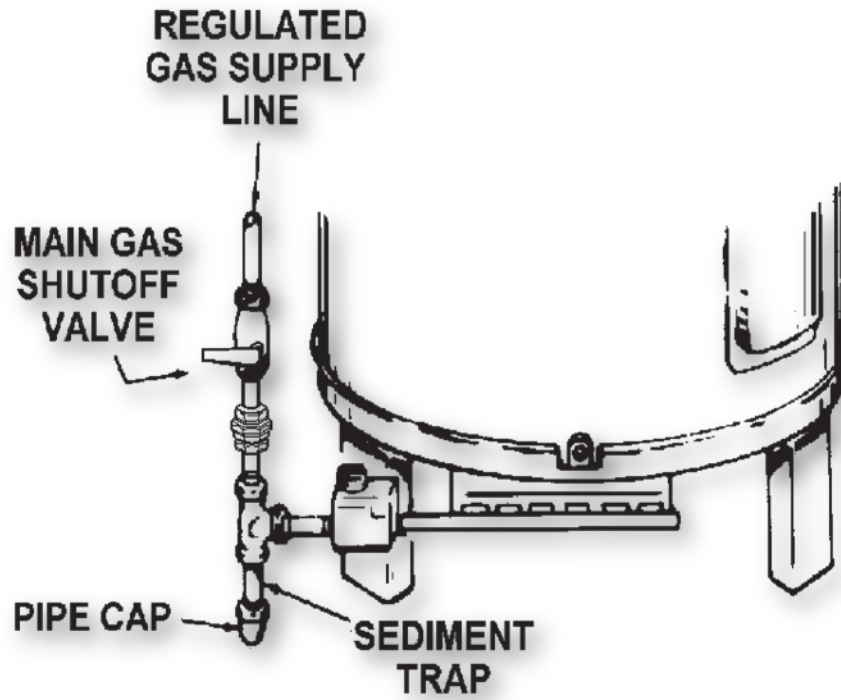
The gas supply inlet for the hot water heater is provided by sections of 1/2 inch pipe. A manual shut-off valve was installed as shown in Figure 4. A pressure regulator is recommended by the water heater manufacturer and should be installed 3-8 feet from the heater unit. The maximum natural gas pressure allowed for operation of the heater unit is 14 inches water column (W.C).

Figure 4. Gas piping diagram for water heater.

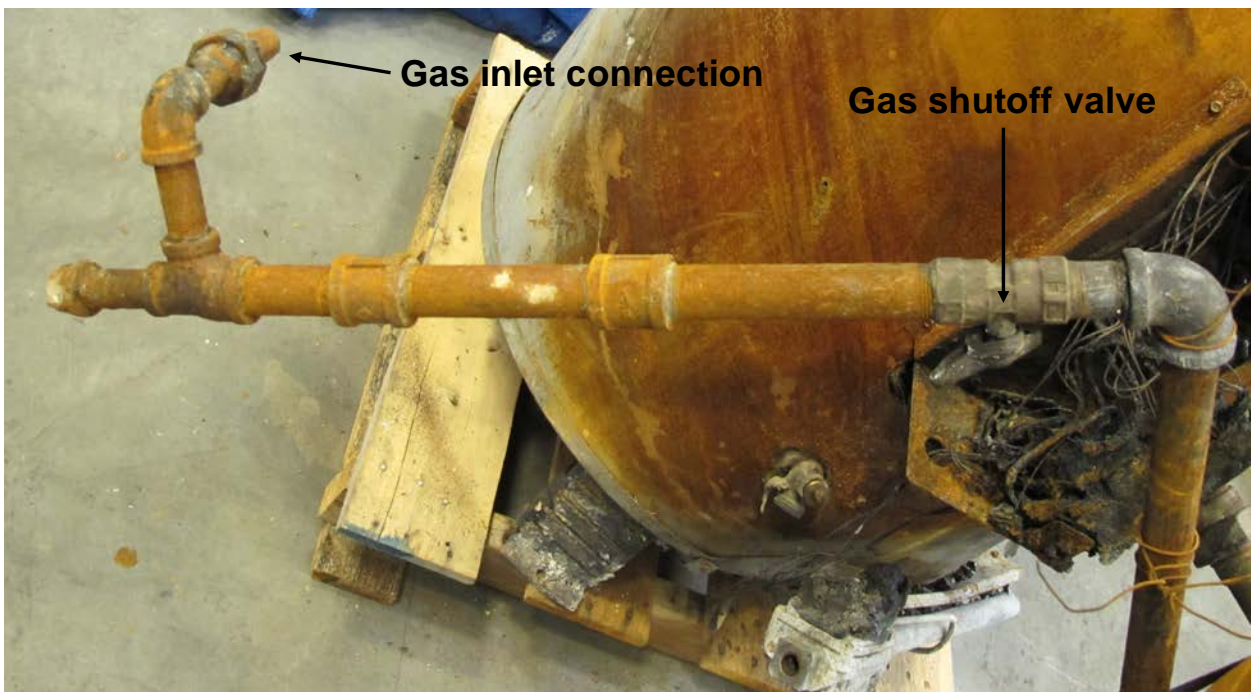
A length of gas piping, shown in Figure 5, was still attached to the heater unit. The piping included the gas shut off valve. The valve handle was thermally damaged as shown in Figure 6. The valve position internal to the handle was not examined. All of the recovered piping was heavily oxidized. The oxidation is consistent with exposure to heat. All of piping connections were examined and found to be attached and threaded completely. The piping was undamaged with the exception of a full diameter, complete thickness fracture at the end of the attached section where the piping connects to the inlet on the thermostat controller of the heater unit. If a natural gas pressure regulator was used in the installation of the hot water heater, it was not recovered after the accident.

Figure 5. Overall photograph of recovered gas piping for water heater.

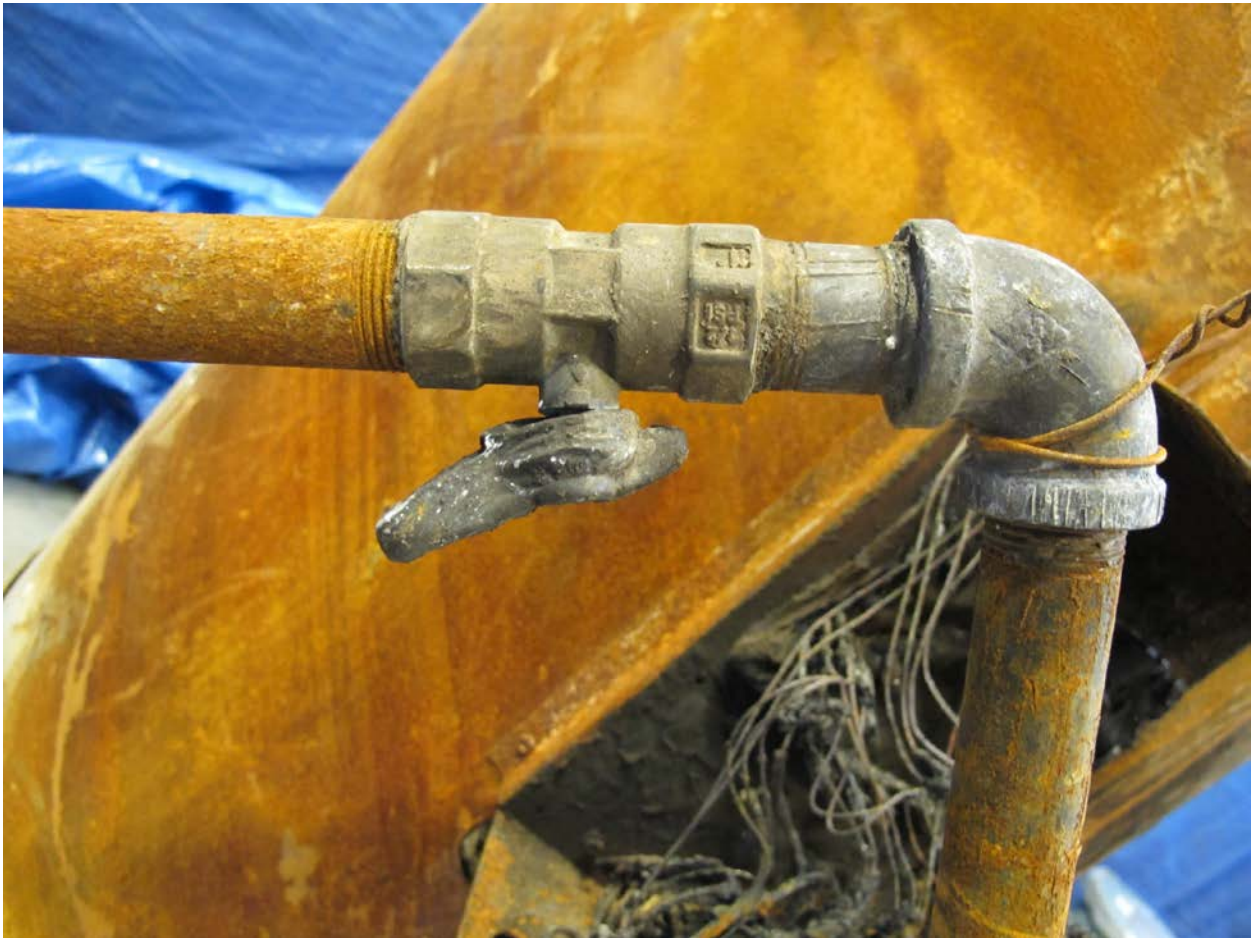
Figure 6. Close-up photograph of manual gas shutoff valve.
