# NATIONAL TRANSPORTATION SAFETY BOARD

MATERIALS LABORATORY FIRE FACTUAL REPORT

Report No. 18-094

Place : West Milford, New Jersey  
Date : May 2, 2018  
Vehicle : Piper PA-32  
NTSB No. : ERA18FA138  
Investigator : Daniel Boggs AS-ERA

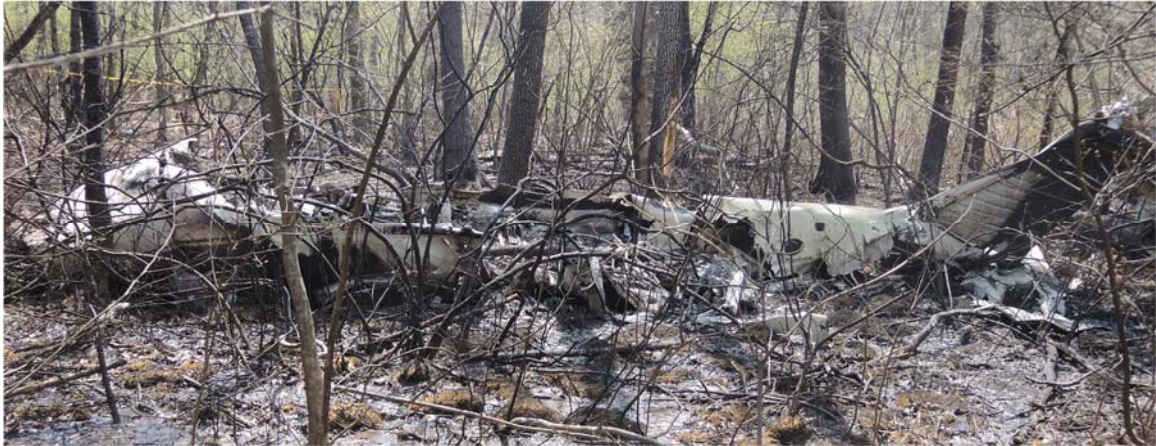
Figure 1. On-scene photograph of fuselage and empennage.

The aircraft fuselage was completely destroyed as shown in Figure 1. The main body, particularly the right side, of the fuselage was melted down to the floor level of the cabin in several spots as shown in Figure 2. The left side of the fuselage near the engine compartment was partially intact as shown in Figure 3. The wings and empennage were relatively intact. There were some areas of localized fire damage consistent with a ground fire as shown in Figures 4-8.

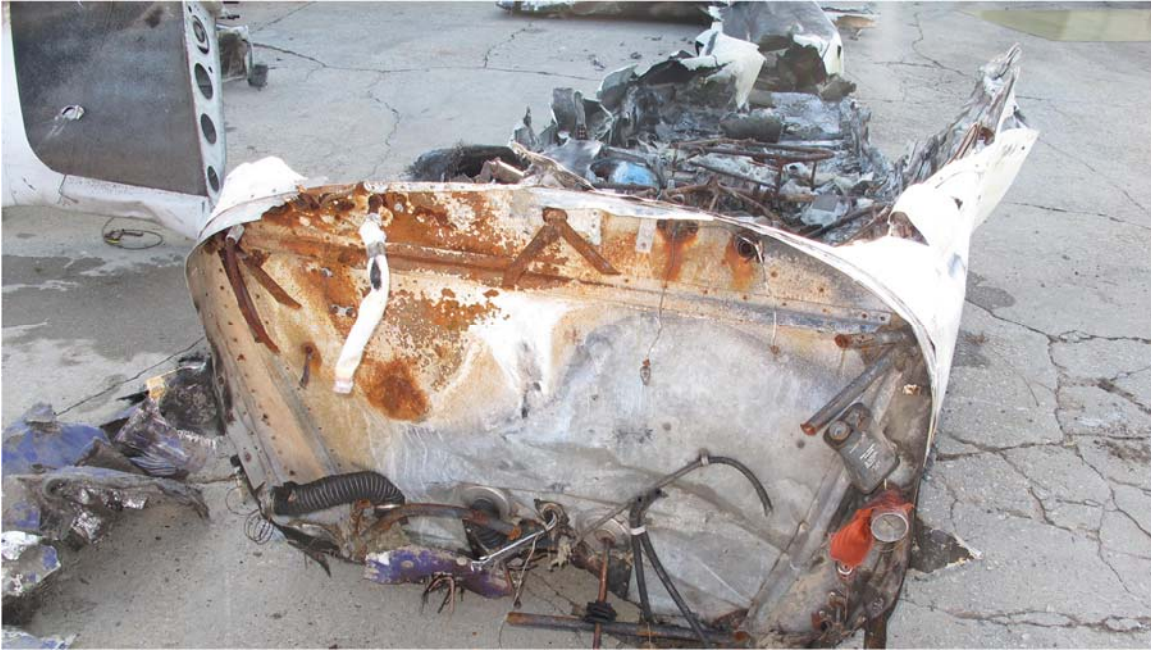
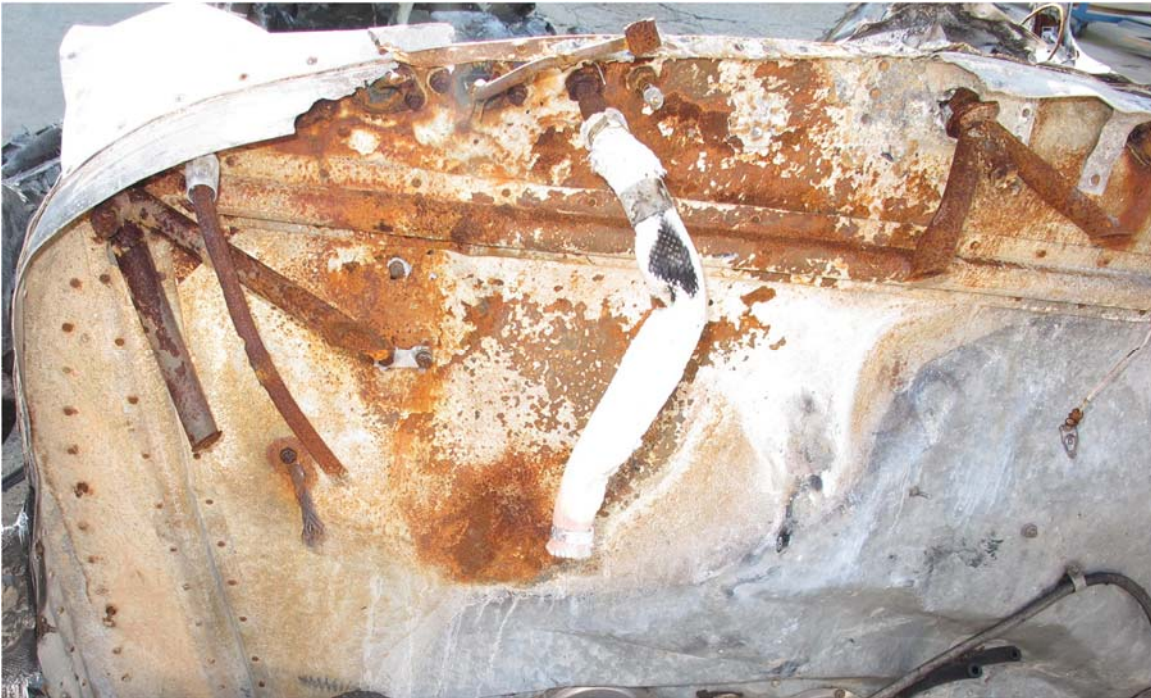
The firewall exhibited buckling consistent with impact. The thermal damage was limited to upper right corner of the firewall where a clean burn area (free of soot) was located as shown in Figures 9 and 10. The area oxidized due to exposure to moisture after the accident. The damage extended through the fire wall and was evident on the cabin-facing surface of the fire wall. This area was located behind the fuel pump. Approximately 15 inches of aluminum strip attached to the top edge of the firewall was missing with melting to the ends of the remaining section as shown in Figure 11.

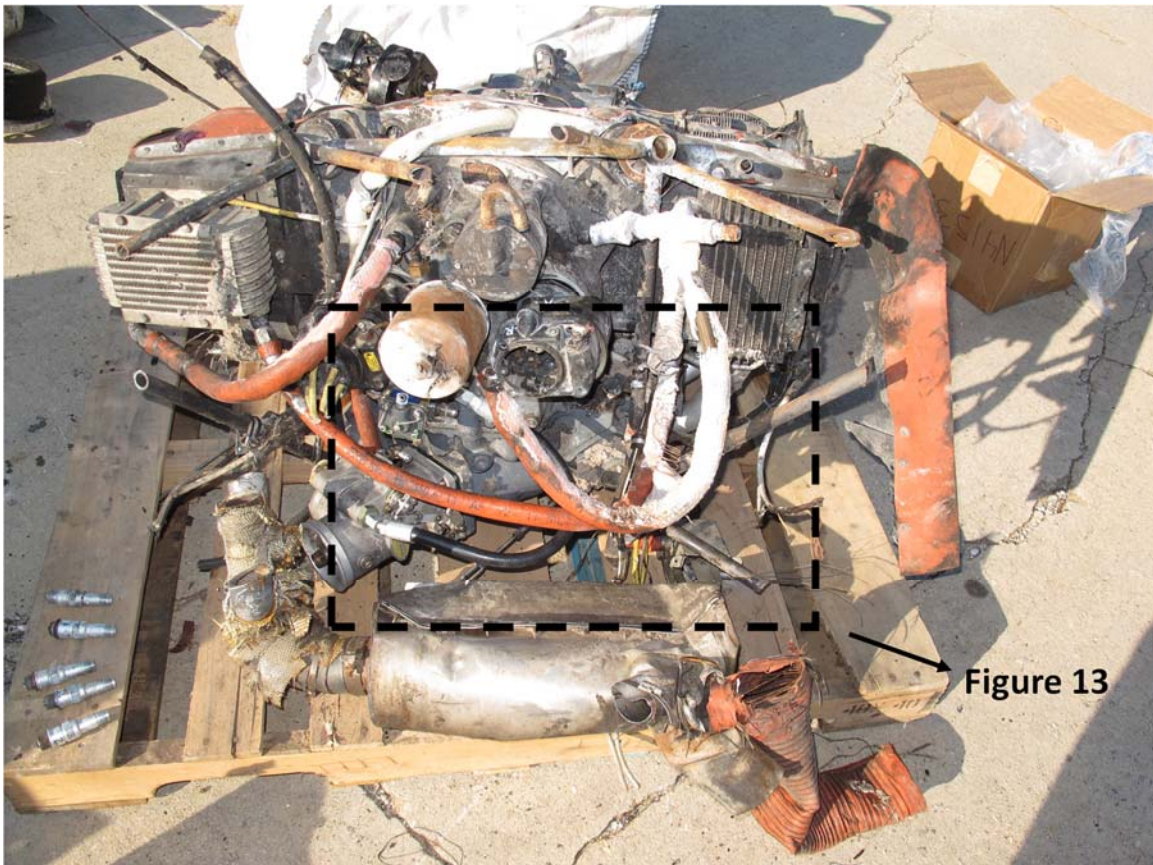
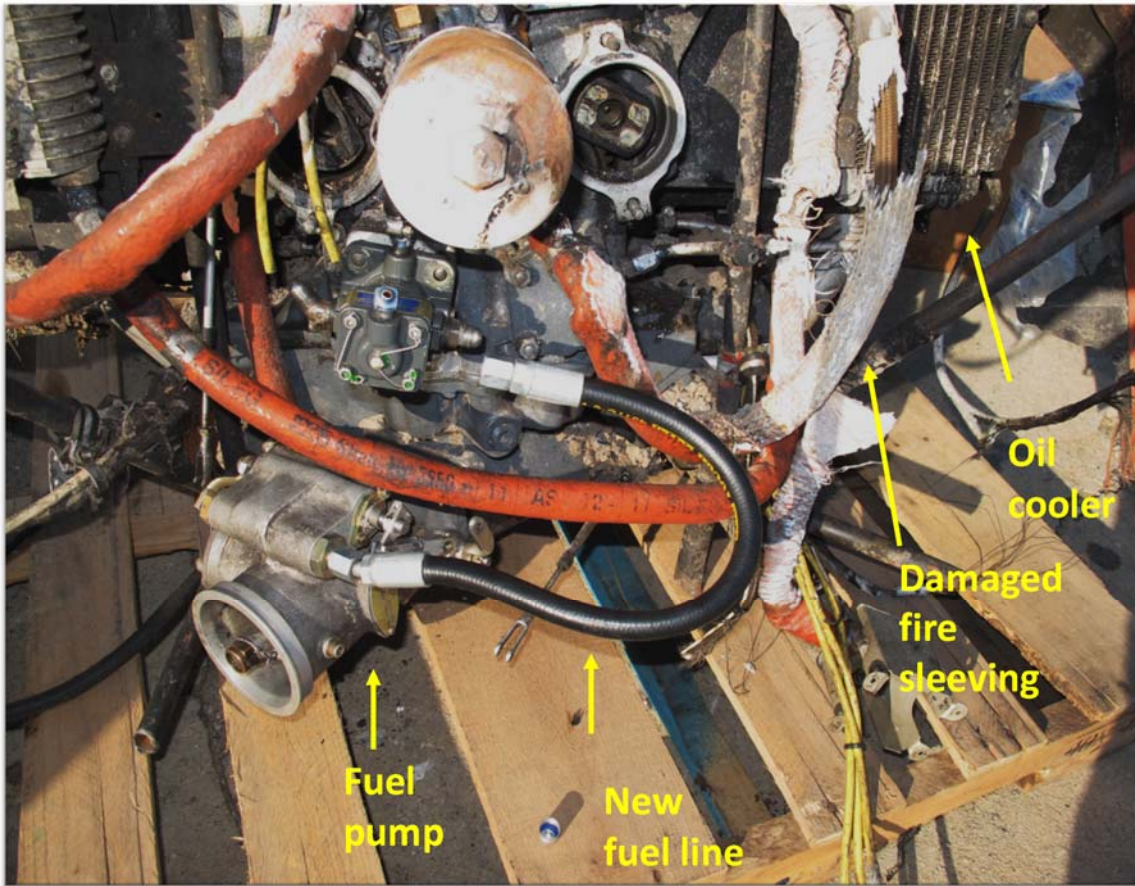
The engine was undamaged except for an area on the aft right side. The damage is shown in Figure 12 and 13. The fire sleeving on the oil lines located in this area exhibited thermal damage. The rubber skirt on the engine was melted in this area as shown in Figure 14. The oil cooler exhibited heavy sooting. During the field engine teardown, a fuel line on the output side of the fuel pump was found to have a loose b-nut connection. The loose condition of the b-nut connection was more than could be accounted for by heat exposure and impact. The fuel line was undamaged and in serviceable condition, however it was not an aircraft-approved fuel line as shown in Figure 15.

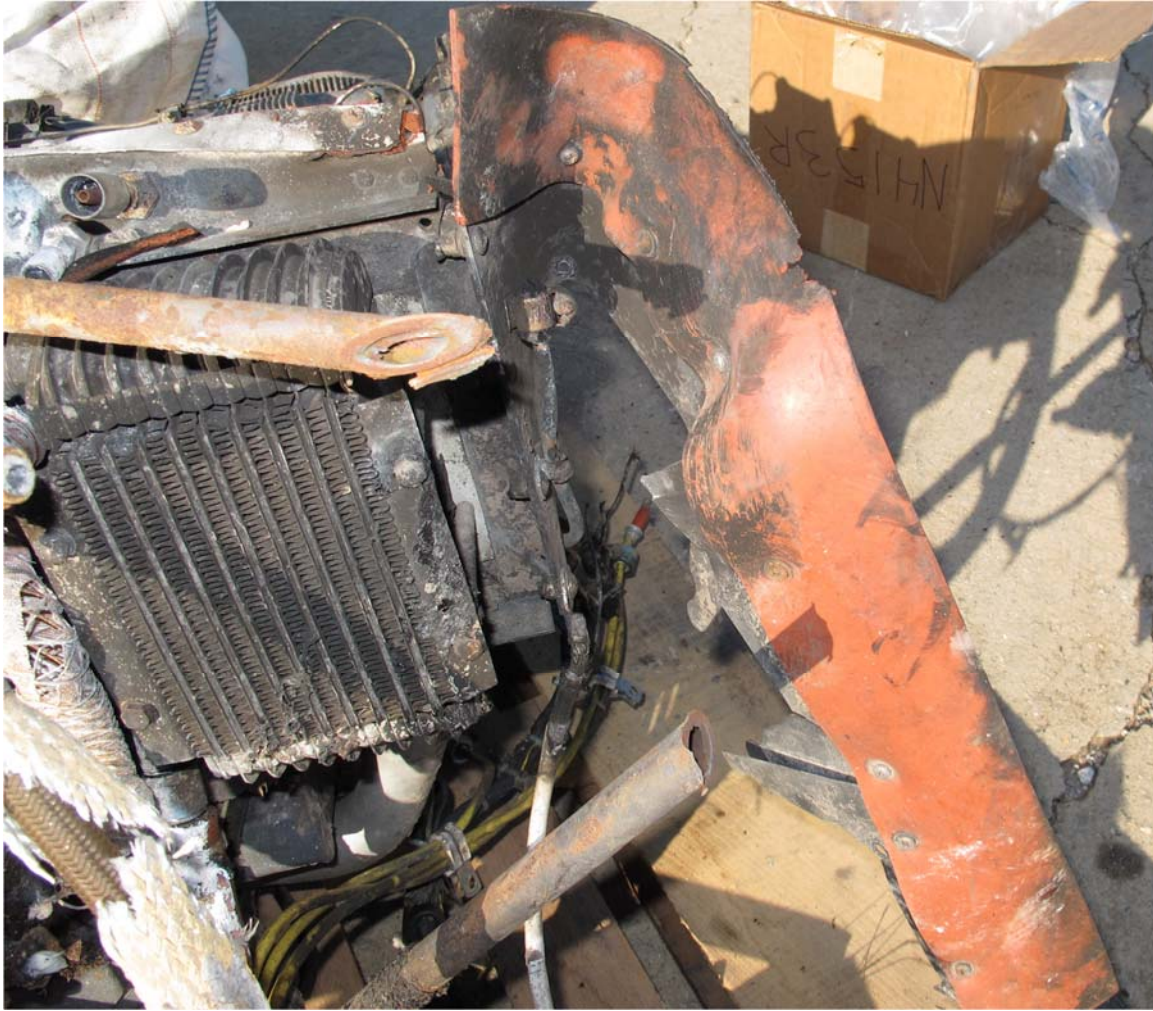
Figure 14. Photograph of damaged rubber strip.

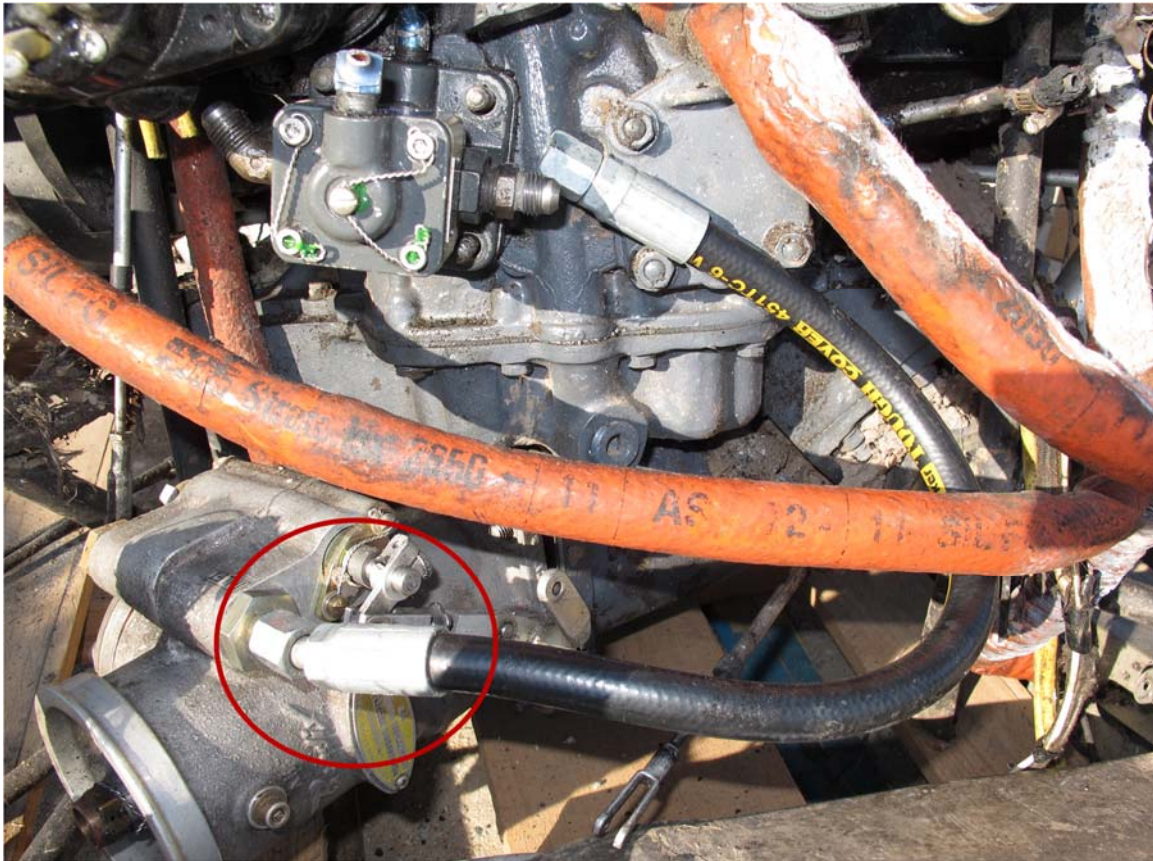
Figure 15. Photograph of unapproved fuel line. The loose connection found on-scene is shown highlighted by the red circle.

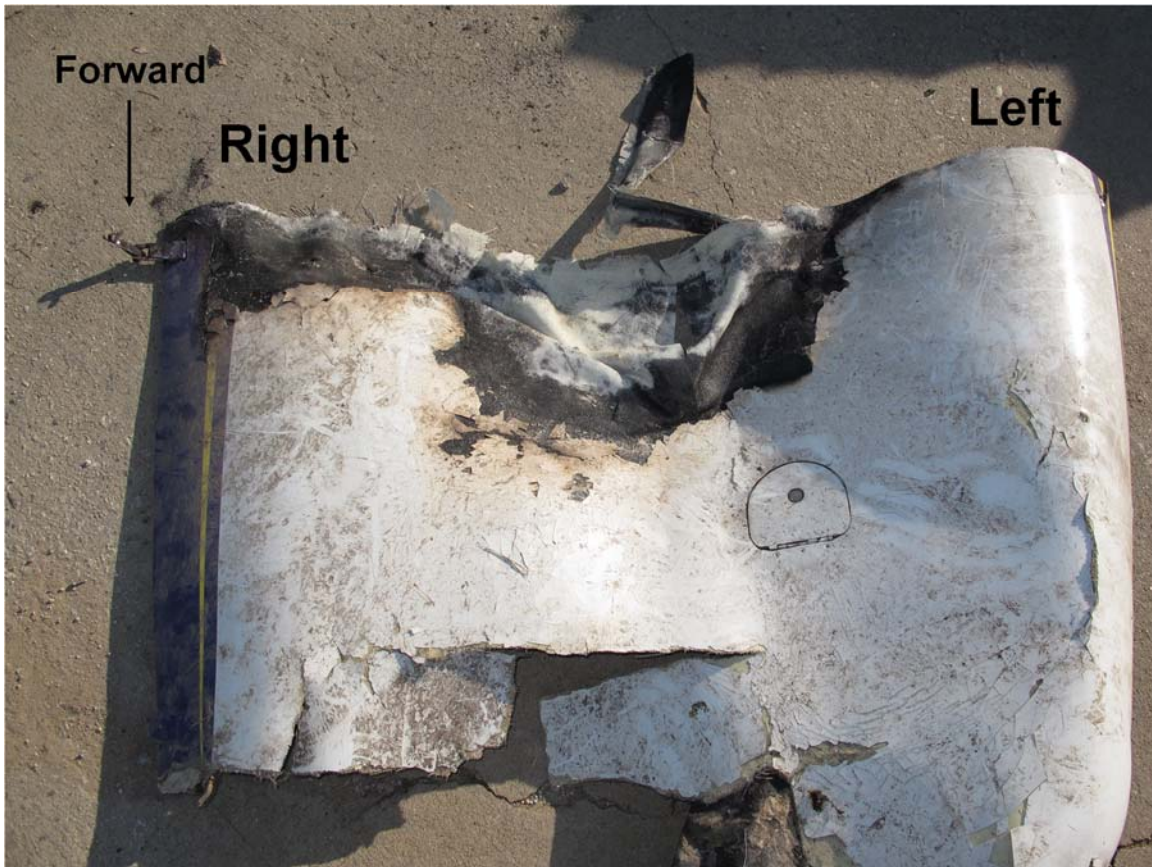
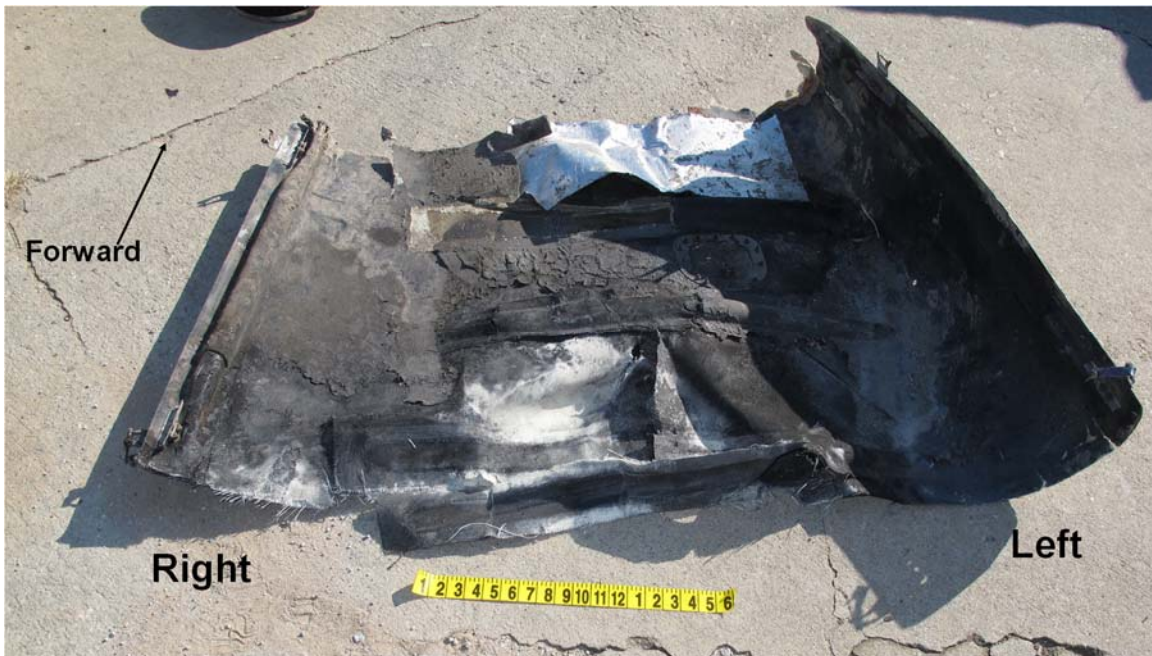
The upper engine cowling was intact but exhibited heavy thermal damage to the aft edge on the right side as shown in Figure 16 and 17. The lower surface (engine-facing side) in this area was heavily sooted and the fiberglass resin was charred and missing in areas, exposing the glass fiber matting. This damage extended from the right edge to the midline of the upper cowling.

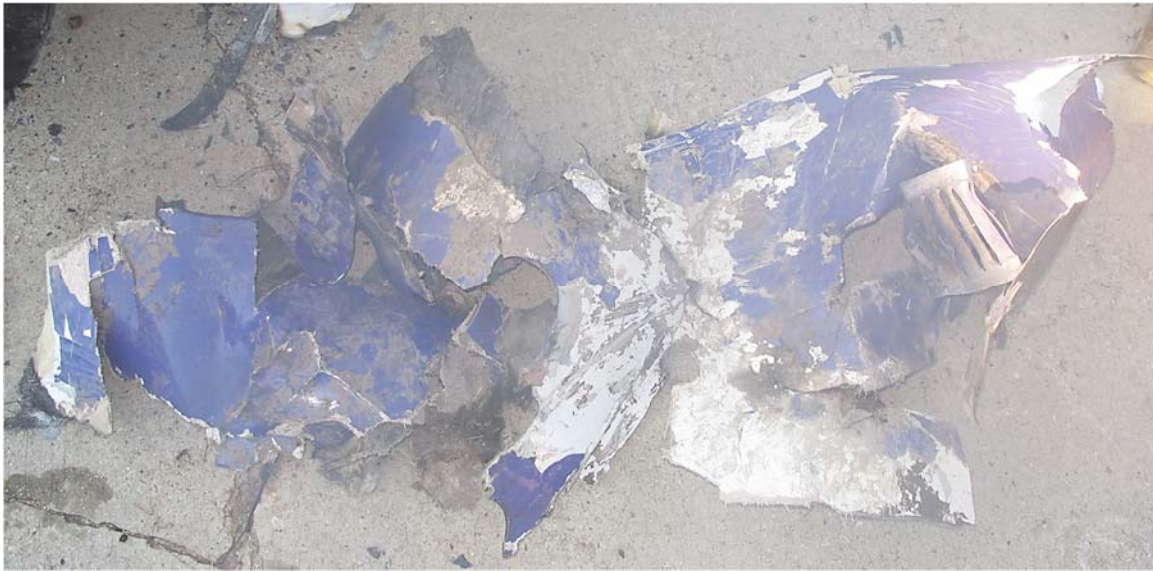
Figure 18. Photograph of lower right cowling.

The right lower engine cowling was heavily sooted and exhibited mechanical damage as shown in Figure 18. The louver on this side was heavily sooted and had some thermal damage to the paint as shown in Figure 19.

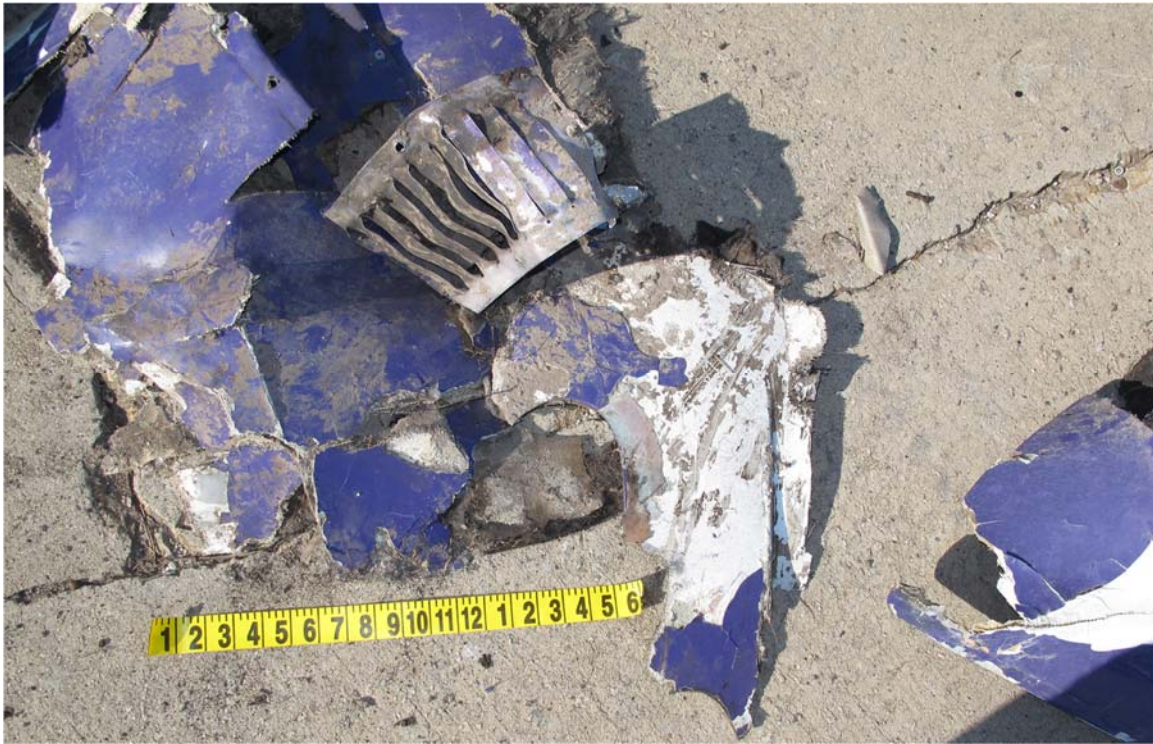
Figure 20. Photograph of lower left engine cowling.

The left lower engine cowling had thermal and mechanical damage, but the thermal damage was to a lesser extent than that found on the right side as shown in Figure 20. The louver on this side was sooted and had some thermal damage to the paint as shown in Figure 21.

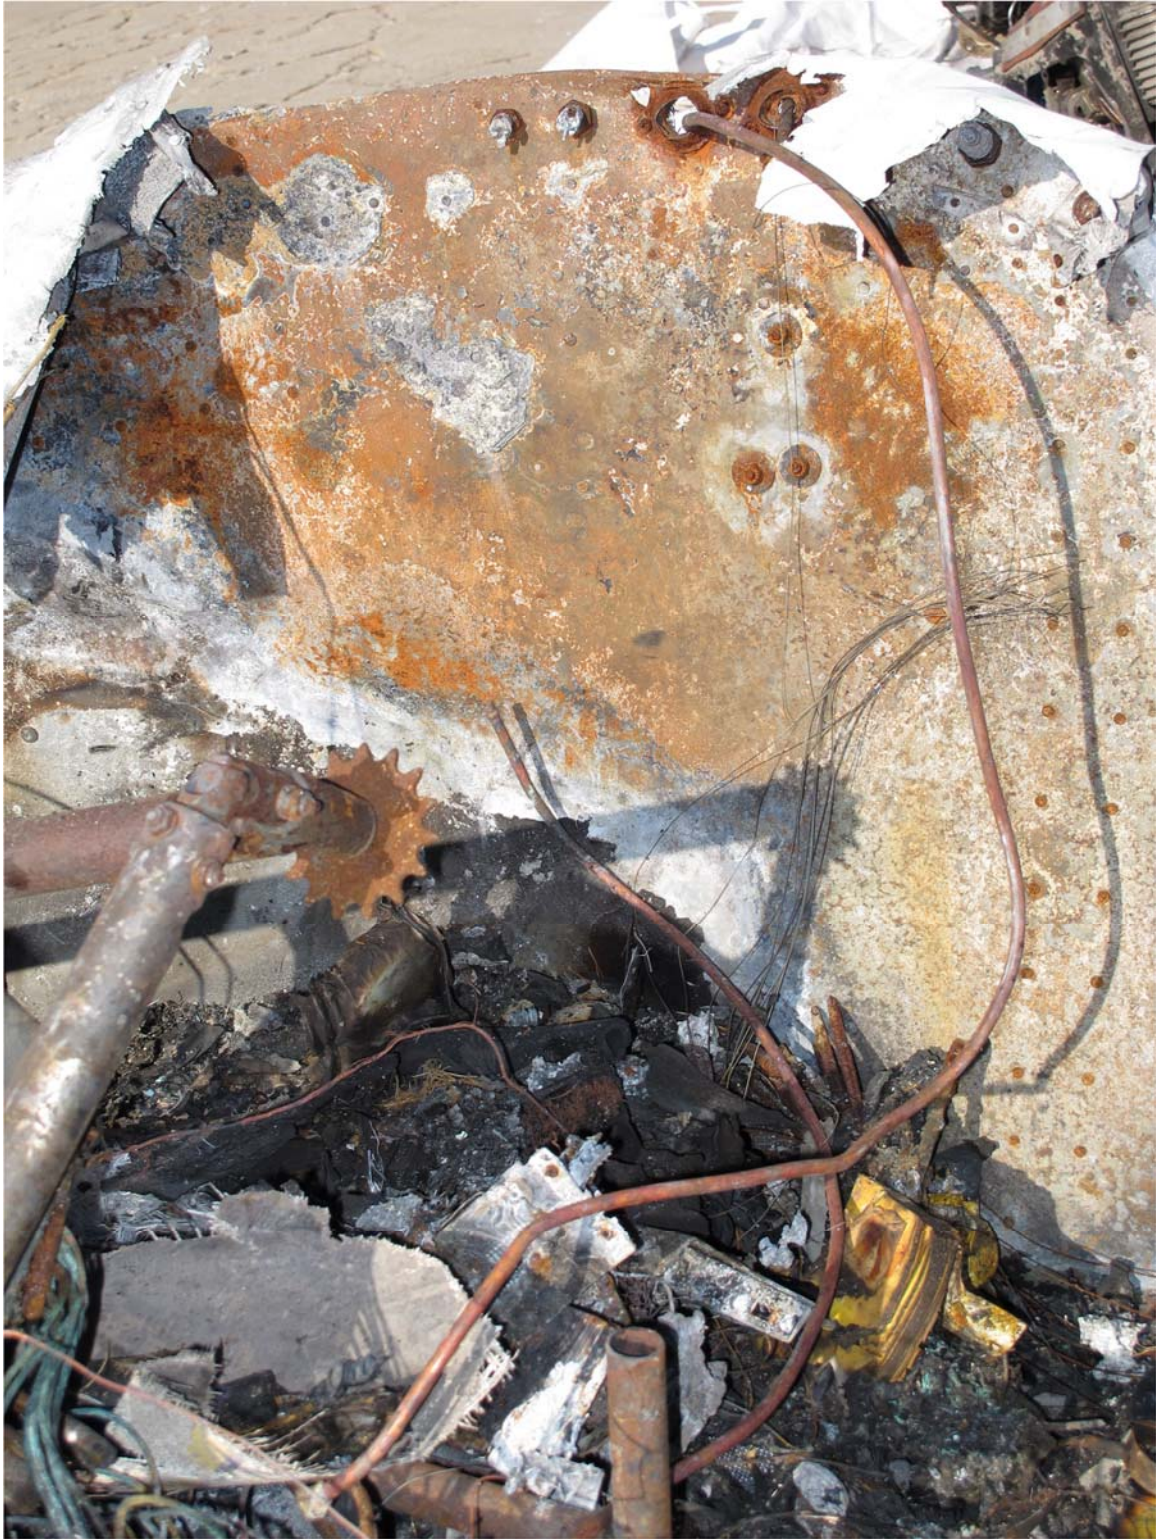
Figure 22. Photograph of aft surface of engine compartment firewall (cargo compartment forward wall).

The thermal damage extended through the firewall and was evident on the aft surface of the firewall as shown in Figure 22. This side of the firewall, which serves as the forward wall of the forward cargo compartment, was normally covered with a vinyl liner. The liner was largely missing, presumed destroyed by fire. A small portion was present near the floor of the compartment.

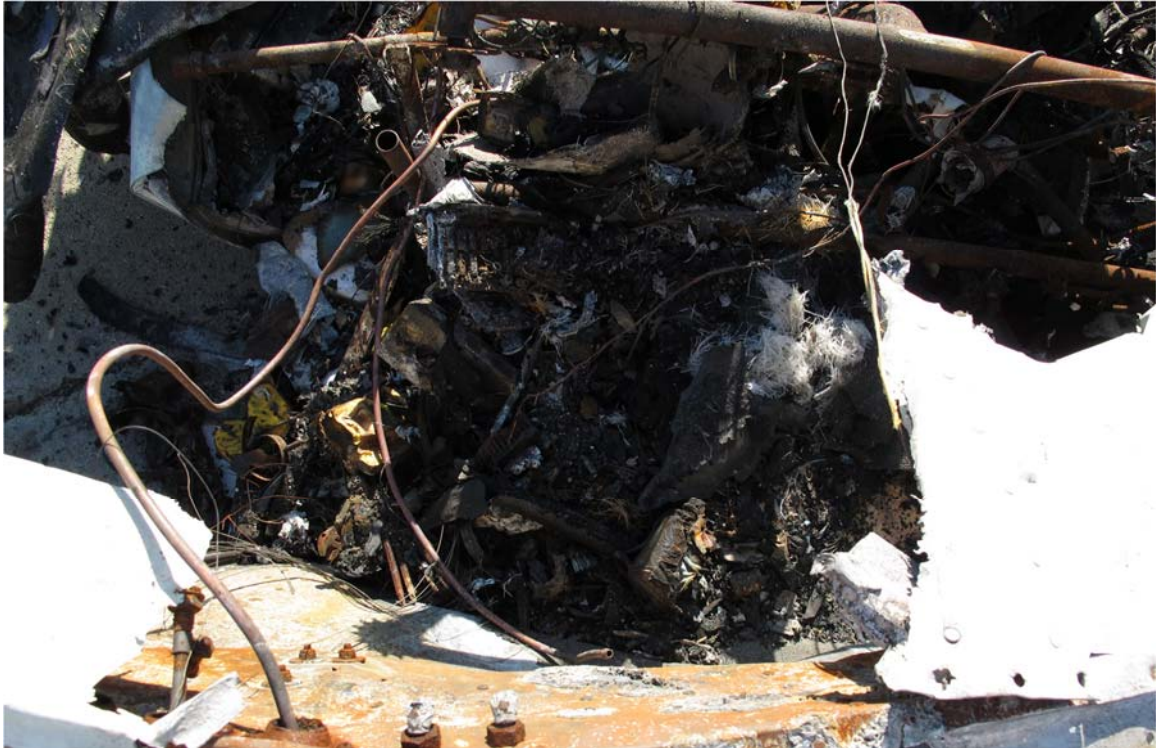
Figure 23. Photograph of overhead view of forward cargo compartment.

The floor of the cargo compartment was lined with carpet. The carpet was relatively intact except where the carpet was in contact with the right side of the firewall. The contents of the cargo compartment (personal items, log books and tool kit) were heavily fire damaged particularly on the top and on the forward-facing side as shown in Figures 23.

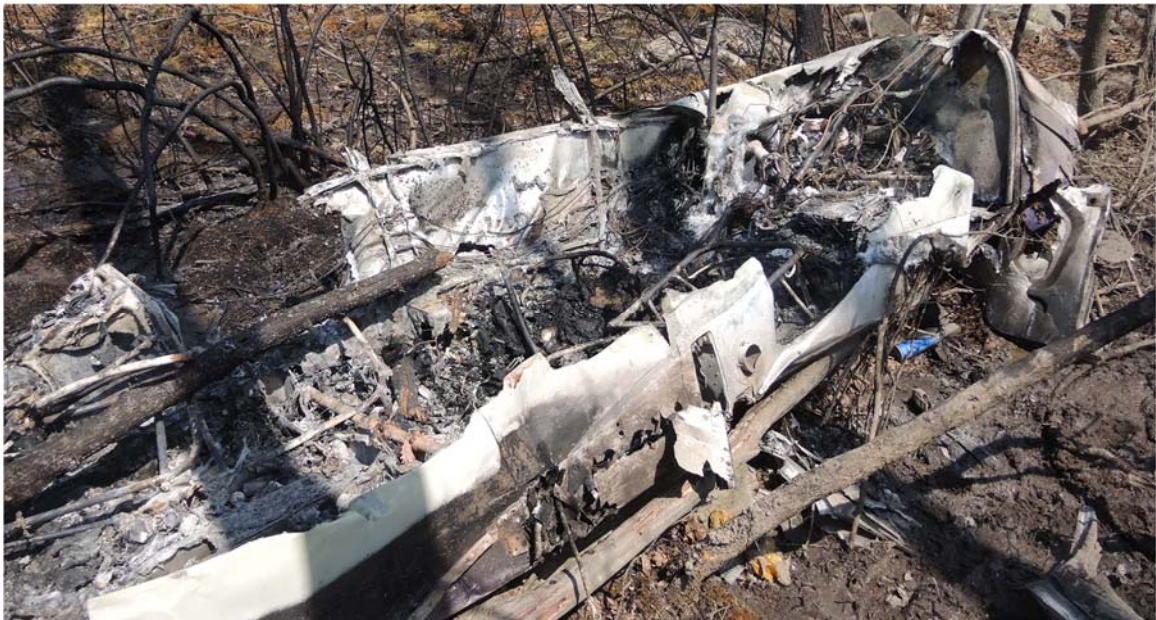
Figure 24. On-scene photograph of cockpit and cabin area.

The rest of the cockpit and cabin area was destroyed as shown in Figure 24. All polymeric and aluminum components were missing or melted. Only ferrous-based components, like the seat frames, remained and were heavily oxidized.
