NATIONAL TRANSPORTATION SAFETY BOARD

MATERIALS LABORATORY FACTUAL REPORT

Report No. 15-107

Place : Bristol, Wisconsin
Date : July 25, 2015
Vehicle : Zenith CH 601XL
NTSB No. : CEN15FA315
Investigator : Edward Malinowski, AS-CEN

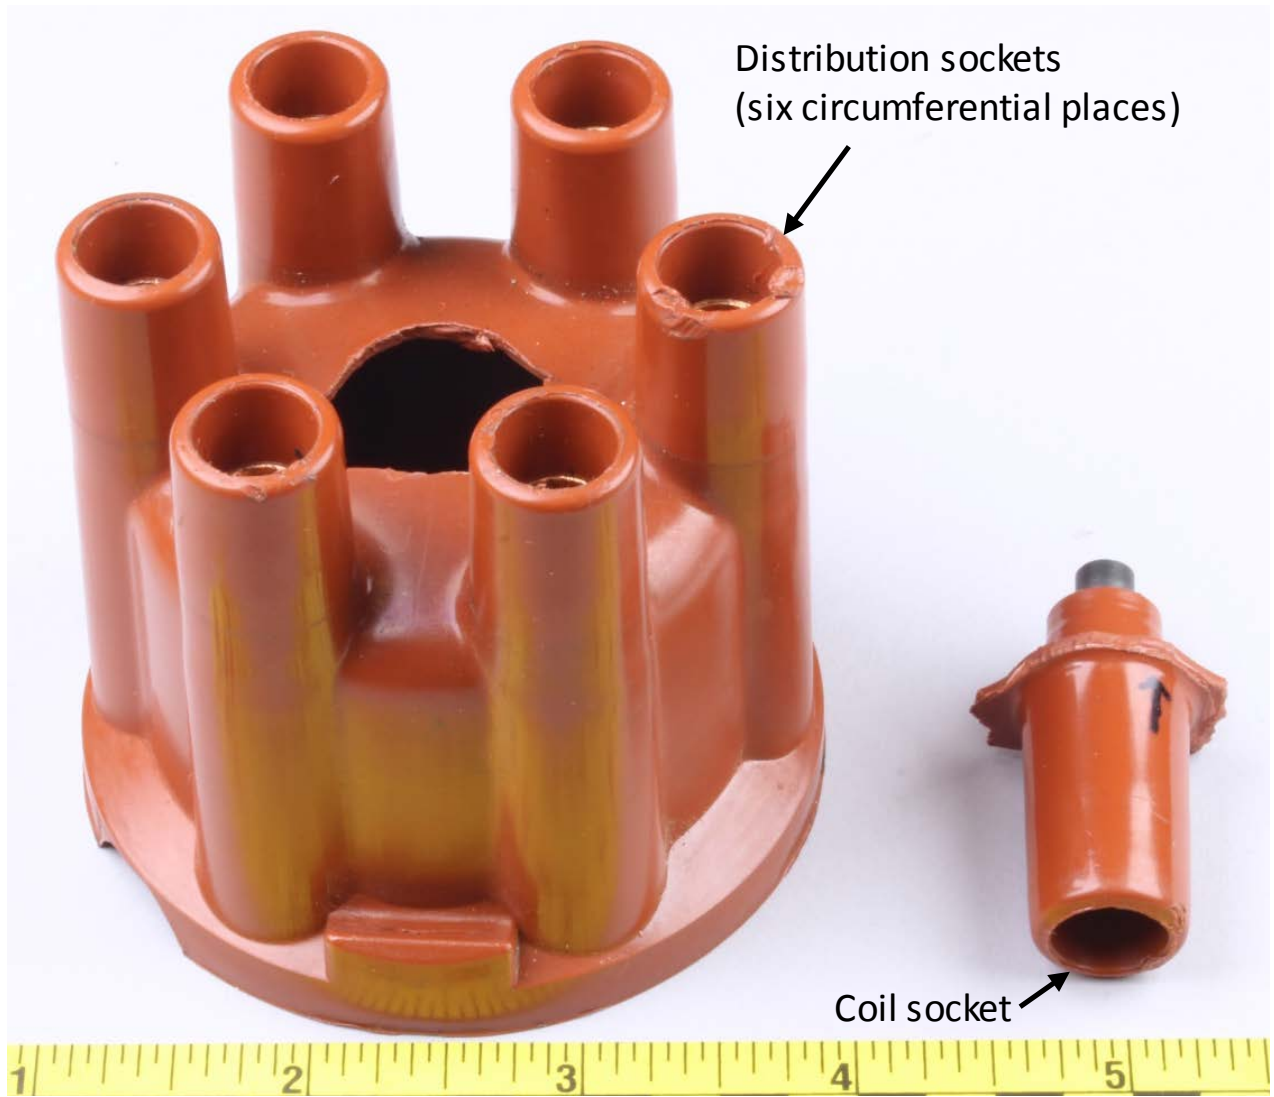
Pieces of the right distributor cap were submitted (Figure 1) for evaluation. The coil socket was fractured from the distributor cap housing. The purpose of this report is to document the fracture.

Figure 1 As received distributor cap pieces.

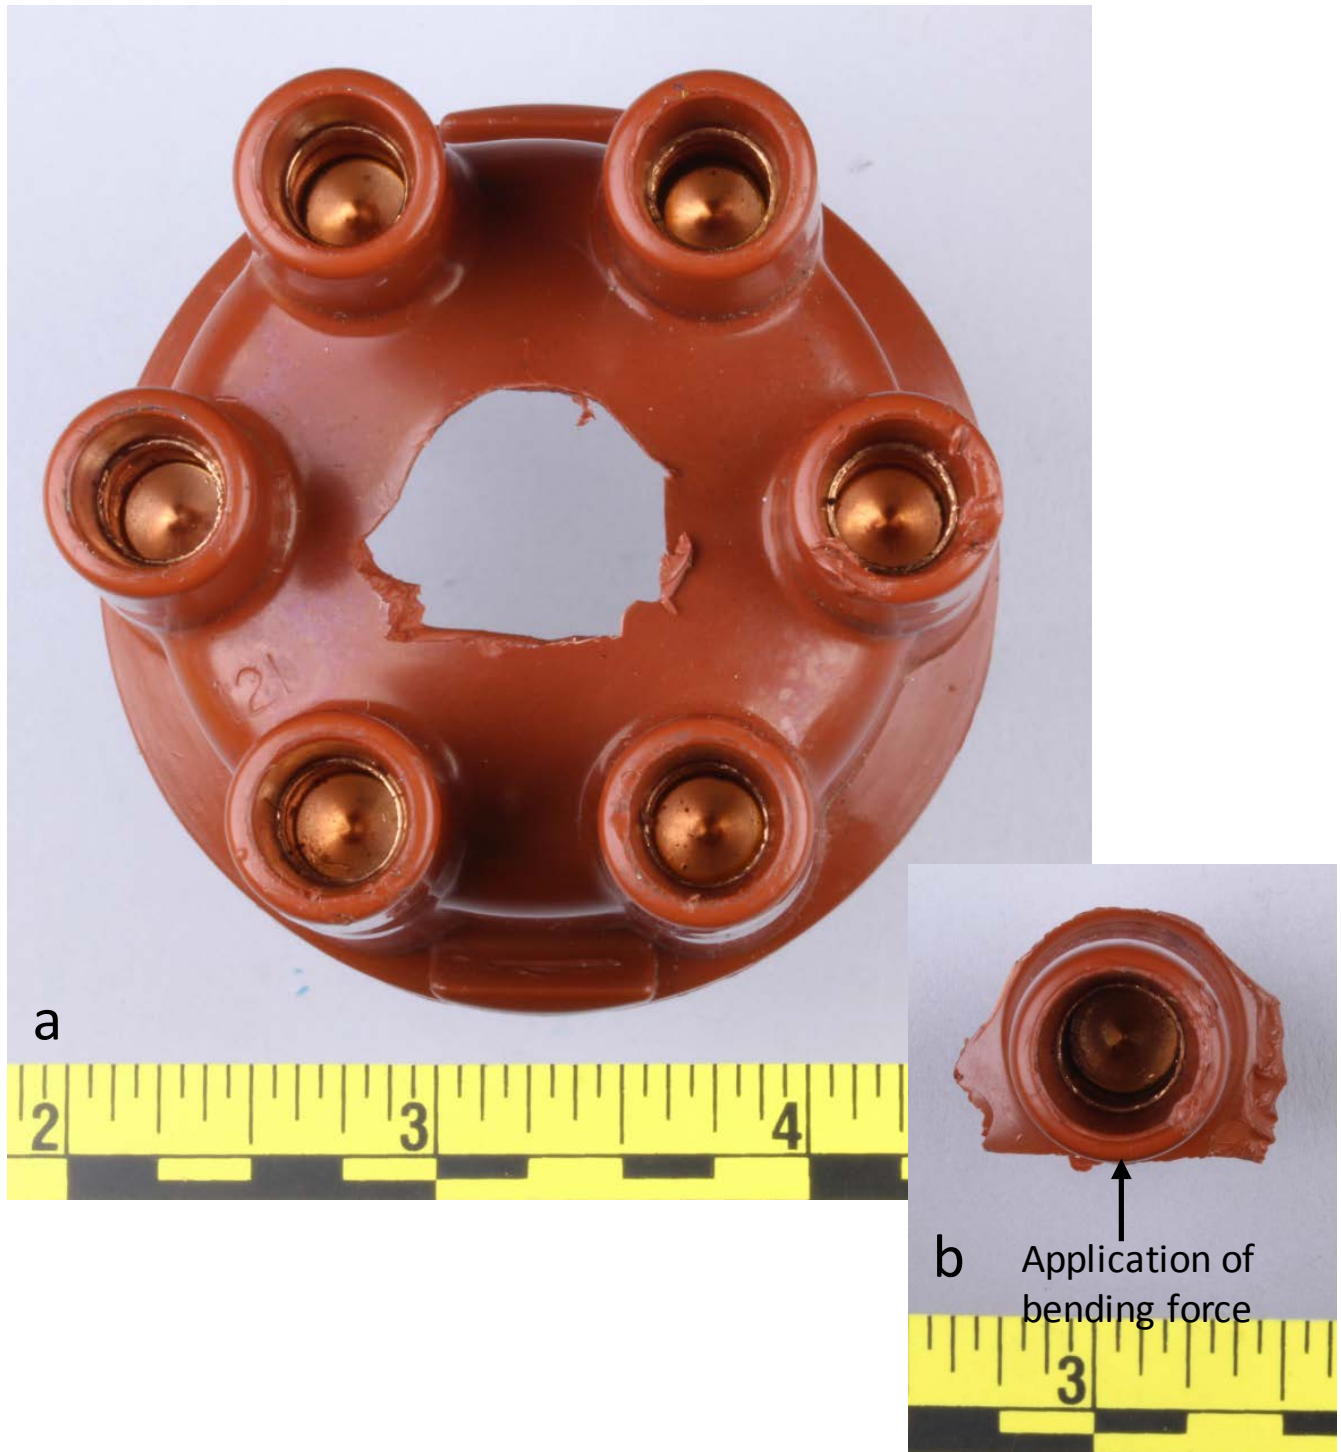
Images of the outside and inside of the top of the distributor cap showing the fractured center coil socket are shown in Figures 2 and 3, respectively. The fracture initiated at the step created by the identification boss shown in Figure 3b. A higher magnification view of the fracture initiation region is shown in Figure 4. For Mode I cracking opening, a bending force was applied to the central coil socket as indicated in Figure 2b. A closer view of the separated center coil socket is shown in Figure 5 with the fracture initiation region identified.

Figure 2 Top view of the distributor cap pieces.

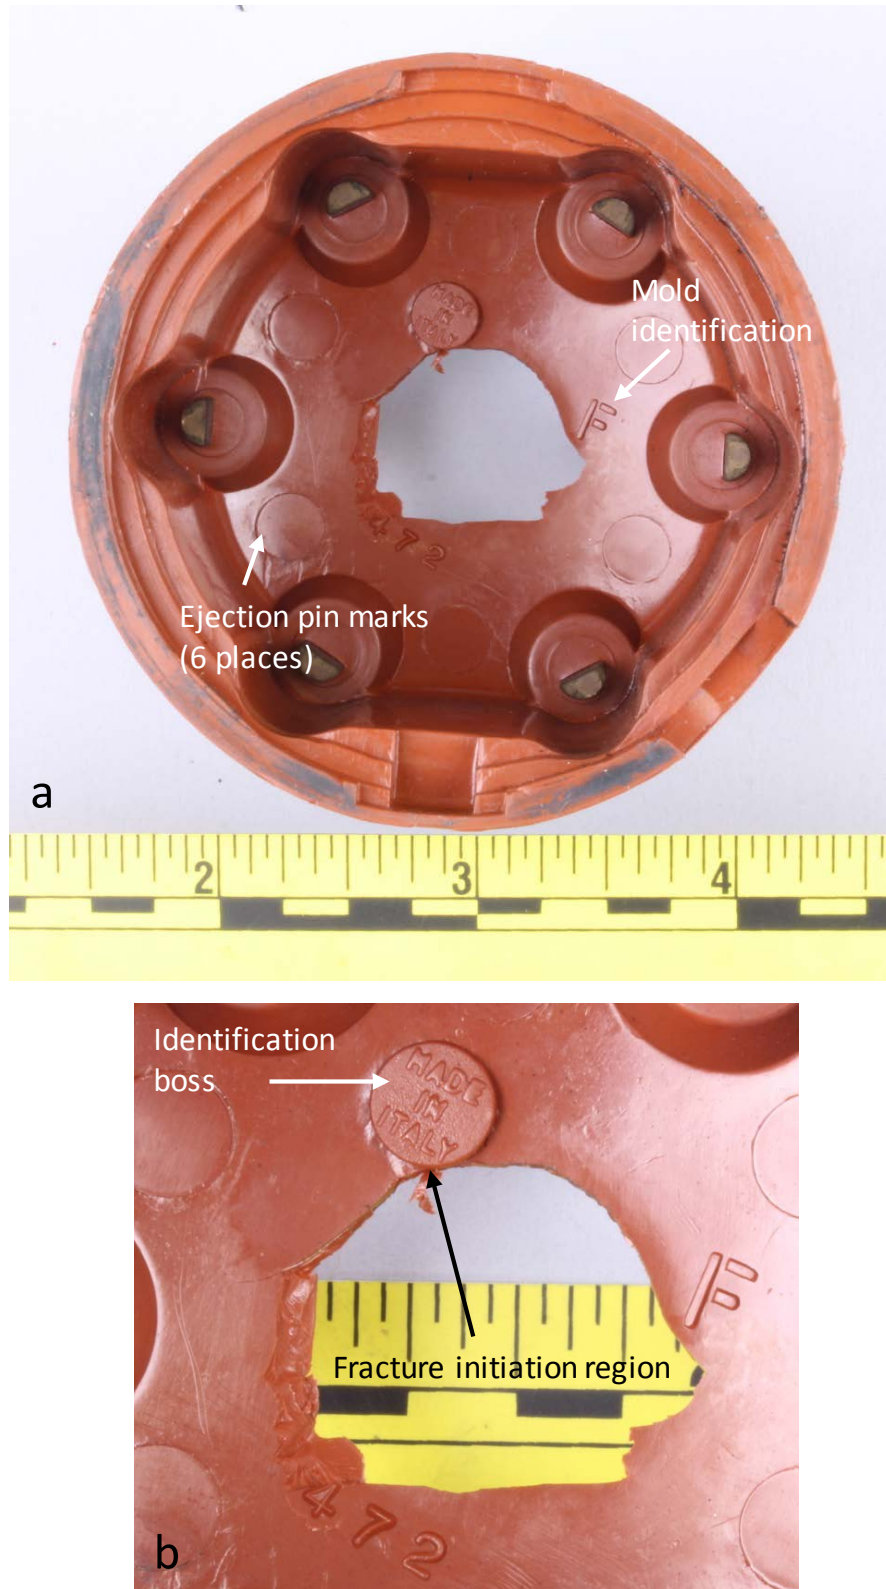
Figure 3 Bottom or inside view of the fractured region on the distributor cap body.

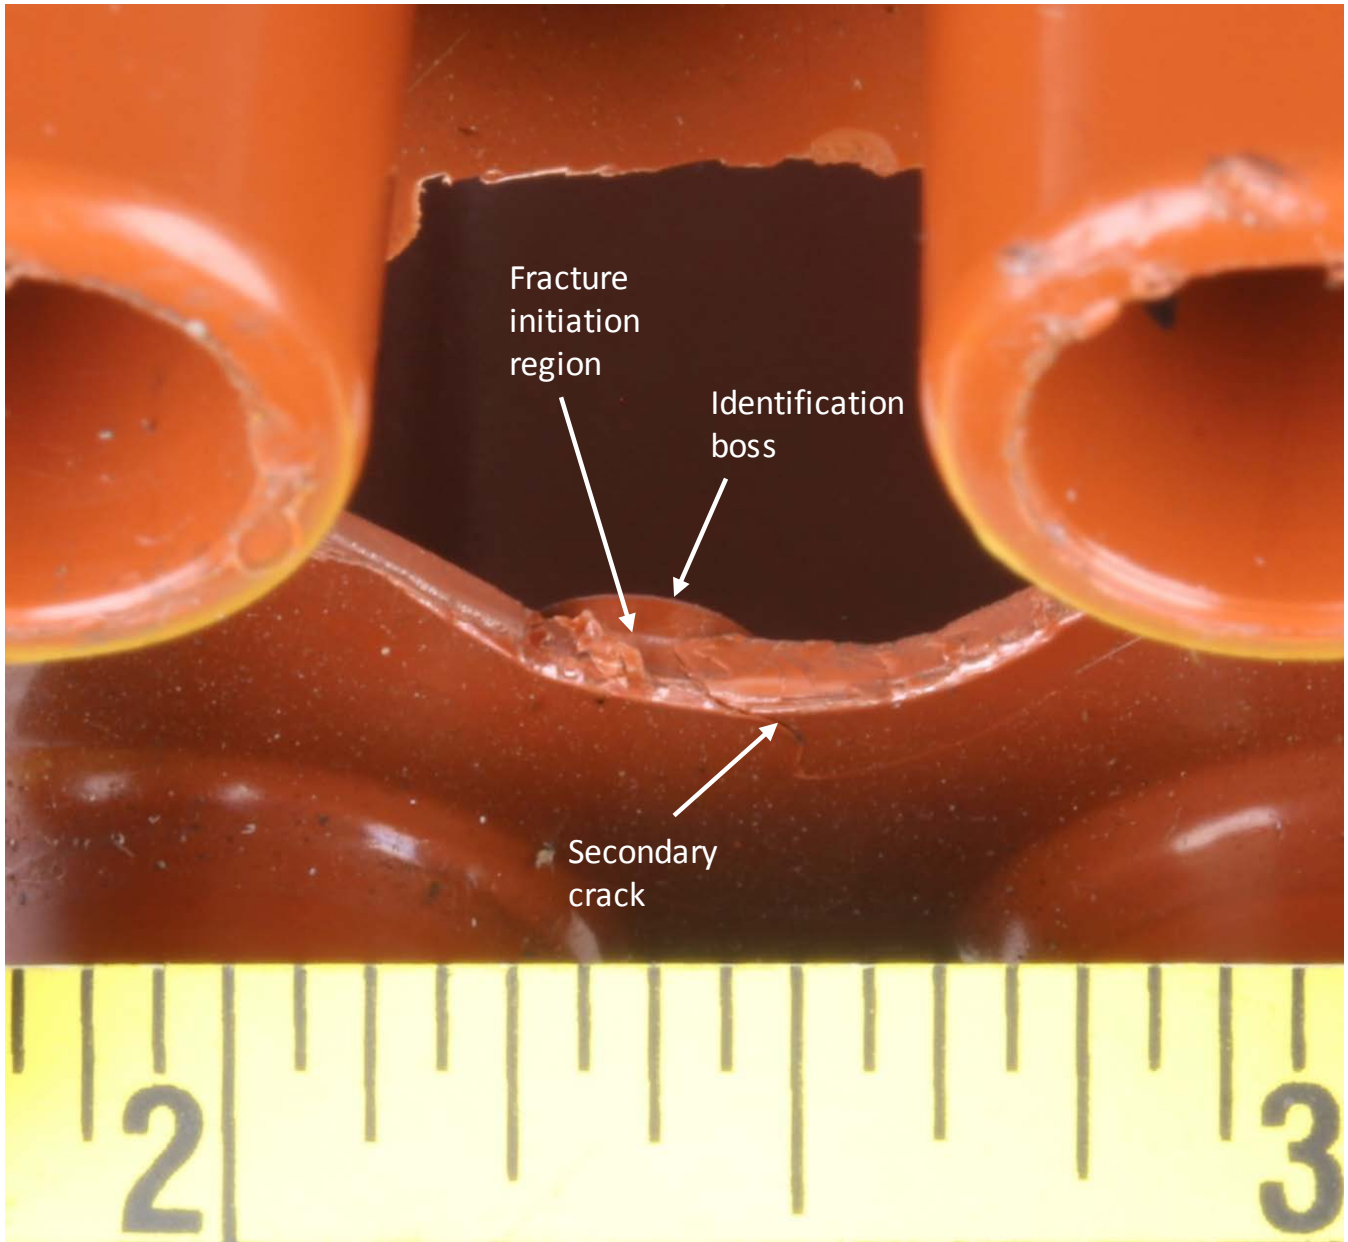
Figure 4 Closer view of the initiation region of the cap fracture.

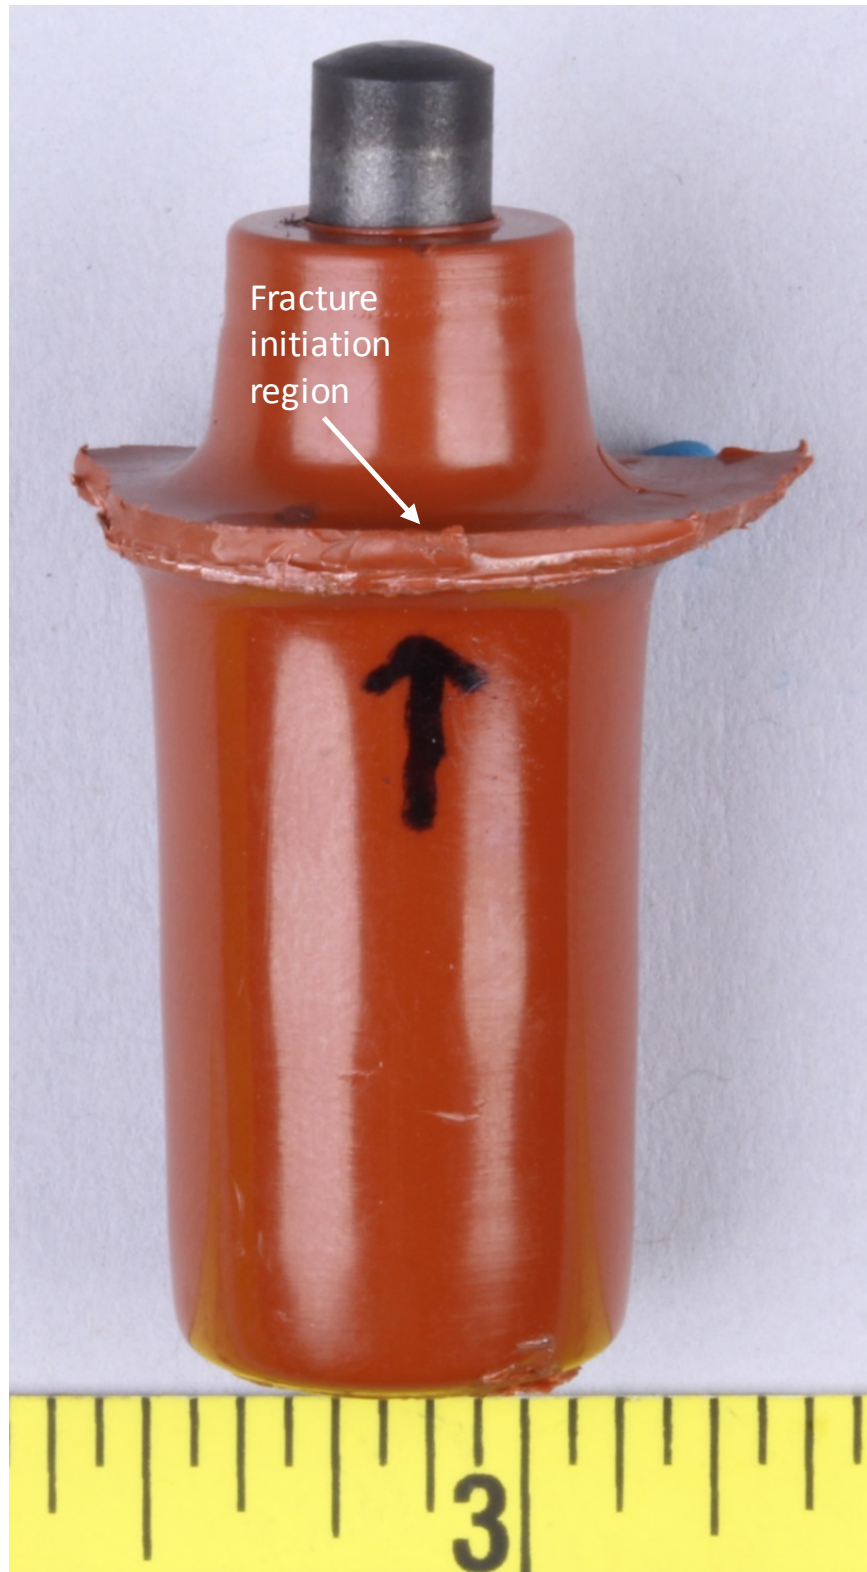
Figure 5 Closer view of the initiation region on the separated coil socket.

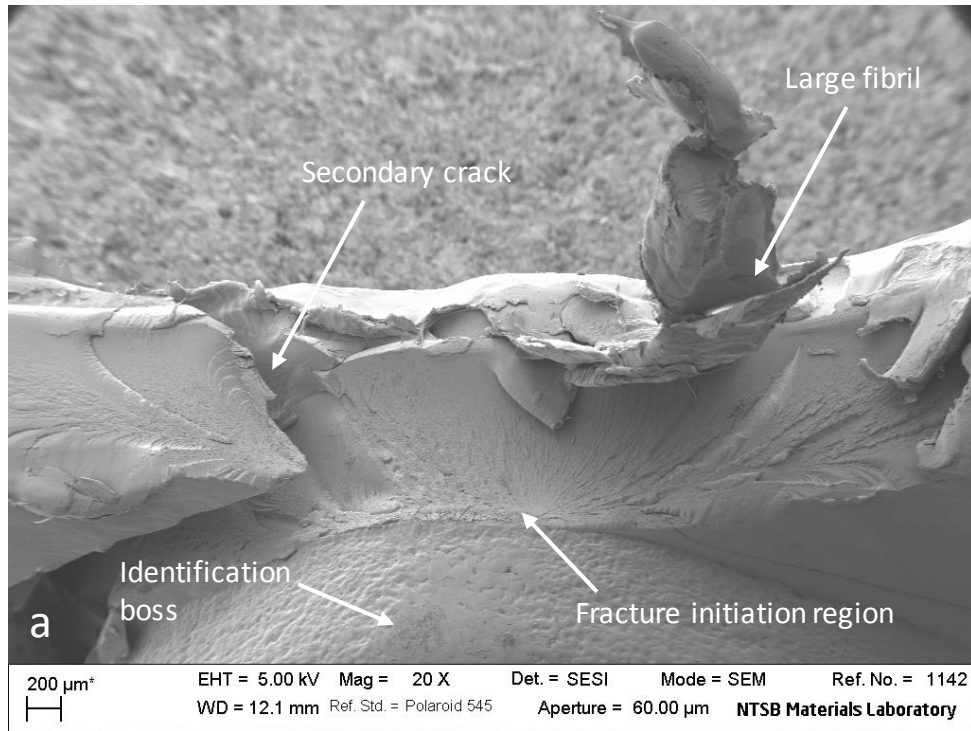
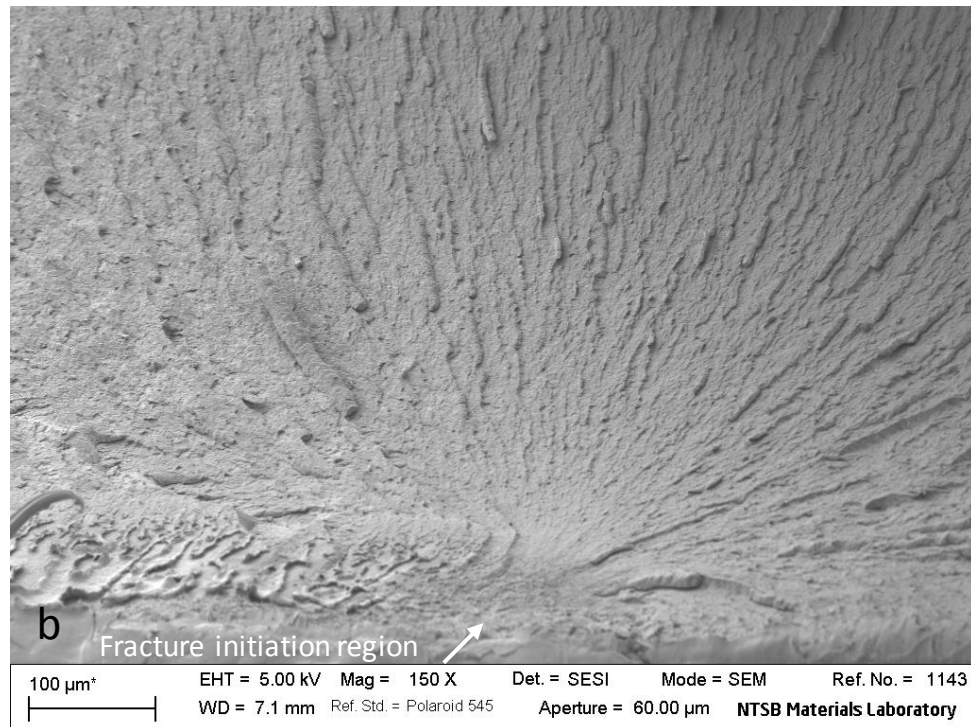
Scanning electron fractographs of the fracture initiation region are shown in Figures 6 and 7. As indicated in Figure 6a, the fracture initiated on the inside of the distributor cap dome at a step created by an identification boss molded into the part. A secondary crack is also noted in Figure 6. The hackle and fine fibril fracture surface features revealed in Figures 6b and 7, as well as the large fibrils at the outer surface of the cap (Figure 6a), are consistent with overstress fracture mode due to bending forces applied to the center coil socket (see Figure 2b). No evidence of progressive cracking, such as fatigue or slow crack growth, was noted.

Figure 6 Scanning electron fractographs of the initiation region of the fracture in the distributor cap. In view a, the fracture initiated at the base of the step created by the identification boss molded into inner surface of the cap.

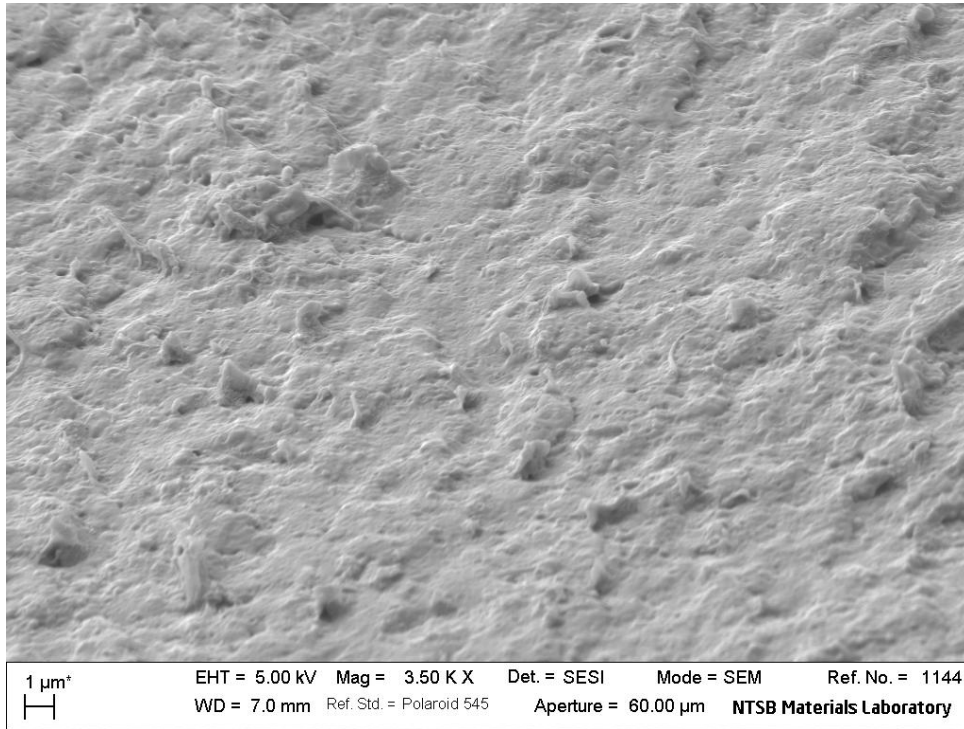
Figure 7 Closer scanning electron fractograph of the fracture surface near the initiation region.
