To: Rayner Brian
Subject: ERA14FA045

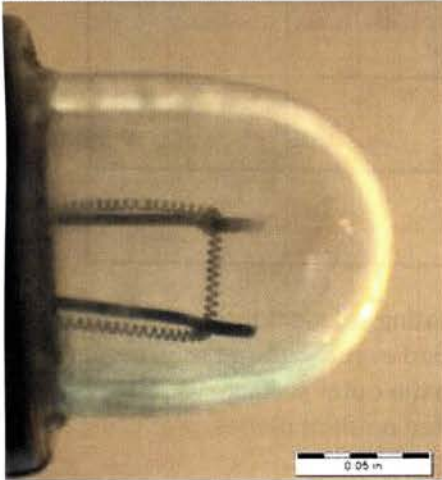
The bulbs identified as "#1 DEPLOY" and "#2 DEPLOY" displayed intact coils and "#1 DEPLOY" is illustrated below.

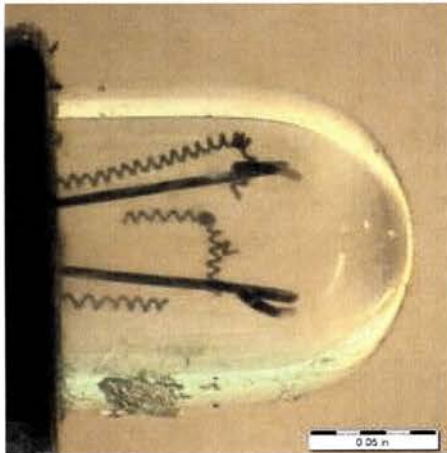
The bulbs identified as "#1 BLEED VALVE", "#2 BLEED VALVE" and "#2 UNLOCK" displayed broken coils and "#2 BLEED VALVE" is illustrated below.

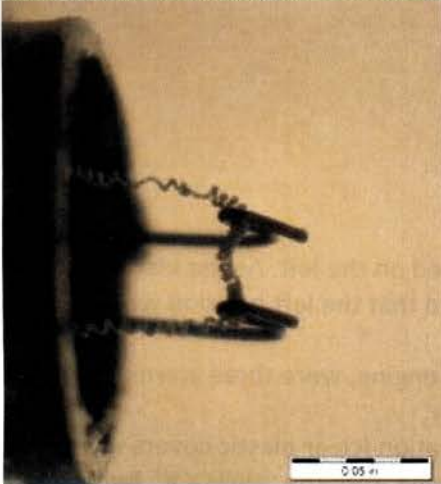
1. Coiled and intact.
2. Coiled and broken, consistent with an impact event while the filament was cold (bulb not illuminated).
3. Stretched, consistent with the filament being at an elevated temperature during the impact event.

The filament in the bulb identified as #1 UNLOCK was difficult to see clearly so the glass envelope was removed to reveal the stretched filament illustrated below.
