National Transportation Safety Board  
Office of Railroad, Pipeline and Hazardous Materials Investigations  
Washington, D.C. 90284

Derailment of U813-18  
CSX Transportation Railroad Coal Train  
Ellicott City, Maryland  
August 20, 2012

Mechanical Group Factual

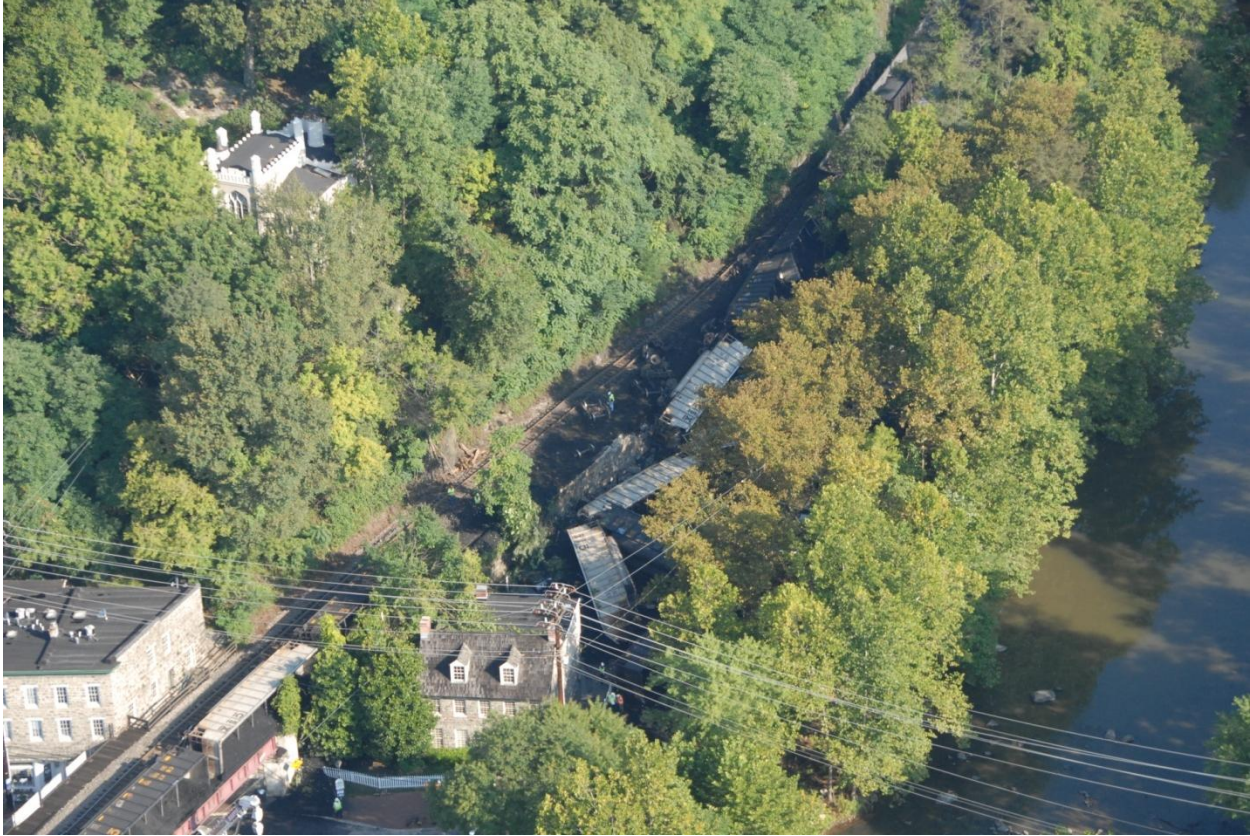
Figure 1-Aerial Photo of the Derailment

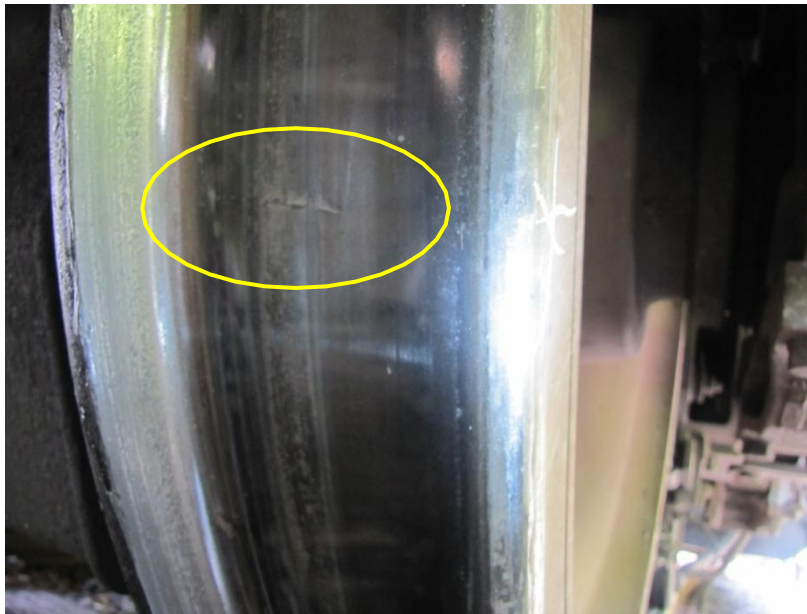
On August 21, 2011, the two locomotives involved in this accident were given a Class 1 mechanical inspection at their point of rest by the Mechanical Group. The brakes on both units applied and released as designed. The group observed very light witness marks on the wheels of the second locomotive that traveled over the north rail. The marks were located on the tread of the wheels perpendicular to the running surface. See Figure 2.

Figure 2-Photograph of Witness Mark on CSXT 4579, Wheel R1

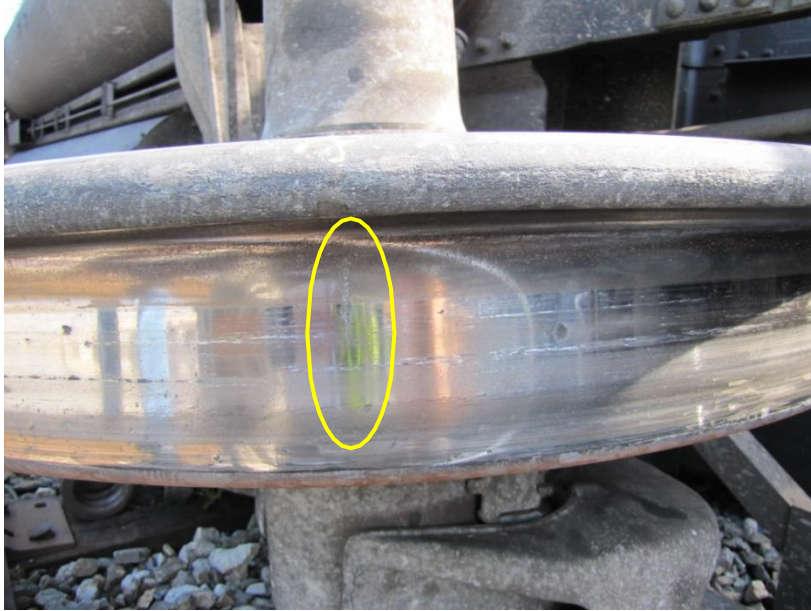
Wheels from these cars that traveled over the north rail were observed to have witness marks in their tread, perpendicular to the running surface. Beginning at car numbers one through car ten, the witness marks became increasingly apparent in both size and depth. See Figure 3.

Figure 3-Photograph of Witness Mark on CSXT 398511, Wheel R4

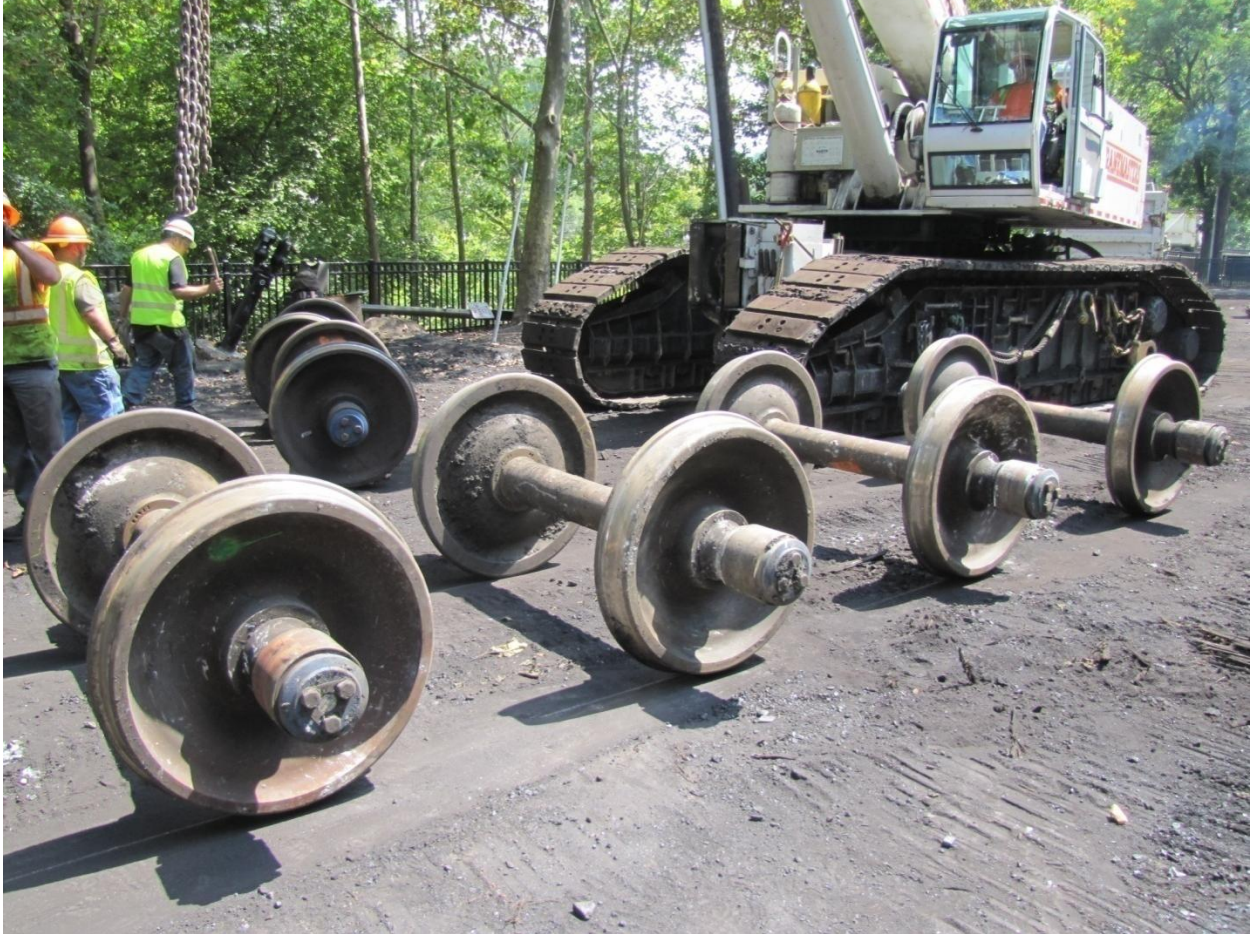
The group noted the presence of witness marks on many wheels examined, similar in appearance to those previously mentioned. The group located wheels from the 12<sup>th</sup> car, CSXT 302724, and placed them in position oriented as they would have been when moving through the derailment area. See Figure 4.

Figure 4-Photograph of Wheel Sets from CSXT 302724

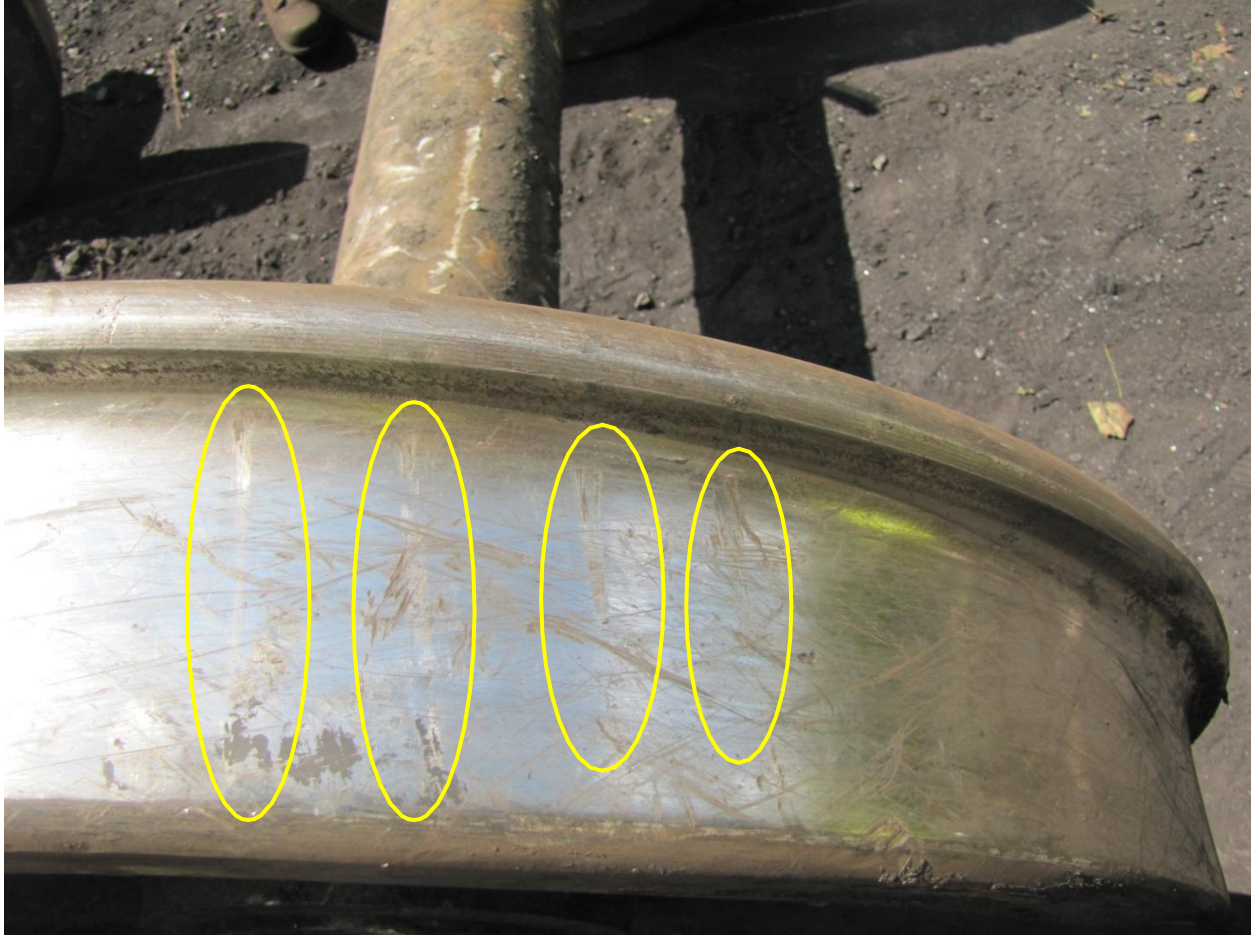
Upon close examination, the group observed several lateral strike marks in the wheel tread of the third set of wheels, specifically the wheel that moved over the north rail (R3). See Figure 5. These series of marks were the first marks observed to have a pattern of successive impacts spaced approximately three-inches apart becoming more apparent in size and depth. These series of marks did not appear on the wheels on axles one and two.

Figure 5-Photograph of Witness Marks on Wheel R3 from CSXT 302724

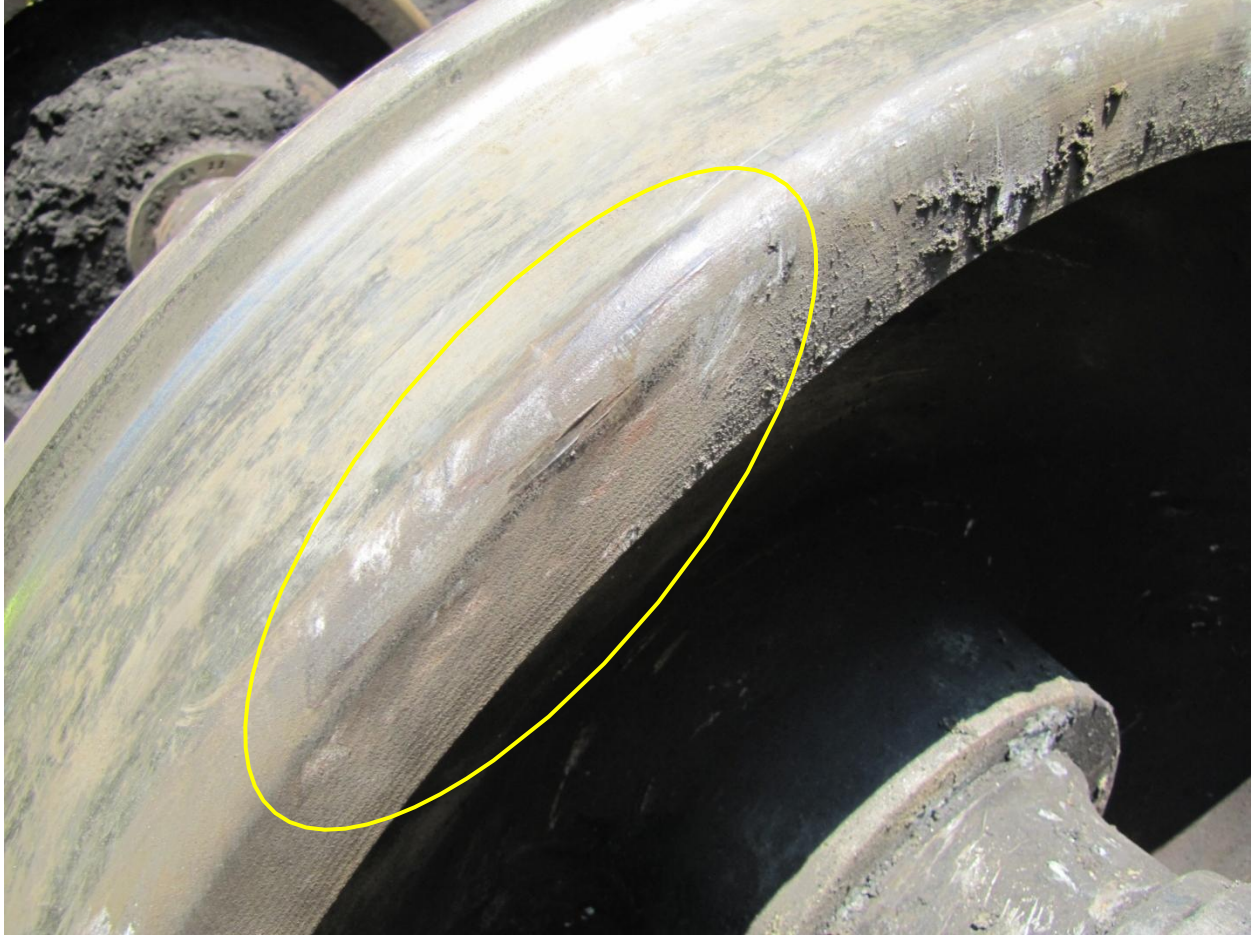
Additionally, a corresponding mark, or a mark on the adjacent wheel in the same horizontal plane of reference, was observed on the on the L3 wheel, located on the outside rim of the wheel. See Figure 6.

**Figure 6-Photograph of Corresponding Witness Mark on Wheel L3 from CSXT 302724**

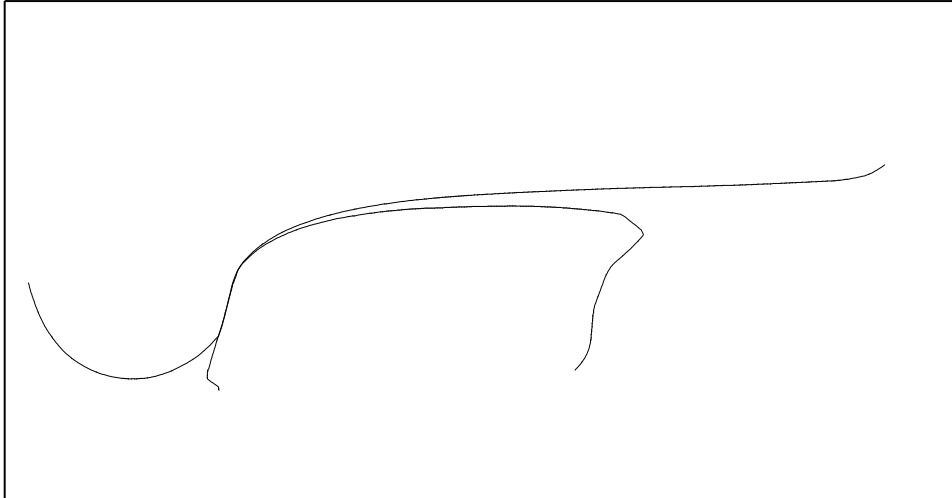
The profile from wheel R3 was overlaid against the profile section of one of the pieces of the high rail (N5)<sup>3</sup> in the area of the POD. See figure 7.

Figure 7-CSXT 302724, Wheel R3 Profile Aligned with High Rail Profile at POD

The alignment represented reflects the wheel and rail interface expected during curving conditions when CSXT 302724 moved through MP 12.9 on the Old Main Line in Ellicott City, MD.

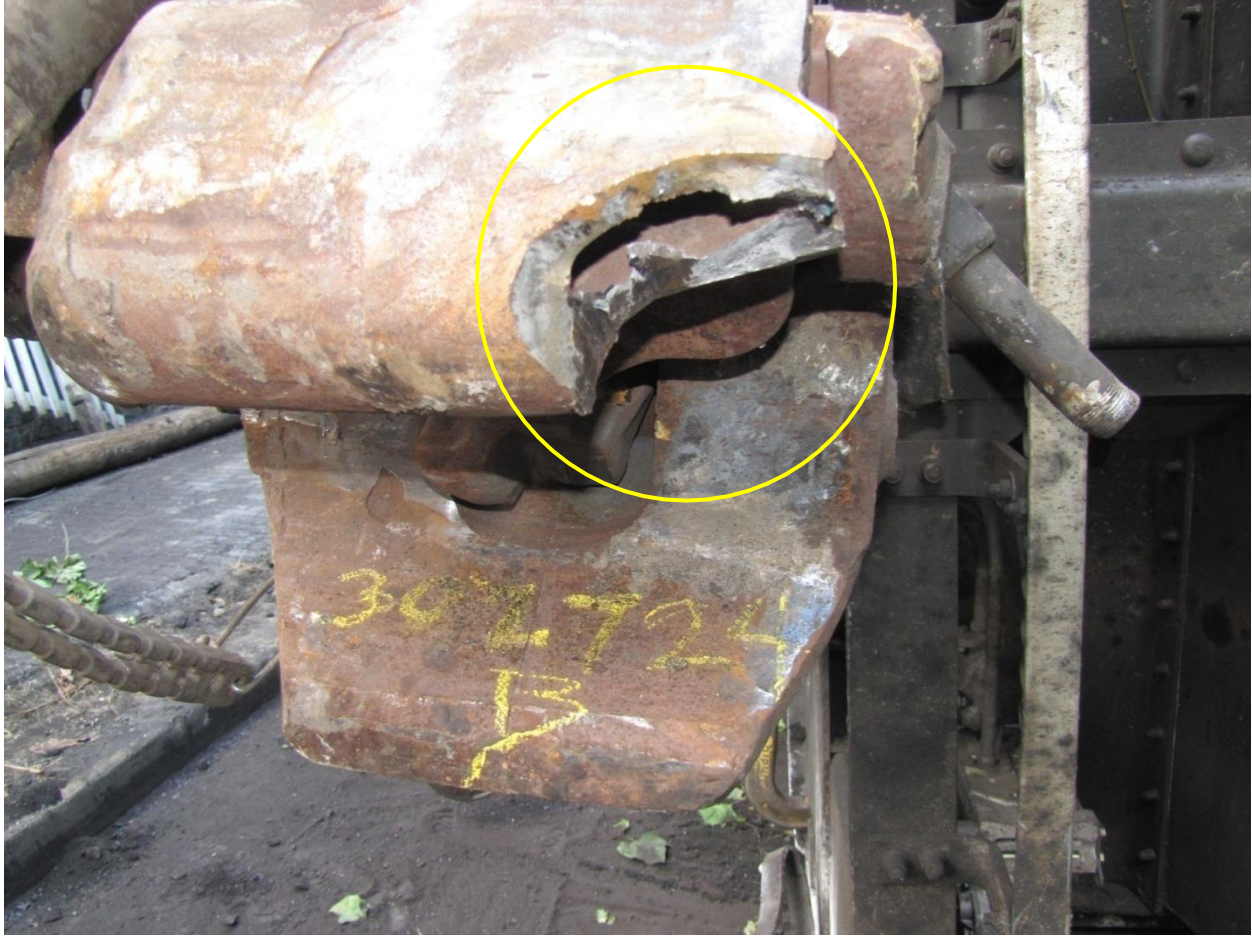
The mechanical coupler assemblies were examined on cars ten eleven and twelve. The mechanical coupler knuckle on the B-end of the 12<sup>th</sup> car, CSXT 302724, was observed to have been severely loaded and fractured in the upper portion of the face. The fracture surfaces were sharp and showed indications that the knuckle was twisted. See Figure 7.

Figure 8-Photograph of CSXT 302724 B-End Fractured Knuckle Assembly

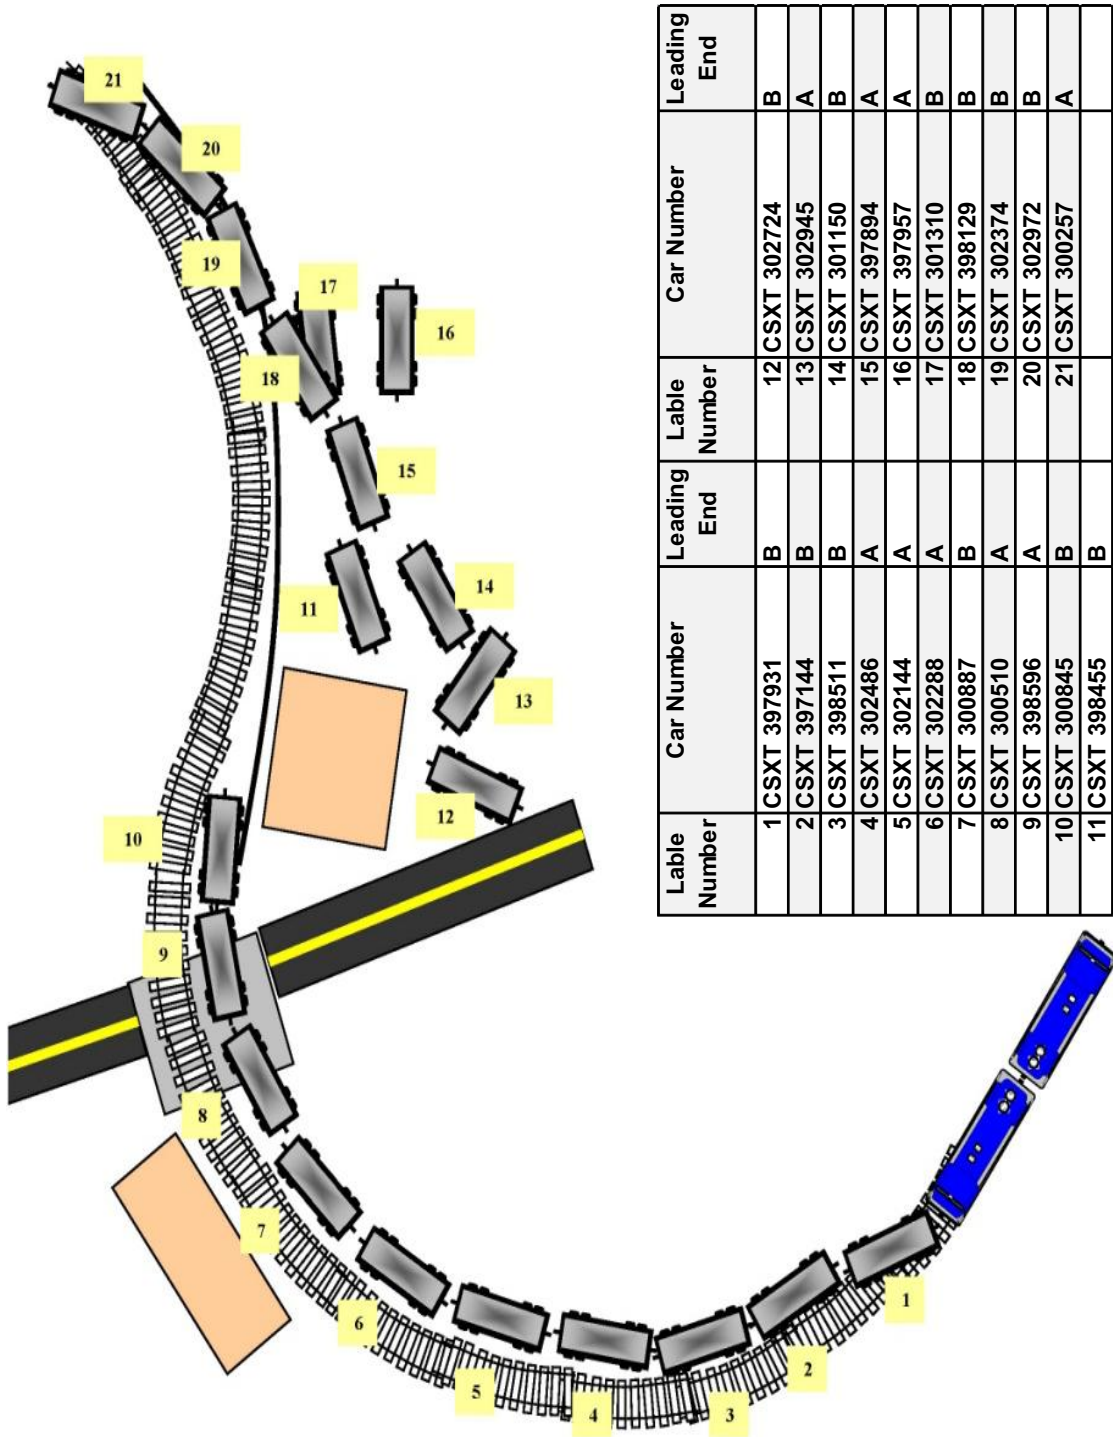
Appendix A

Cars 18 through 20 were on their side to the north side of the main. The last car to derail was car number 21. The leading two axles on this car were derailed and the trailing two were still on the rail. The leading end of the car was buried about 3-4 feet into the ballast. See Appendix A. Additionally, the rail under the car was destroyed with several sections lying nearby. Some of the sections of rail had indications of fresh overstress fractures, characterized by a shiny, granular appearance with sharp edges around the freshly exposed metal.
