Derailment of BNSF Grain Train G-RYLRGT9-26A
and Subsequent Collision BNSF Oil Train U-FYNHAY4-05T

Casselton, North Dakota

Mechanical Group Factual

NTSB Accident Number: DCA-14-MR-004
Date of Accident: December 30, 2013
Time of Accident: 2:11p.m. (CDT¹)
Type of Trains: BNSF Freight Trains, G-RYLRGT9-26A & U-FYNHAY4-05T
Railroad Owner: BNSF Railroad
Train Operator: BNSF Railroad
Fatalities: 0
Injuries: 0
Location of Accident: Casselton, ND

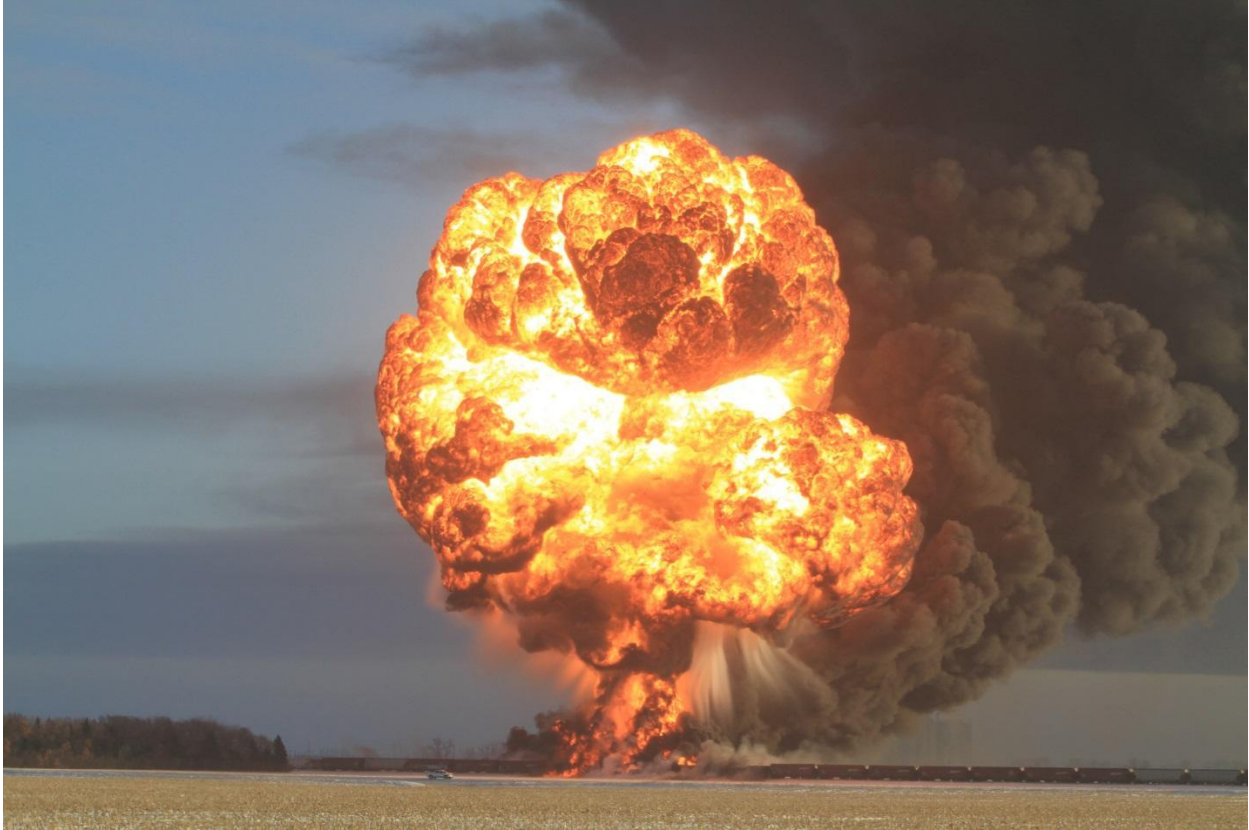
Figure 1-Photograph of Exploding Tank Cars as a Result of a Collision of Two BNSF Freight Trains

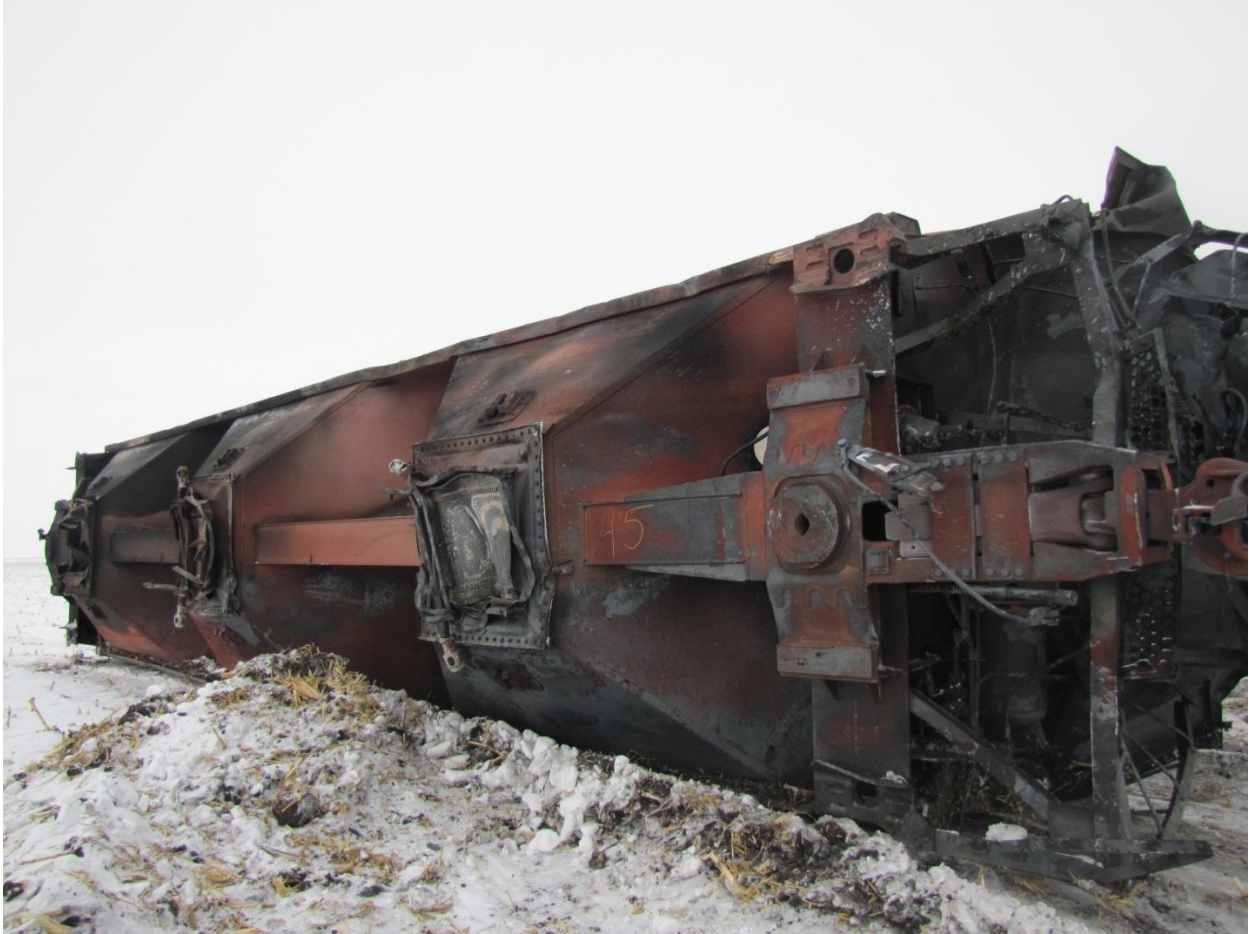
BNSF 486653, the 45th car was inspected after it was removed from the derailment area during emergency response actions. The car was assessed laying on its side. Investigators noted the damage present on the bottom of the car. All bottom outlet gates appeared to have been damaged as the result of raking or sliding across a surface. The damage originated at the A-End of the car, or the leading end of the car as it would have been oriented in the westbound train. See Figure 7.

Figure 6-BNSF 486653, the 45th Car With bottom Outlet Gate Damage

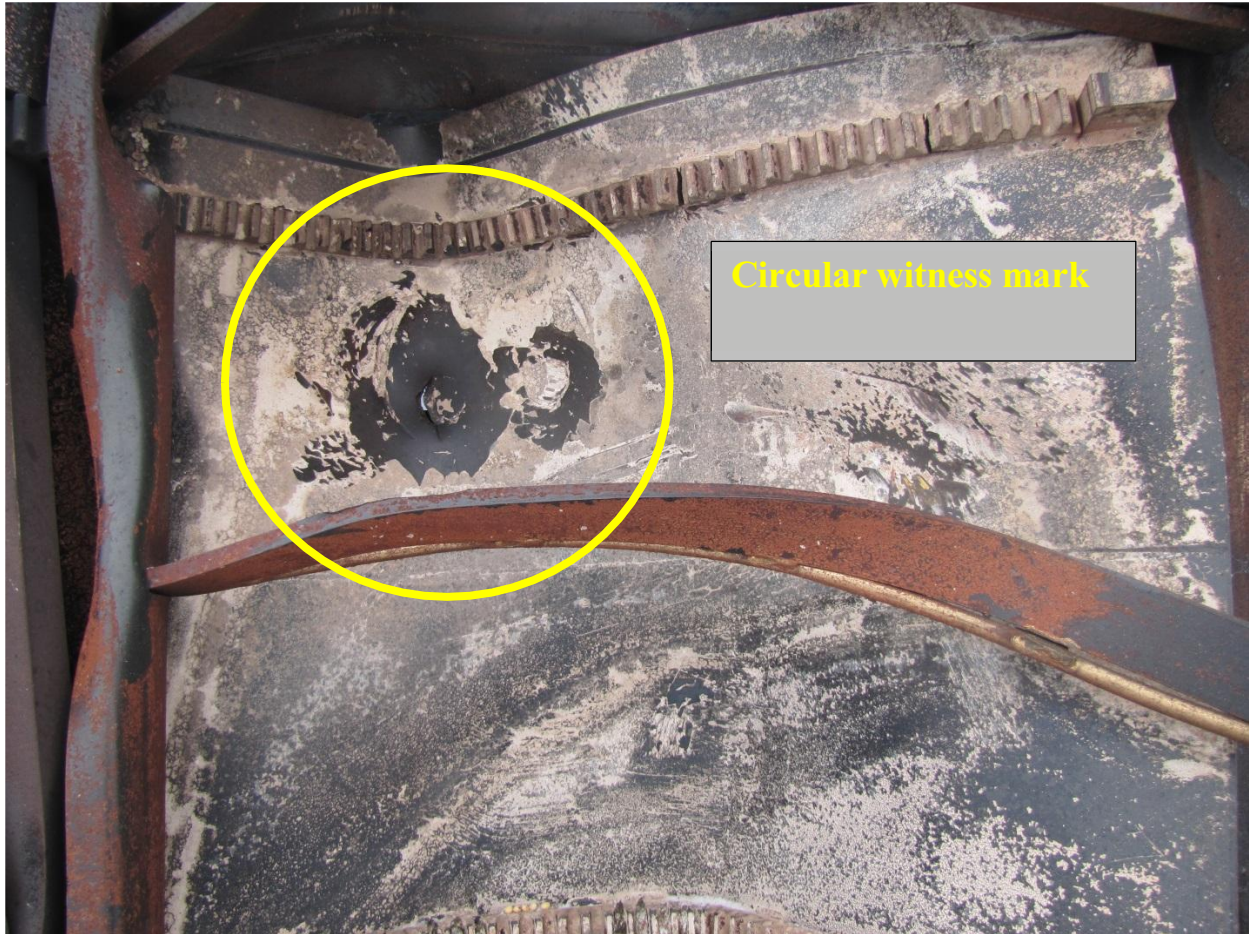
Investigators also identified a circular witness mark about 8-inches in diameter with smaller impressions located within the witness mark, triangularly displaced in an equidistant pattern. This impression was consistent with the end of an axle assembly. See Figure 8.

Figure 7-BNSF 486653, the 45th Car With 8-Inch Diameter Circular Witness Mark

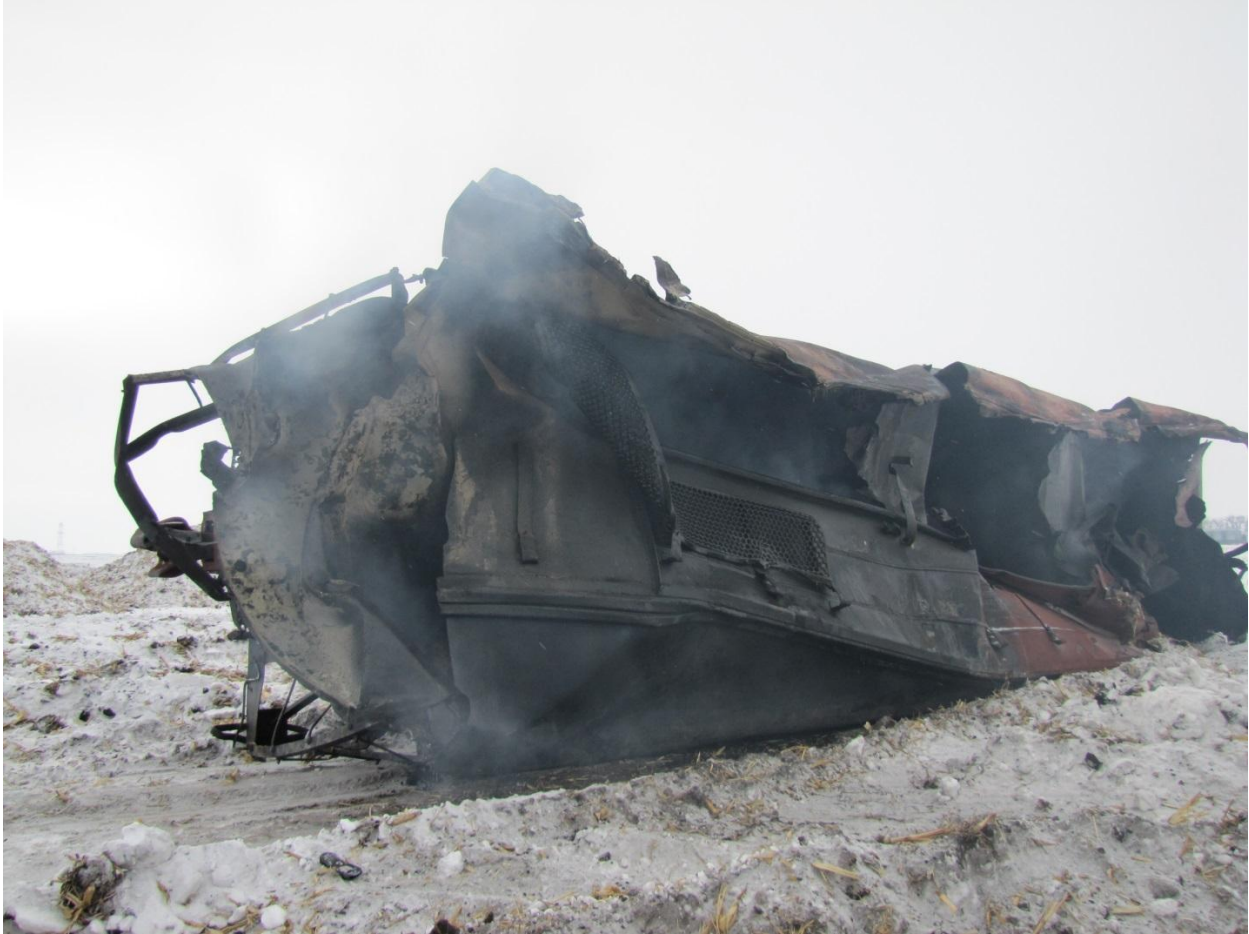
Investigators also observed damage to the A-End, or leading end of the car structure. The car structure and end sill sustained severe longitudinal load collision damage resulting in tearing and shearing of the structure. The top of the car also exhibited severe collision damage along its entire length. See figure 9.

Figure 8-Figure 6-BNSF 486653, the 45th Car Showing Car Damage on the Top of the Car

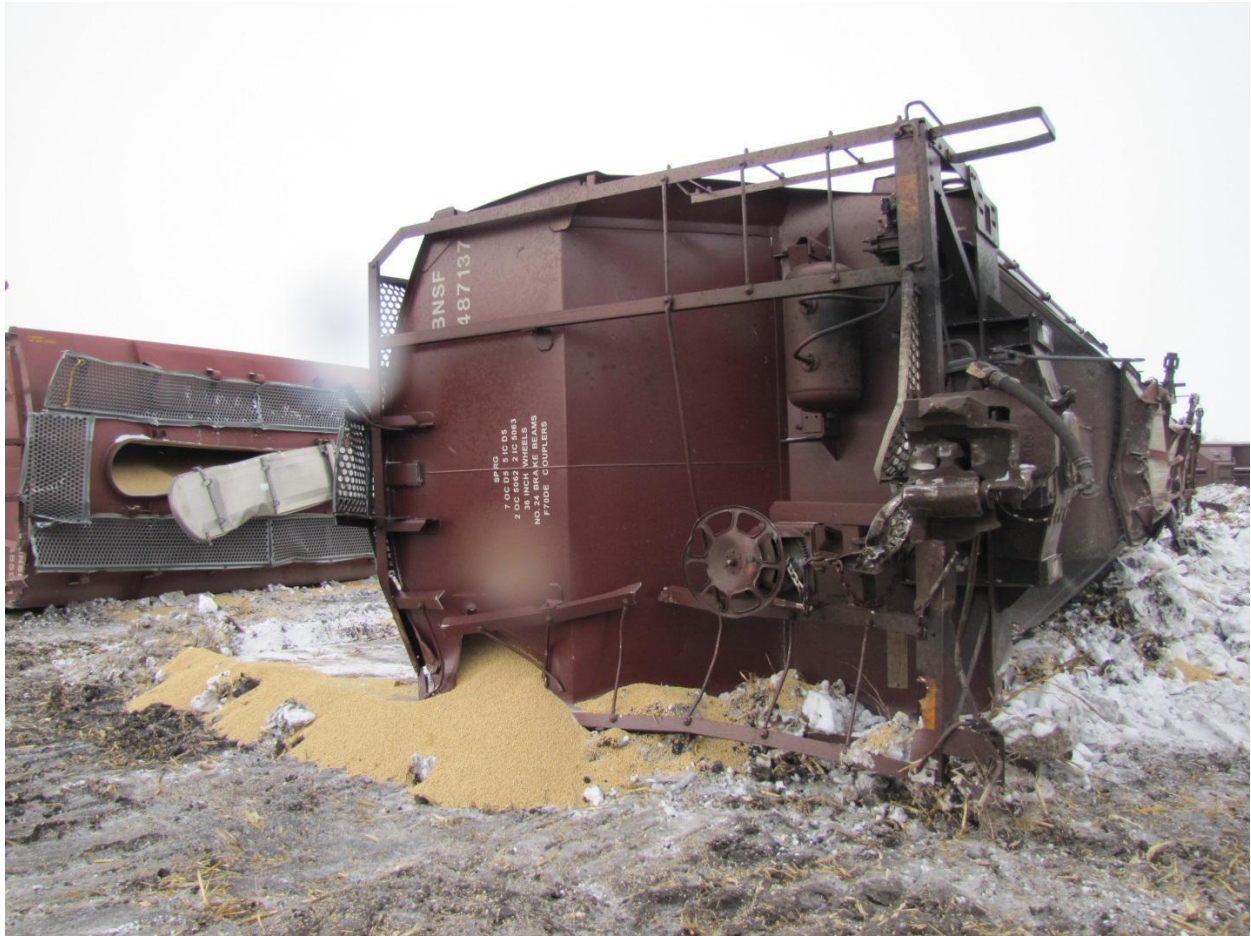
BNSF 487137, the 46th car was inspected after it was removed from the derailment area during emergency response actions. The car was assessed laying on its side. Investigators noted the B-End of the car was relatively undamaged, this was the leading end of the car in the westbound train. Investigators also noted the car's structure did not exhibit collision damage.

Figure 9-BNSF 487137, the 46th Car Showing the Leading End Relatively Undamaged

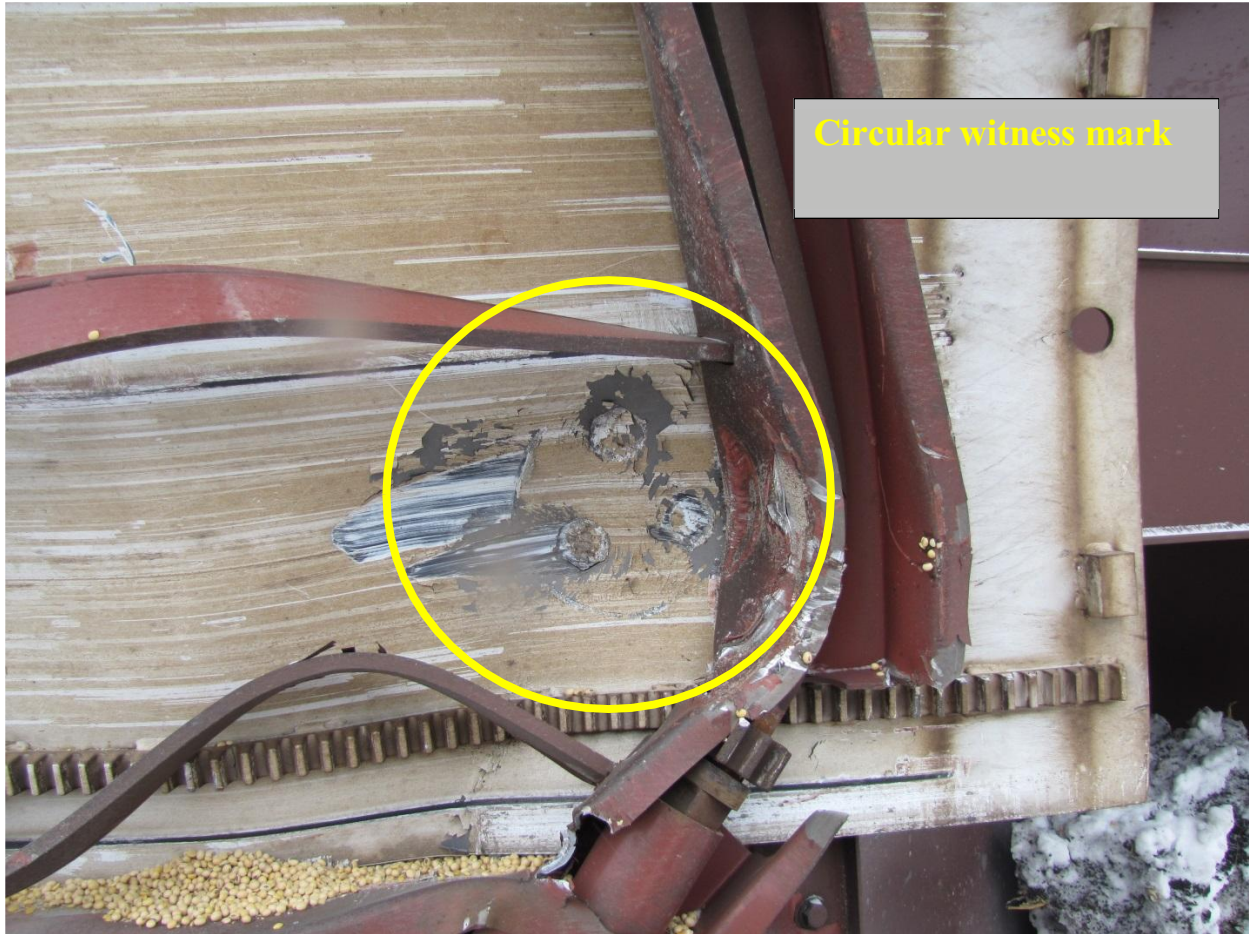
Investigators also noted two circular witness marks about 8-inches in diameter with smaller impressions located with the witness mark, triangularly displaced in an equidistant pattern. This impression was consistent with the end of an axle assembly. See Figure 11.

Figure 10- BNSF 487137, the 46th Car With 8-Inch Diameter Circular Witness Mark

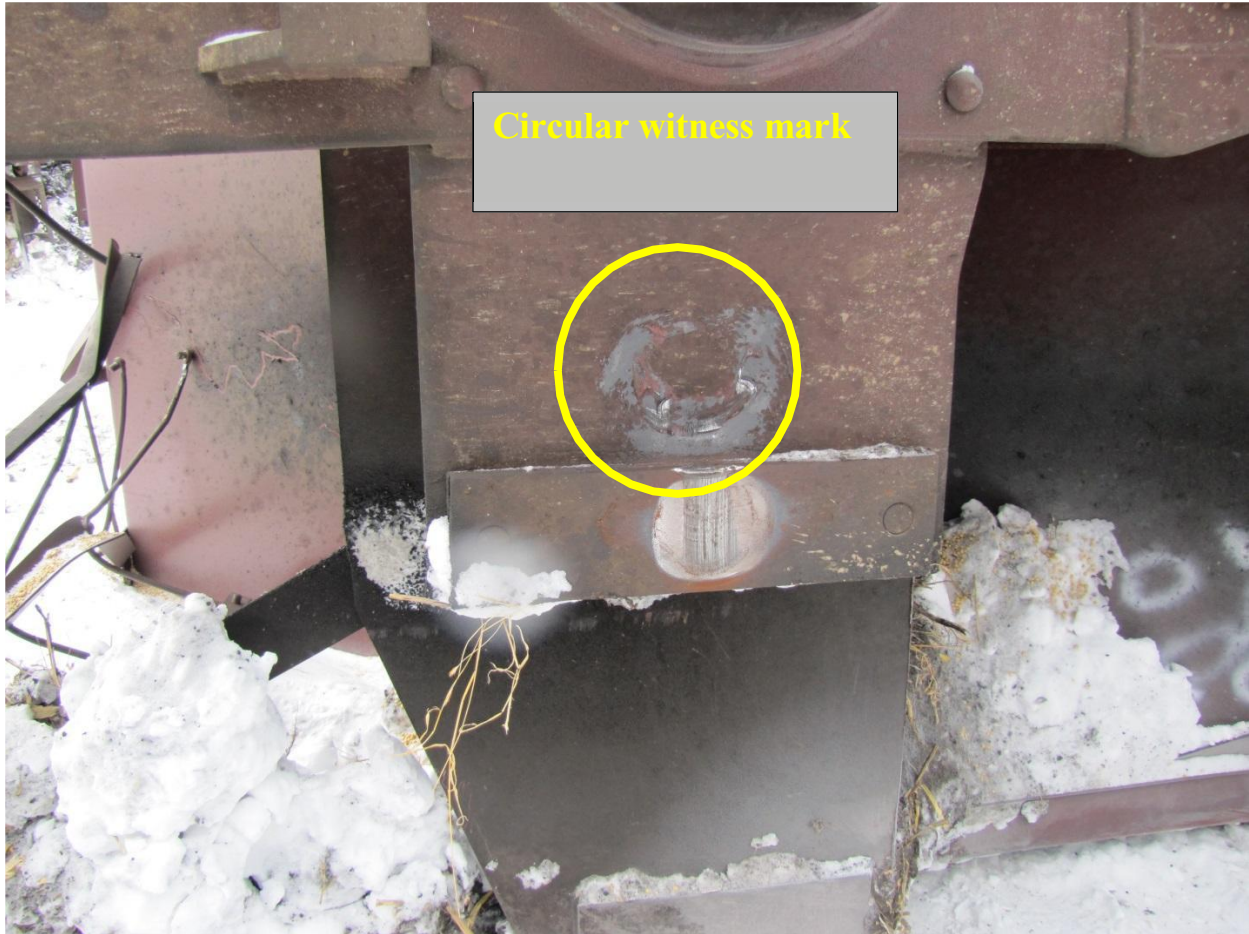
Investigators also observed one circular witness marks about 8-inches in diameter with smaller impressions located within the witness mark, triangularly displaced in an equidistant pattern. This impression was consistent with the end of an axle assembly. See Figure 12.

Figure 11-BNSF 480263, the 48th Car With 8-Inch Diameter Circular Witness Mark

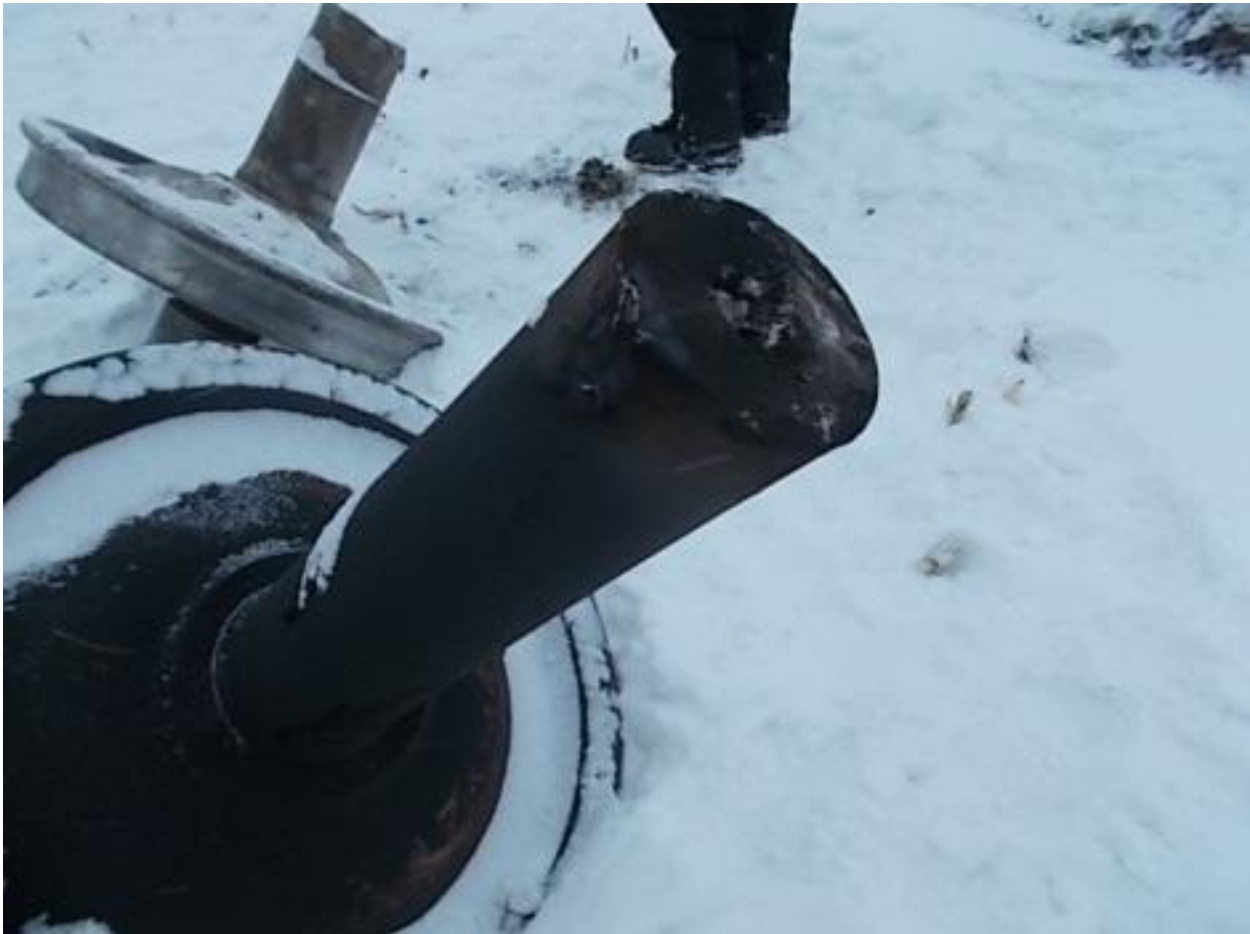
During examination of the wreckage, investigators located an axle assembly broken in half. The axle is an AAR Class K (6 ½ X 9) manufactured for freight car service. The wheels mounted to the axle were 36-inch, AAR 1-B, wide flange with a 1:20 taper for freight car service. Each wheel was stamped with a manufacturing date of January 2010. The axle serial number stamped on the end of the broken axle is SSD 1102 7A1 E 0912 F³. The serial number indicates it was made by Standard Steel, L.L.C. (SS), in November 2002.

The NTSB Materials Laboratory received the broken axle from the Casselton derailment; however, initial indications are consistent with the axle having fractured from a void defect⁴ along the longitudinal center axis of the axle.

Research of BNSF documentation and maintenance history showed that two derailed cars from the grain train had recent wheel axle assembly change outs in the past four years. Records show the axle bearings and wheels on the broken axle were installed, or remounted, in April 2010, at the BNSF Havelock Wheel Shop, in Havelock, Nebraska.

Figure 12-Broken Axle Assembly; Serial number SSD 1102 7A1 E 0912 F
