**National Transportation Safety Board
Office of Railroad, Pipeline and Hazardous Materials Investigations**

Derailment and Fire with Hazardous Materials Release
CSX Railroad
Lynchburg, Virginia
April 30, 2014

DCA 14 FR 008

Mechanical Group Factual Report

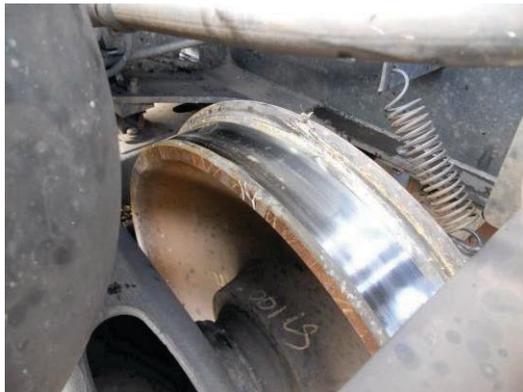
L1 Wheel

The 34th head car, CTCX 735749, was placed in the CSX Lynchburg yard for inspection. On May 2, 2014 the mechanical group inspected the car. Significant abrasion was observed on the L1 wheel. The abrasion was pronounced from the top of the flange to the tread. Metal had been extruded from the scour marks and was curled around the edges at multiple locations. There was no corresponding mark on the R1 wheel. The number one axle was the trailing axle on the trailing truck in the direction of travel at the time of the derailment. Members of the mechanical group had inspected the car on the night of the accident; the L2 wheel had displayed a light horizontal abrasion across the tread. The car had been moved about one mile to the Lynchburg yard at the time the full mechanical group inspected it on May 2nd. Only minor evidence remained on the L2 tread at that time.

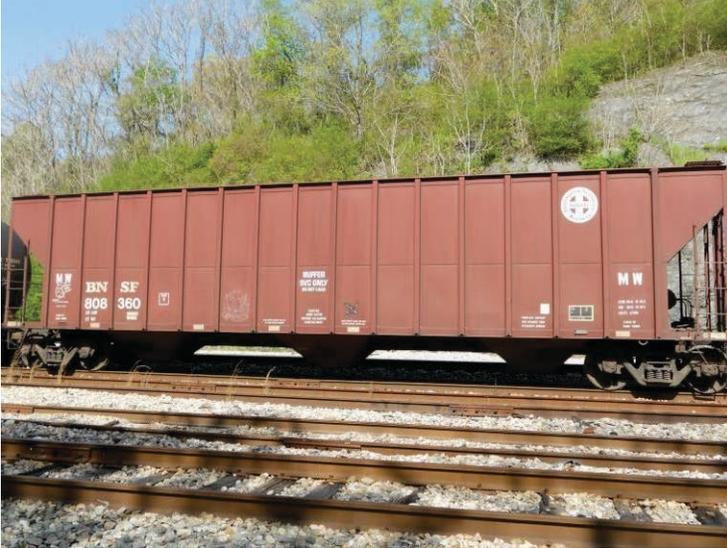
BNSF 808360

“BNSF 430560”. The B-end truck side frame was cast by ASF in January 1967; the A-end side frame was cast by Ride Control in August 1968. The car was stenciled on both sides with white paint “BUFFER SVC ONLY Do Not Load”.
