Collision of Union Pacific Trains AMNML 07 and ALDAS 06

Texarkana, TX

Mechanical Group Factual Report

Accident # DCA15FR014

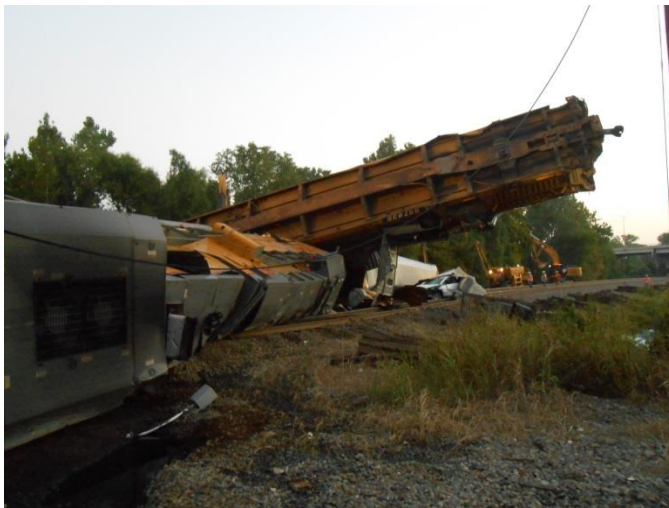
Figure 1 Photo at accident site of damaged locomotives and auto carriers.
