National Transportation Safety Board  
Office of Railroad, Pipeline and Hazardous Materials Investigations  
Washington, D.C. 20594

Derailment of Amtrak Passenger Train 4(12)  
Cimarron, Kansas  
March 14, 2016  
Mechanical Group Factual Report

NTSB Accident Number: DCA16MR004  
Date of Accident: March 14, 2016  
Time of Accident: 12:02 a.m. (CDT)  
Type of Trains: Passenger  
Railroad Owner: BNSF  
Train Operator: Amtrak  
Fatalities: 0  
Injuries: 10-33  
Location of Accident: Cimarron, KS

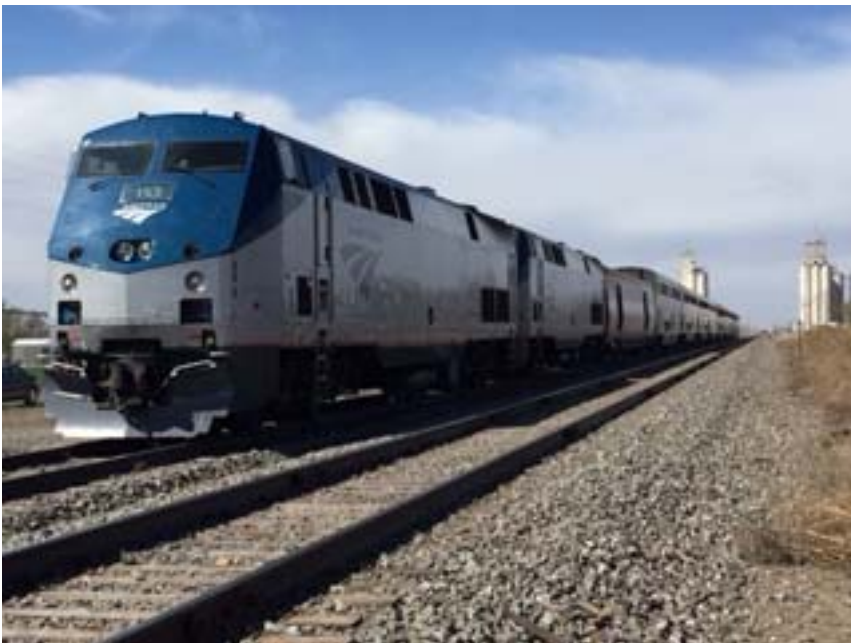
**Figure 1 Photo Amtrak Train 4(12) at MP 372.9 of the Lajunta Subdivision staged for inspection.**

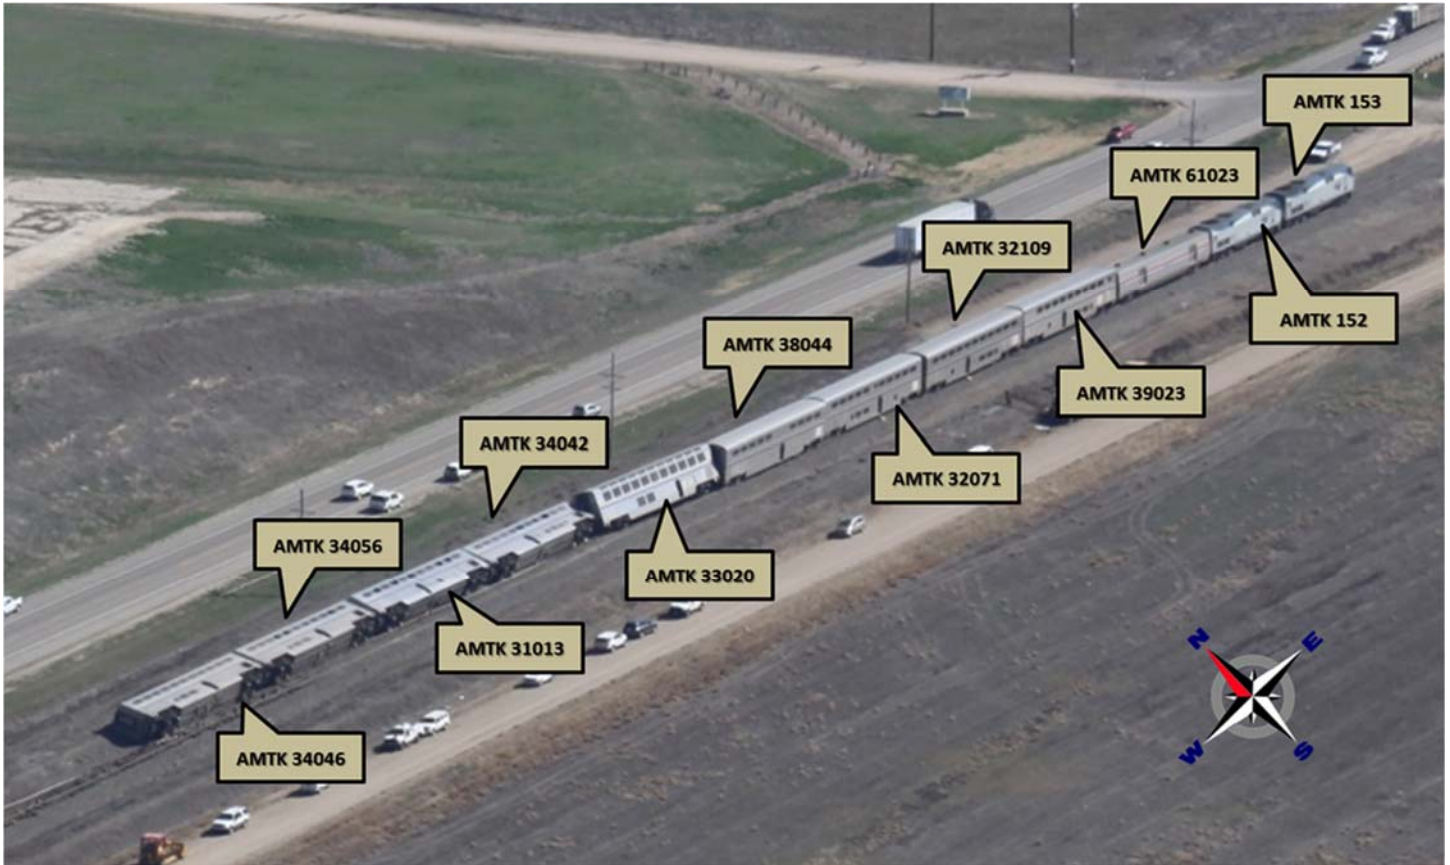
Figure 2-Aerial photograph of derailed Amtrak number 4. (Photo State of Kansas Highway Patrol)
