National Transportation Safety Board

BNSF Railway
Roadway Worker Fatalities
Edgemont, South Dakota
January 17, 2017

NTSB Accident Number DCA17FR004

Mechanical Group Factual Report
Joey Rhine, Mechanical Group Chairman

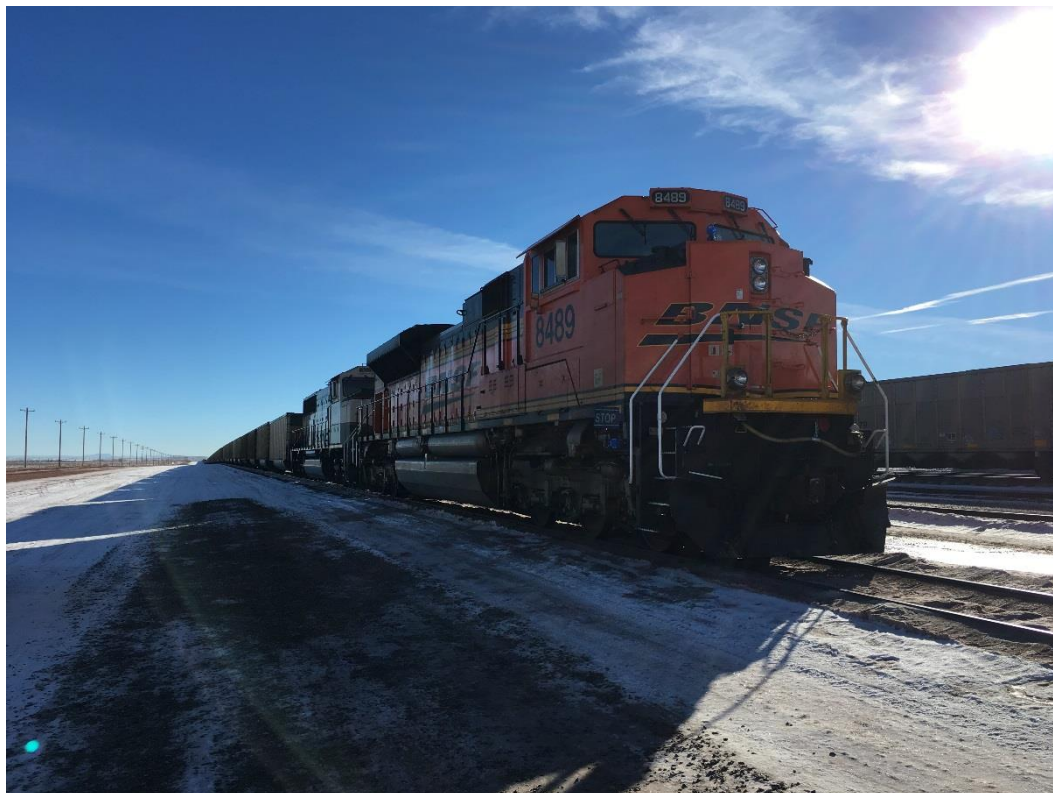
Figure 1. Train E DOLEBM0 01E staged at Donkey Creek for the Class I Air Brake Test.

On January 19, 2017, the mechanical group met at the Donkey Creek Yard and conducted a Class I air brake test on train E DOLEBM0 01E. (See Figure 1.) The air brakes applied and released without exception and the brake components showed normal wear patterns. The mechanical group noted eleven FRA defects during its inspection. Ten cars had one brake shoe worn to the backing plate, and one car had insufficient piston travel.

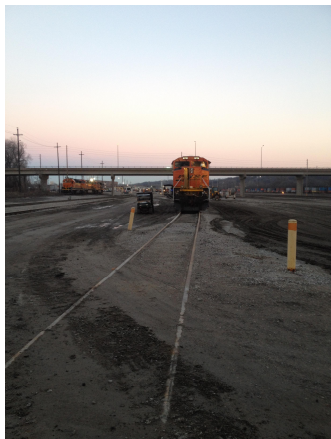
Photo #1 Locomotive BNSF 8489
Positioned at test location facing west.
Photo taken from sample location

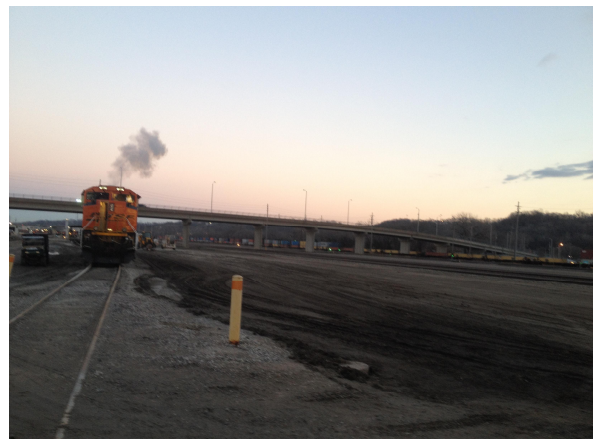
Photo #2 Locomotive BNSF 8489
No reflective obstructions 200ft to the
south

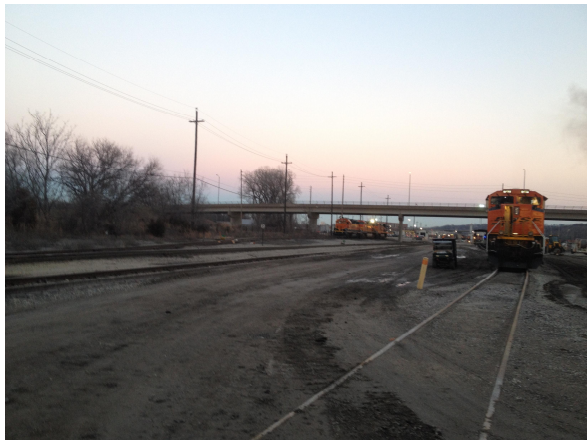
Photo #3 Locomotive BNSF 8489
No reflective obstructions 200 ft to the
north

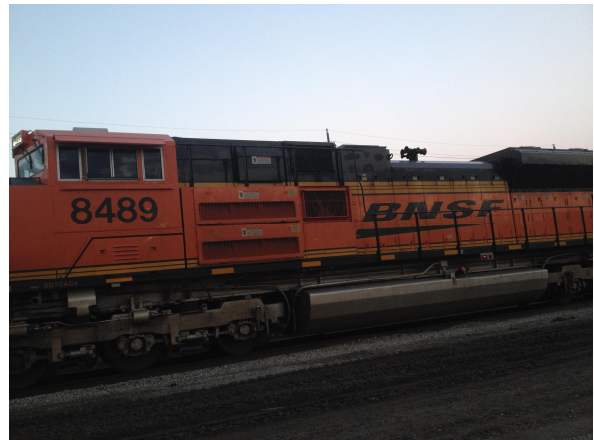
Photo #4 Locomotive BNSF 8489
Side view of locomotive indicating horn
position mid-vehicle
