National Transportation Safety Board

Collision of Southeastern Pennsylvania Transit Authority
Trolley Car 9085 with Trolley Car 9101
At 38th Street and Lancaster Avenue in
Philadelphia, Pennsylvania
January 4, 2017

Mechanical Group Factual Report
Mike Hiller, Mechanical Group Chairman

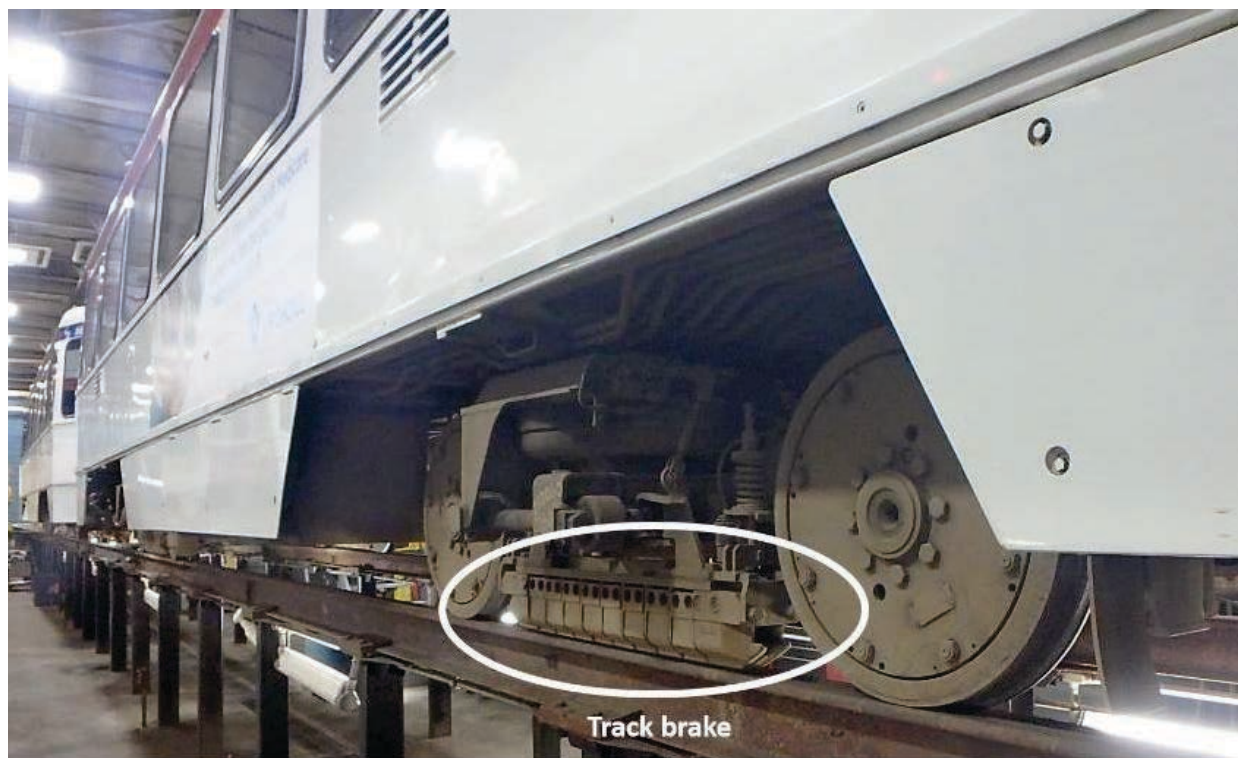
The nominal contact force of each track brake is approximately 16,000 lbs. Investigators observed the spring suspension linkage, wiring, transfer members and friction elements to be intact and within tolerance. (See figure 4.)

Figure 4. SEPTA LRV 9085 truck assembly showing track brake (circled)

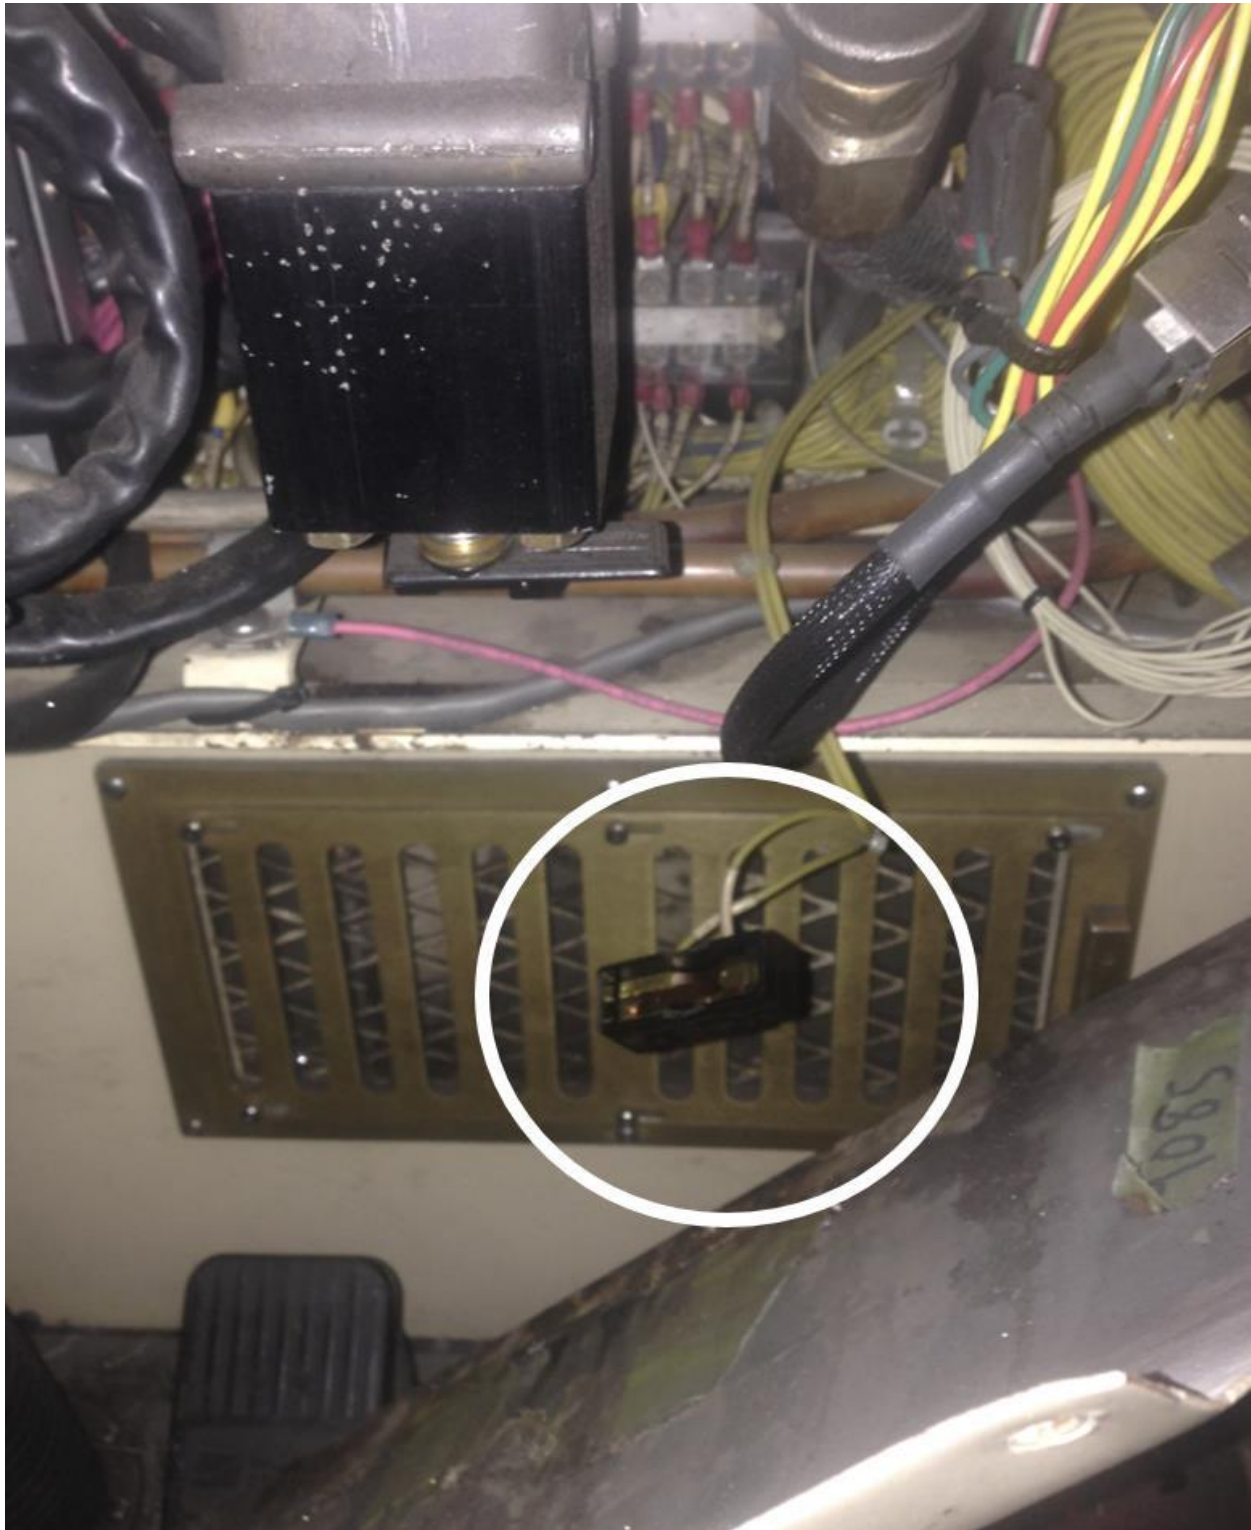
Investigators observed that the track brake did not function during tests 3 and 4 when using the emergency brake push-button. After post-accident brake performance testing, investigators returned LRV 9085 to the Elmwood maintenance facility to troubleshoot the inoperative track brake. Investigators removed the inspection panel under the operator console and found a broken electrical switch no longer attached to the emergency brake push-button.⁷ (See figure 5.)

Figure 5. Broken emergency brake push-button electrical switch

The electric switch is a type of plunger switch with a threaded portion inserted in the end of the emergency stop push-button. (See figure 6.) When the emergency stop push-button is depressed, the plunger on the electrical switch is depressed thus activating the electromagnetic track brake. The track brake was not functional for brake test numbers 3 and 4 because the switch was damaged.

Qualified SEPTA technicians installed a new electrical switch into the emergency stop push-button and function tested the track brake. The track brake operated as designed. (See figure 7.)

In January 2017, SEPTA completed a fleet inspection of all LRVs equipped with an emergency brake push-button to ensure the electrical switches were unbroken, correctly installed and performed as designed. On February 3, 2017, SEPTA developed an engineering change notice for the electrical switch detailing an installation procedure along with the addition of a support bracket to mitigate future switch failure potential. A copy of their procedure appears as attachment 3 in the NTSB Docket, DCA17FR003.

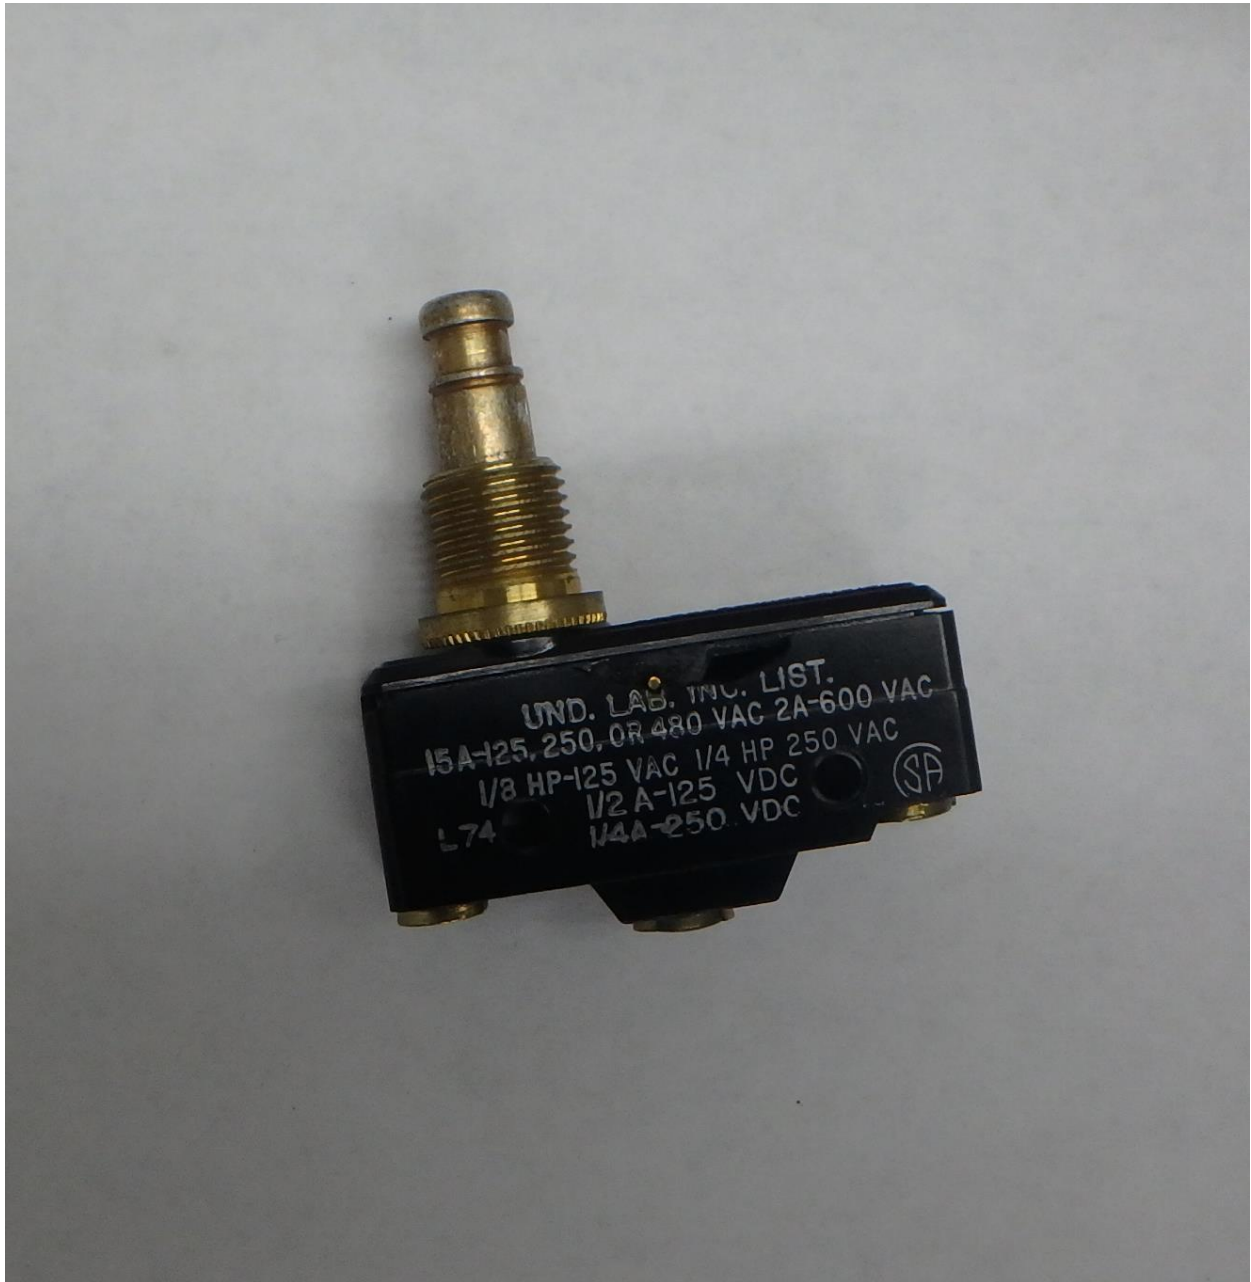
Figure 6. Exemplar emergency brake push-button electrical switch

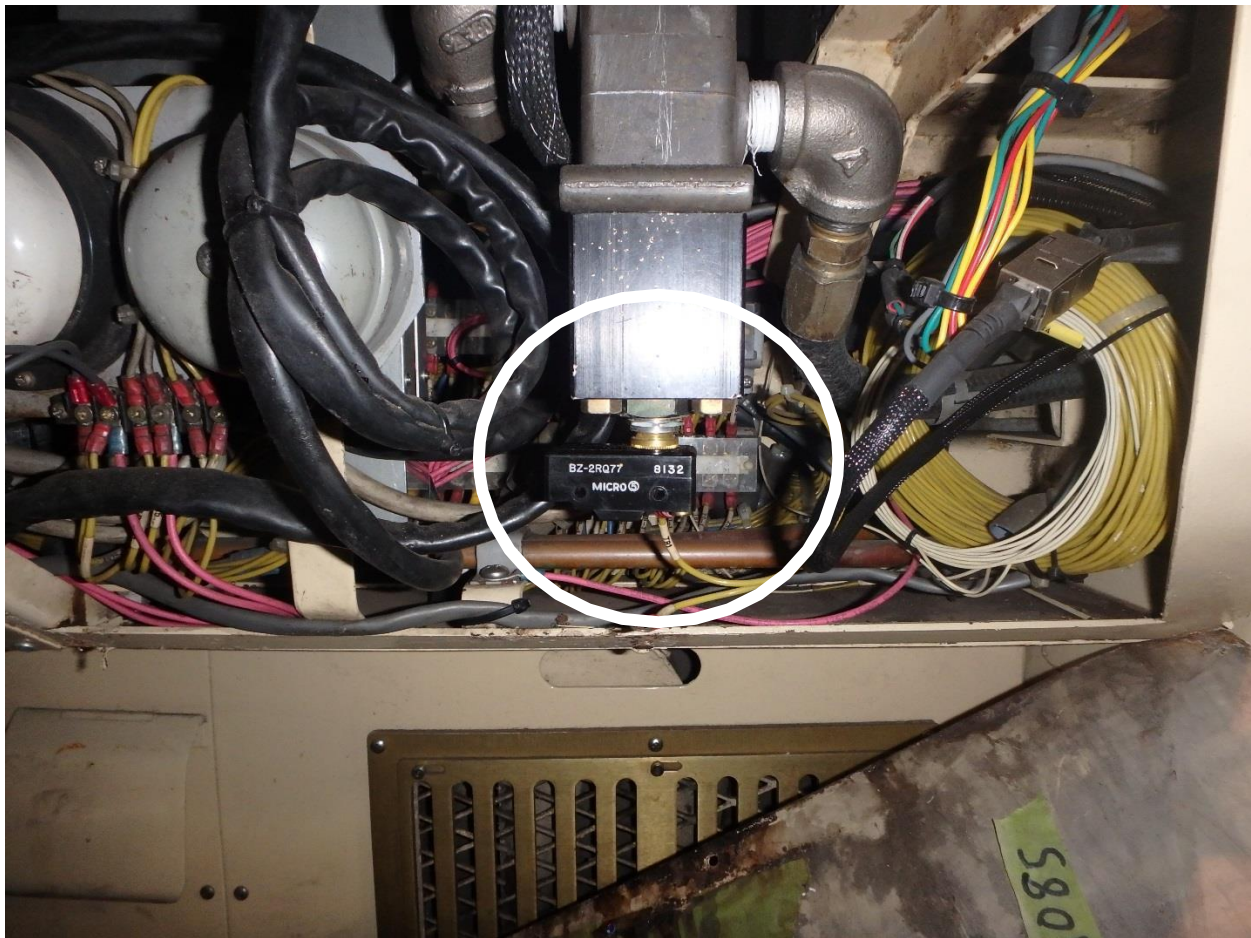
Figure 7. Emergency brake push-button electrical switch installed
