National Transportation Safety Board

Long Island Rail Road Passenger Train 2817 Derailment
Brooklyn, New York
Atlantic Terminal
January 4, 2017

NTSB Accident Number DCA17FR002

Mechanical Group Factual Report
Joey Rhine, Mechanical Group Chairman

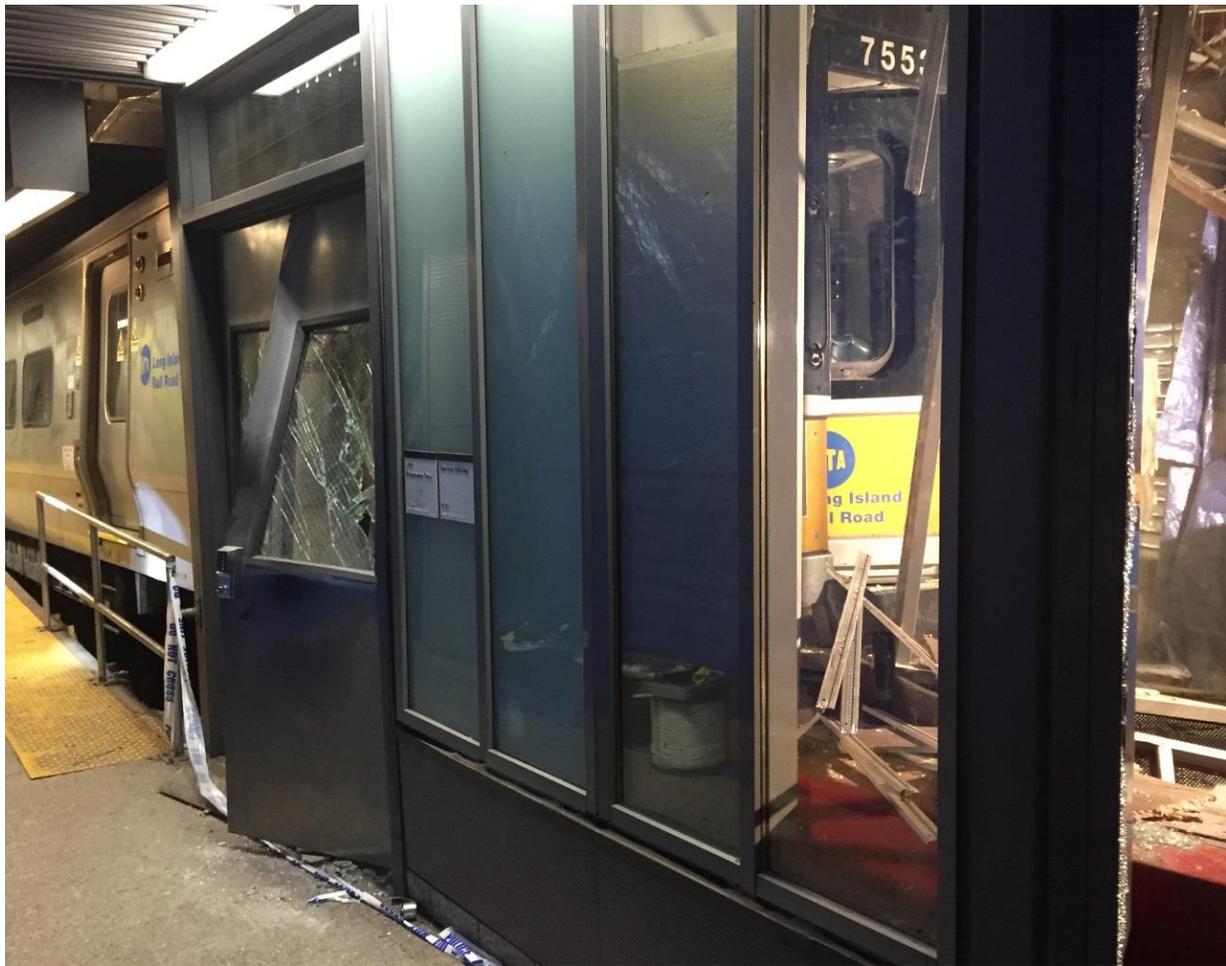
Figure 1. Lead car 7533 at final resting point.

Cars 7067, 7073, and 7074 remained in the upright position and did not derail. The lead car 7553 sustained the majority of the damage. It derailed upright with the front end of the car resting on the end platform. The front end truck became disconnected from the carbody during the collision and the force shoved it about six feet rearward. The no. 4 axle also derailed.
