Derailment & Hazardous Materials Release with Fire of Train UEGKOT-09

Graettinger, Iowa

Mechanical Group Factual Report

NTSB Accident Number: DCA17MR007  
Date of Accident: March 10, 2017  
Time of Accident: 12:50 a.m. (CDT)  
Type of Trains: UEGKOT-09 (Unit Train)  
Railroad Owner: UP  
Train Operator: UP  
Fatalities: 0  
Injuries: 0  
Location of Accident: Graettinger, Iowa

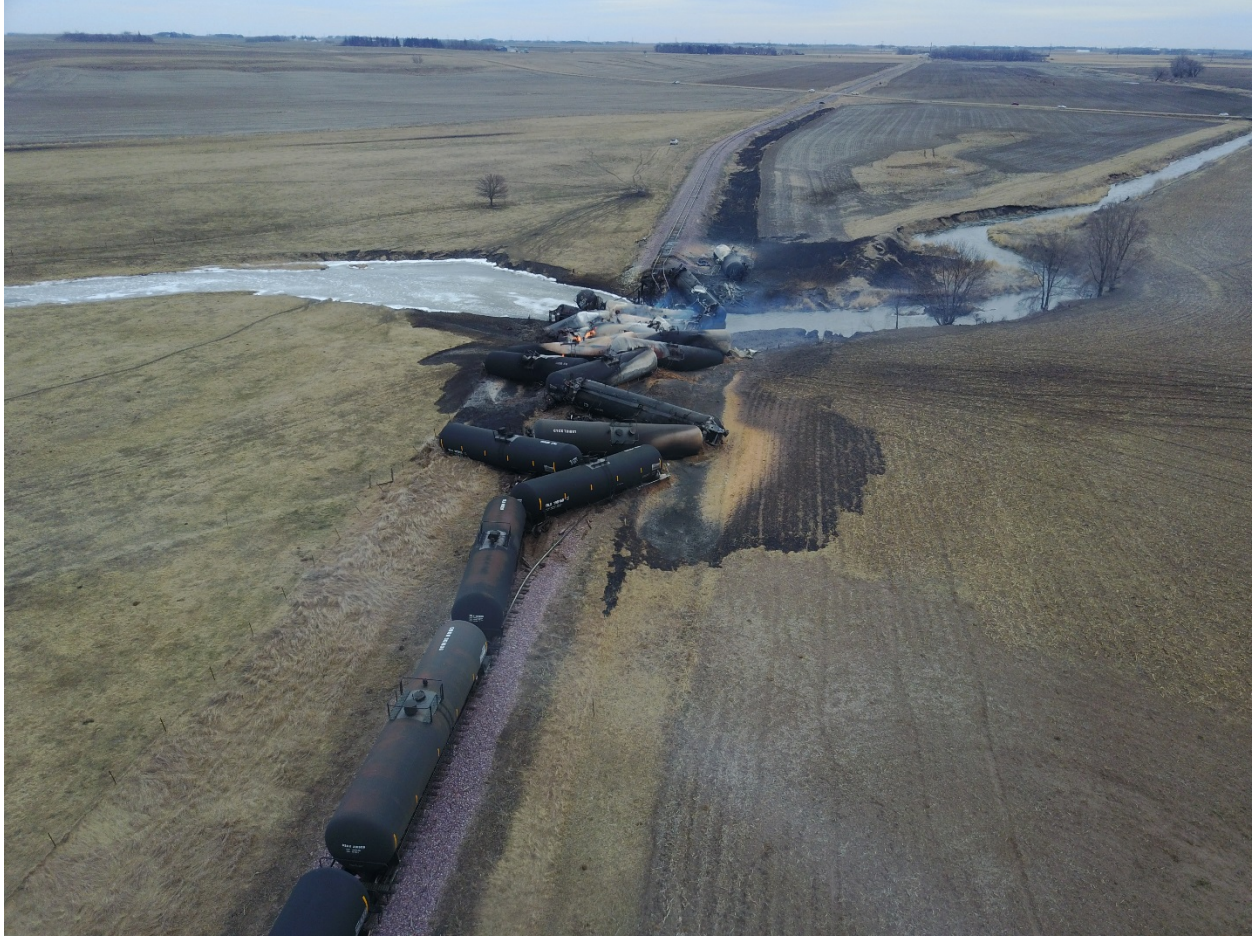
Figure 1-Aerial Photograph of accident location

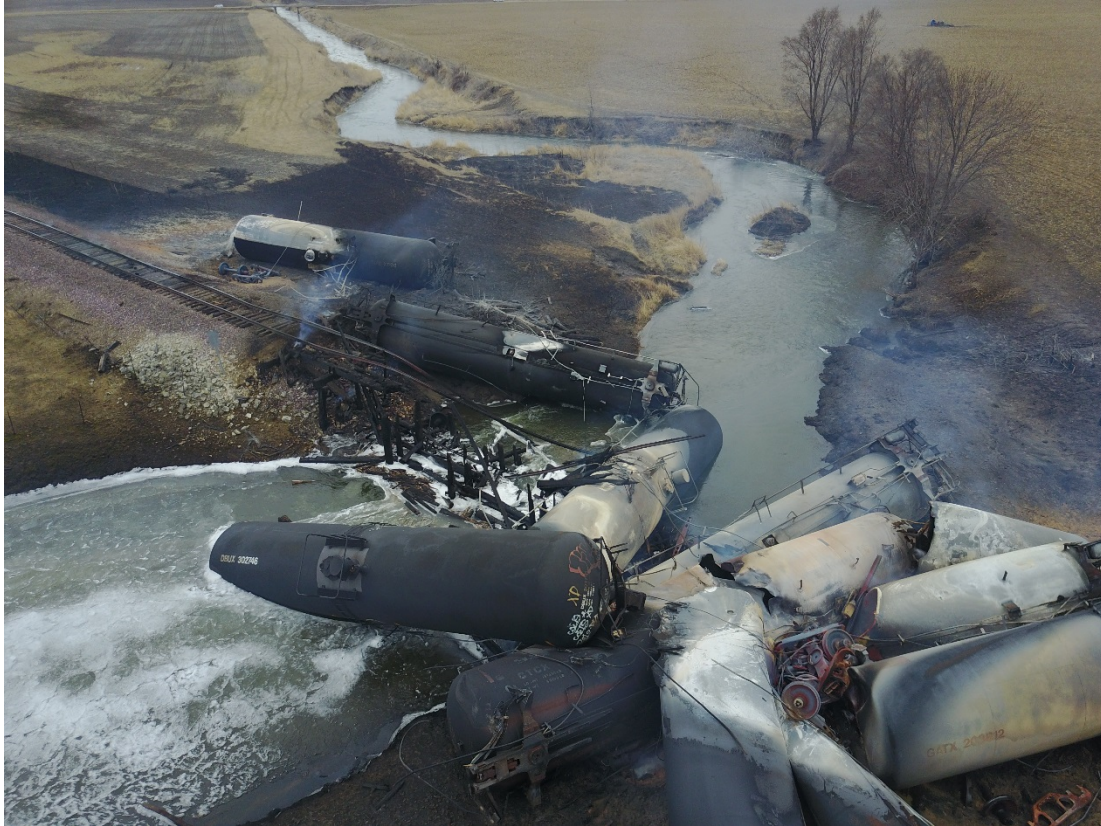
As a result of the accident the 21<sup>st</sup> through the 40<sup>th</sup> cars in the train were derailed (see summary below):

Figure 2-Aerial photograph of the derailed tank cars

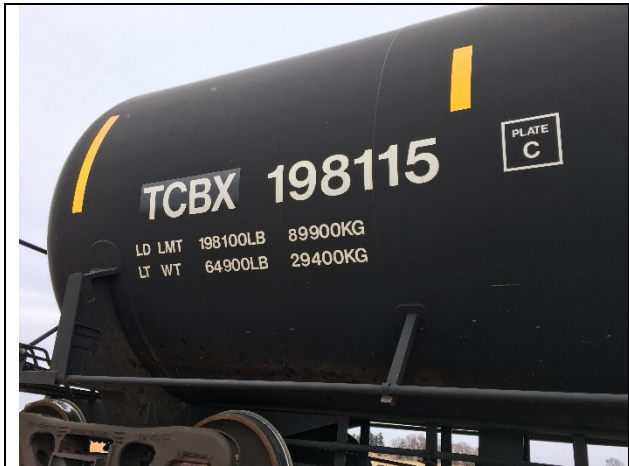
The series of photographs below (figures 3 through 6) document the location and position of remarkable horizontal damage on a southside wheel tread (on TCBX 198115) that traveled over the point-of-derailment (POD). In the photographs, note that there are two marks on the tread.

Figure 3-TCBX 198115 (Photo FRA)

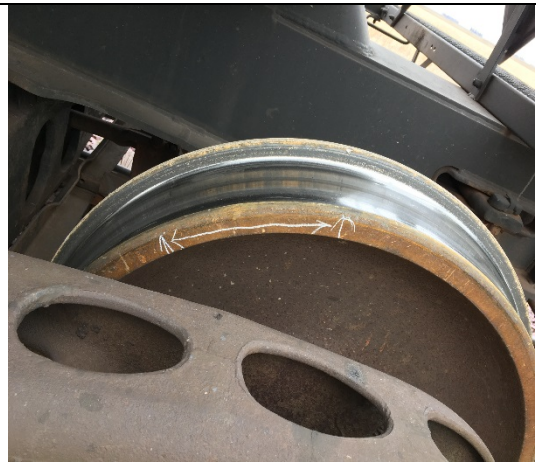
Figure 4-TCBX 198115 wheel damage. (Photo FRA)

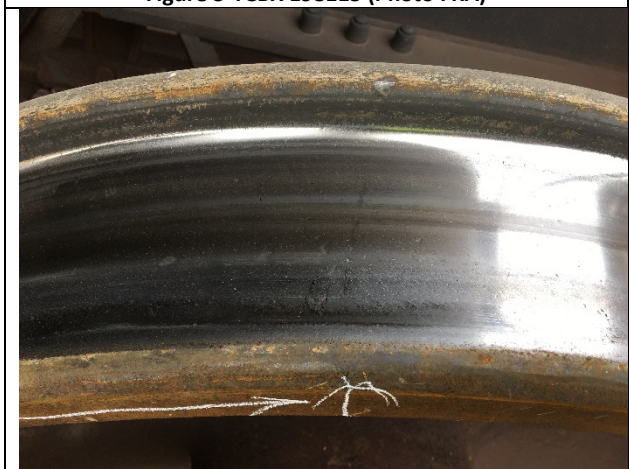
Figure 5- TCBX 198115 wheel damage (Photo FRA)

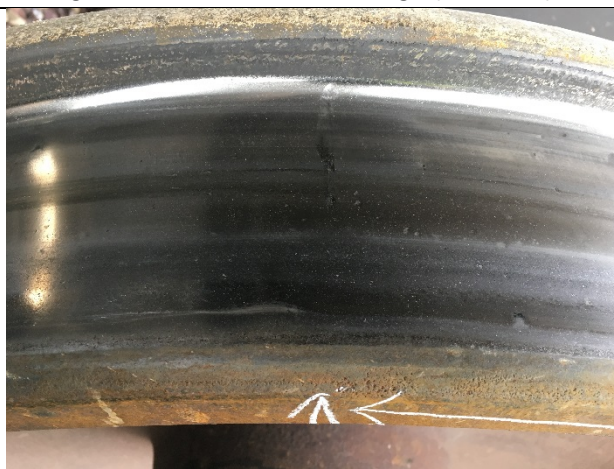
Figure 6- TCBX 198115 wheel damage (Photo FRA)
