**MECHANICAL GROUP CHAIRMAN'S
FACTUAL REPORT**

**Grade Crossing Accident
Valhalla, New York**

**DCA15MR006
(6 Pages)**

**NATIONAL TRANSPORTATION SAFETY BOARD
OFFICE OF RAILWAY SAFETY
WASHINGTON, D.C. 20594**

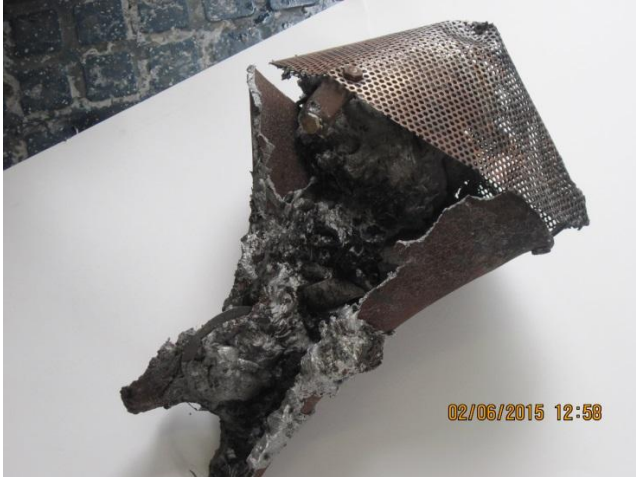
On February 6, 2015, the horn from car 4333 was recovered. Upon inspection of the horn, it was deemed untestable due to the diaphragms being destroyed in the fire. Only the bell portion of one of the chimes remained.

Figure 1 Horn from lead car 4333 destroyed in the fire.
